Interim Reclamation and Stormwater Inspection

Operator: VERDAD RESOURCES LLC - 10651

Location ID: 433228

Inspection Document #: 708200544

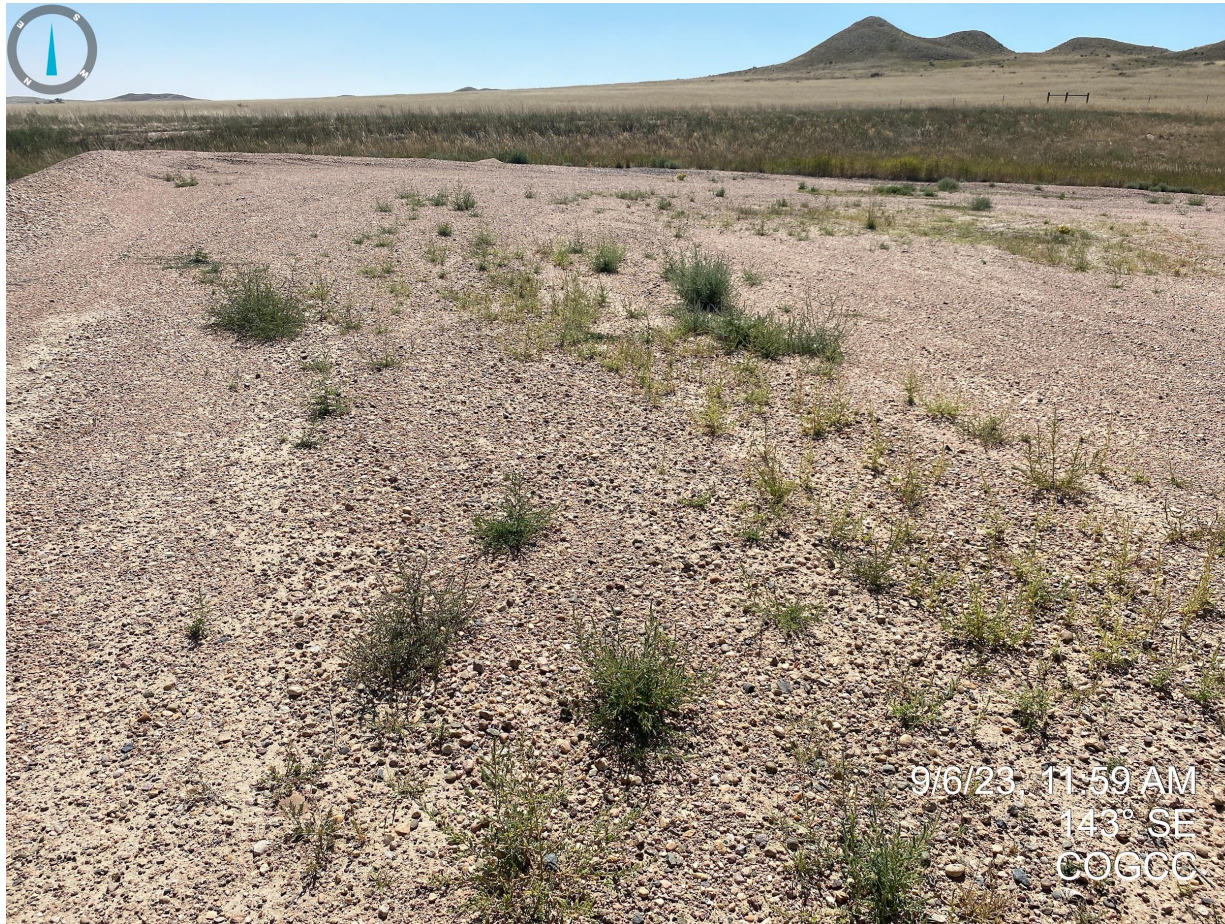
Photo 1. Taken from the northern portion of the location. Undesirable vegetation (e.g. russian thistle and kochia) observed growing on the production areas.

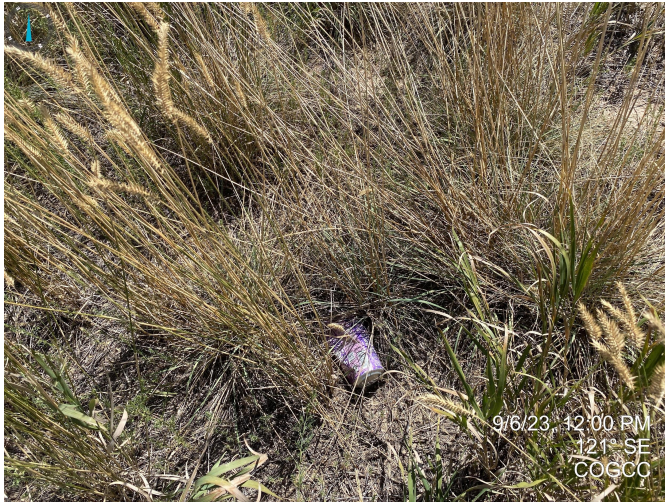
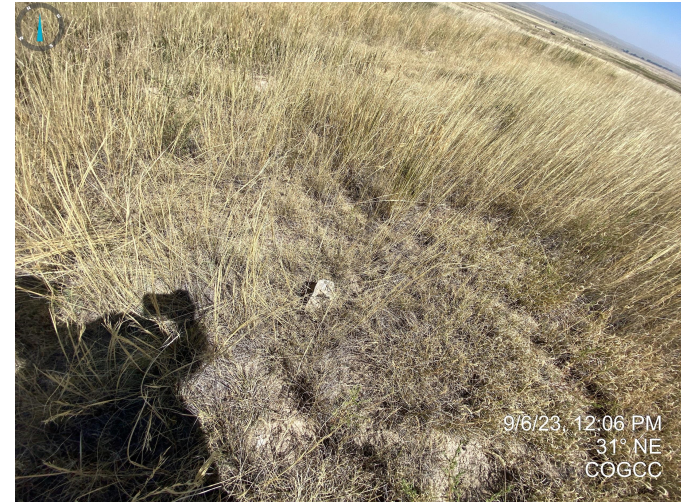
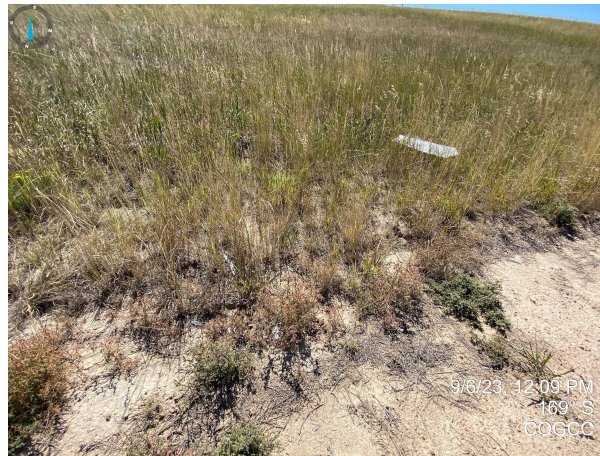
Photos 2-4. Trash observed throughout the location will need to be removed. The Operator shall self inspect the location to identify any and all trash..

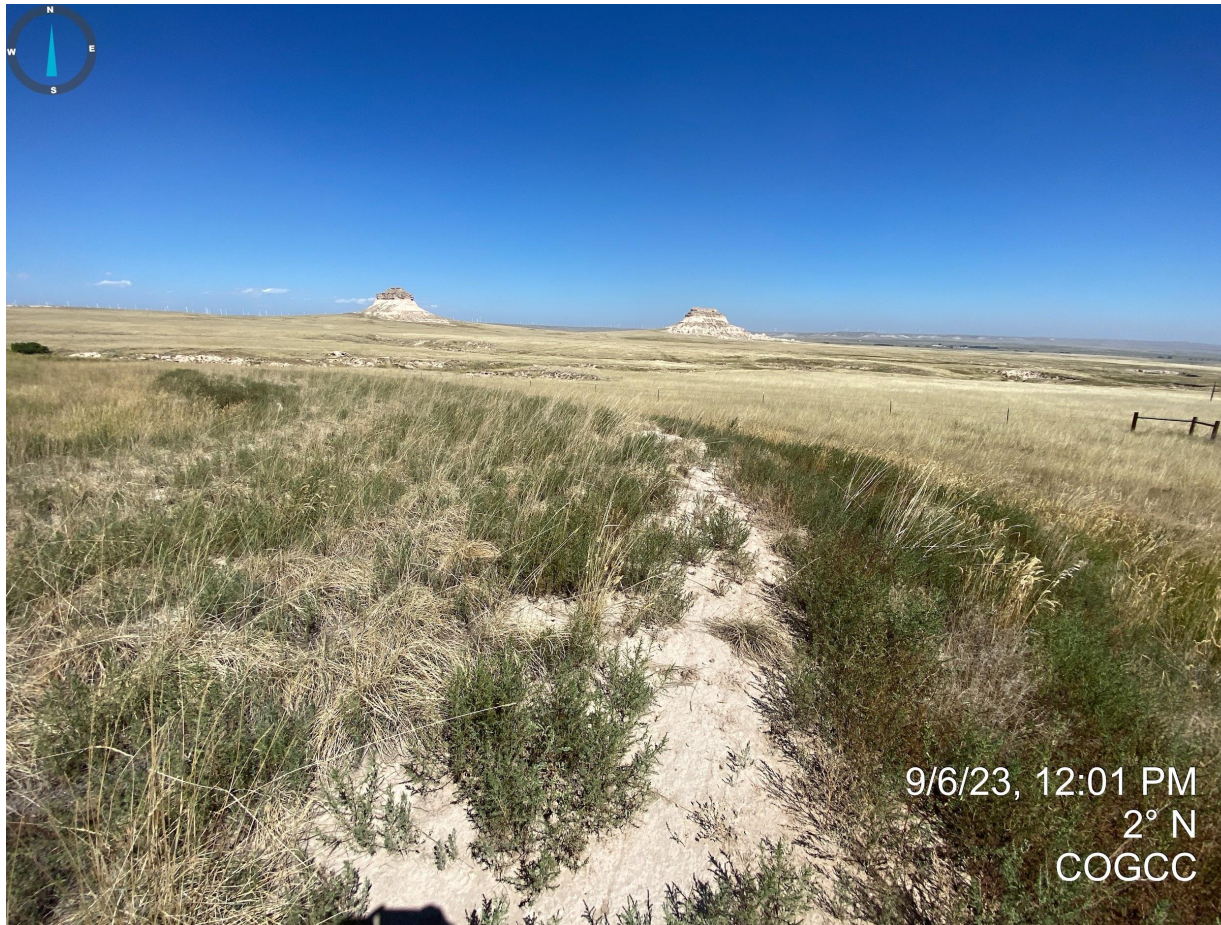
Photo 5. Taken from the northeast corner. Interim areas do not appear to be progressing towards Rule 1003 standards and regulations with evidence of undesirable vegetation (e.g. russian thistle and kochia) and areas of non-uniform vegetation cover resulting in bare soils.

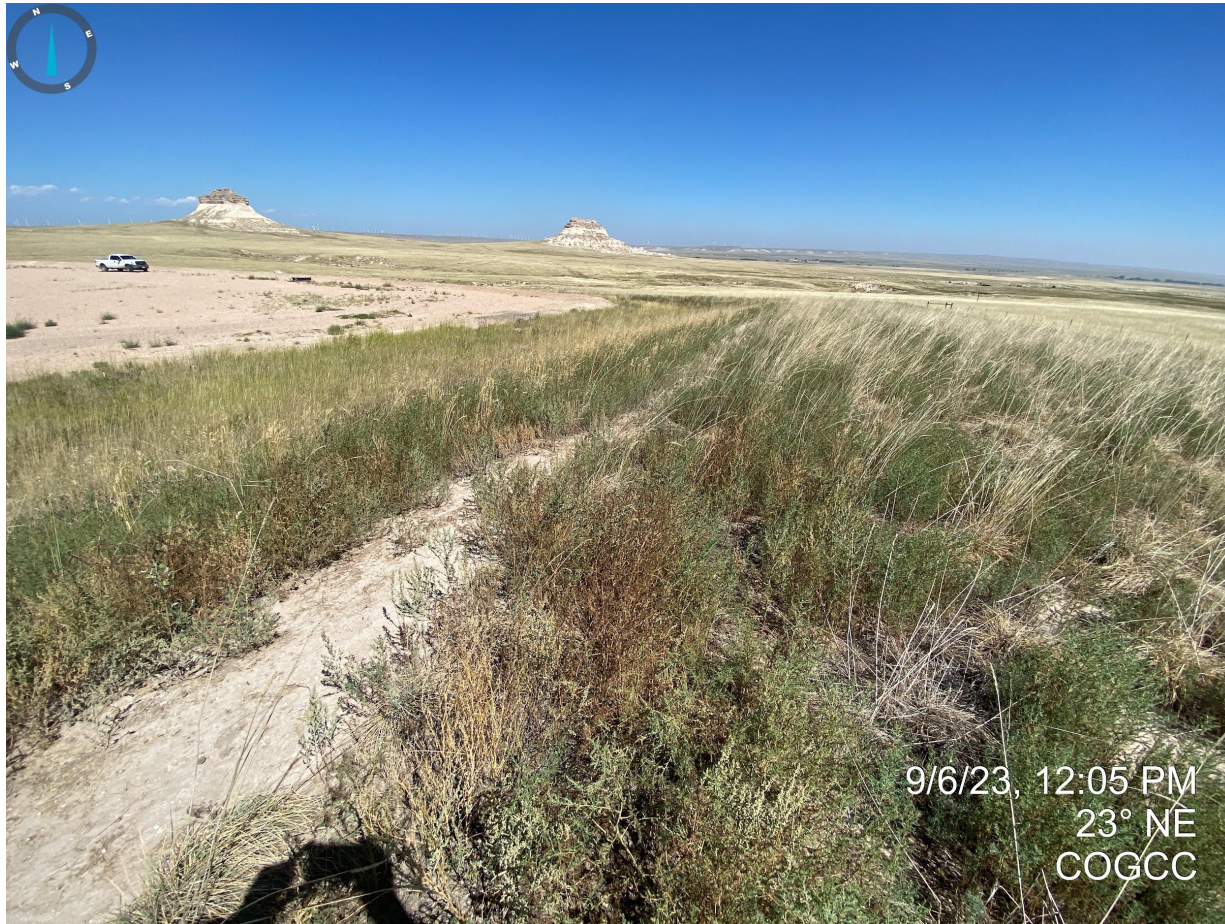
Photo 6. Taken from the east side of location; see comments in Photo 5.

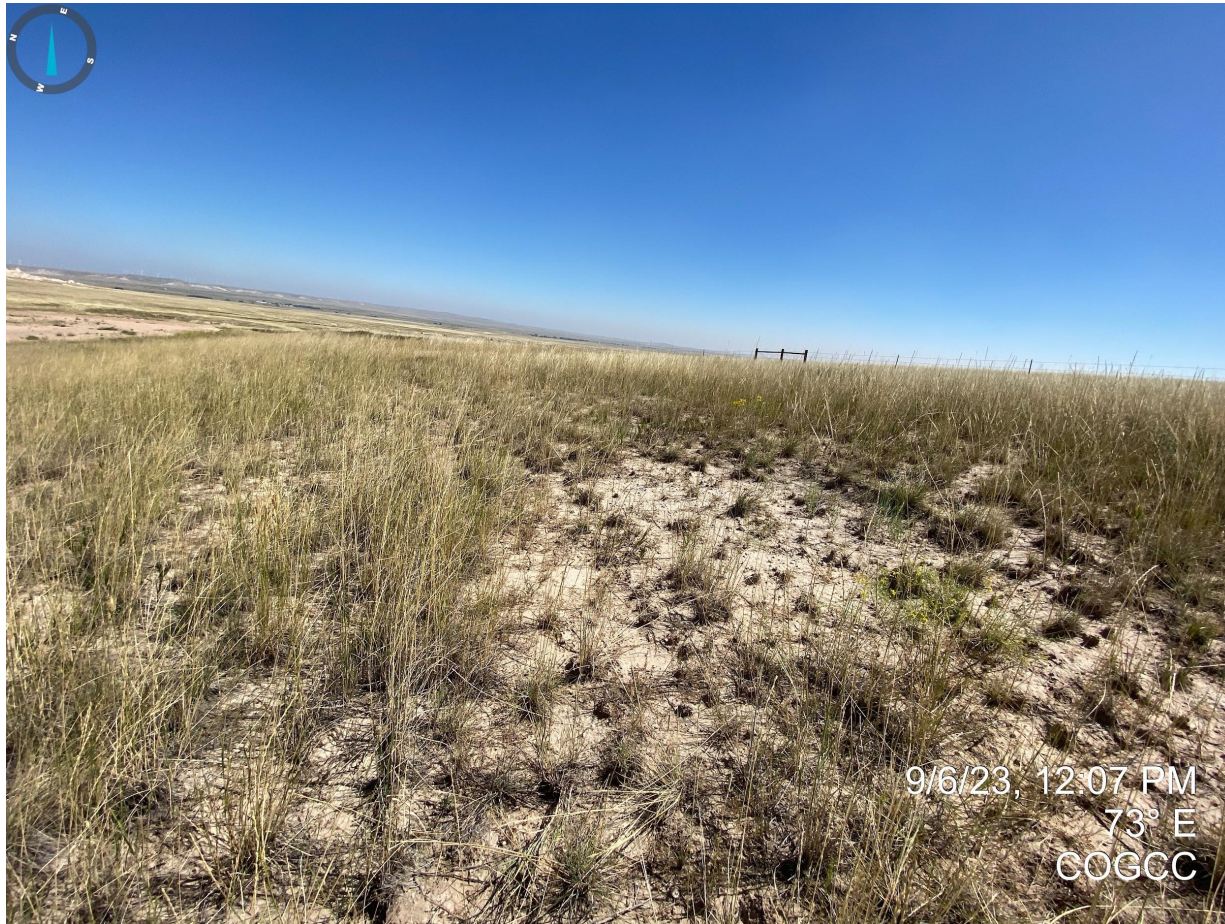
Photo 7. Taken from the east side of location; see comments in Photo 5.

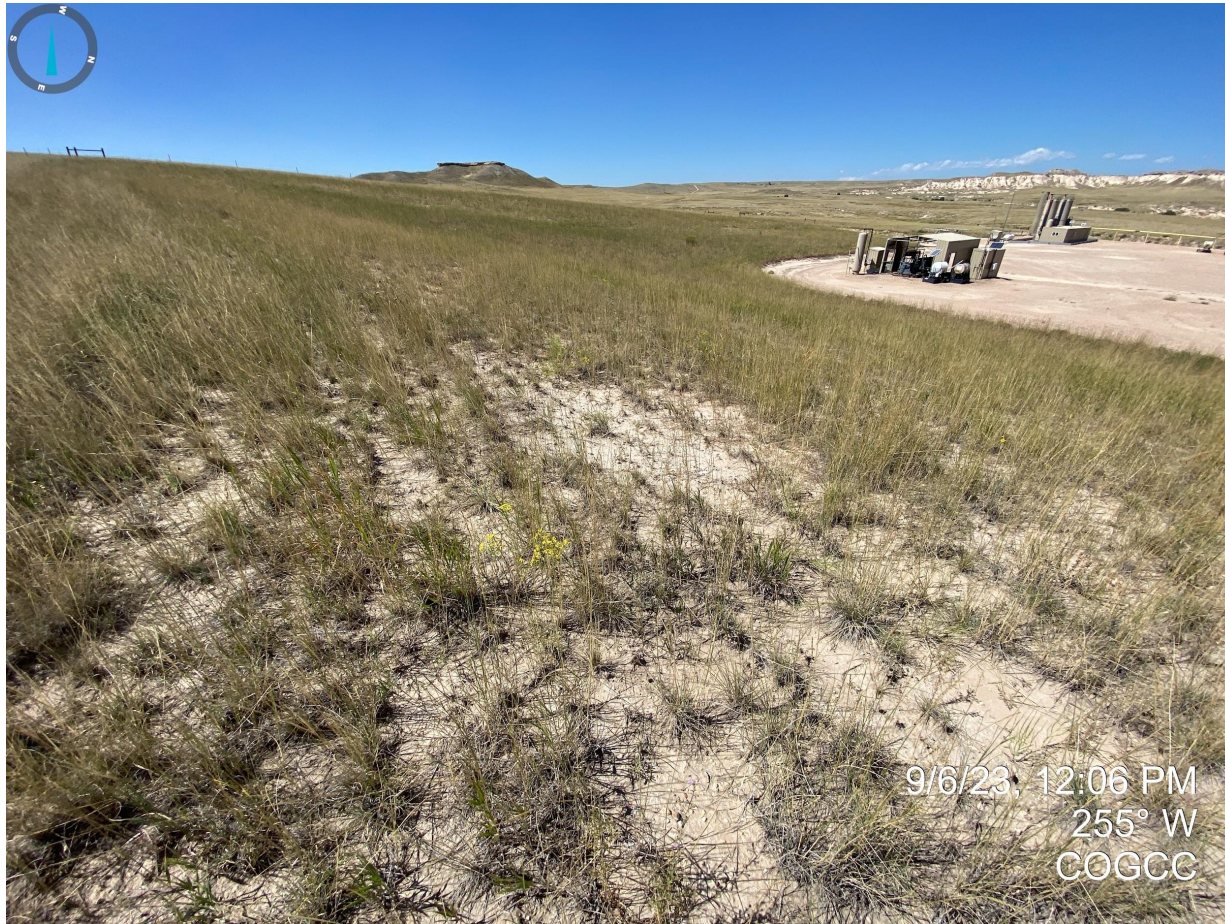
Photo 8. Taken from the east side of location; see comments in Photo 5.

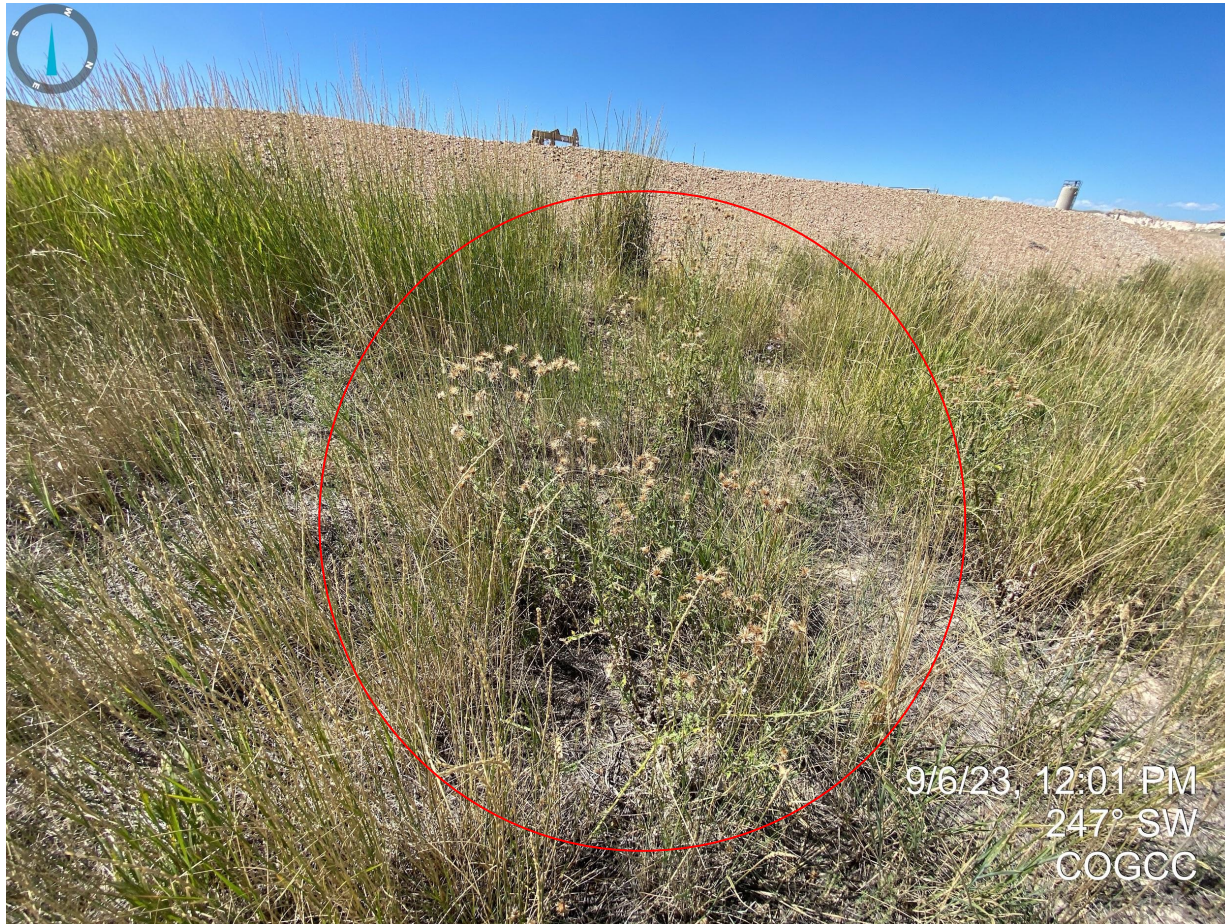
Photo 9. Taken from the northern end of the location. CO List B Noxious Weed-Canada Thistle- was observed within the interim areas. This noxious weed will need to be actively managed for to prevent spread onto adjacent lands.

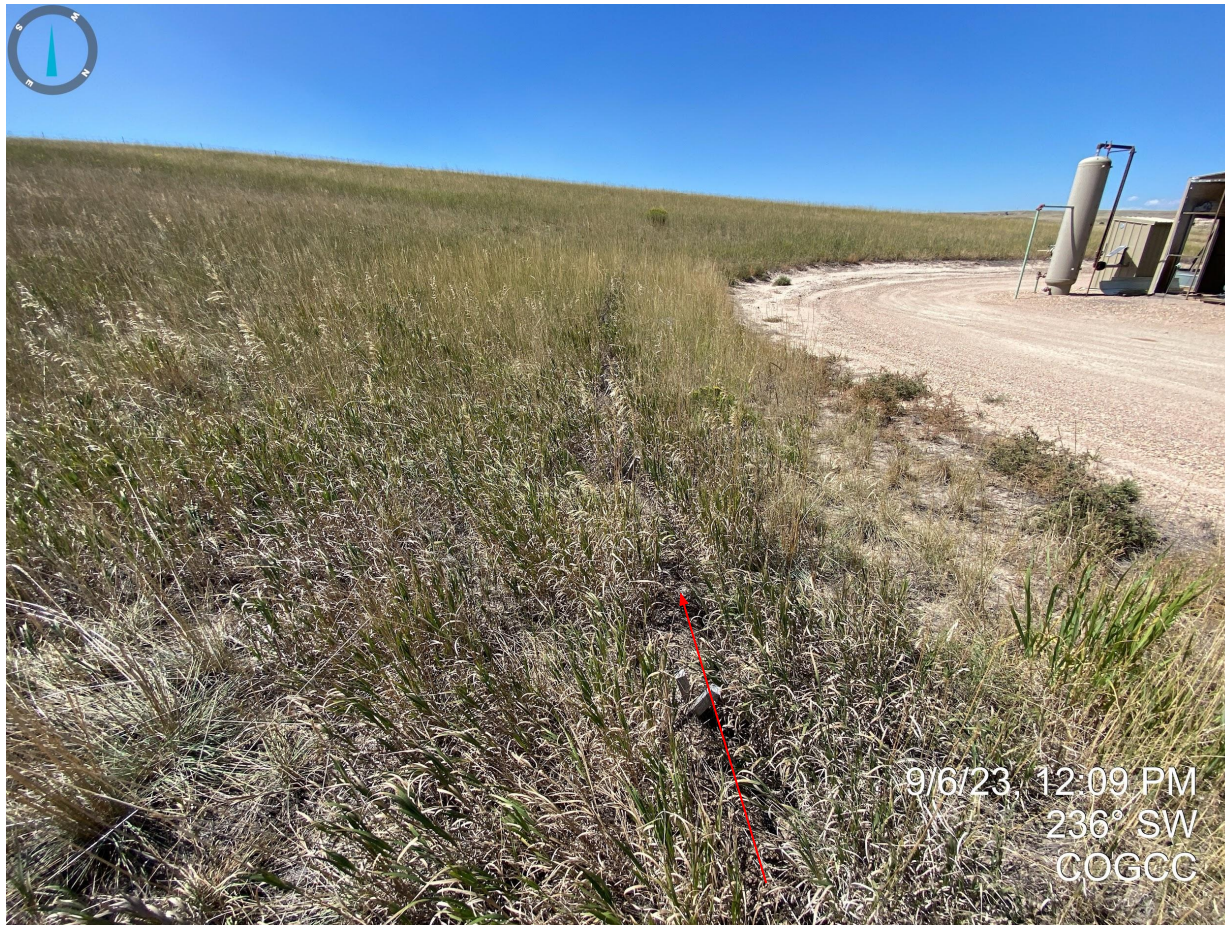
Photo 10. Taken from the eastern side of location. Degraded straw wattles were observed throughout the location and are now considered debris. All debris shall be removed from the location per Rule 606.

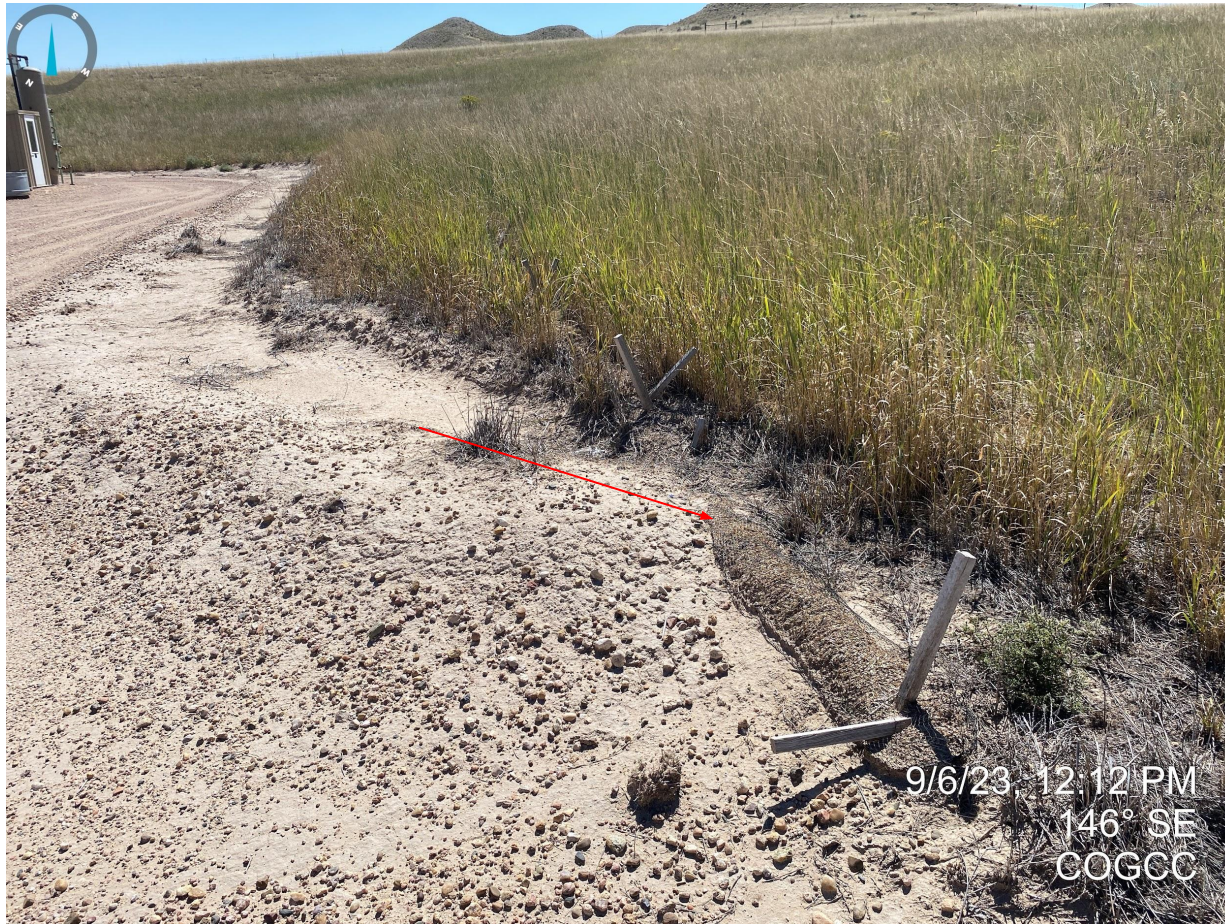
Photo 11. Taken near the entrance to location; see comments in Photo 10.

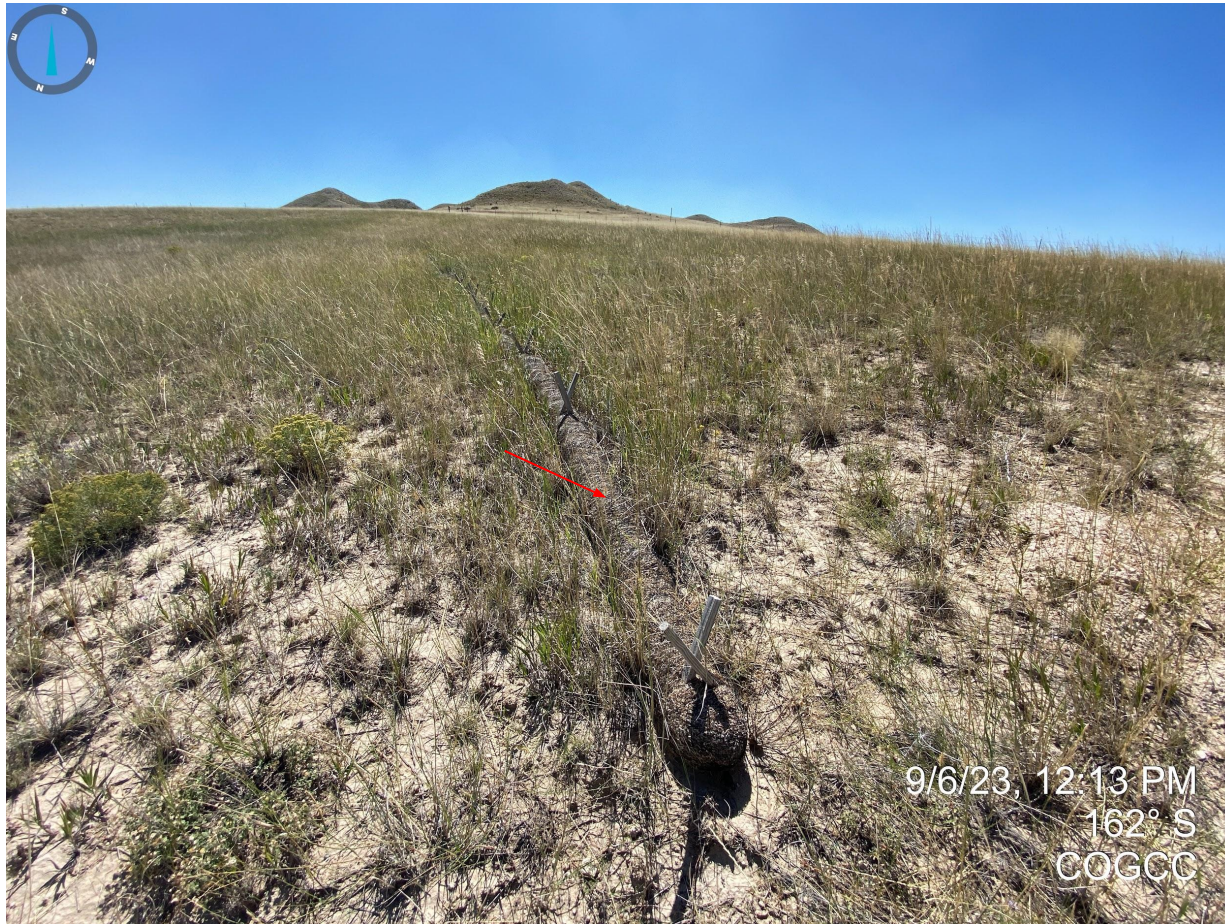
Photo 12. Taken near the southern end of location; see comments in Photo 10.

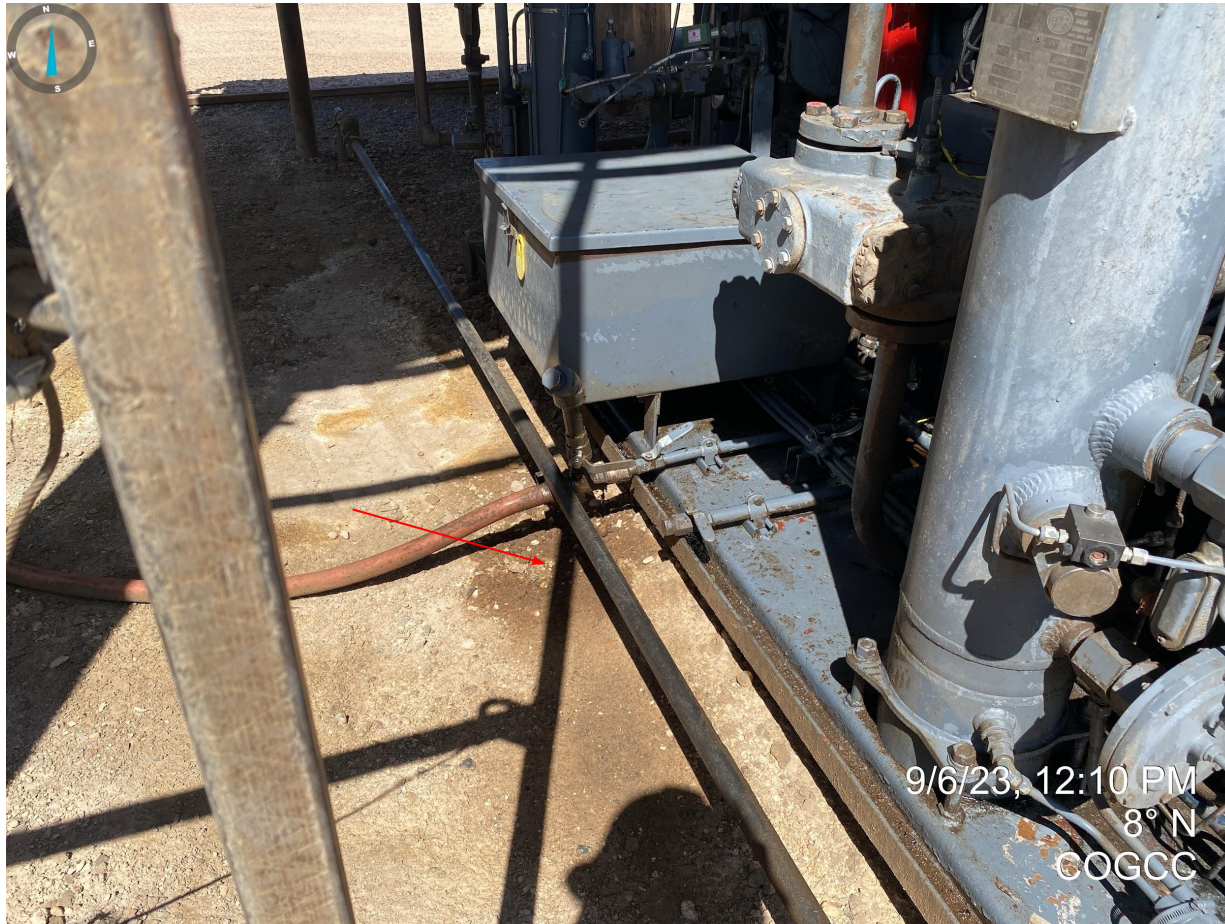
Photo 13. Stained soil observed at compressor.

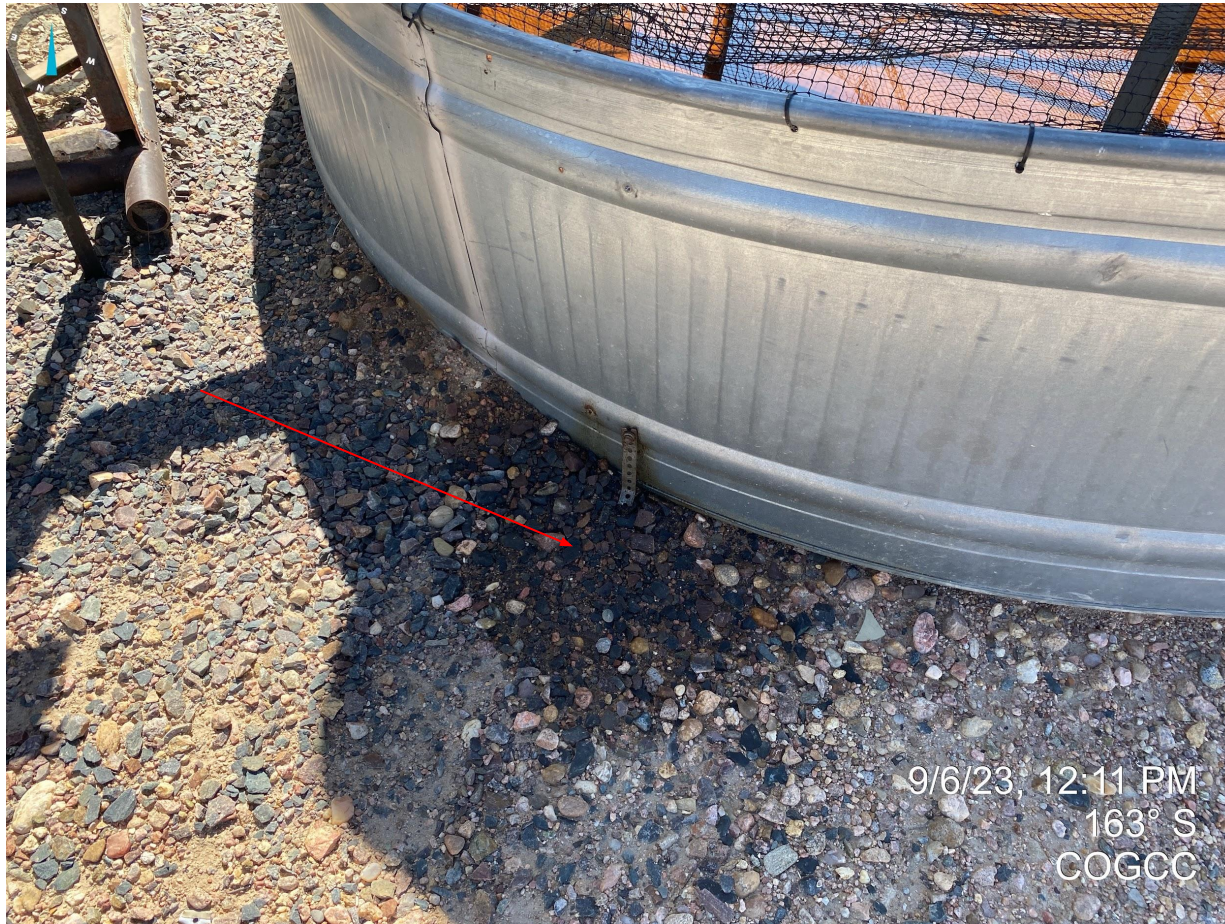
Photo 14. Stained soil at day tank next to compressor.

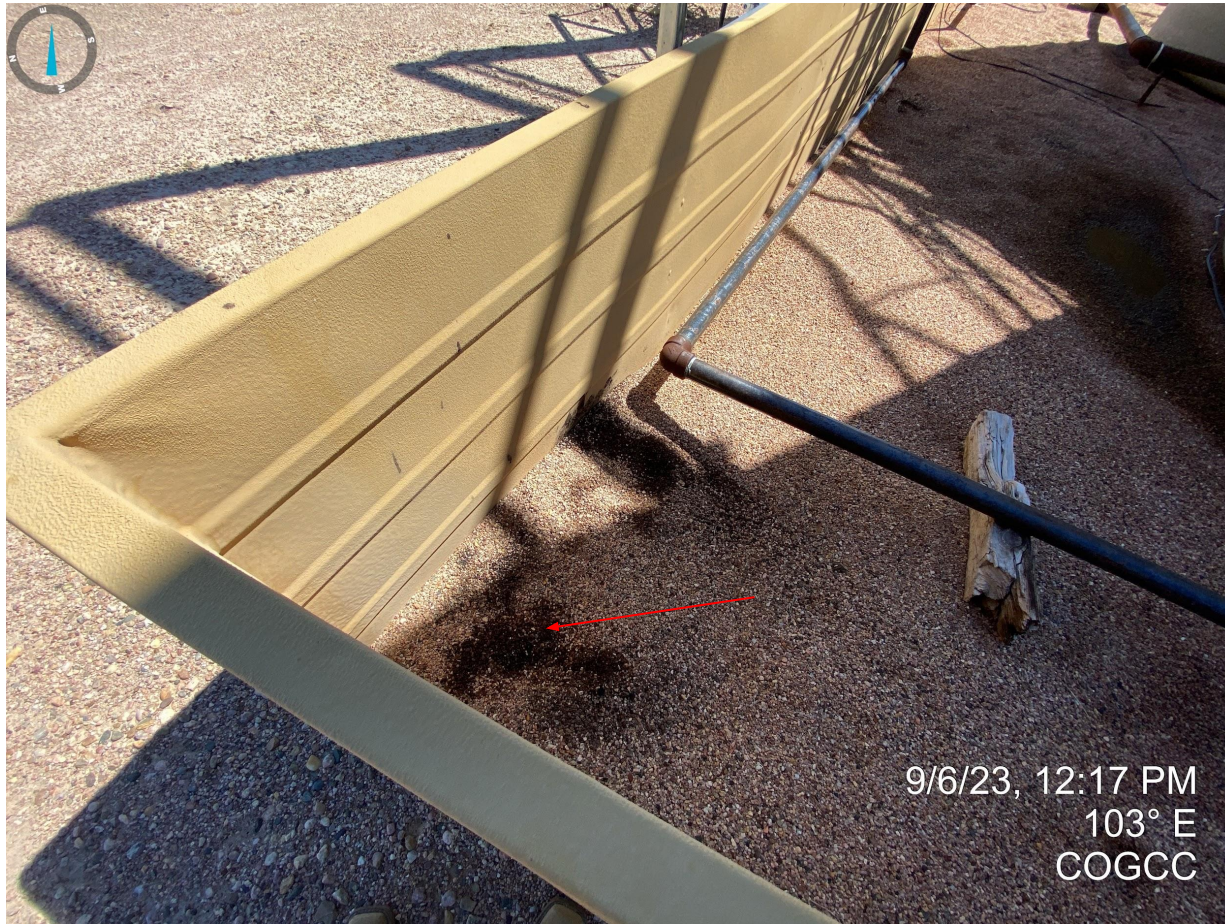
Photo 15. Stained soil within secondary containment at tank battery.

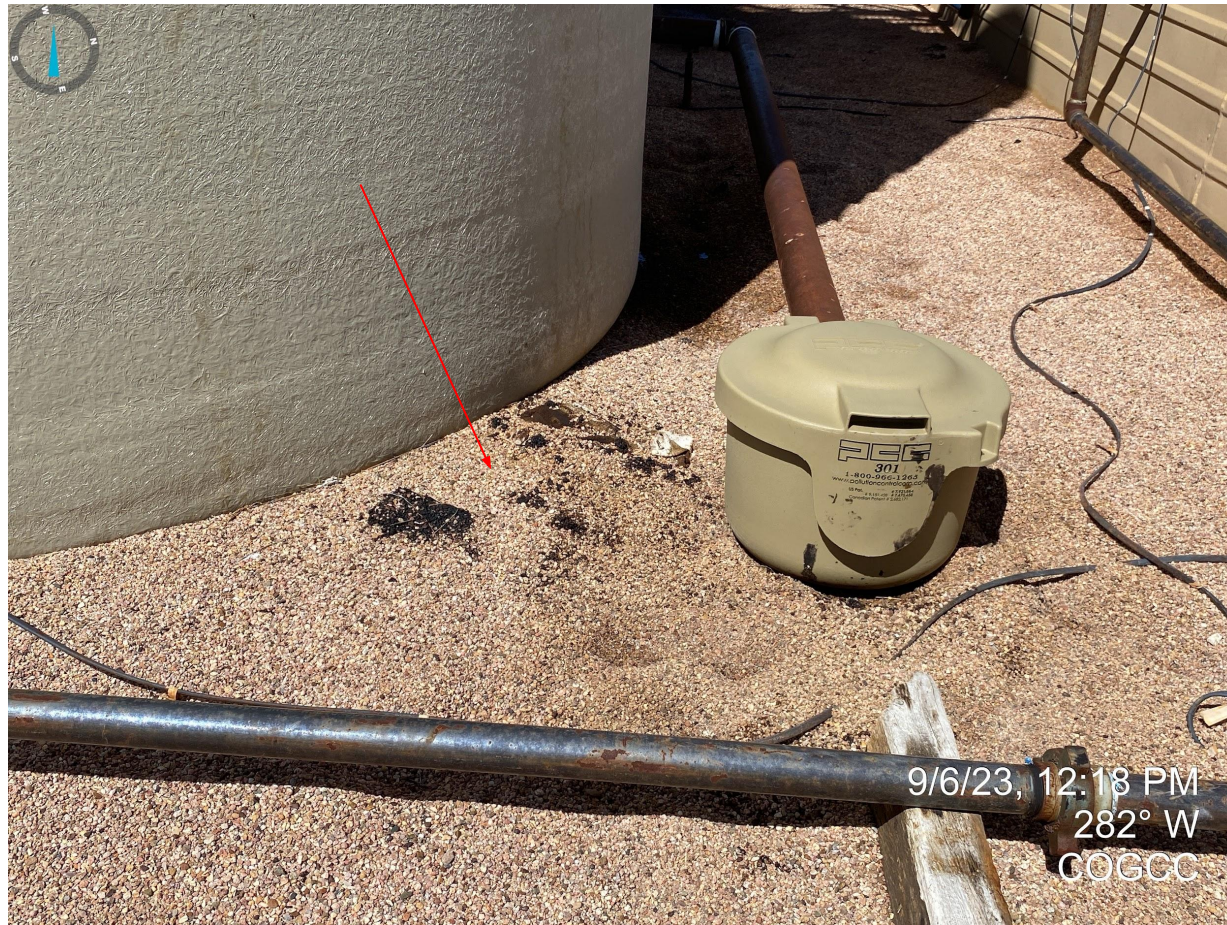
Photo 16. Stained soil at loadout lines.

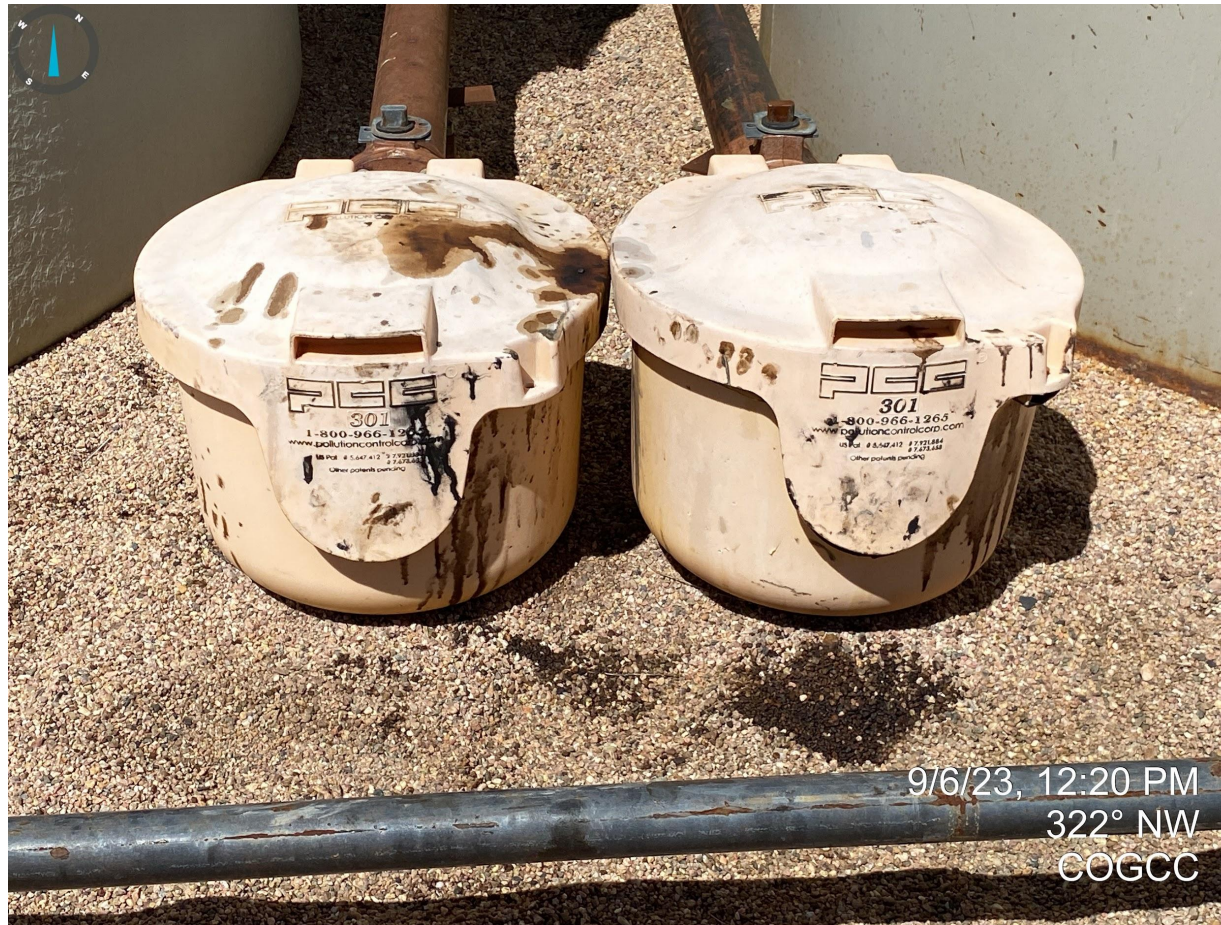
Photo 17. Stained soil at loadout lines.

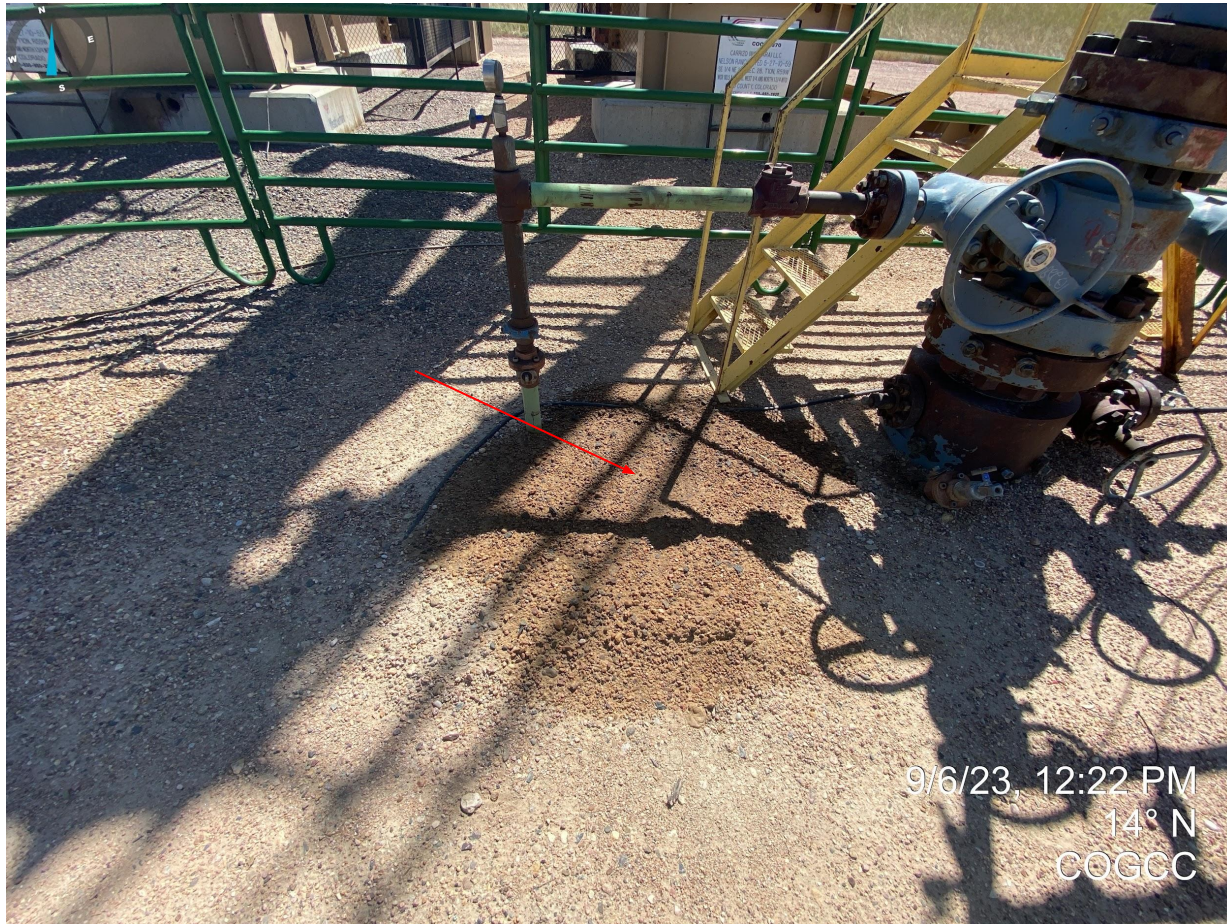
Photo 18. Stained soil at wellhead.

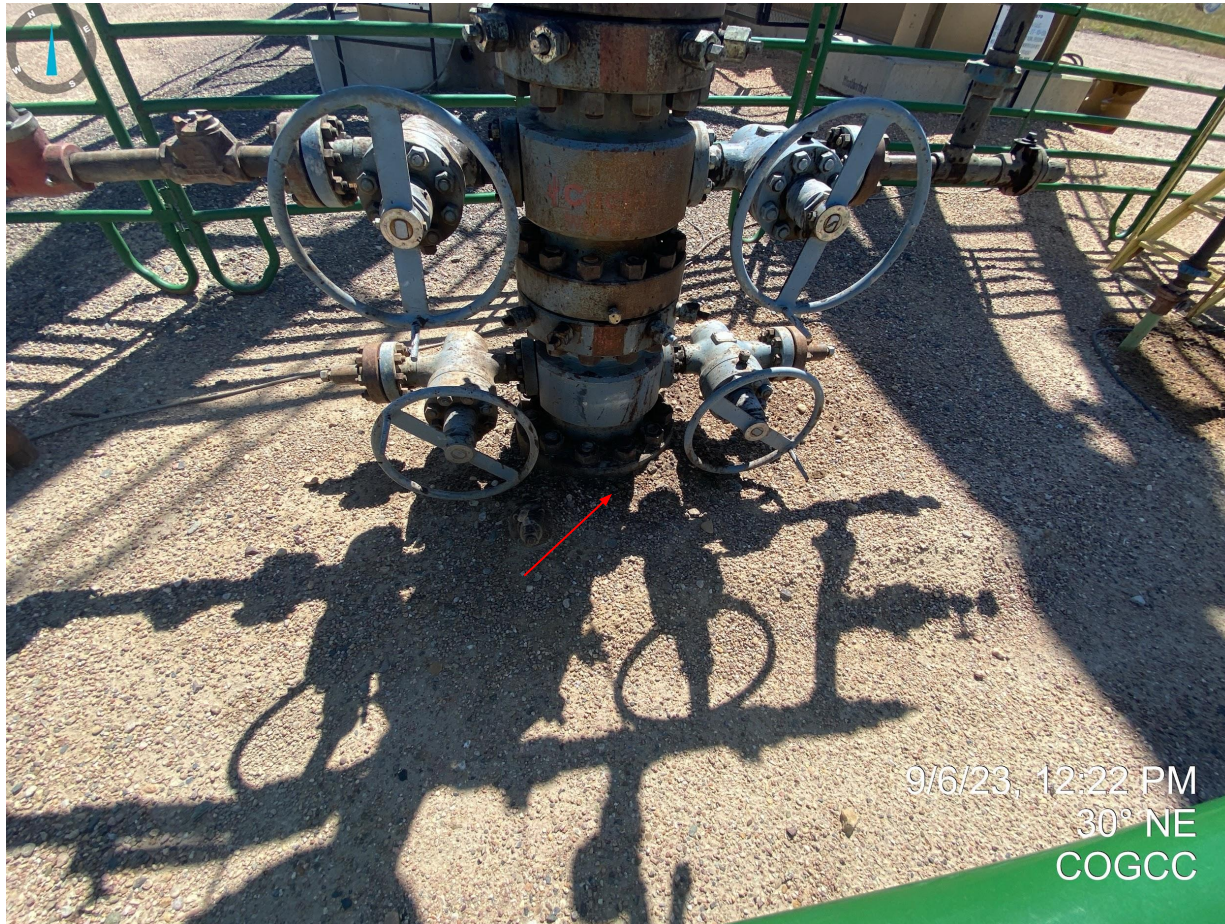
Photo 19. Stained soil at wellhead.

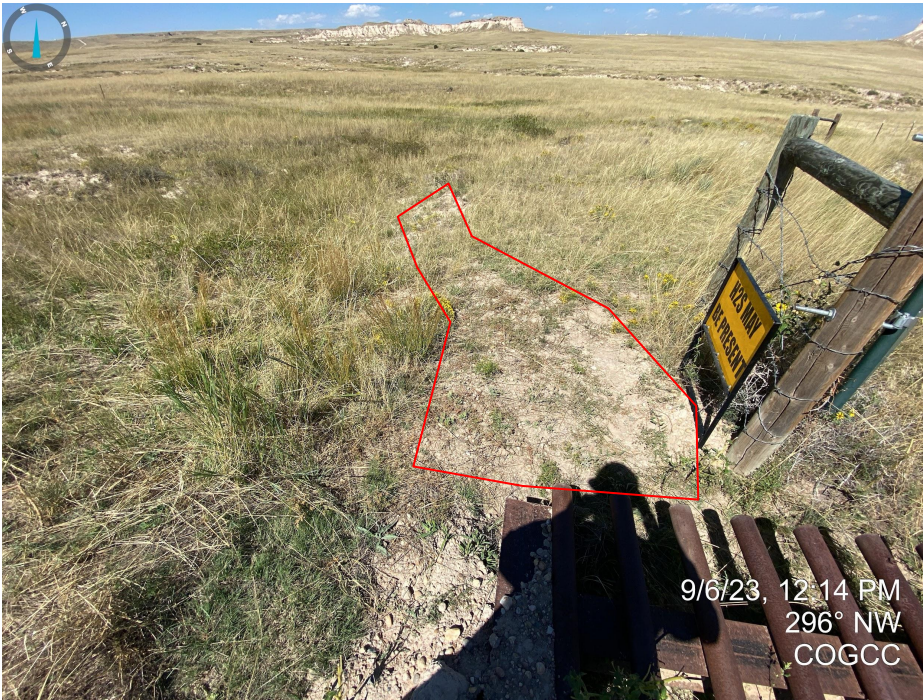
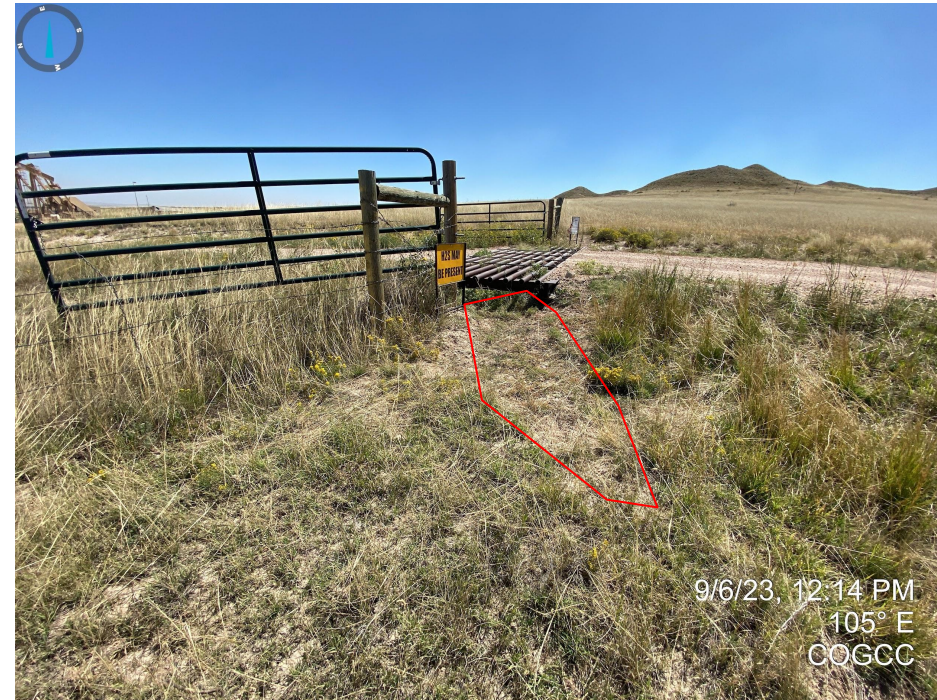
Photos 20 & 21. Erosion degradation and offsite sediment transport observed at the location's entrance. Additional stormwater control measures are required in order to prevent continued erosion degradation.

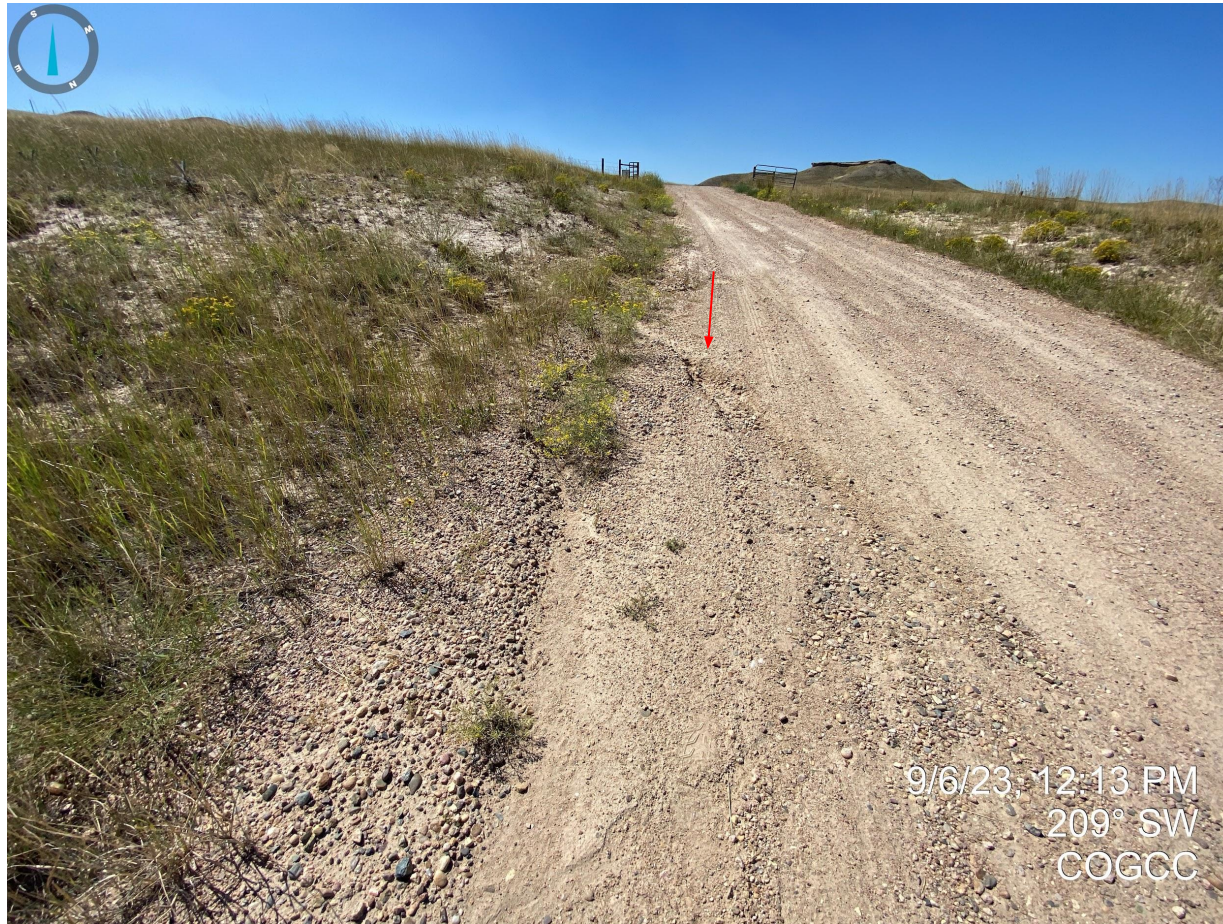
Photo 22. Erosion degradation (rilling) occurring on the access road on the location.

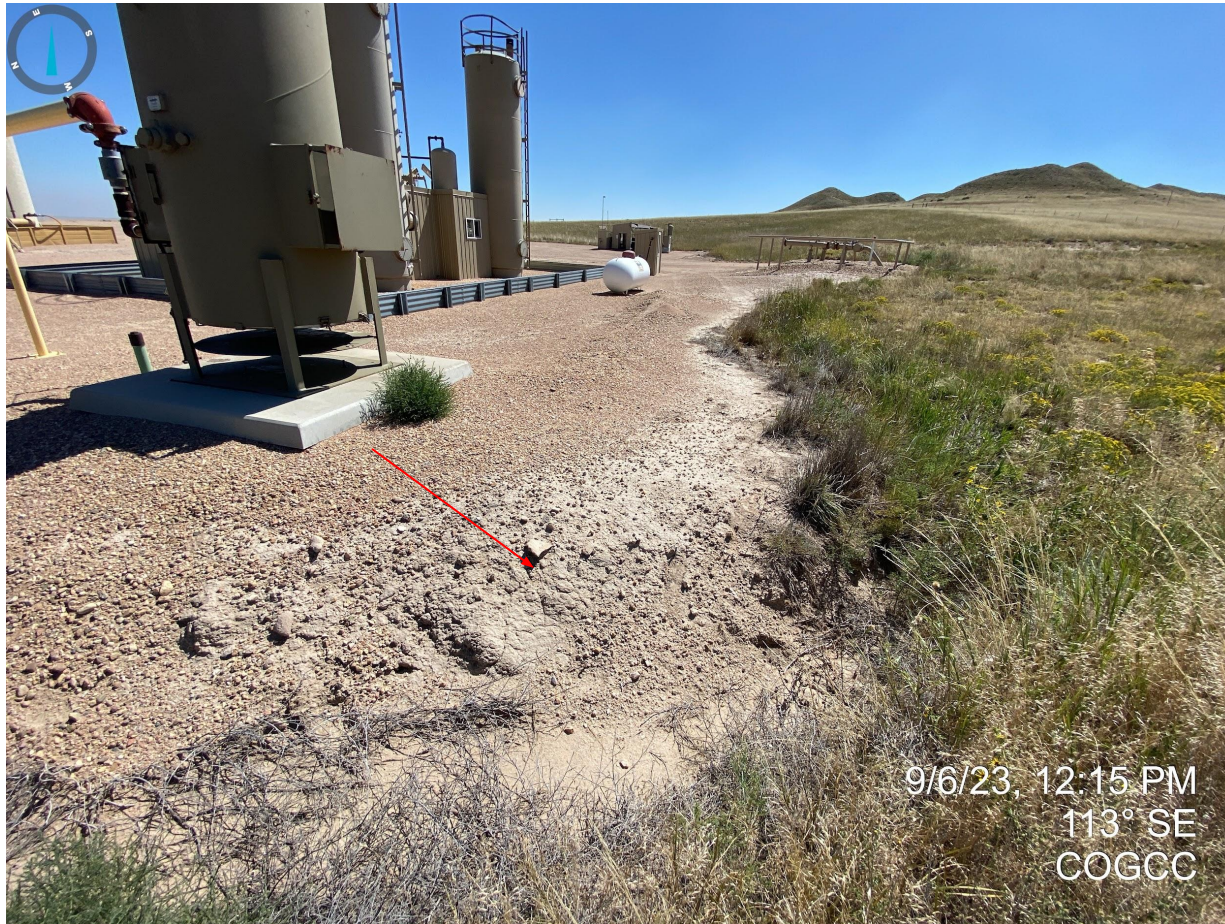
Photo 23. Production areas do not appear to be adequately stabilized with evidence of unconsolidated material. Taken from the southwest corner of the location.
