Interim Reclamation and Stormwater Inspection

Operator: VERDAD RESOURCES LLC - 10651

Location ID: 433228

Inspection Document #: 708200544

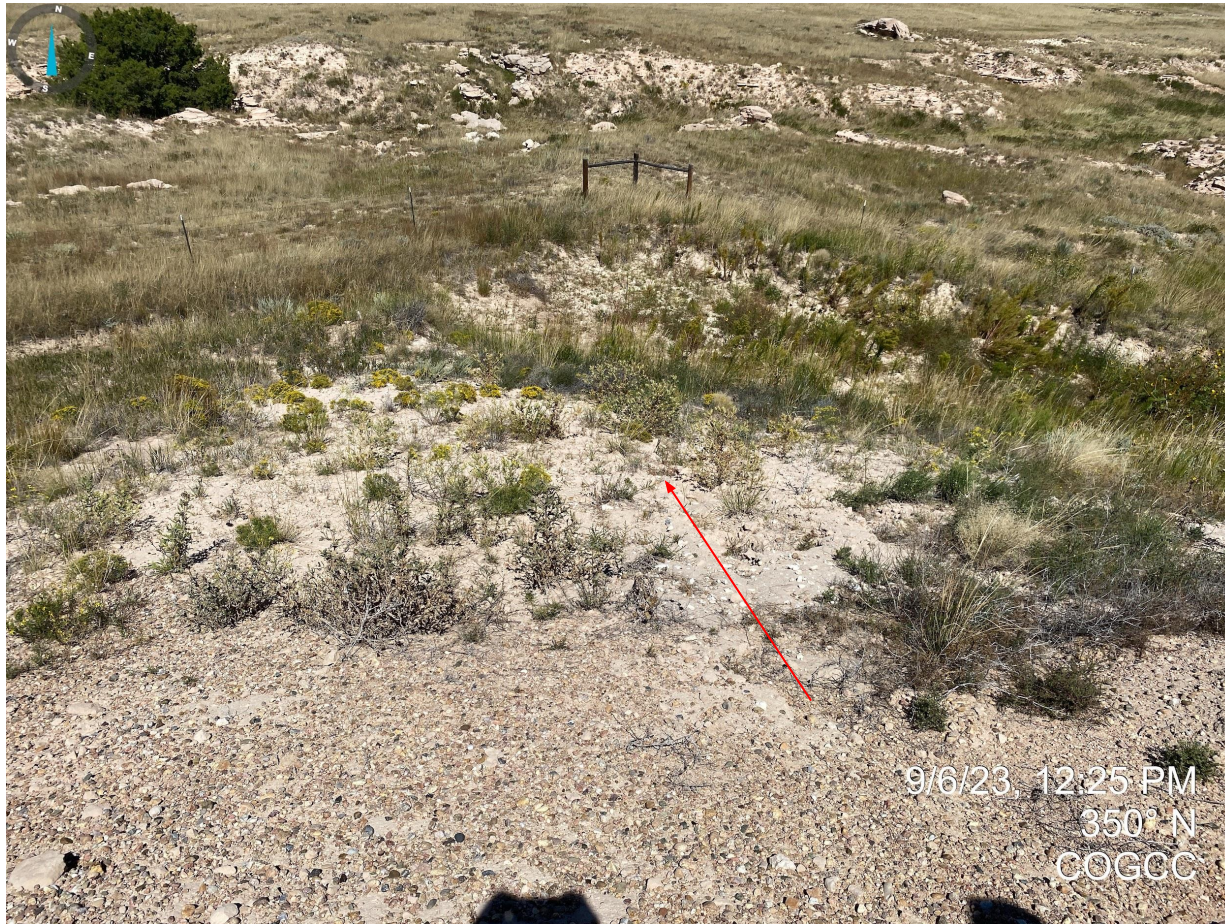
Photo 24. Taken from the northwestern portion of the location. The interim/production areas do not appear to be properly stabilized as no stabilization or stormwater control measures/BMPs were observed on bare and exposed soils.

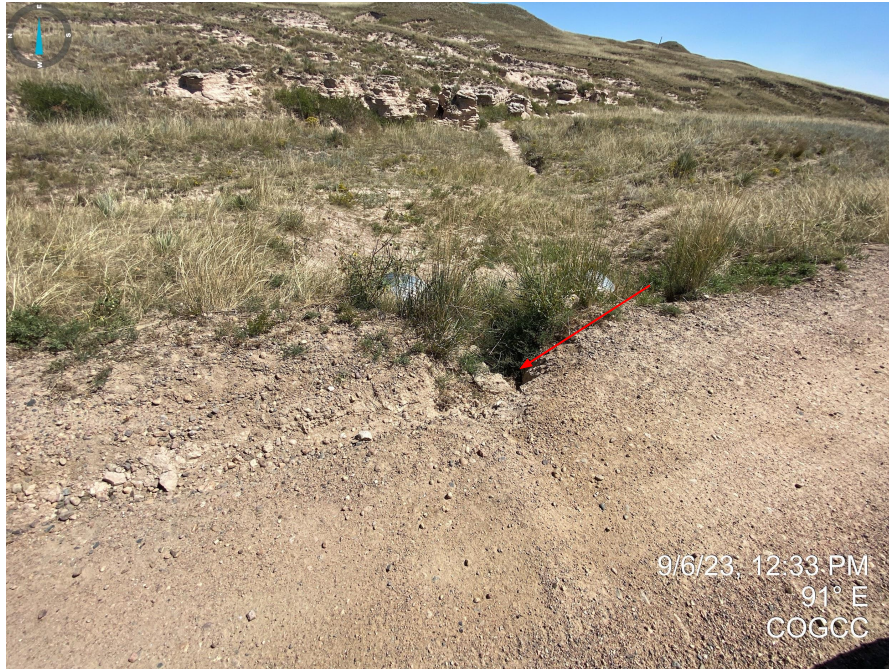
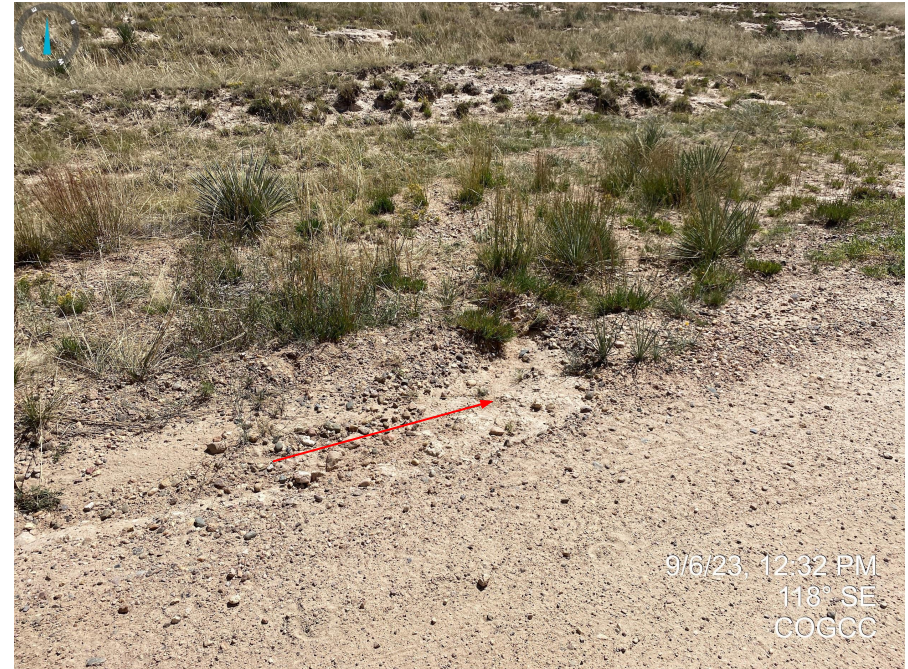
Photos 25 & 26. Taken approximately 1/4mi south of the location entrance along the access road. Erosion degradation observed near the water/culvert crossing. Additional stormwater control measures/BMPS are required to prevent further erosion from occurring.
