Inspection Photos
Location Name: Oxnard East 0607-8CH
Location ID: 452516

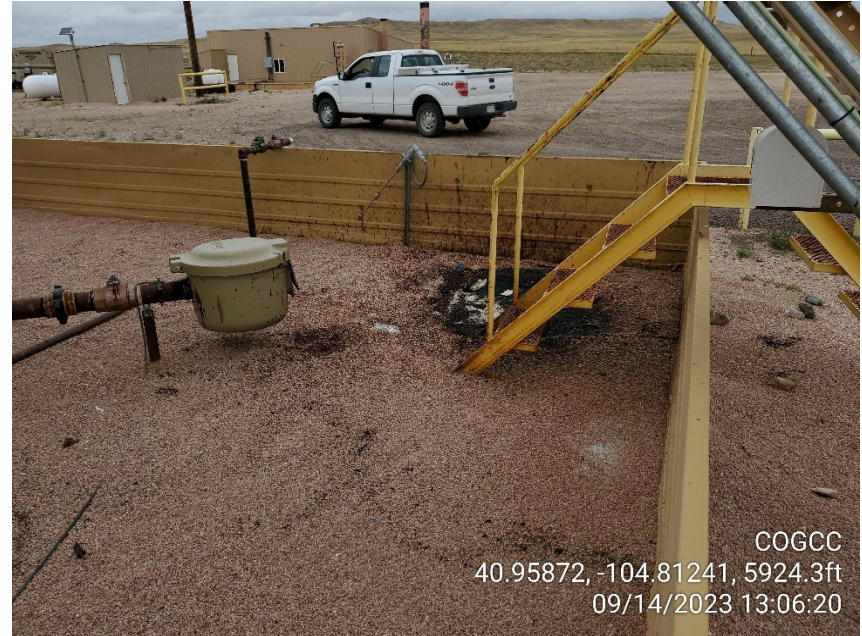
Photo 2 Oily waste around sump in northeast corner of secondary containment

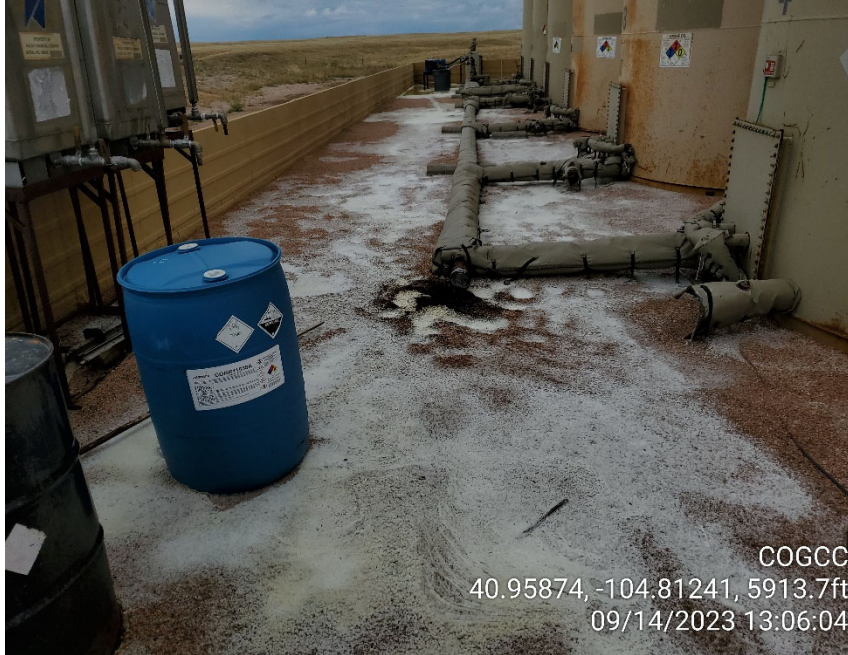
Photo 3 Salt crystals along south side of secondary containment

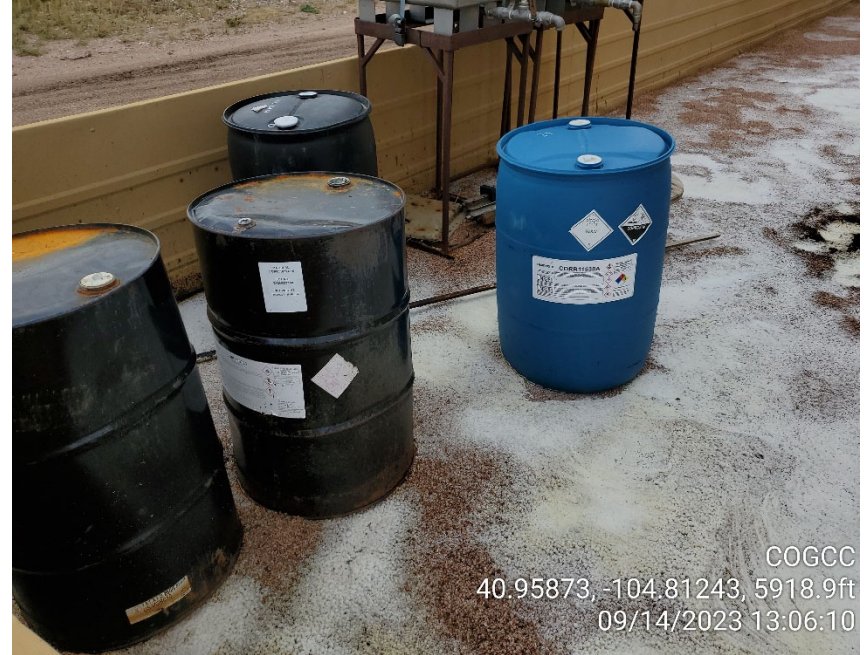
Photo 4 Salt crystals along south side of secondary containment

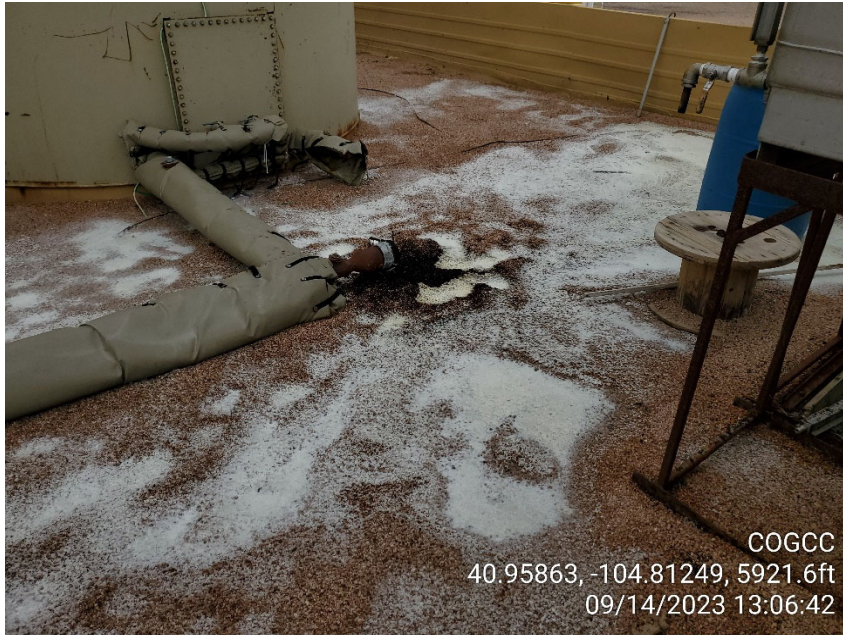
Photo 5 Saline water and salt crystals in southwest corner of secondary containment

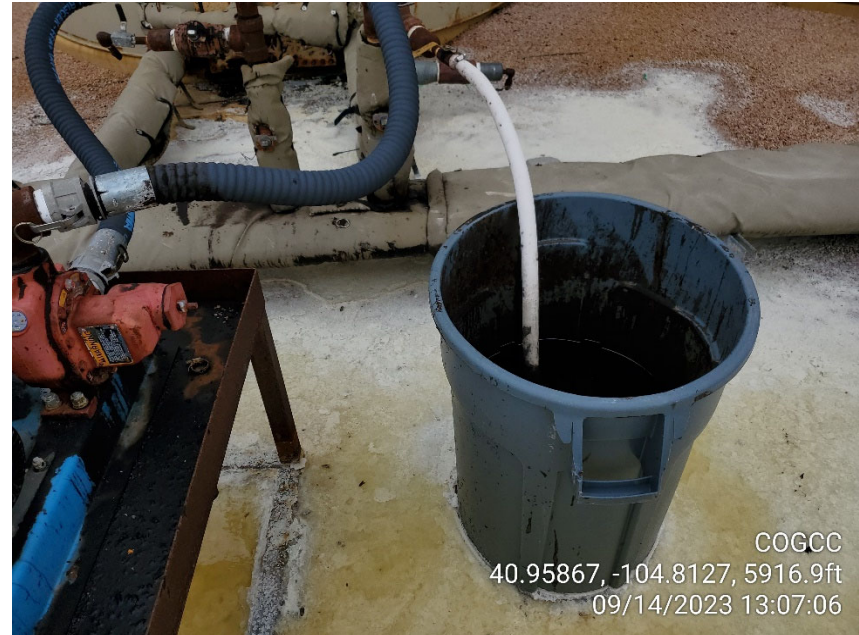
Photo 6 Bucket of crude oil at recycle pump in standing saline water in southwest corner of secondary containment

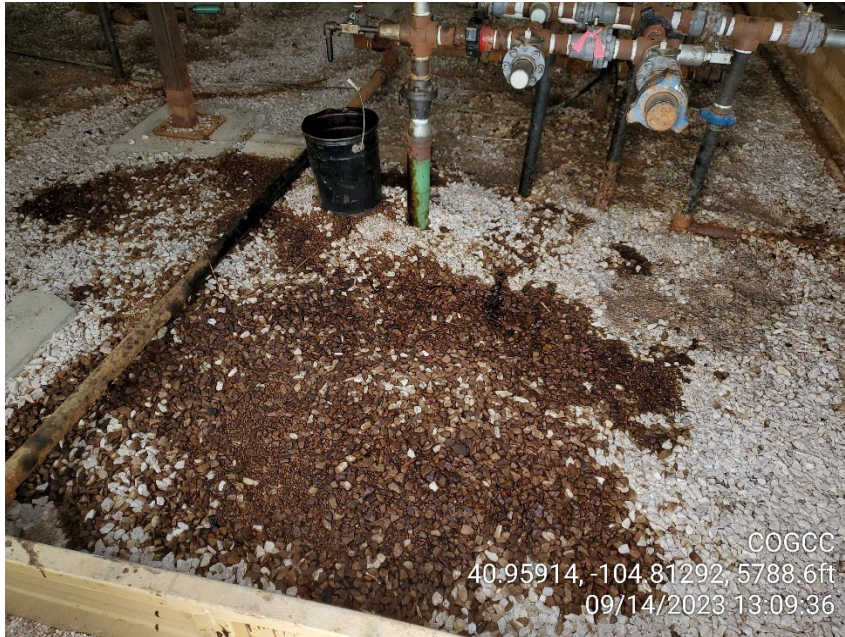
Photo 7 Evidence of blowdown onto ground in separator building

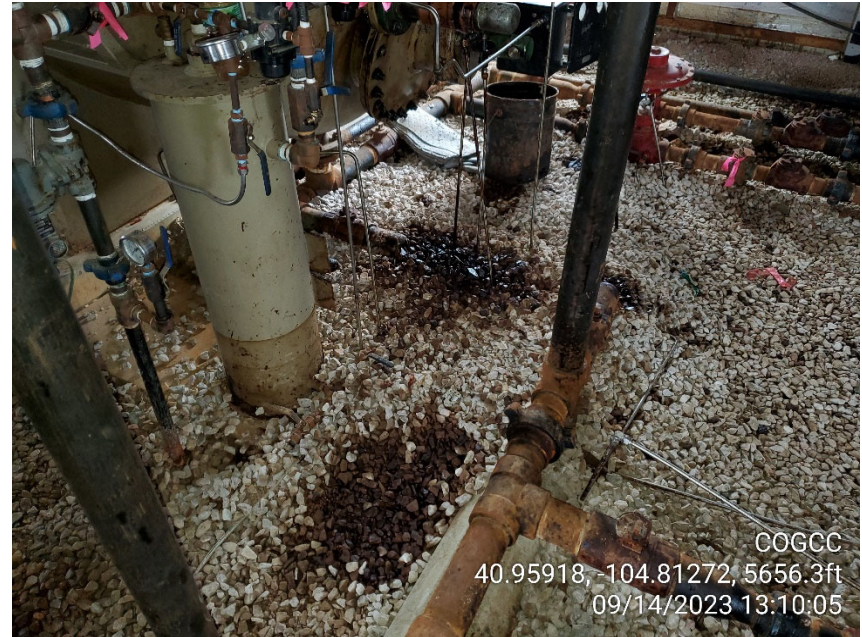
Photo 8 Evidence of blowdown at separator inside separator building

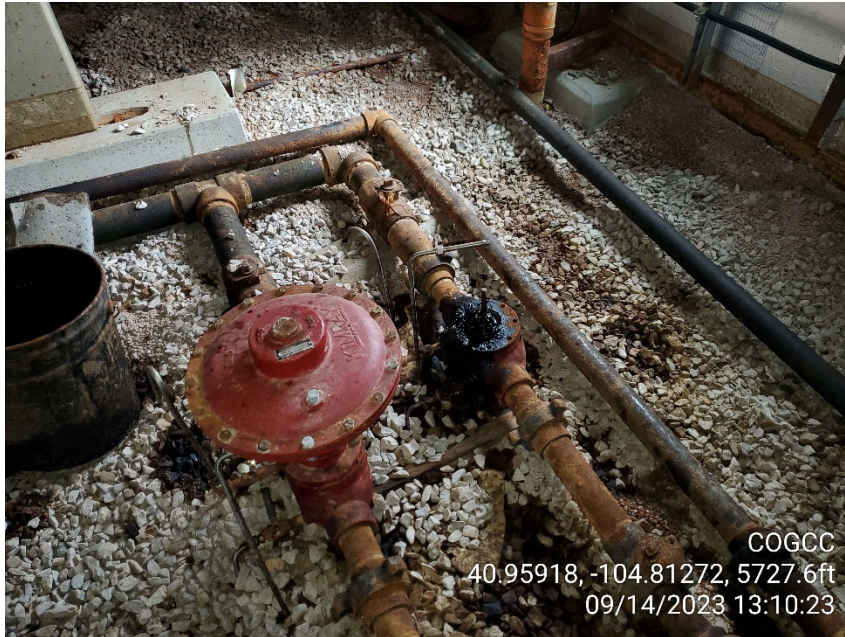
Photo 9 Leaking fittings inside separator building

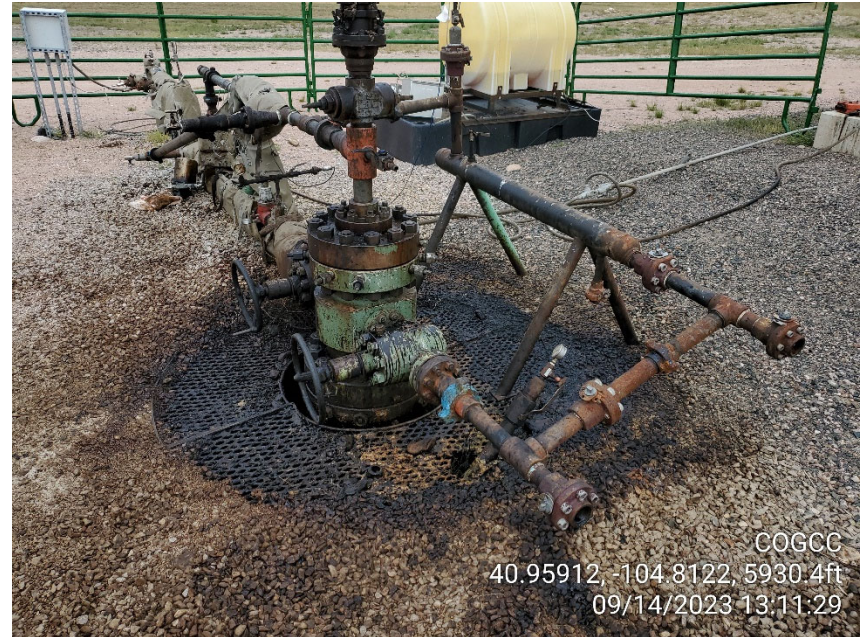
Photo 10 oily waste around wellhead
