Construction and Stormwater Inspection

Date: 09/15/2023

Operator: MDS ENERGY DEVELOPMENT LLC - 10814

Inspection Photos
Location Name: Daffy Pad
Location ID: 477495

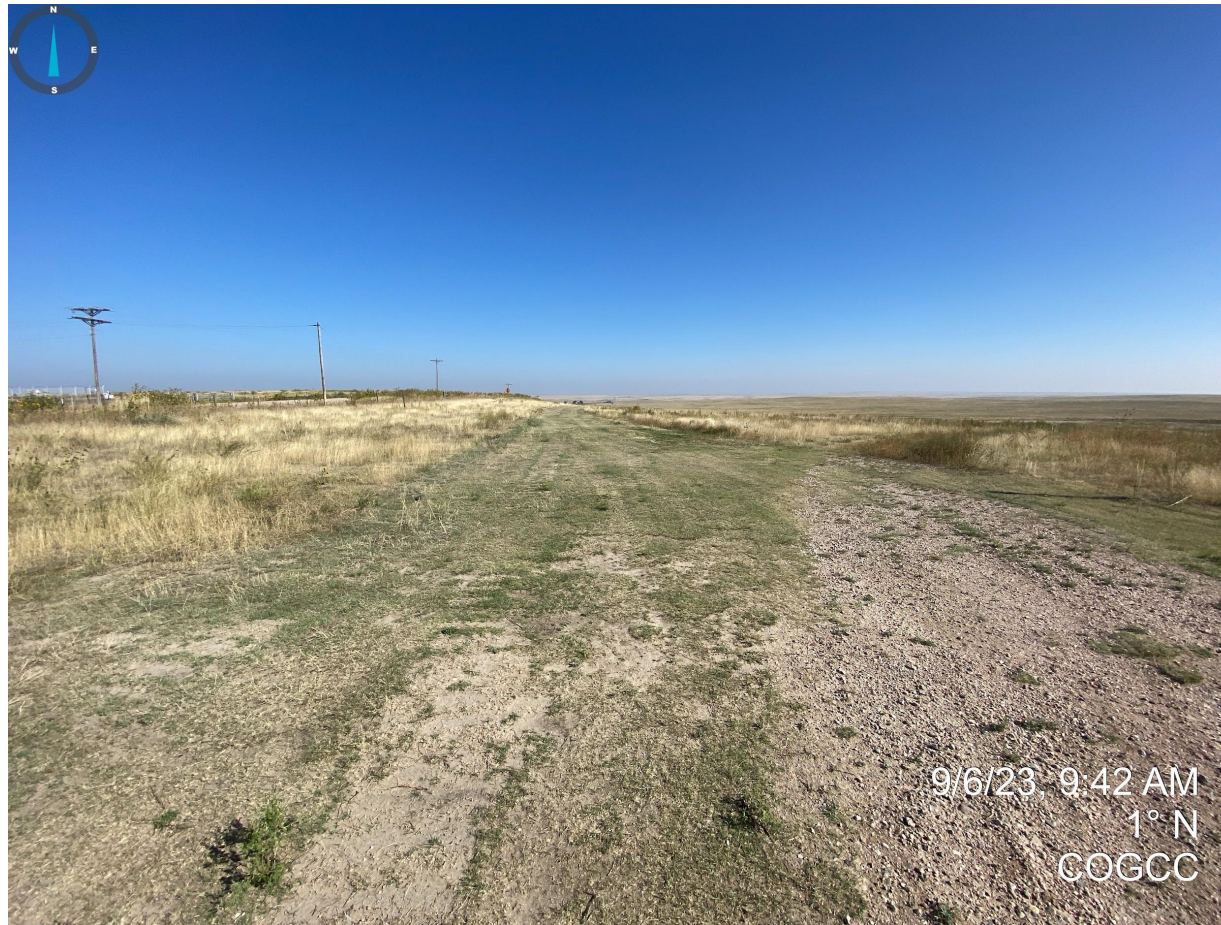
Photo 1. Taken from the revised/new access road entrance, approximately 500' south of HWY 14 and the previously used access road entrance. It does not appear the access road has been salvaged for topsoil at the time of this inspection.

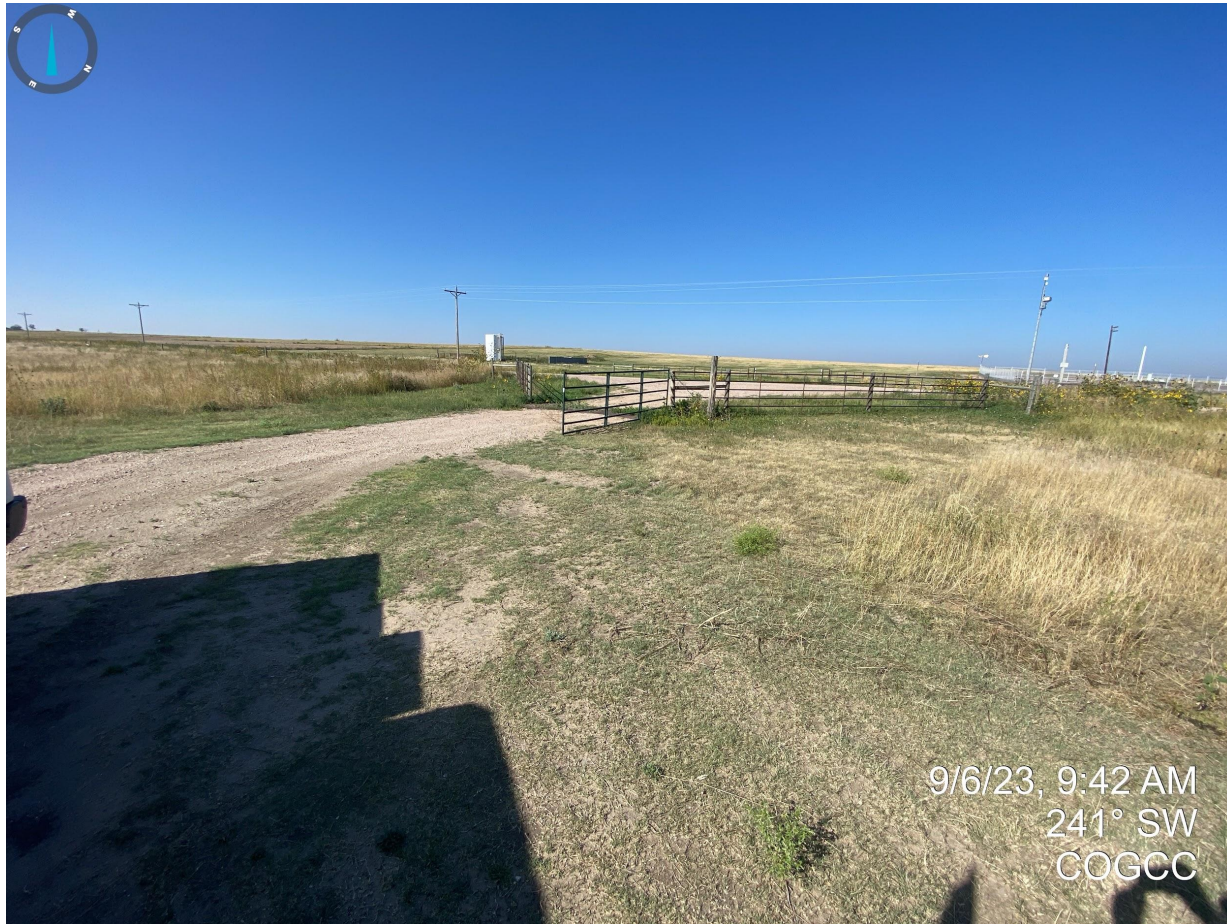
Photo 2. See comments in Photo 1.

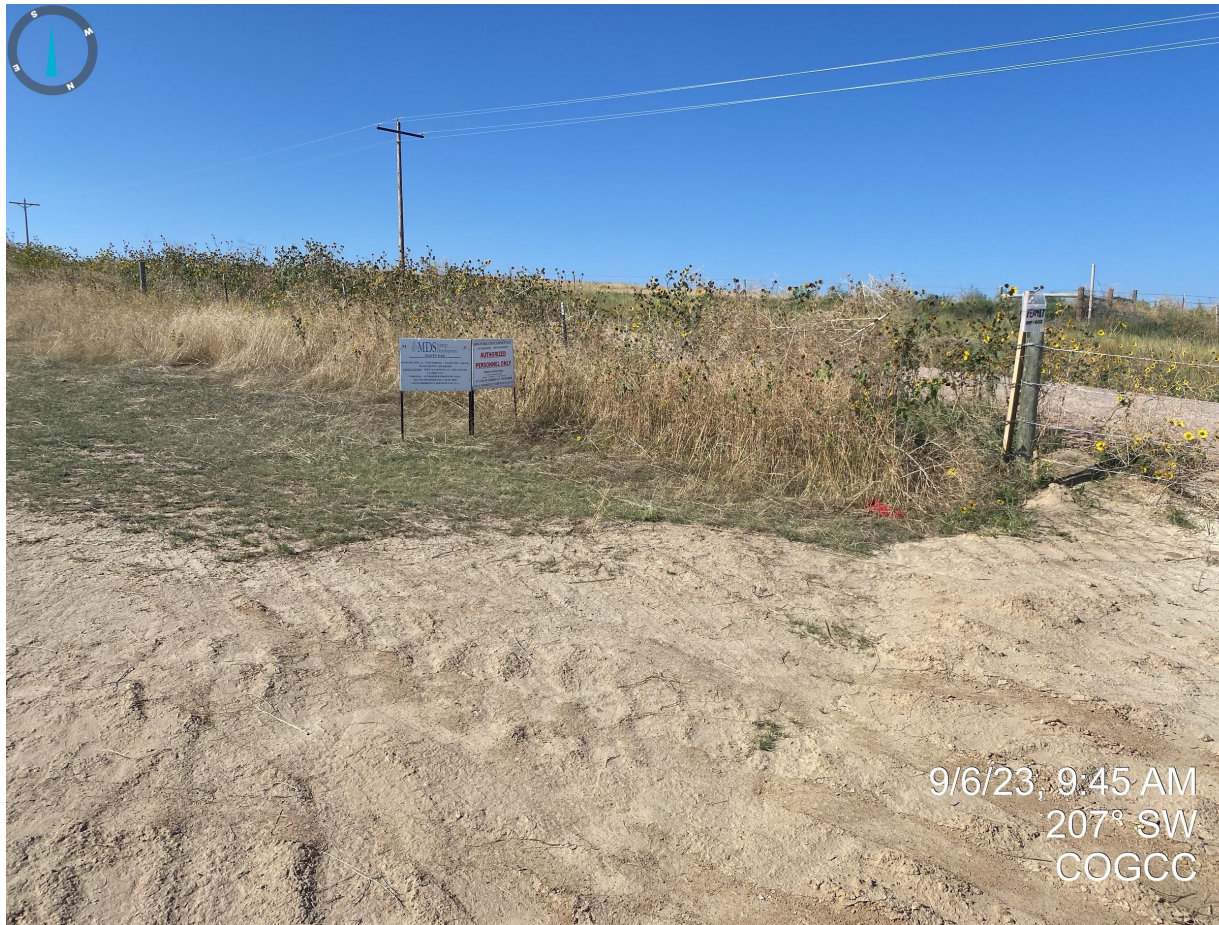
Photo 3. Taken from the newly constructed access road, approximately 25' south of HWY 14. Location signage needs to be placed at the entrance to the location and an adjacent county road. The signs pictured here will need to be moved to comply with 605.a.

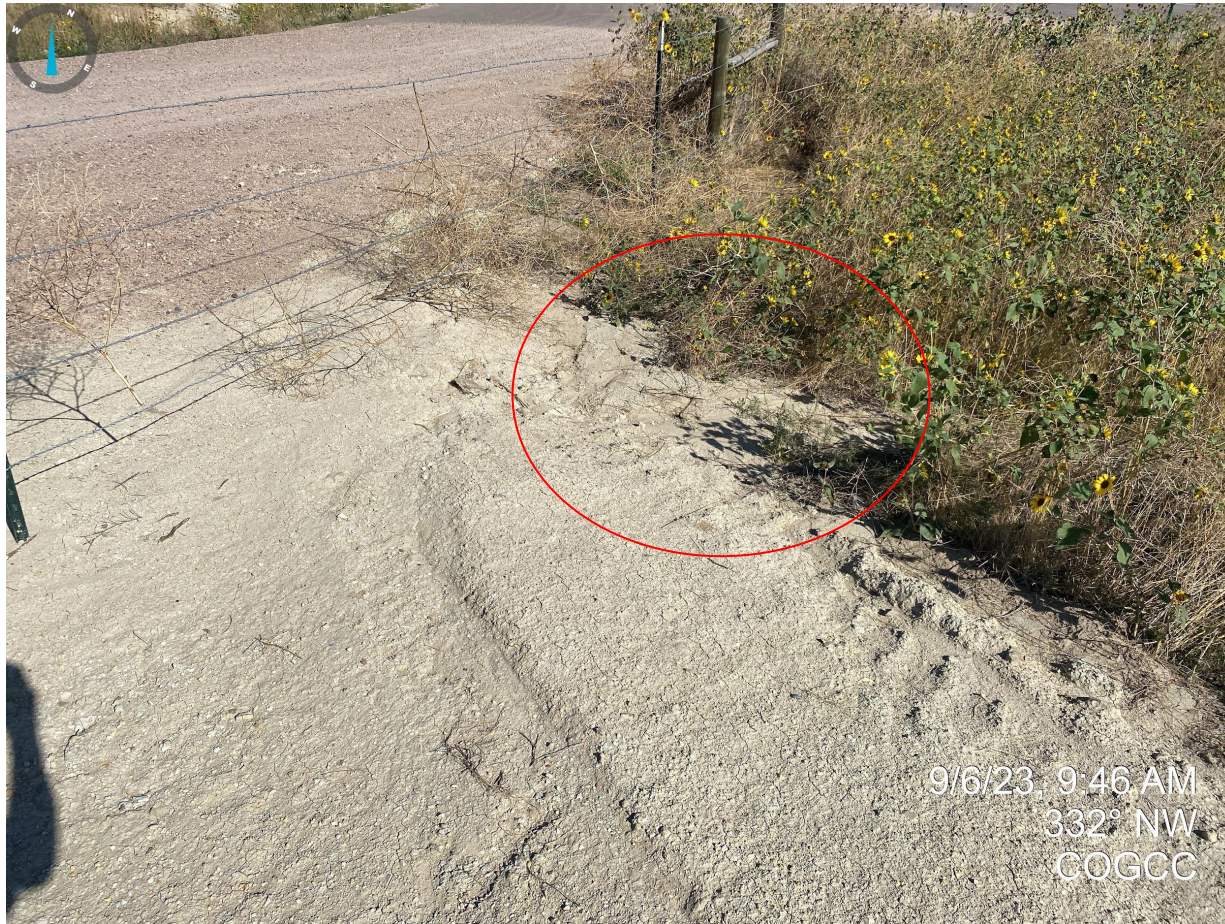
Photo 4. Taken from the newly constructed access road, approximately 25' south of HWY 14. Evidence of sediment transport (red circle) from unstabilized soils. Additional control measures/BMPS and/or maintenance required.

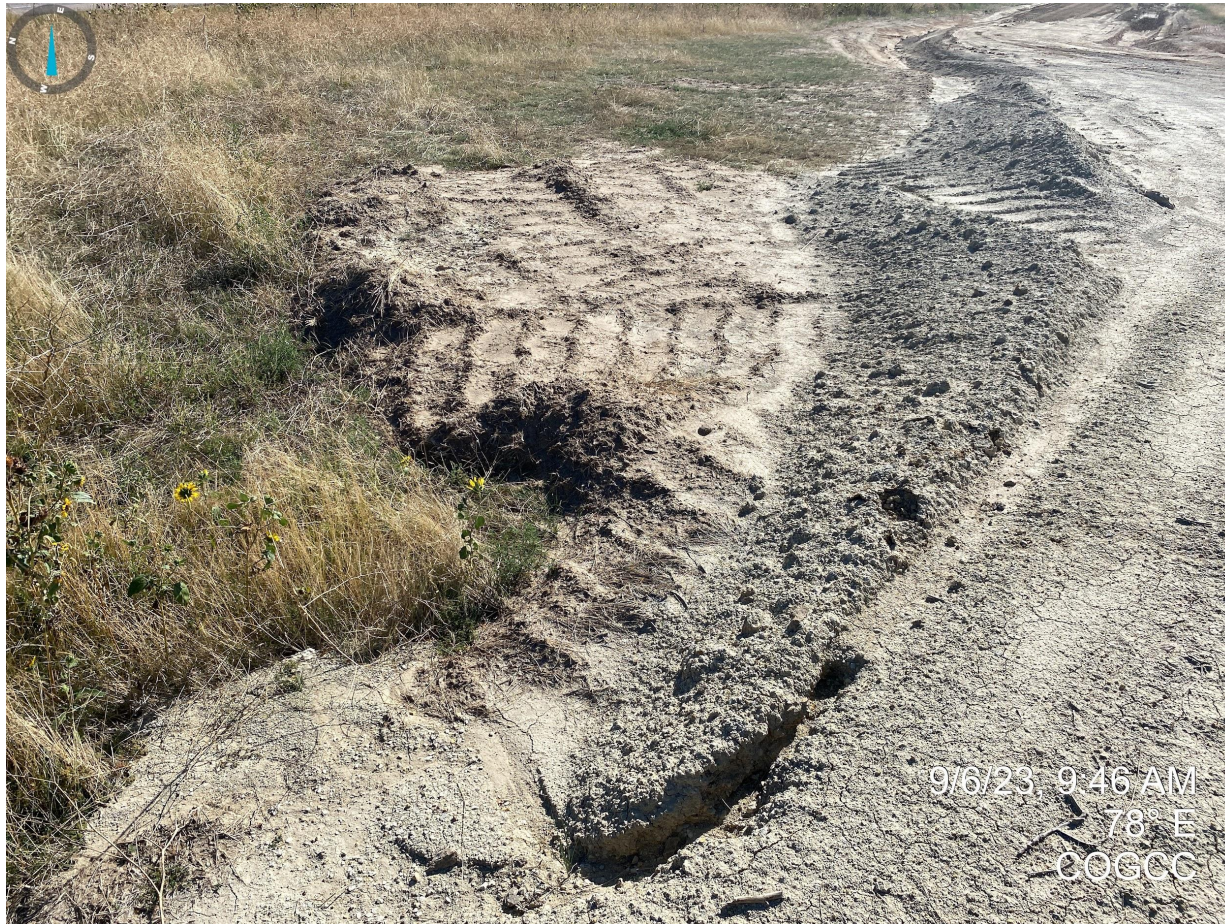
Photo 5. Taken from the newly constructed access road, approximately 25' south of HWY 14. Photo illustrates unconsolidated material along the access road.

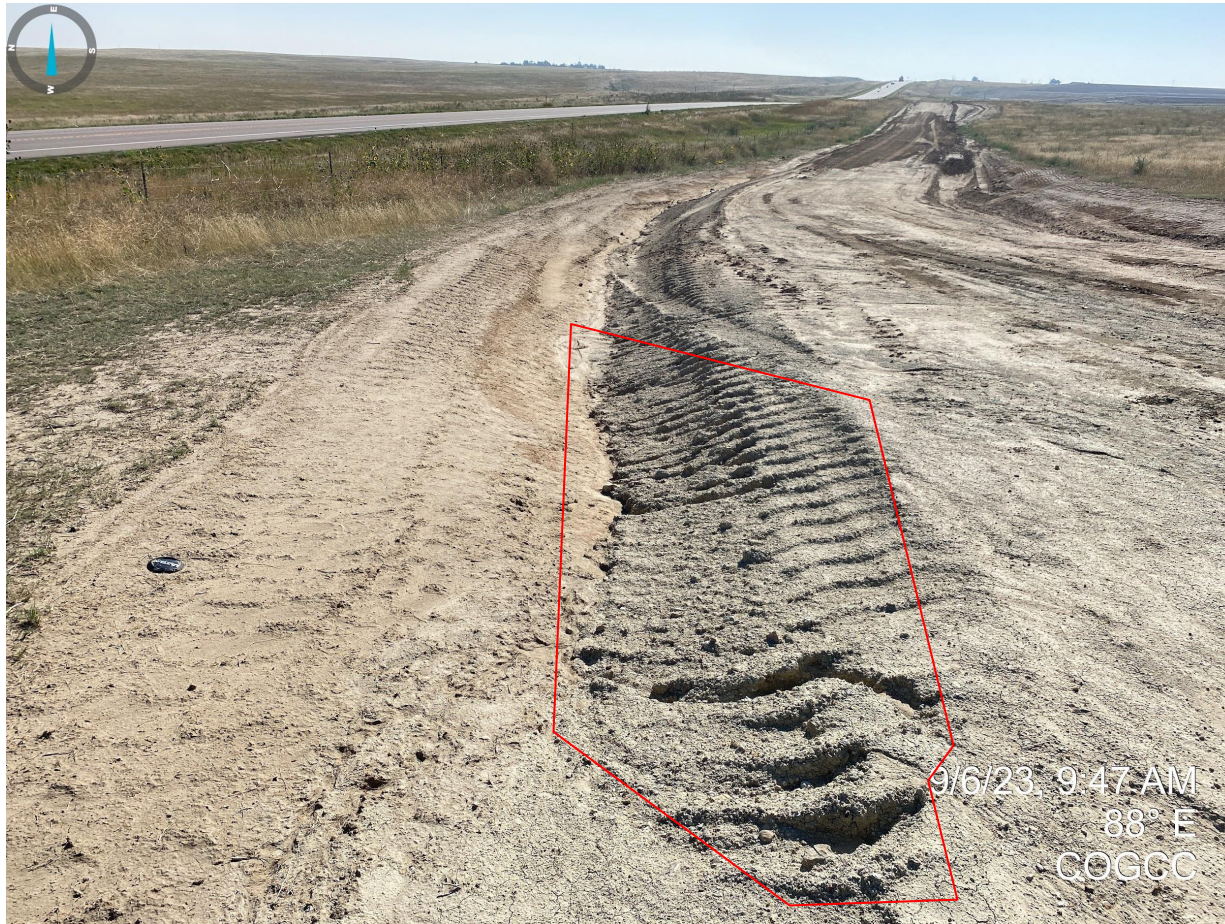
Photo 6. Taken from the western portion of the access road. Photo illustrates erosion degradation (e.g. rilling) occurring along the shoulder of the access road. Additional maintenance and/or stormwater control measures required.

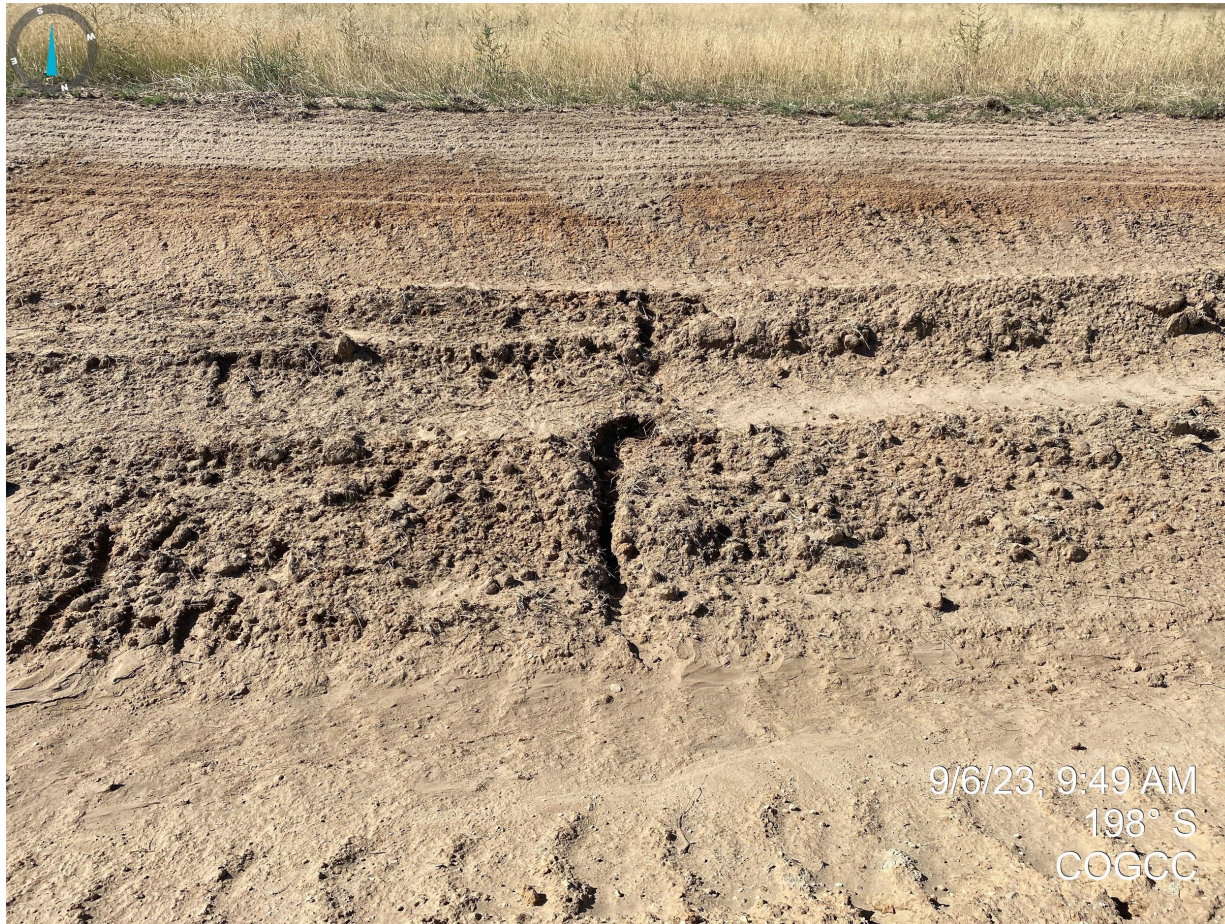
Photo 7. Taken from the midsection of the access road; see comments in Photo 6.

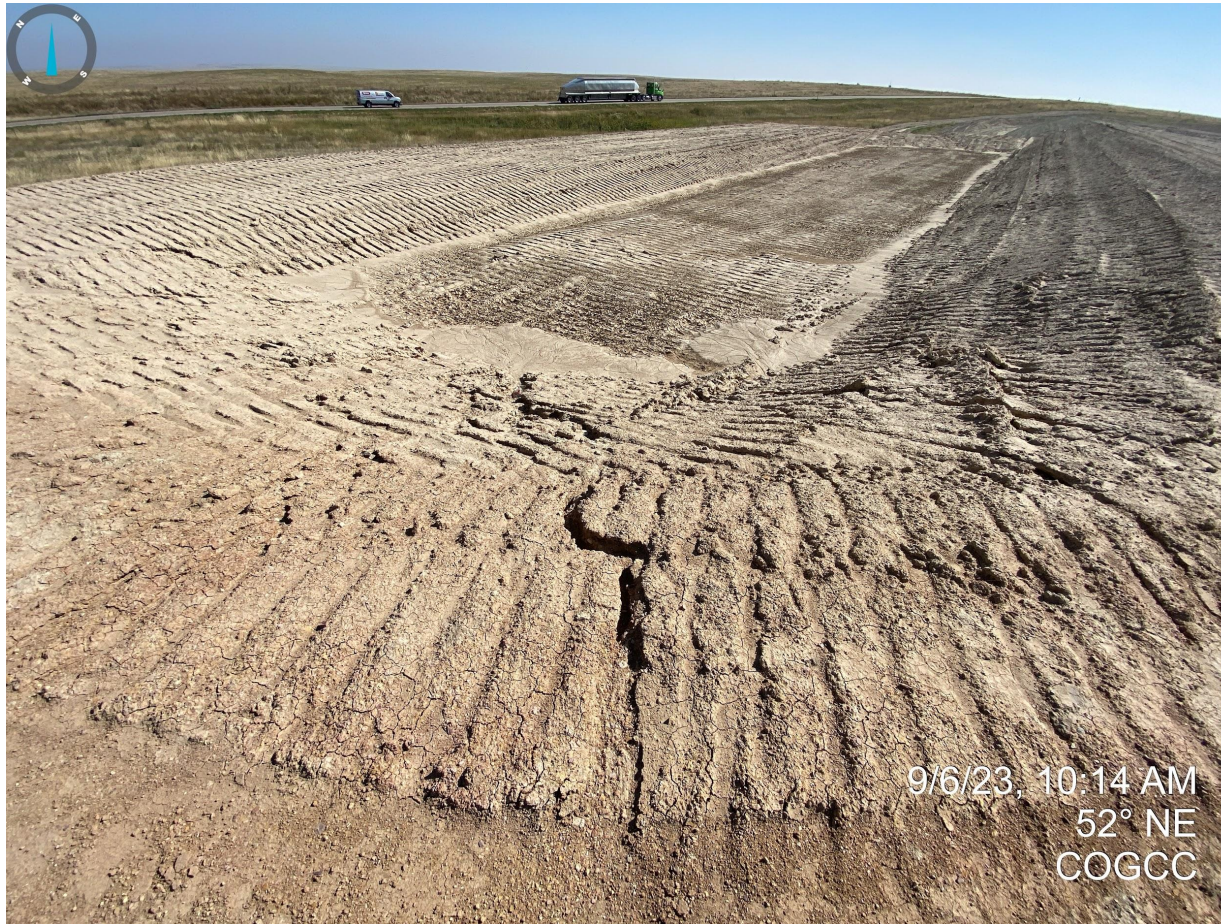
Photo 8. Taken from the sediment trap on the northern portion of the location. Photo illustrates erosion degradation (e.g. rilling) occurring from improper temporary stabilization techniques (equipment tracking that is parallel to slope). The sediment trap did not have any apparent inflow or outflow protection measures in place at the time of this inspection.

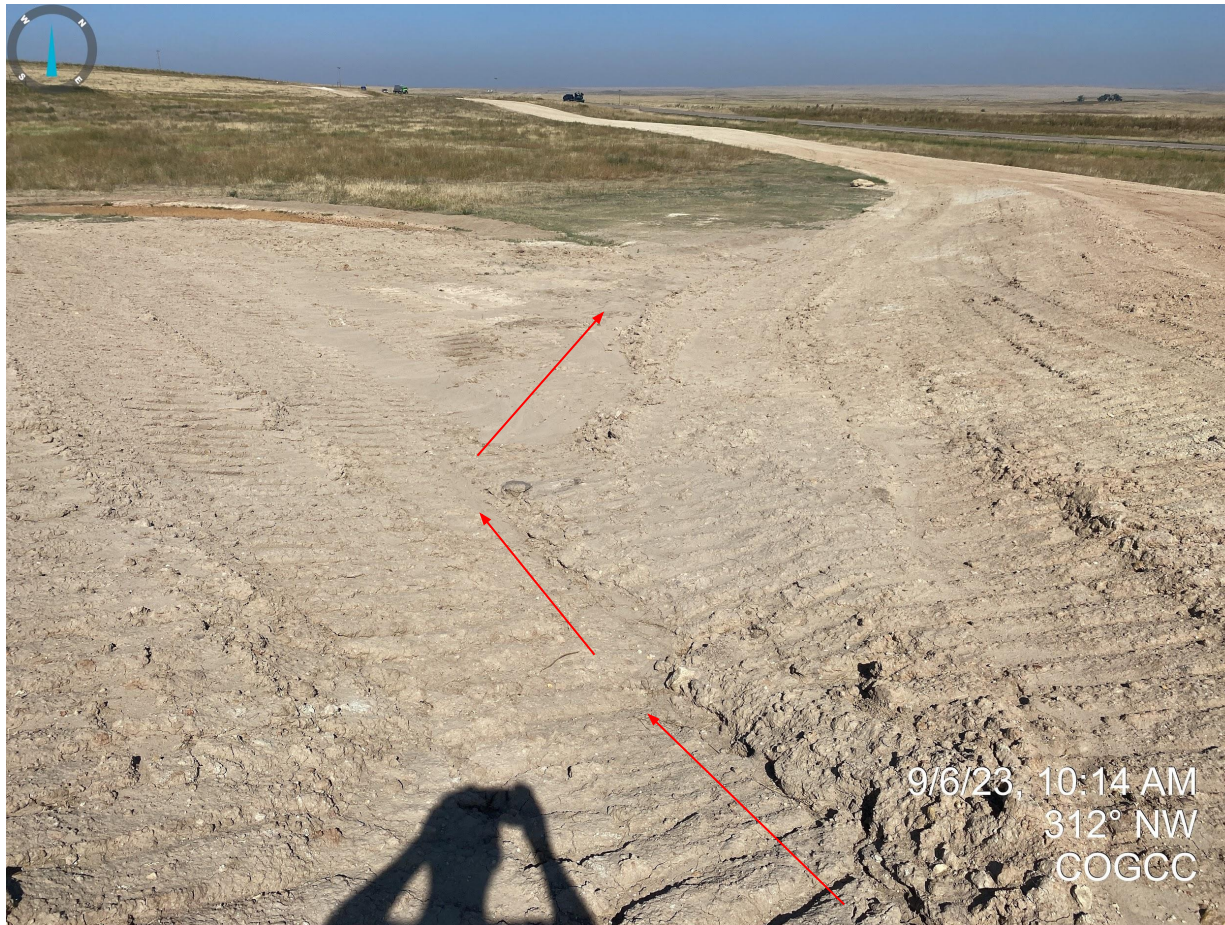
Photo 9. Taken north of the sediment trap. Erosion degradation (e.g. rilling) observed on slopes.

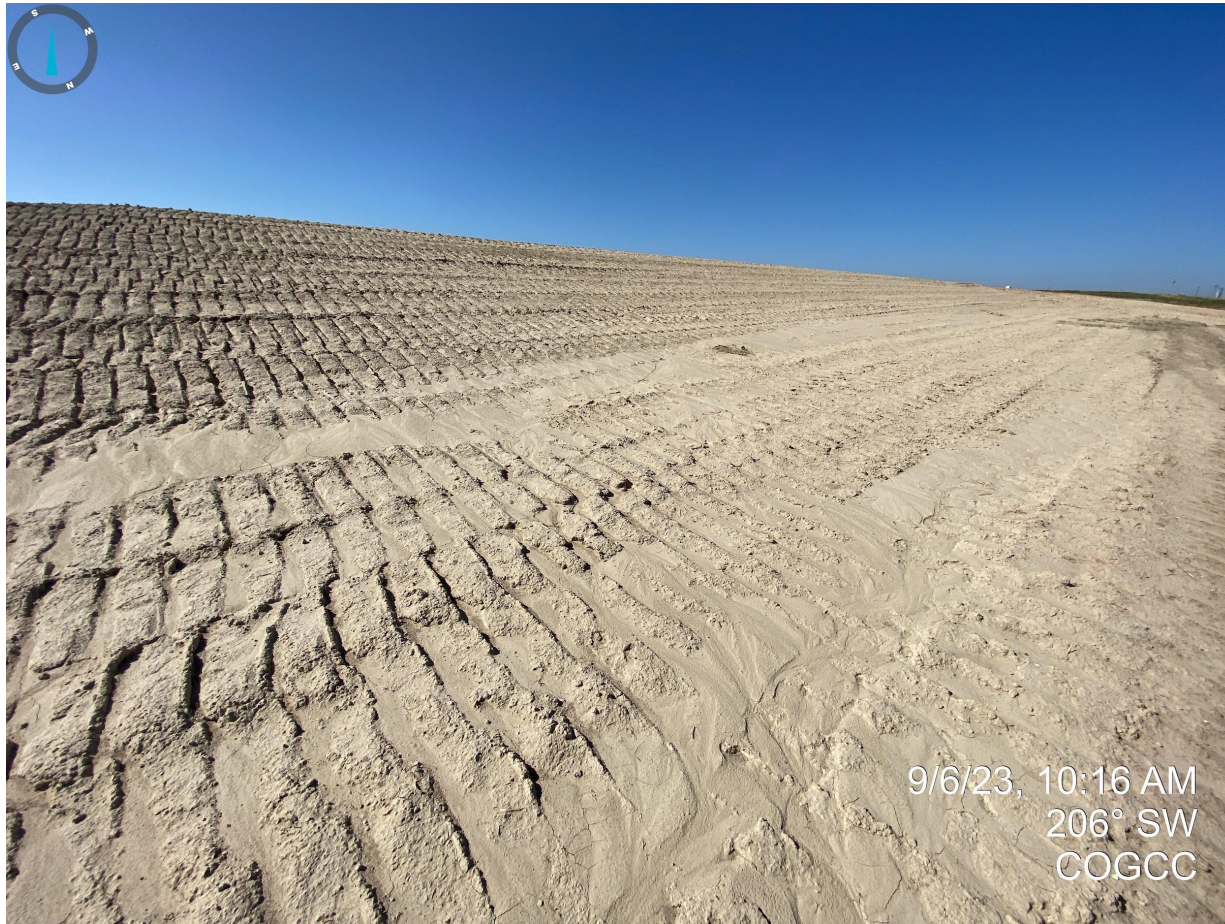
Photo 10. Taken north of the sediment trap. Photo illustrates erosion degradation (e.g. rilling) occurring from improper temporary stabilization techniques (equipment tracking that is parallel to slope).

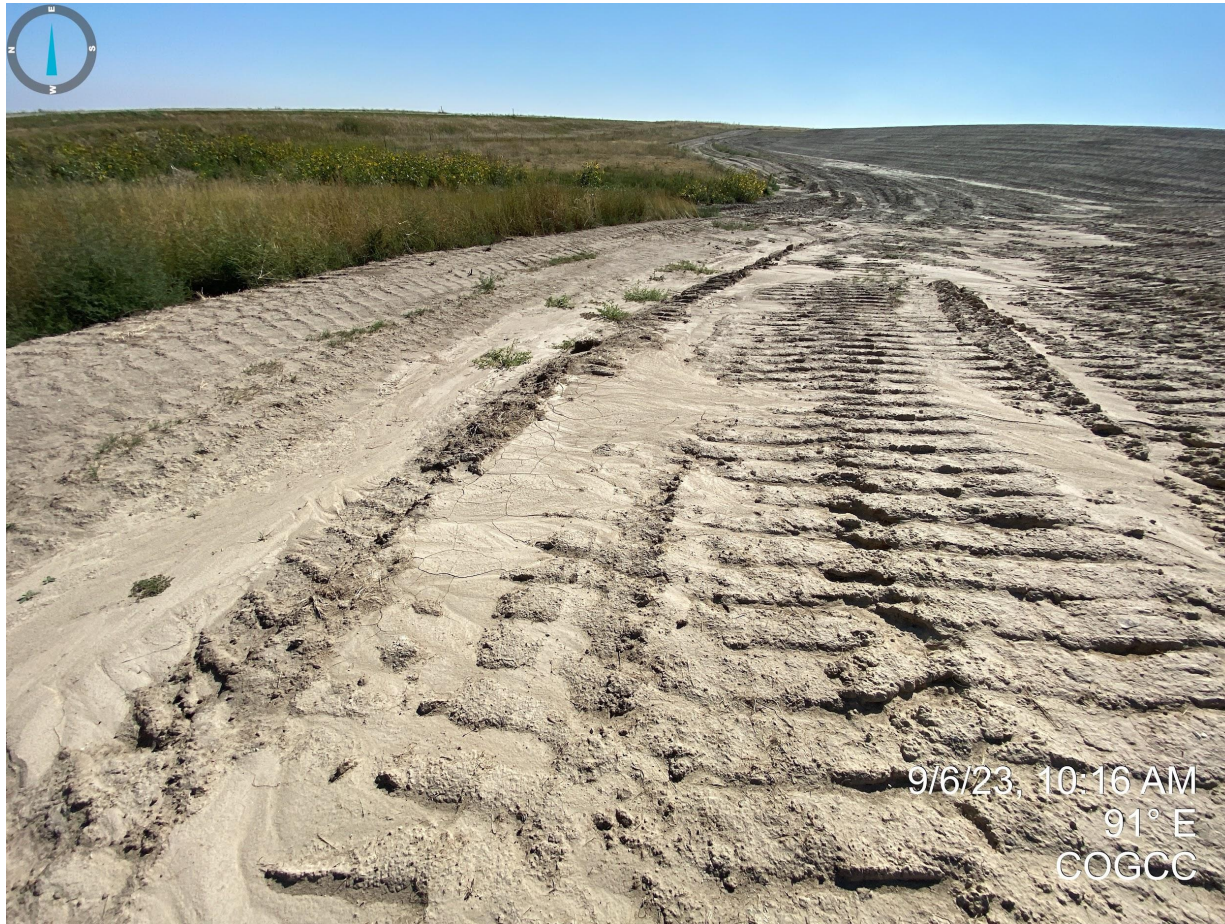
Photo 11. Taken north of the sediment trap. Photo illustrates sediment transport around the perimeter stormwater BMPs.

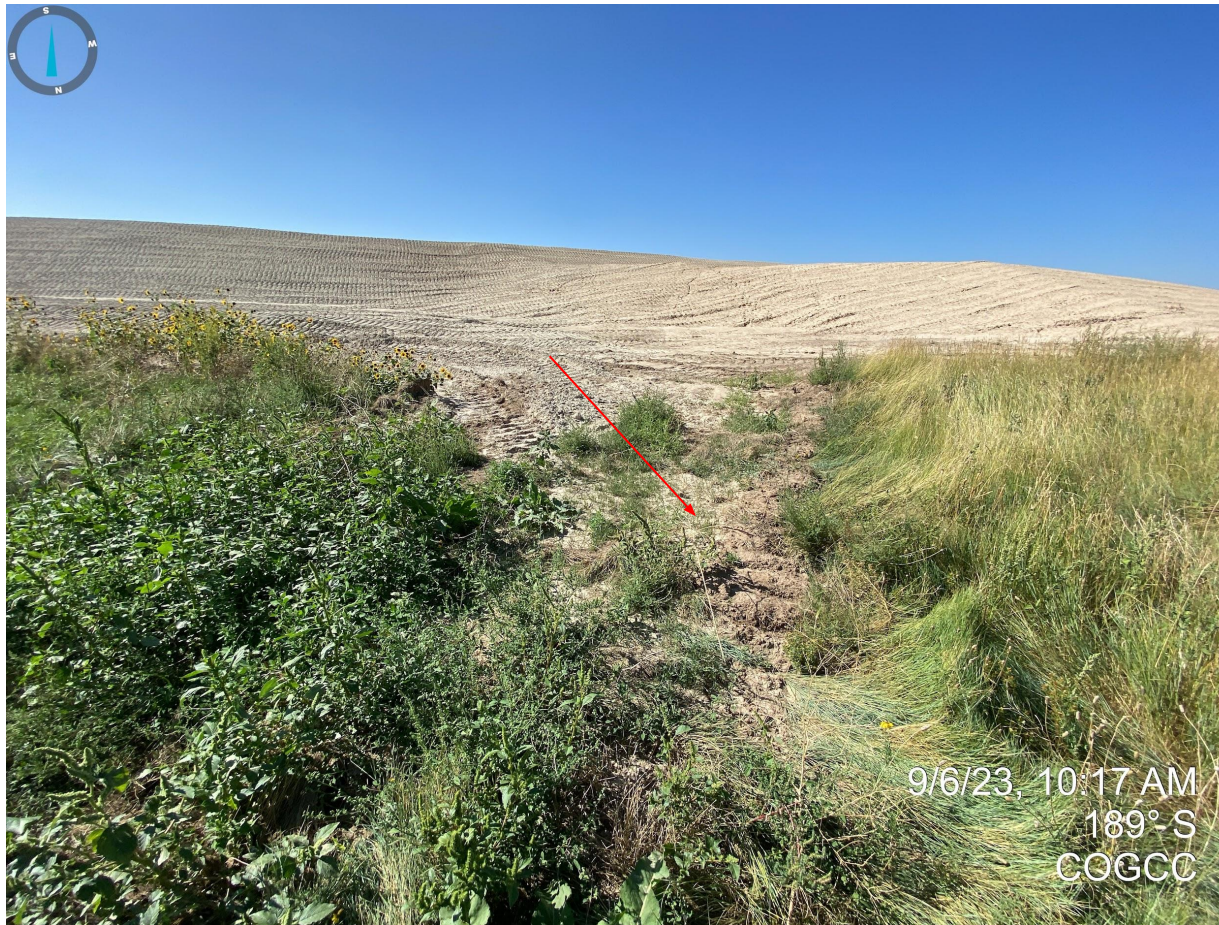
Photo 12. Taken north of the sediment trap. Photo illustrates off-location sediment transport into the adjacent areas. More robust stormwater control measures are required to prevent further erosion degradation.

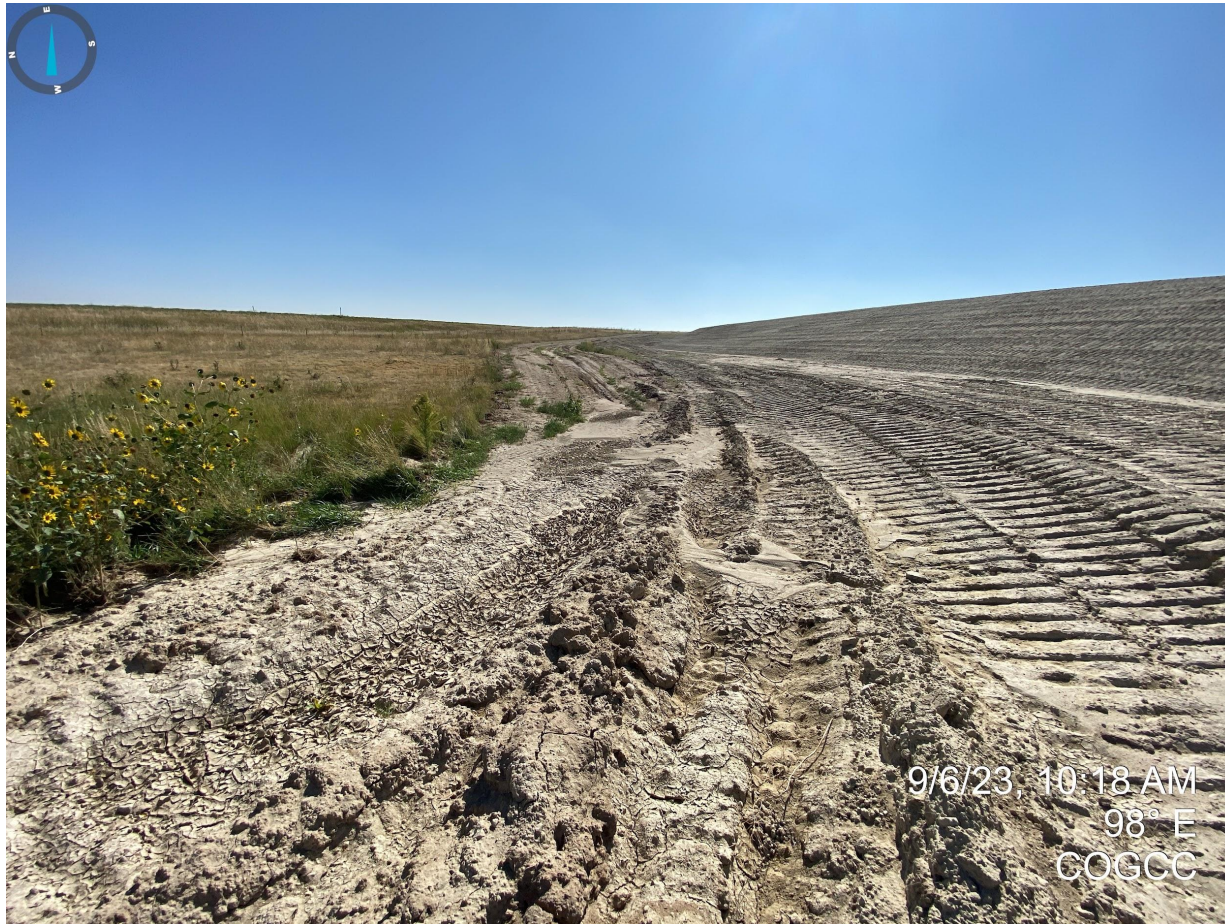
Photo 13. Taken north and east of the sediment trap. The perimeter stormwater ditch and berm requires maintenance and repairs.

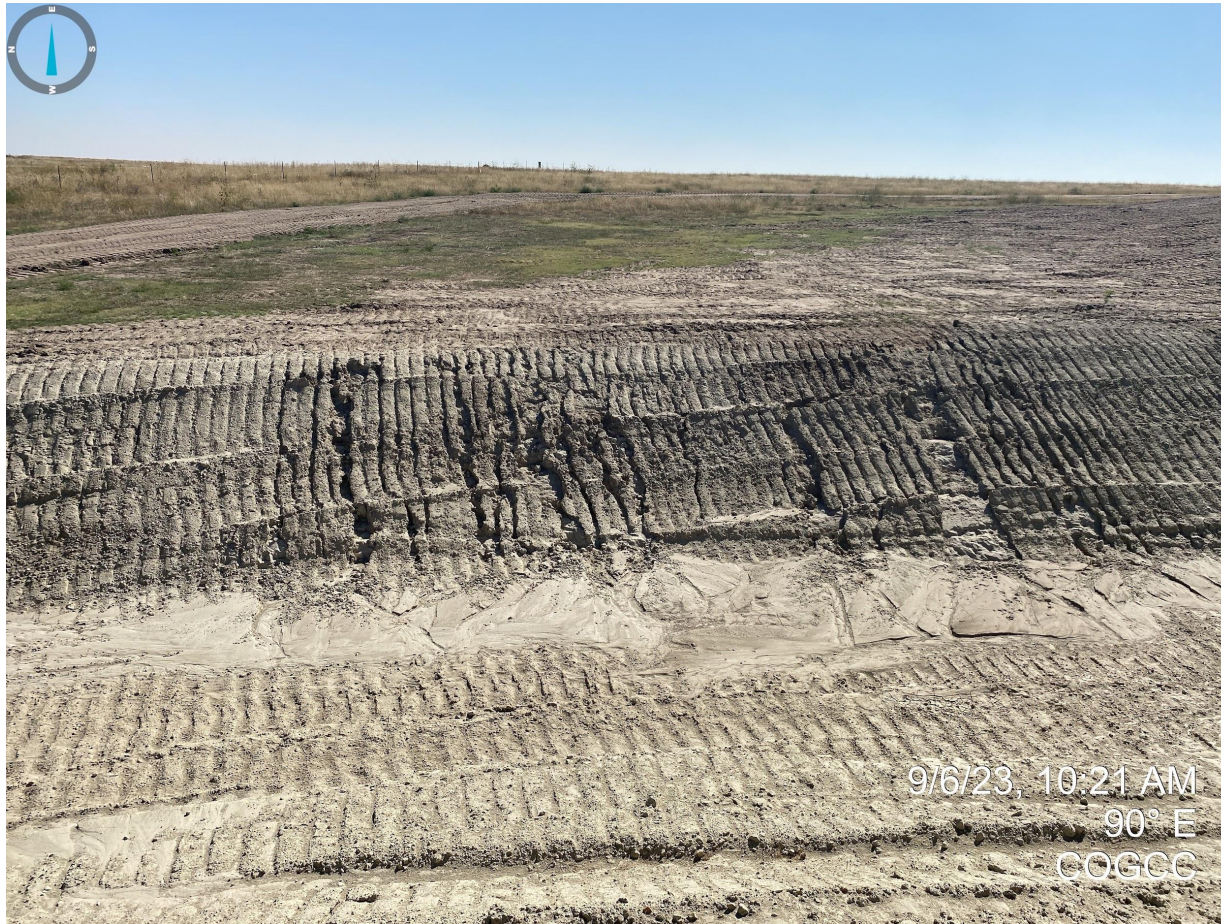
Photo 14. Taken near the northeast corner of the location. Photo illustrates erosion degradation (e.g. rilling) occurring from improper temporary stabilization techniques (equipment tracking that is parallel to slope). Also pictured, sediment transport into the stormwater ditch.

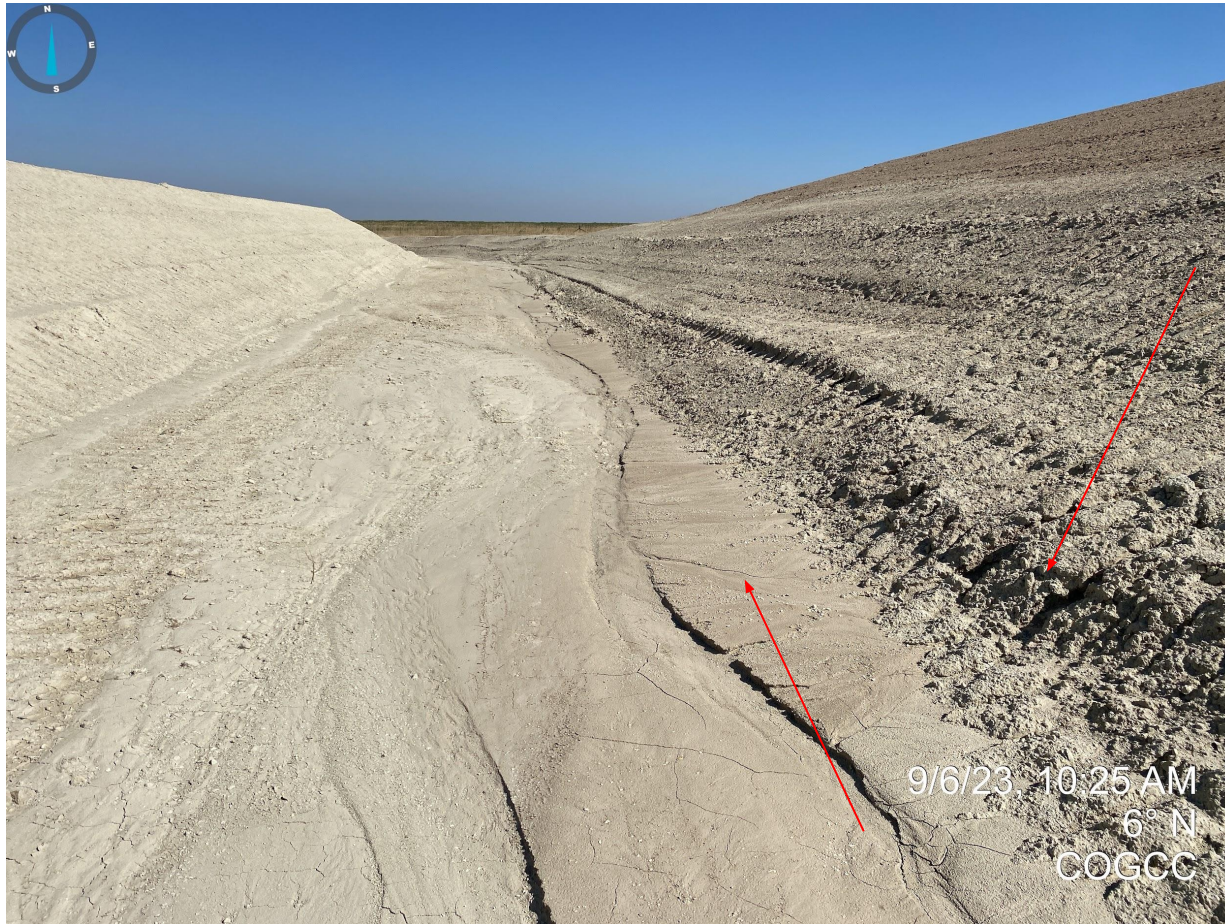
Photo 15. Taken from the eastern portion of the production area; see comments in Photo 14.

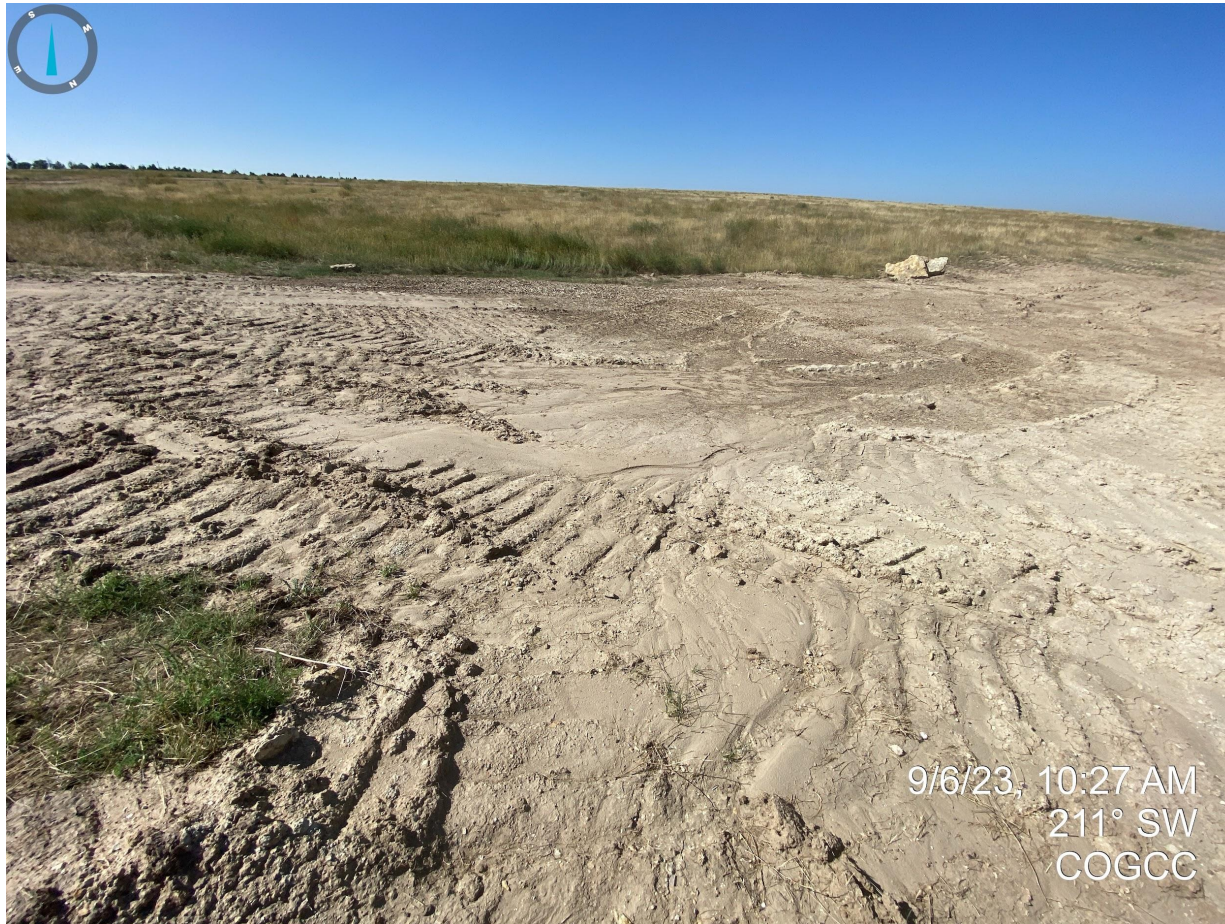
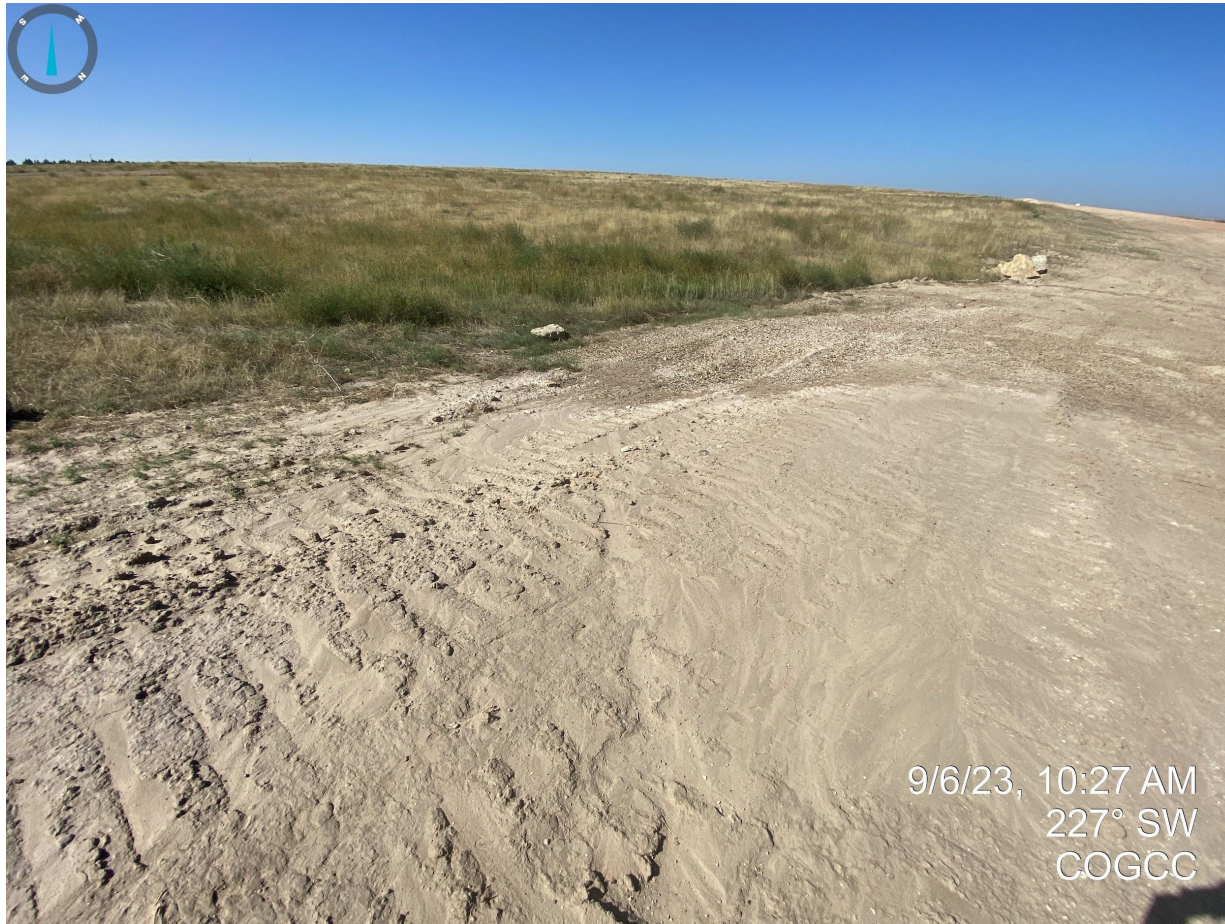
Photo 18. Taken from the southeast corner of the production area. No apparent stormwater control measures were identified to manage run on or runoff from the production areas.

Photo 19. Continued from Photo 18.

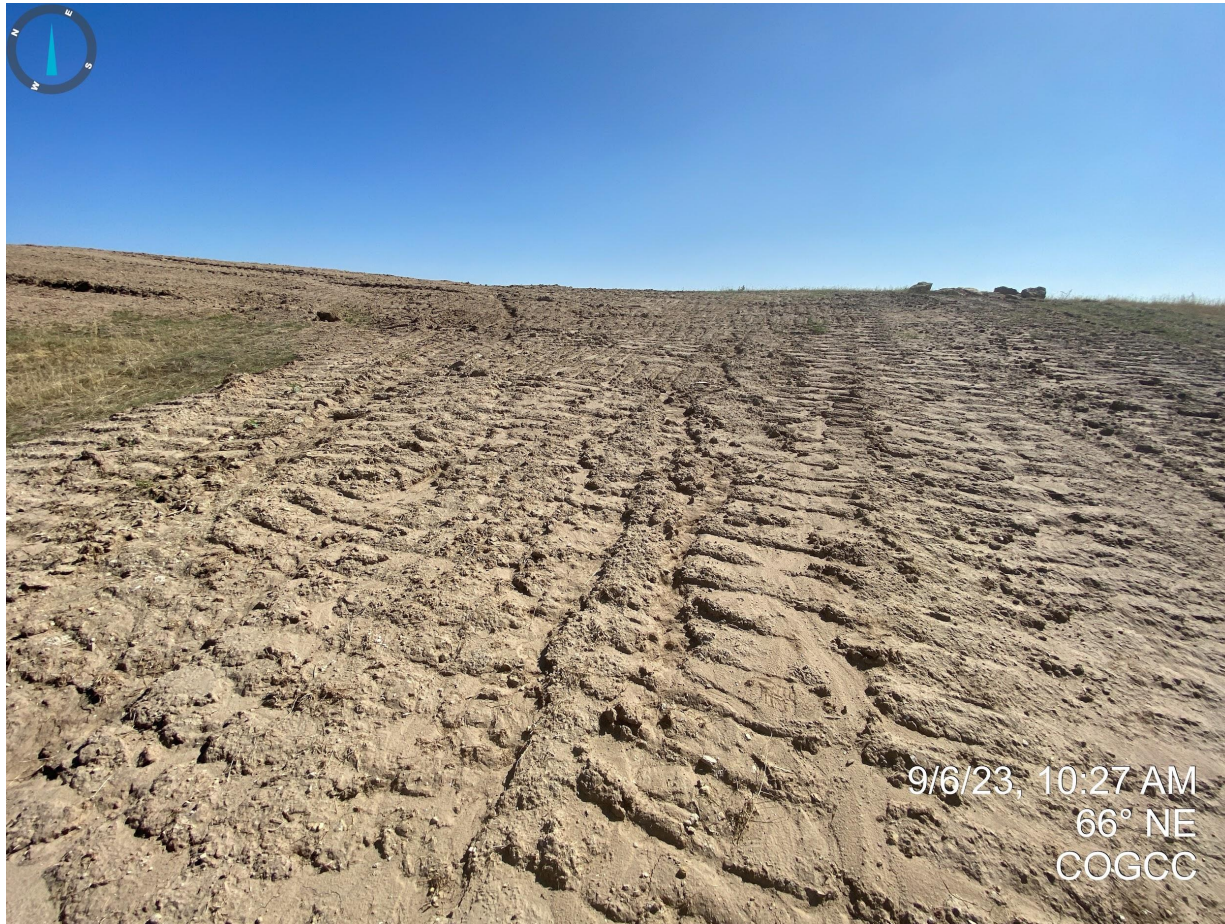
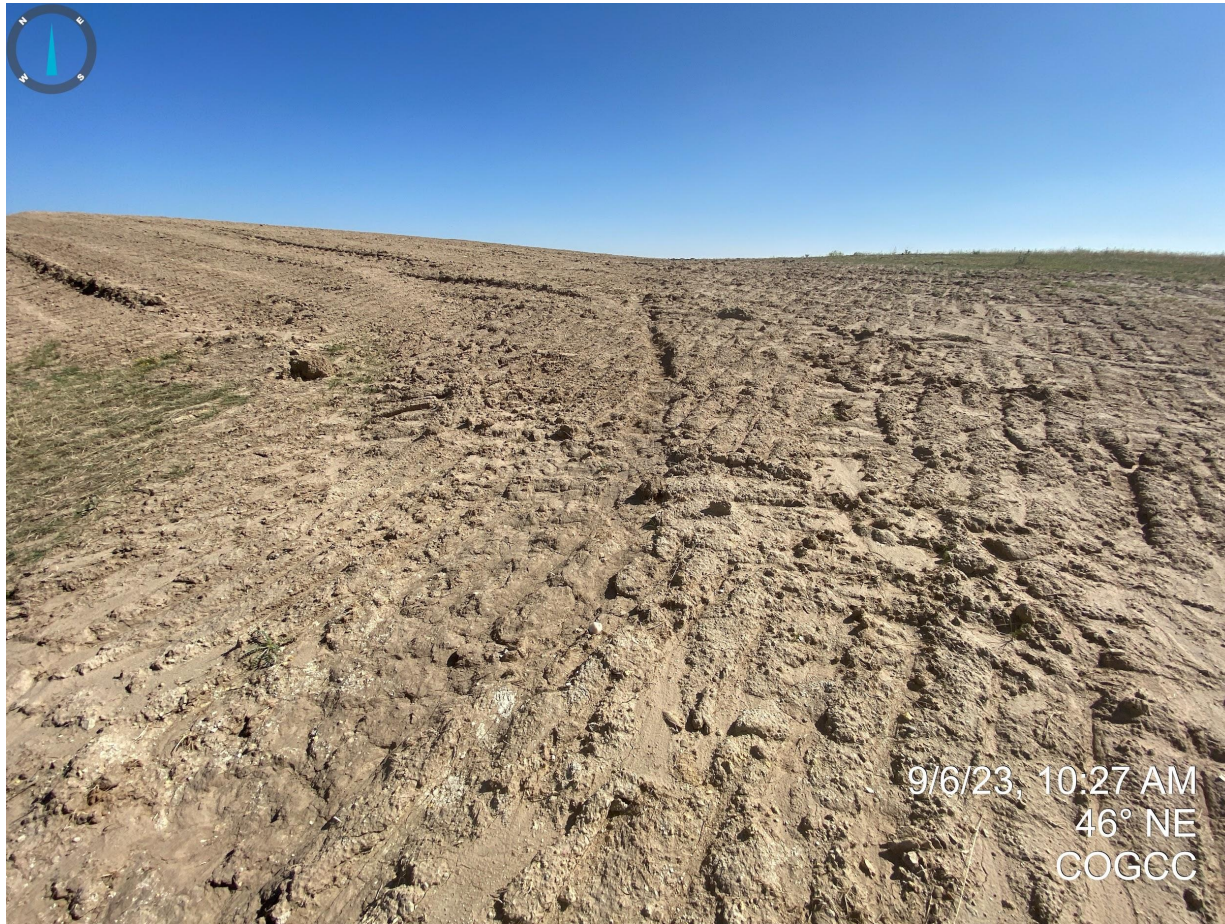
Photo 20. Taken from the southwestern end of the topsoil stockpile area. Erosion degradation (e.g. rilling) observed.

Photo 21. Continued from Photo 20.
