Construction and Stormwater Inspection

Date: 09/15/2023

Operator: MDS ENERGY DEVELOPMENT LLC - 10814

Inspection Photos
Location Name: Daffy Pad
Location ID: 477495

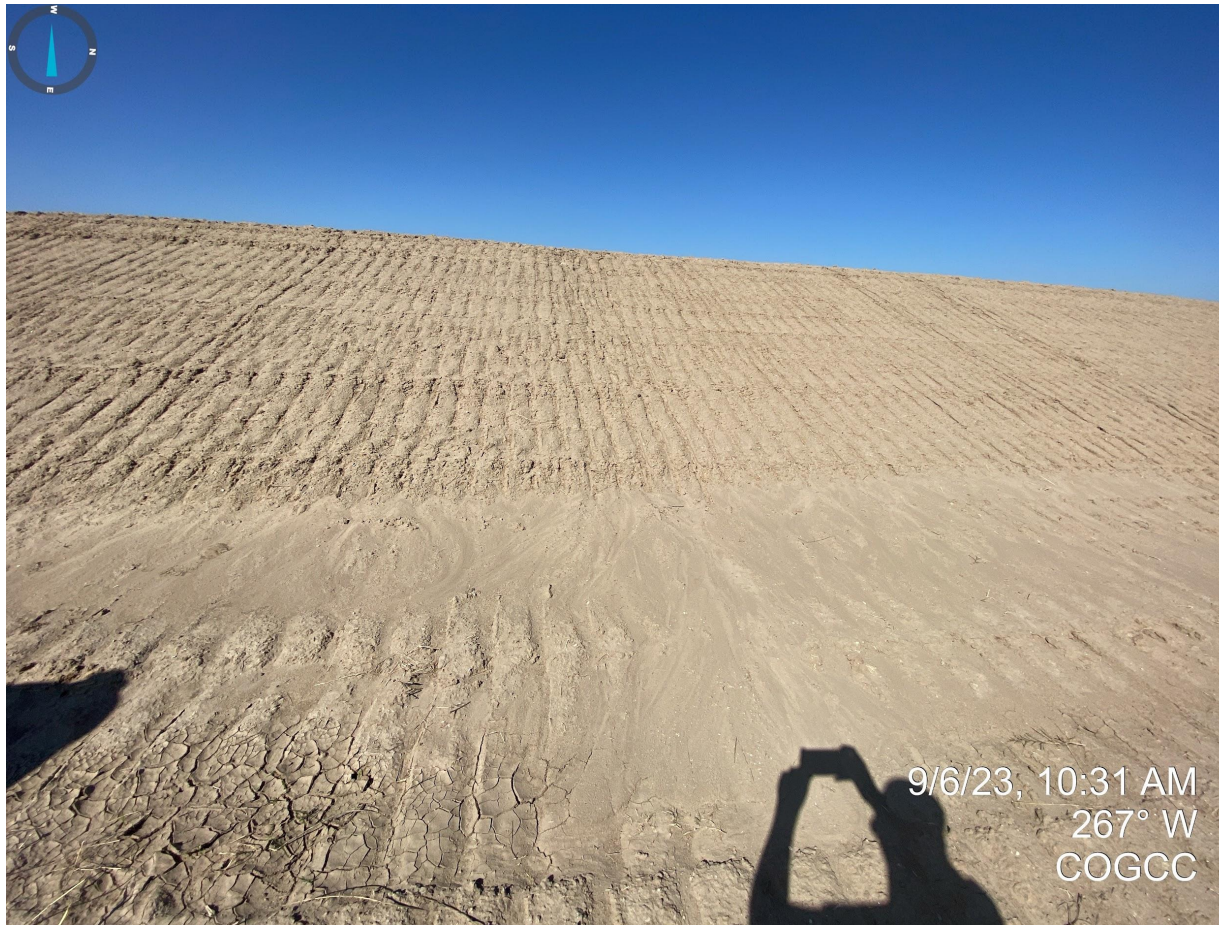
Photo 22. Taken from the eastern side of the topsoil stockpile. Photo illustrates erosion degradation (e.g. rilling and sediment transfer) occurring from improper temporary stabilization techniques (equipment tracking that is parallel to slope).

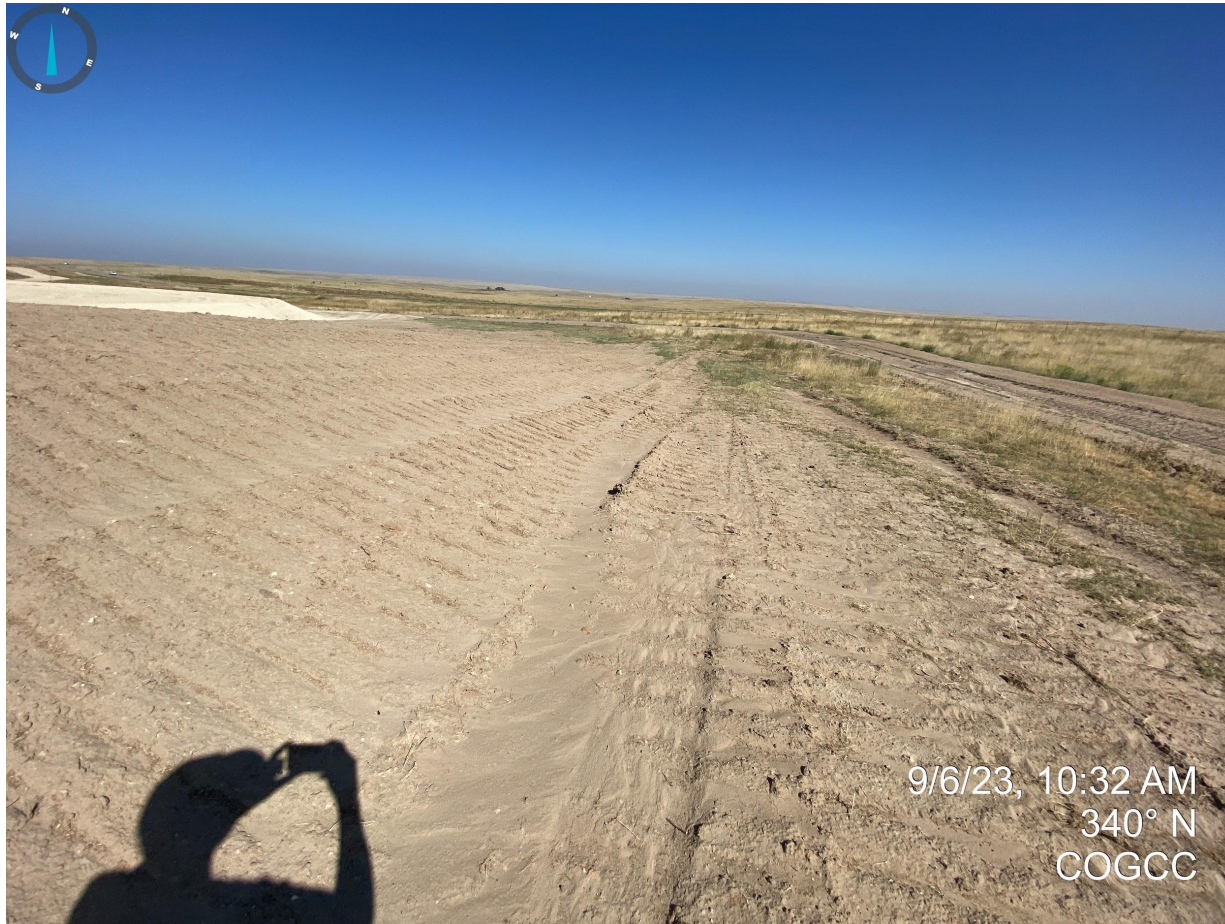
Photo 23. Taken from the northeastern corner of the topsoil stockpile; see comments in Photo 22.

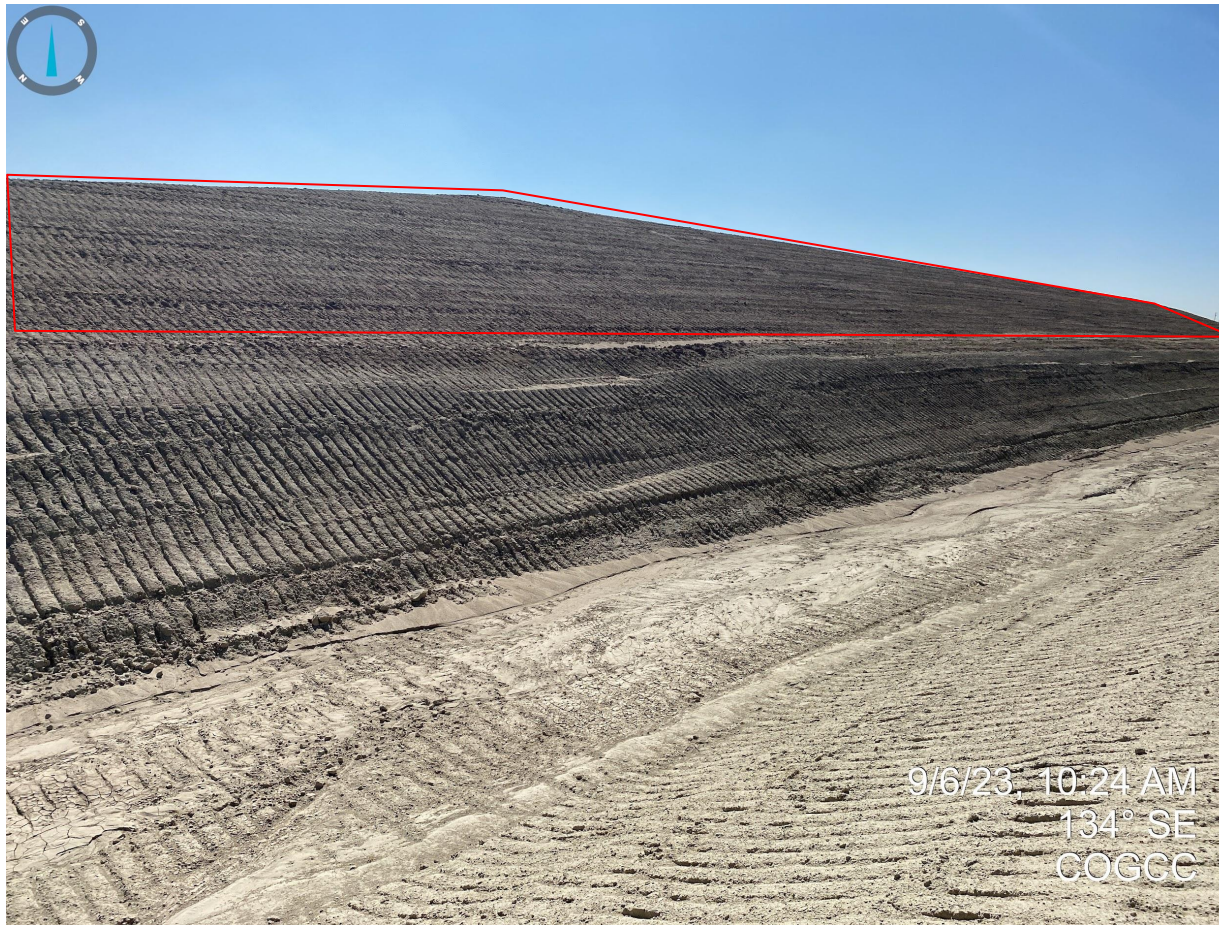
Photo 24. Taken from the northeastern portion of the topsoil stockpile. Photo (red outline) illustrates that the slopes of the stockpile are not properly stabilized as the equipment tracking is parallel to the slope or grade. Additional stabilization techniques are required to prevent degradation to the topsoil stockpile.

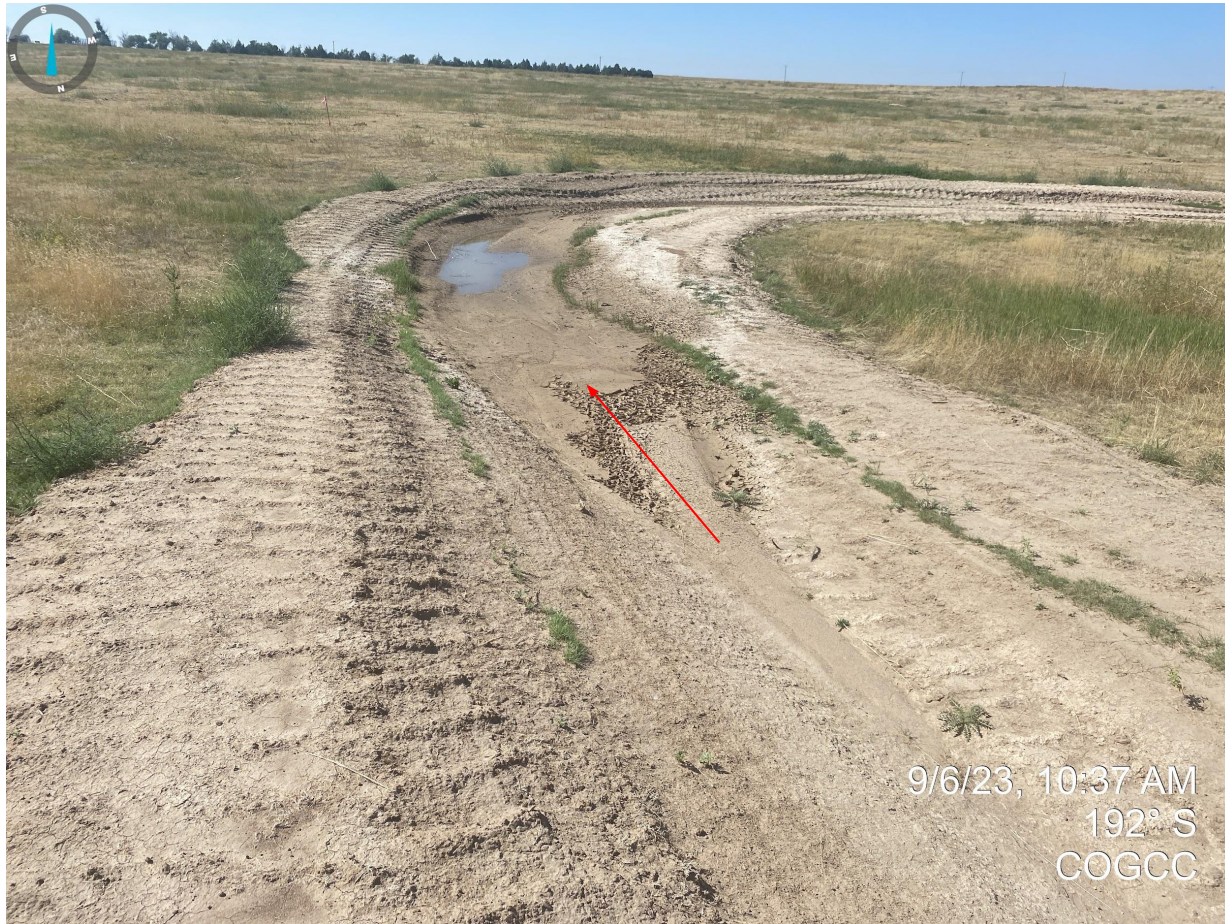
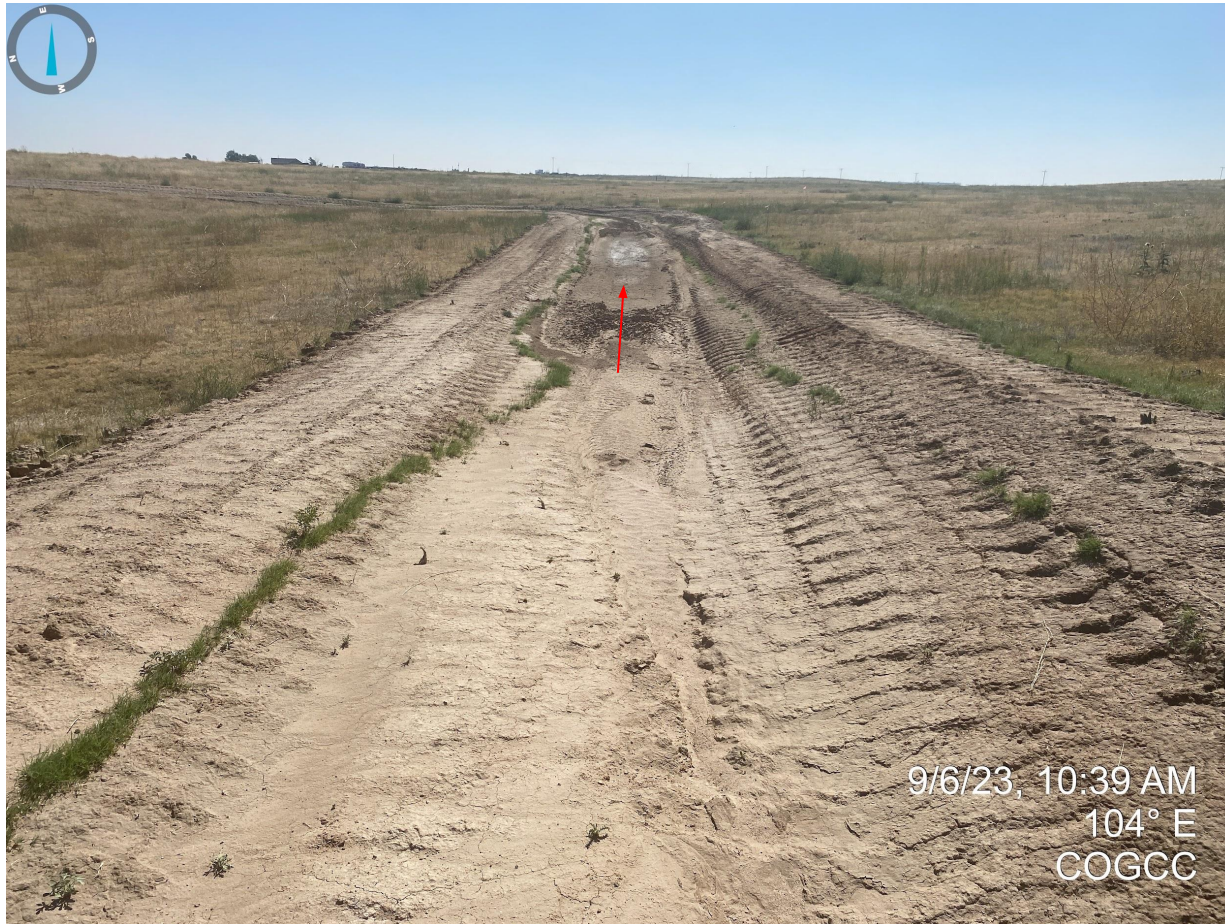
Photo 25. Taken from the southeast corner of the location. The perimeter stormwater controls are beginning to fill with sediment and require maintenance.

Photo 26. Continued from Photo 25.

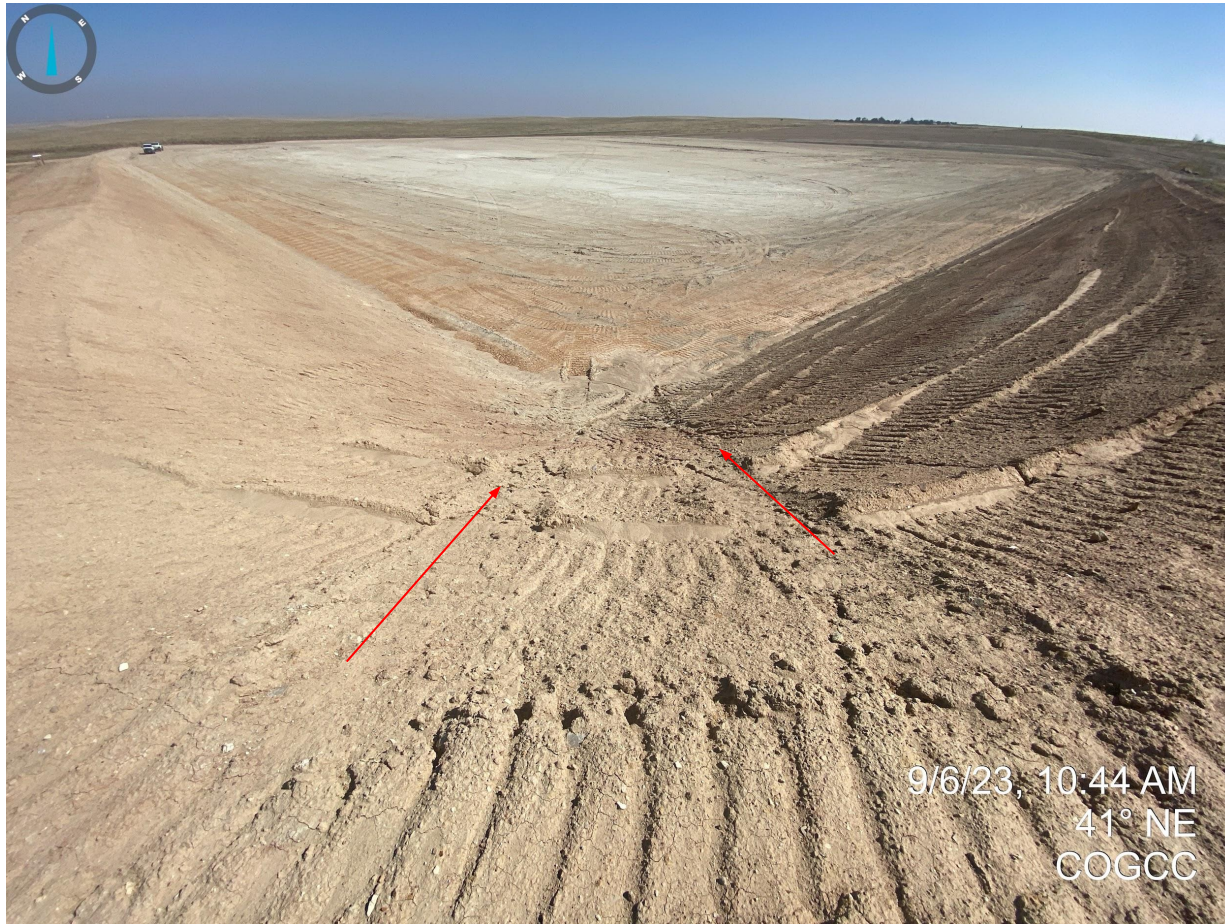
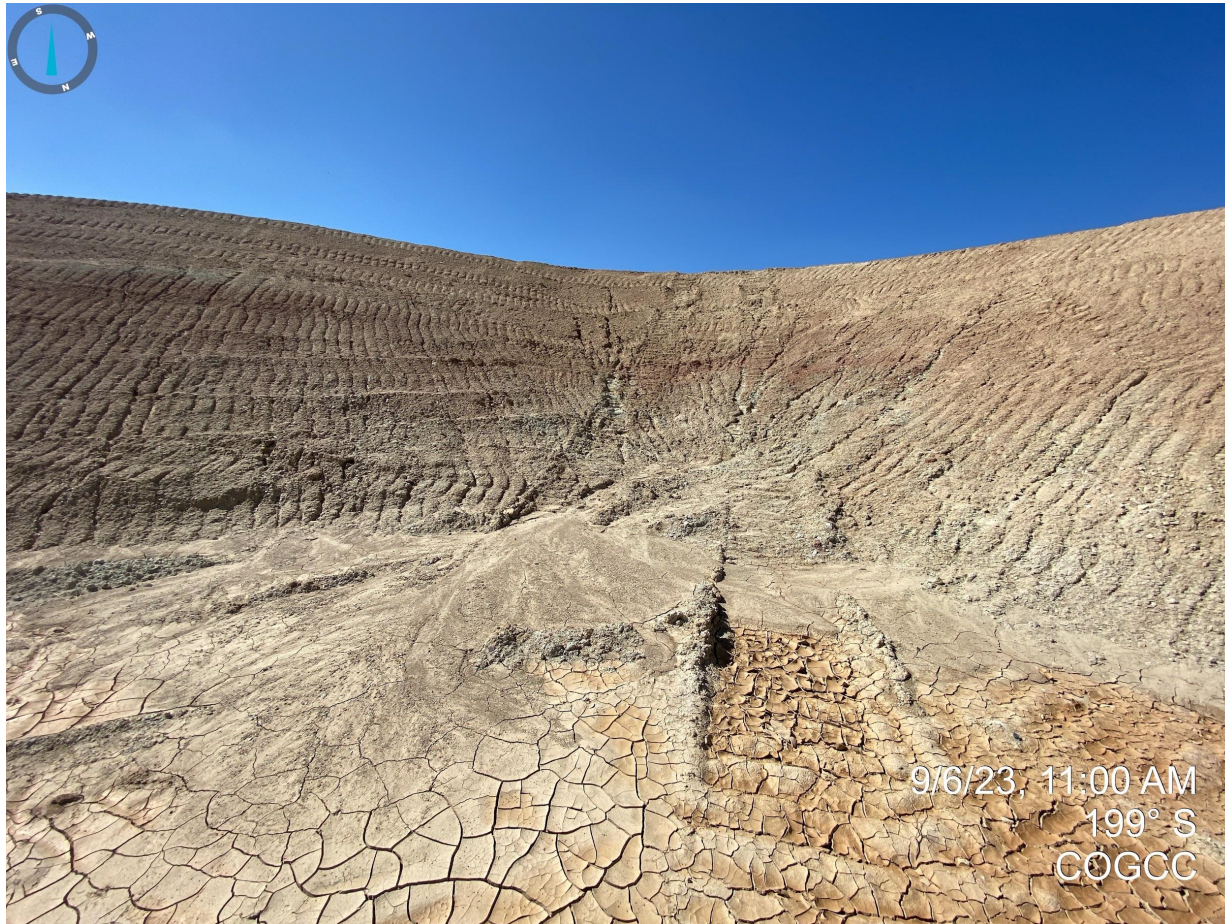
Photo 27. Taken from the southwestern portion of the production area. Photo illustrates erosion degradation (e.g. rilling) occurring from improper temporary stabilization techniques (equipment tracking that is parallel to slope).

Photo 28. Continued from Photo 27.

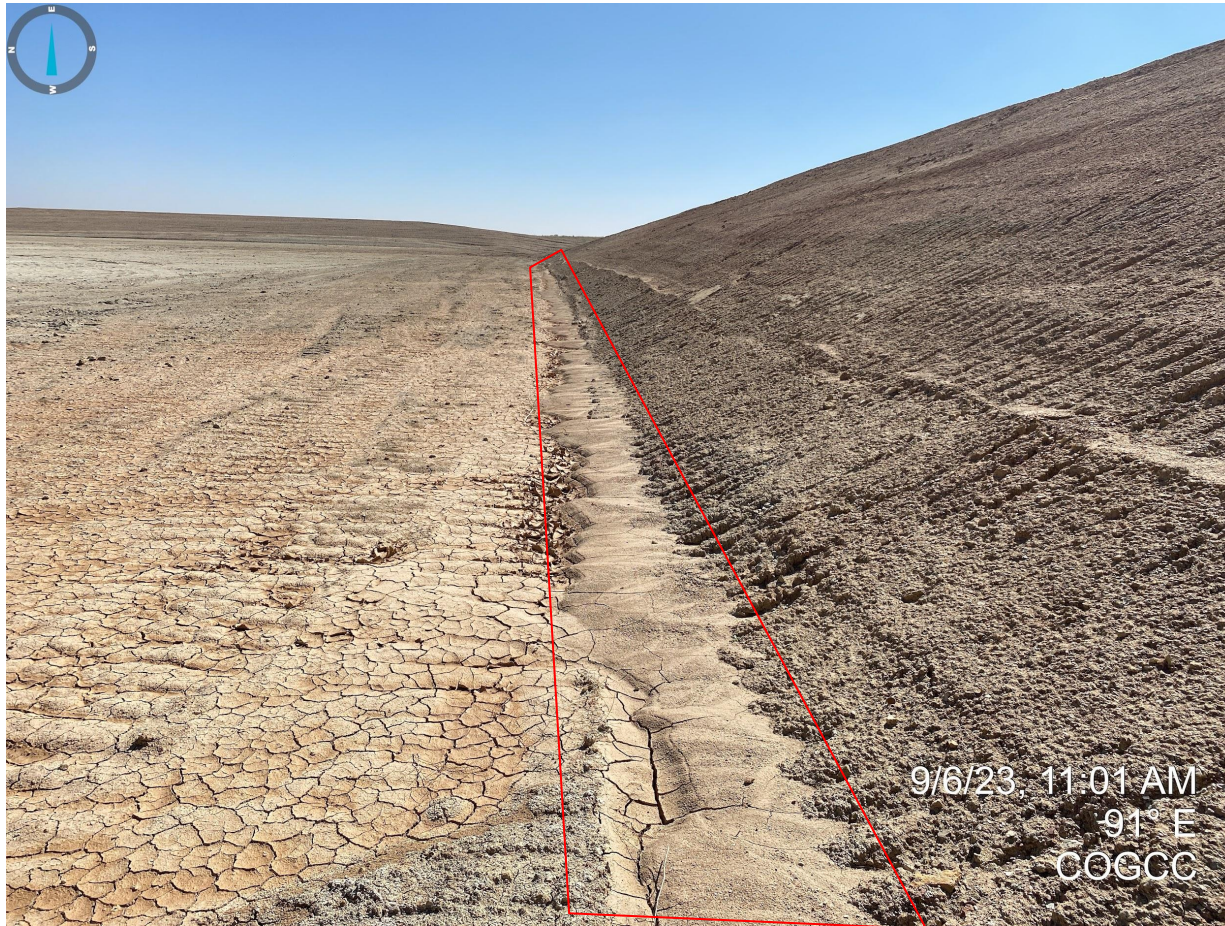
Photo 29. Continued from Photo 27 & 28. Sediment transport onto the production areas pictured.

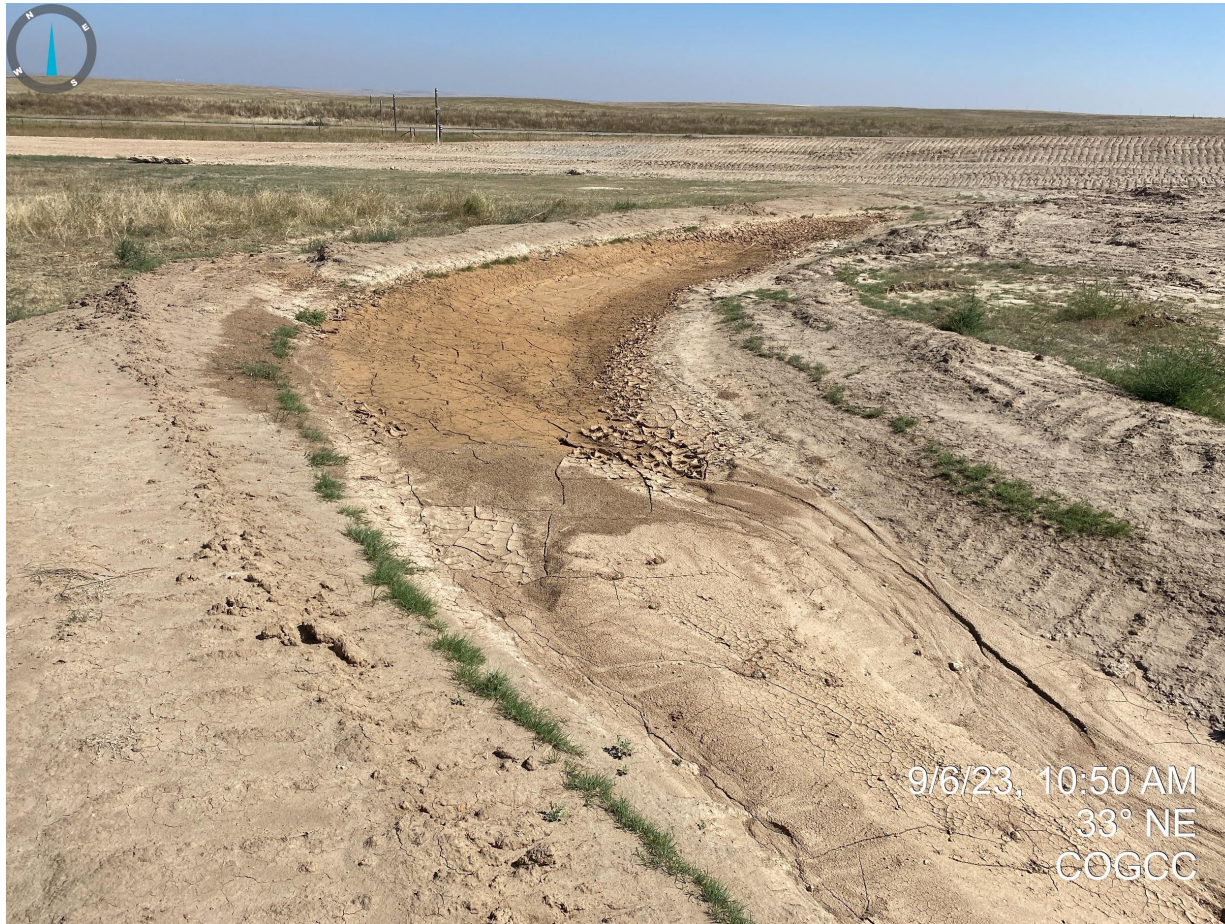
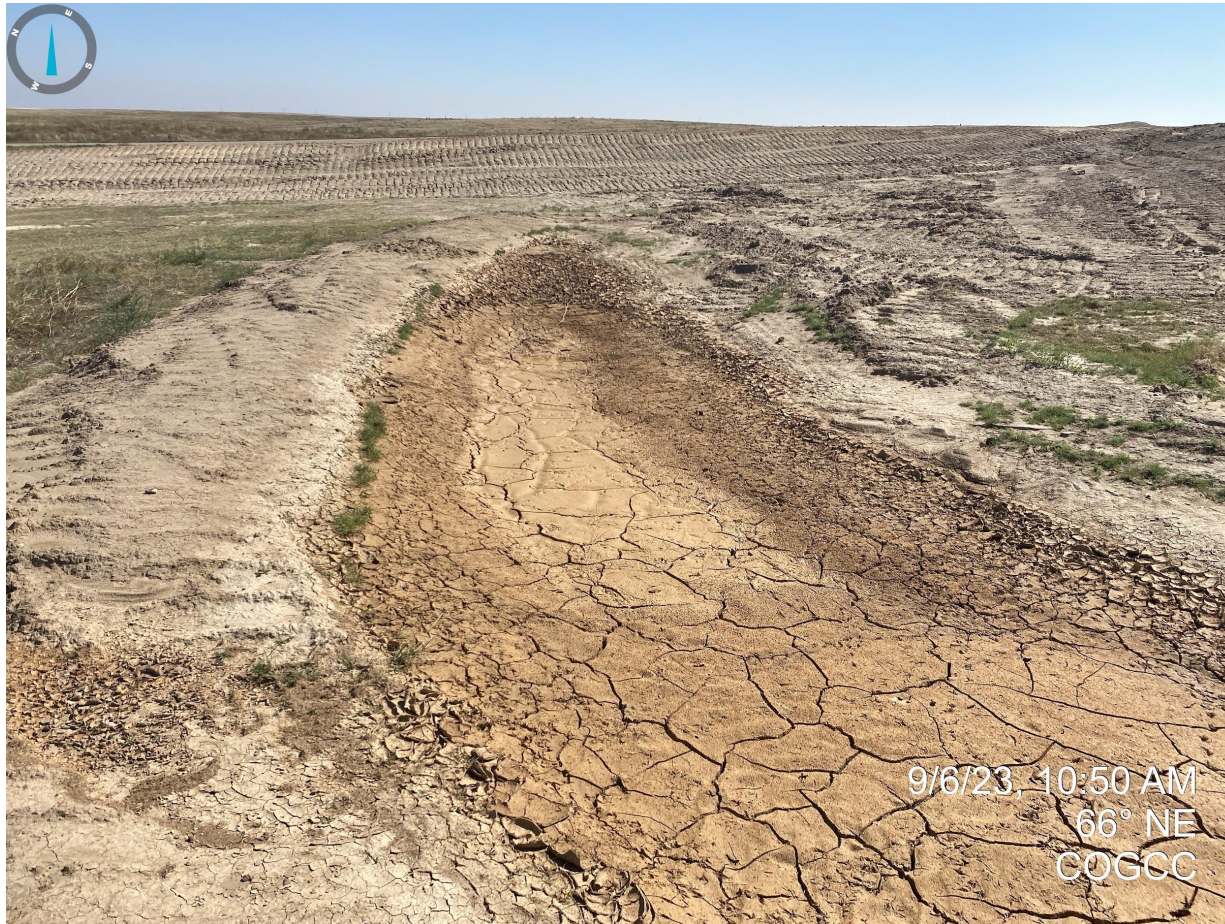
Photo 30. Taken from the northwest corner of the location. The perimeter stormwater controls are beginning to fill with sediment and require maintenance.

Photo 31. Continued from Photo 30.

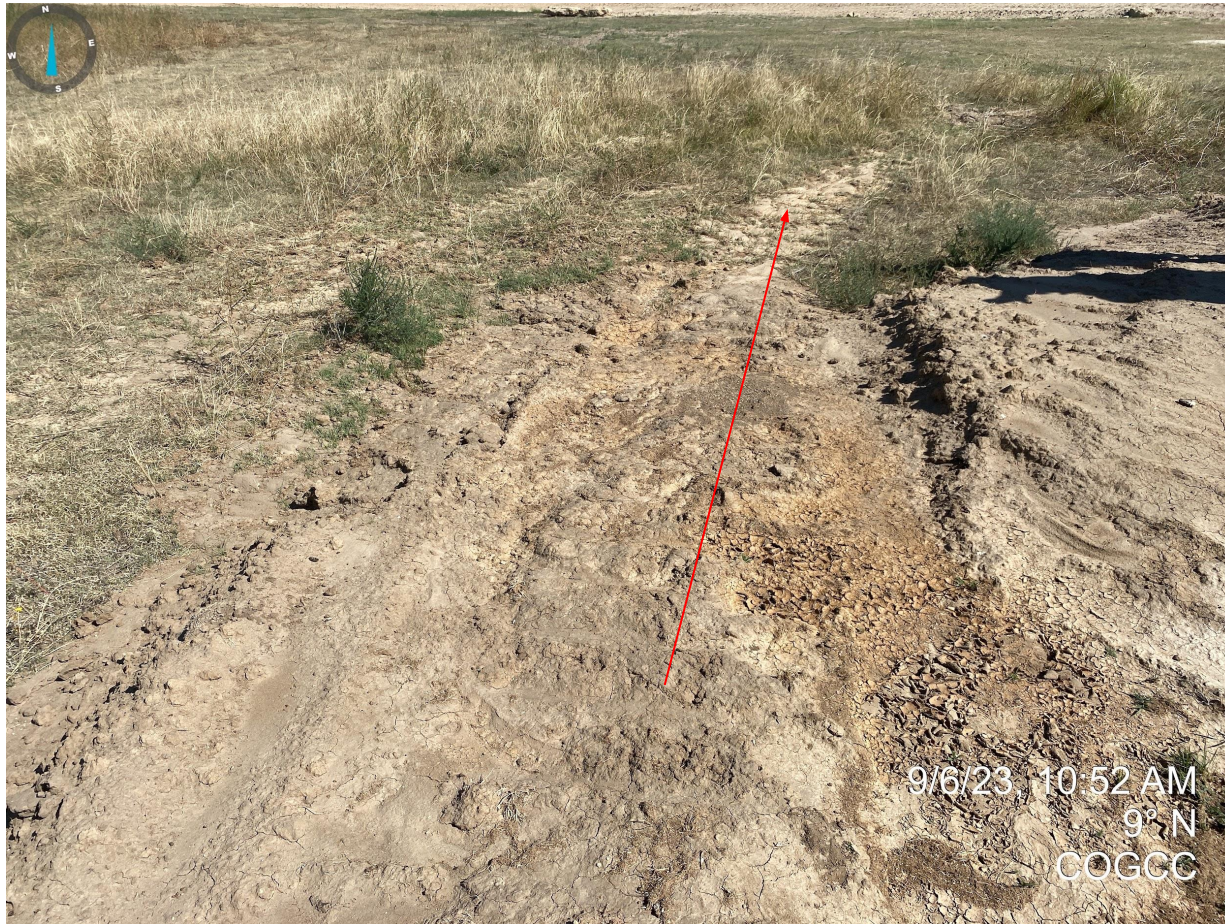
Photo 32. Continued from Photo 30 & 31. Photo illustrates that perimeter stormwater controls do not appear to be adequate to control stormwater runoff with evidence of off location sediment transport.

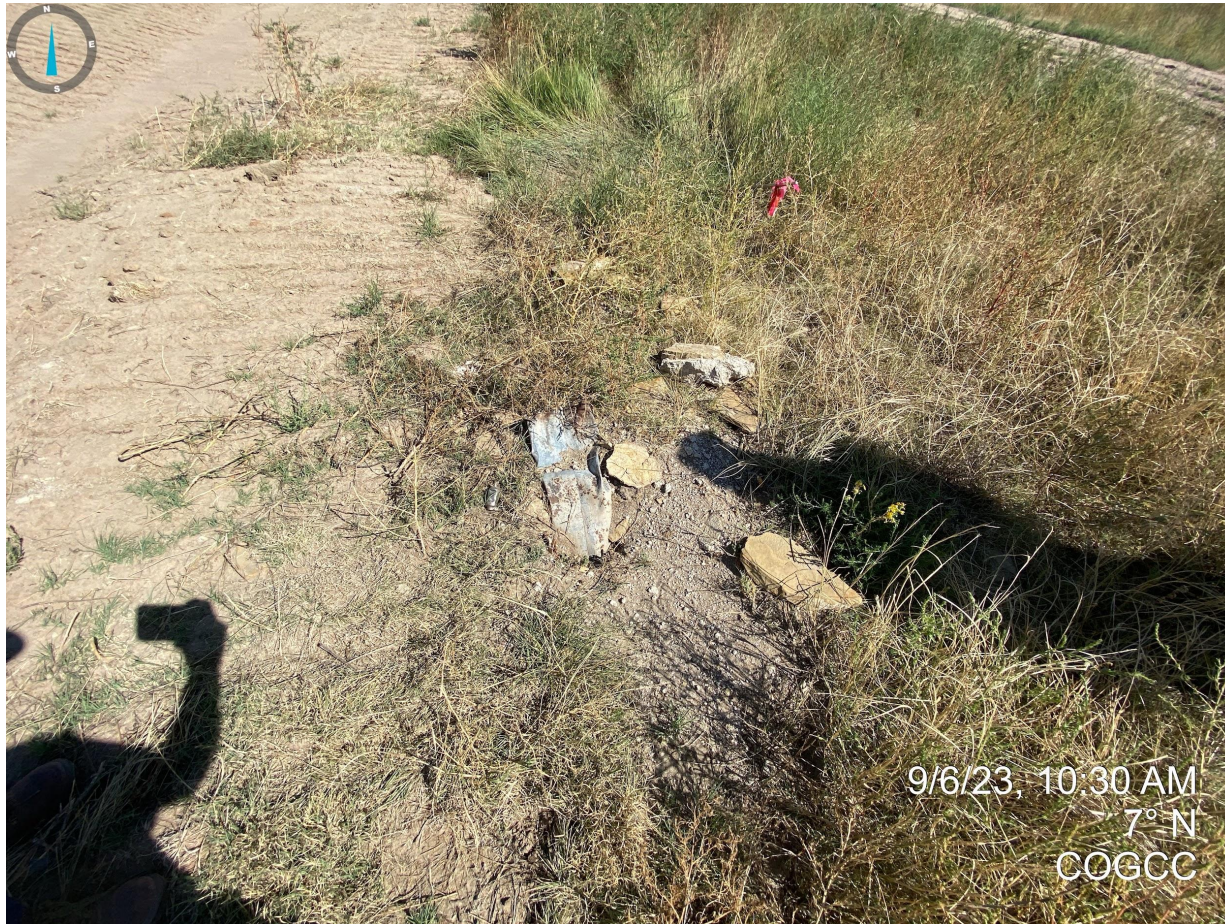
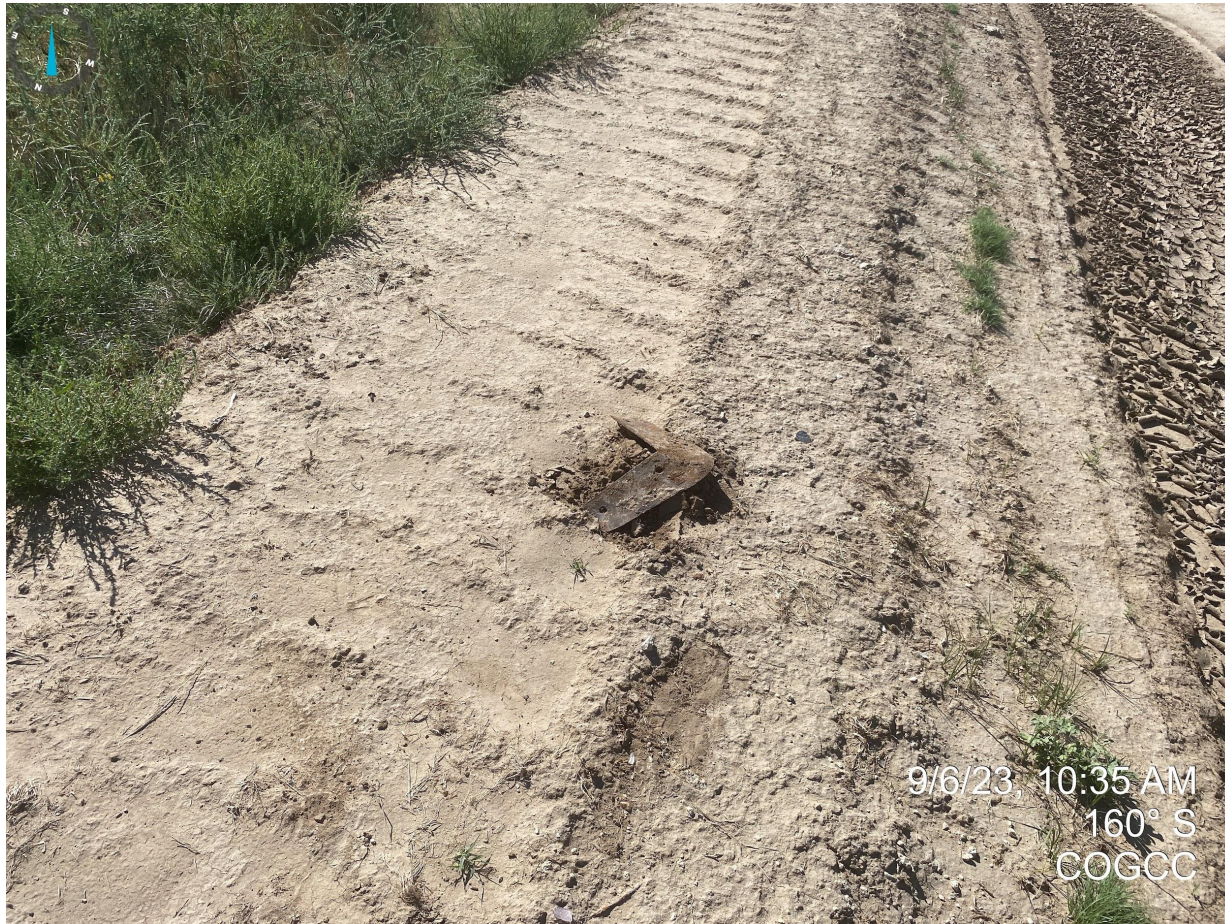
Photo 33. Trash and debris observed on the east side of the location, next to the topsoil stockpile.

Photo 34. Continued from Photo 33.
