Construction and Stormwater Inspection

Operator: VERDAD RESOURCES LLC - 10651

Location ID: 481827

Inspection Photos
Location Name: Peanut Fed 3403
Location ID: 481827

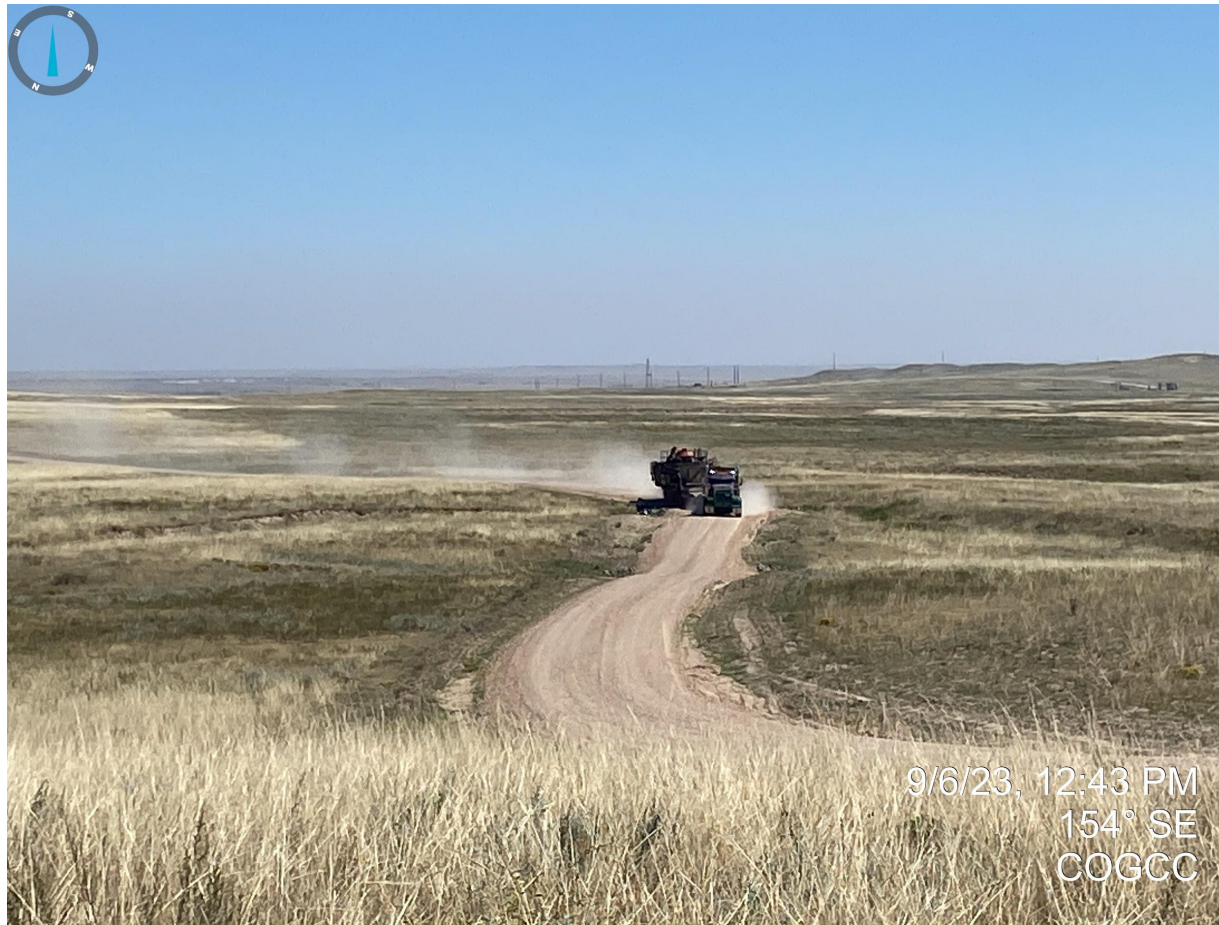
Photo 1. Taken from the entrance to the access road. Photo illustrates fugitive dust occurring from vehicle traffic. The Operator shall take actions to control fugitive dust per Rule 427.c.

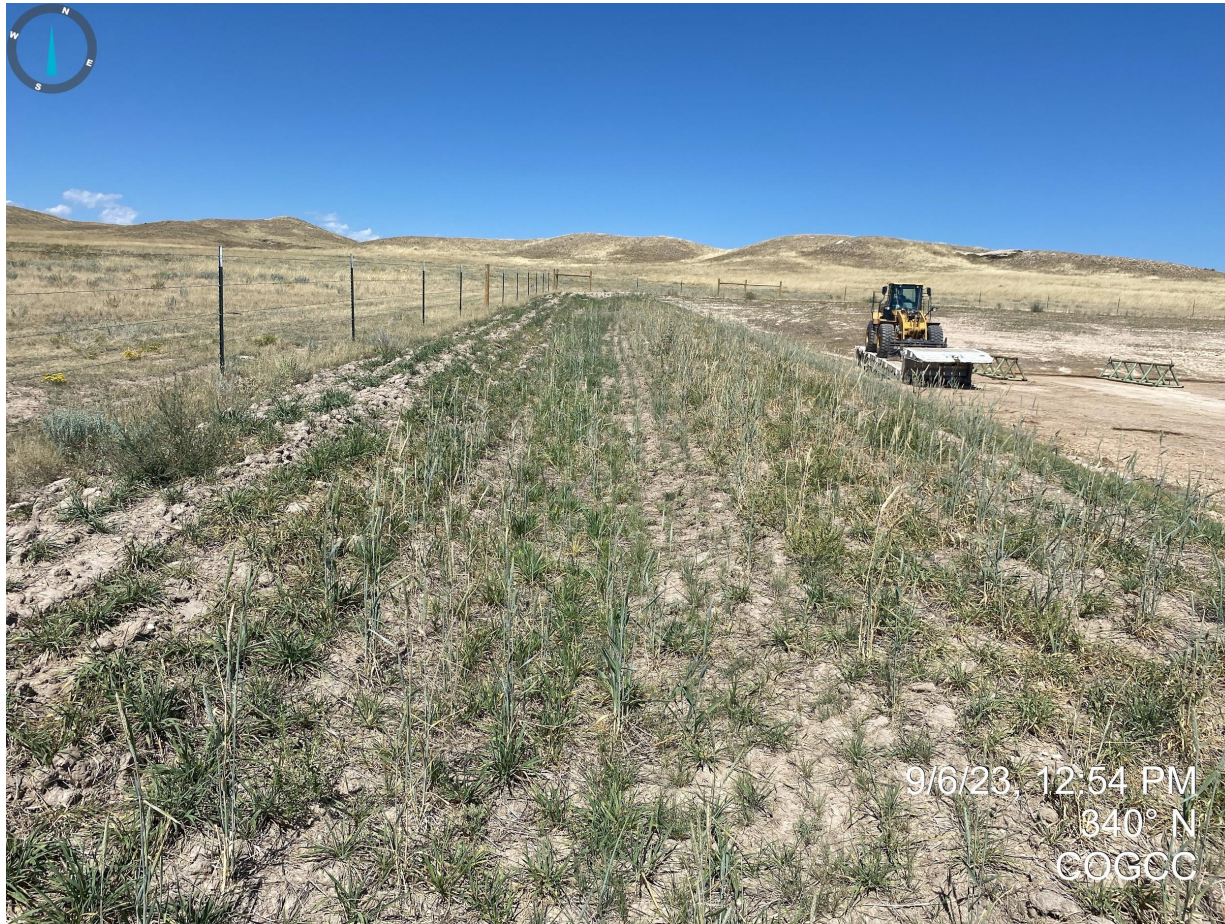
Photo 2. Taken near the locations entrance. It appears the Operator planted an annual crop species (e.g. triticale) as part of temporary stabilization. The Operator shall ensure the location is stabilized for longer term by utilizing desirable perennial plant species reflective of adjacent reference areas.

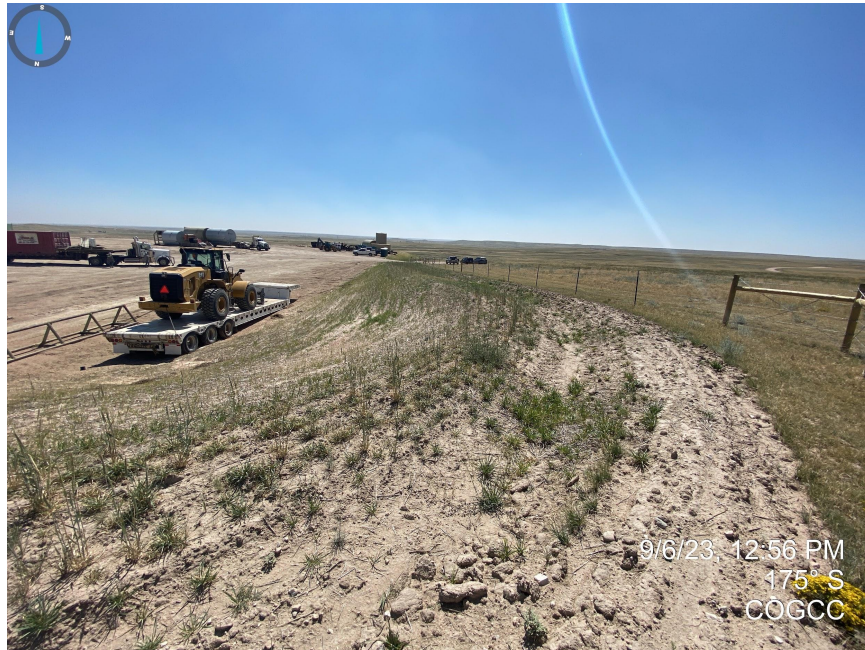
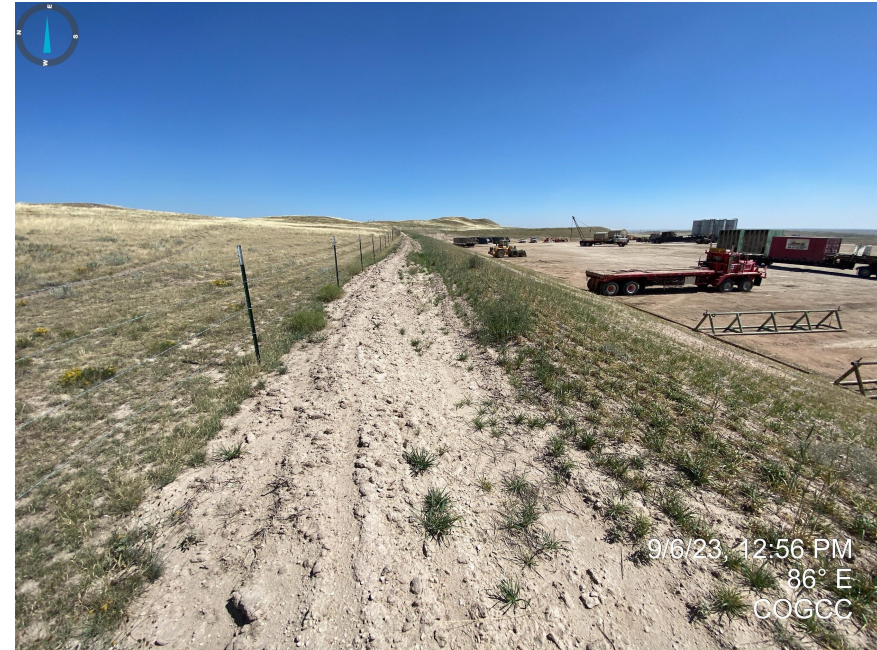
Photos 3 & 4. Taken from the northwest corner of the location. Photo illustrates that the perimeter ditch and berm BMP is comprised of unconsolidated material and is not properly stabilized. Additional maintenance/repairs are required.

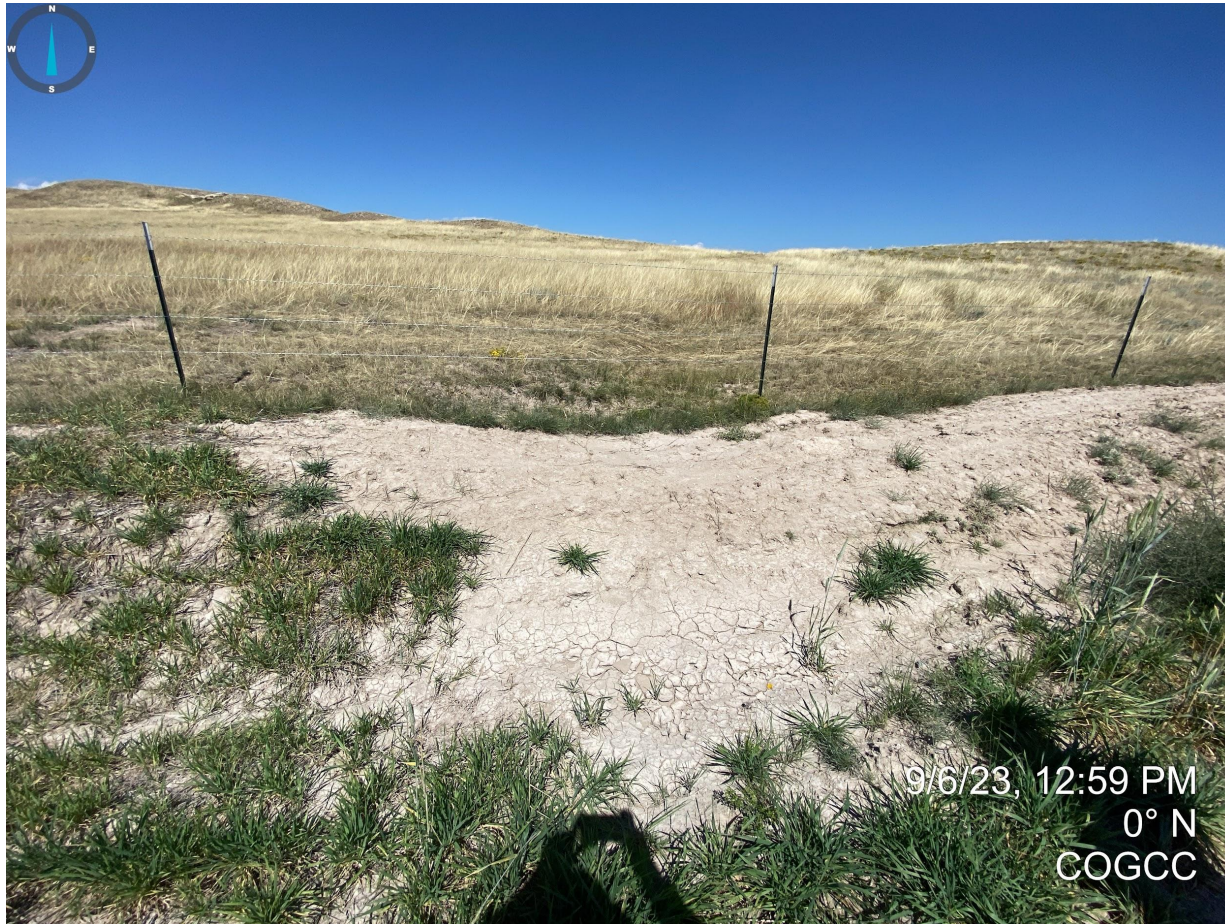
Photo 5. Taken from the center/northern portion of the location. Photo illustrates that the perimeter stormwater controls/BMPs do not appear to be adequate at controlling stormwater run on with evidence of sediment transport into the diversion ditch.

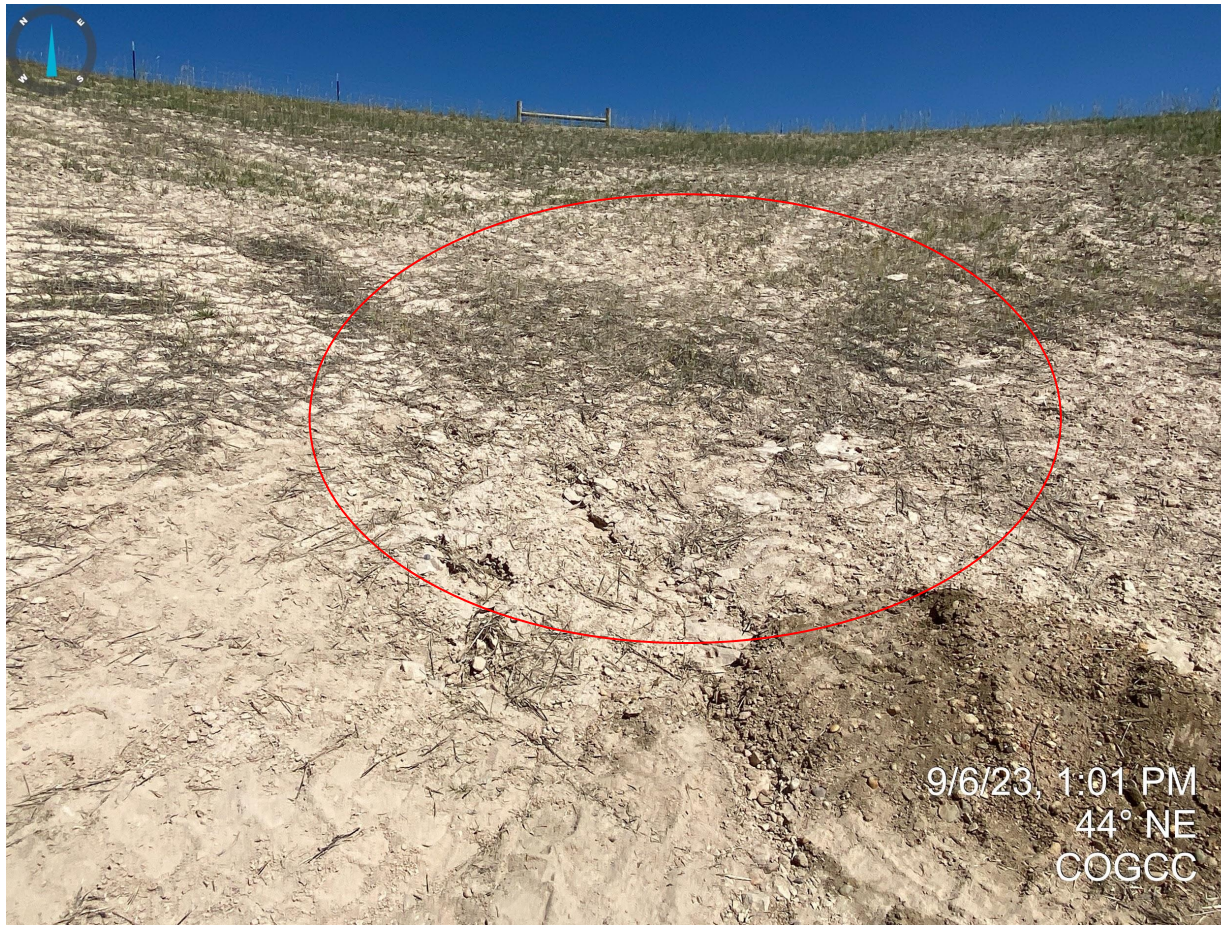
Photo 6. Taken from the northeast corner of the location. Photo illustrates that cut slopes do not appear to be properly stabilized as evidence by bare/exposed soils and no apparent stormwater controls to prevent erosion degradation (e.g. rilling).

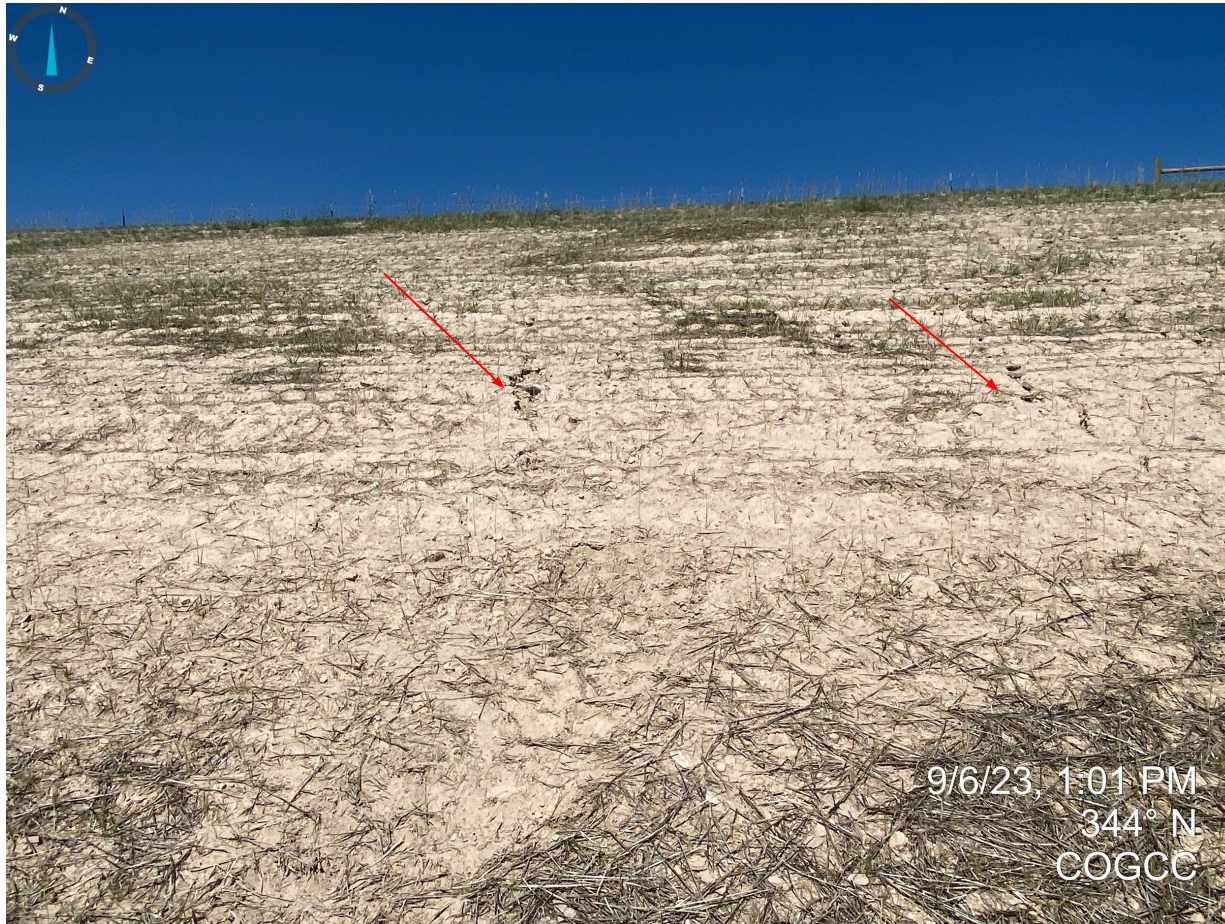
Photo 7. See comments in Photo 6.

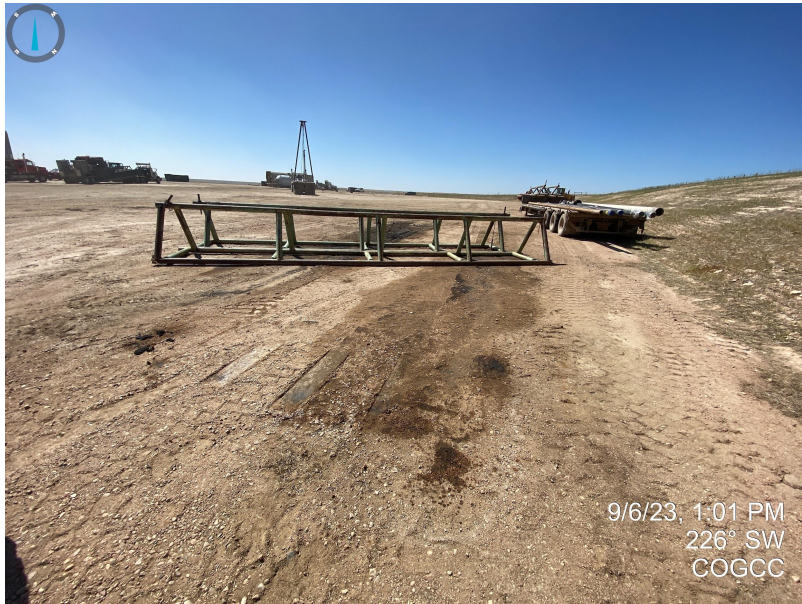
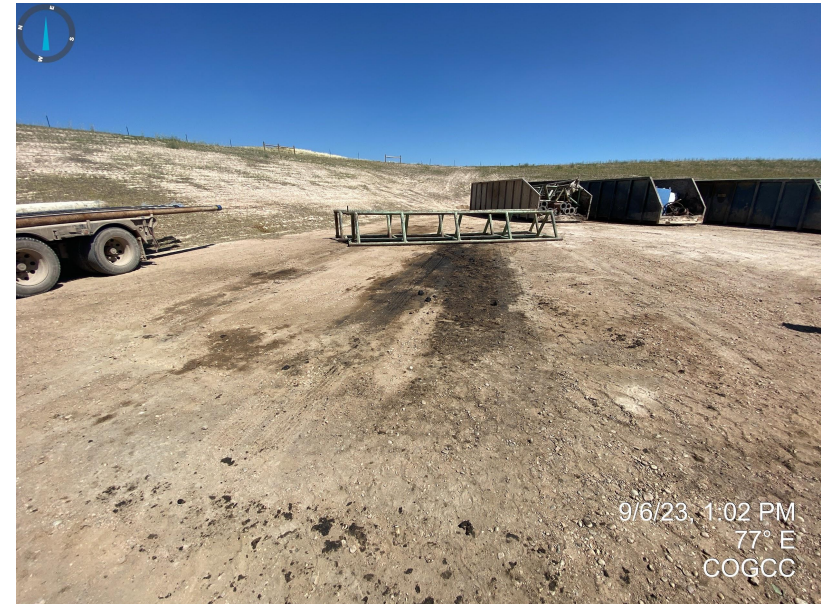
Photo 8 & 9. Taken from the northeast corner of the production area. Stained soil observed.

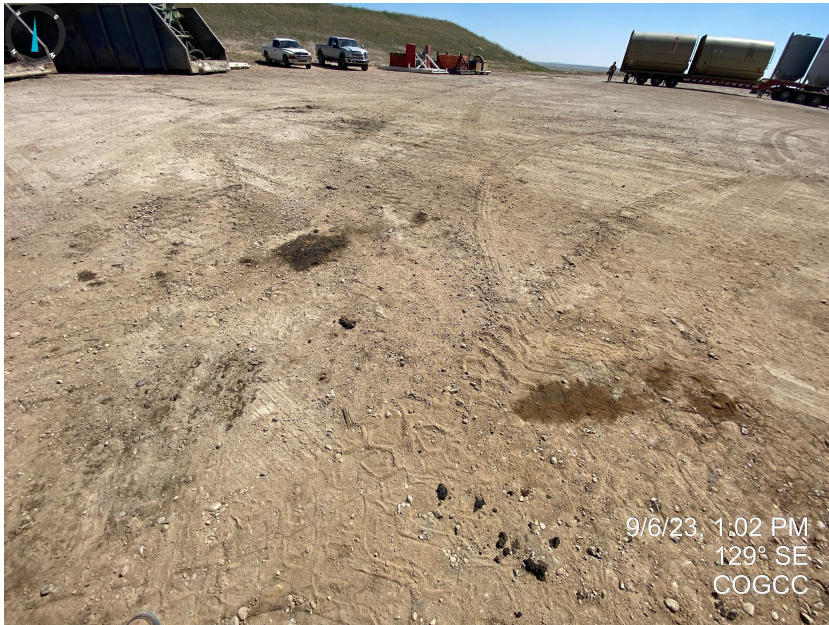
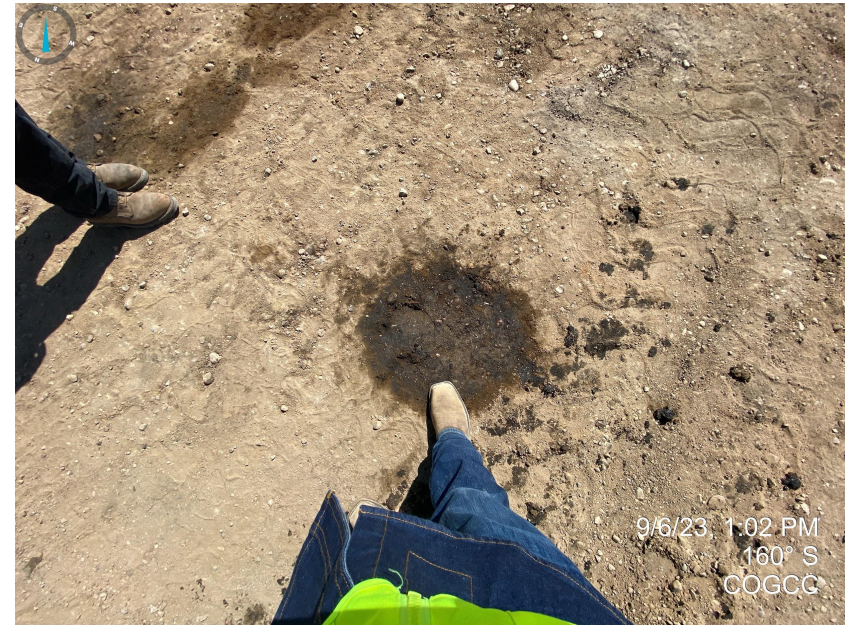
Photo 10 & 11. See comments in Photos 8 & 9.

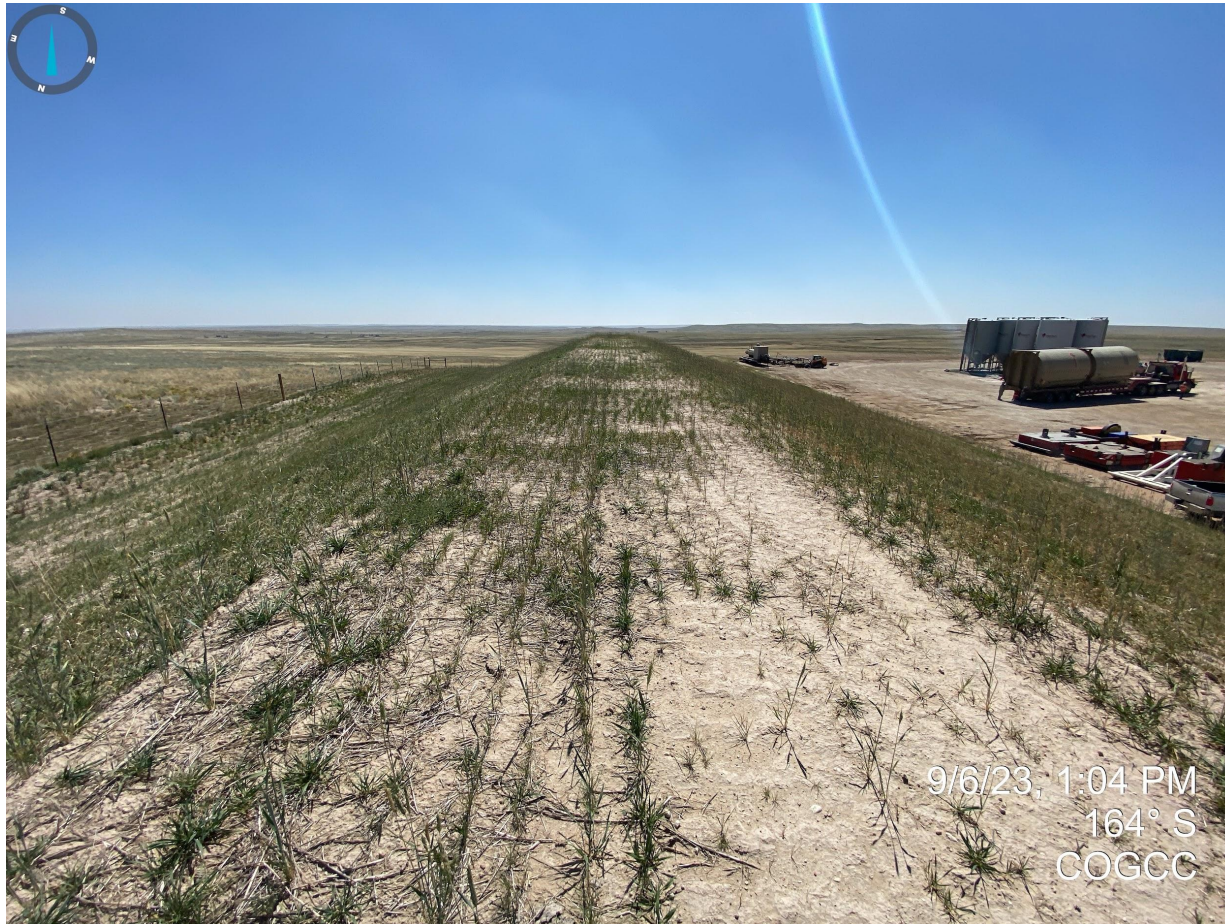
Photo 12. Taken from on top, center portion, of the topsoil stockpile. It appears the Operator planted an annual crop species (e.g. triticale) as part of temporary stabilization. The Operator shall ensure the location is stabilized for longer term by utilizing desirable perennial plant species reflective of adjacent reference areas. Additional stabilization activities are required on areas of bare/exposed soils.

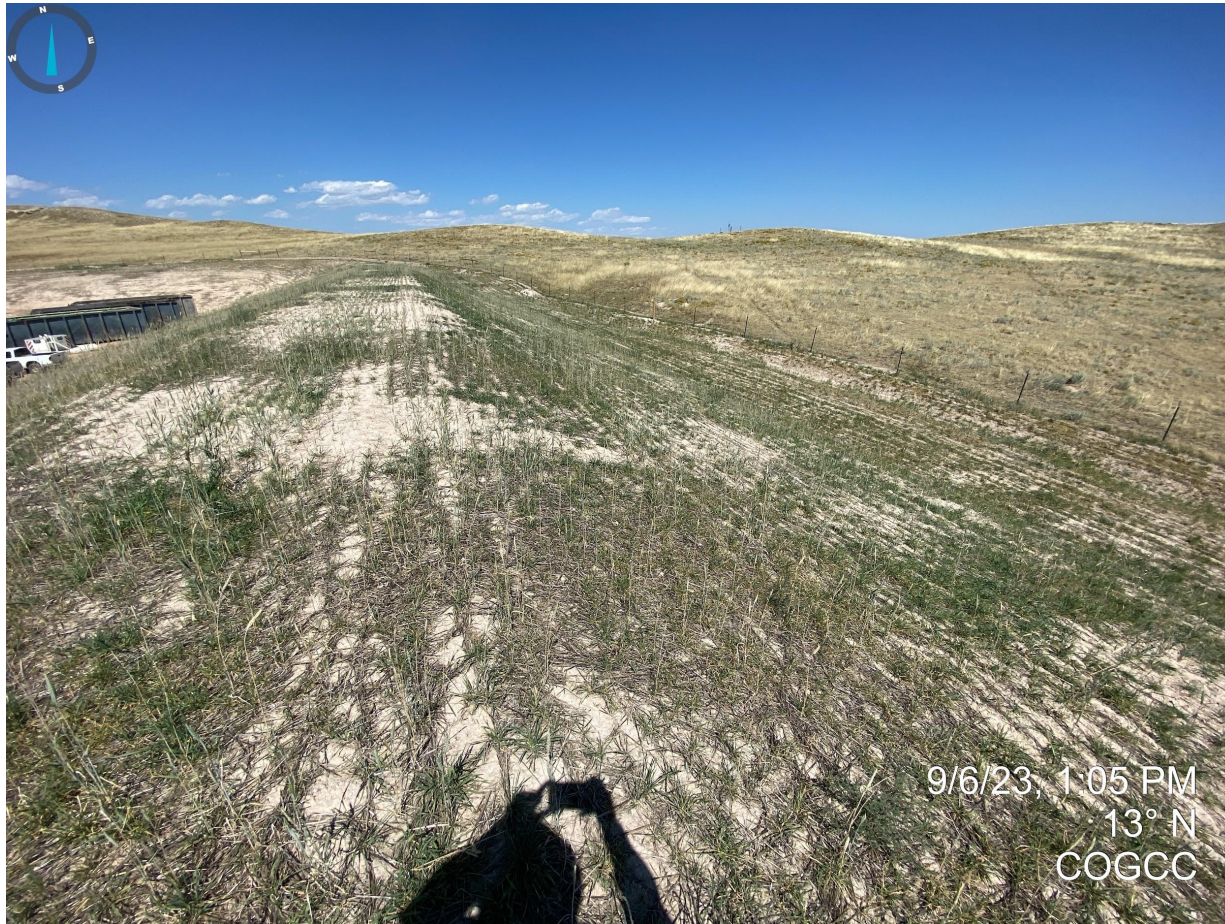
Photo 13. See comments in Photo 12.

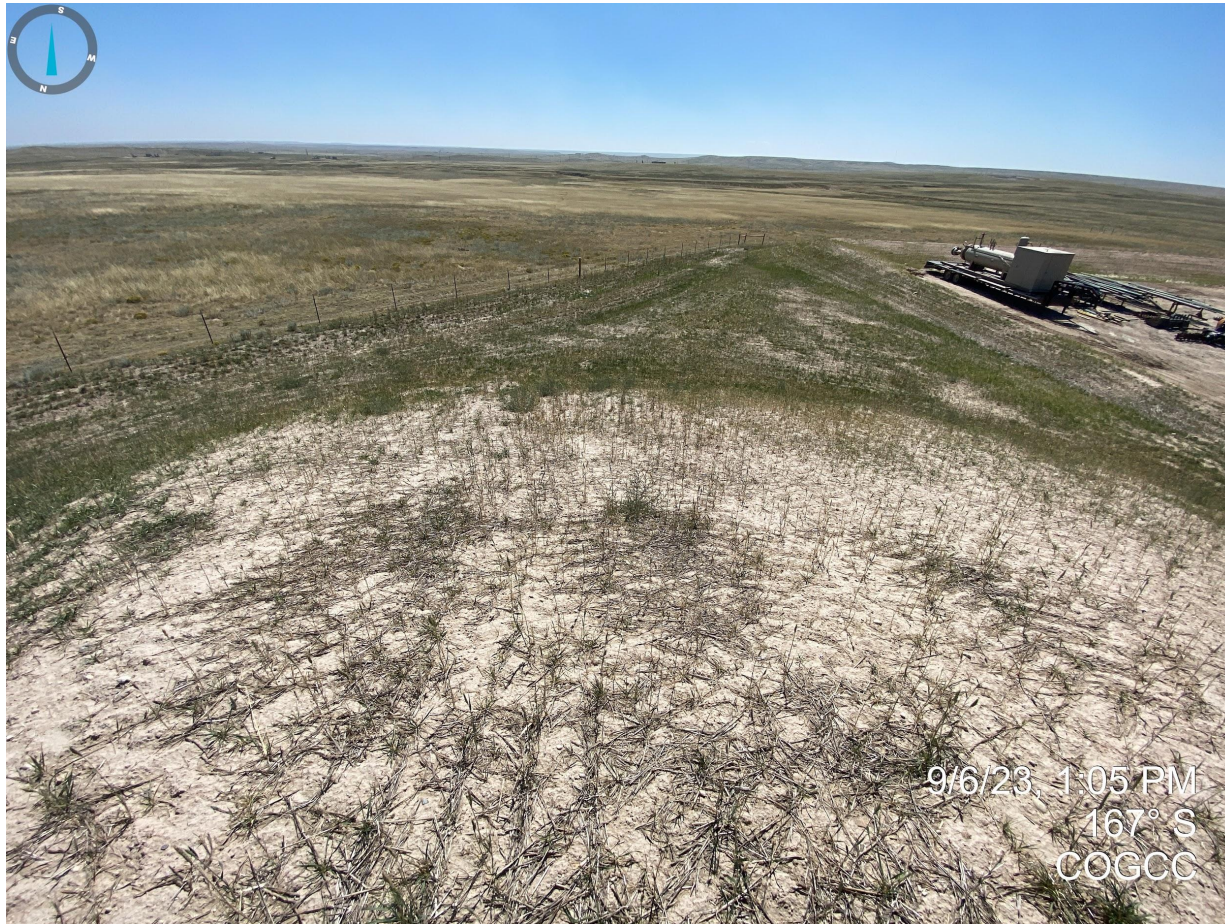
Photo 14. Southern end of the topsoil stockpile. See comments in Photo 12.

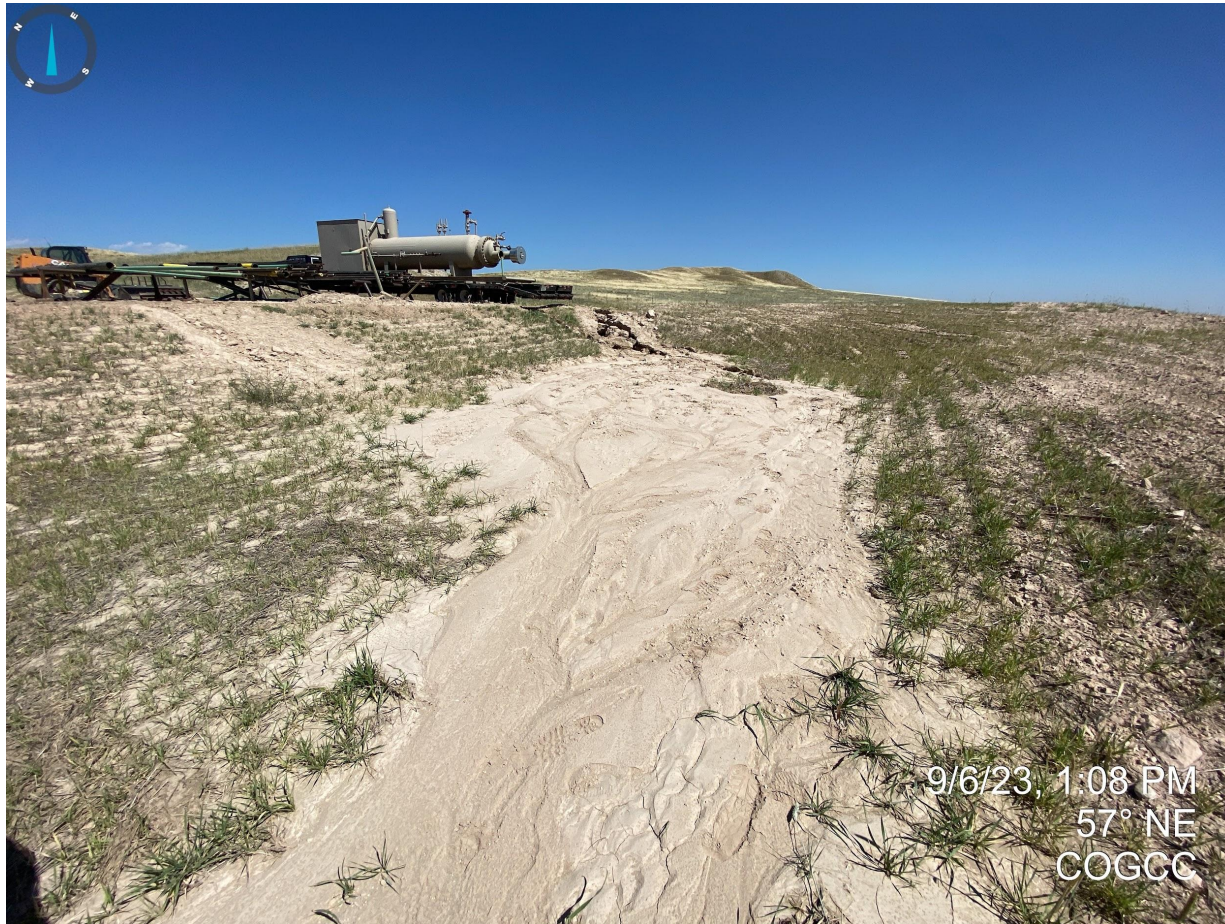
Photo 15. Taken within the southern sediment basin. Photo illustrates sediment deposition within the sediment trap. Maintenance and repairs are required in order to comply with Rule 1002.f.

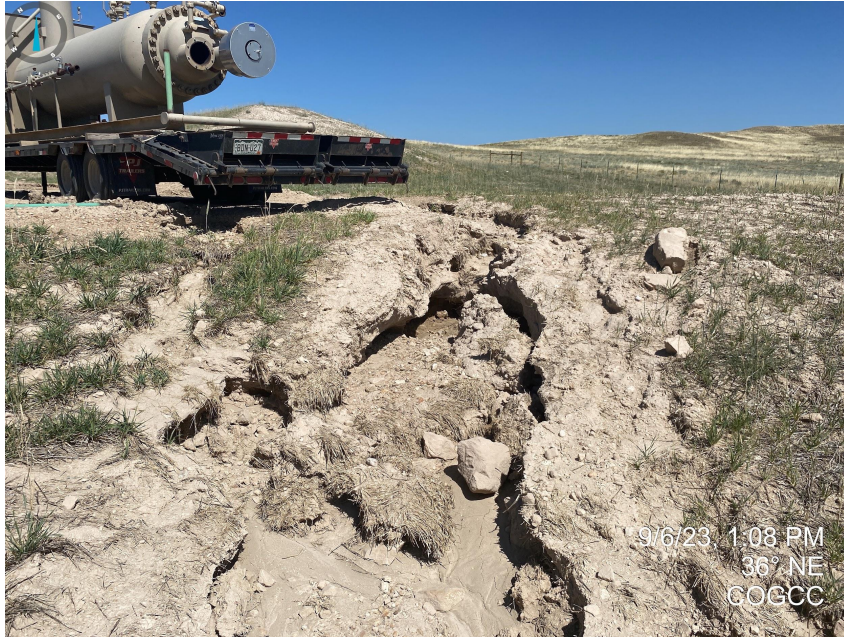
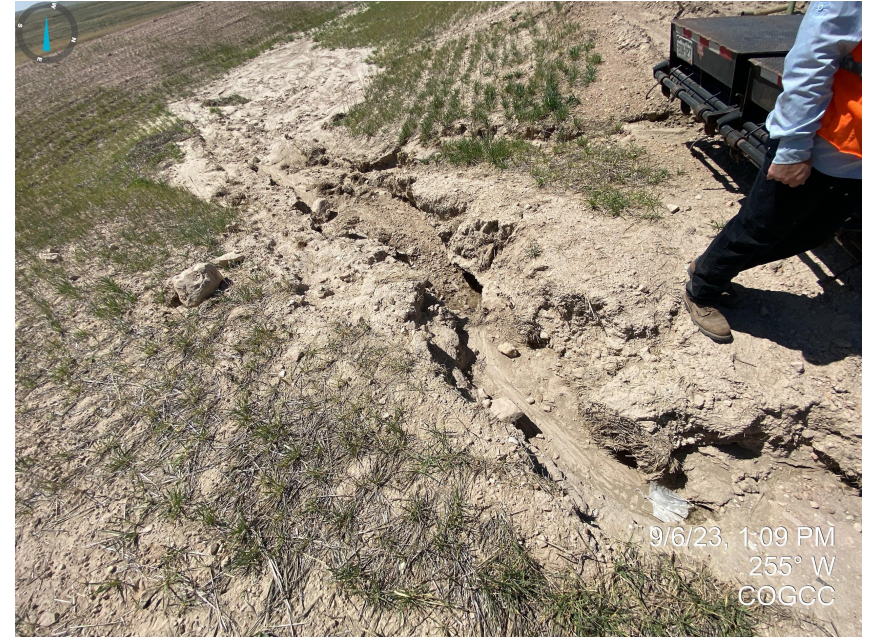
Photos 16 & 17. Erosion degradation (e.g. gully) observed on the northeast portion of the sediment trap. No apparent armored (e.g. rip rap) inflow protection was observed. More robust stormwater control measures/BMPs are required.

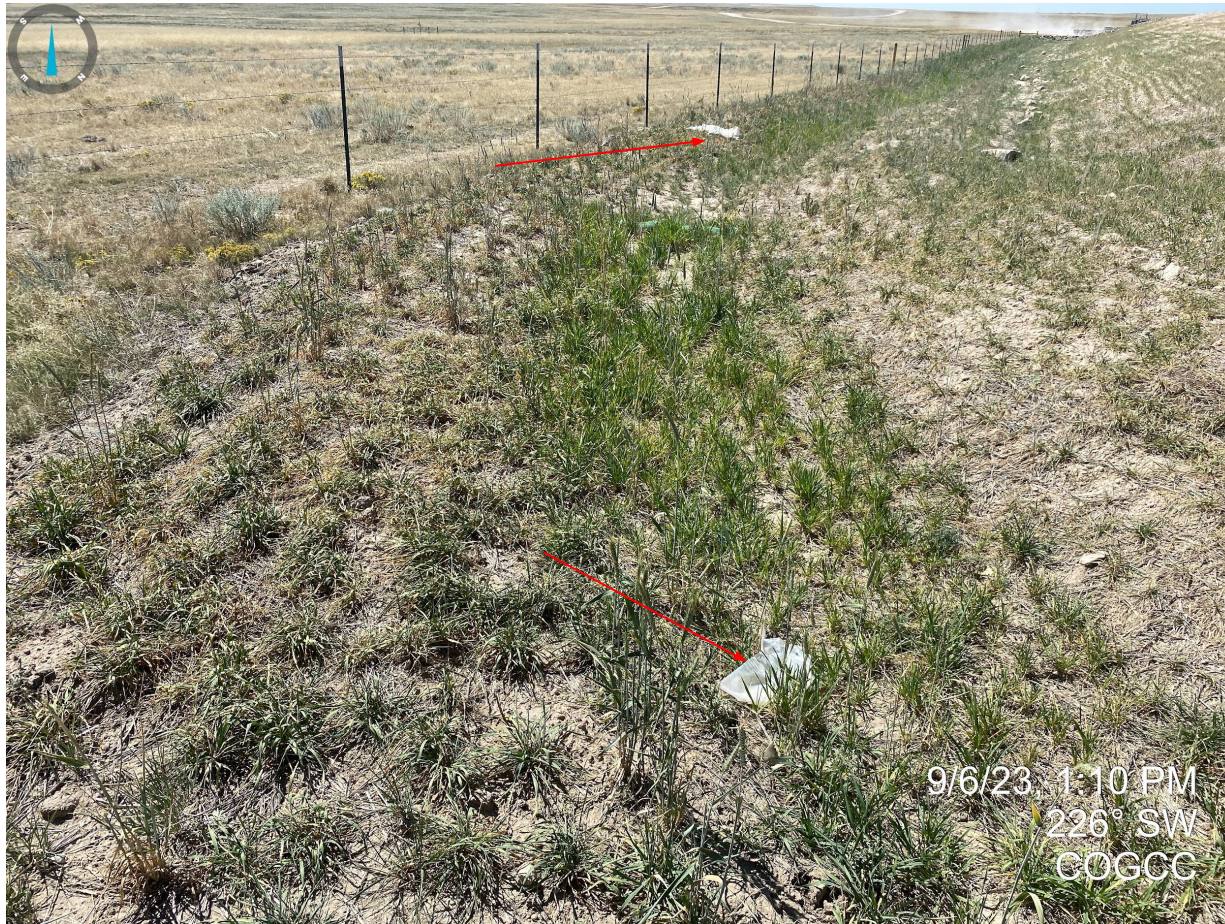
Photo 18. Trash observed on the southern portion of the location. The Operator shall self inspect the location and identify and dispose of all trash, including any trash/debris identified off location.

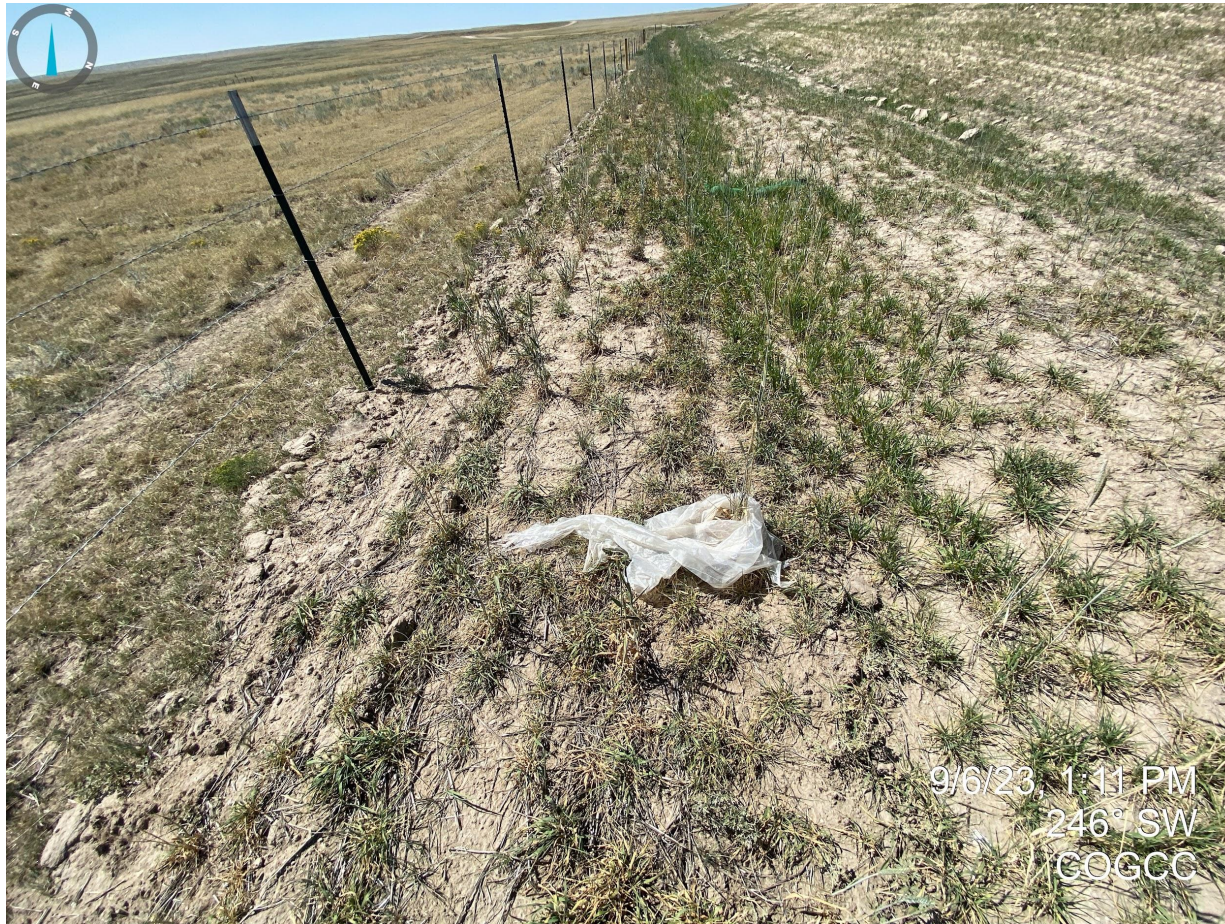
Photo 19. See comments in Photo 18.

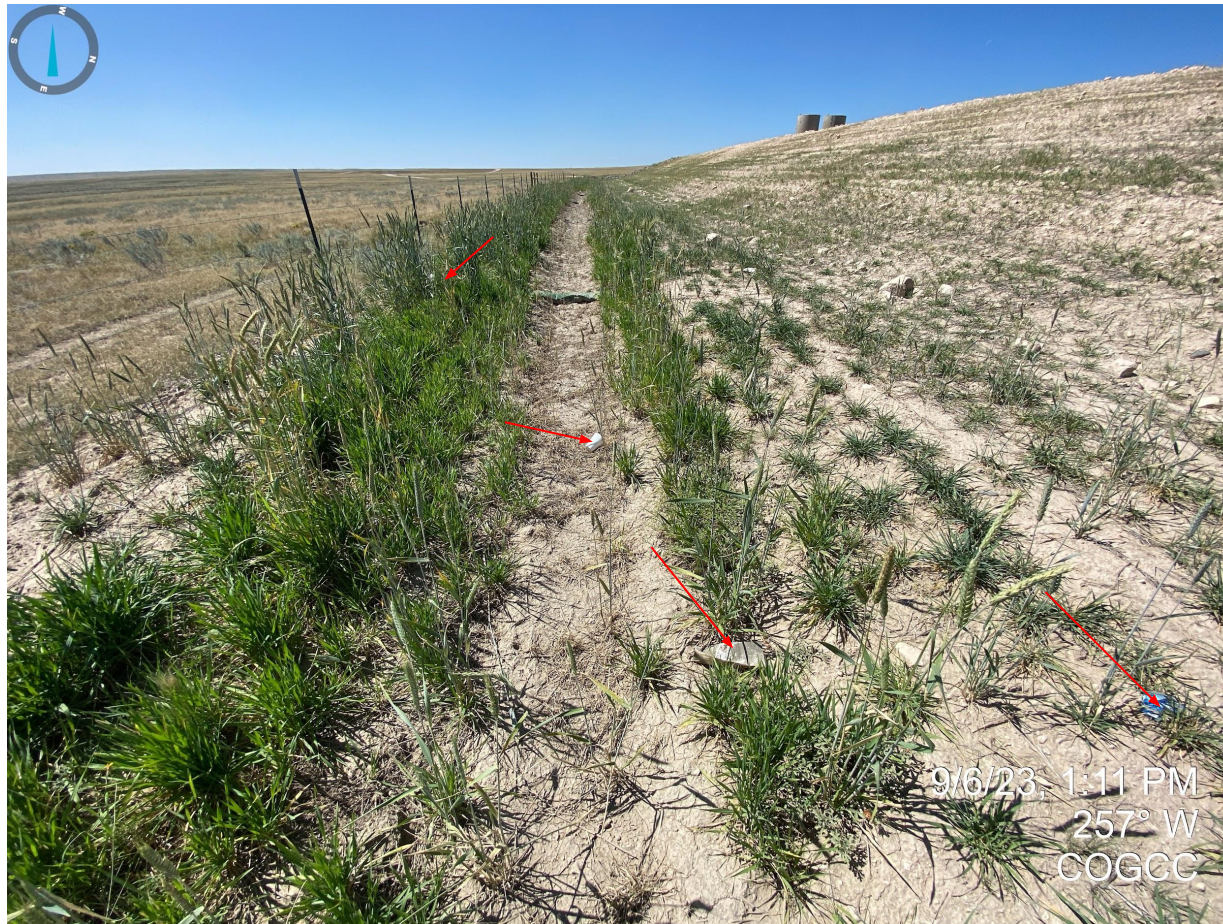
Photo 20. See comments in Photo 18.

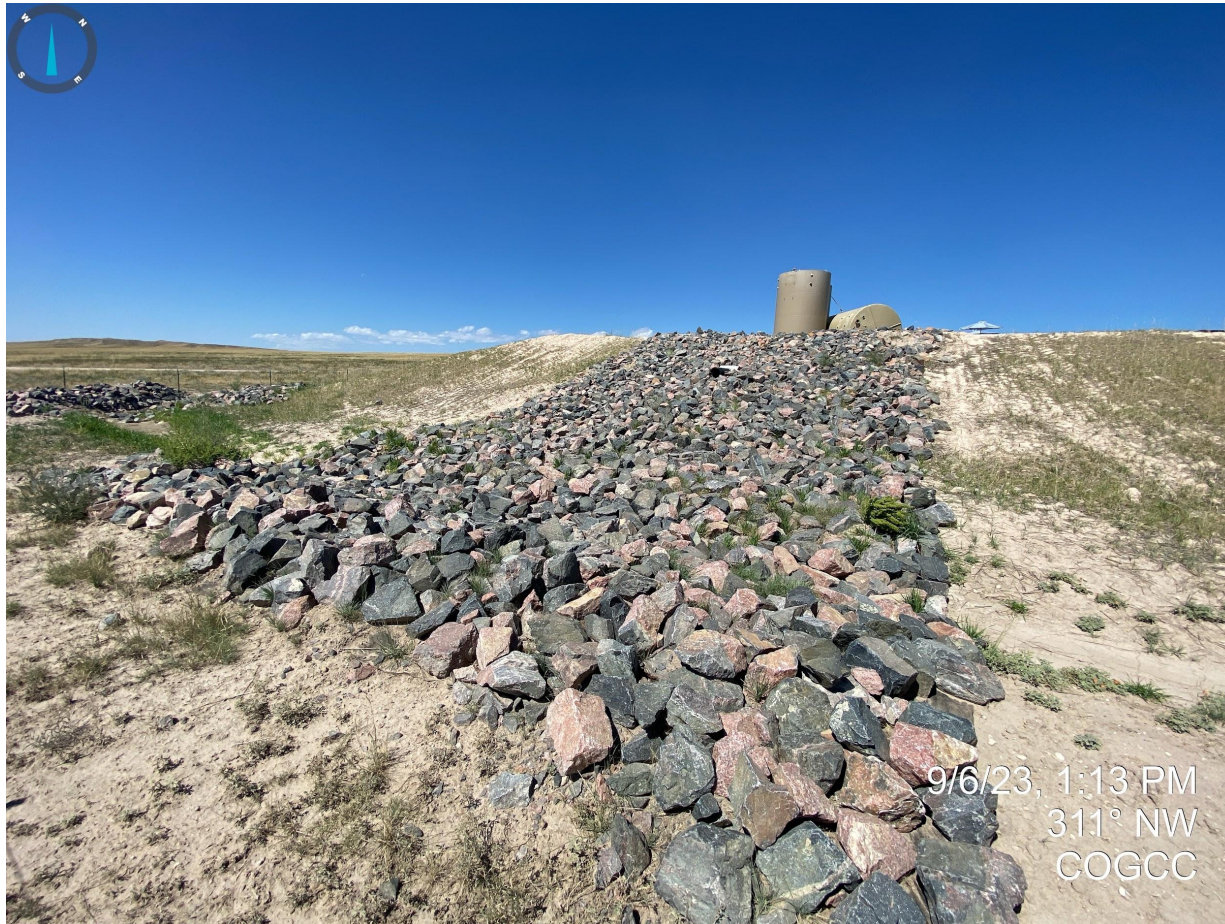
Photo 21. Taken from the southwest corner of the location. Photo illustrates armored outflow of sediment basin.

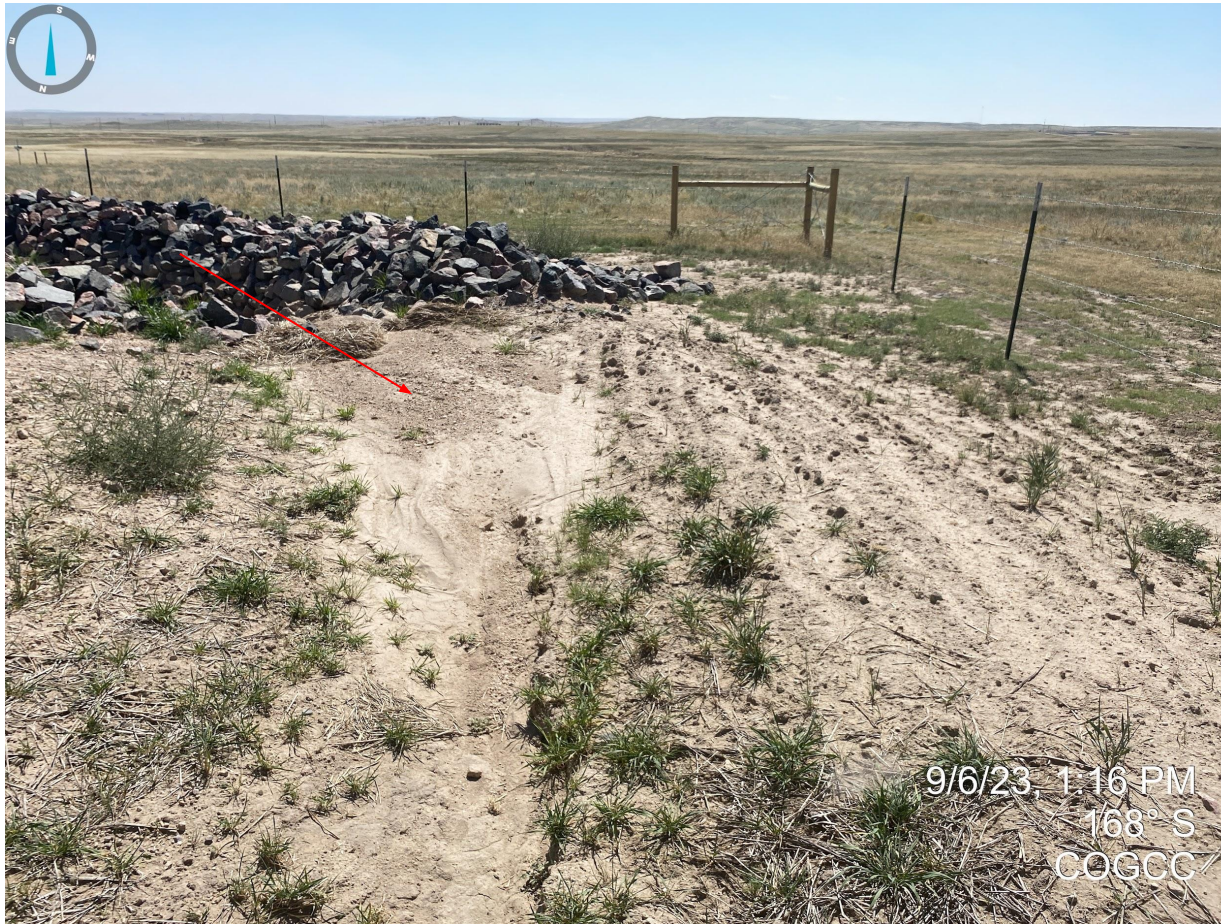
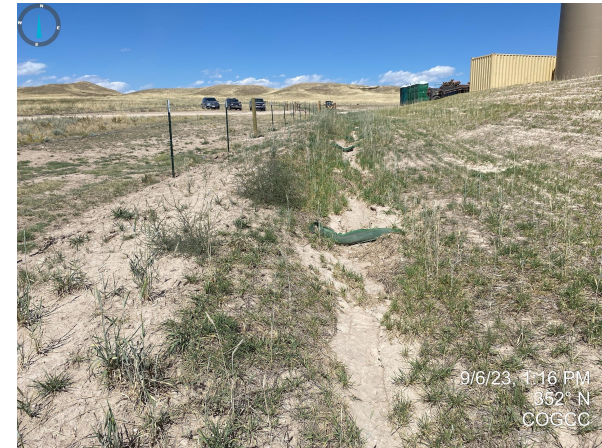
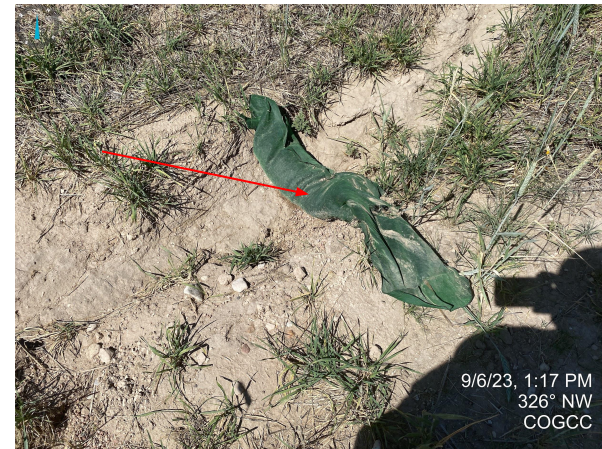
Photos 22-24. Taken from the southwest corner of the location. The perimeter stormwater diversion ditch is beginning to fill with sediment and requires maintenance and or repairs in order to adequately manage stormwater run on and runoff from the location. Additionally, erosion control logs are beginning to degrade and require replacement/maintenance.

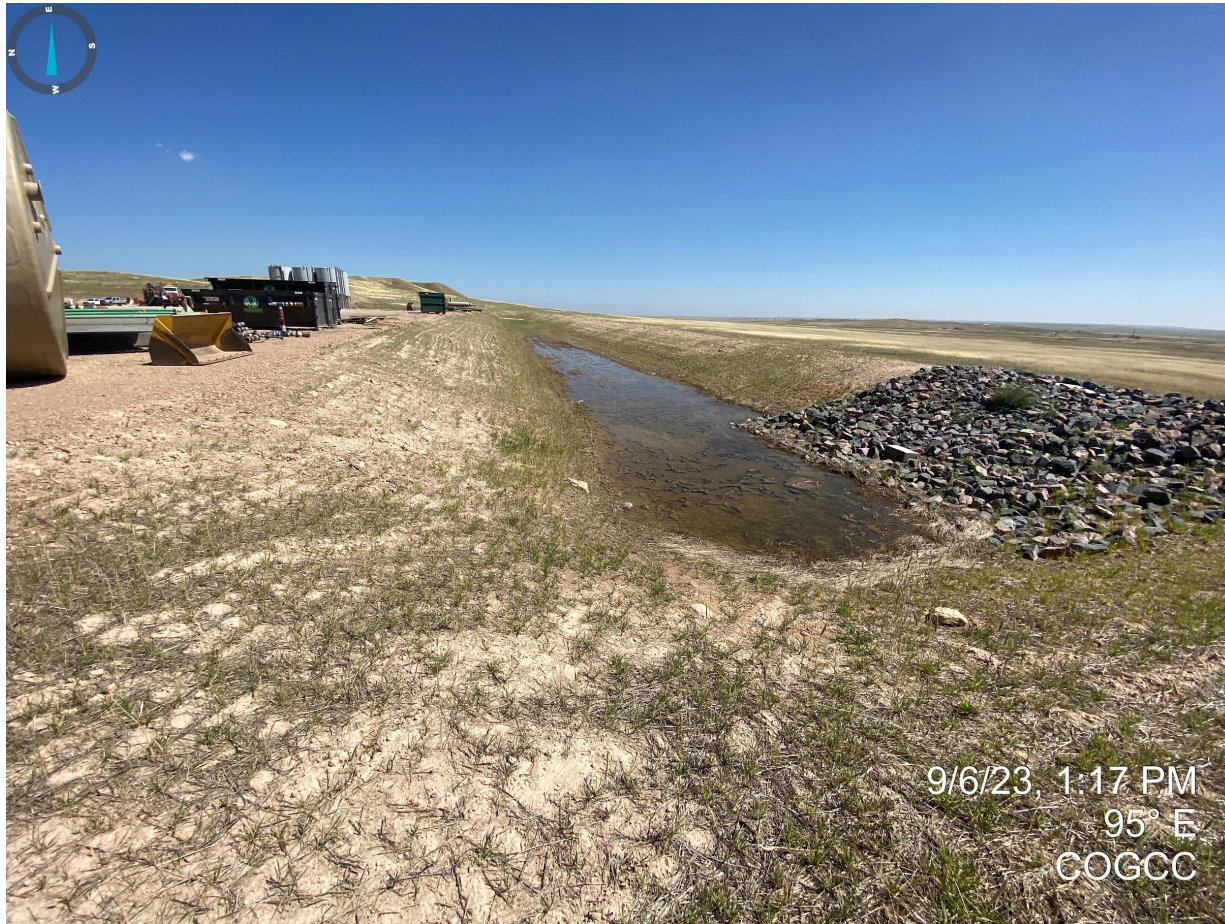
Photo 25. Overview of sediment basin observed on the southern portion of the production area.
