Construction and Stormwater Inspection

Operator: VERDAD RESOURCES LLC - 10651

Location ID: 481827

Inspection Photos
Location Name: Peanut Fed 3403
Location ID: 481827

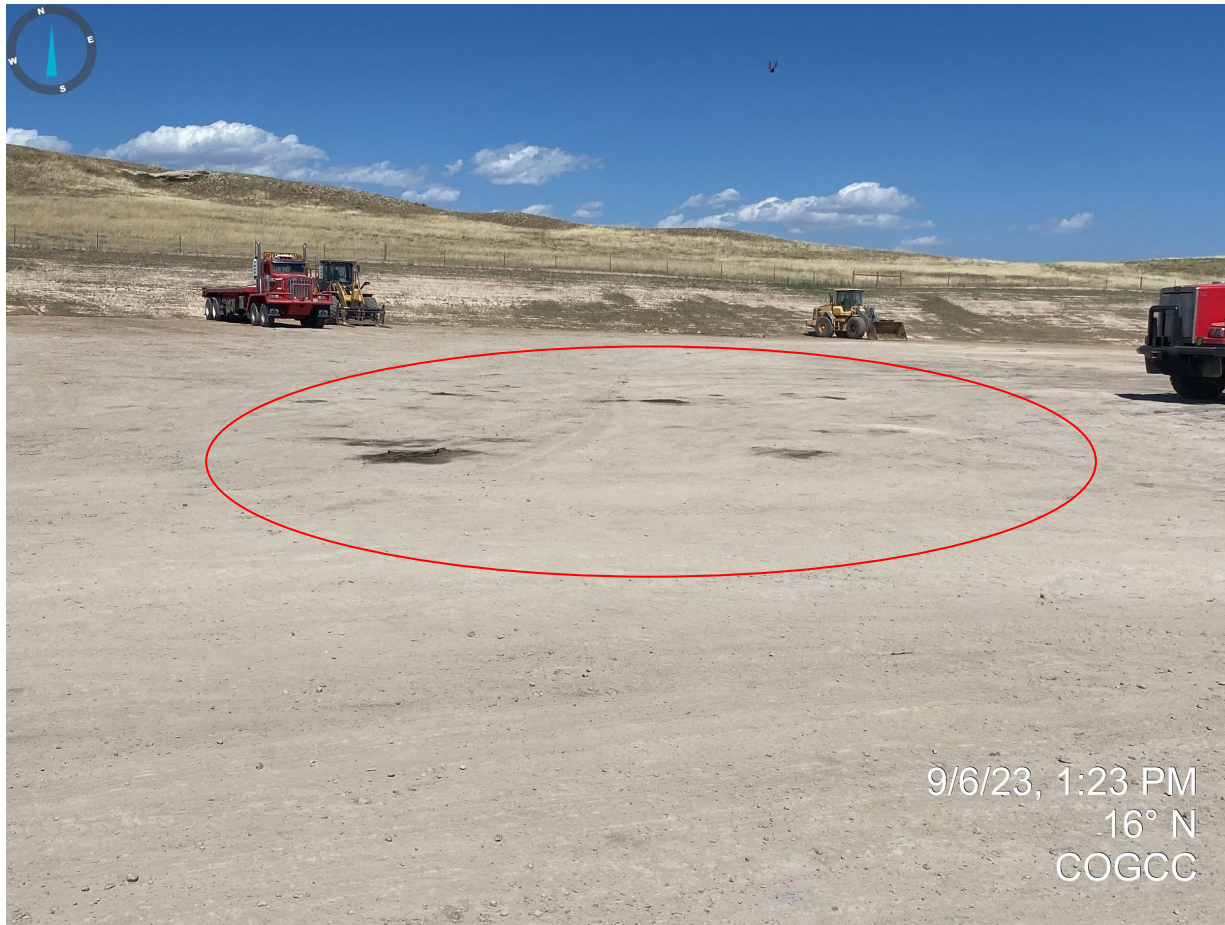
Photo 26. Stained soil observed within the center portion of the production area.

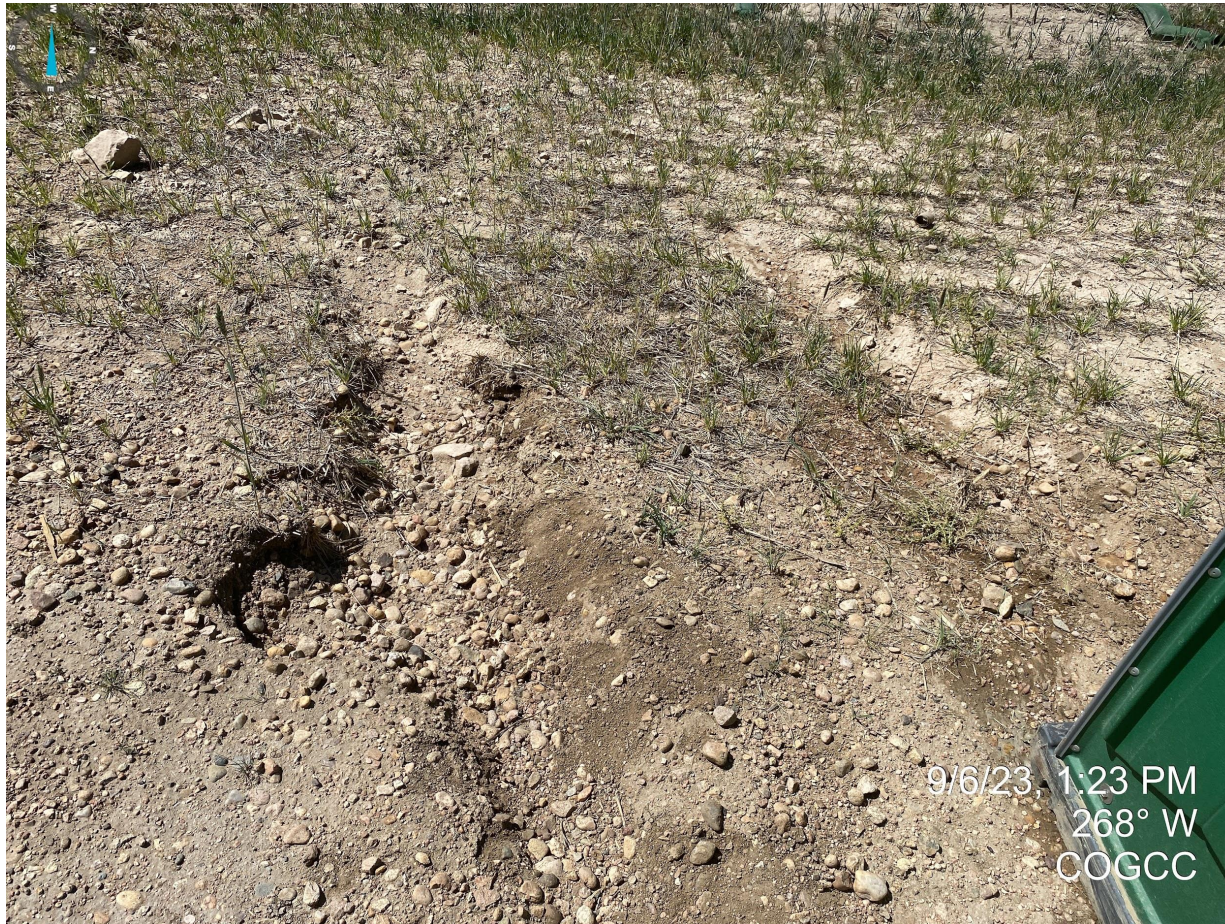
Photo 27. Taken on the western portion of the location. Erosion degradation observed next to the porta-johns.
