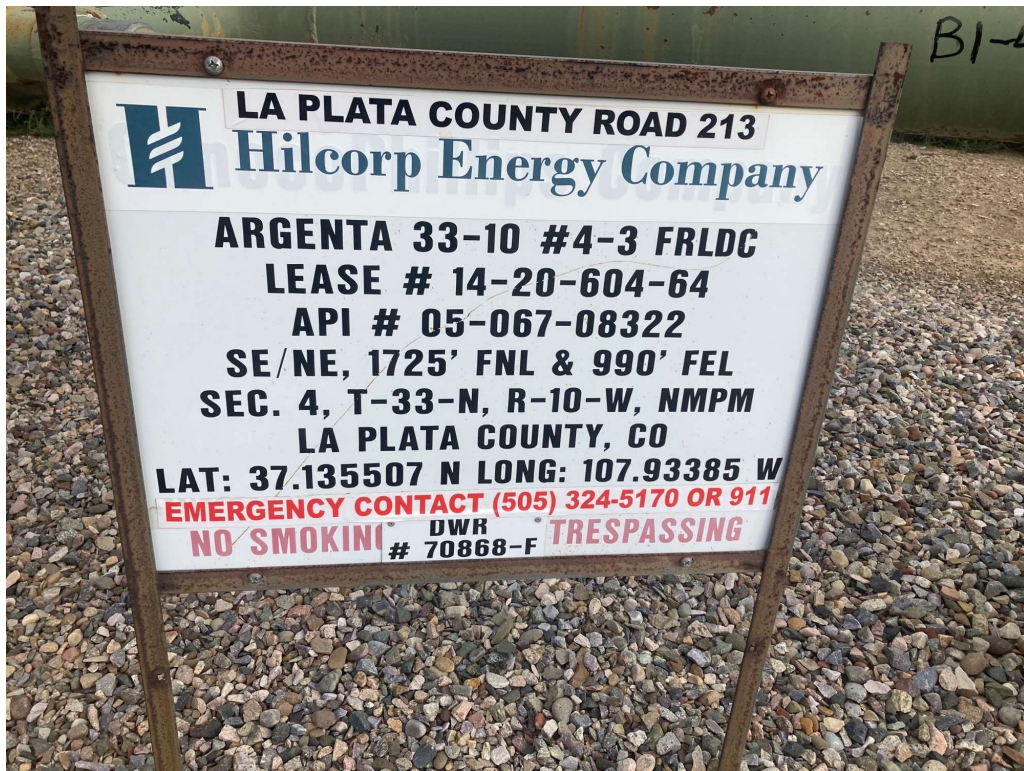
Impacted soil has been removed and the staining has been cleaned on the pumping unit concrete pad
