## Inspection Photos

Location Name: MUSTANG RESOURCES LLC JUHAN FEDERAL 1-35-6S-94W Pad

Location ID: 322298

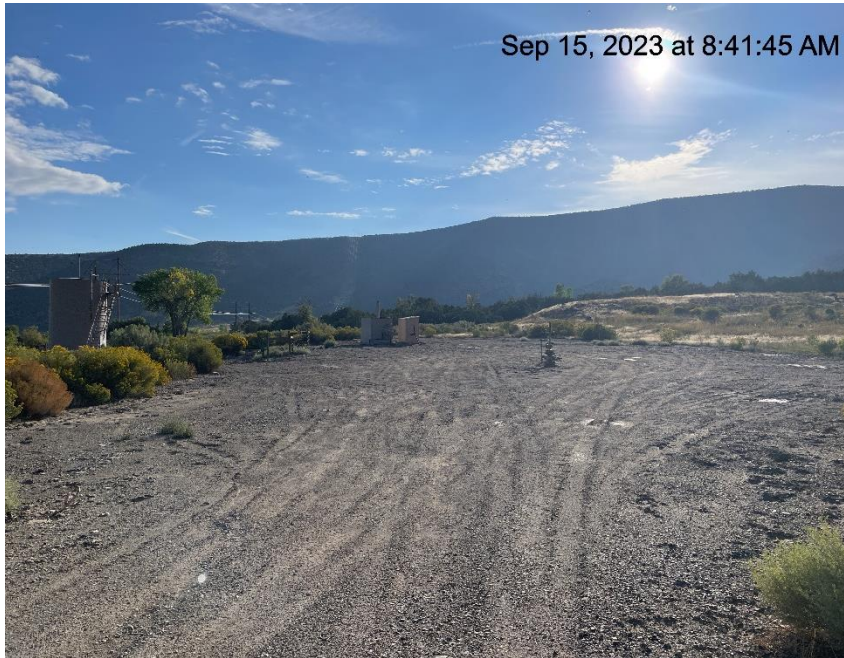
Photo # 9421 From entrance to location

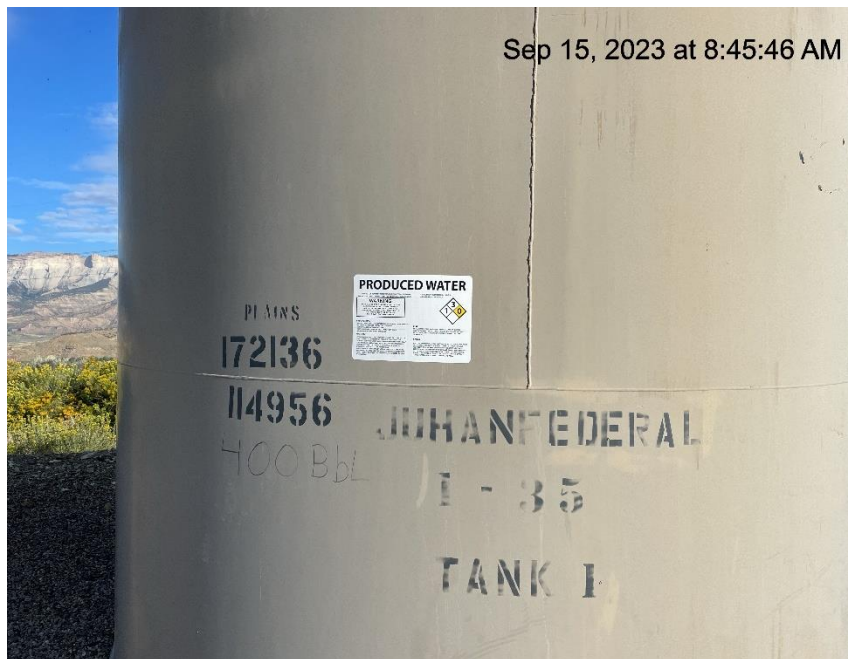
**Photo # 9425 Tank not properly labeled, missing required information**

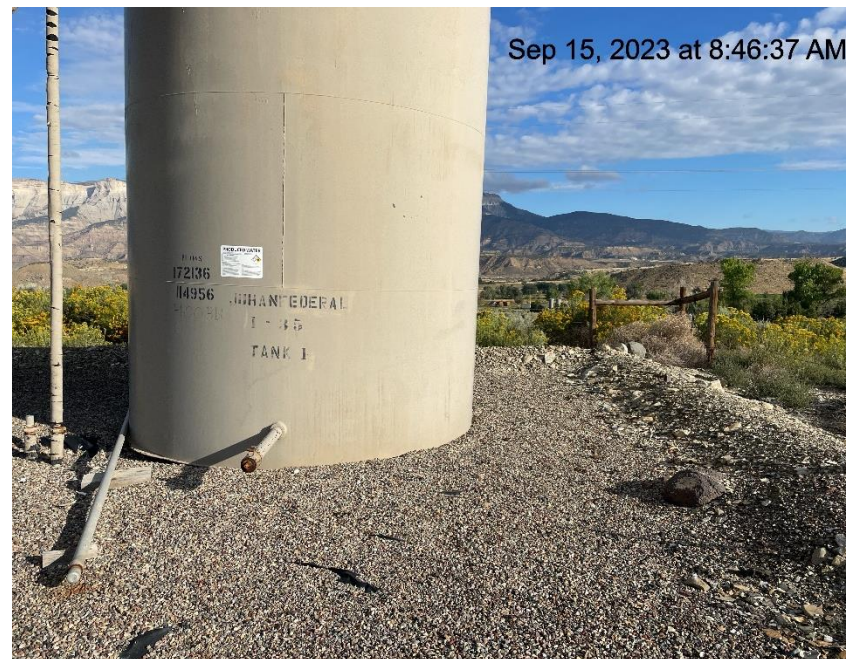
**Photo # 9426 Secondary containment not sufficient to contain spilled or released materials**

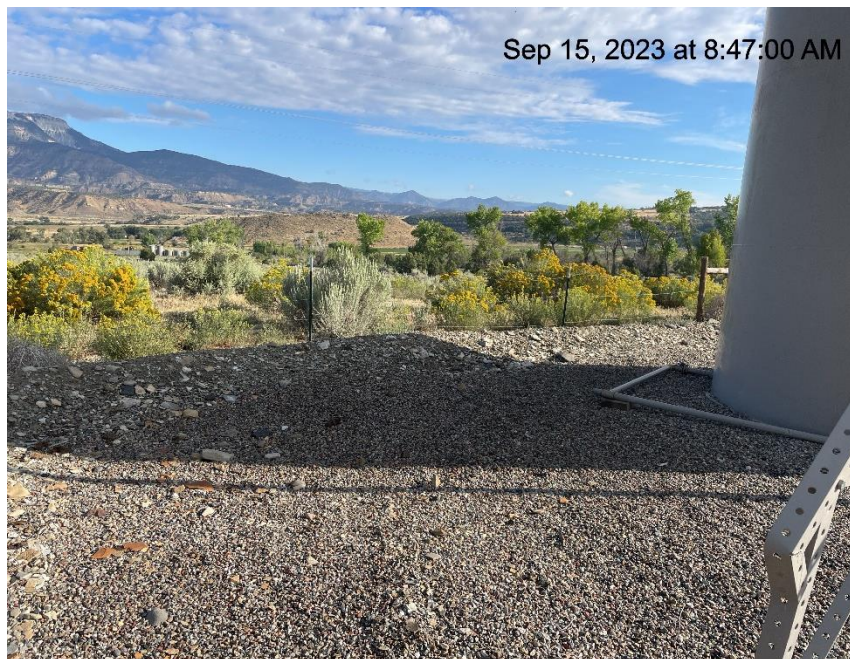
**Photo # 9427 Secondary containment not sufficient to contain spilled or released materials**

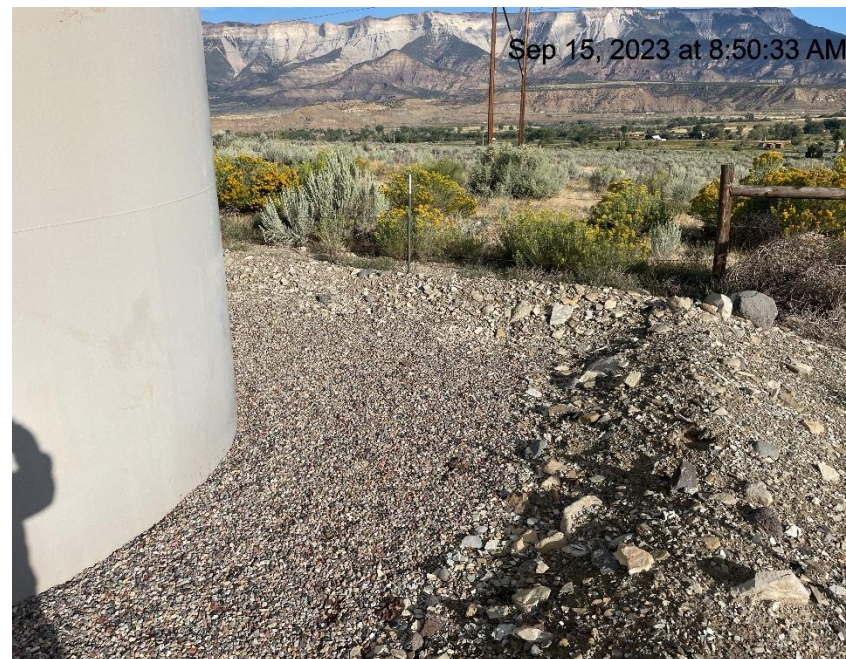
**Photo # 9431 Secondary containment not sufficient to contain spilled or released materials**

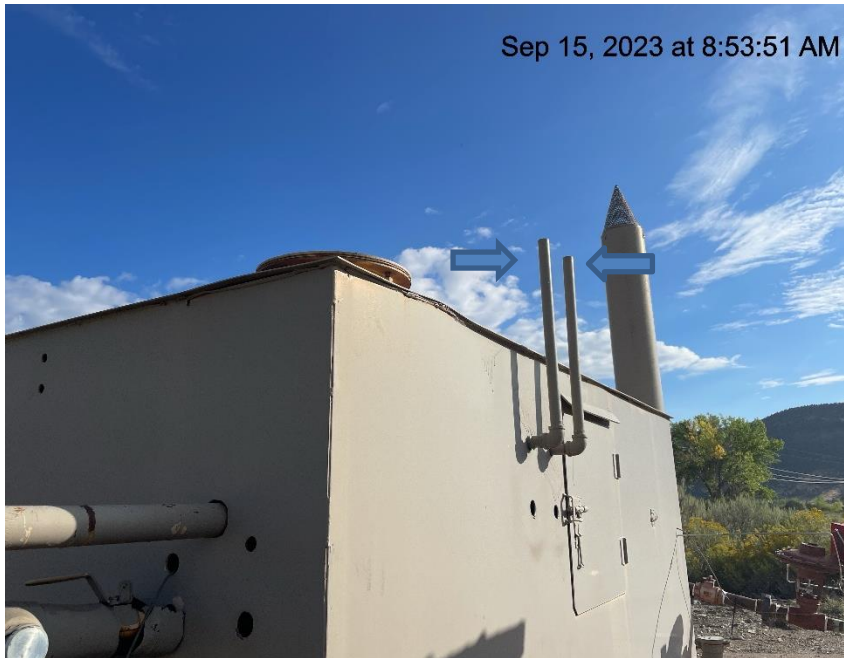
Photo # 9441 PRV vent & rupture disc vent lack caps

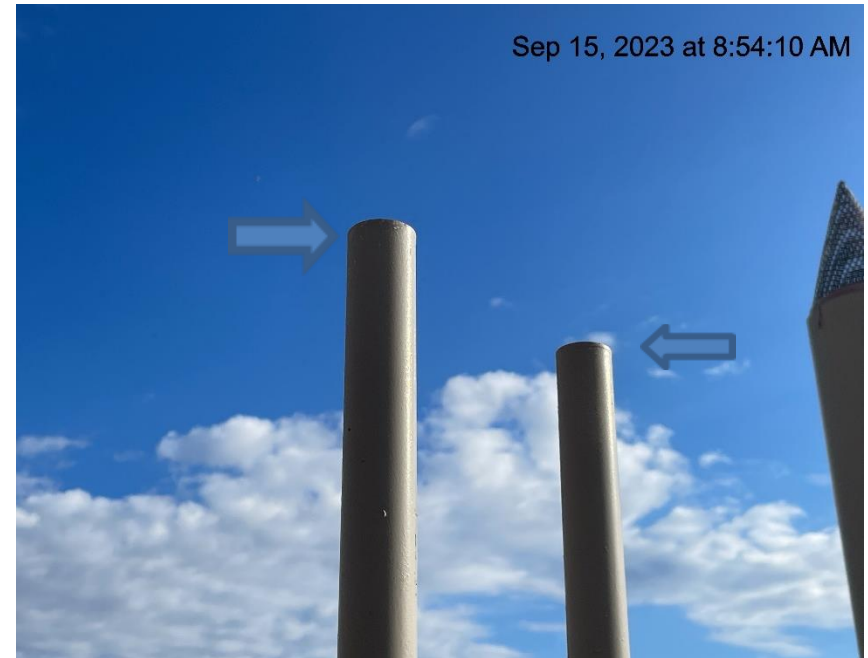
Photo # 9442 PRV vent & rupture disc vent lack caps
