# Inspection Photos

Loc: 333761

Operator: EVERGREEN NATURAL  
RESOURCES LLC

Inspection Date: 9/18/2023

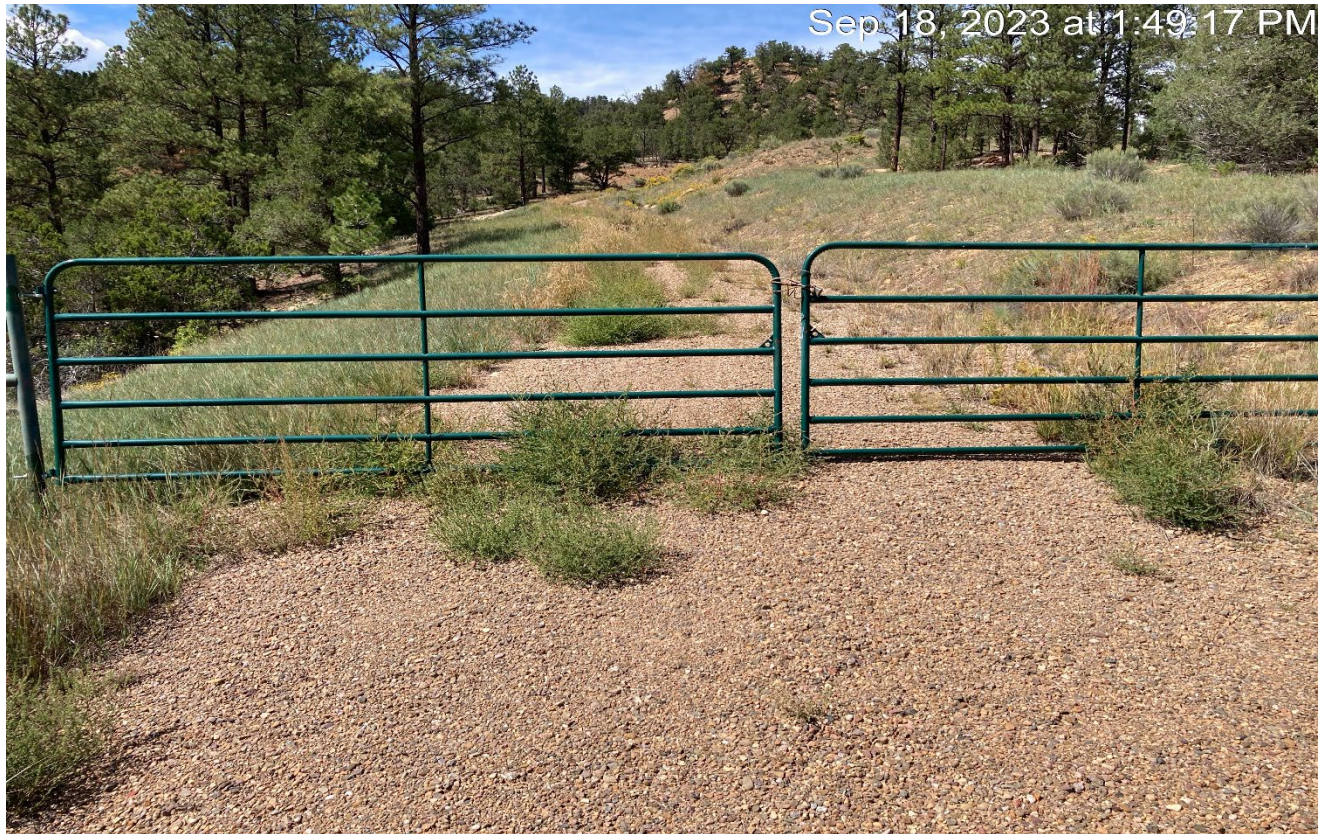
**Photo 1.** Facing northwest at the beginning of the access road.

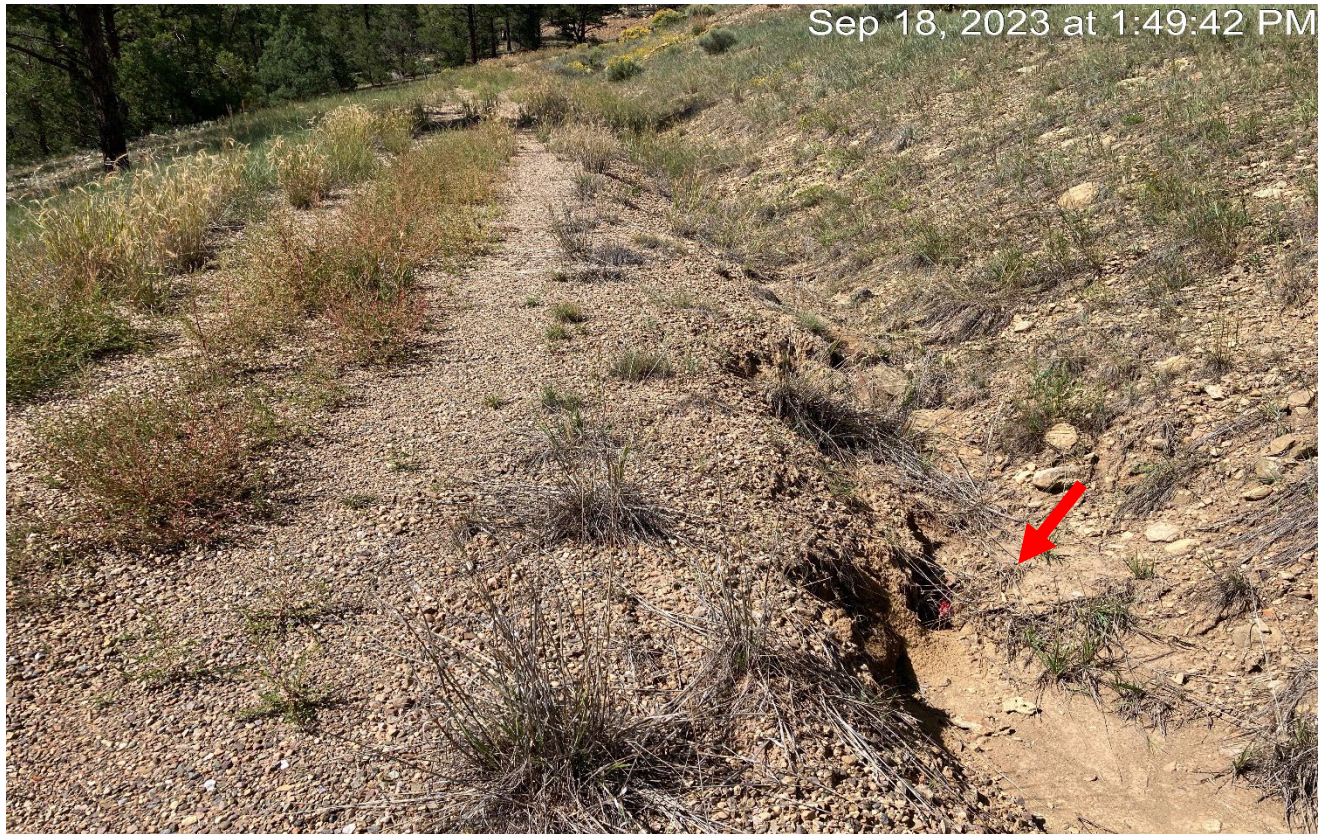
**Photo 2.** Facing northwest along the access road. There is erosion at the red arrow that will require BMP's for stabilization..

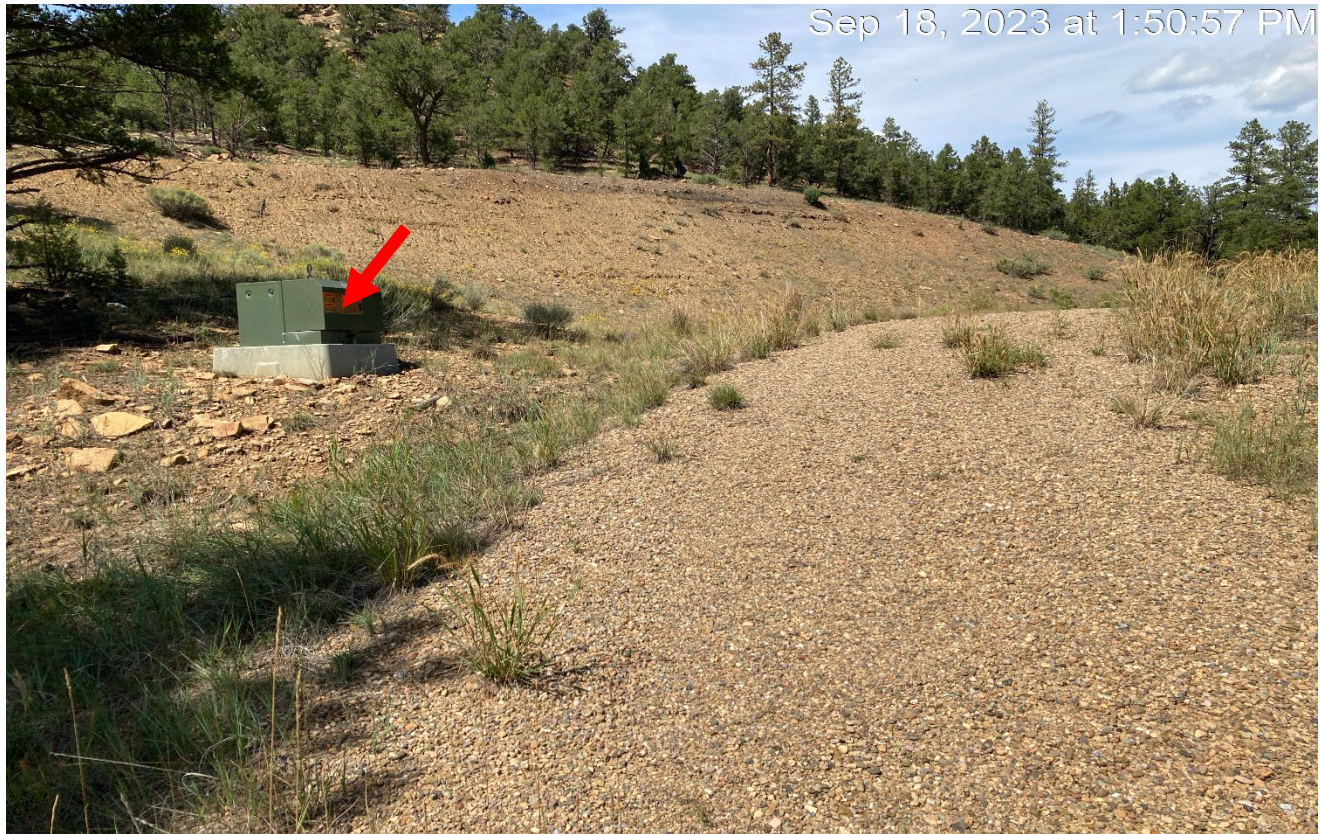
**Photo 3.** Facing northwest toward the location. There is an electric utility at red arrow.

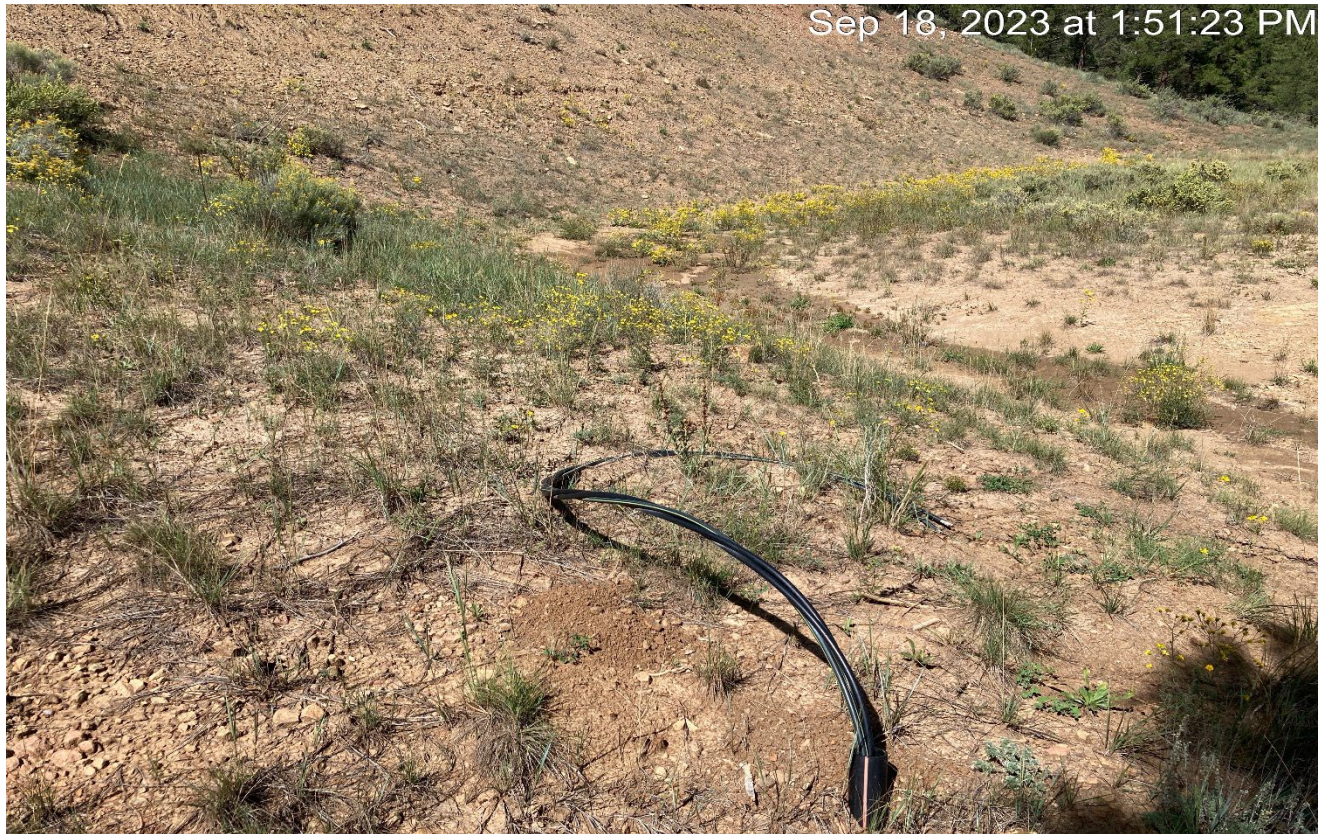
**Photo 4.** This electric utility at south side remains unsecured.

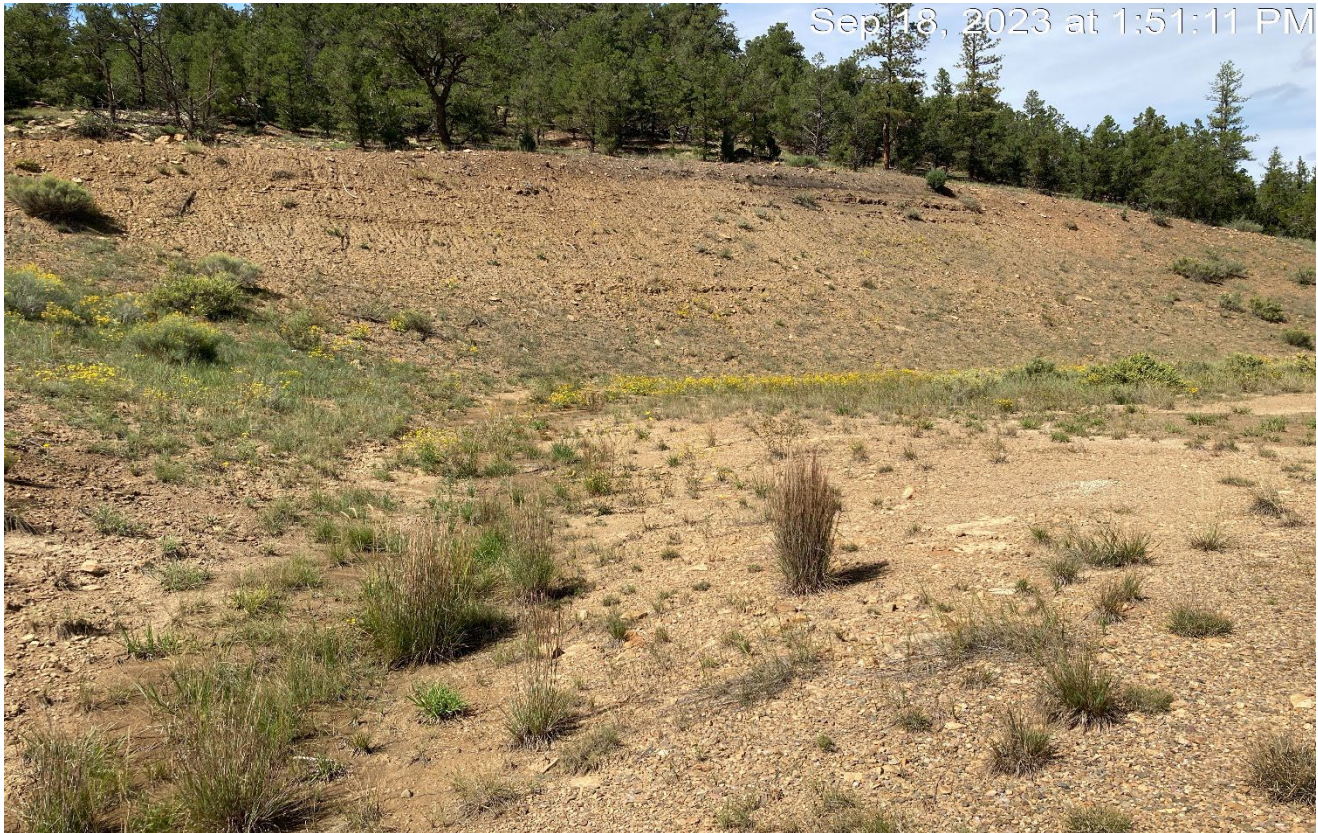
**Photo 5.** Facing northwest toward the cut slope.

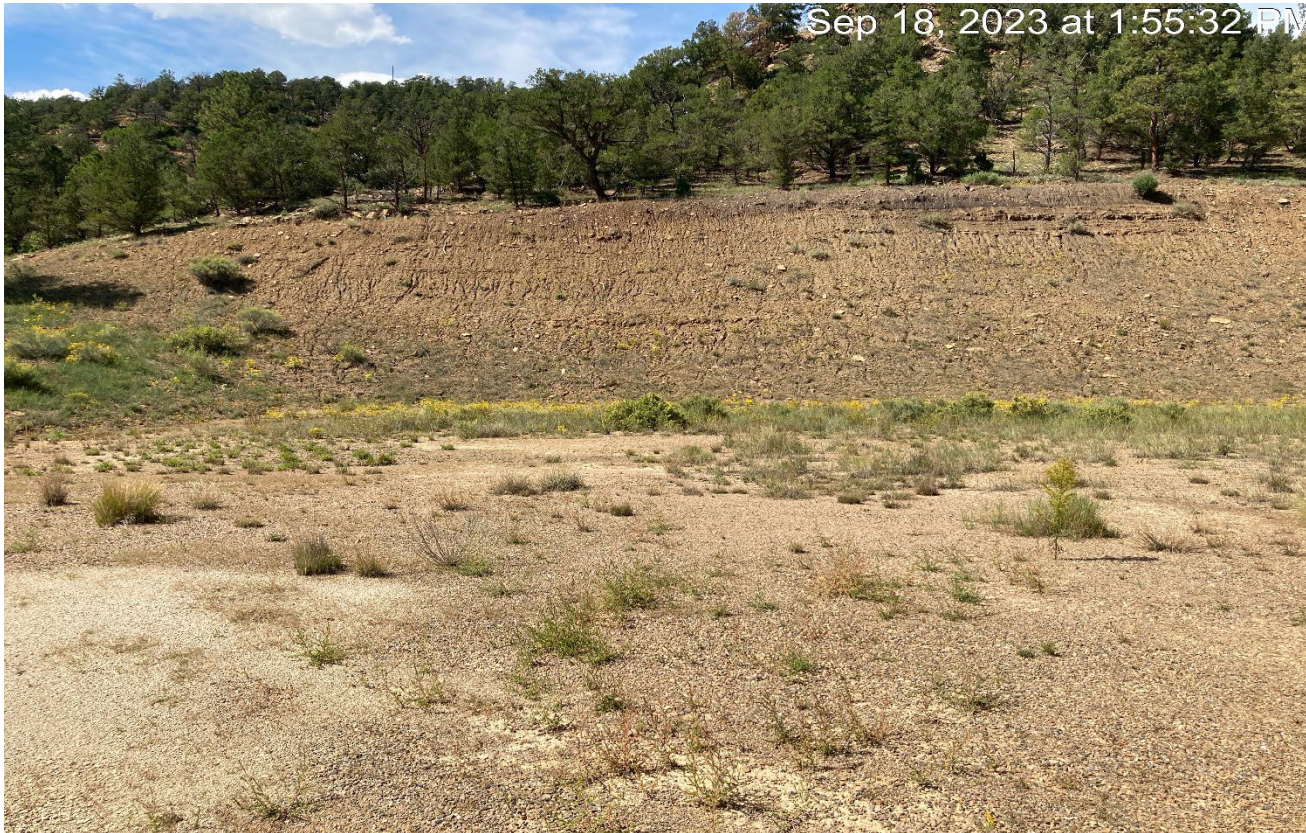
**Photo 6.** Center of the location facing west toward the cut slope. There are signs of erosion along the cut slope which is not stabilized.

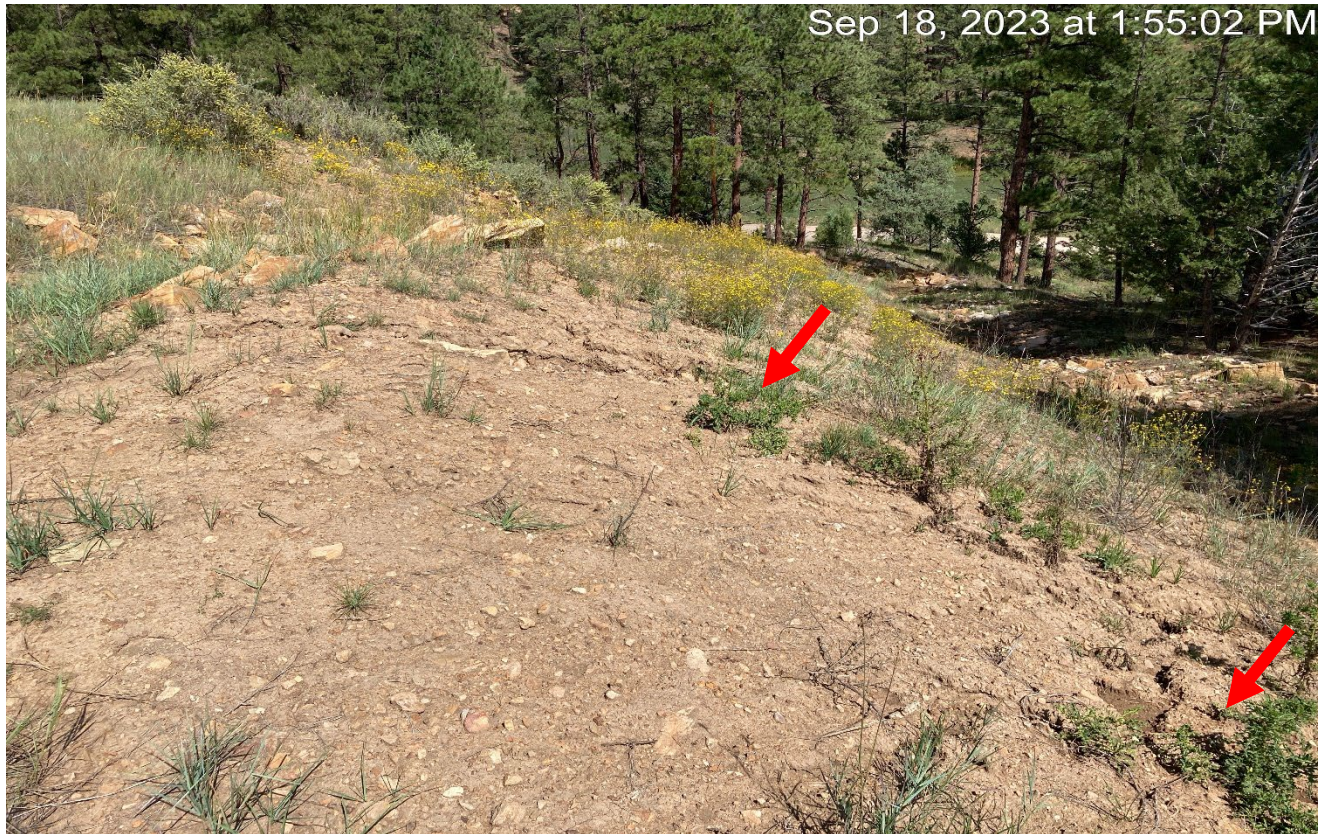
**Photo 7.** Facing north along the fill slope. There are noxious weeds (Canada thistle) shown at red arrows that need to be controlled..

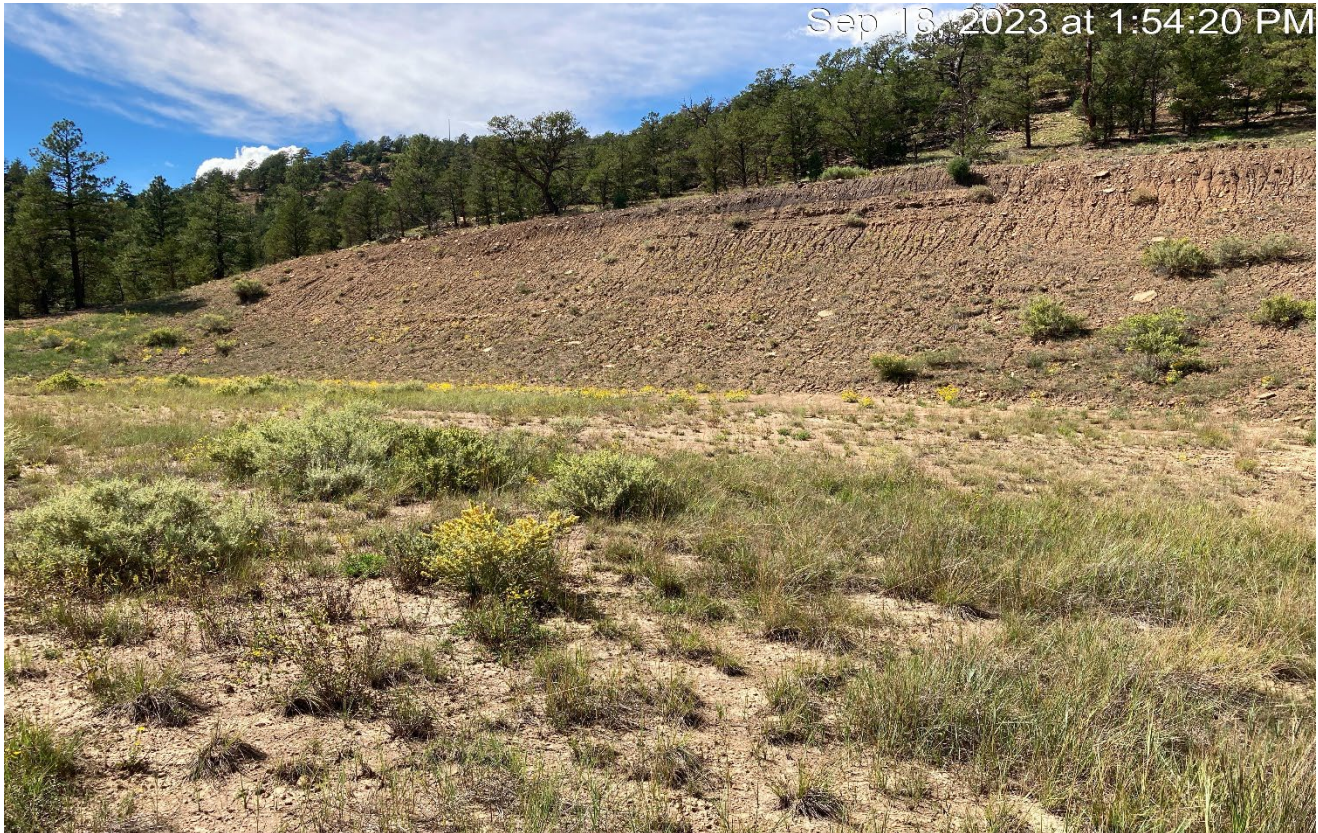
**Photo 8.** Facing southwest toward the cut slope. There are signs of erosion along the cut slope which is not stabilized.

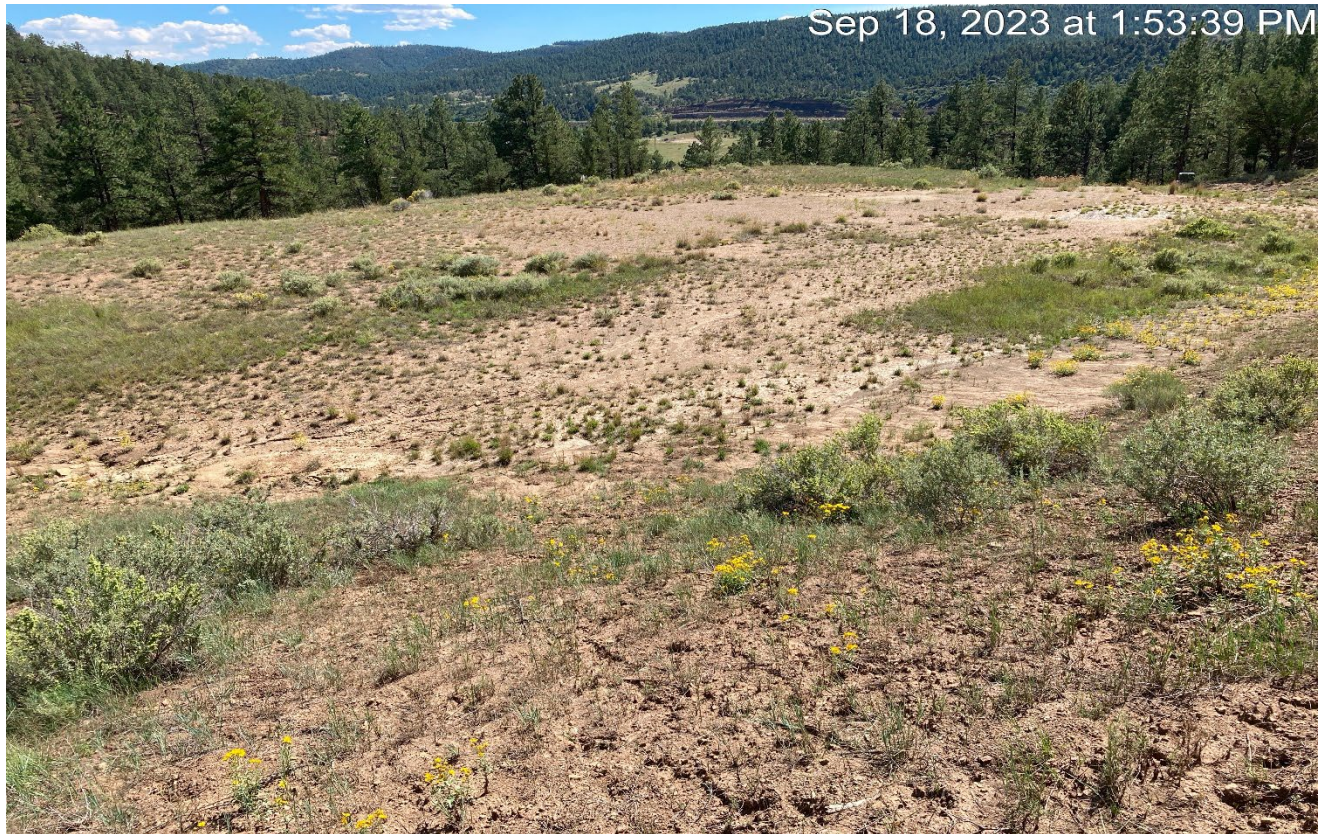
**Photo 9.** Facing southeast toward the well pad location which was not recontoured.

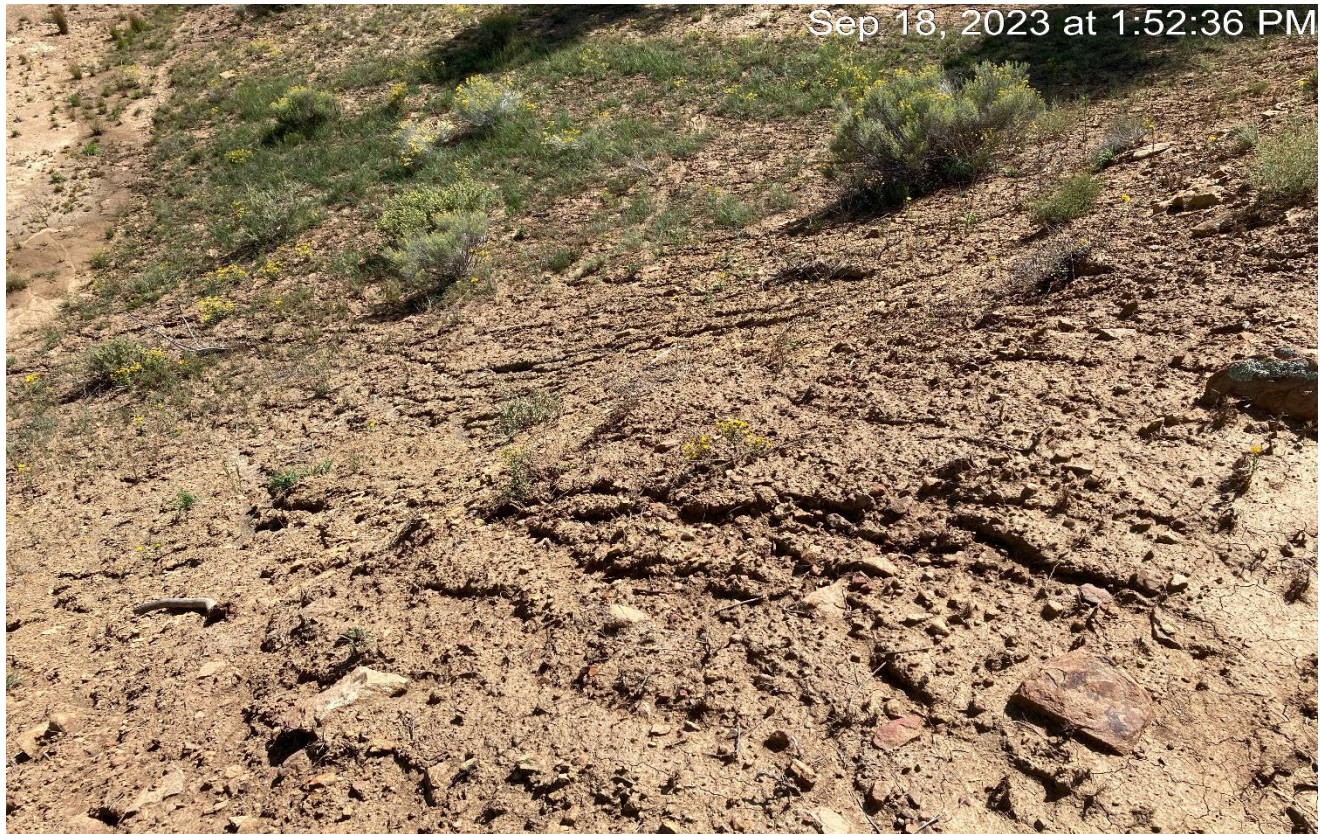
**Photo 10.** View of erosion occurring along the cut slope..
