**Crowheart Energy LLC
Peppler Fee Com 12-18
Location ID: 313060**

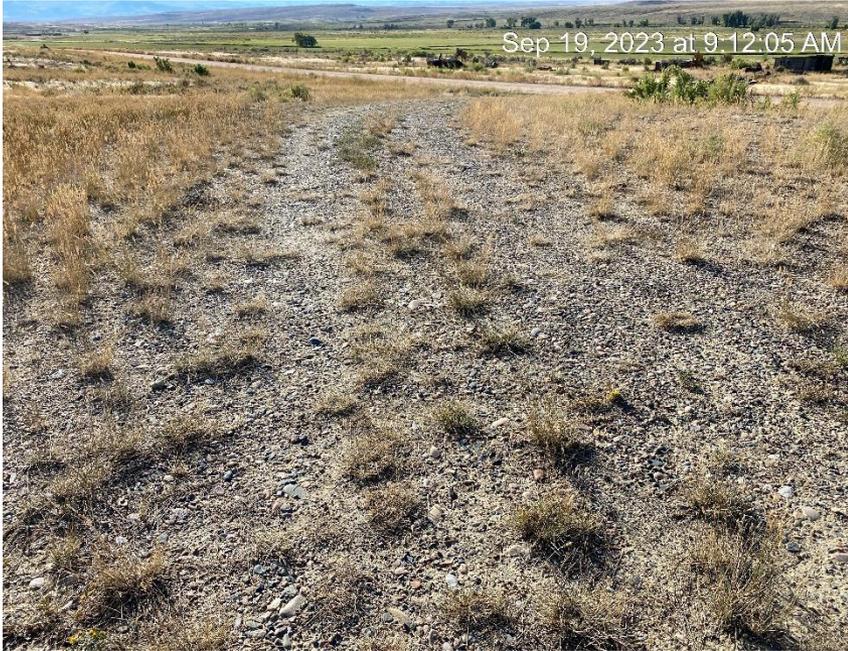
Access road to location

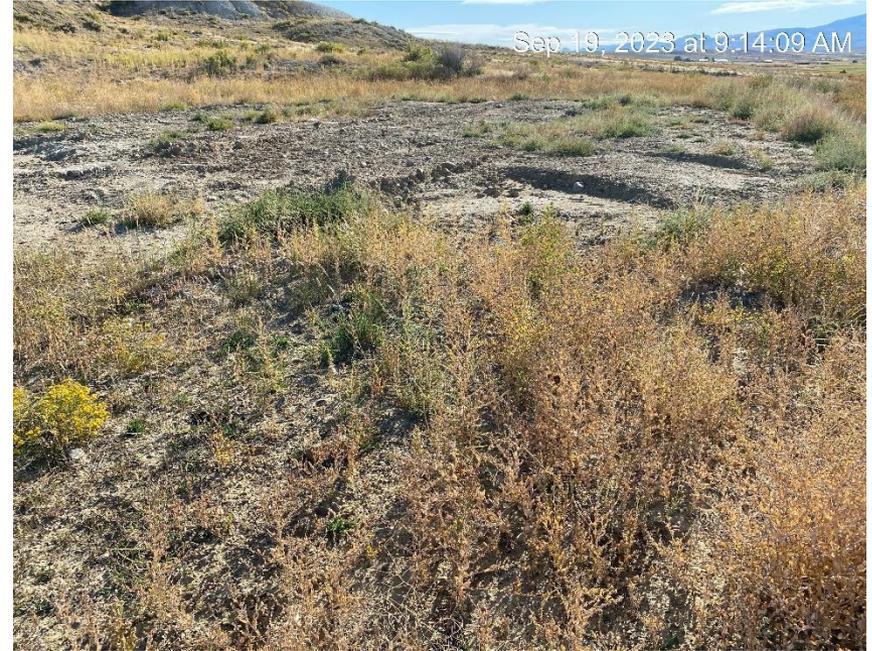
Removed tank battery

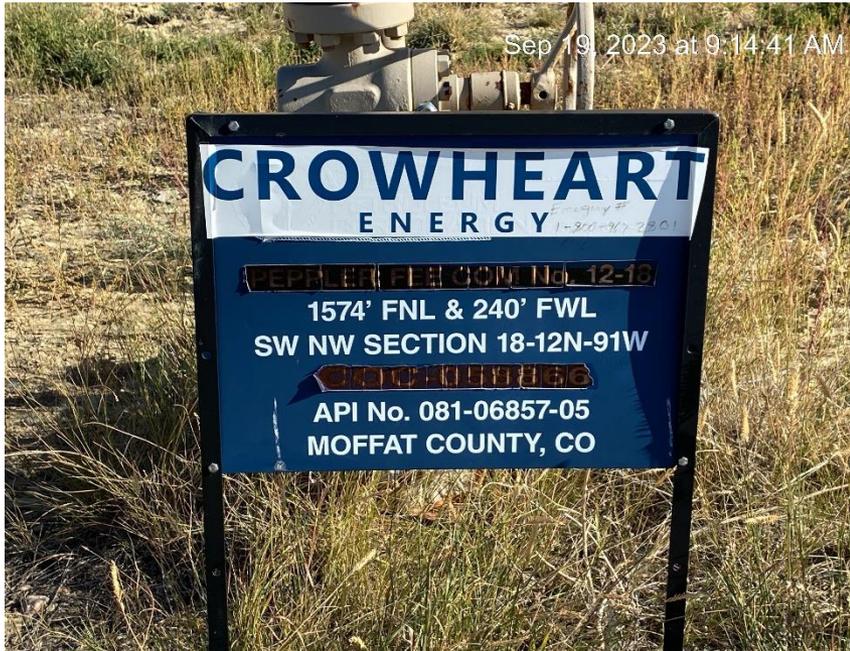
Wellhead sign illegible

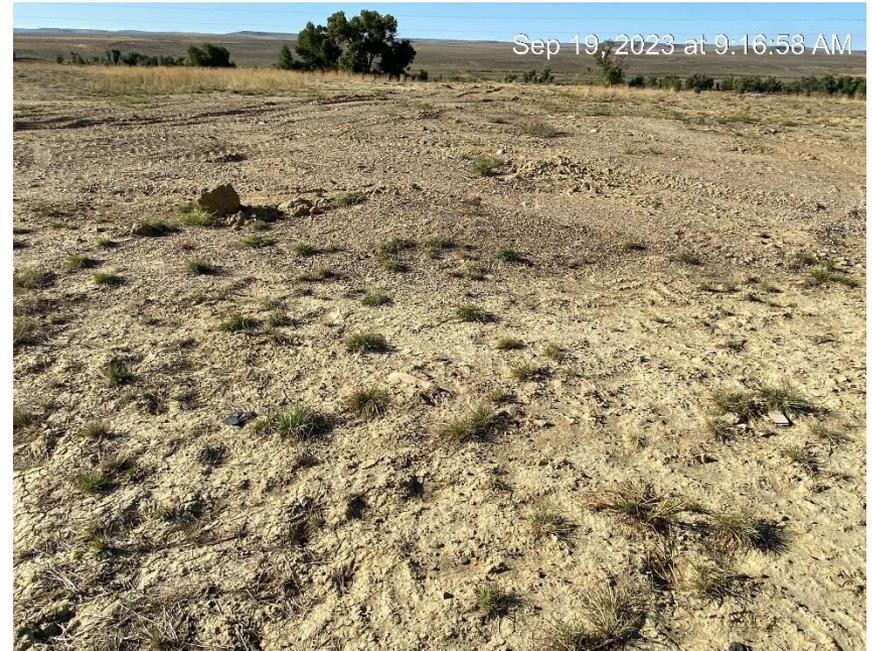
Removed meter house and separator equipment

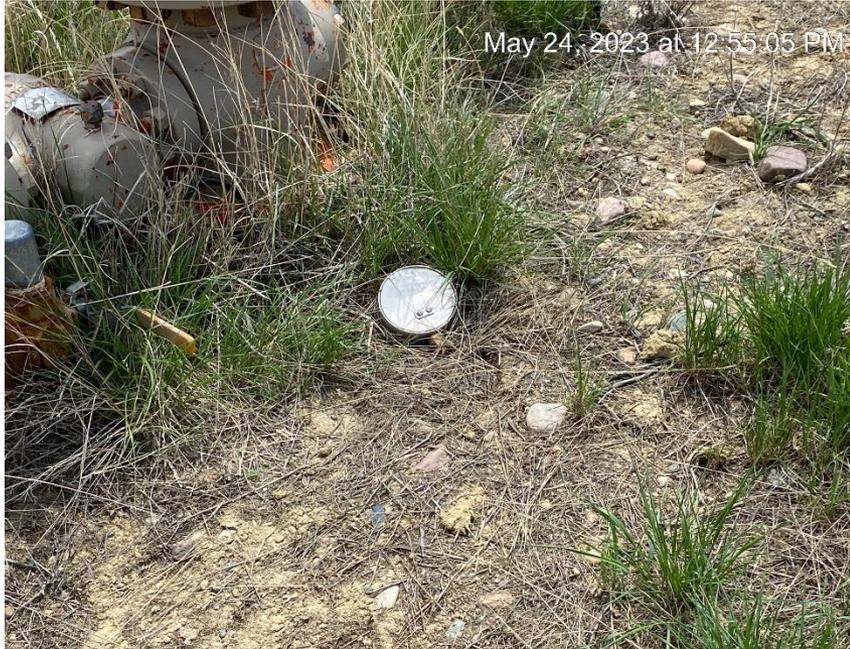
Debris from 5/24/23

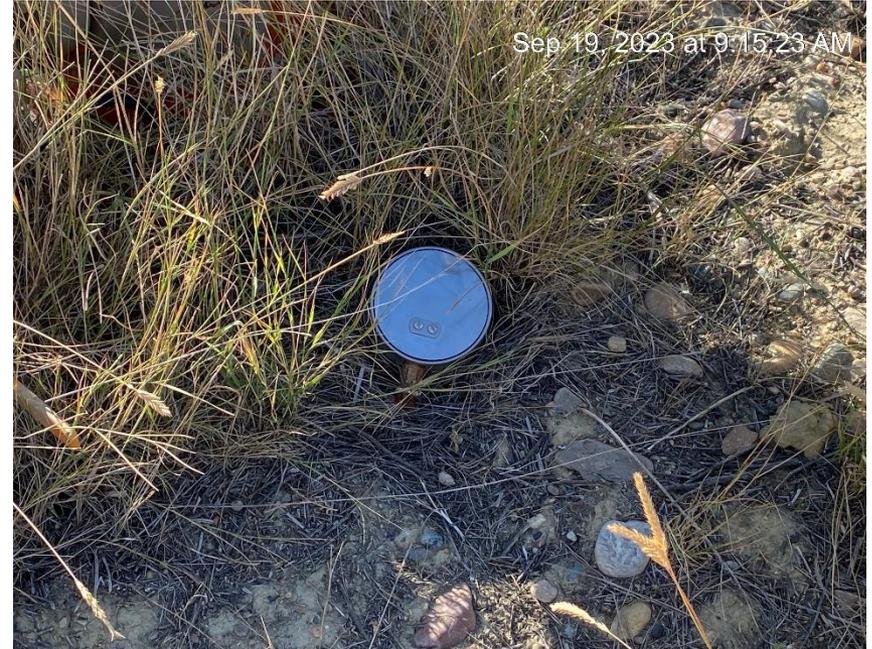
Debris from 9/19/23

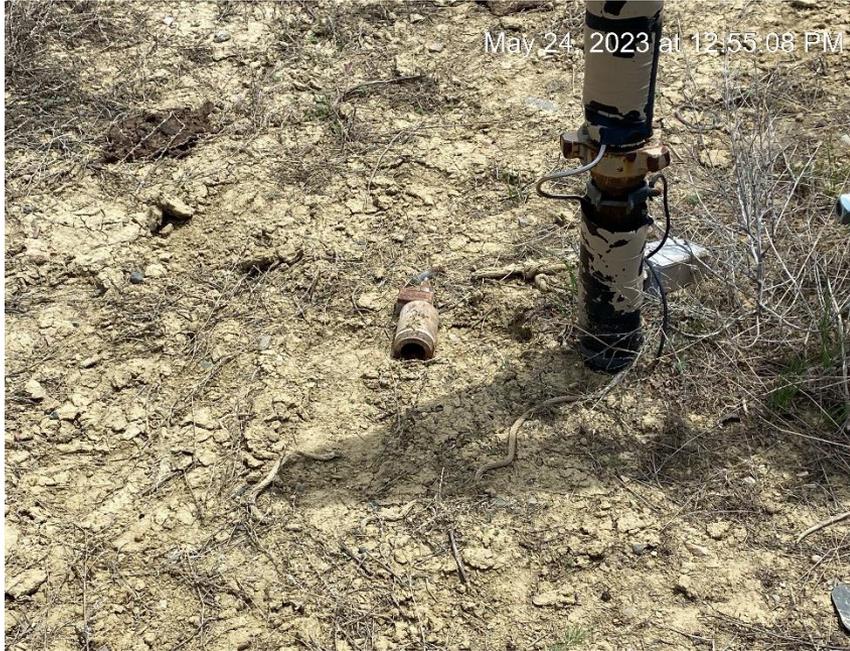
Debris from 5/24/23

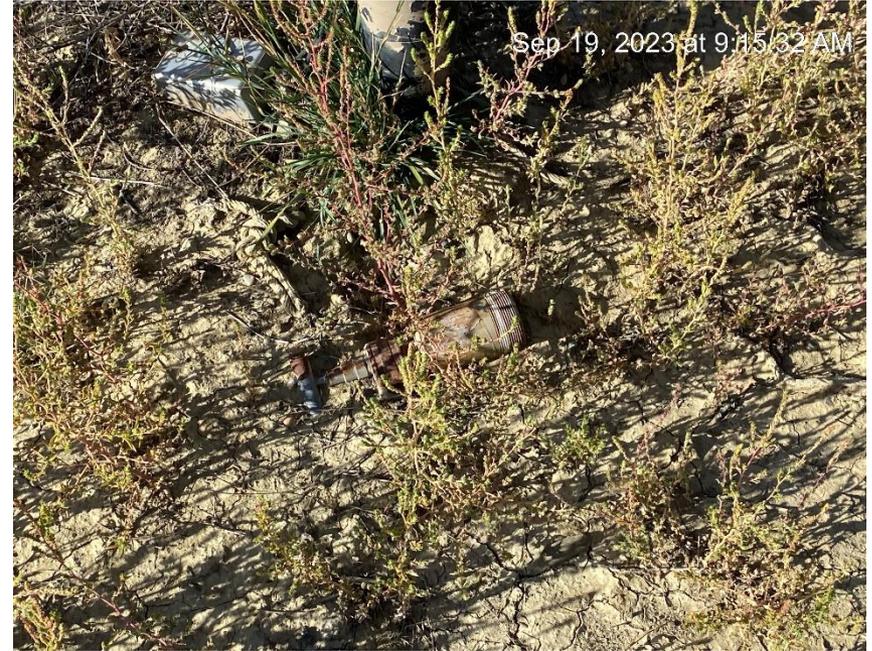
Debris from 9/19/23

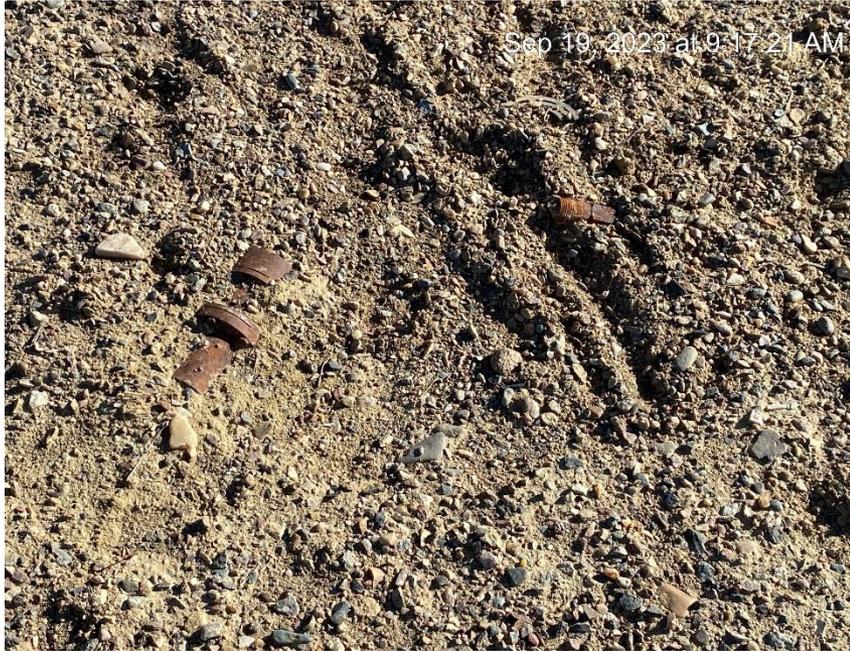
Debris

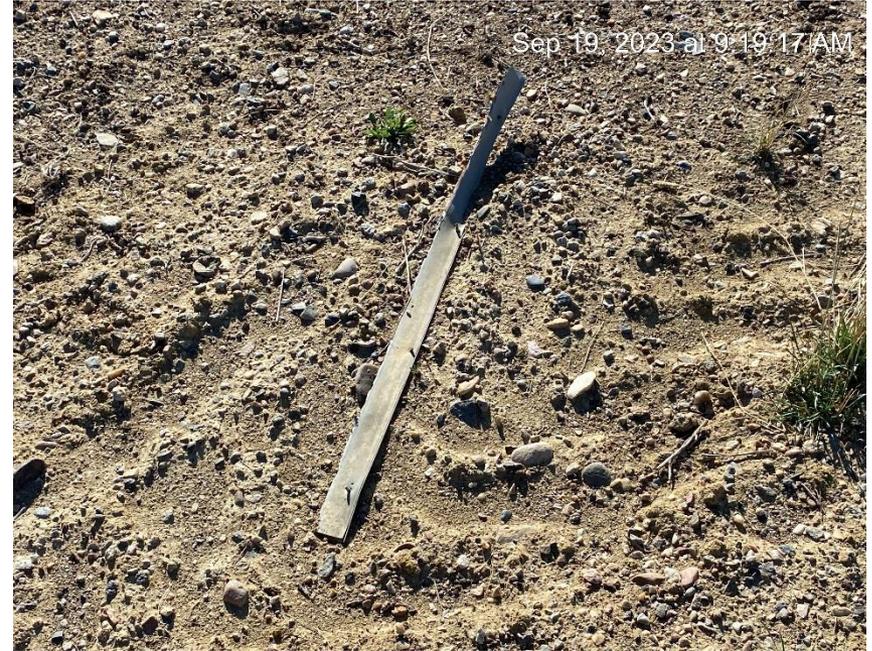
Debris

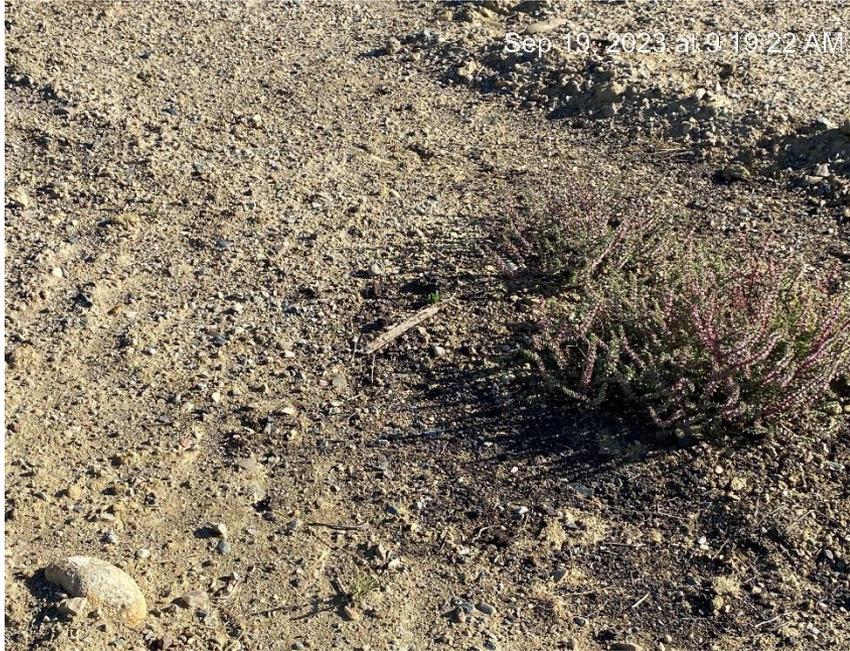
Debris

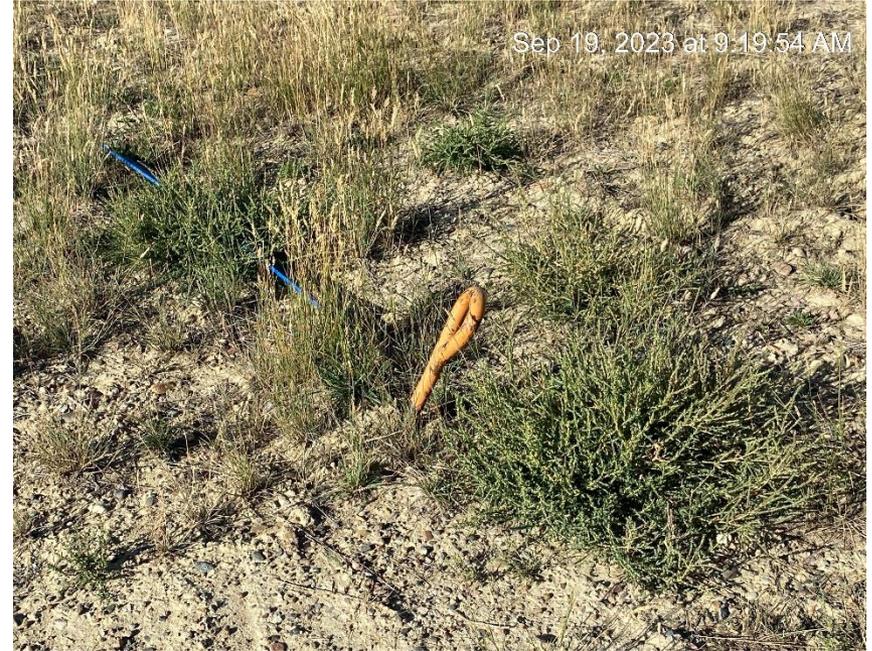
Anchor not securely marked

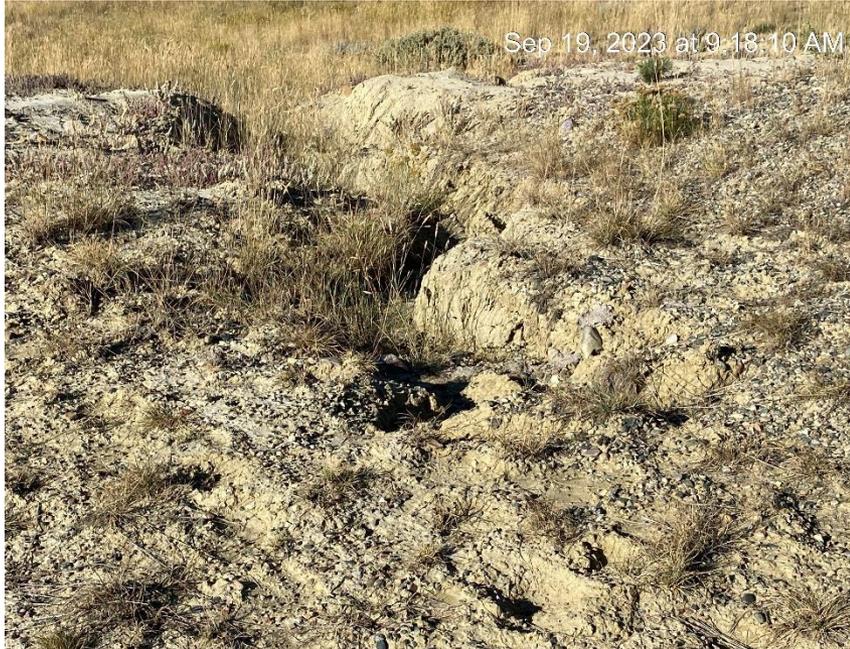
Erosion. Sediment migration leaving location

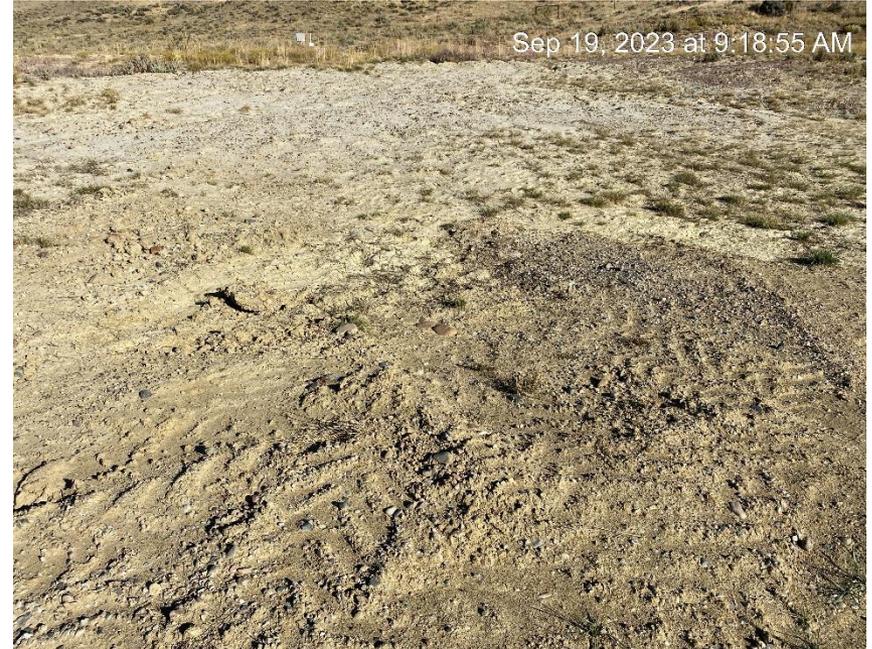
Sediment migration entering location
