Inspection Photos

Location Name: MUSTANG RESOURCES LLC JUHAN FEE 26-94-6S-94W Pad

Location ID: 322316

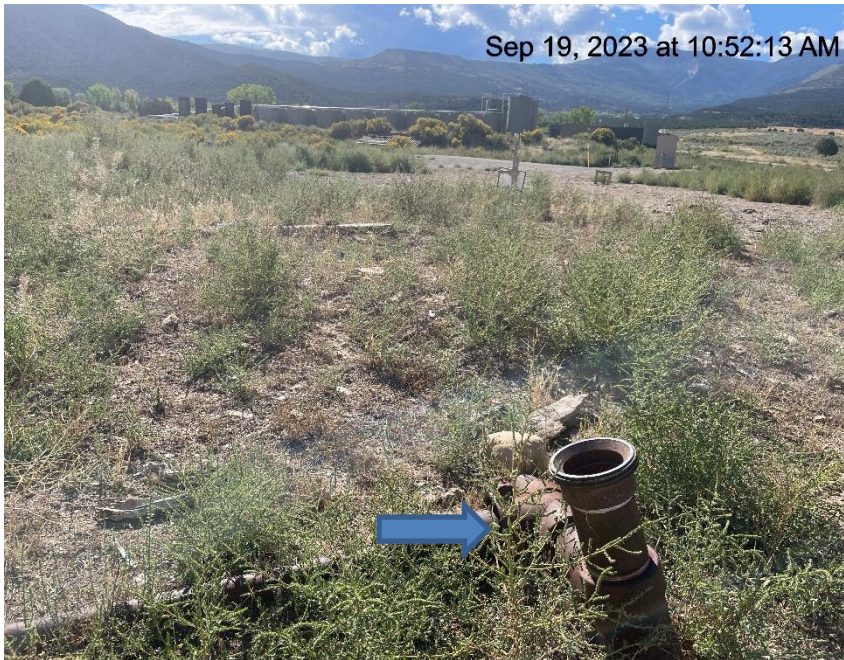
Photo # 9830 Debris
