Final Reclamation and Stormwater Inspection

Operator: MAGPIE OPERATING INC - 52530

Location ID: 312143

Inspection Document #: 708200559

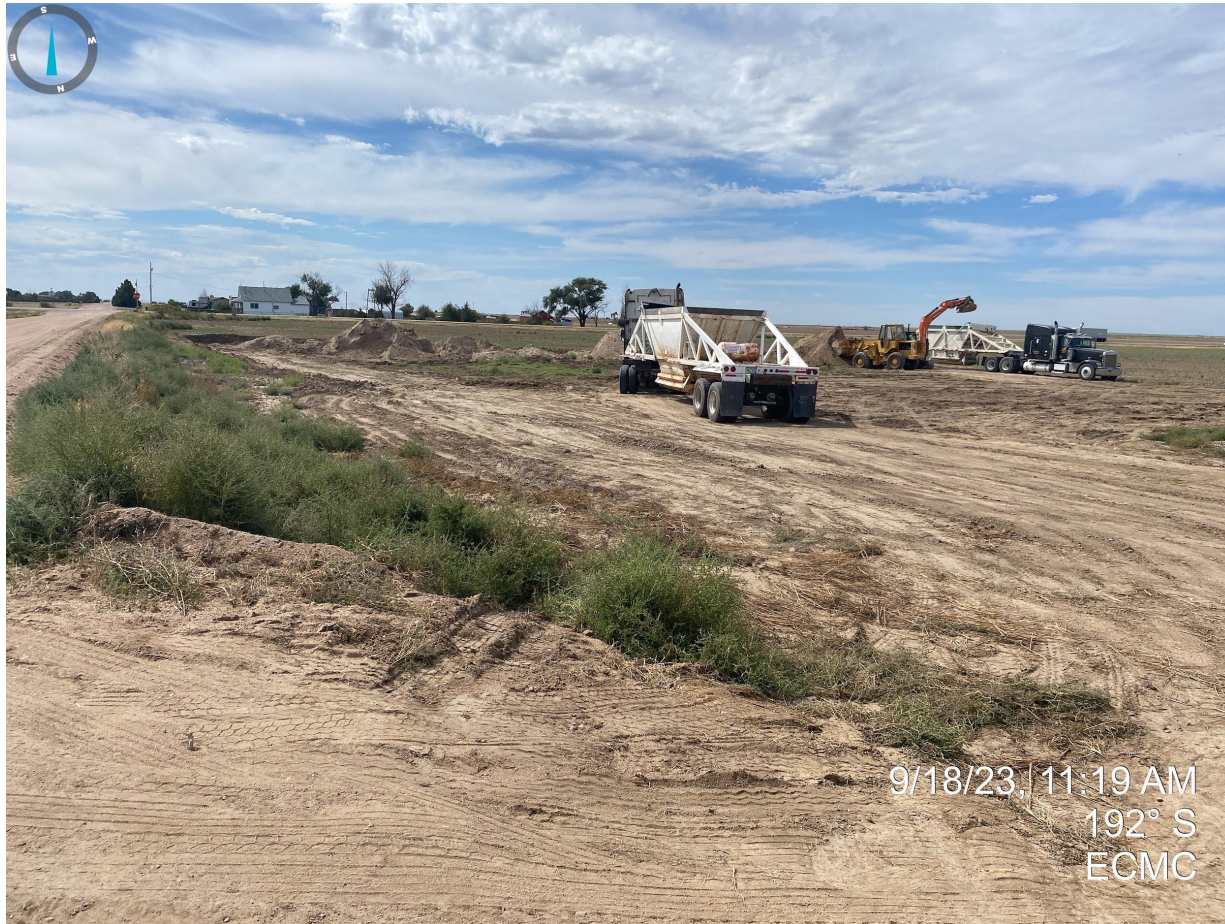
Photo 1. Taken at the location's entrance. Photo illustrates excavation operations (digging and hauling) of the former pit area.

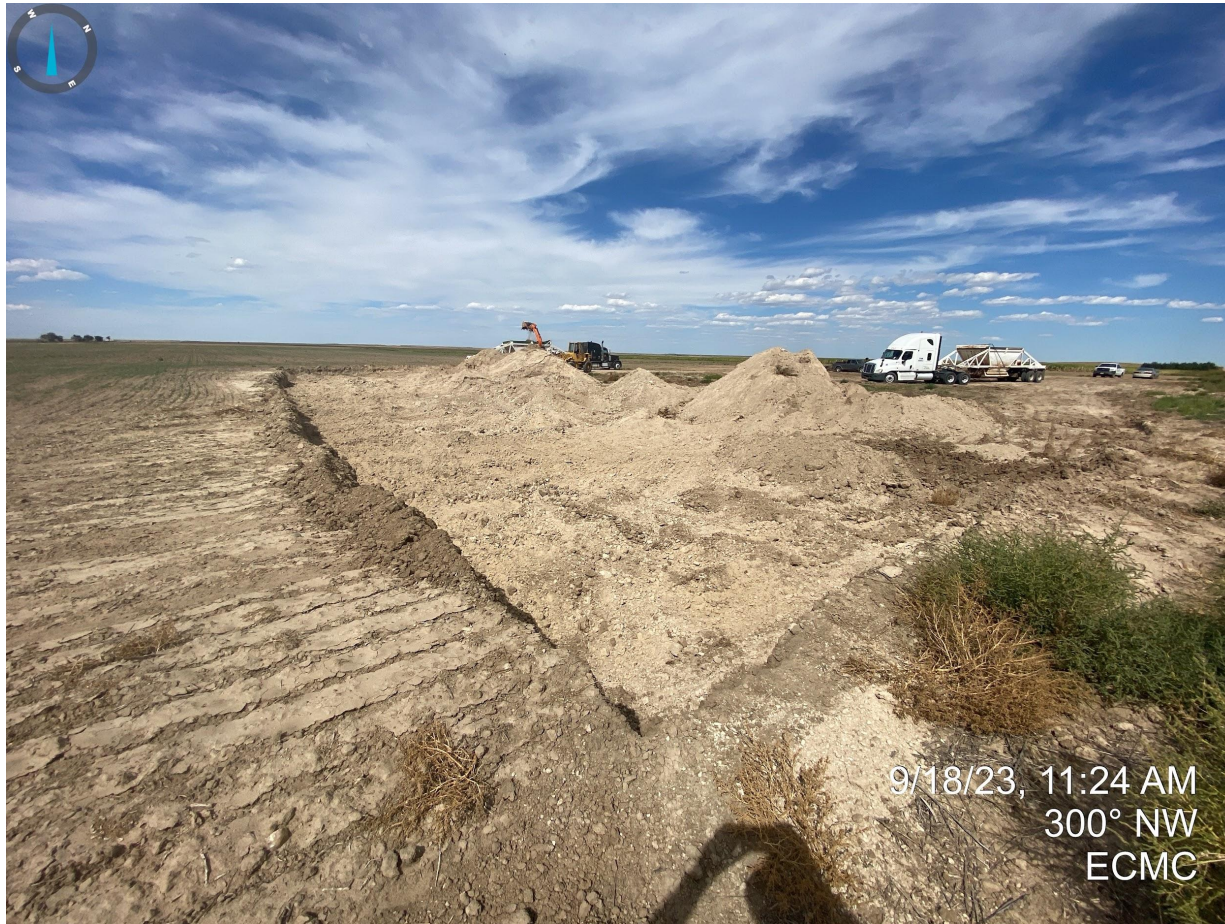
Photo 2. Taken from the southeast corner of the former pit. Photo illustrates excavation operations of E&P waste occurring over the former pit. Onsite Operator representative informed Staff that the waste was being sent to Washington County Landfill for disposal.

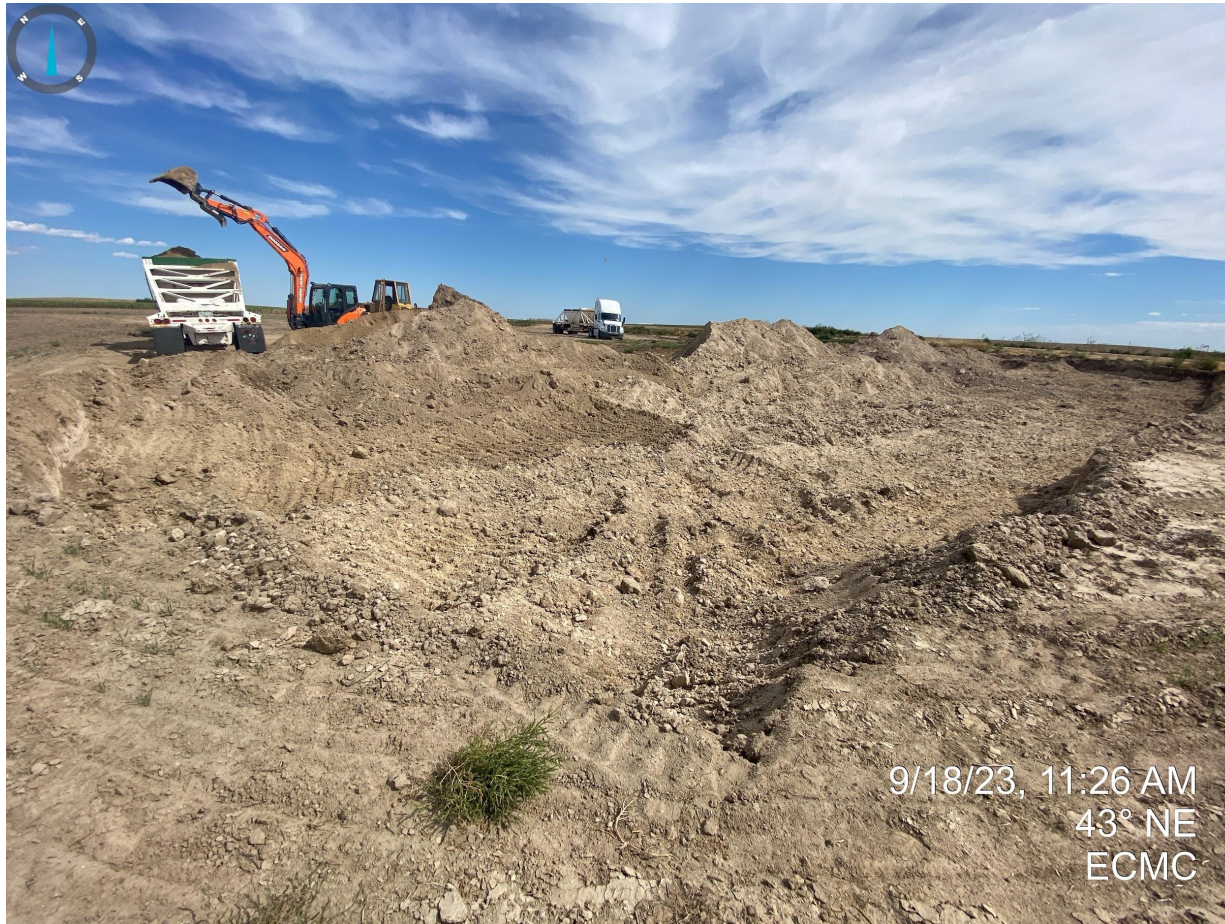
Photo 3. Taken from the southwest corner of the pit; see comments in Photo 2.

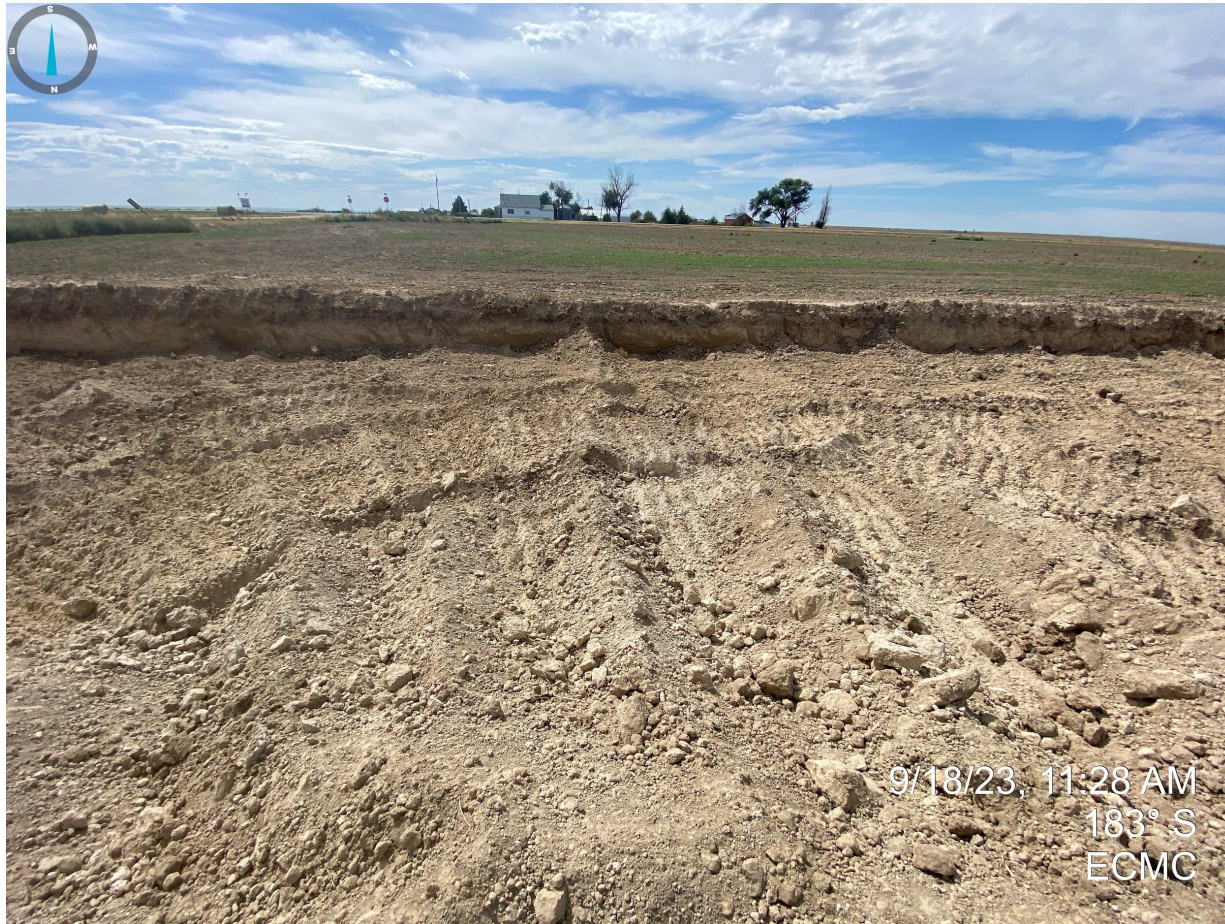
Photo 4. Taken from the center portion of the former pit; see comments in Photo 2.

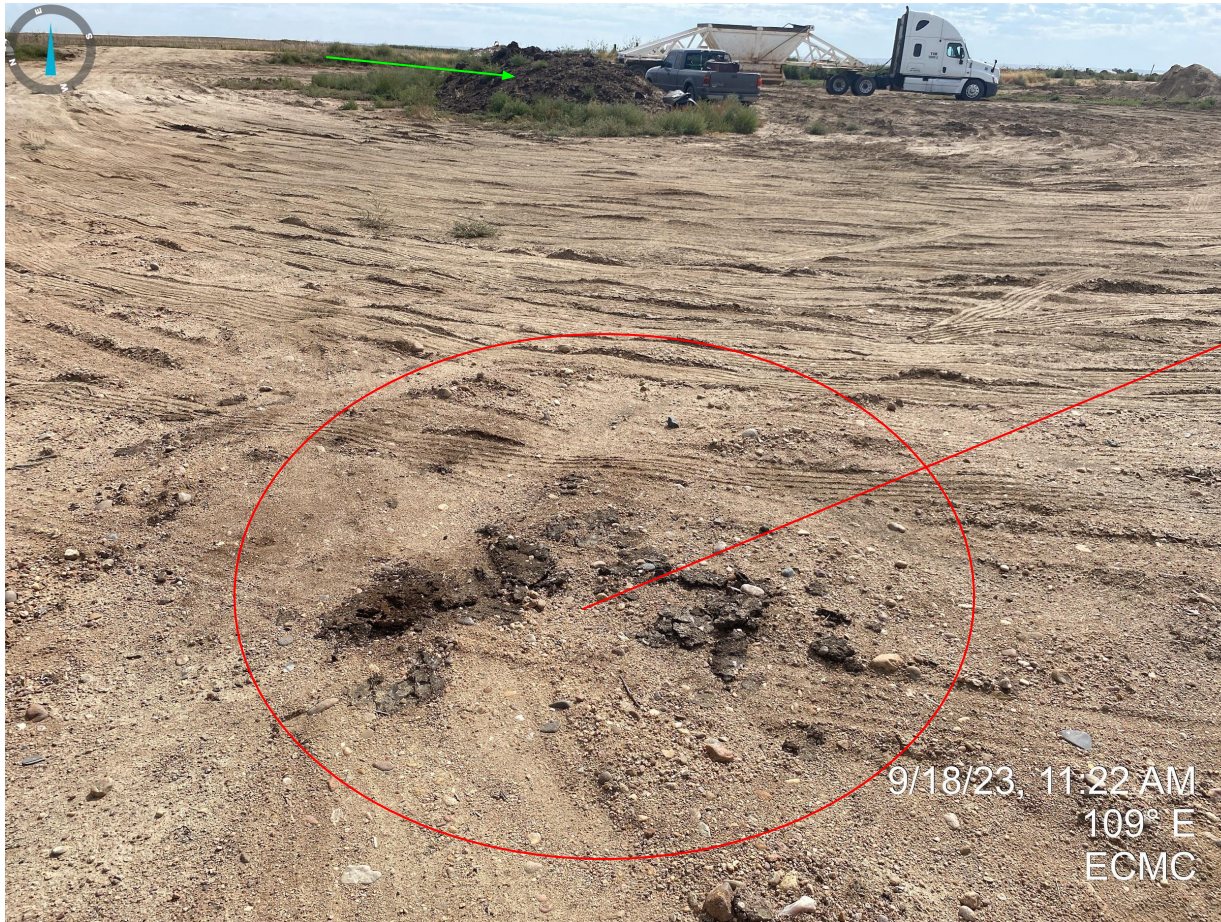
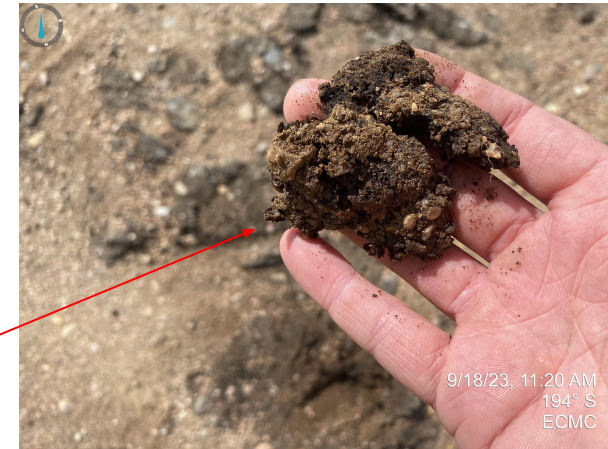
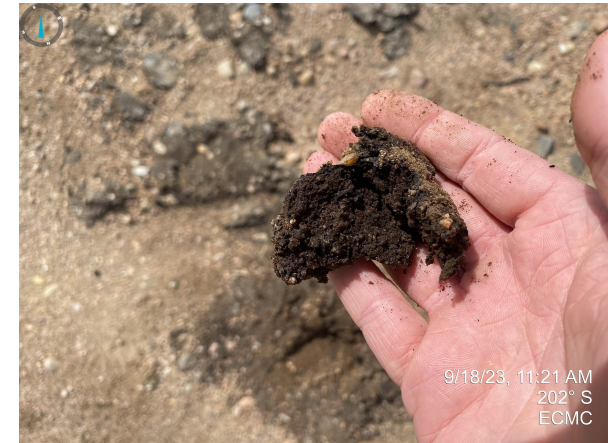
Photo 5. Stained soils observed on the western portion of the former production area. Staff first observed the stained soil on 08/03/2023 (doc #708200446); Operator submitted FIRR (doc #403526856) stating that all hydrocarbon impacted material was removed from the location and indicated that the corrective action was completed on 01/12/2023. Based on field observations during this inspection, the corrective action has not been completed. Manure pile pictured in the background (highlighted with green arrow).

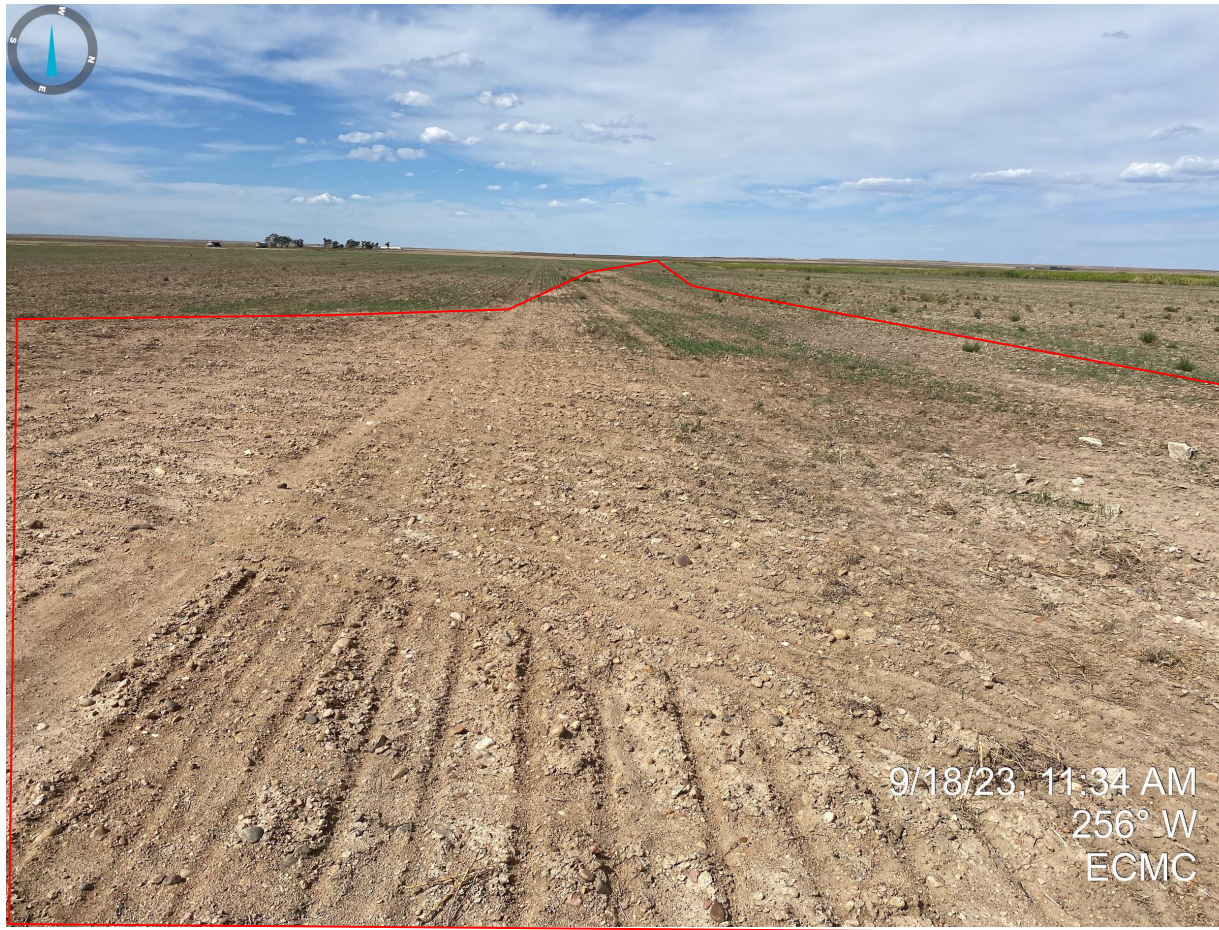
Photo 6. Taken north of the former production areas. Photo illustrates that road base/gravel remains throughout the northern portion of the production areas and along the former access road to the wellhead. Final reclamation activities are required.

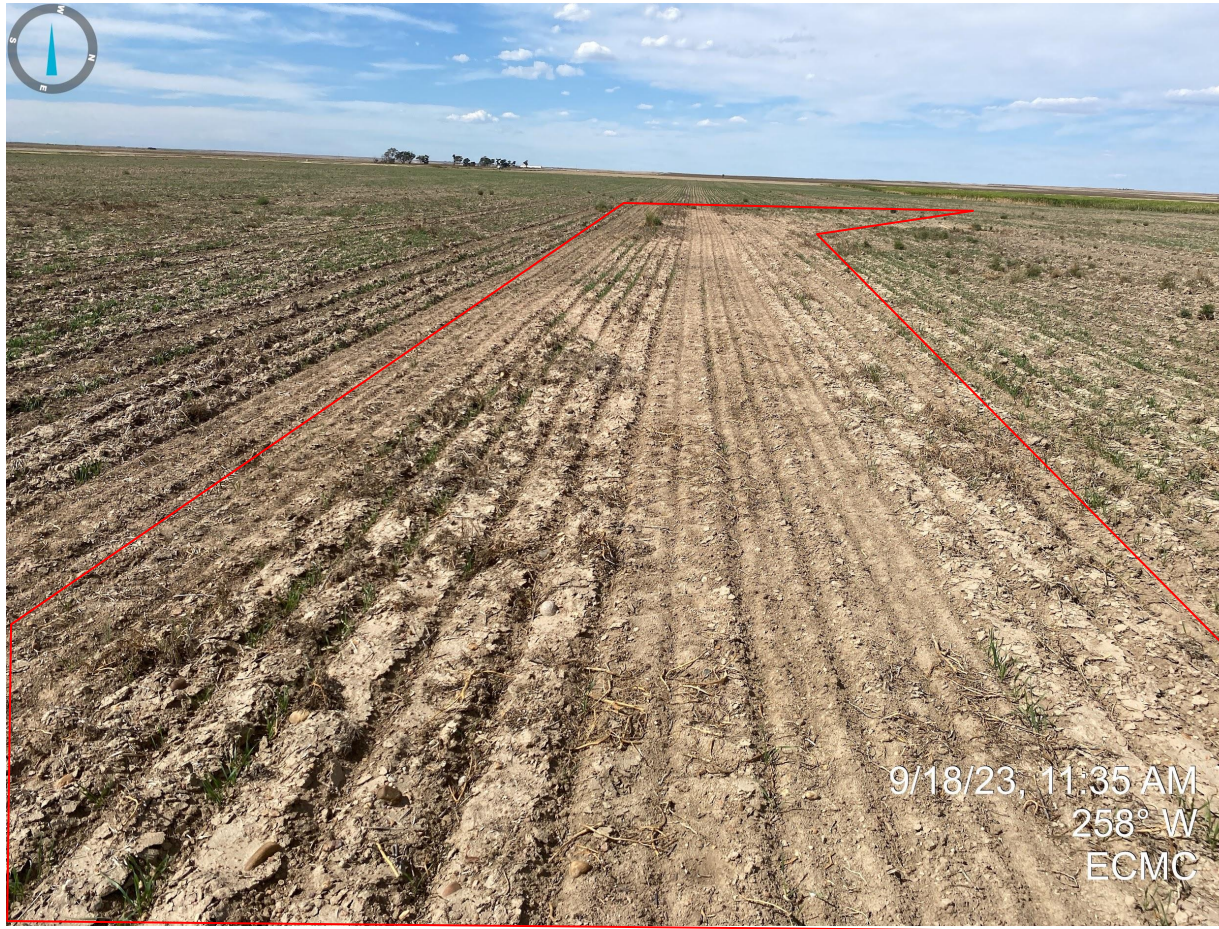
Photo 7. Taken halfway between the former production areas and the wellhead location. See comments in Photo 6.

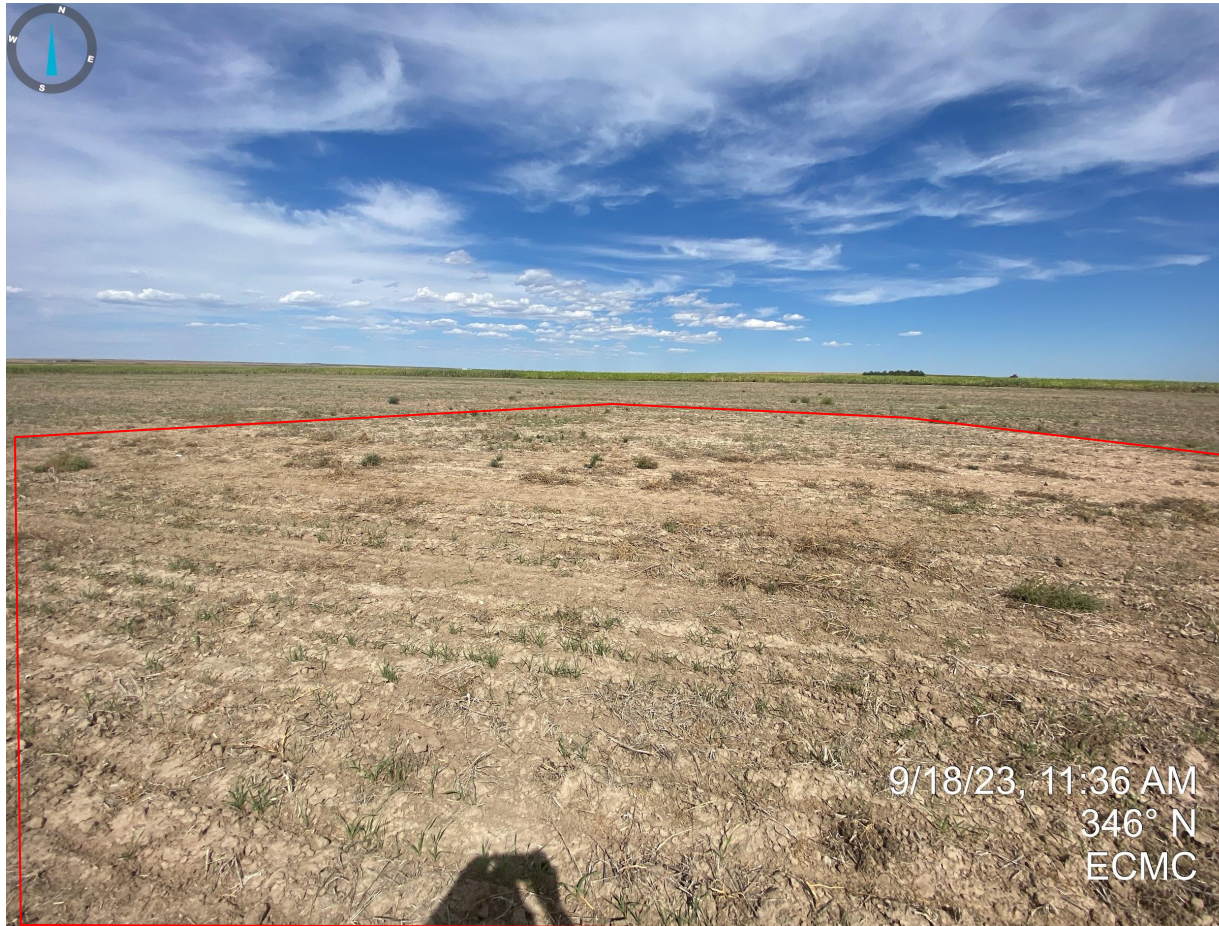
Photo 8. Taken from the southern portion of the former wellhead location. Road Base and gravel remain throughout and the location will need to be leveled and/or graded to reflect pre-disturbance topography.

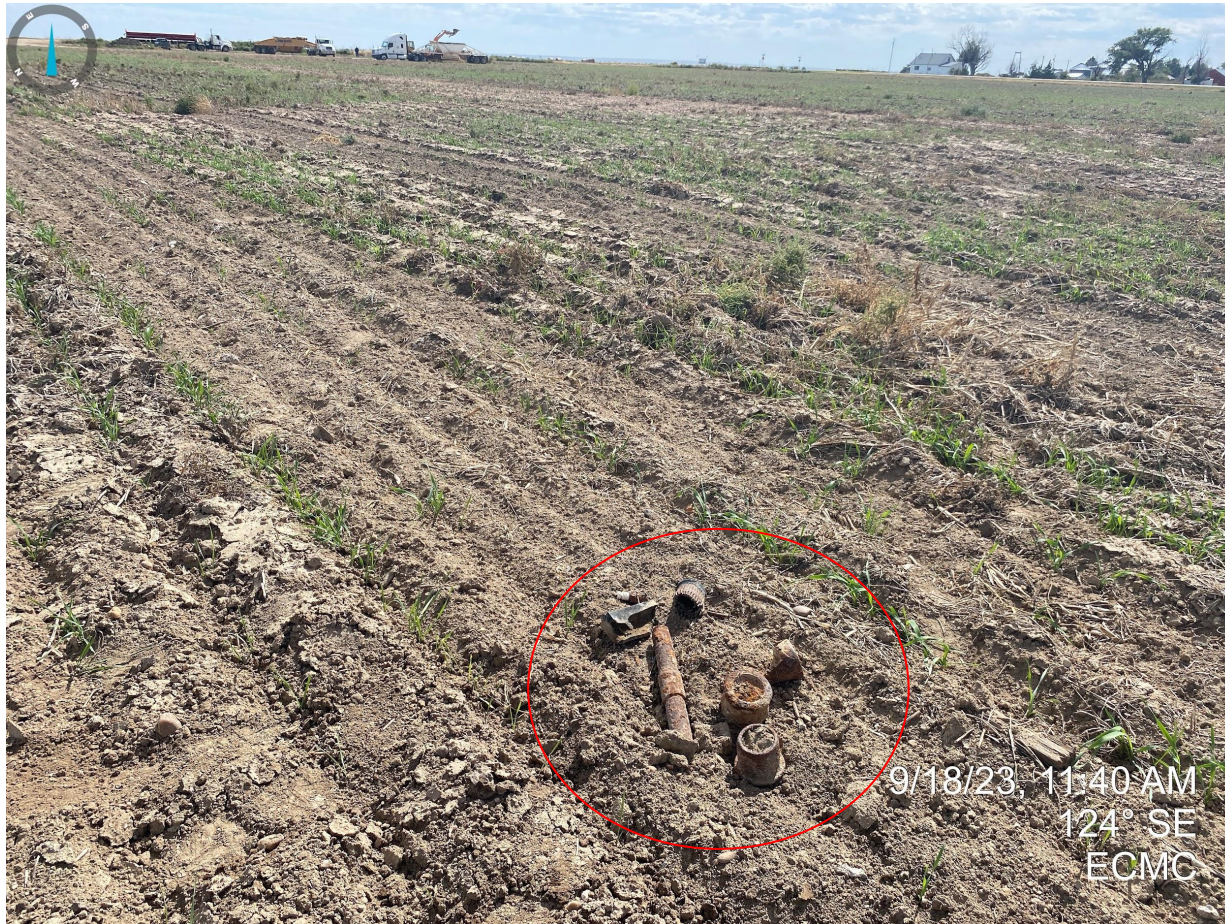
Photo 9. Taken from the northern portion of the former wellhead location. During this inspection, Staff observed debris located throughout the former location. Debris was placed in a pile for removal.

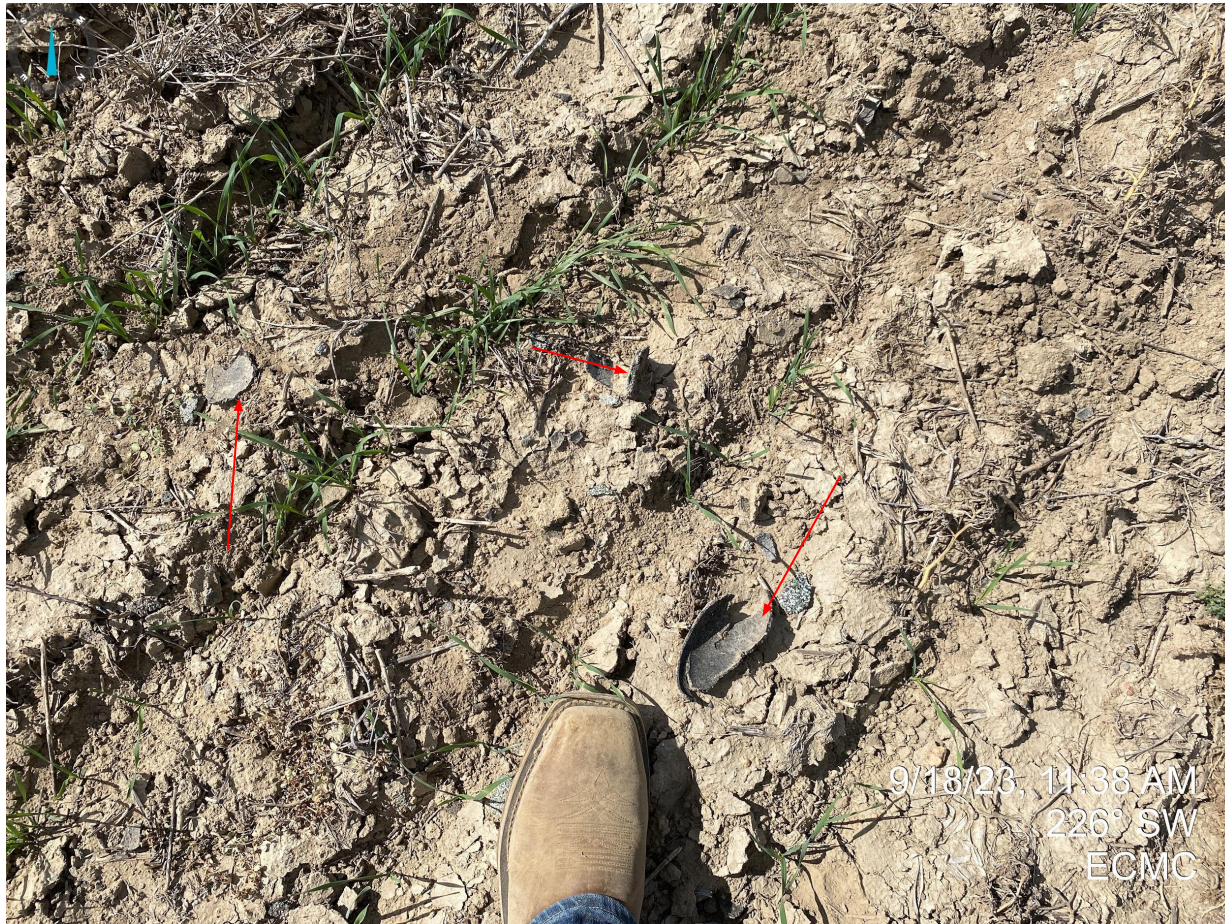
Photo 10. Taken from the former wellhead location. Roofing shingle debris was observed throughout and will need to be removed.

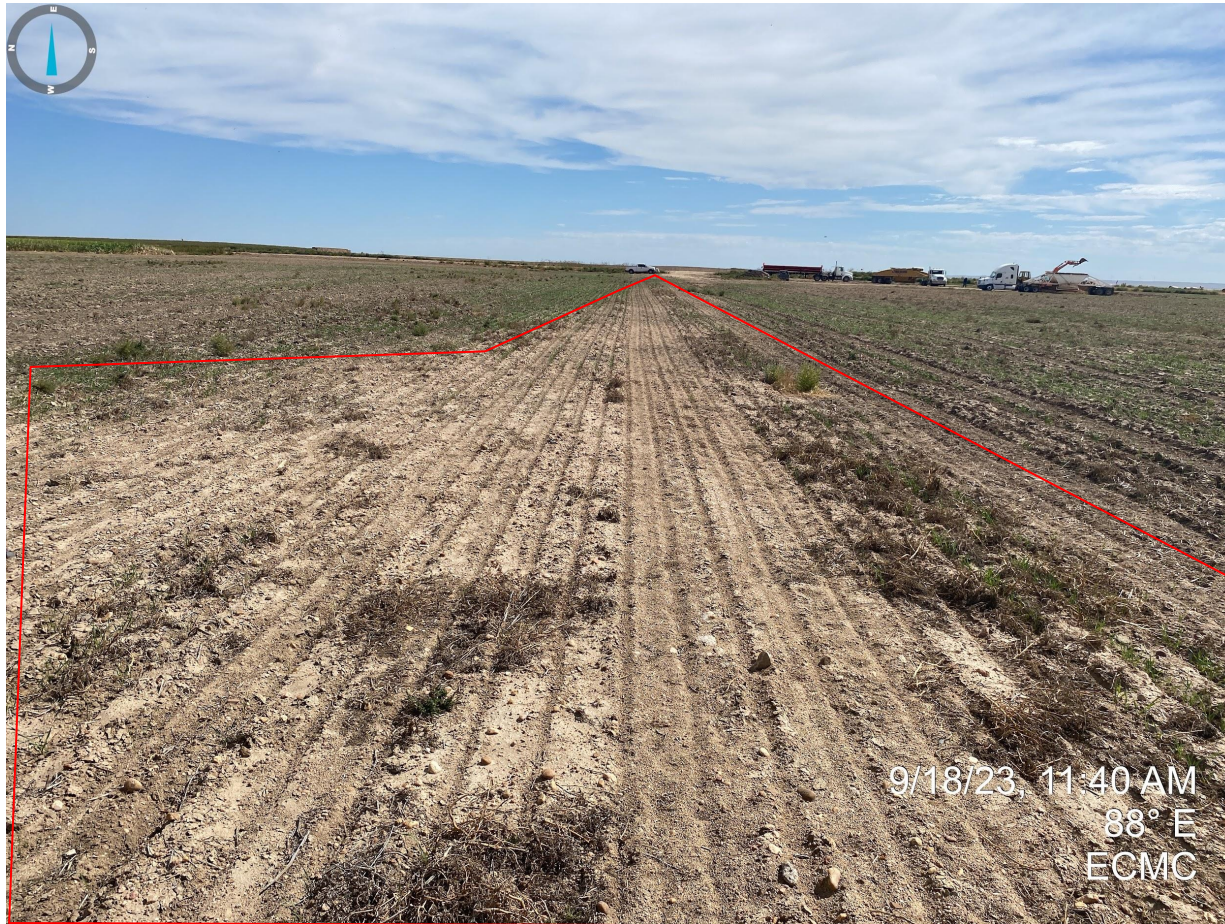
Photo 11. Facing east from the former wellhead location. See comments in Photo 6.
