Inspection Photos

Operator: LARAMIE ENERGY LLC #10433

Location ID: 335647

Inspection No: 696205263

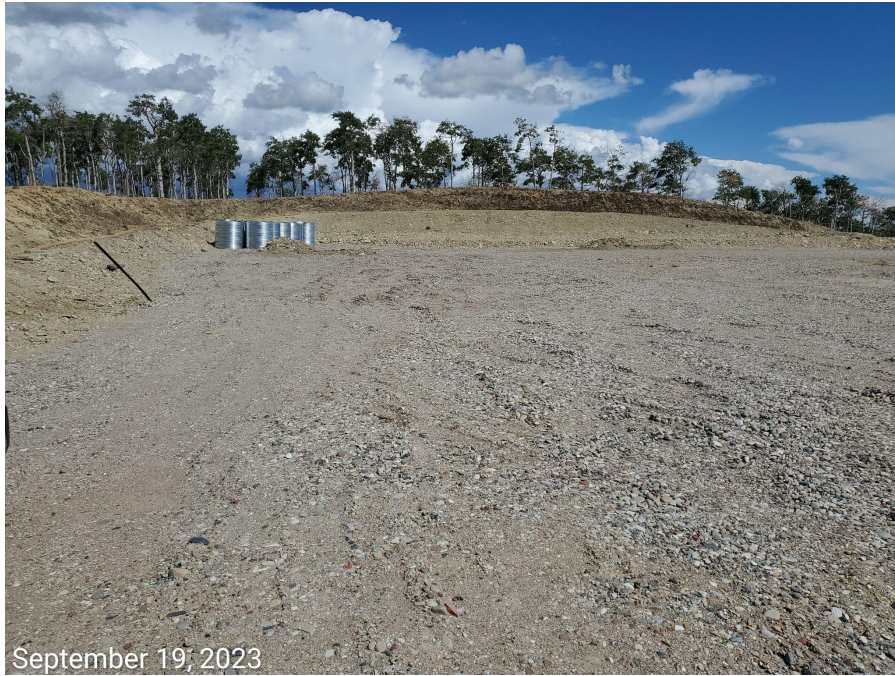
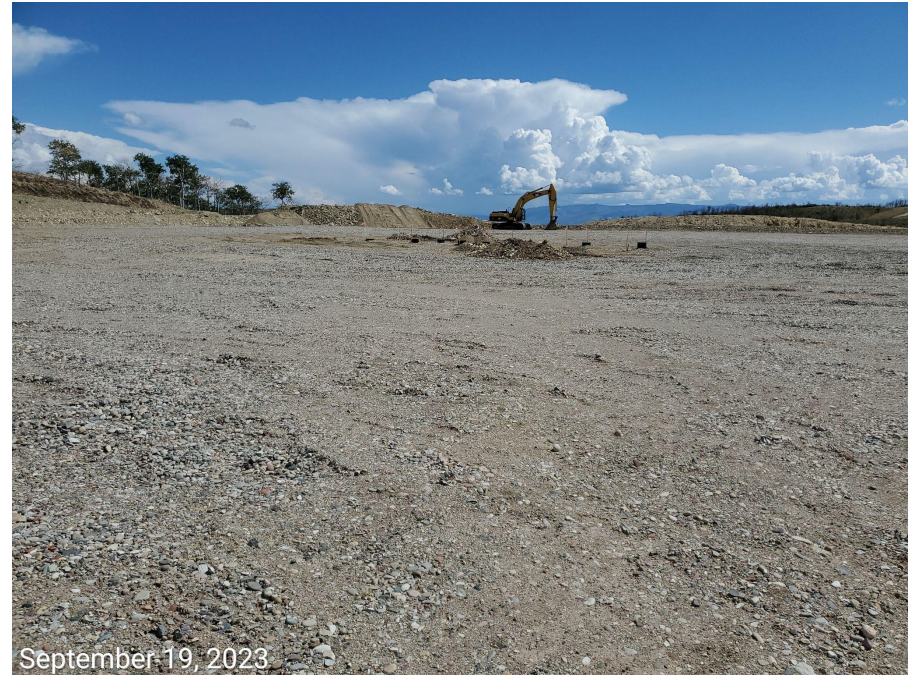
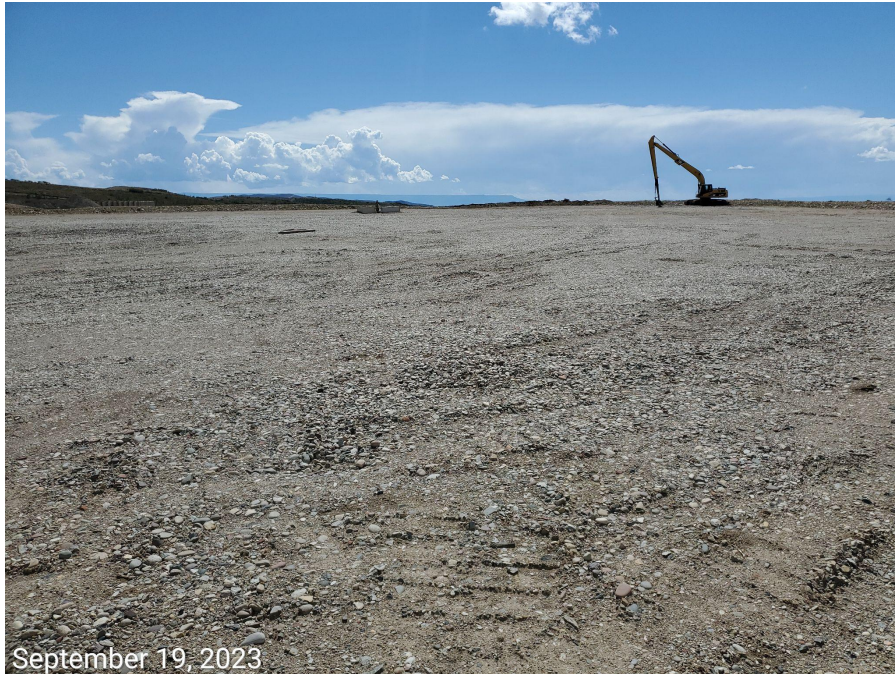
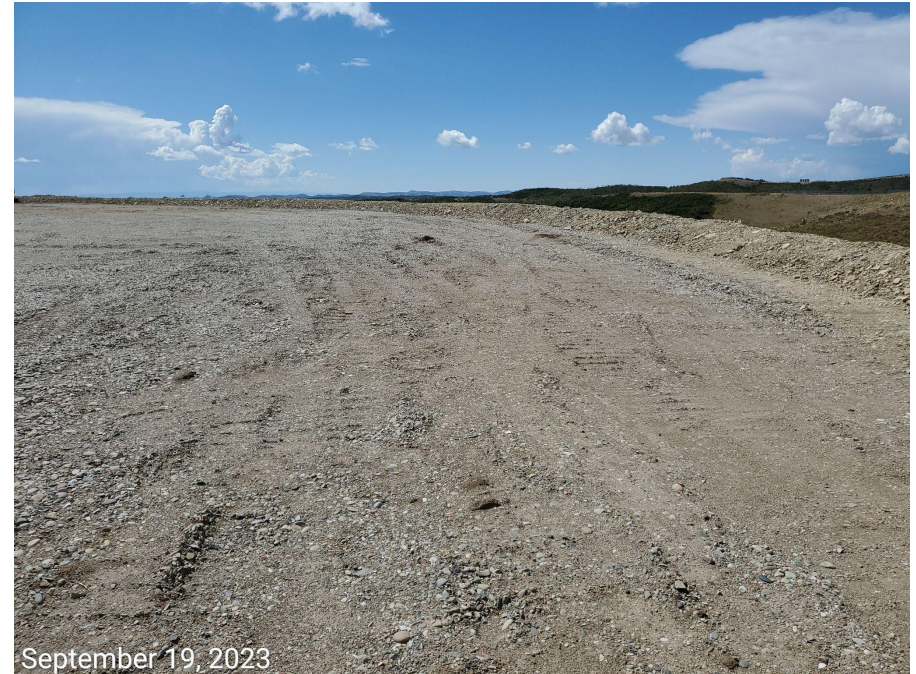
Photo 1: Photos taken from the north end of the Working Pad Surface. Photos 1-2 provide an overview of the Location from east, southeast, southwest to west.

Photo 2: See comments under photo 1.

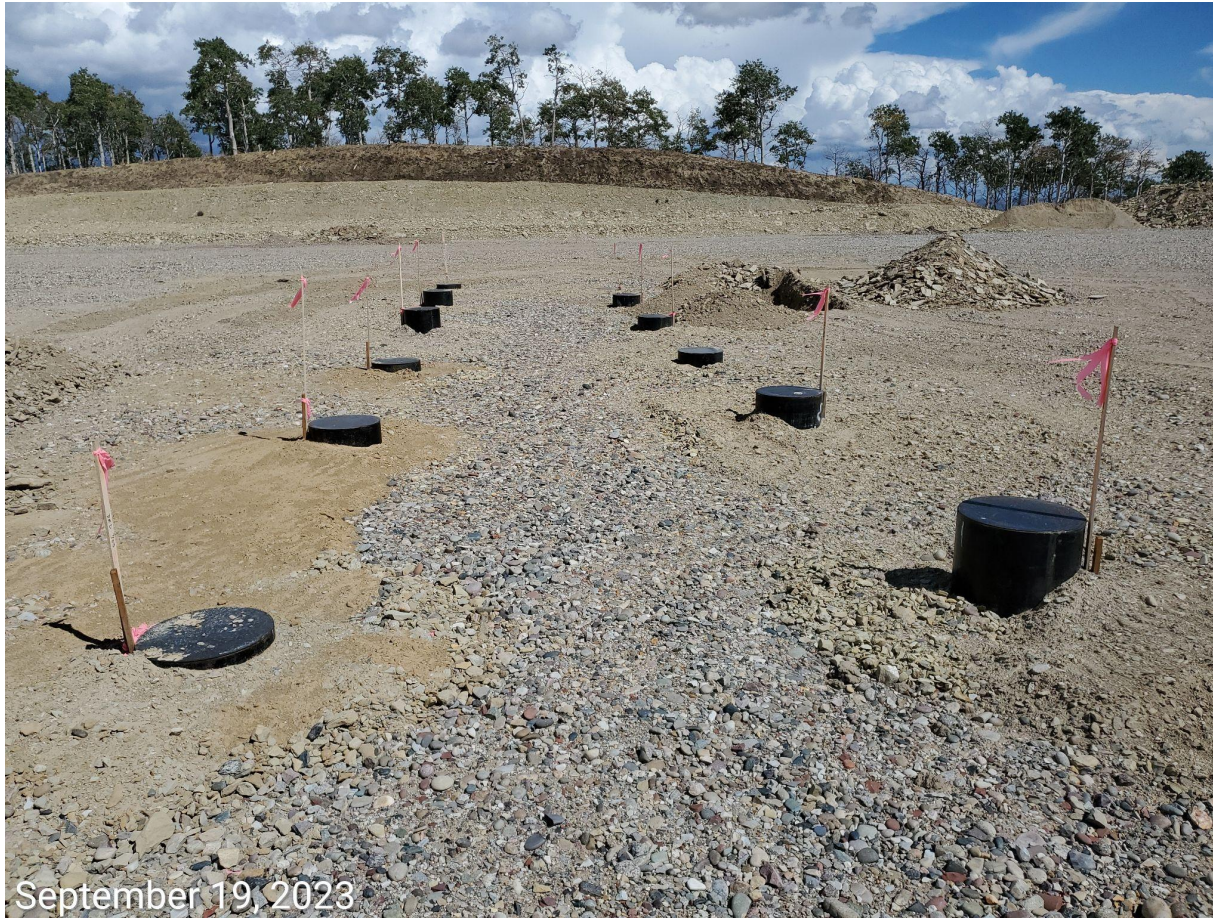
Photo 3: Photo shows conductors on Location.

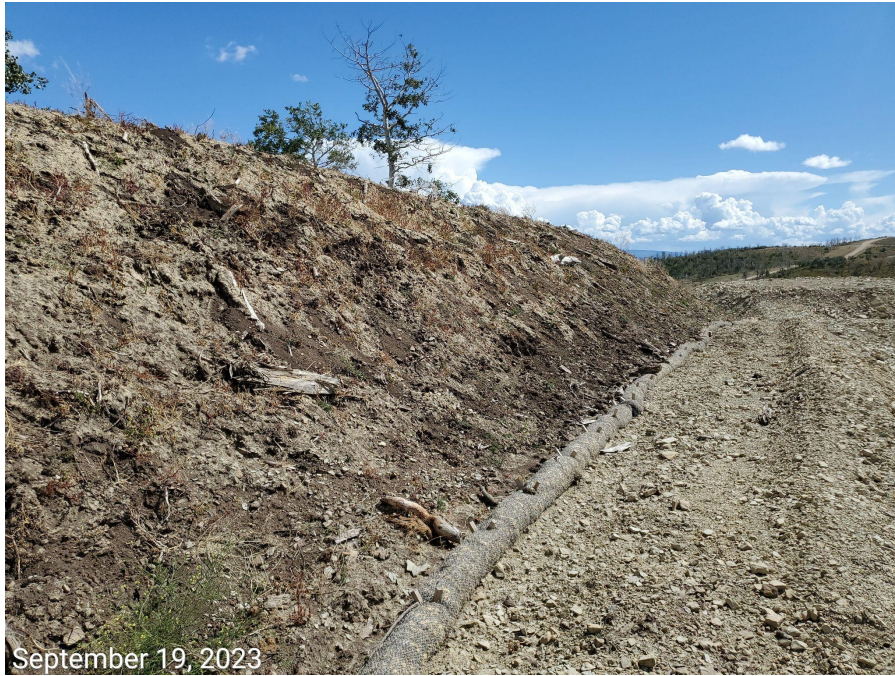
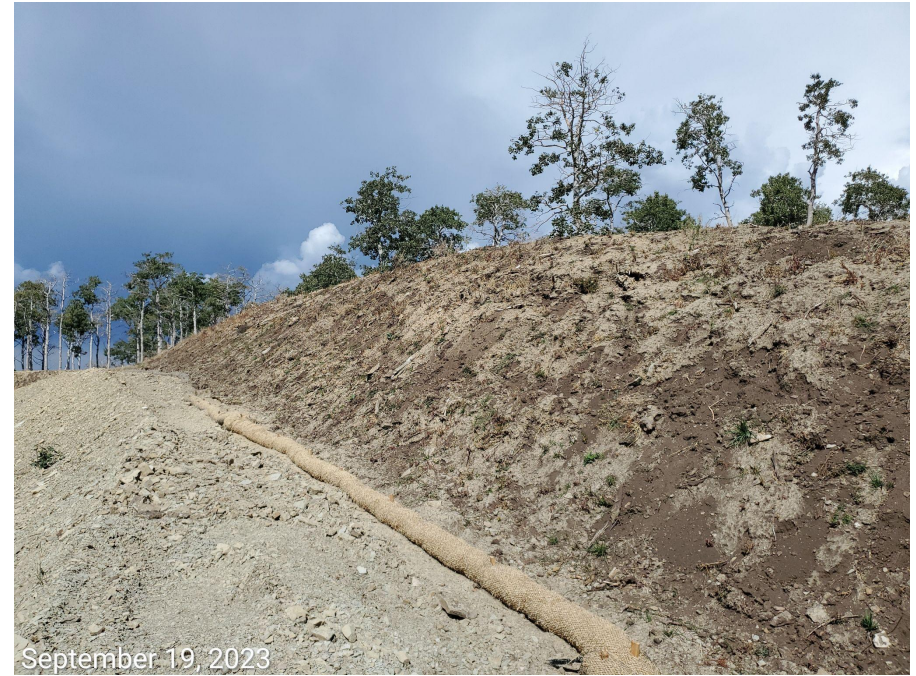
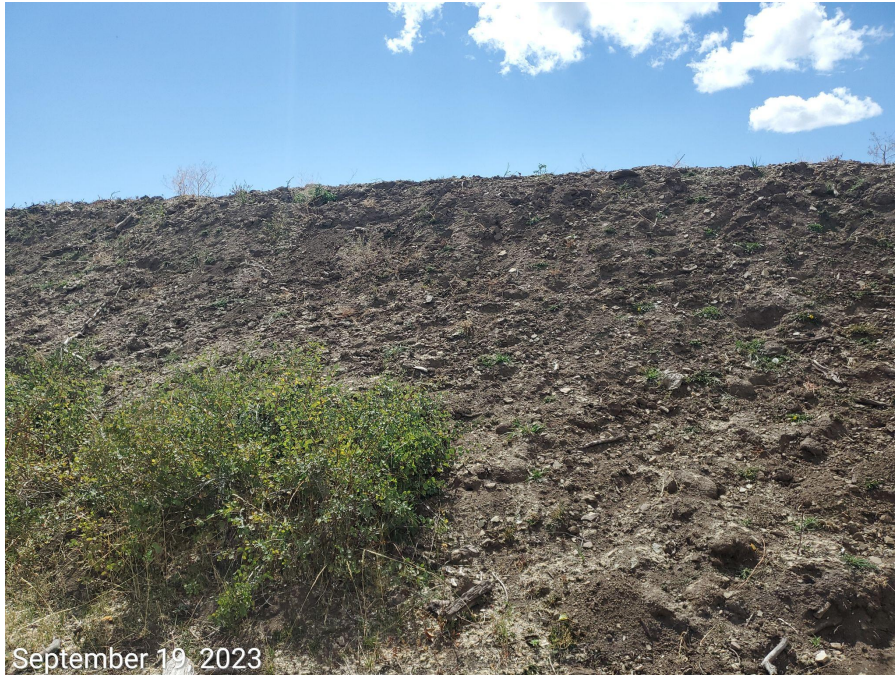
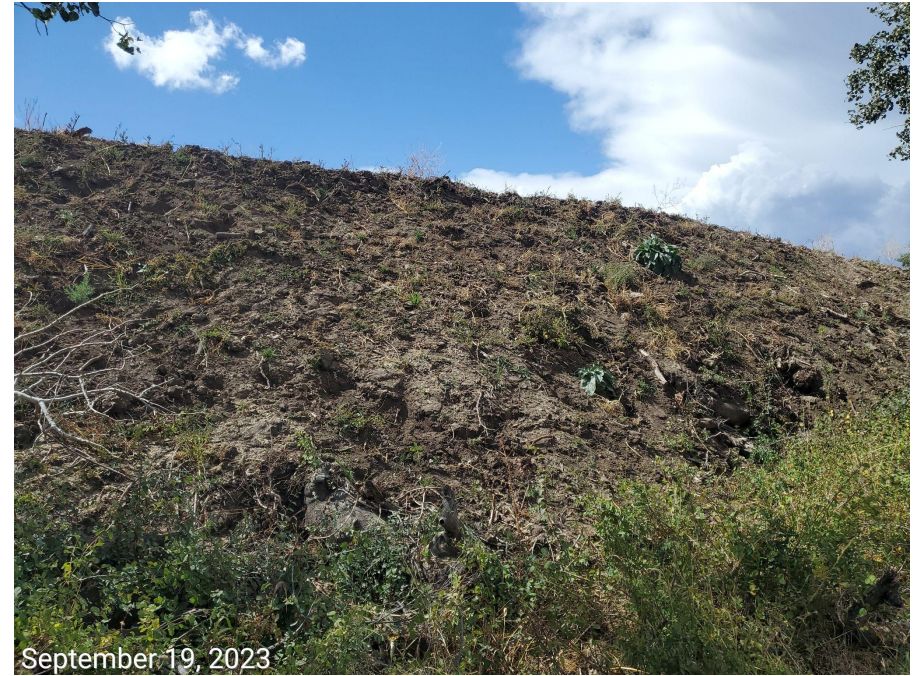
Photo 4: Photo 4-6 taken from the topsoil stockpiles on the north and east end of the Location. Photos examples showing BMPs (hydromulch) has not been installed or maintained in accordance with good engineering practices, in accordance with Rules 1002.c and 1002.f

Photo 5: See comments under photo 4.

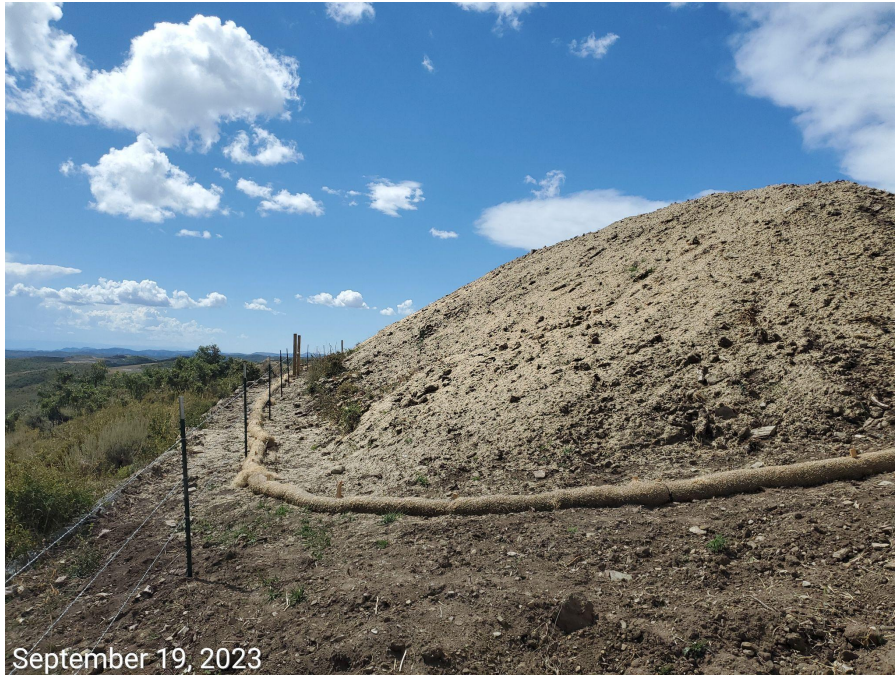
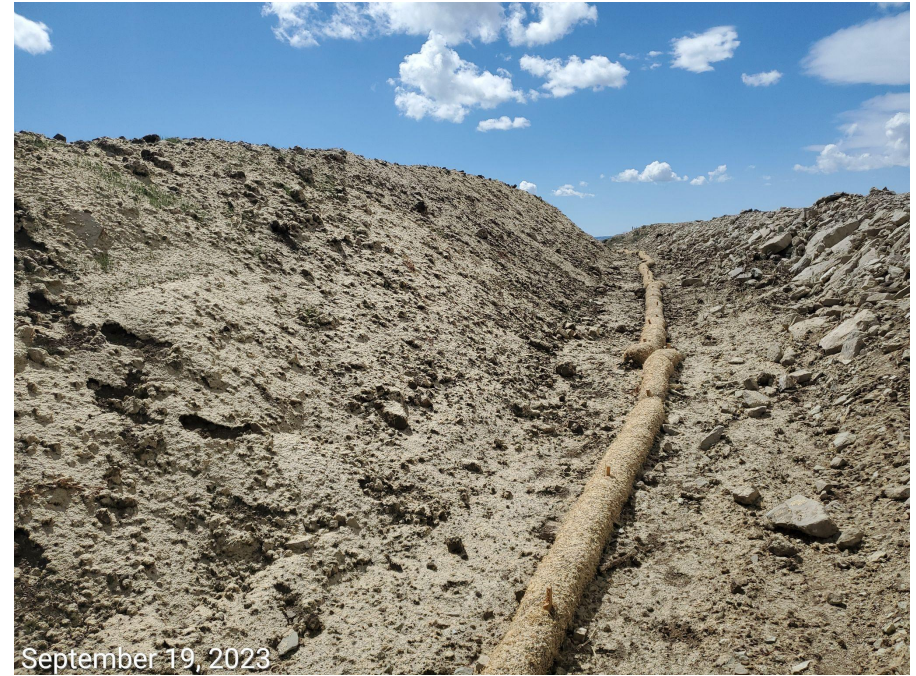
Photo 6: Photos taken from the topsoil stockpile on the south end of the Location, facing southwest/west. Operator has implemented hydromulch in conjunction with an erosion log to protect the stockpile from wind/water erosion, weeds, and to minimize sediment transport. BMPs appeared to be in proper functioning condition at time of inspection.

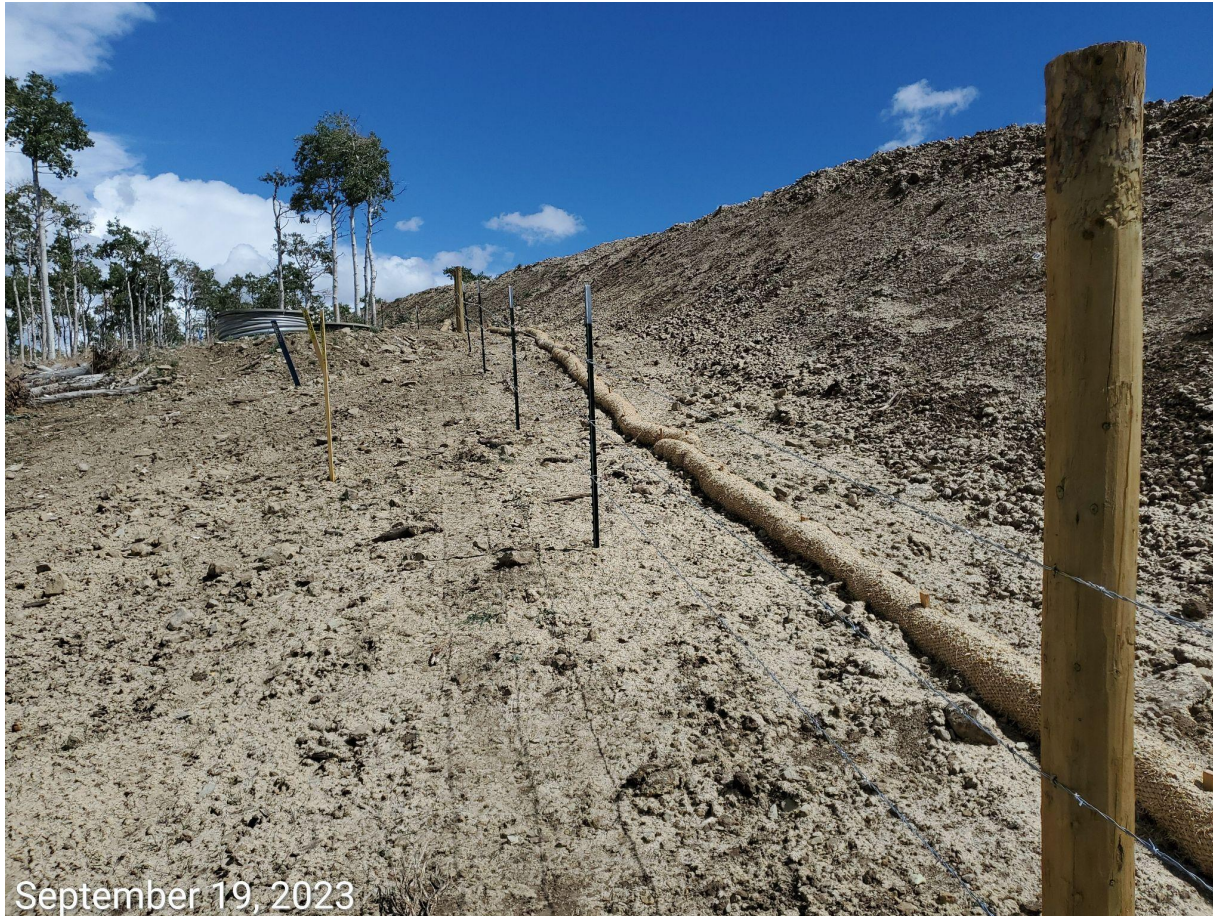
Photo 7: Photo taken from the northern perimeter of the Location's disturbance area. Photo shows Operator has implemented an erosion log to minimize off-site sediment transport in conjunction with hydromulch.

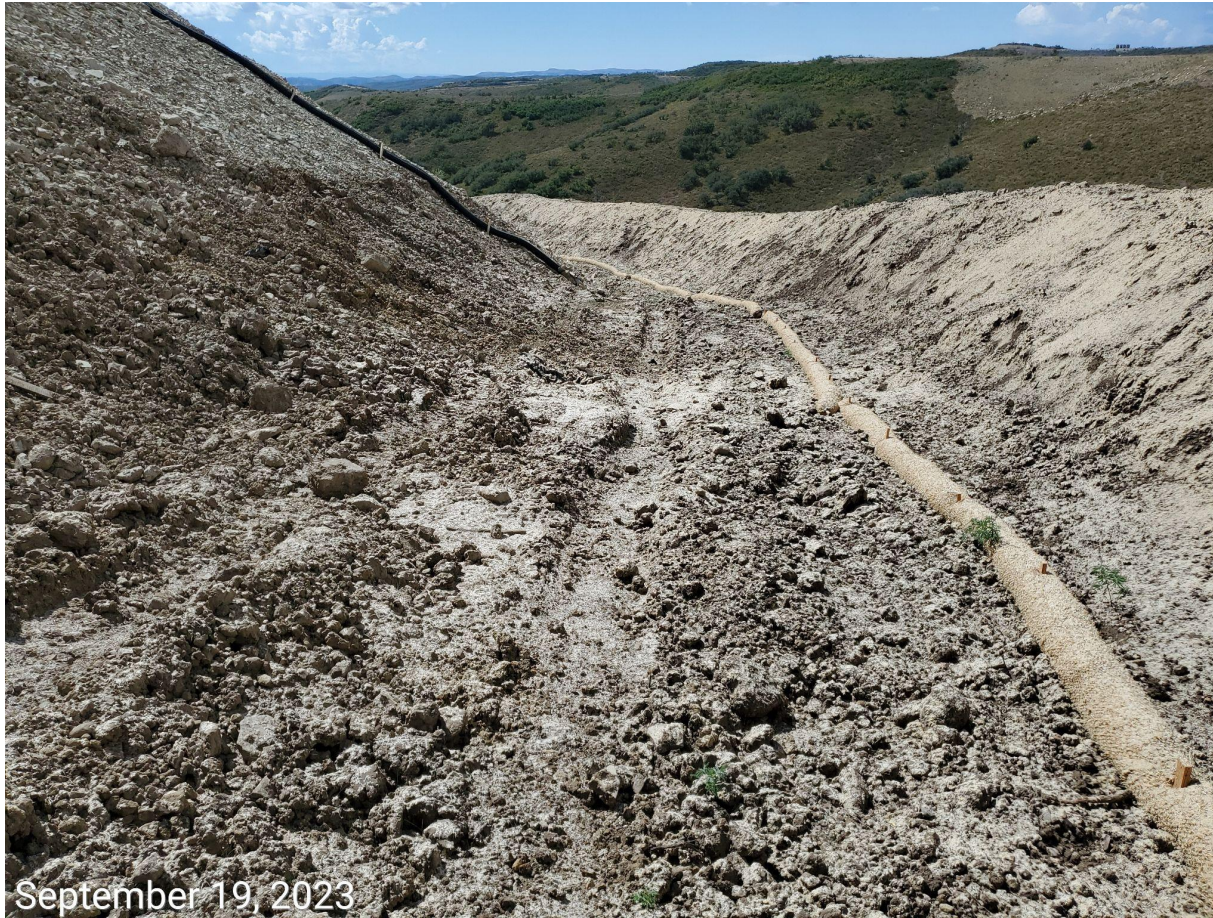
Photo 8: Photo taken from the northwest end of the Location (toe of the fill slope) facing southwest. Photo shows ditch has not been constructed in accordance with good engineering practices; ditch lacks a defined channel and is unconsolidated soils that will contribute to sediment-laden stormwater discharge.

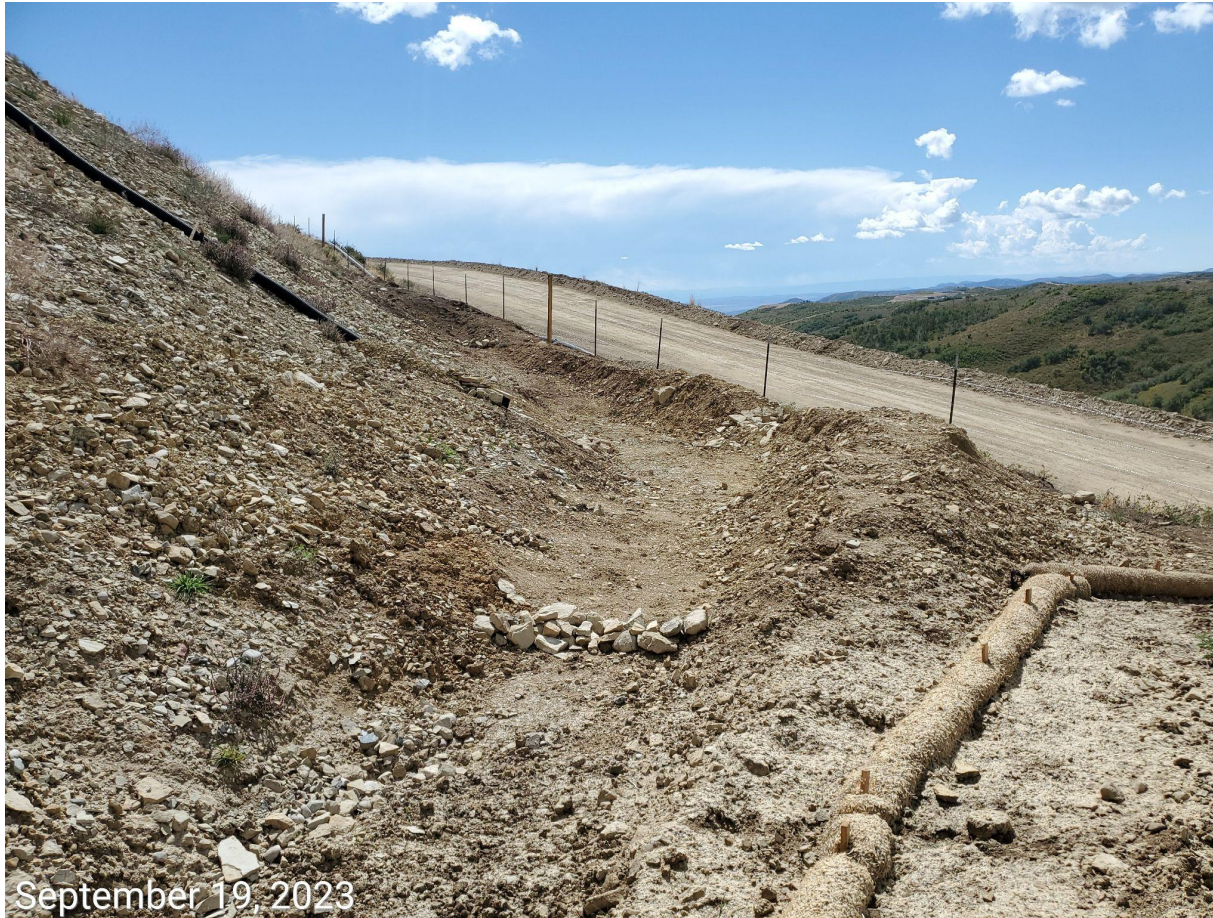
Photo 9: Photo taken from the west end of the Location, facing south. Photo shows sediment trap installed at the toe of the fill slopes. BMP has not been constructed in accordance with good engineering practices; BMP is inadequate in size and has not been constructed with a properly engineered outlet.
