Inspection Photos

Location Name: MUSTANG RESOURCES LLC DOWNING 24-22-6S-94W Pad

Location ID: 323818

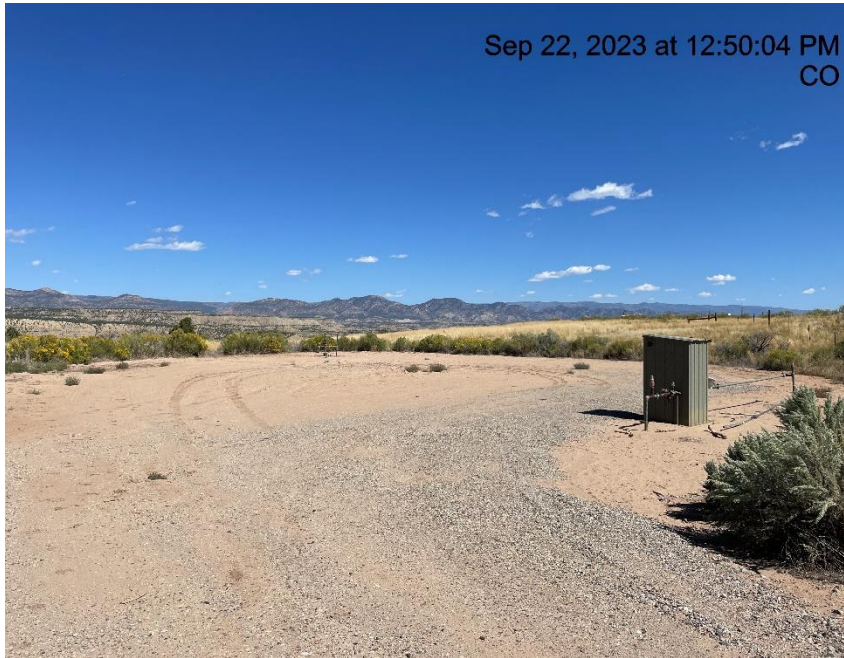
Photo # 500 From entrance to location

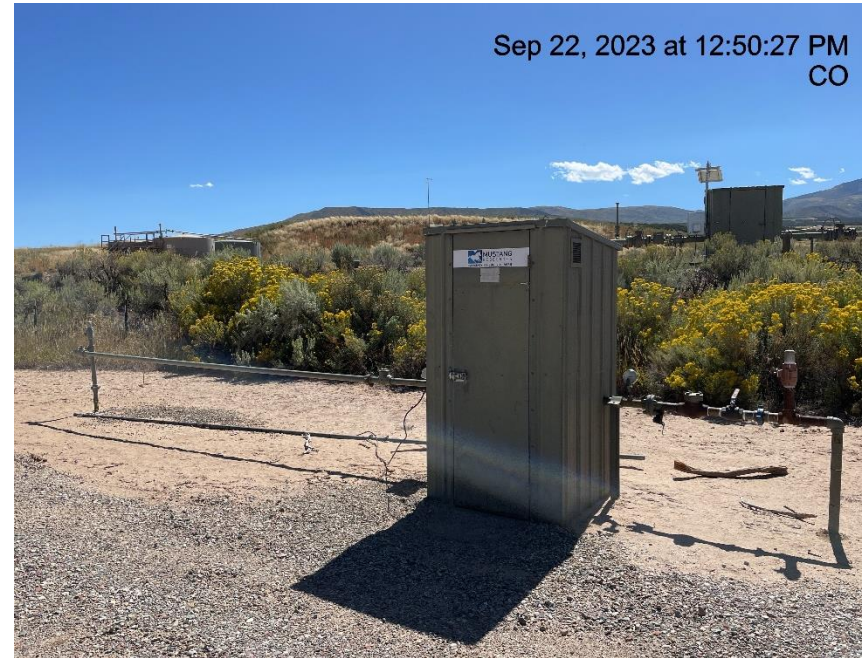
Photo # 501 Location

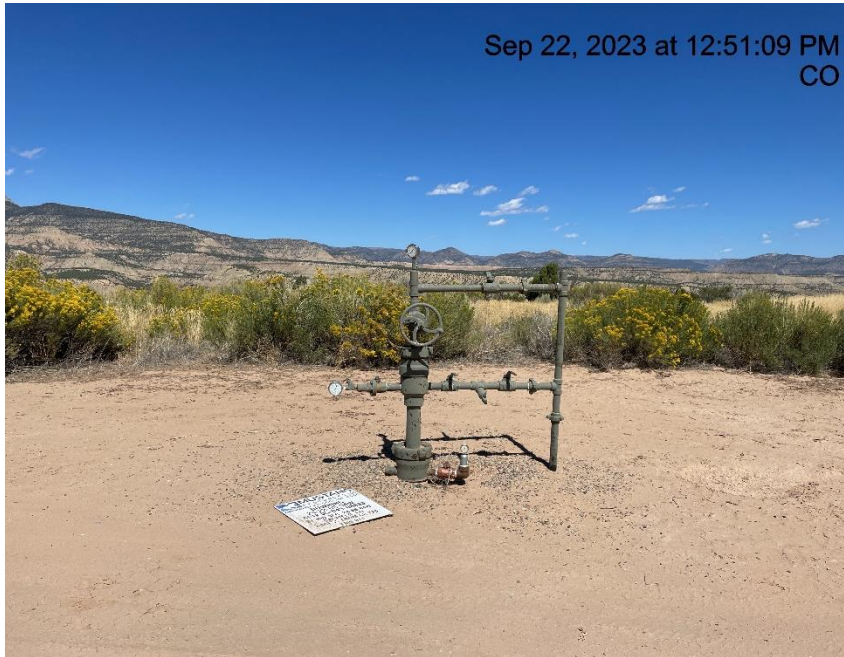
Photo # 502 Location

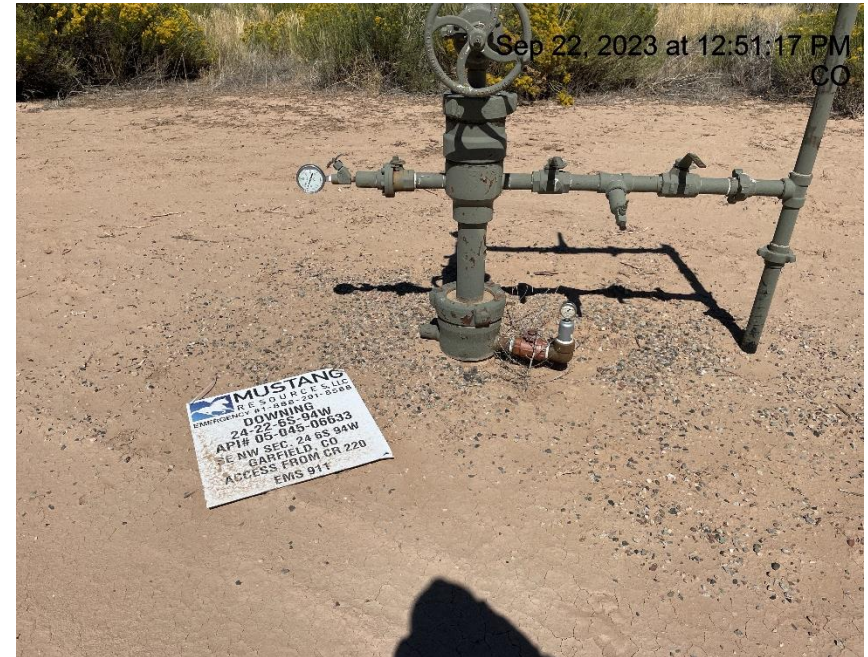
Photo # 503 Wellhead sign laying on the ground/not conspicuously located
