## Inspection Photos

Location Name: MUSTANG RESOURCES LLC Mead 24-14 Pad

Location ID: 335234

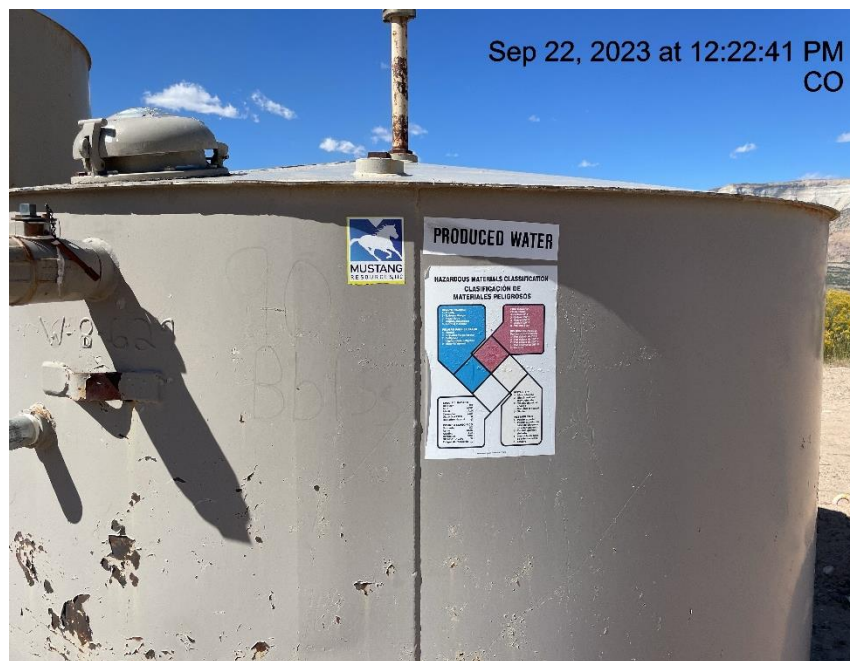
Photo # 442 Tank not properly labeled/missing required information

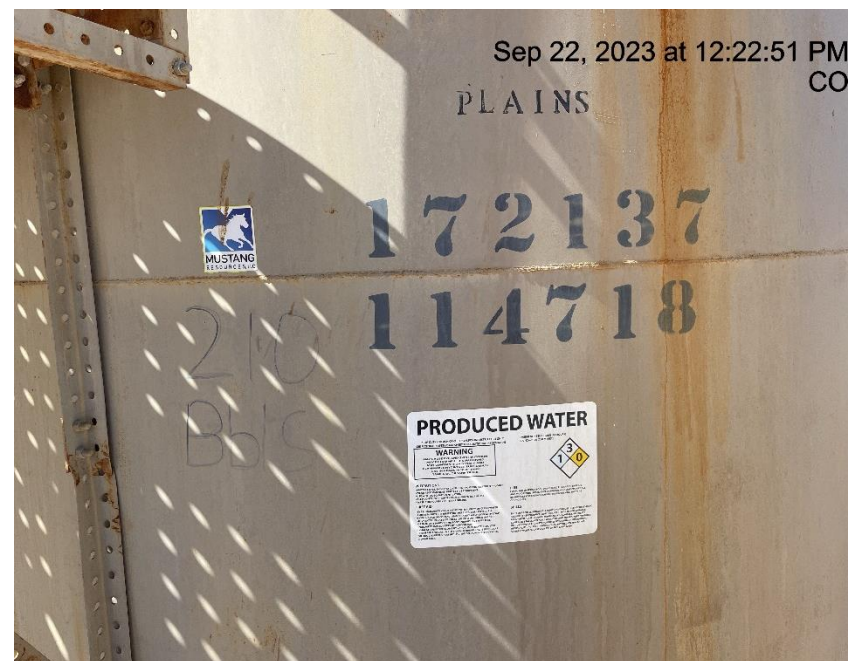
Photo # 443 Tank not properly labeled/missing required information

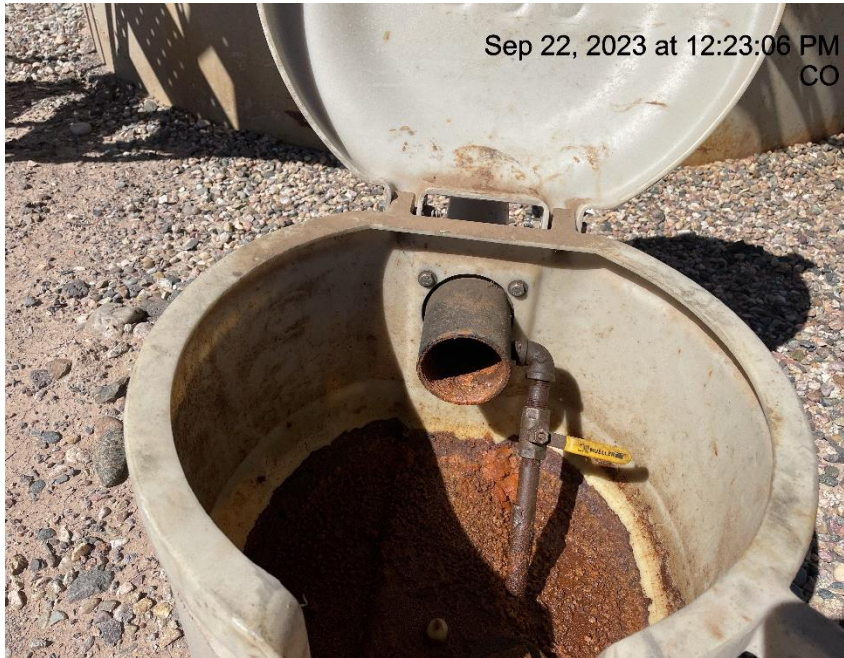
Photo # 444 Open ended load line

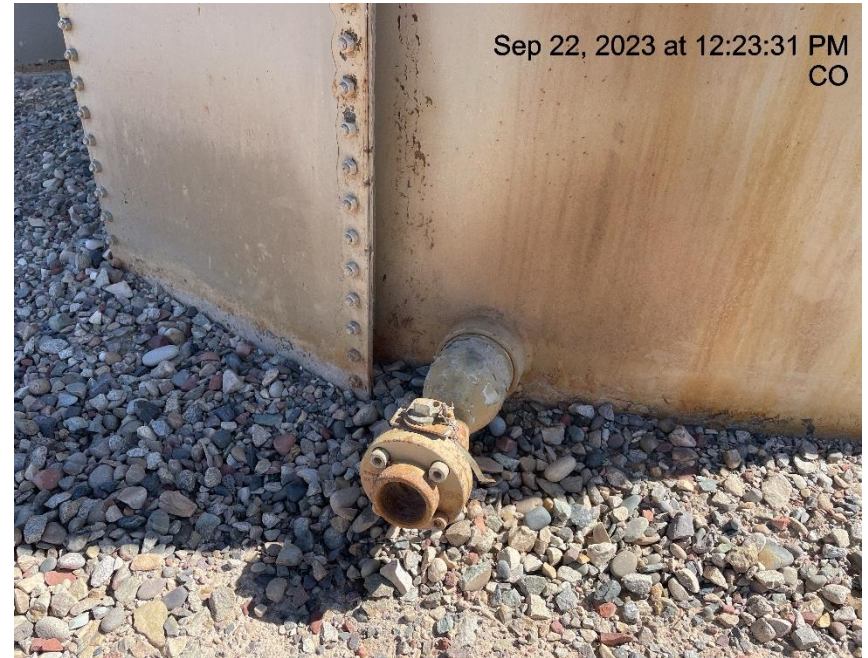
Photo # 445 Open ended load line

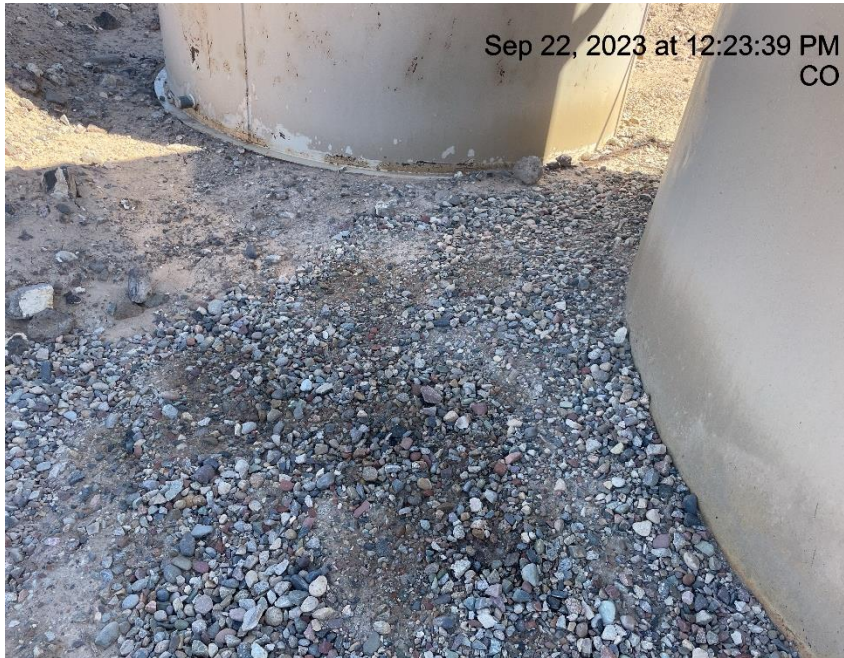
**Photo # 446 Stained soils & gravel inside tank battery secondary containment**

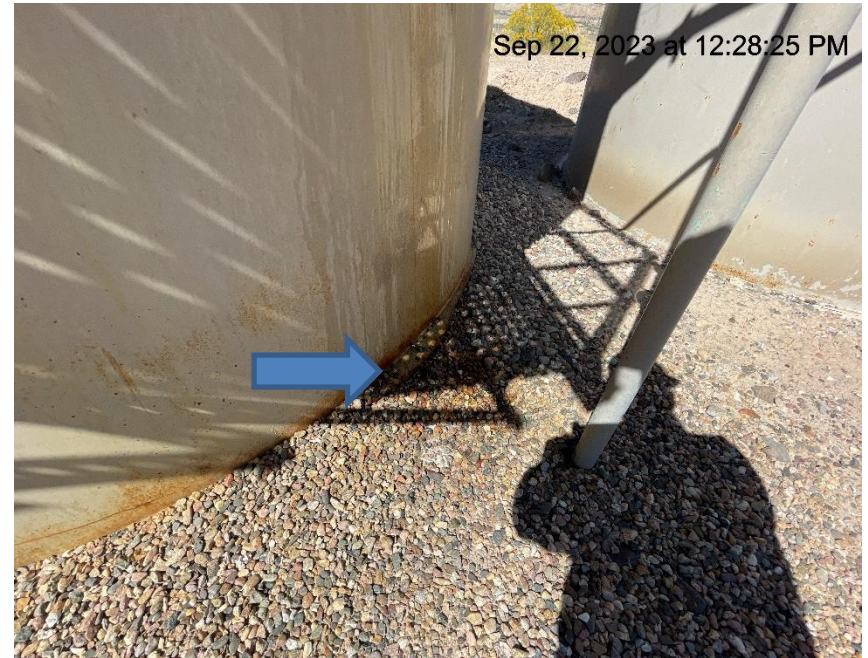
**Photo # 468 Stained soils & gravel inside tank battery secondary containment/fluid running down side of tank**

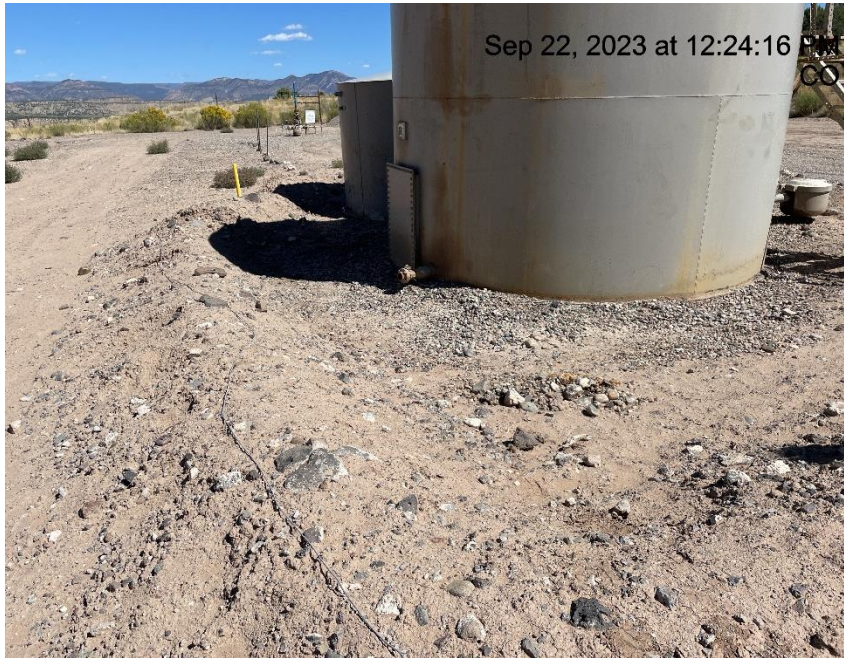
**Photo # 450 Secondary containment not sufficient to contain spilled or released materials**

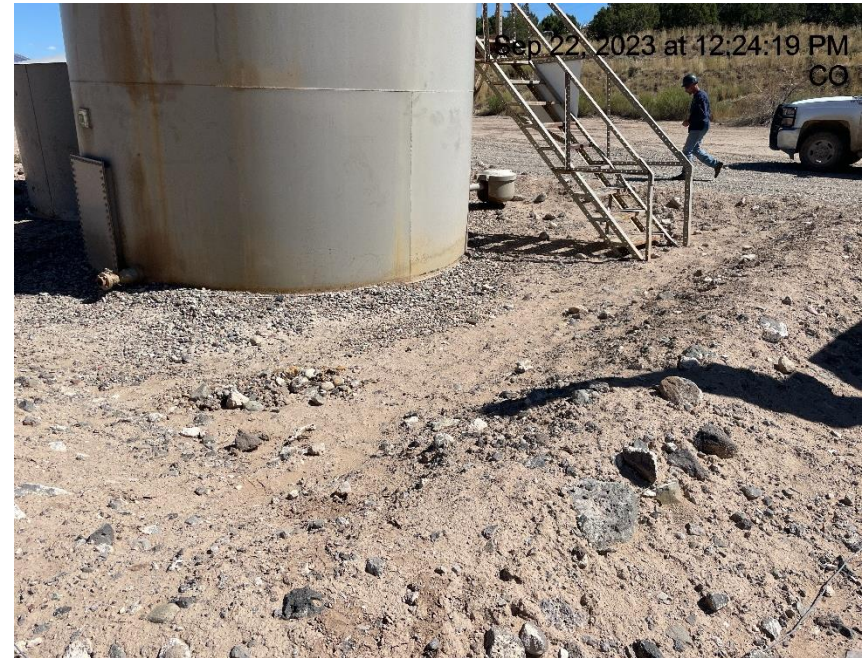
**Photo # 451 Secondary containment not sufficient to contain spilled or released materials**

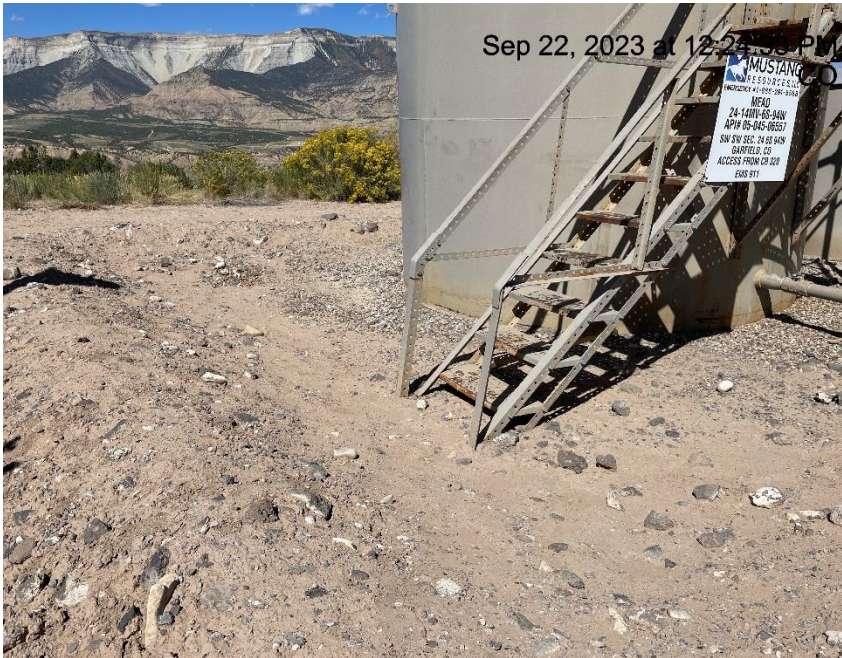
**Photo # 452 Secondary containment not sufficient to contain spilled or released materials**

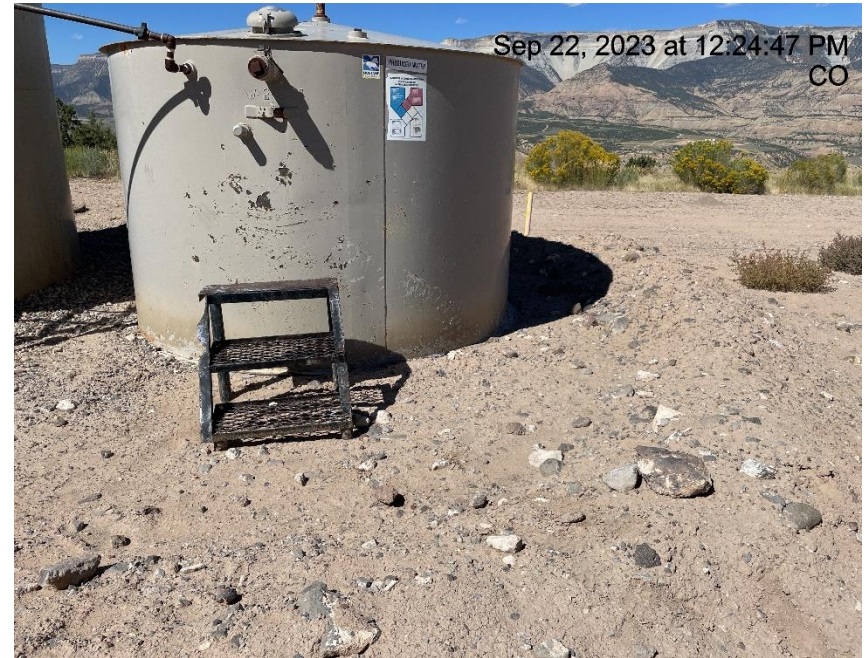
**Photo # 453 Secondary containment not sufficient to contain spilled or released materials**

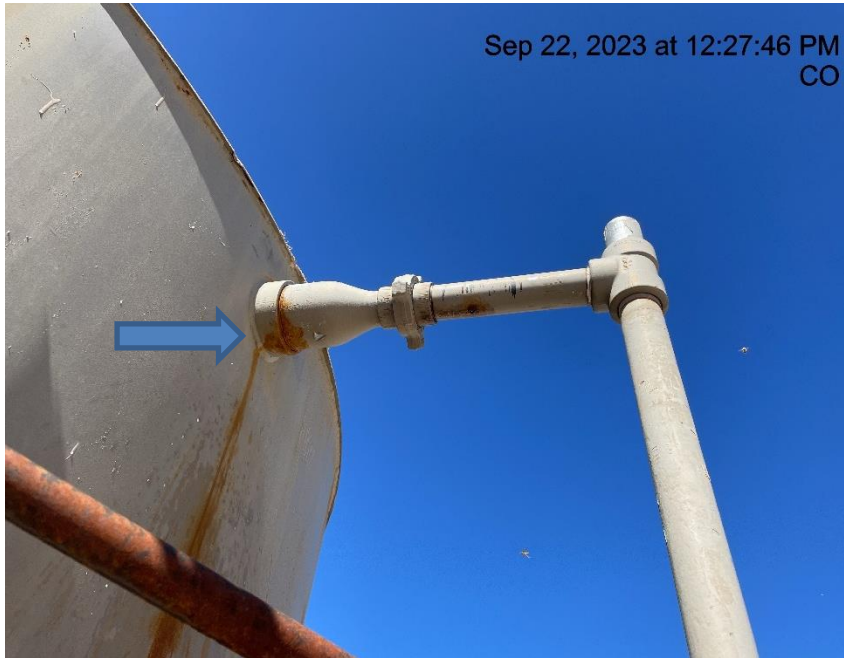
Photo # 463 Fluid leaking from swedge on tank

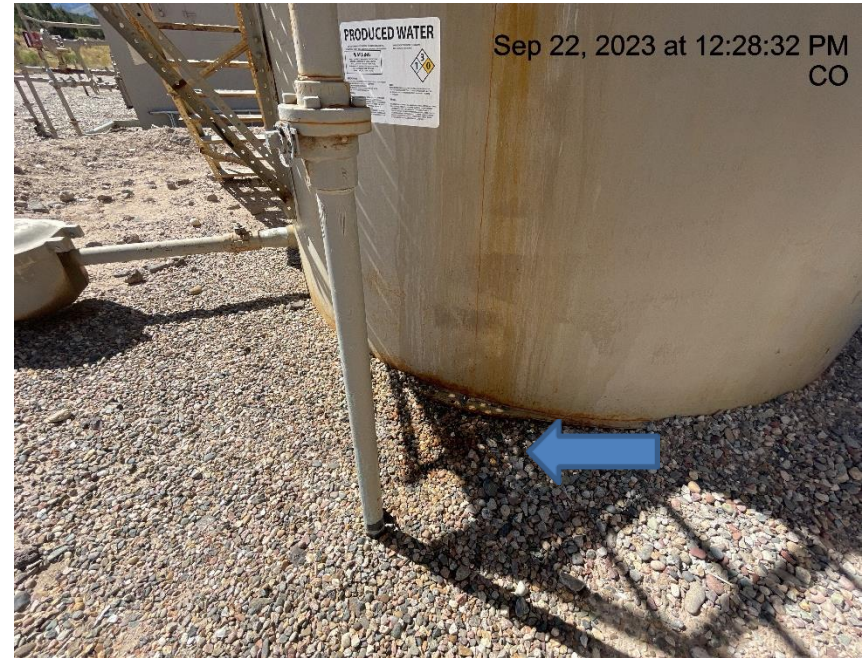
Photo # 469 Stained soils & gravel inside tank battery  
secondary containment/fluid running down side of tank

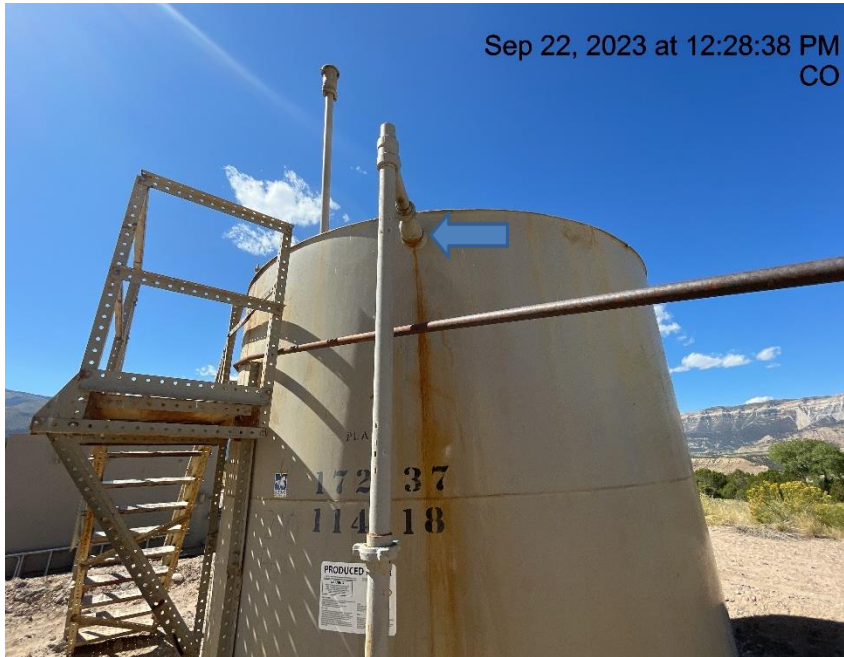
Photo # 470 Swedge leaking & fluid running down tank

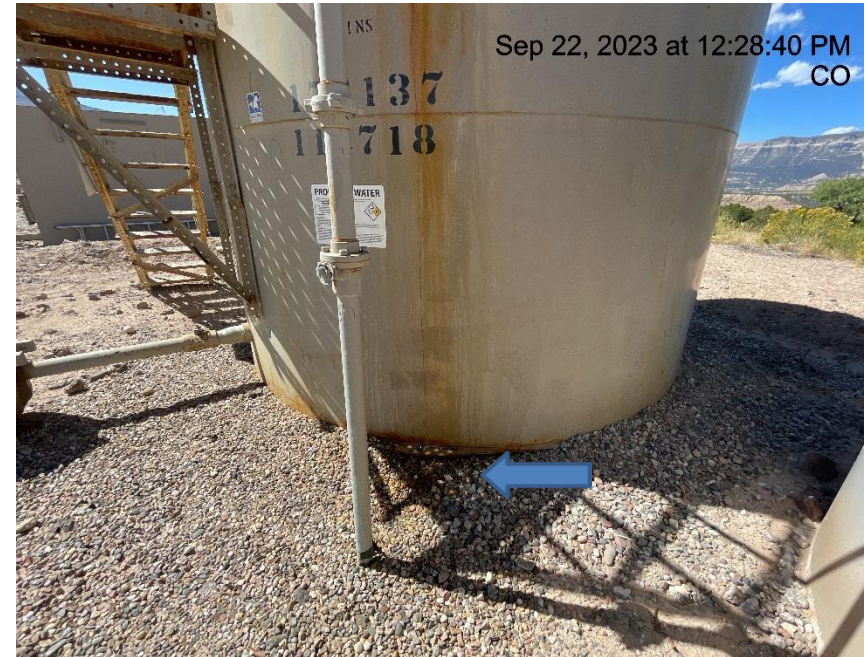
Photo # 471 Stained soils & gravel inside tank battery secondary containment/fluid running down tank

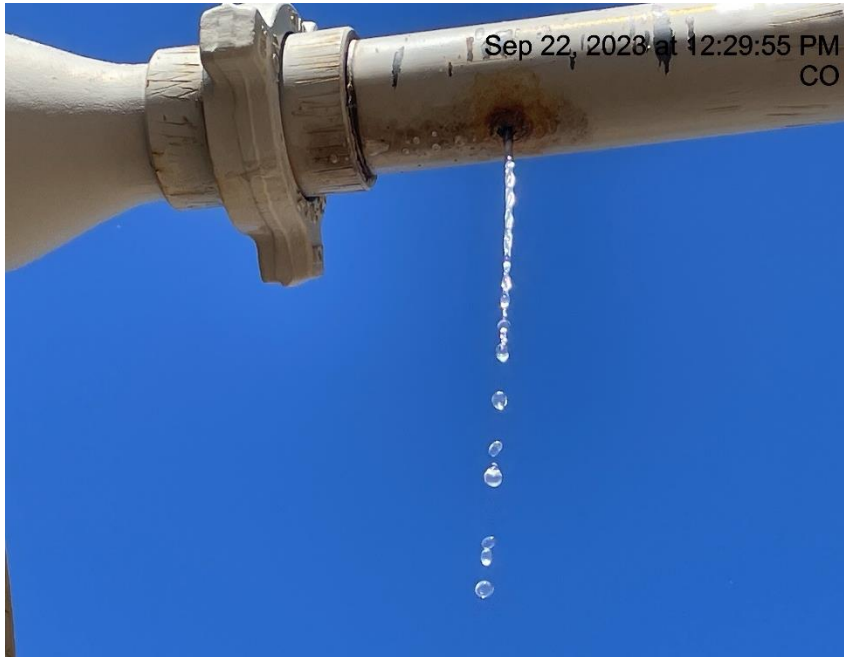
**Photo # 489 Hole in production tank flowline & fluid leaking out**

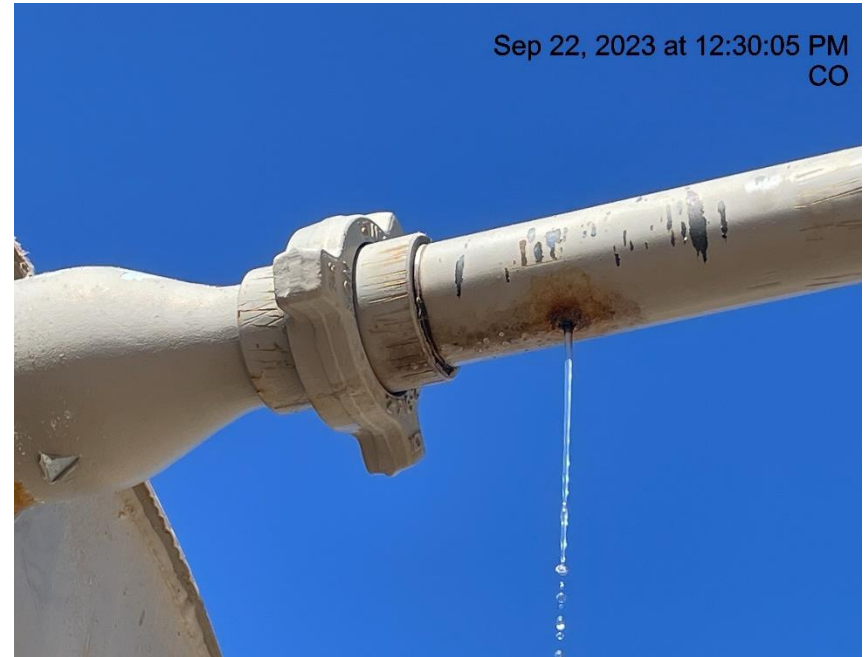
**Photo # 494 Hole in production tank flowline & fluid leaking out**

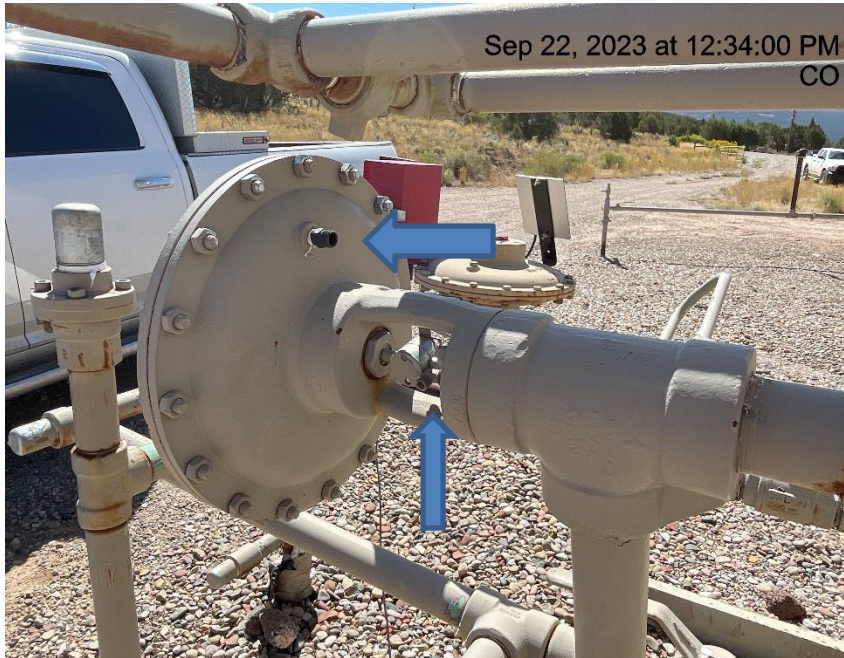
**Photo # 498 Supply gas disconnected from A valve & stainless fitting propping valve open**

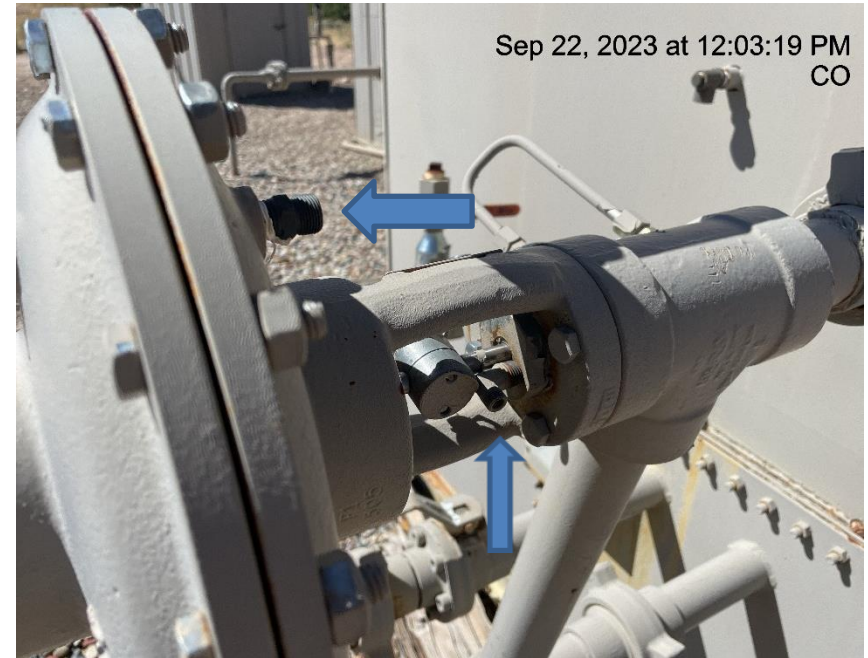
**Photo # 499 Supply gas disconnected from A valve & stainless fitting propping valve open**
