**Inspection Photos**  
**Location Name: CAERUS PICEANCE LLC RJ2 Pad**  
**Location #: 334698**

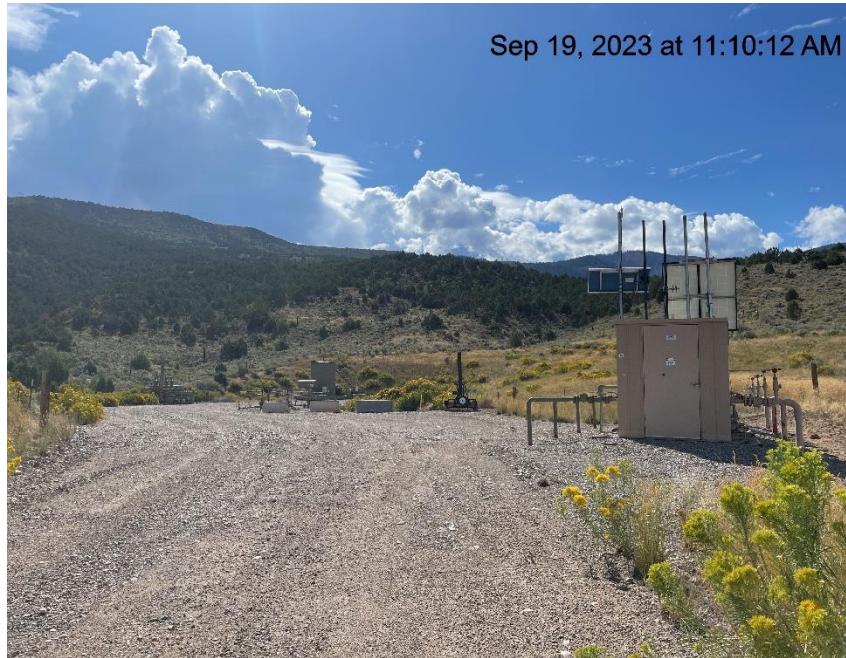
**Photo # 9838 From entrance to location**

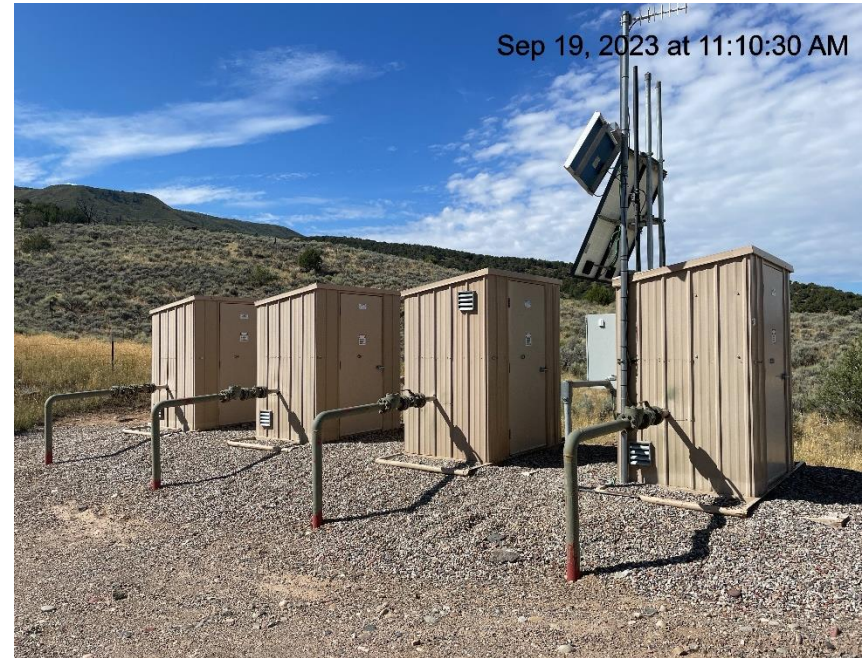
**Photo # 9839 Location**

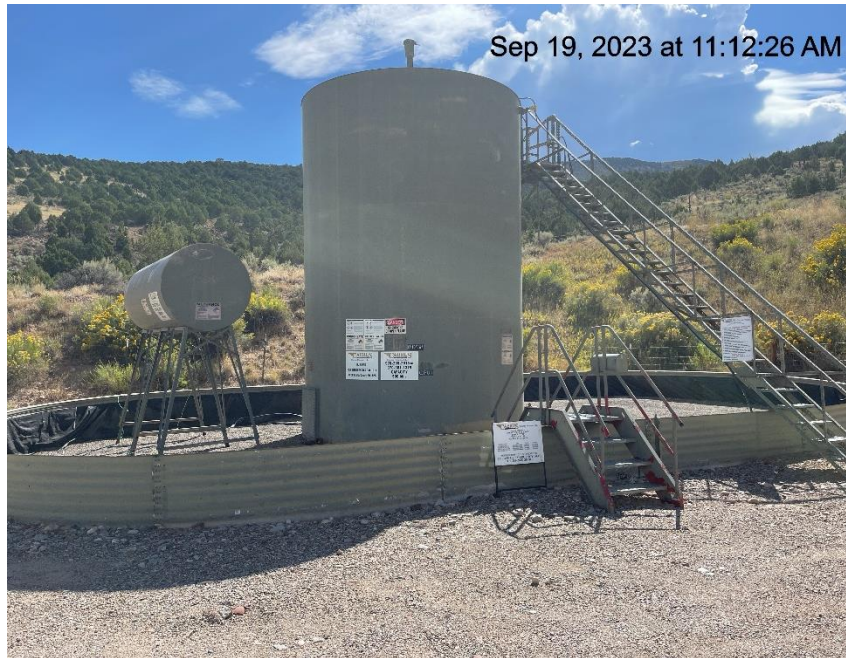
**Photo # 9840 Location**

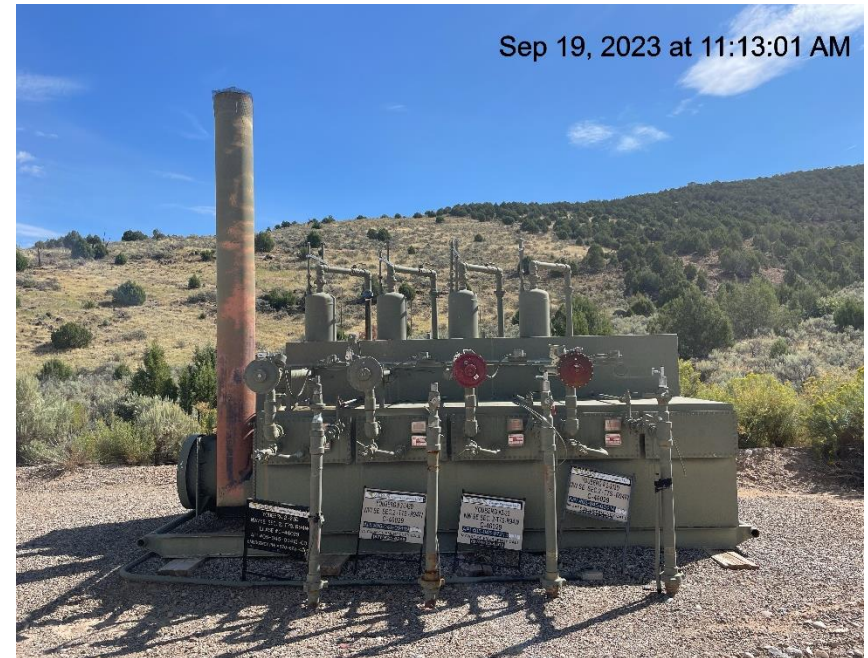
**Photo # 9841 Location**

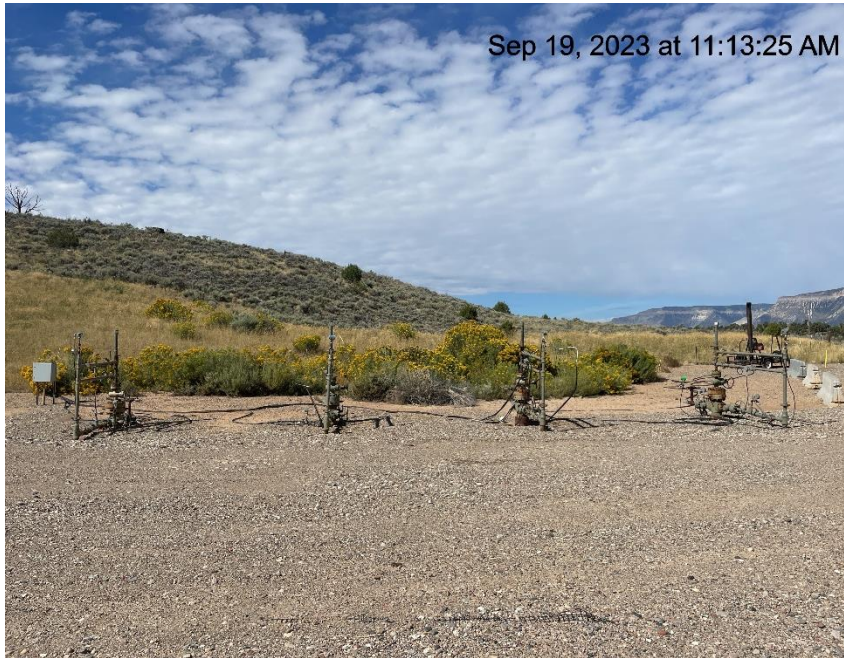
**Photo # 9842 Location**

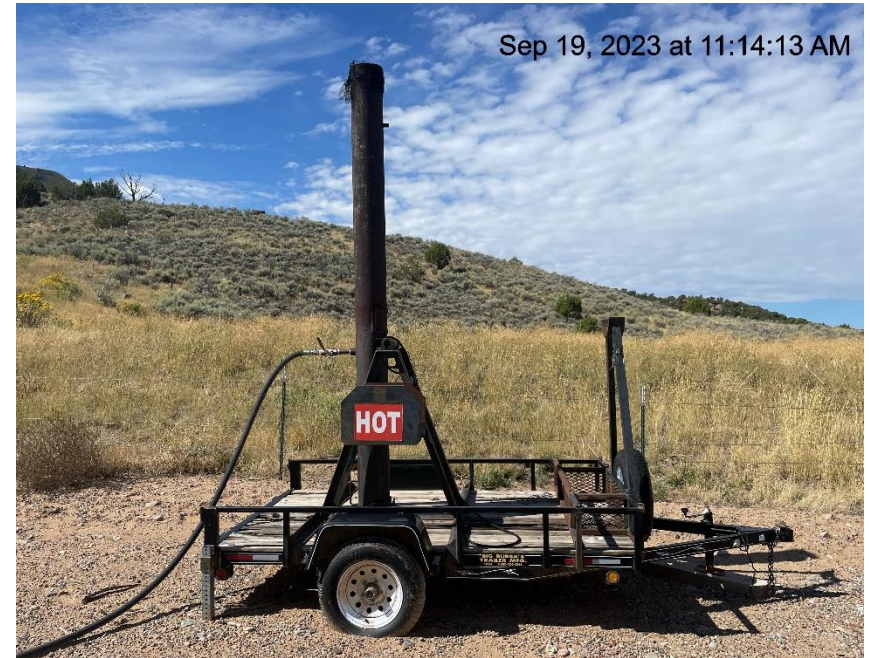
**Photo # 9843 Location**

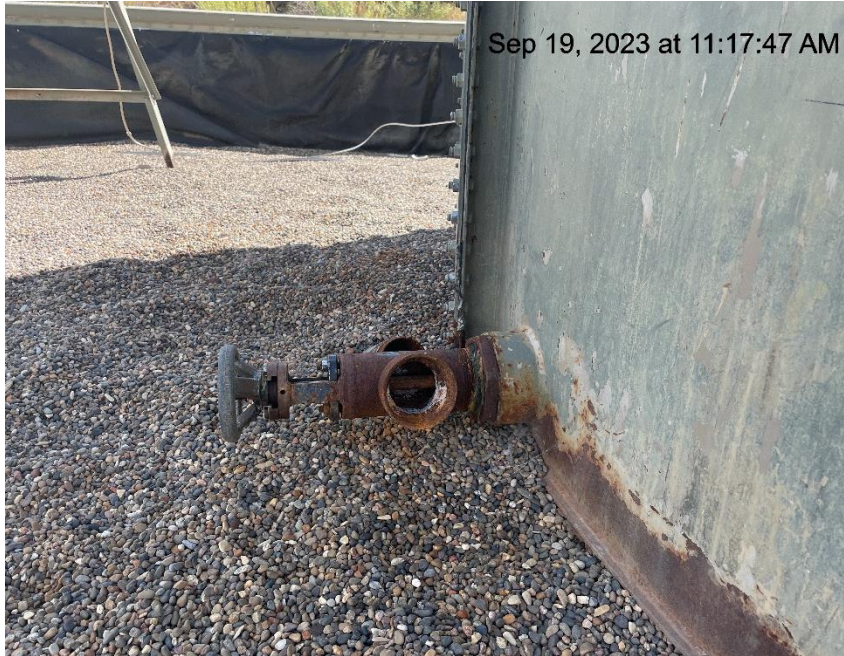
**Photo # 9851 Open ended load line**

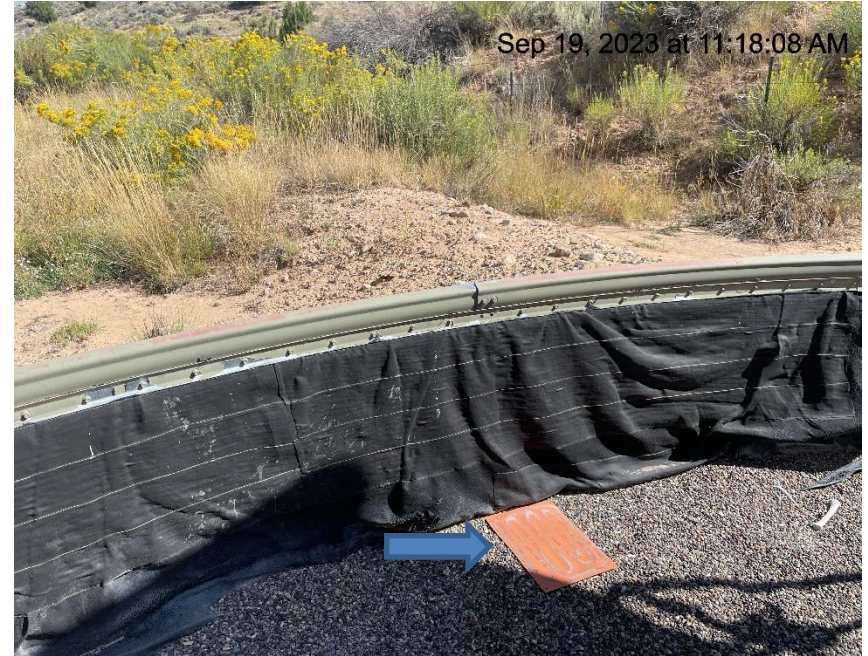
**Photo # 9852 Debris**

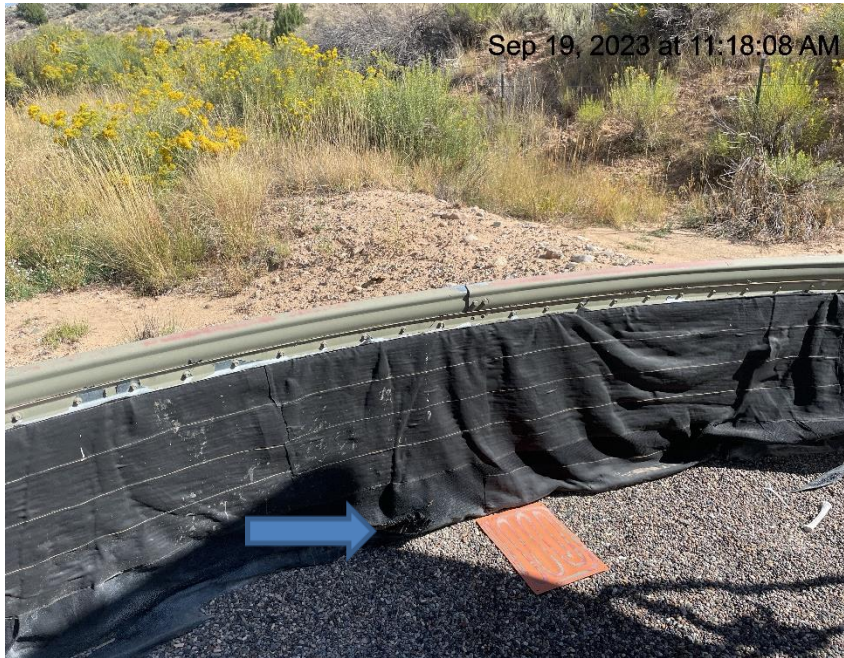
**Photo # 9852 Holes in containment liner**

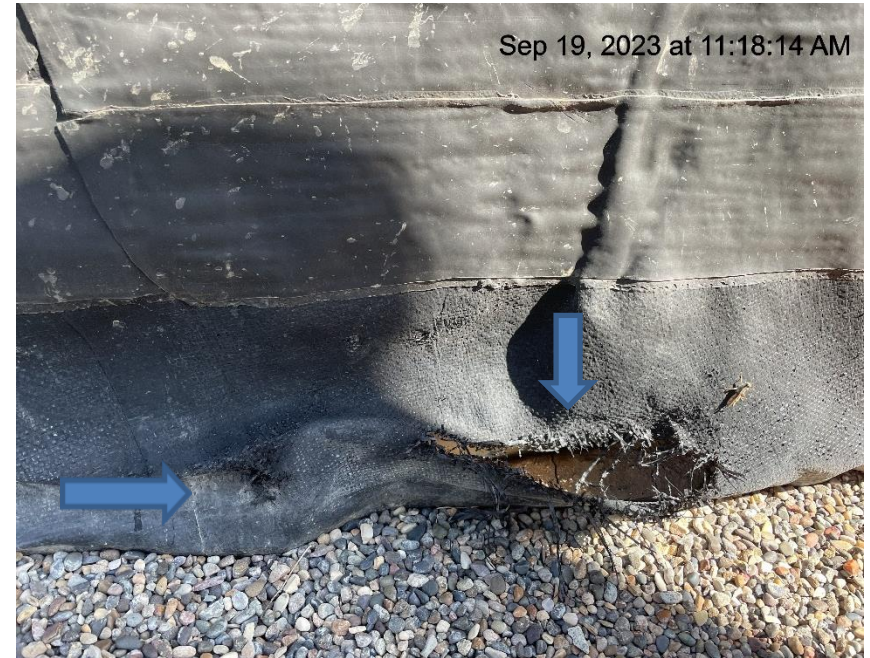
**Photo # 9853 Holes in containment liner**

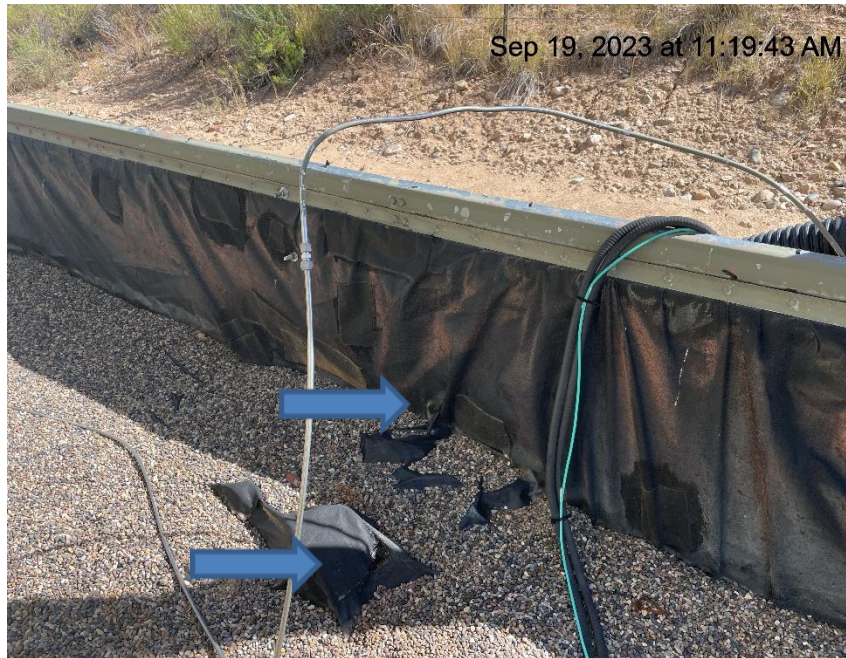
**Photo # 9854 Holes in containment liner**

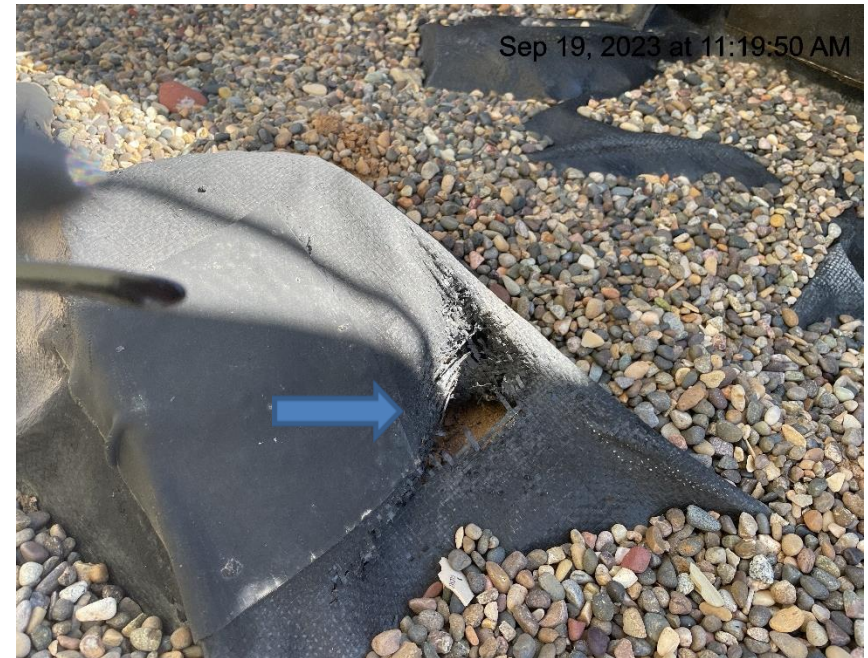
**Photo # 9855 Hole in containment liner**

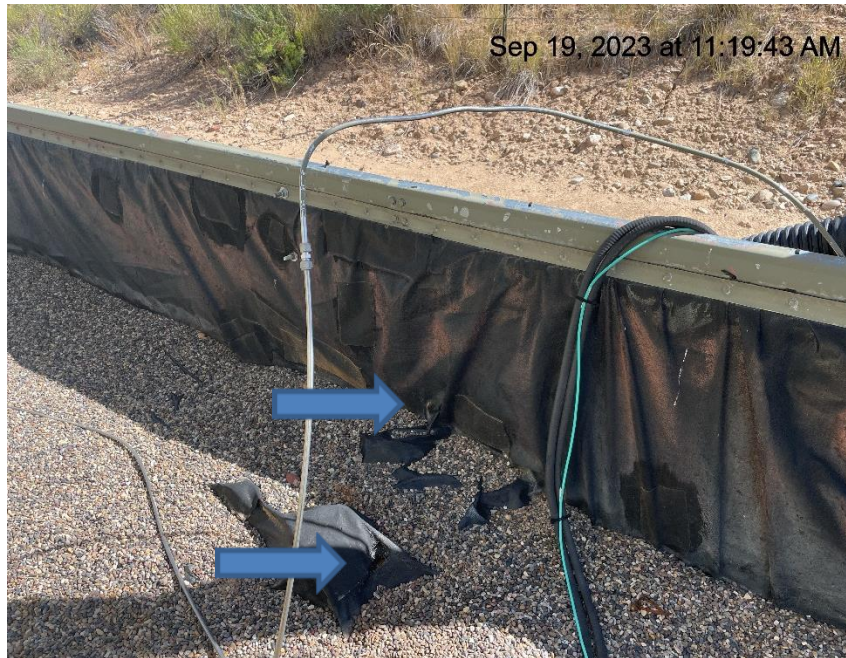
**Photo # 9854 Holes in secondary containment liner**

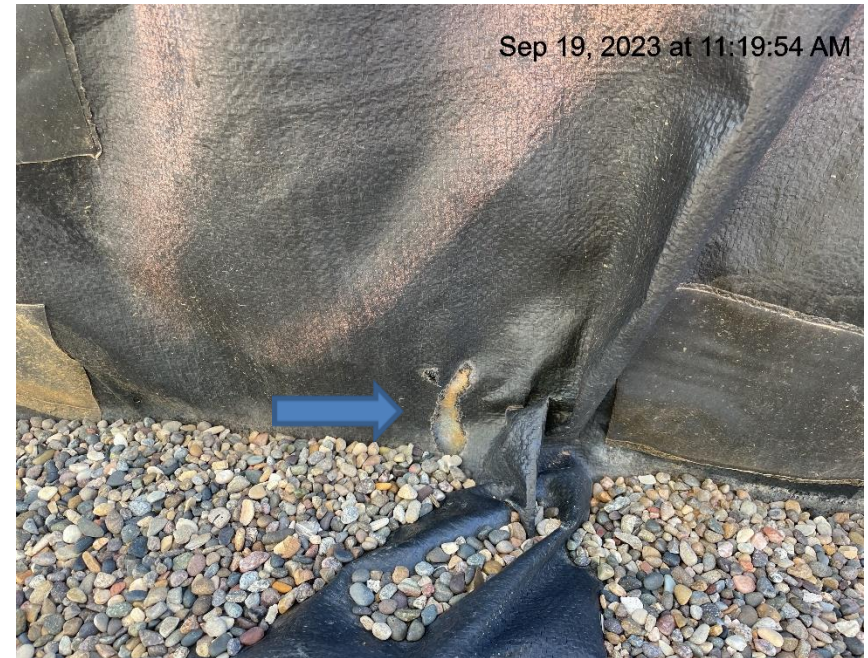
**Photo # 9856 Hole in secondary containment liner**

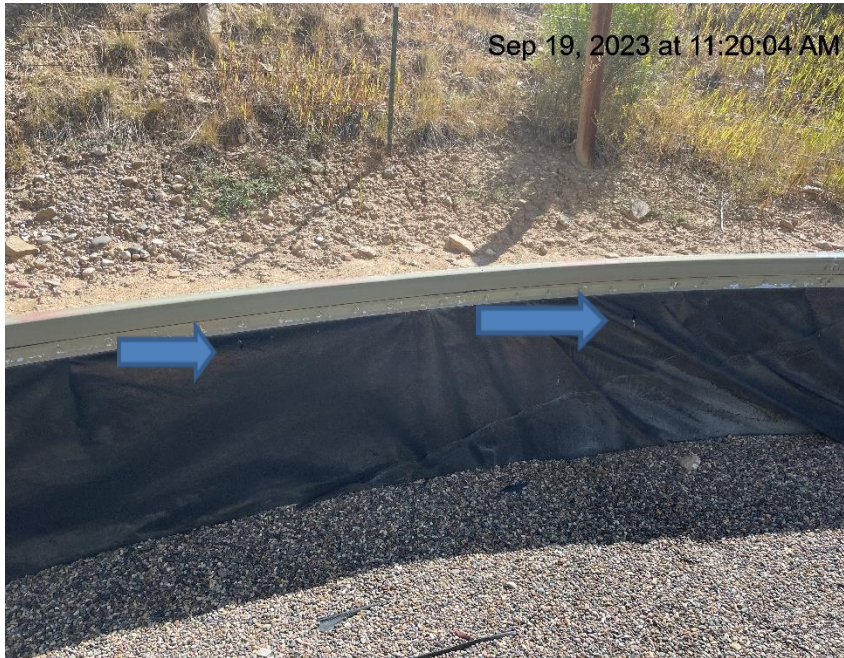
**Photo # 9857 Holes in secondary containment liner**

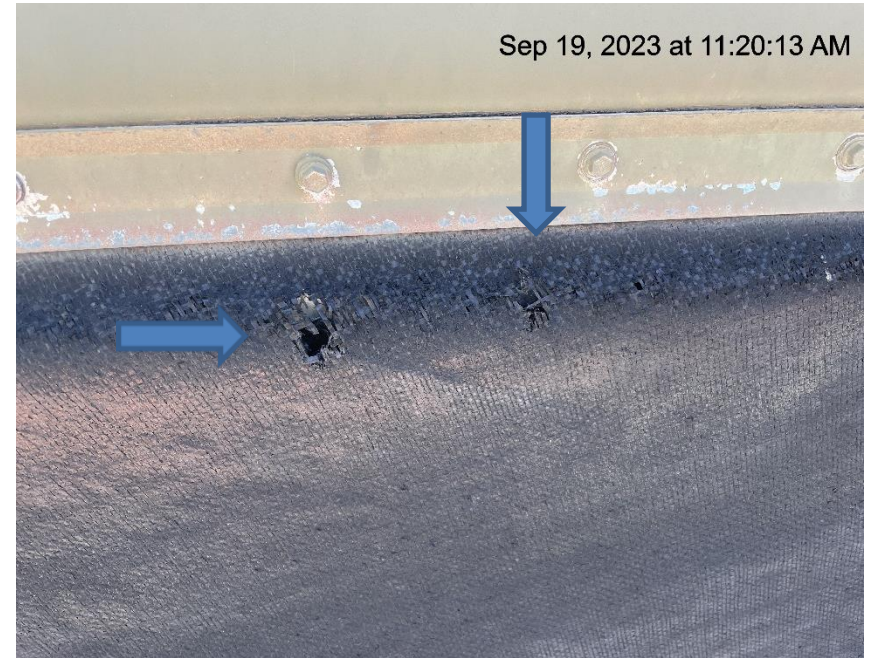
**Photo # 9858 Holes in secondary containment liner**

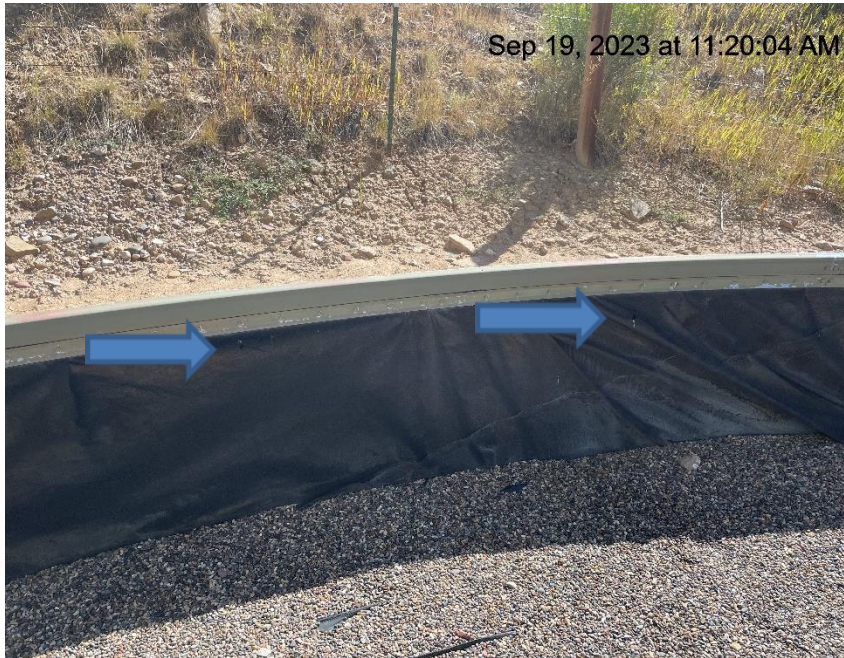
**Photo # 9857 Holes in secondary containment liner**

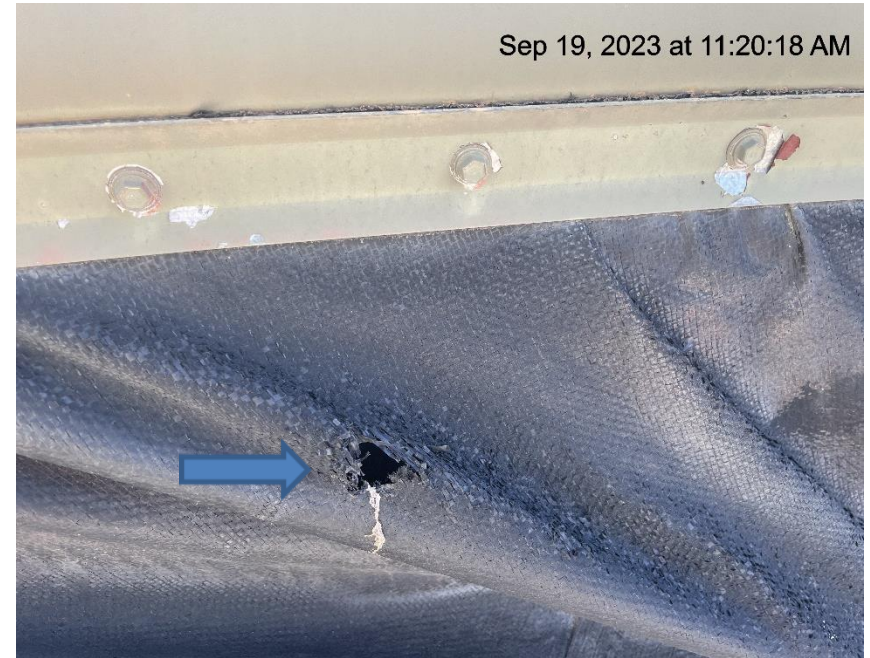
**Photo # 9859 Hole in secondary containment liner**

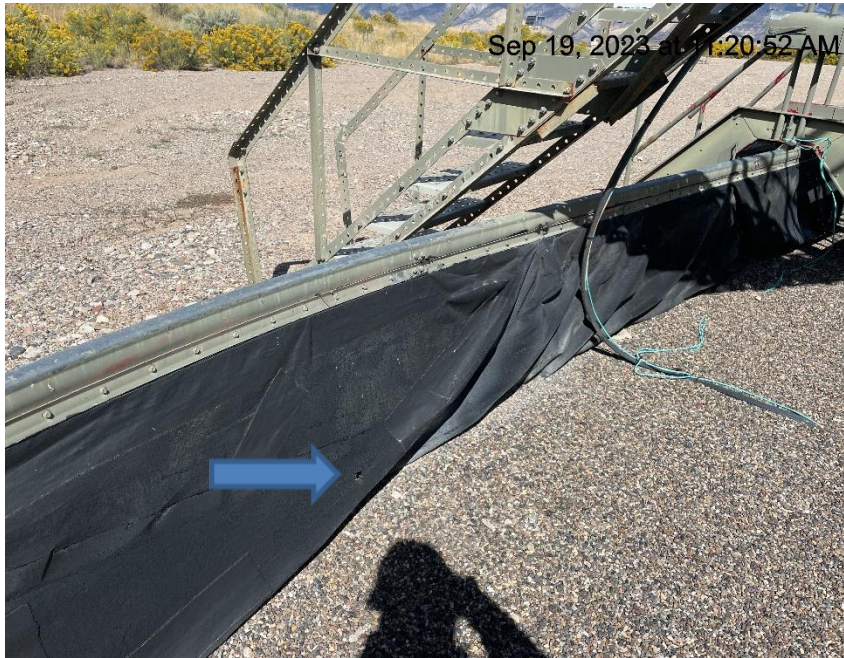
**Photo # 9862 Holes in secondary containment liner**

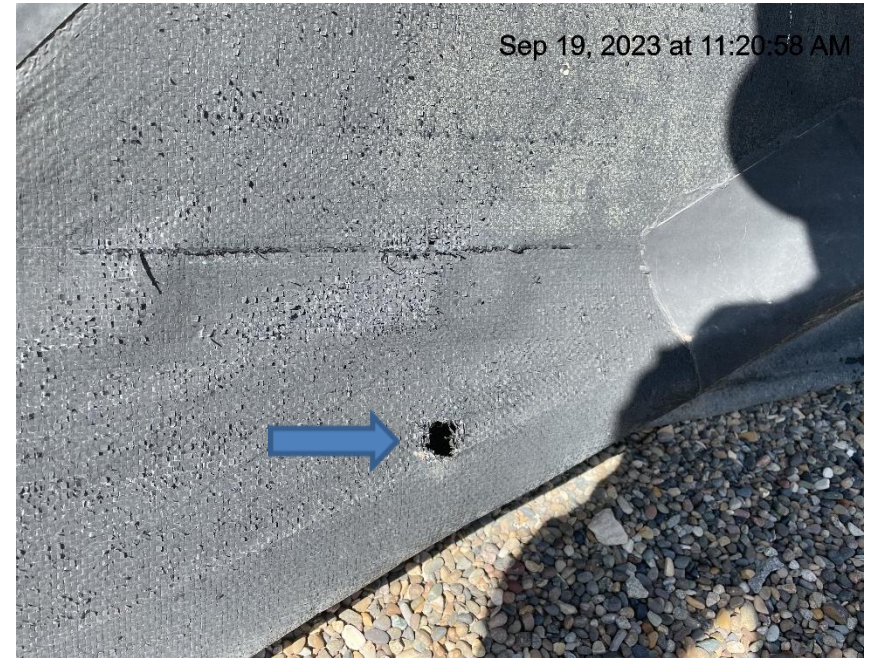
**Photo # 9863 Hole in secondary containment liner**

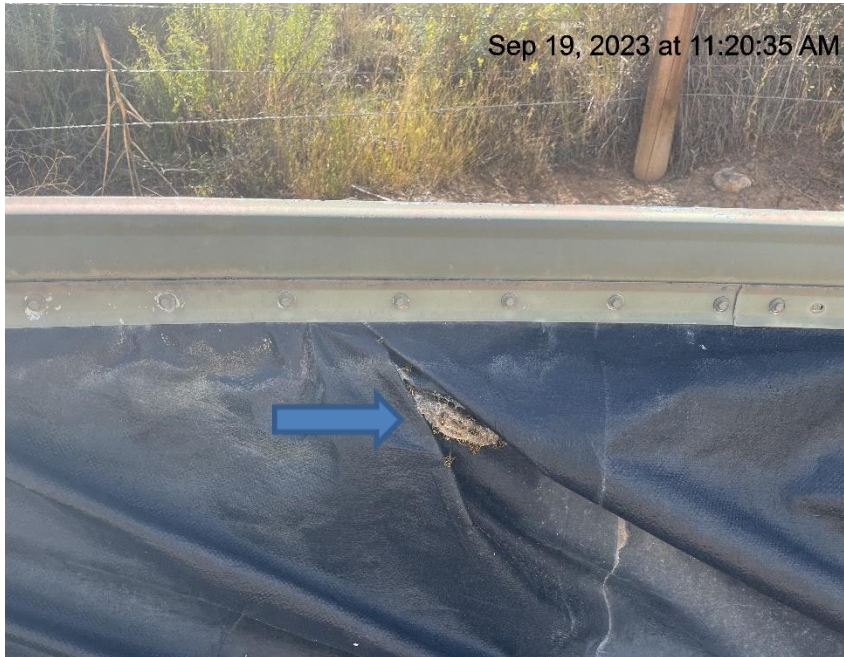
**Photo # 9861 Wasp nest on secondary containment liner**

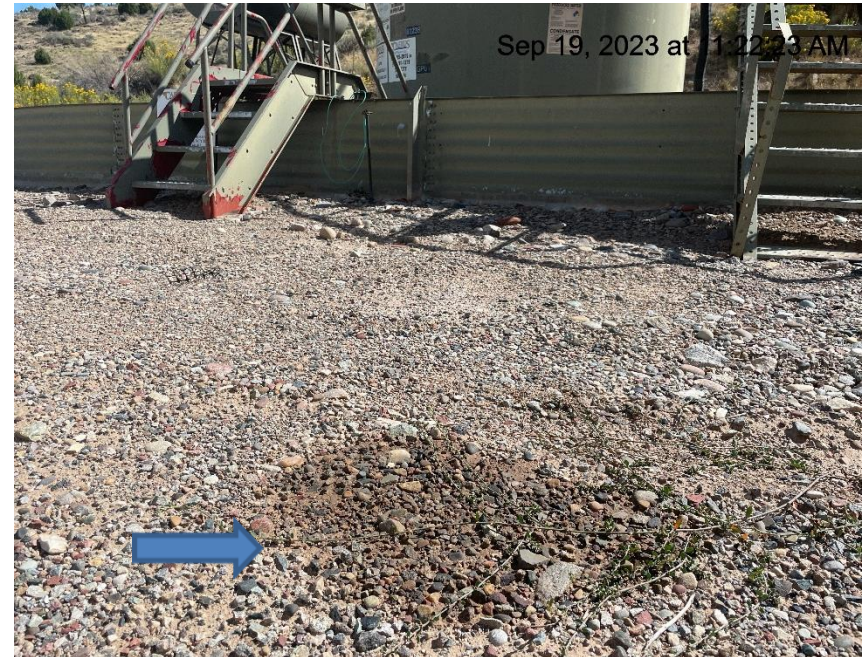
**Photo # 9867 Stained soils & gravel**

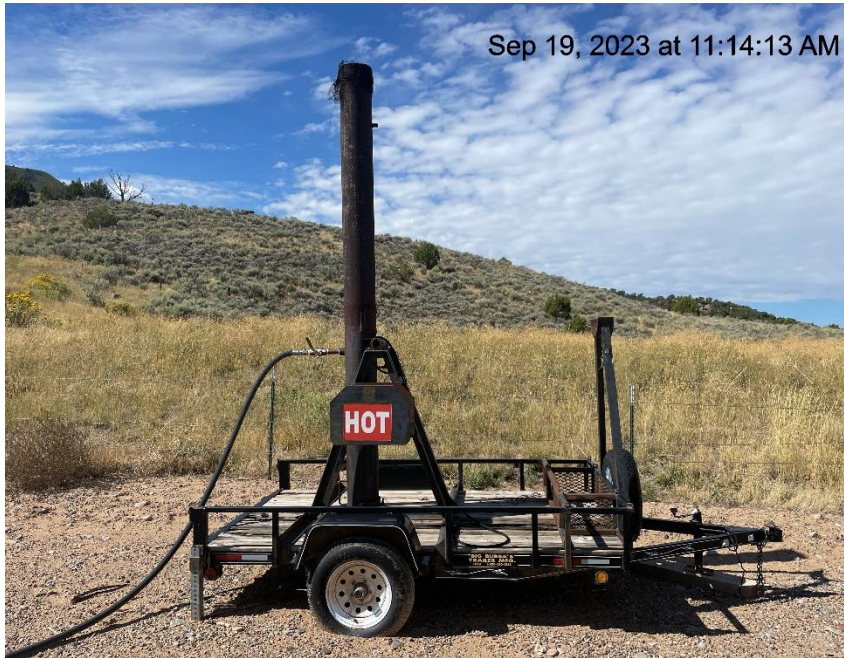
**Photo # 9861 Flare lacks auto-igniter or continuous pilot light**
