Inspection Photos

Location Name: TEP ROCKY MOUNTAIN LLC RWF 13-23 Pad

Location ID: 335508

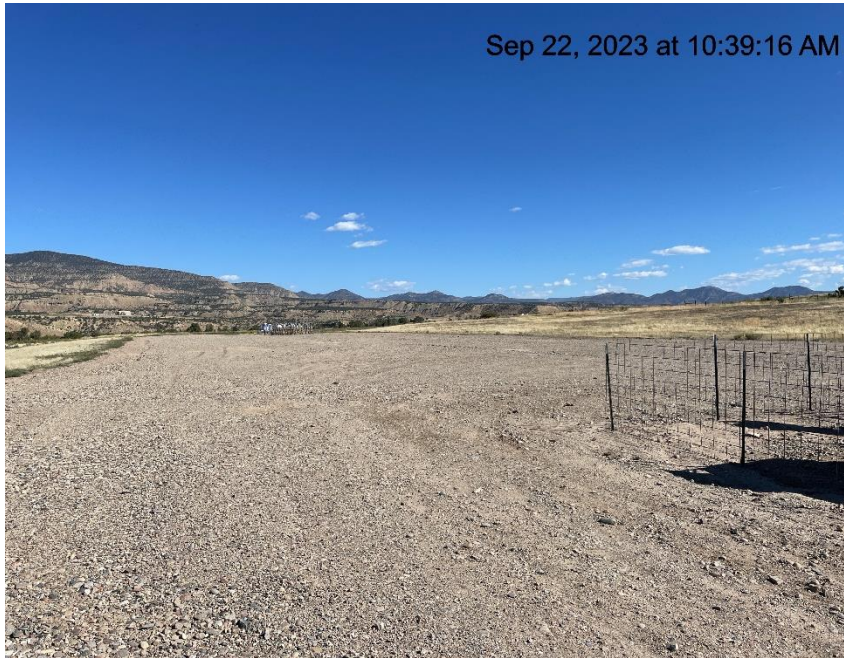
Photo # 206 From entrance to location

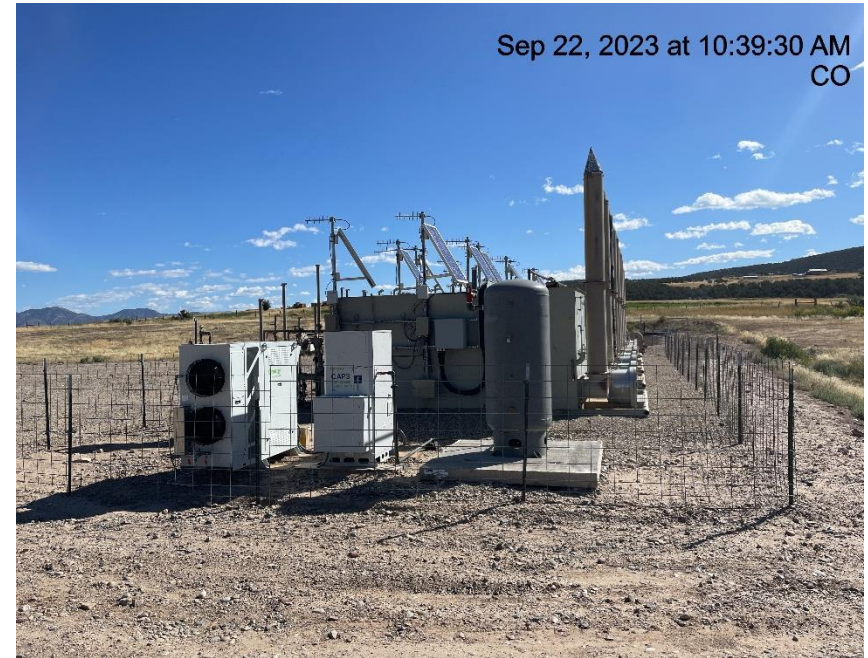
Photo # 207 From entrance to location

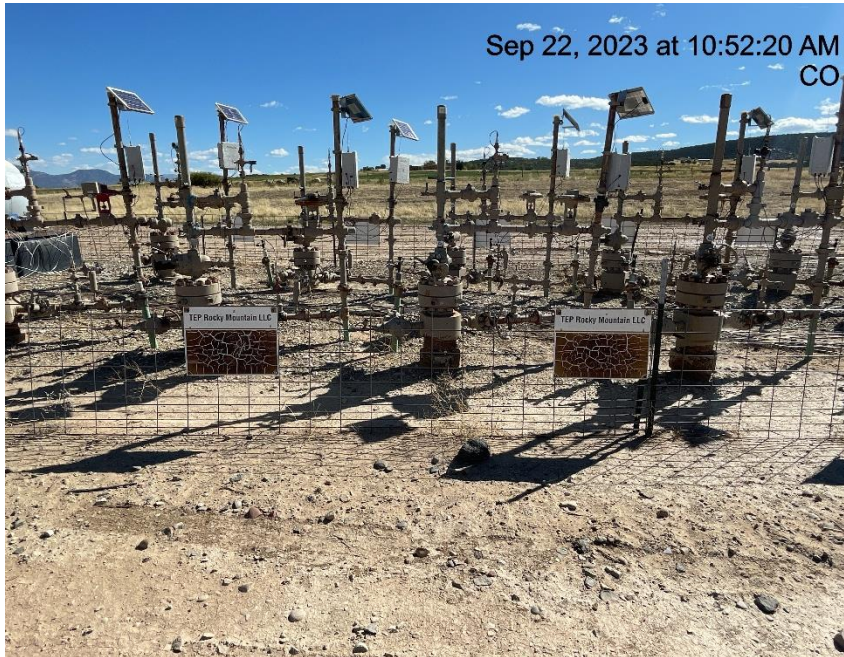
Photo # 230 RWF 313-23 & 413-23 wellhead signs weathered & illegible.

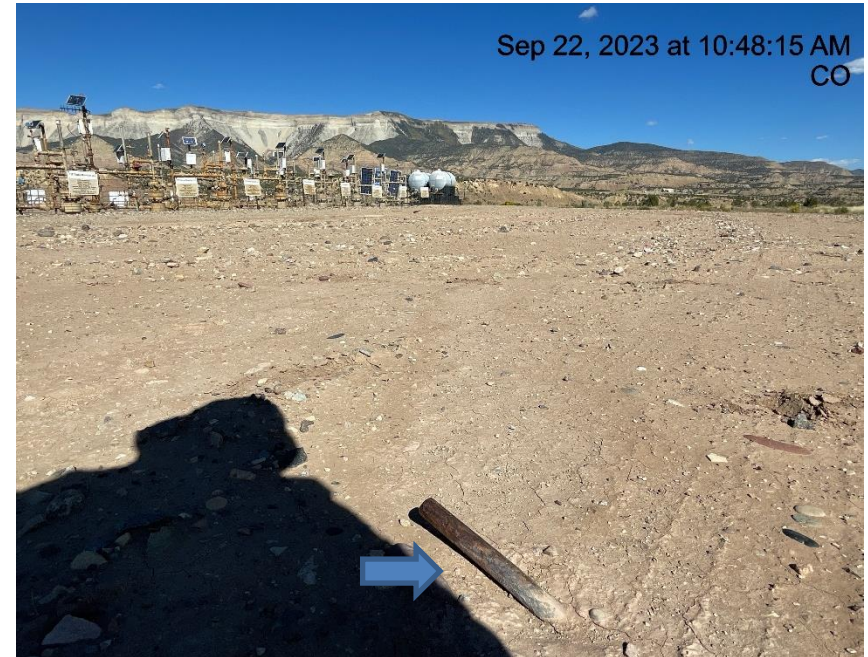
Photo # 221 Debris

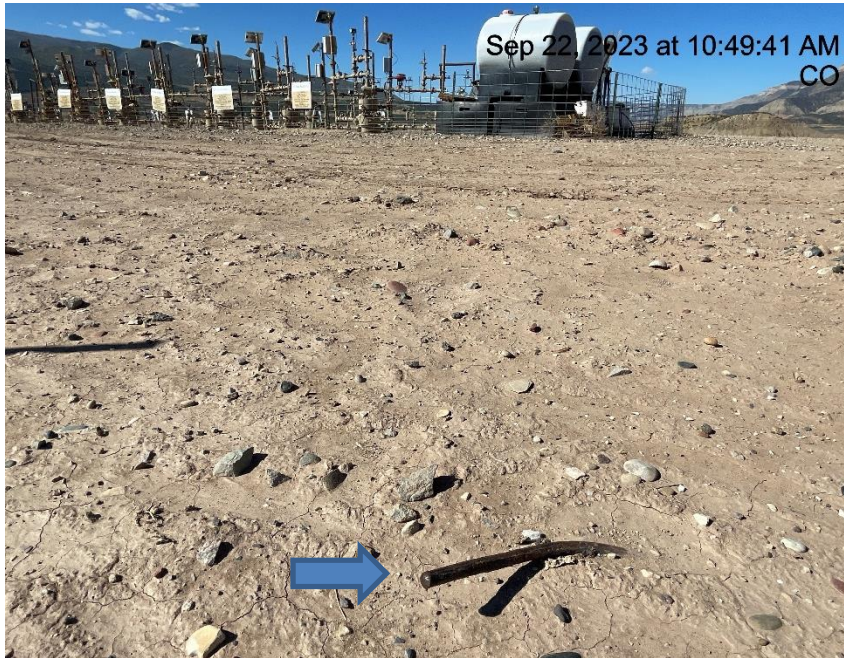
Photo # 226 Debris

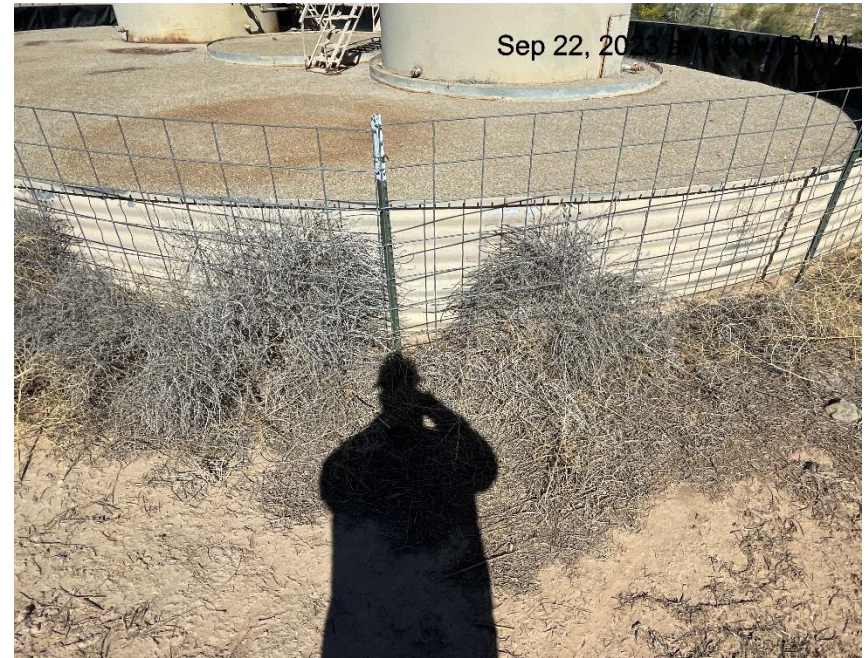
Photo # 247 Debris

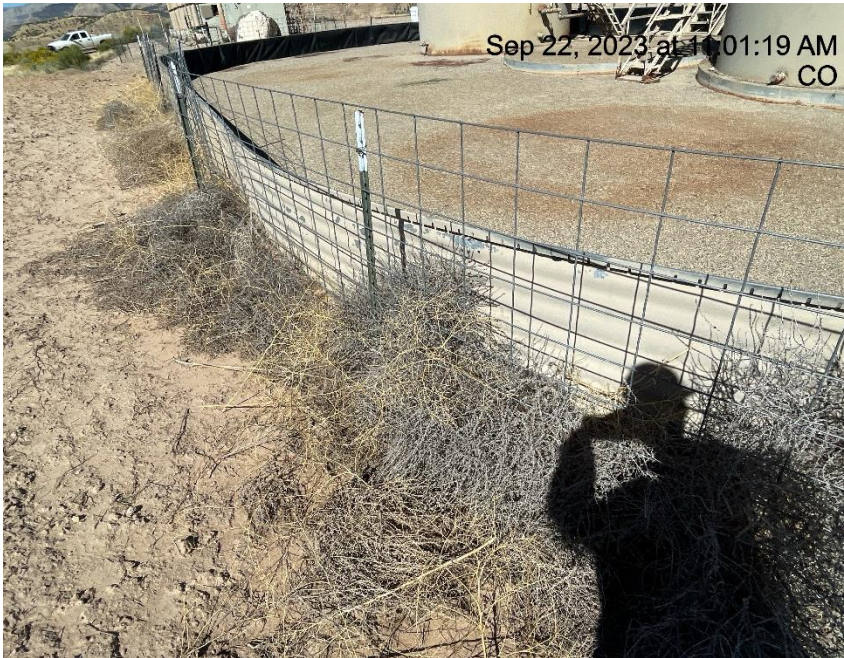
Photo # 248 Debris
