Construction and Stormwater Inspection

Date: 09/18/2023

Operator: BISON IV OPERATING LLC - 10670

Inspection Photos
Location Name: Shoveler Pad
Location ID: 455365

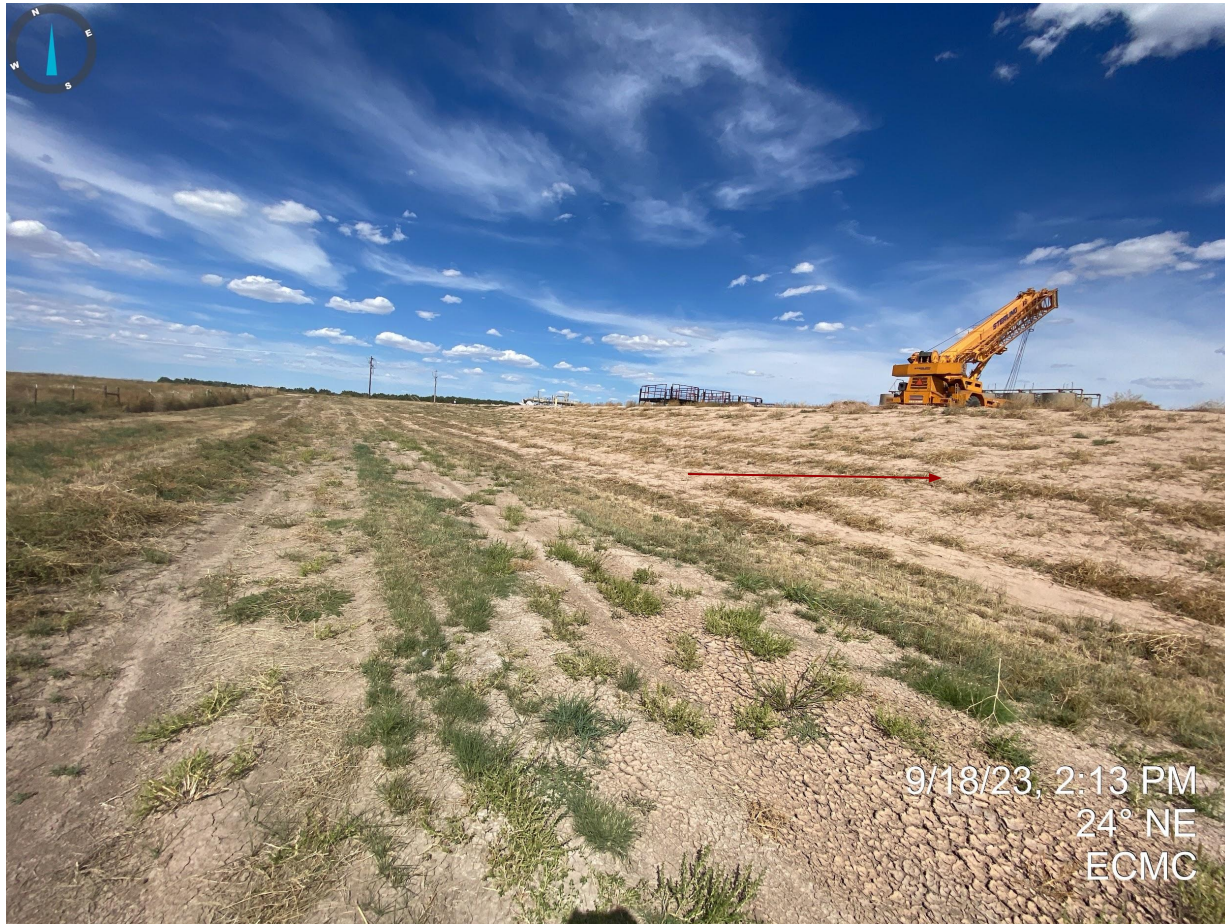
Photo 1. Taken from the western portion of the location. Portions of the production areas do not appear to be properly stabilized with evidence of bare and exposed soils. Additionally, undesirable vegetation (e.g. kochia and russian thistle) was observed throughout and will need to be properly managed for.

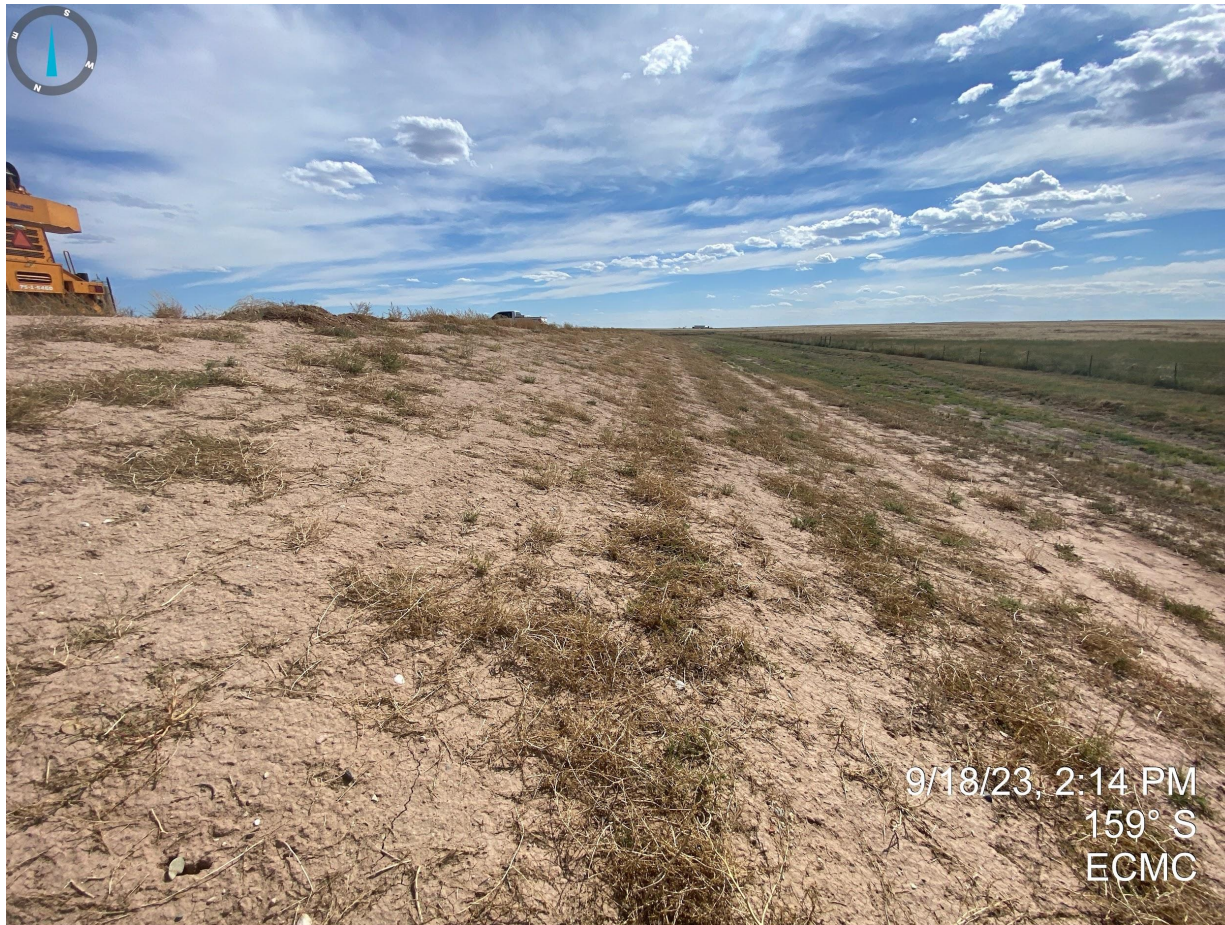
Photo 2. Taken from the western portion of the location; see comments in Photo 1.

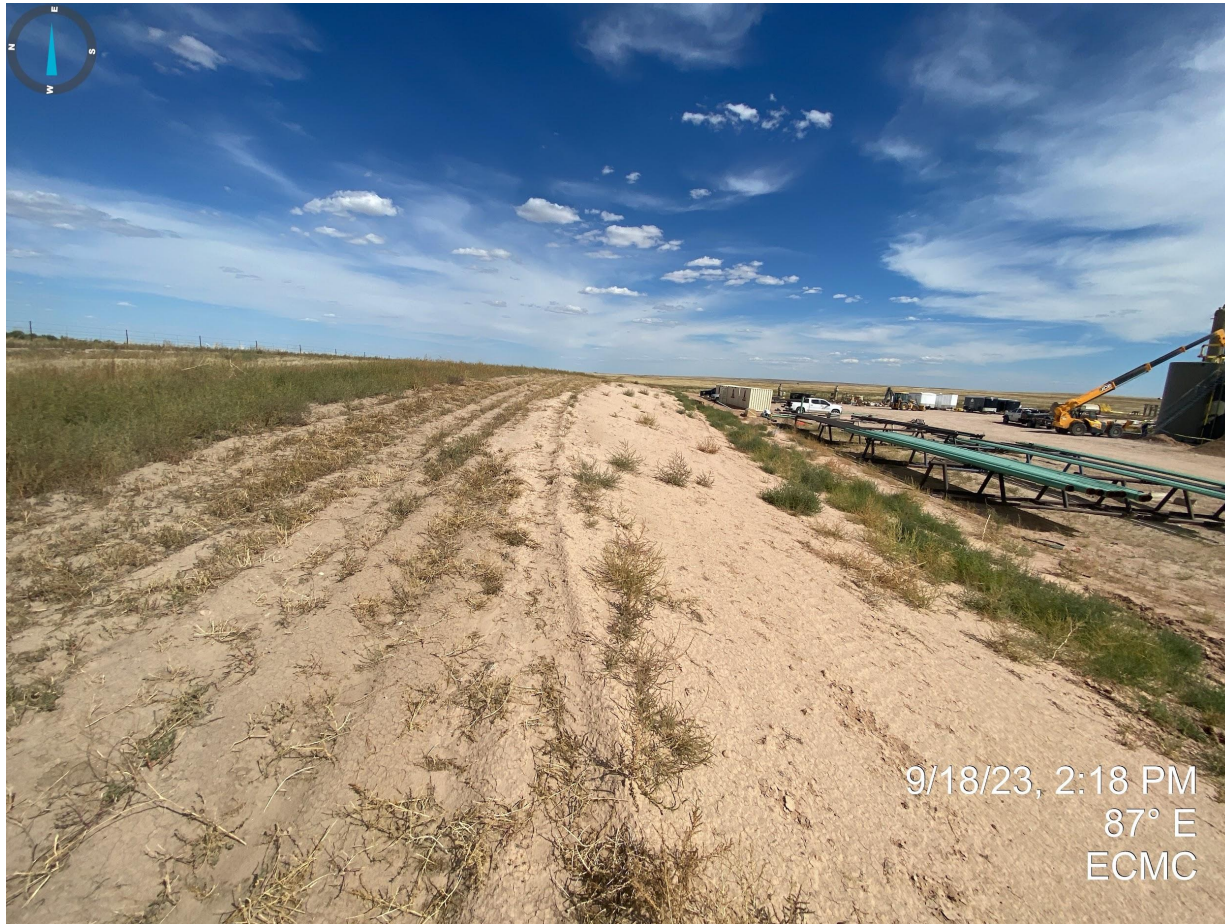
Photo 3. Taken from the northern portion of the location; see comments in Photo 1.

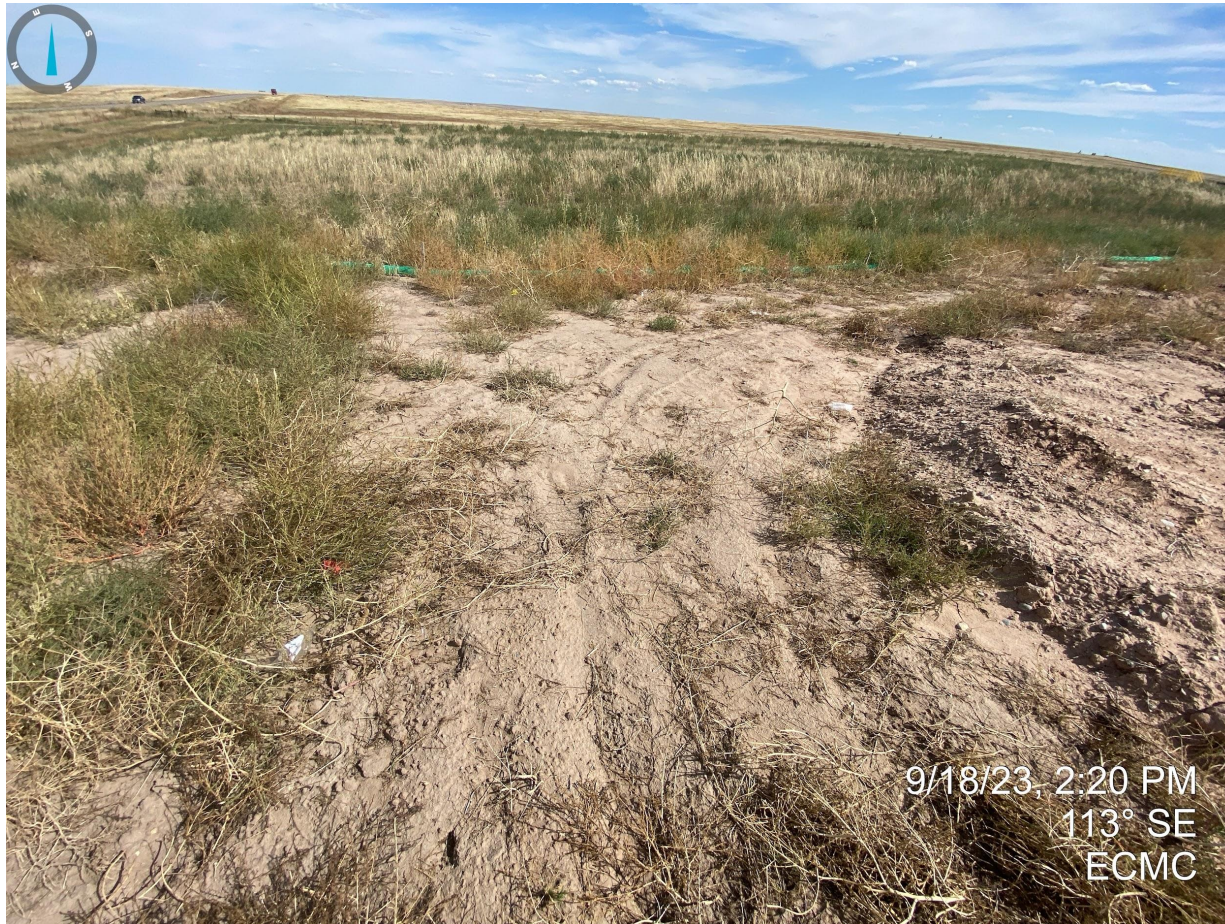
Photo 4. Taken from the northern portion of the location near the topsoil stockpile; see comments in Photo 1.

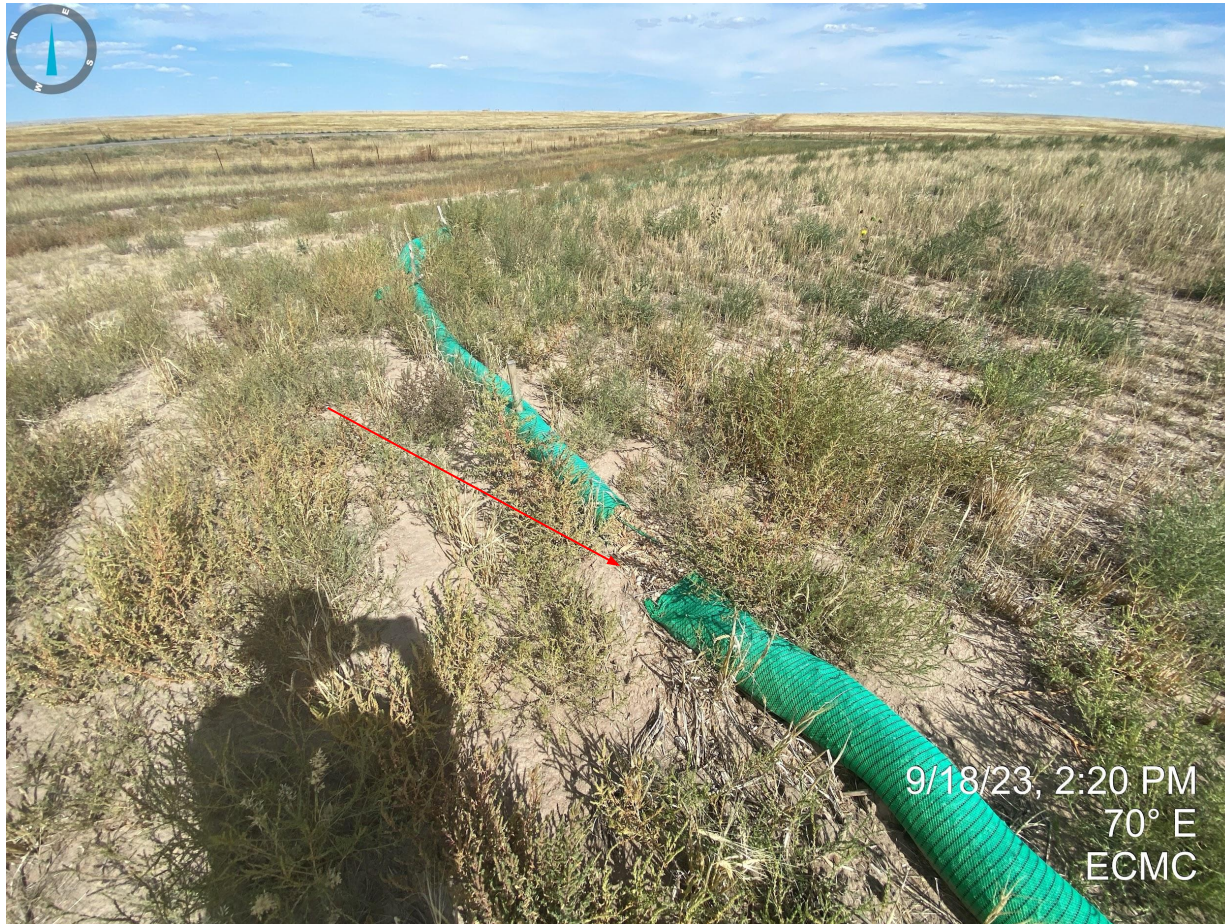
Photo 5. Taken from the northwestern portion of the topsoil stockpile. Photo illustrates that stormwater control measures (e.g. filtrex) are beginning to degrade and fill with sediment.

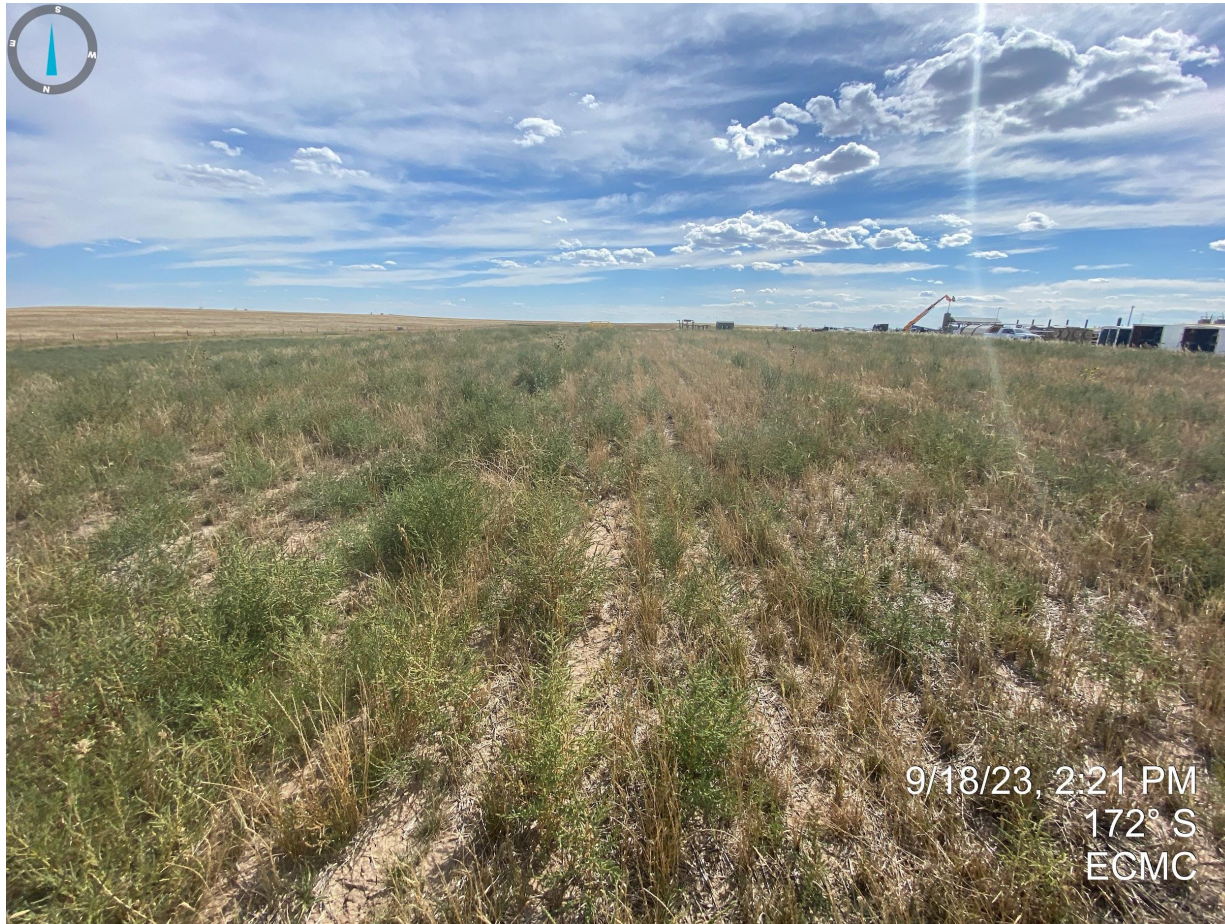
Photo 6. Taken from the northern portion of the topsoil stockpile. The topsoil is predominantly undesirable vegetation (e.g. kochia and russian thistle). Management of the undesirable vegetation should be implemented immediately as this is not in compliance with Rule 1002.c.

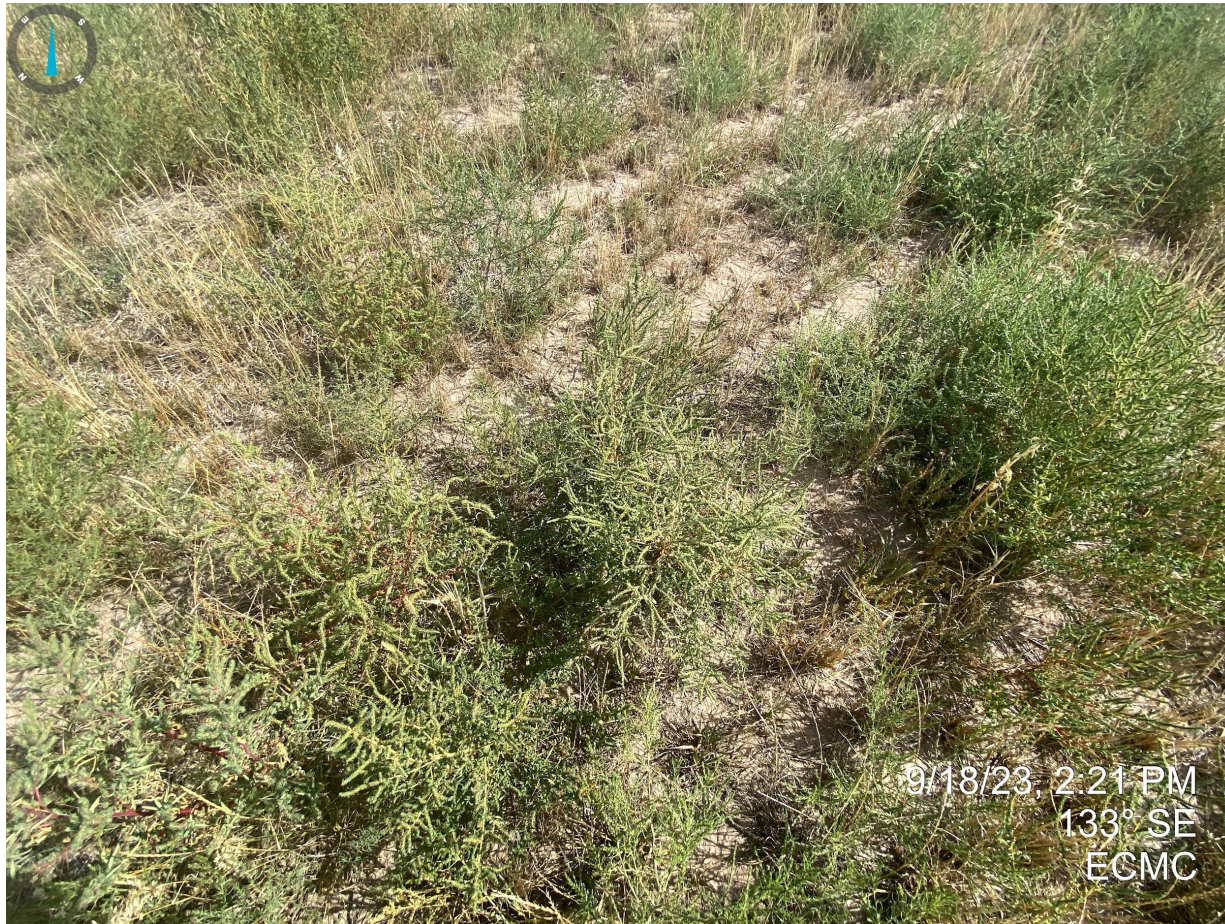
Photo 7. Continued from Photo 6. Close up photo of undesirable vegetation on topsoil stockpile.

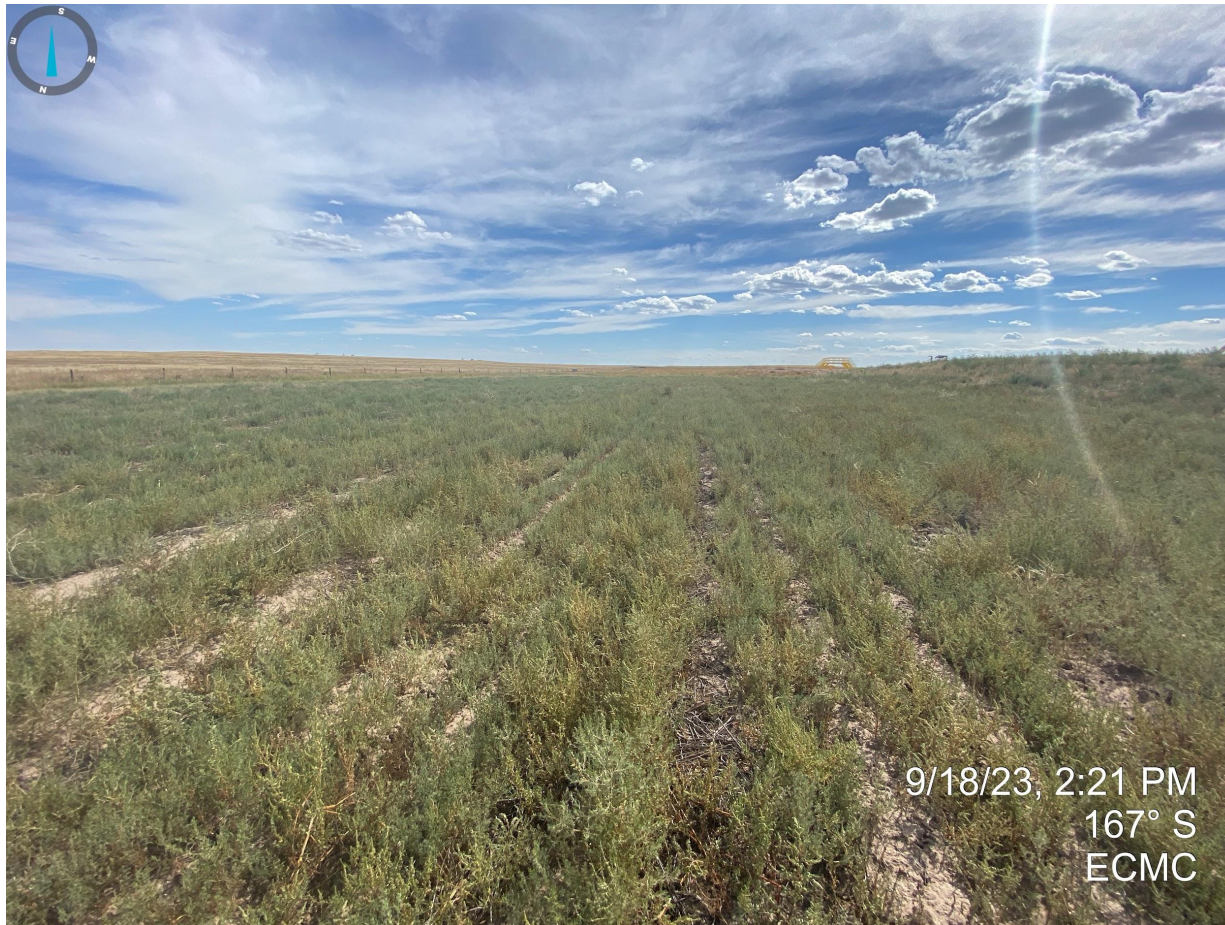
Photo 8. Taken east of the topsoil stockpile. The former interim areas were re-disturbed as part of additional drilling and pad expansion activities; it does not appear this area was needed for additional drilling operations. The disturbance area now consists of a uniform vegetative cover of undesirable species (e.g. kochia and russian thistle) that requires management.

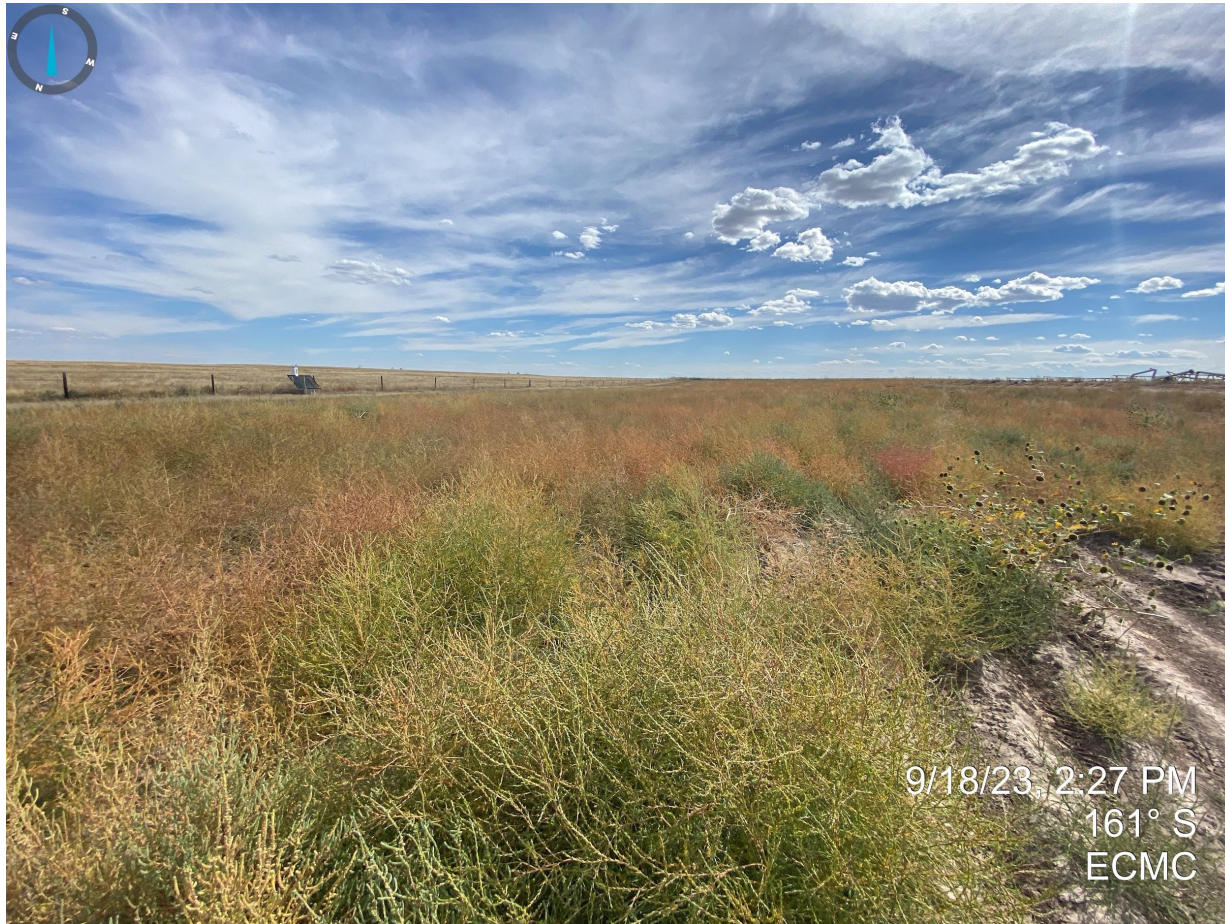
Photo 9. Taken from the southeast side of the topsoil stockpile. See comments in Photo 8.

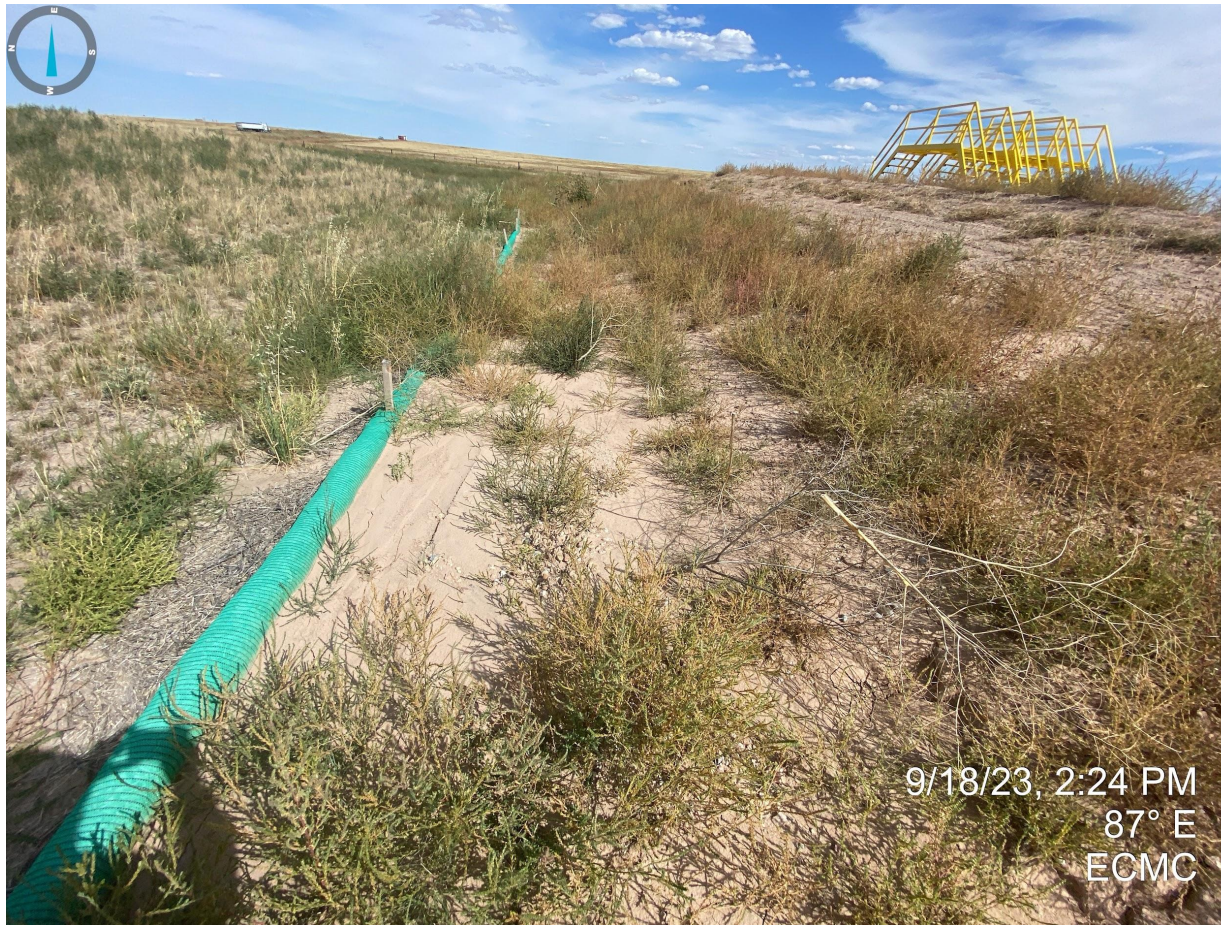
Photo 10. Taken south of the topsoil stockpile. Erosion degradation observed coming off of the production pad. Stormwater control measures (e.g. filtrex) are beginning to fill with sediment and require maintenance.

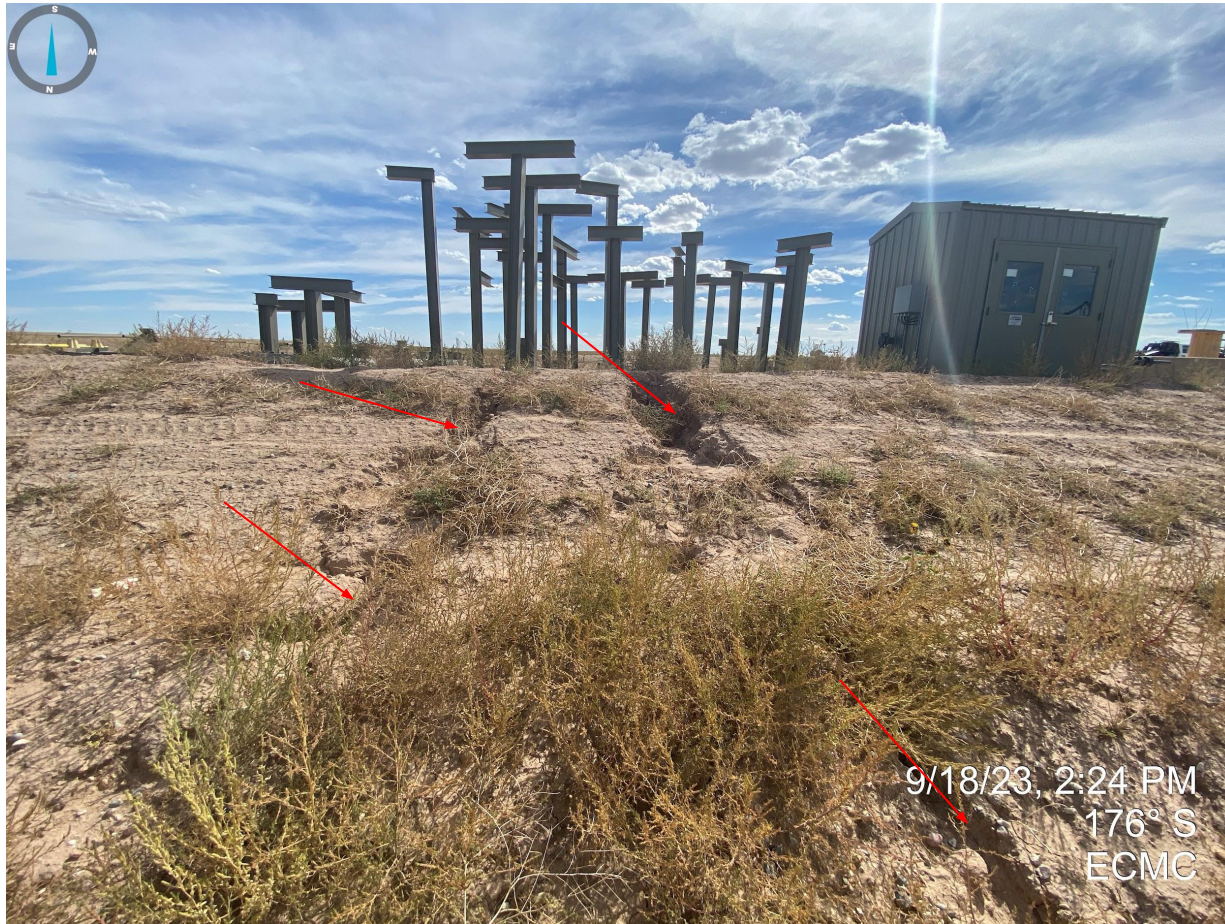
Photo 11. Continued from Photo 10; erosion degradation (e.g. gullying) pictured.

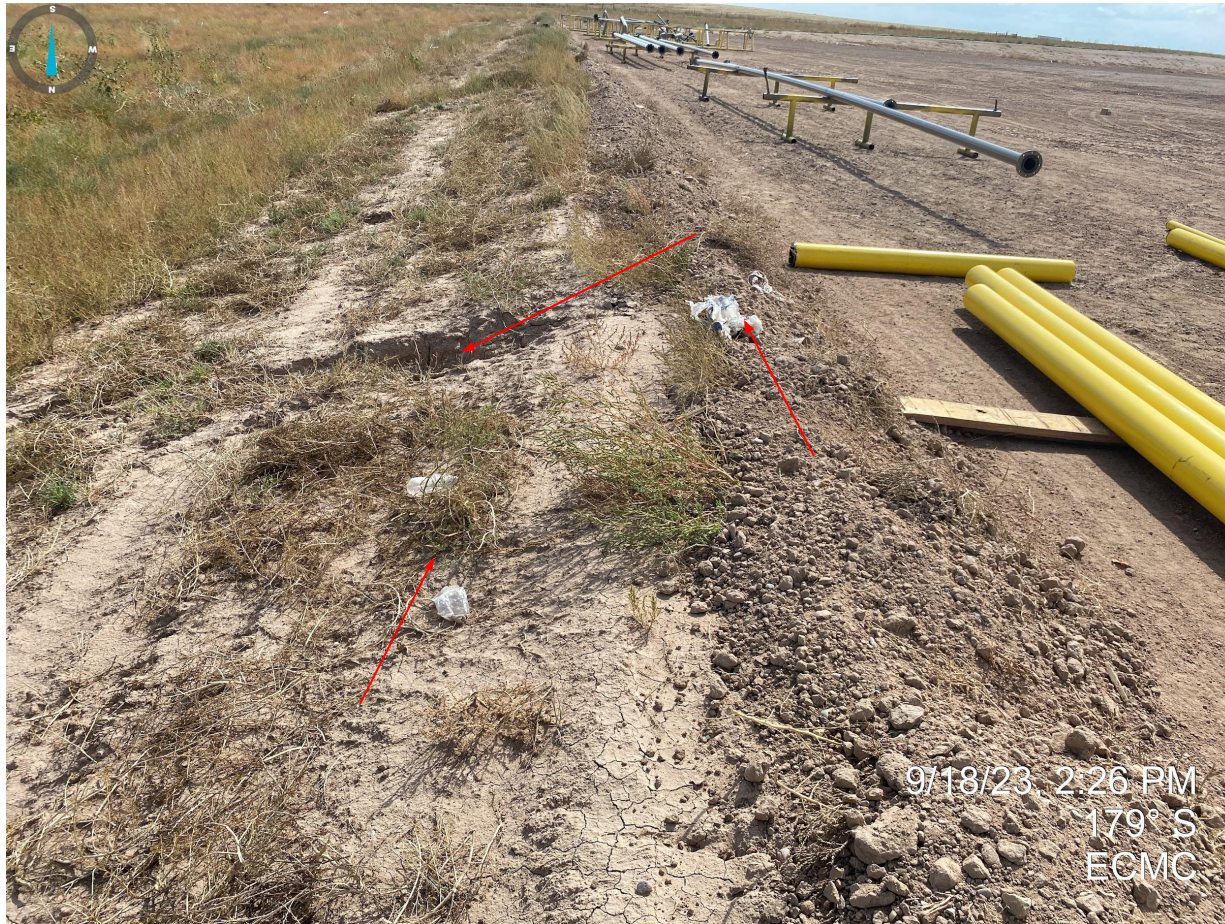
Photo 12. Taken from the eastern side of the production pad. Erosion degradation (e.g. gully) and trash pictured.

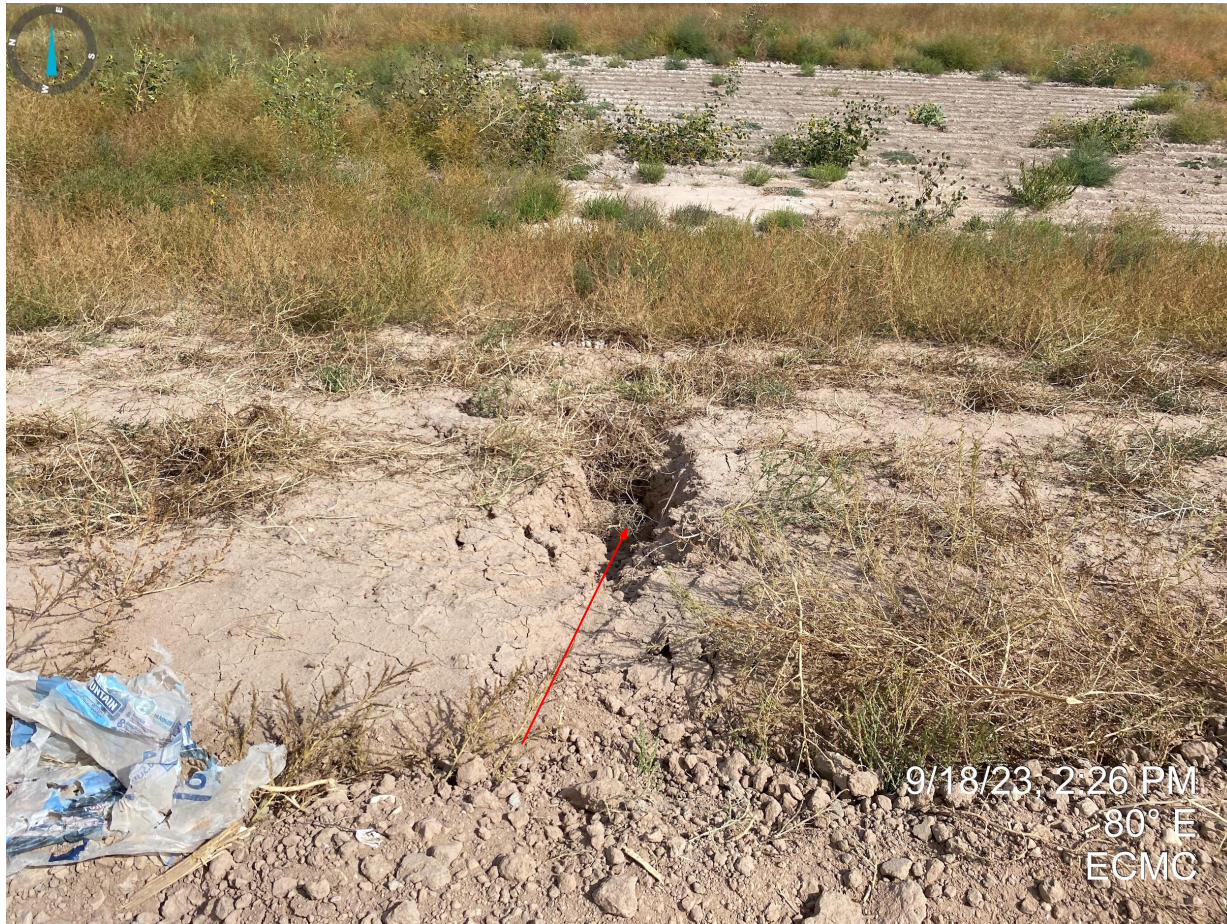
Photo 13. Continued from Photo 12.

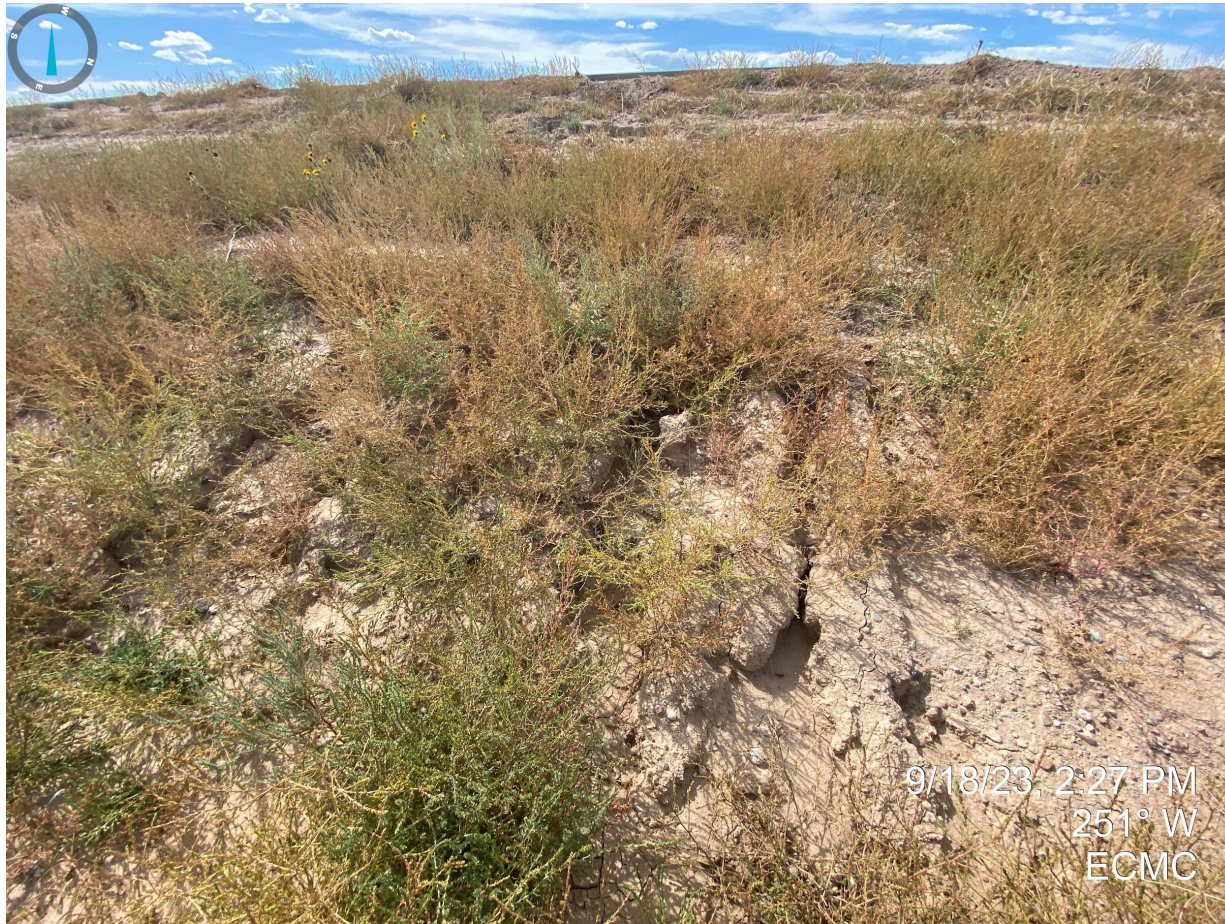
Photo 14. Taken from the eastern side of the production pad. Erosion degradation and undesirable vegetation observed.

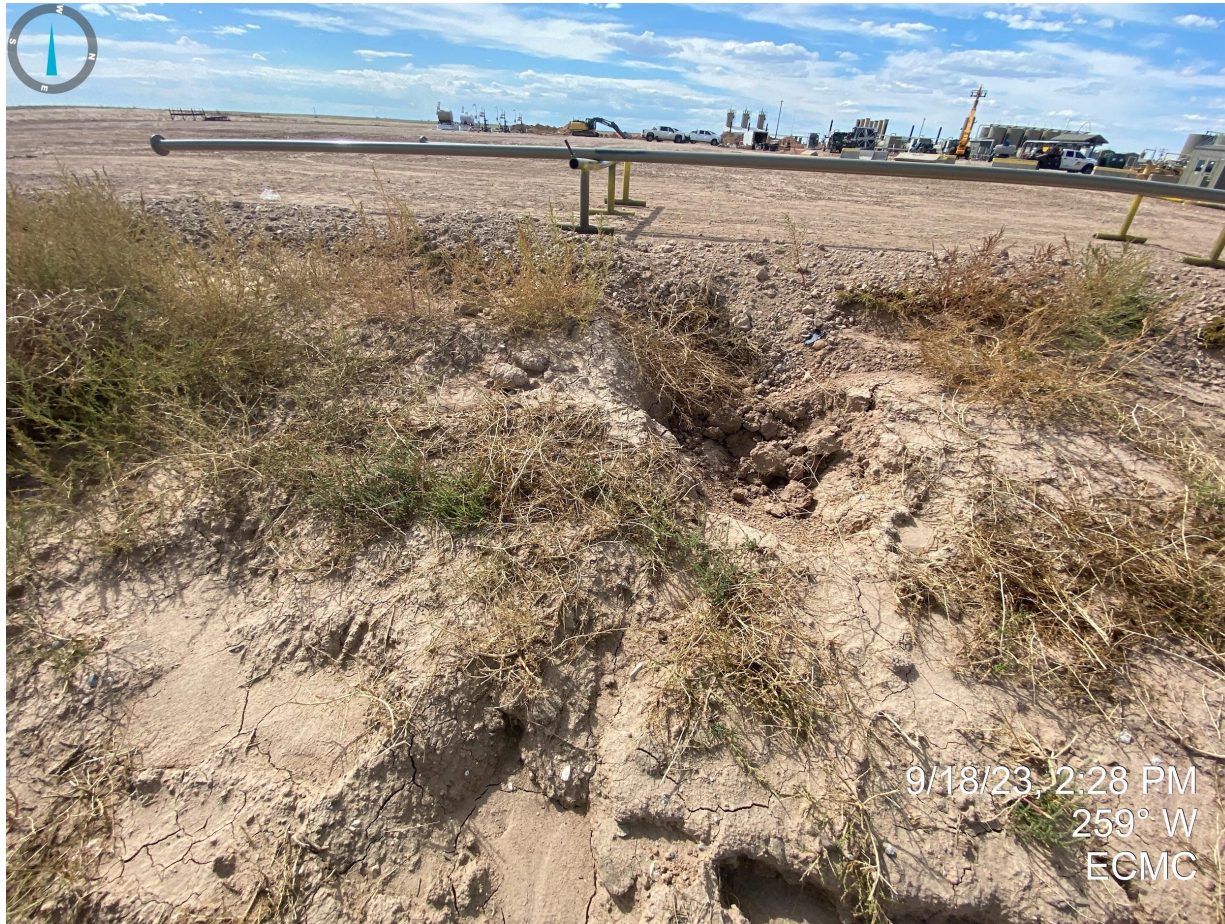
Photo 15. Taken from the eastern side of the production pad. Erosion degradation and undesirable vegetation observed.

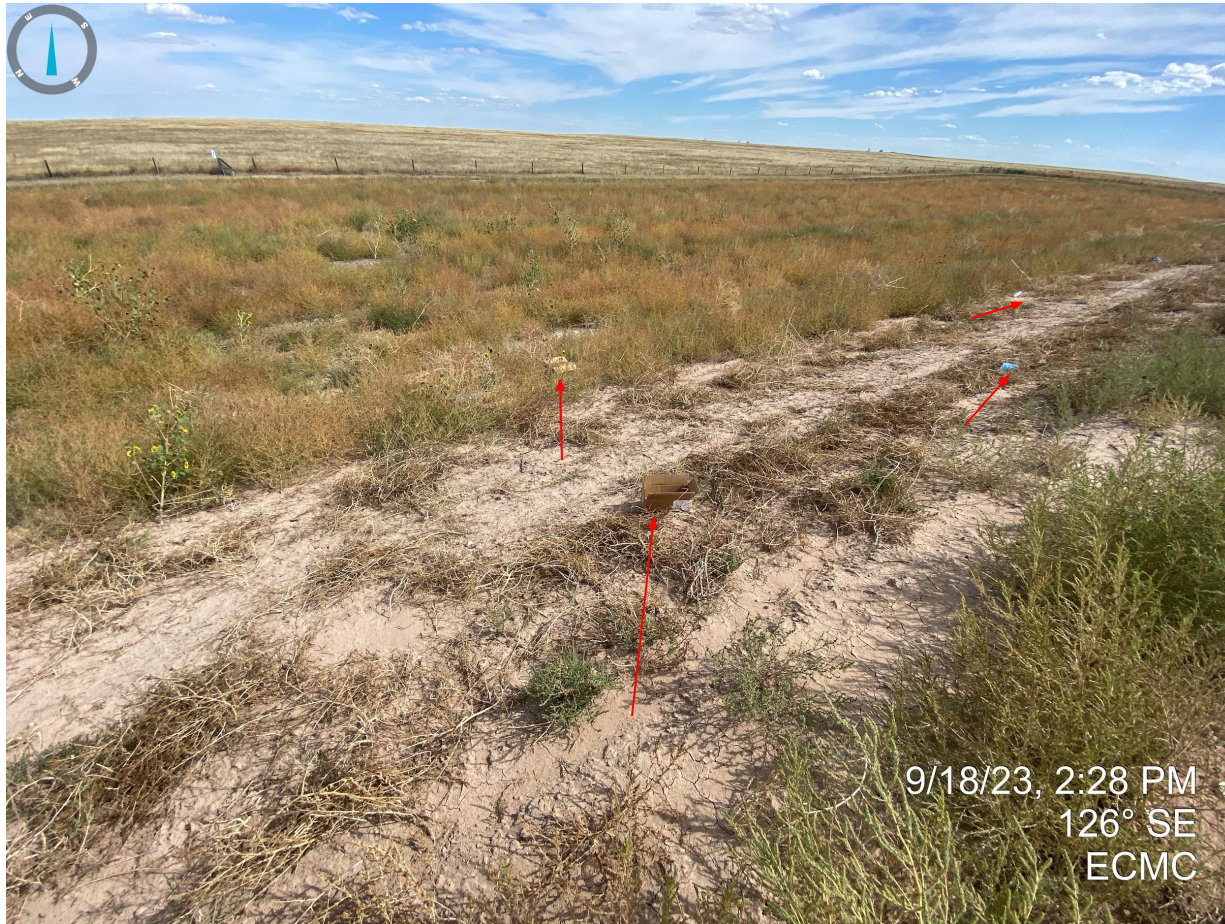
Photo 16. Taken from the eastern side of the production pad. Trash observed.

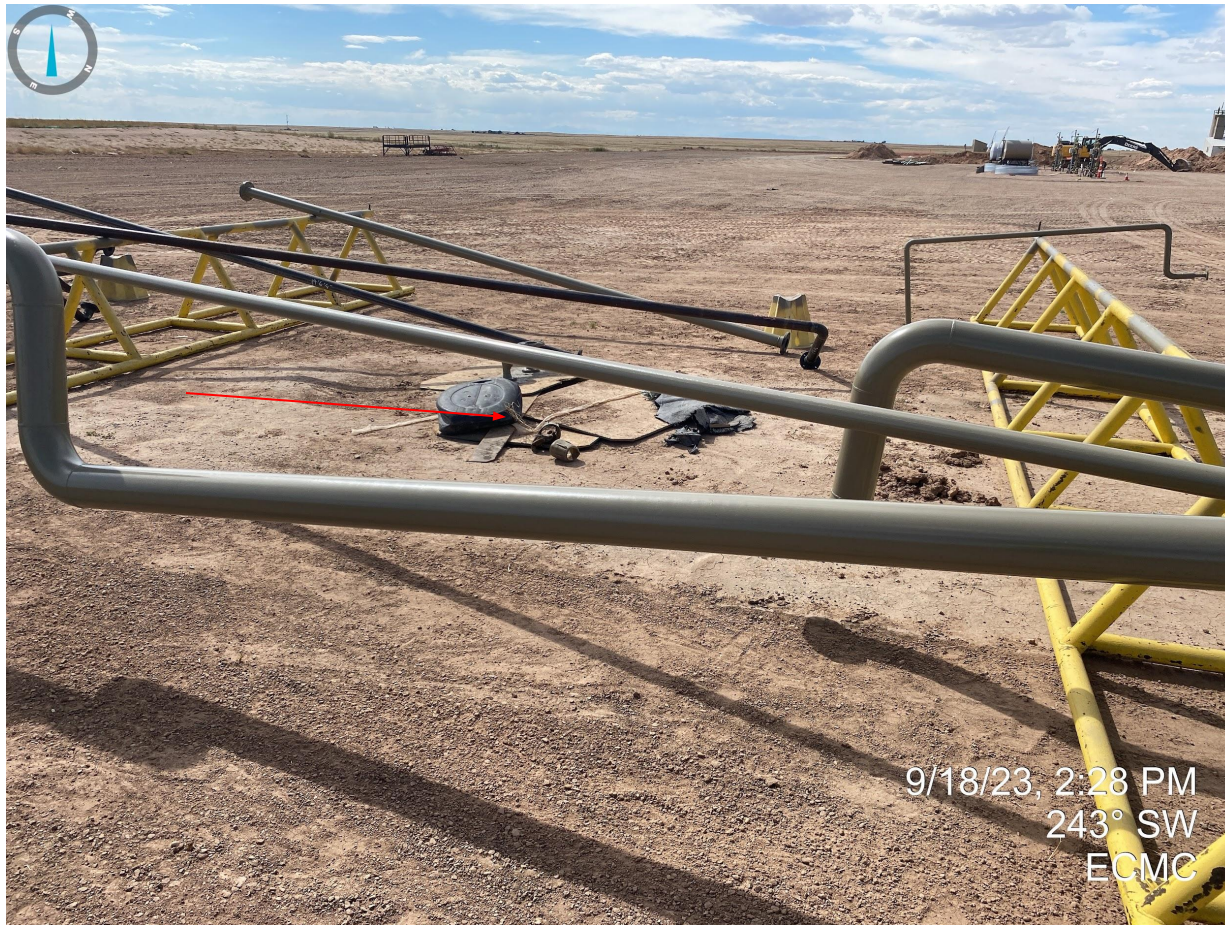
Photo 17. Trash observed on the eastern side of the production area.

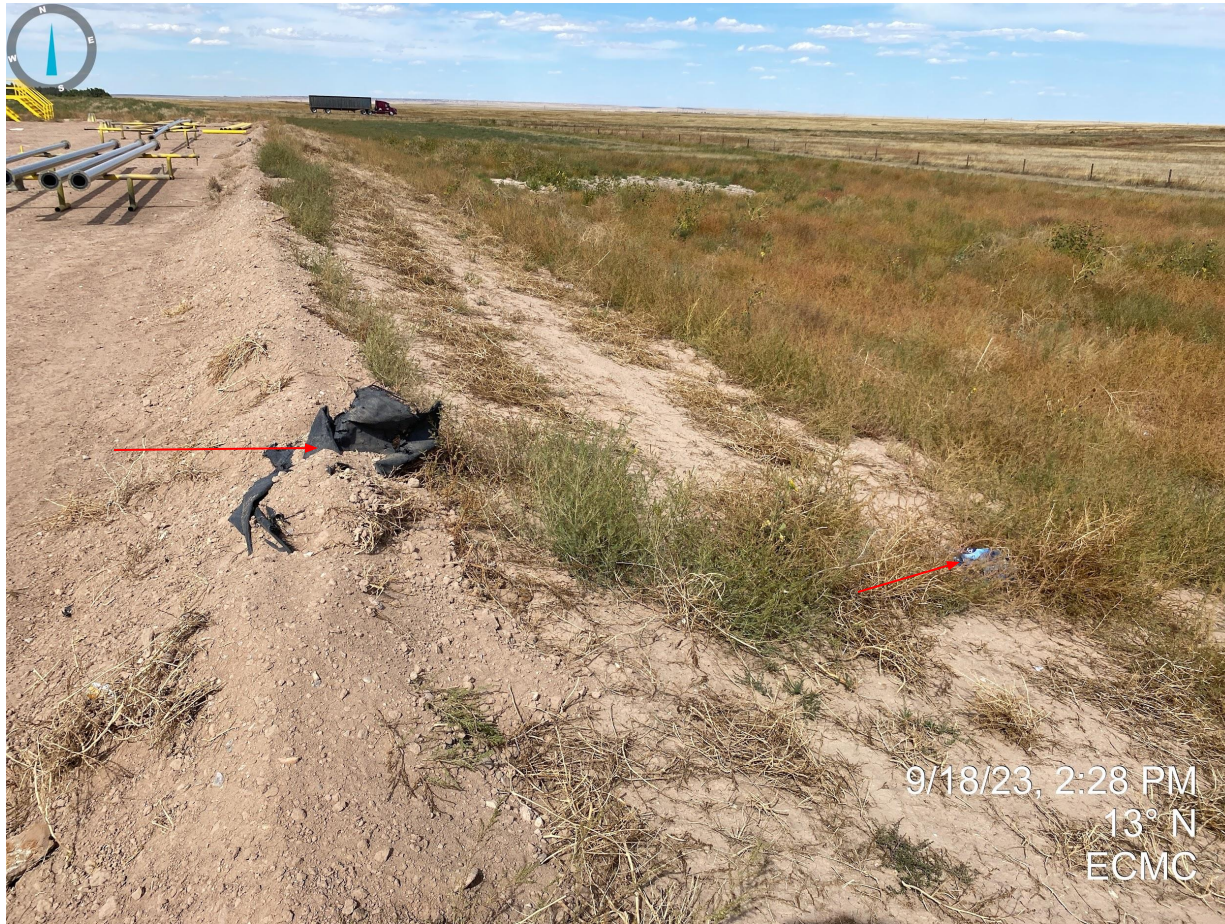
Photo 18. Trash observed on the eastern side of the production area.

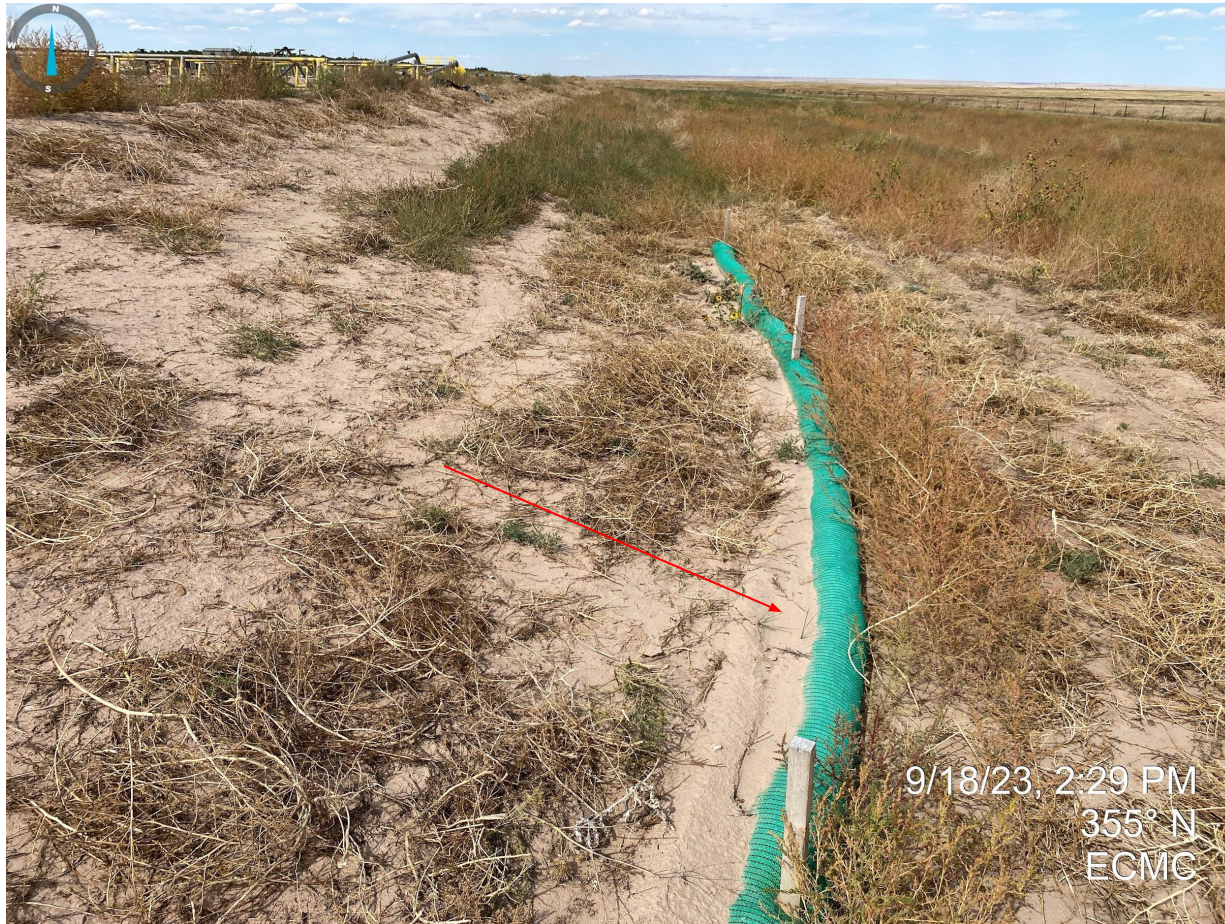
Photo 19. Taken from the eastern side of the production area. Stormwater control measures require maintenance to be properly functioning.
