Construction and Stormwater Inspection

Date: 09/18/2023

Operator: BISON IV OPERATING LLC - 10670

Inspection Photos
Location Name: Shoveler Pad
Location ID: 455365

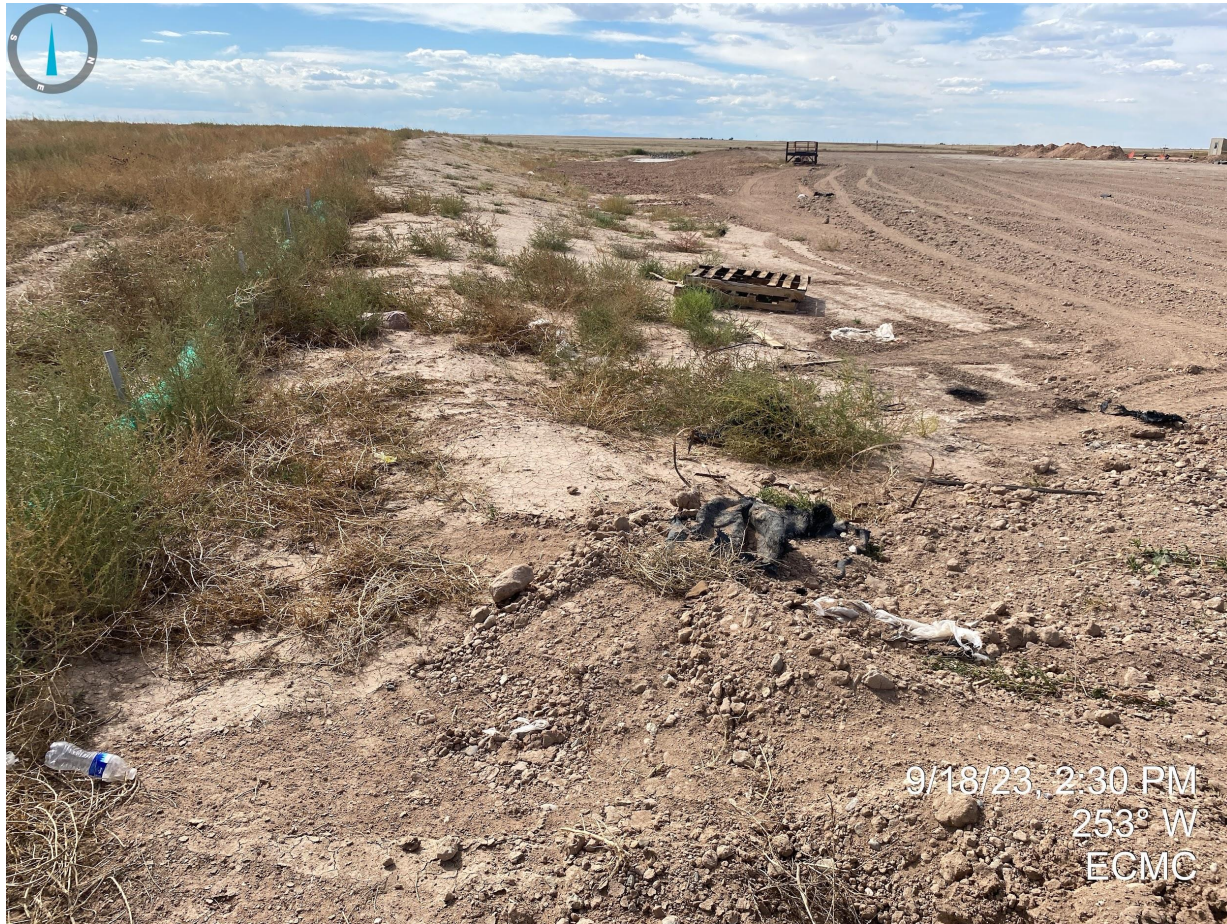
Photo 20. Trash observed on the southeast corner of the production area.

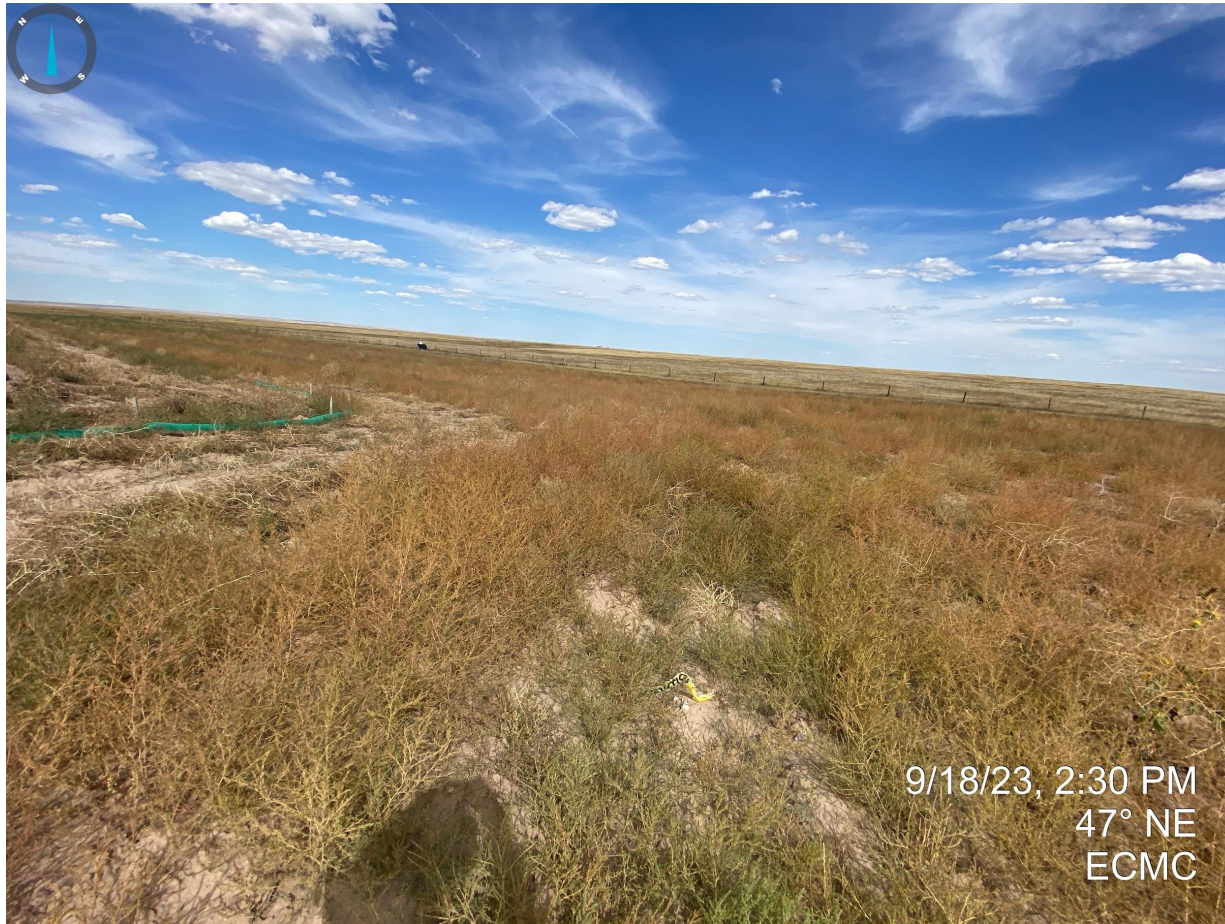
Photo 8. Taken east of the topsoil stockpile. The former interim areas were re-disturbed as part of additional drilling and pad expansion activities; it does not appear this area was needed for additional drilling operations. The disturbance area now consists of a uniform vegetative cover of undesirable species (e.g. kochia and russian thistle) that requires management.

Photo 21. Taken near the southeast corner of the location; see comments in Photo 8.

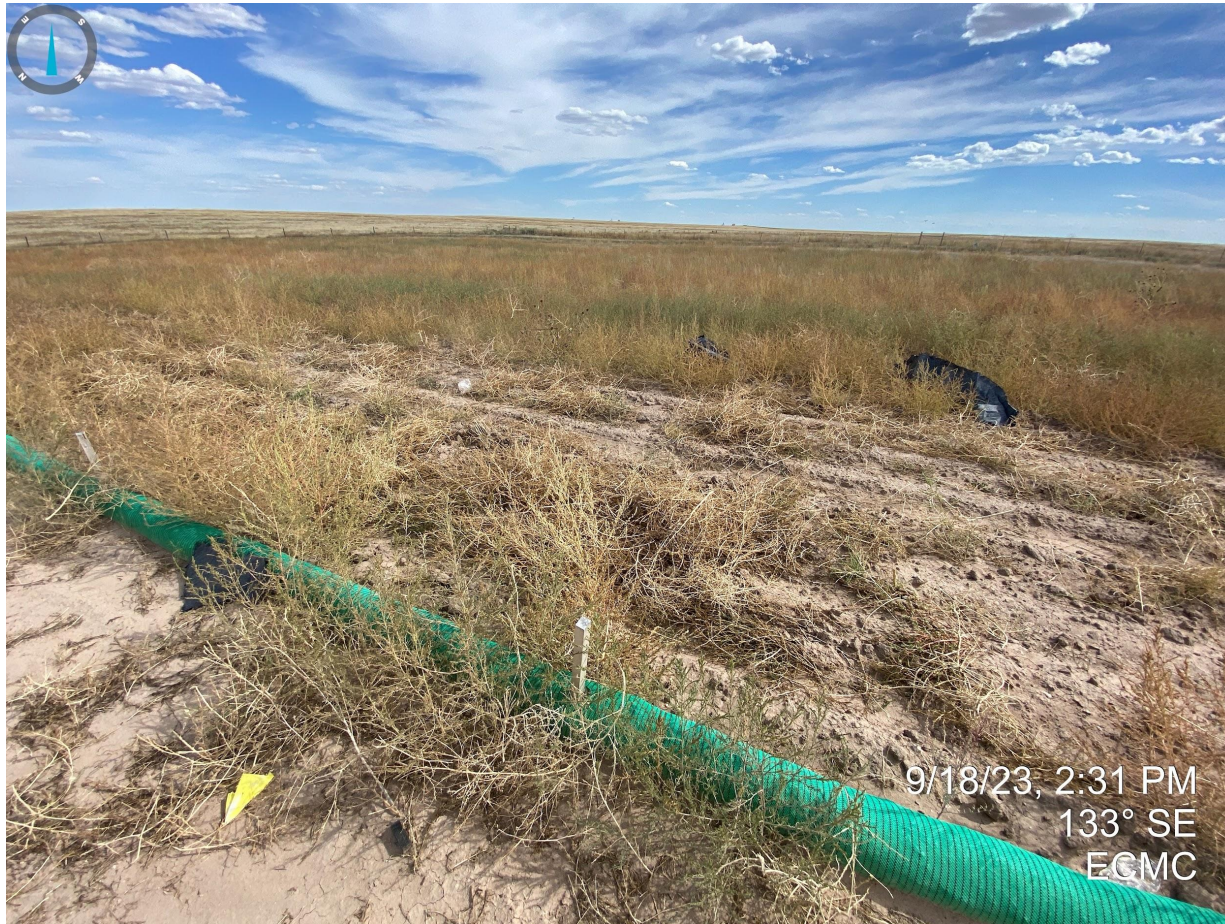
Photo 22. Trash observed on the southern portion of the production areas.

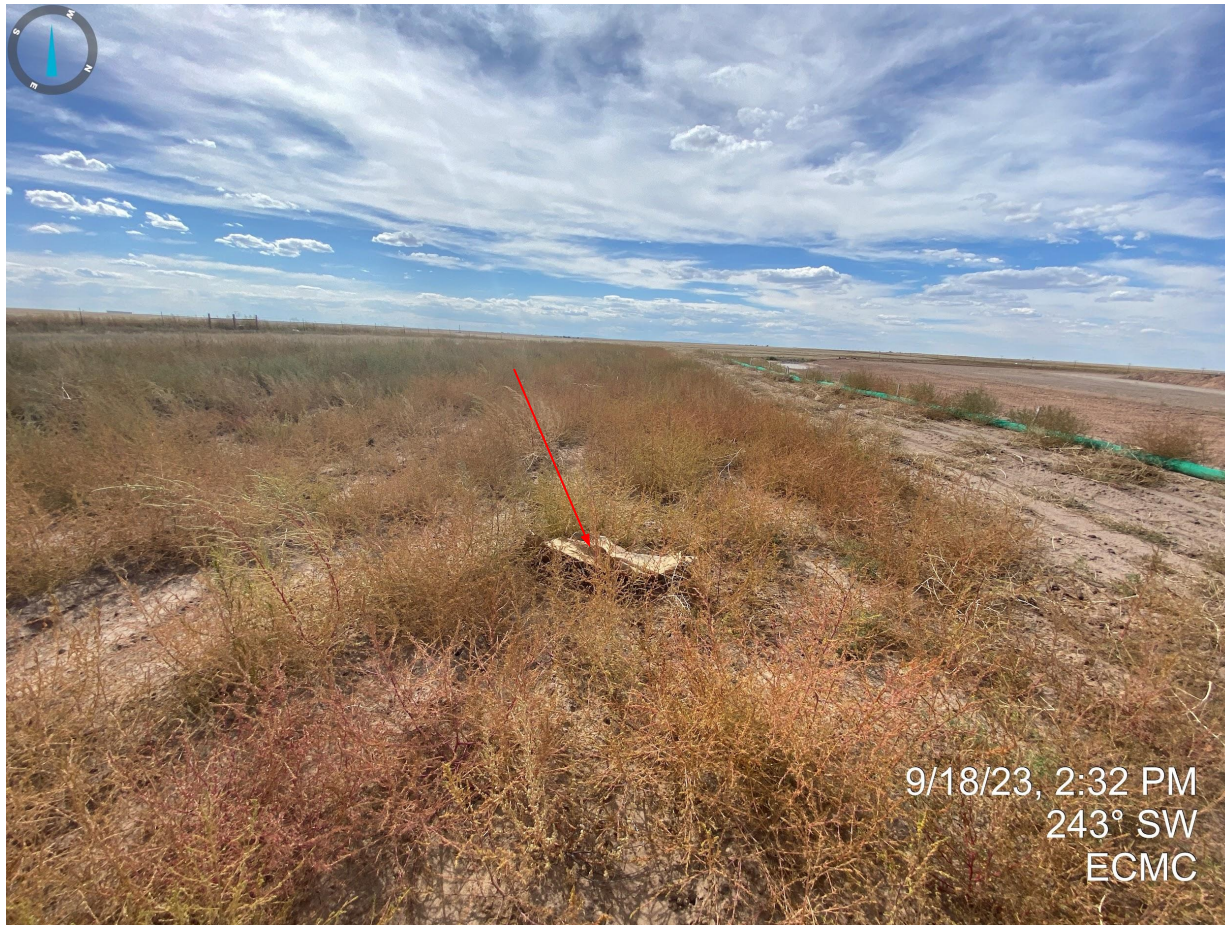
Photo 23. Trash observed on the southern portion of the production areas.

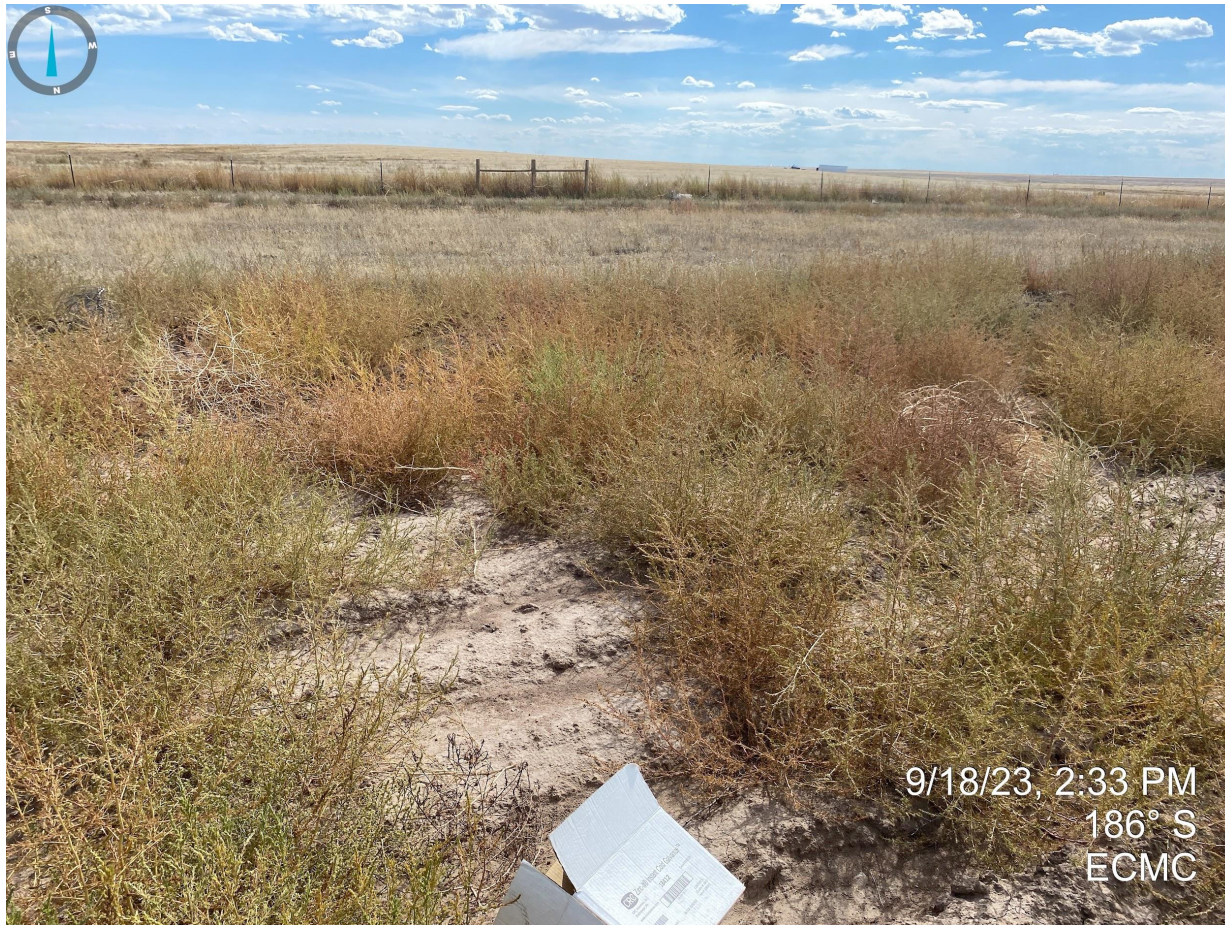
Photo 24. Trash observed on the southern portion of the production areas.

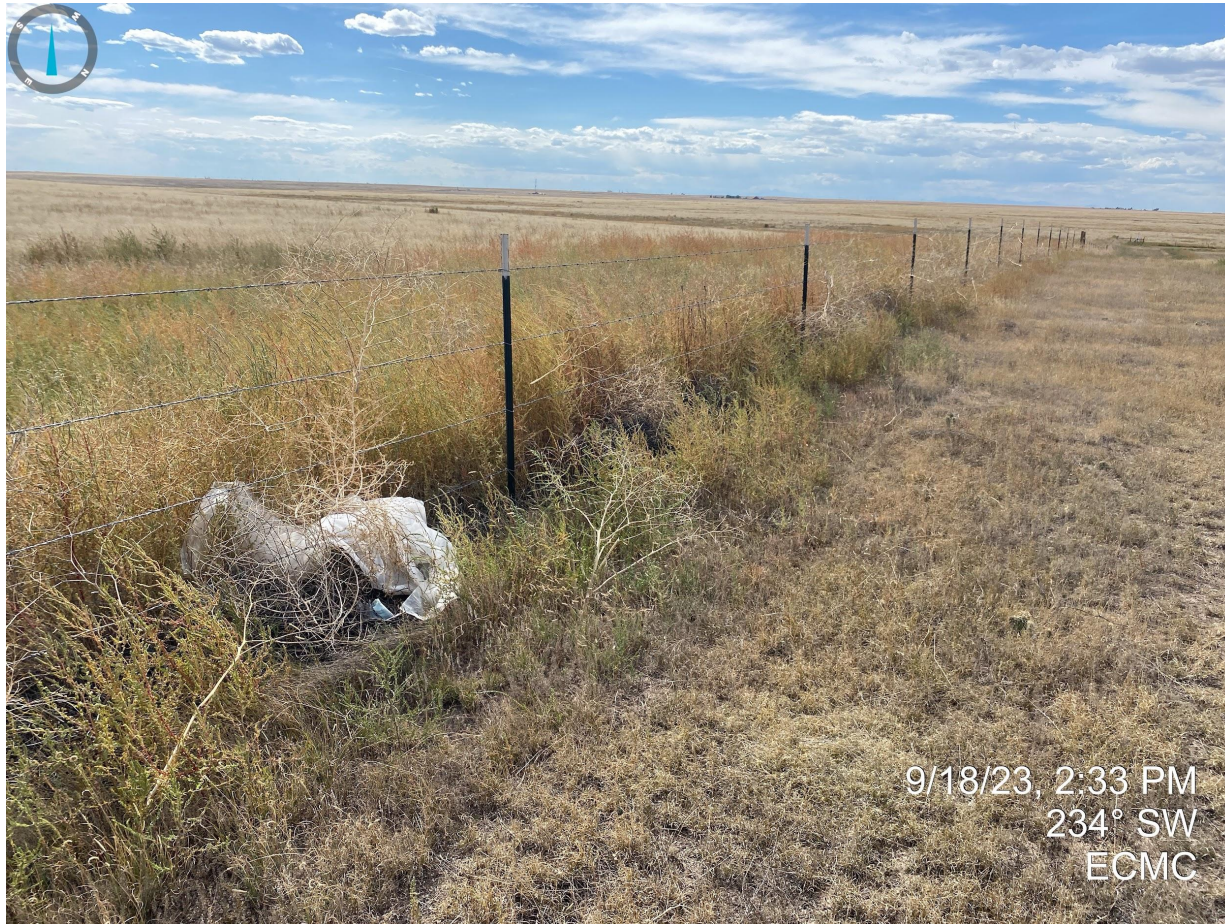
Photo 25. Trash observed on the southern fence of the location.

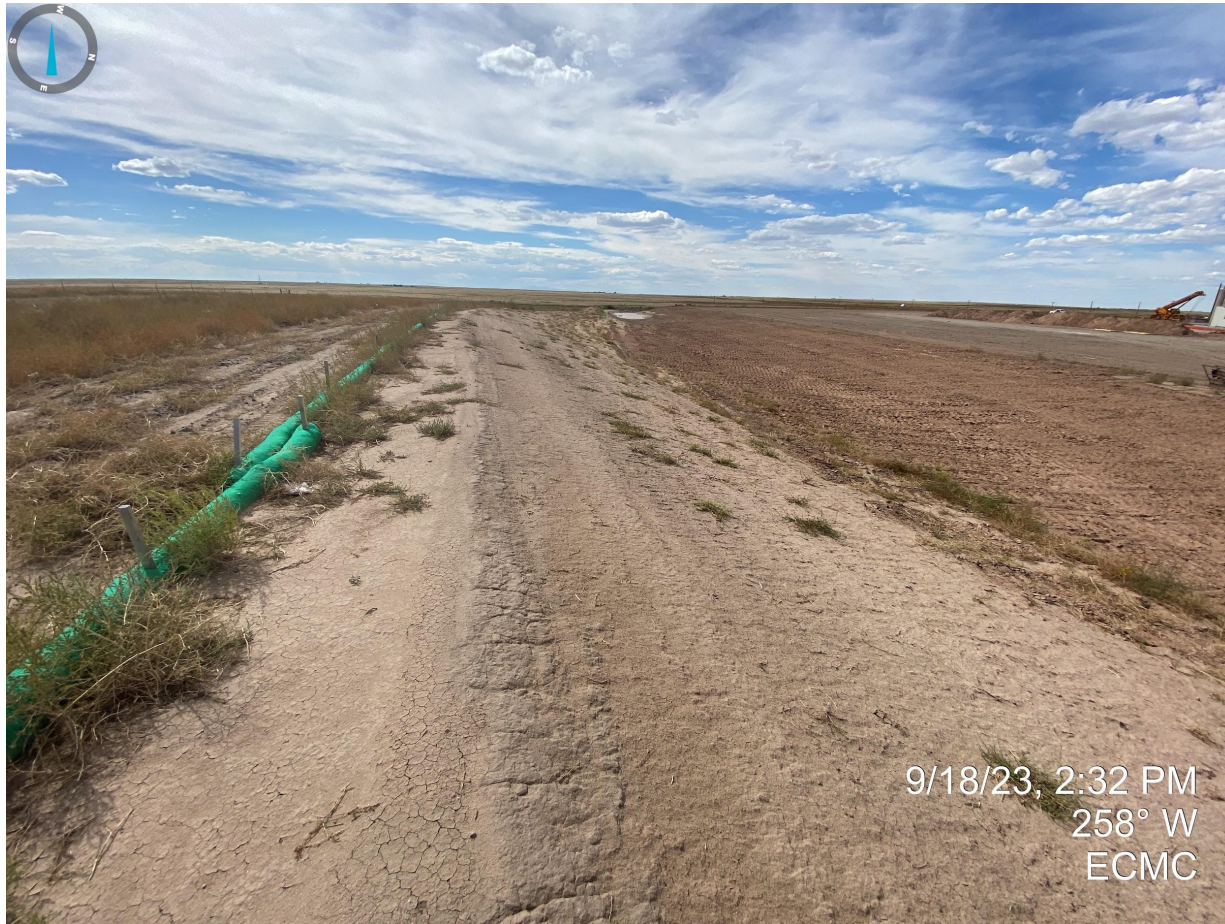
Photo 26. Taken from the center/southern portion of the location. Stormwater control measures do not appear to be properly stabilized with evidence of bare and exposed soils.

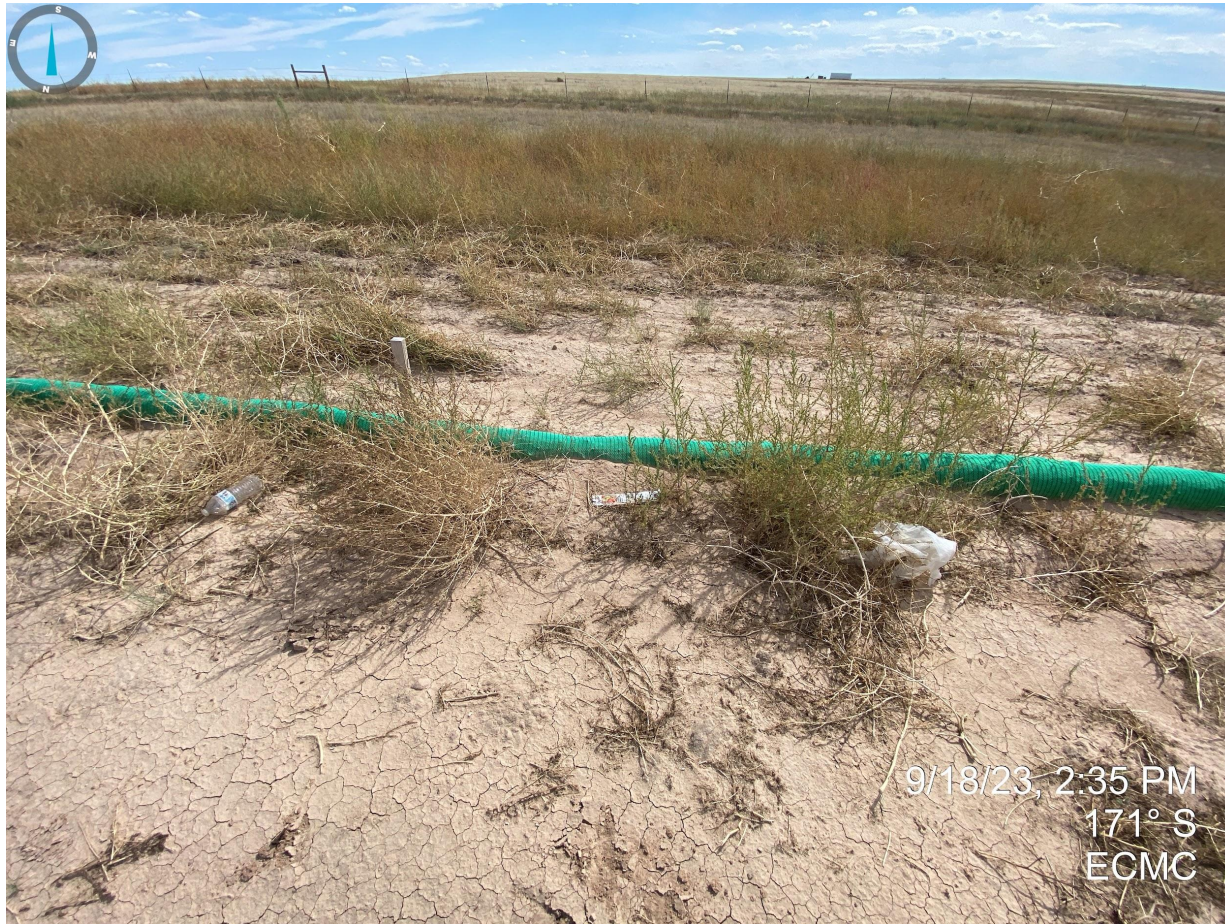
Photo 29. Trash observed on the southern portion of the location.

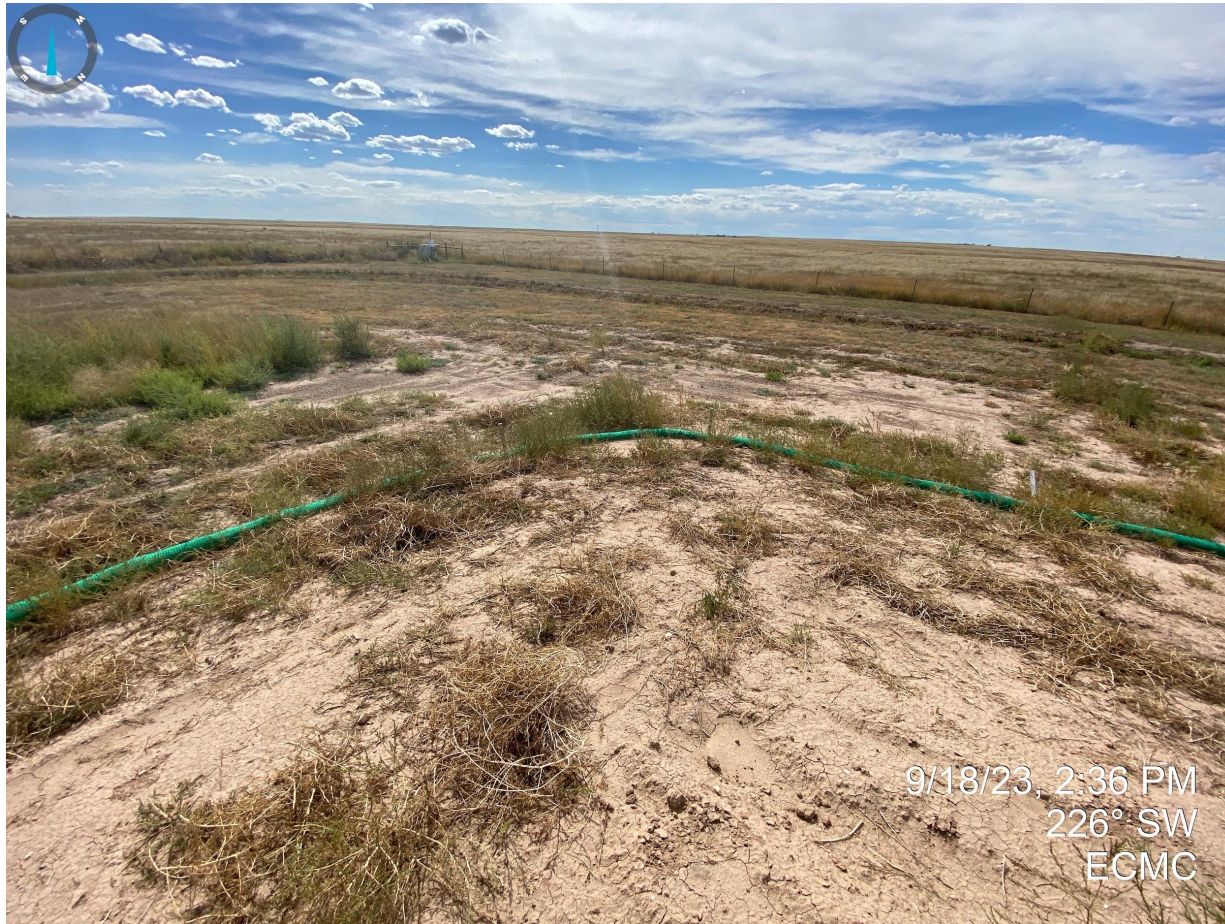
Photo 28. Taken from the southwest corner of the sediment detention area; see comments in Photo 26.

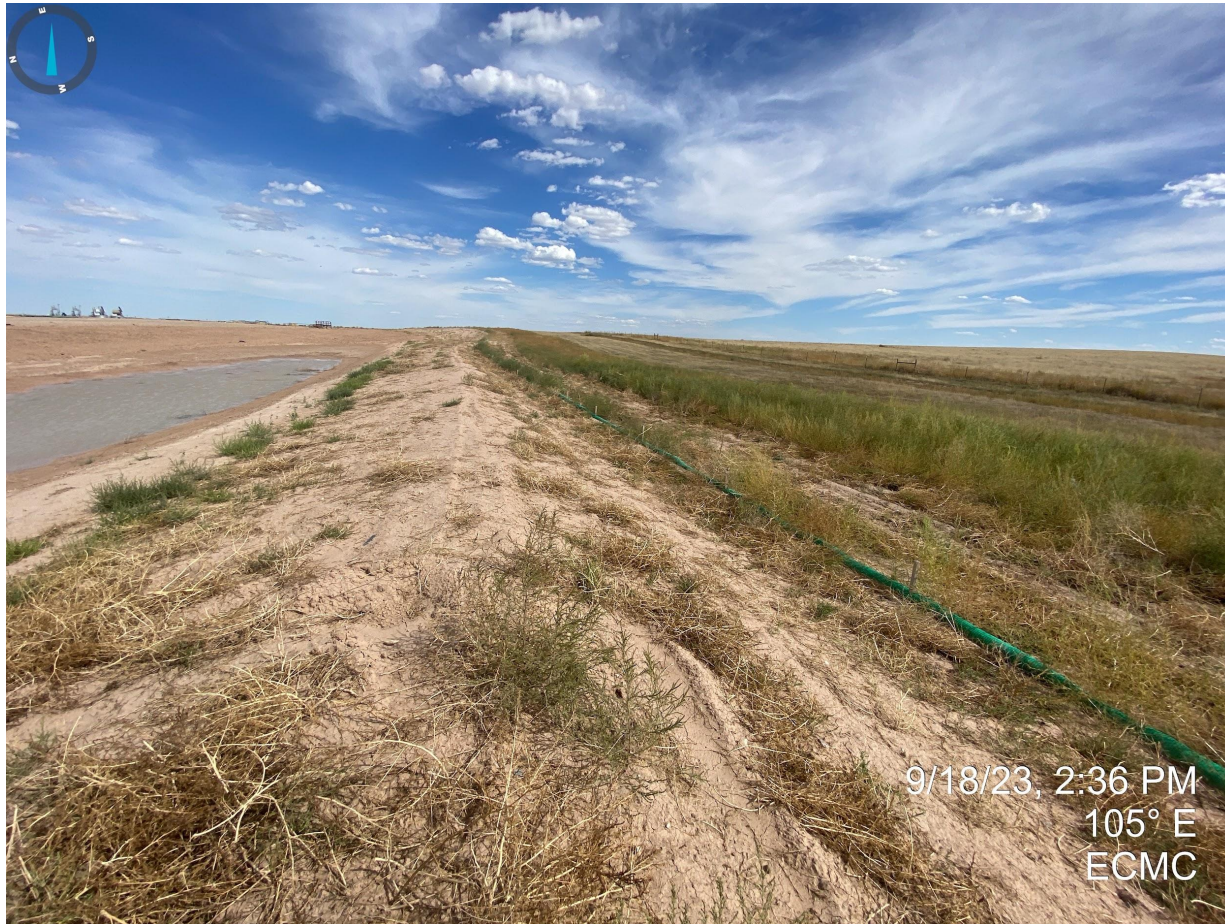
Photo 29. See comments in Photo 28.

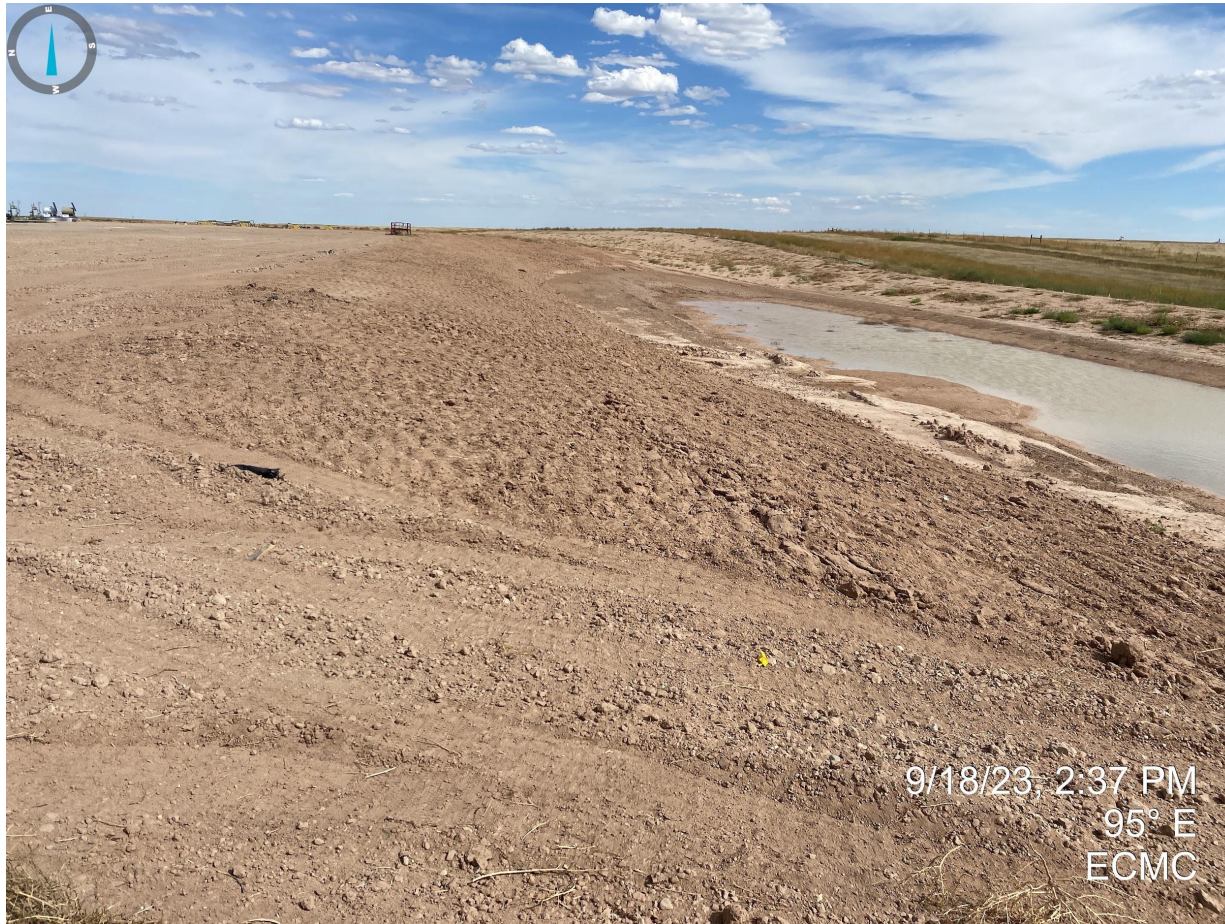
Photo 30. Taken from the northwestern corner of the sediment detention area. See comments in Photo 26.

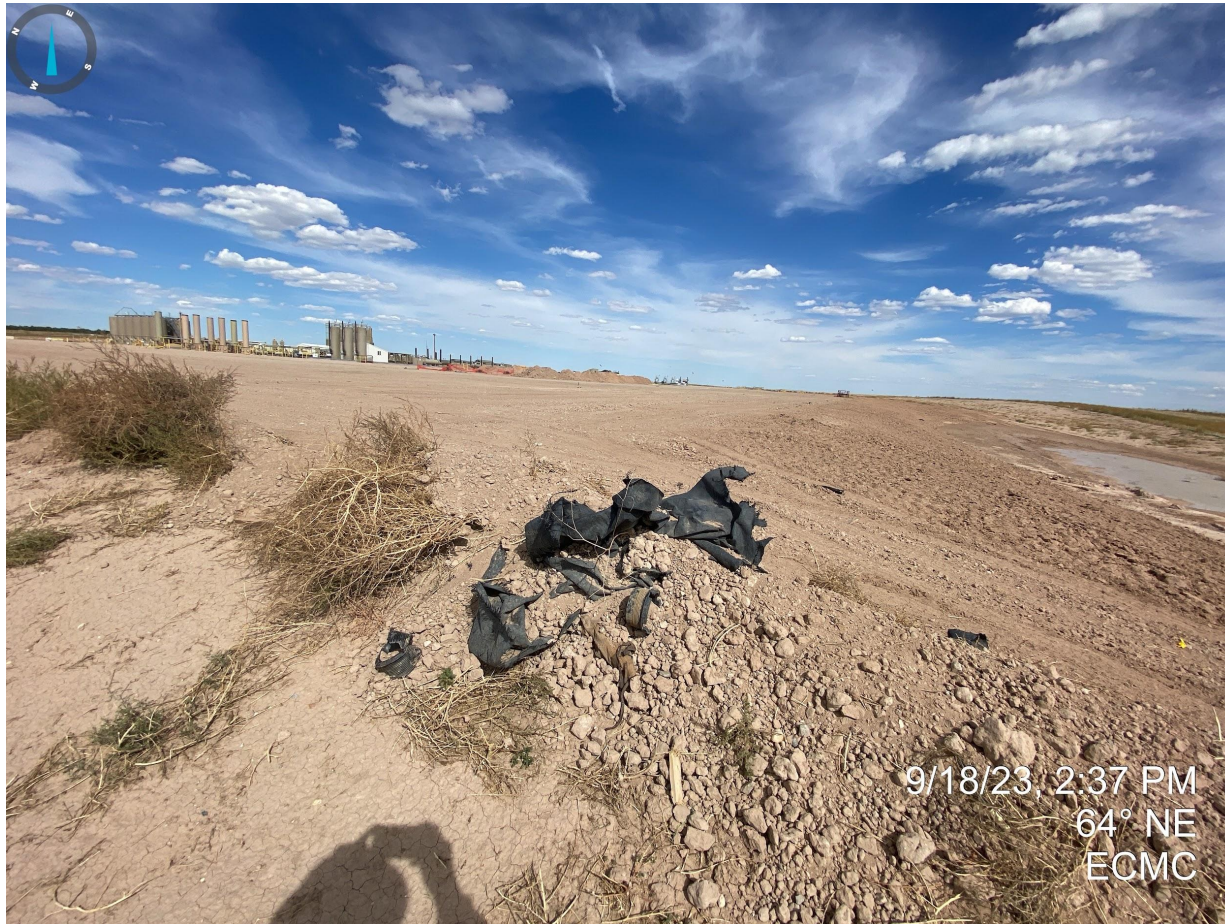
Photo 31. Trash observed on the southwestern portion of the production area.
