WELL NAME: HILL RANCH 04-15V, API #: 071-07148, INSP. # 695108698

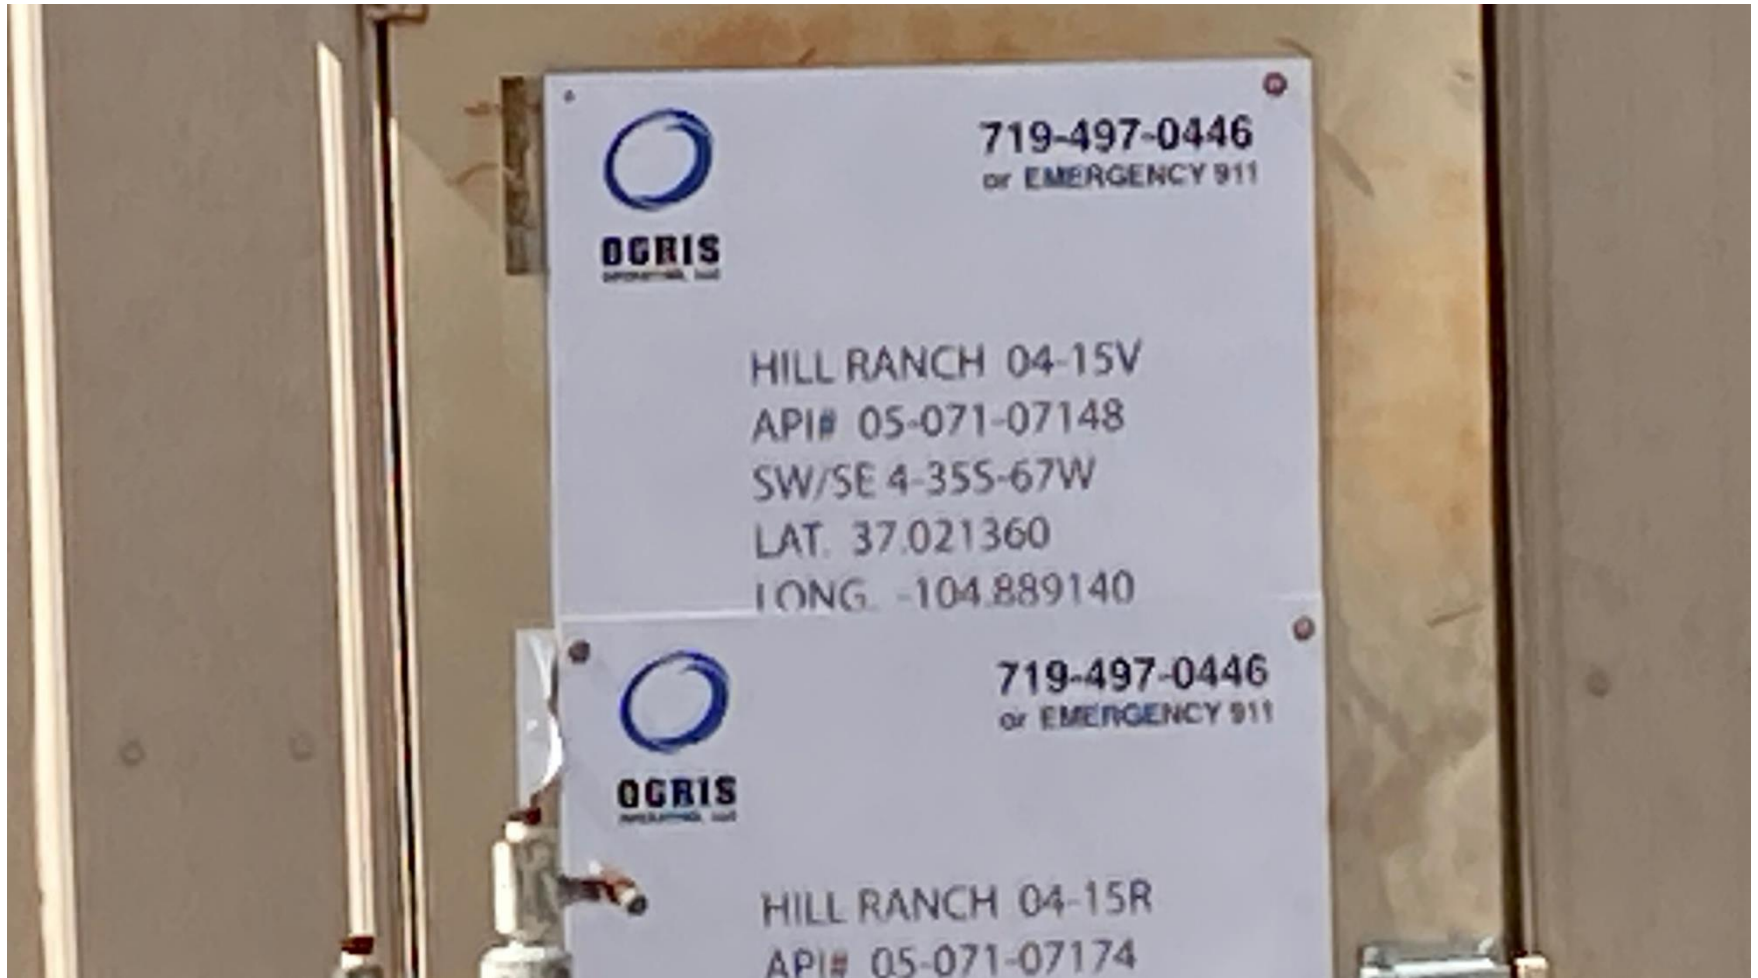
PHOTO 1: WELL SIGN

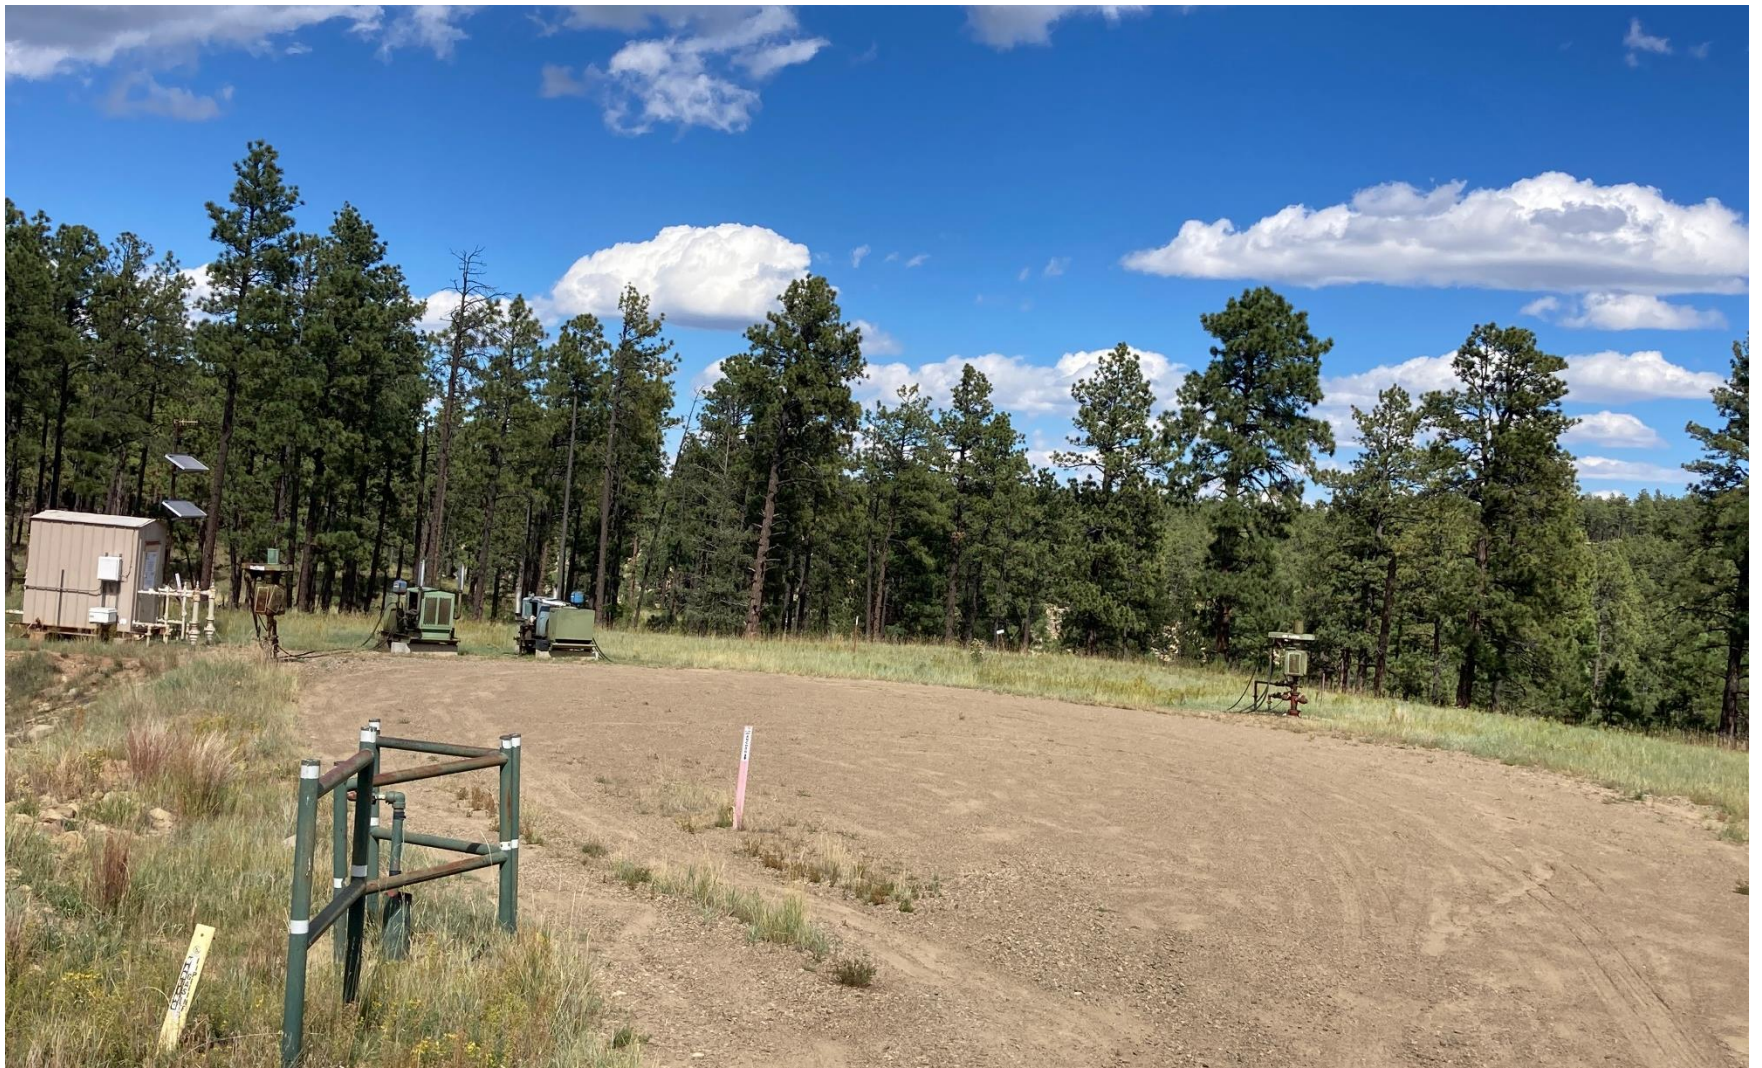
**PHOTO 2: LOCATION**

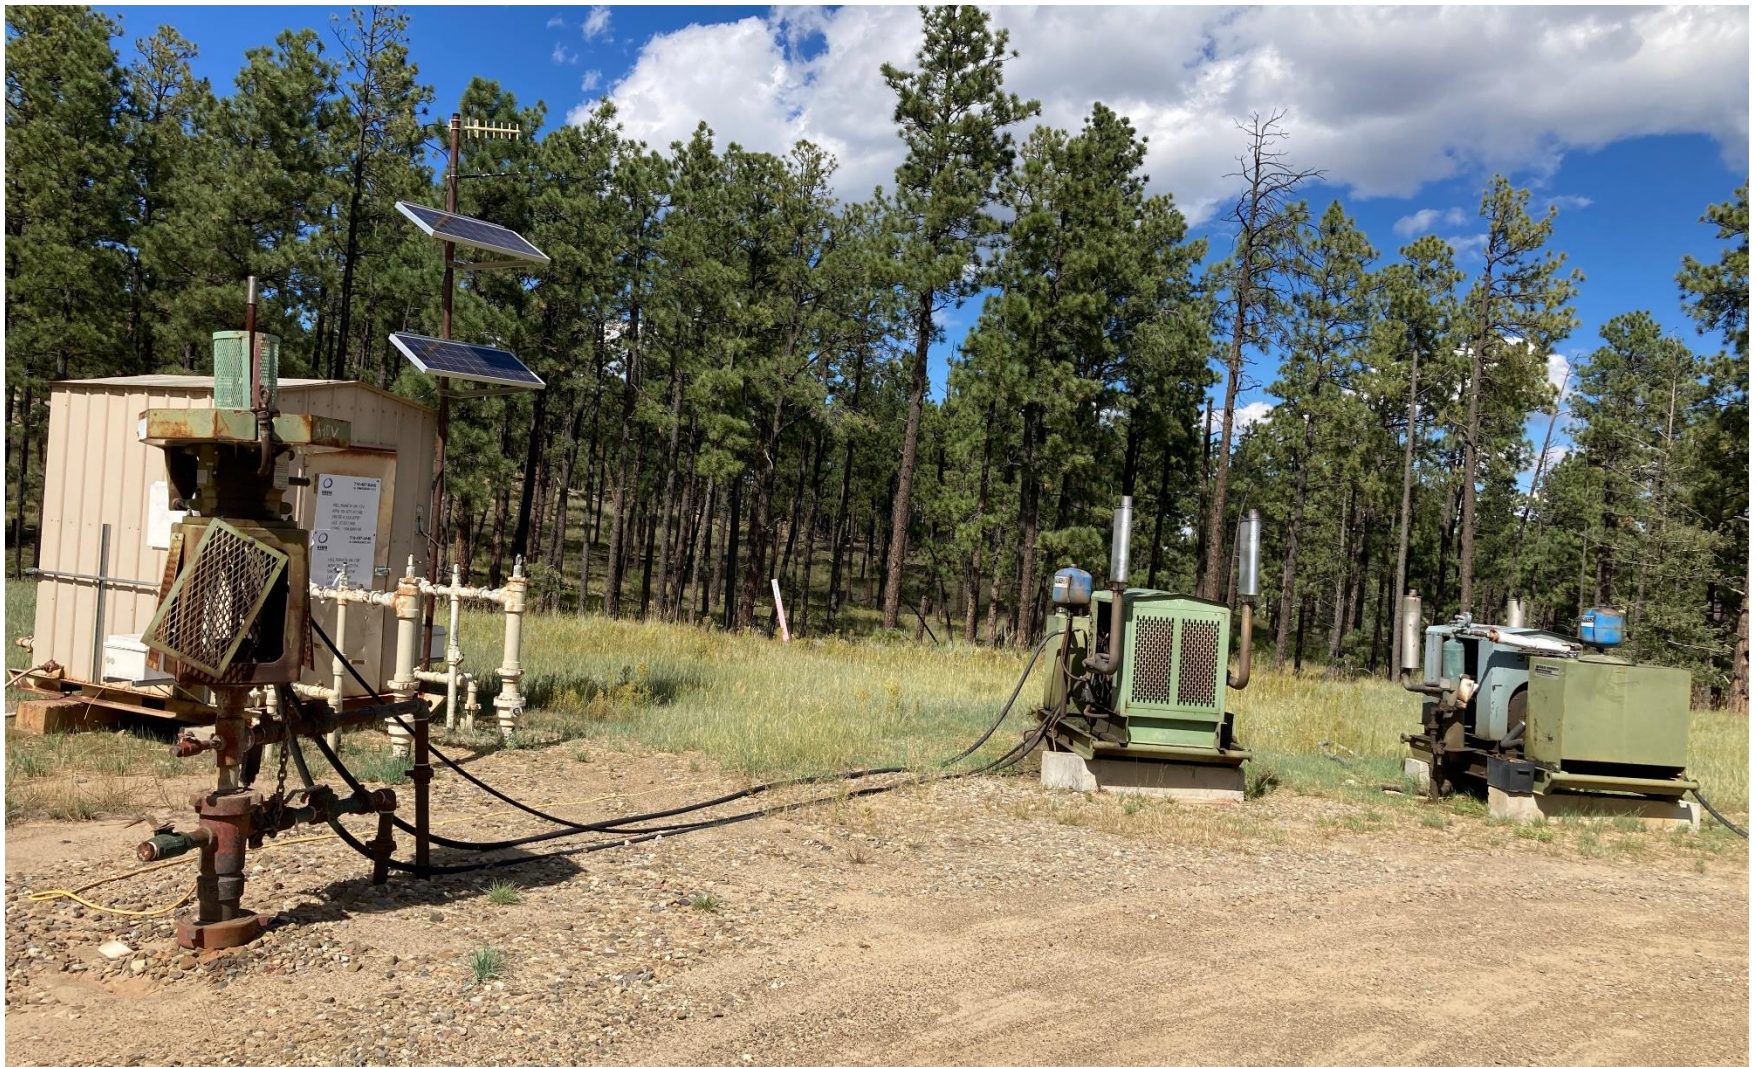
**PHOTO 3: V WELLHEAD AND EQUIPMENT**

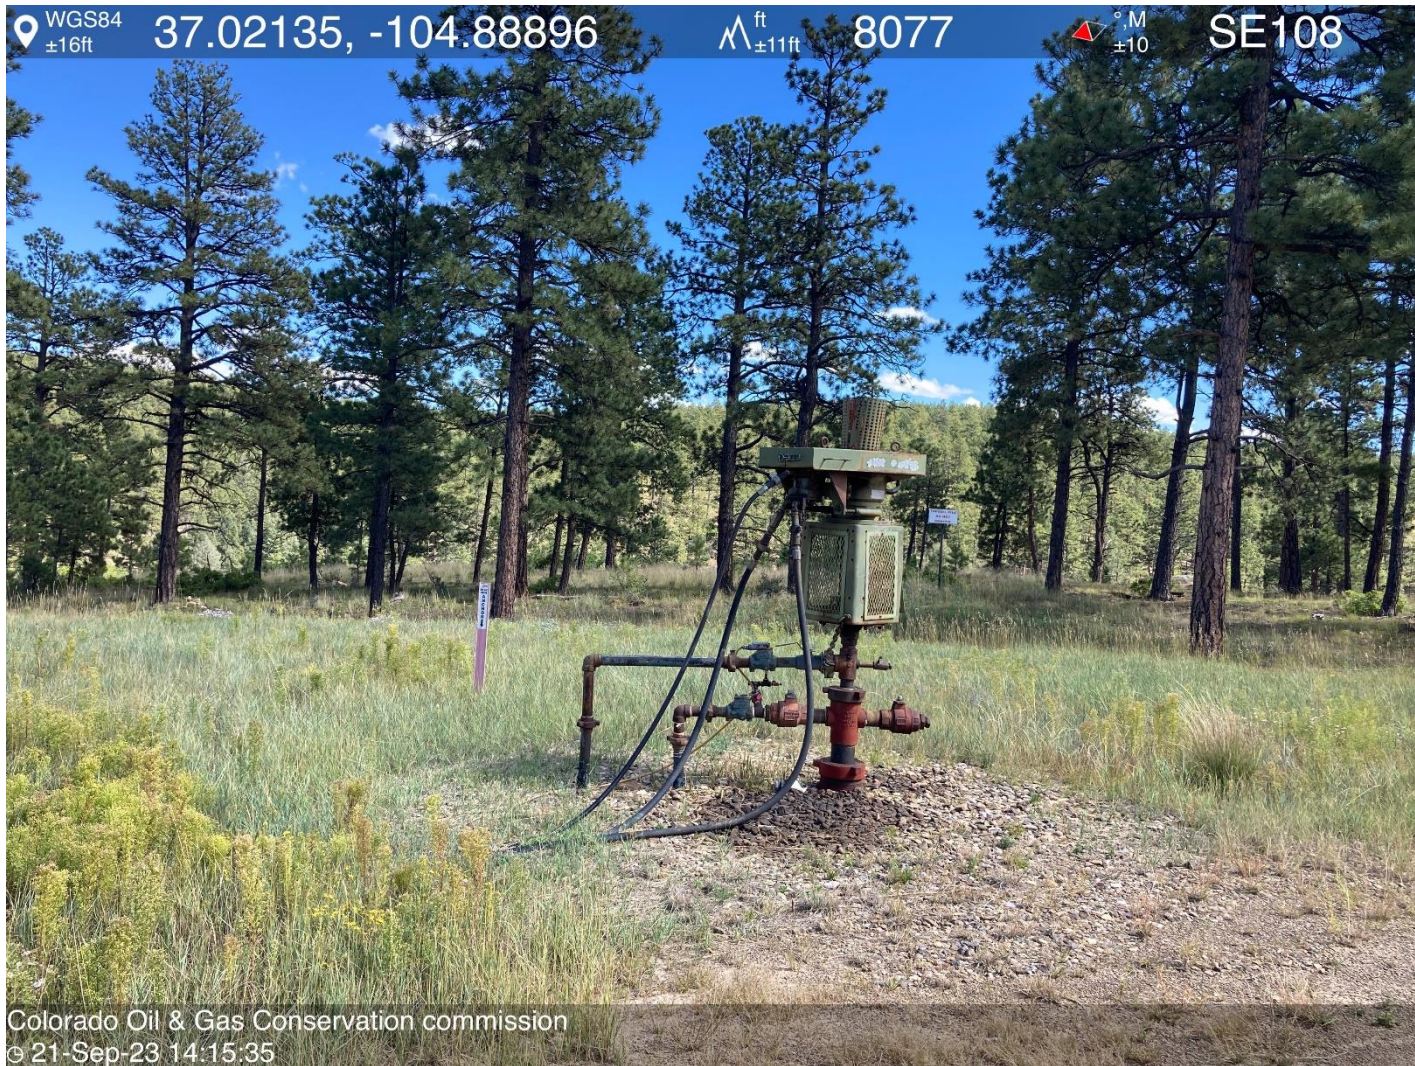
**PHOTO 4: WELLHEAD/ AREA OF IMPACTED SOIL NEAR R WELLHEAD APPEARS TO BE FROM LEAKING HYDRO HOSES IN THE PAST, HOSED DID NOT APPEAR TO BE LEAKING AT TIME OF INSPECTION. Conduct maintenance on equipment, cleanup stained material and review self inspection processes. COMPLY WITH RULE 1002,(2).D (BE SURE TO INSPECT HYDRO HOSES AND CONNECTIONS FOR ANY LEAKS AND REPAIR. CA DATE 10-26-2023.**
