Donovan Brothers Incorporated

Engineering Field Observation
August 8, 2022, between 8:45 AM and 2:30 PM
Plug and Abandon Off Location Pipeline
Livengood 7-7 flowline
Facility ID 481142
SWNE Section 7, Township 7 North, Range 59 West, 6th P.M.
Weld County, Colorado
Local access: from the intersection of County Roads 86 and 105:
East 2.5 miles, South 1.5 miles, and West 0.4 miles

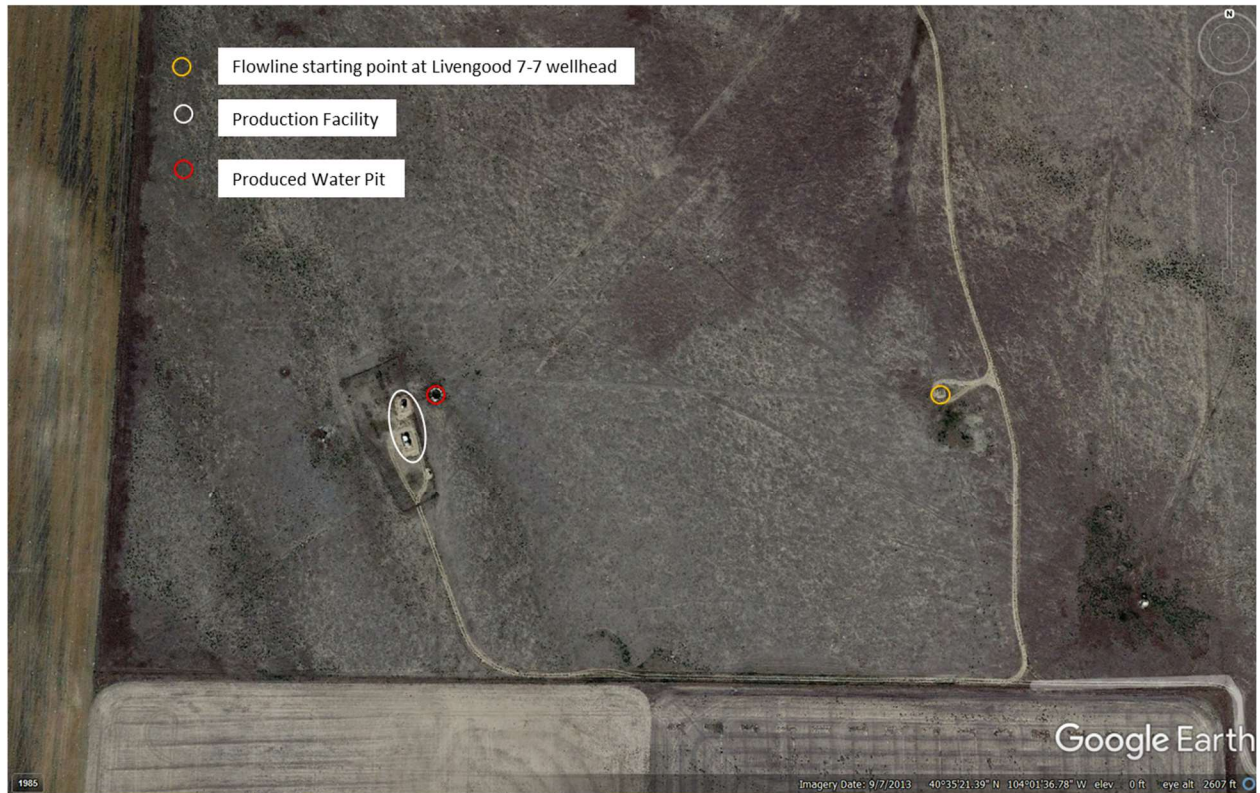
Figure 2-Aerial Photograph

The provided aerial photograph (see figure 2) shows the abandoned well location and abandoned production pad. The approximate flowline path between the abandoned well and production was visually inspected. The visual inspection of the surface from the abandoned well to the abandoned production pad was performed. Walking in a zig-zag pattern to the abandoned well from the abandoned production pad and back again showed that no surface valves or valve

boxes existed along the length of the flowline. This observation confirmed what was expected.

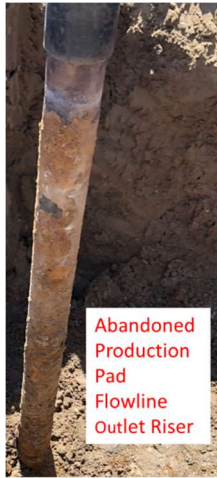
Figure 3- The Abandoned Production Pad Flowline Outlet Riser

At approximately 10:45 AM, the abandoned production pad flowline outlet riser to the west (see figure 3) was observed to be evacuated and opened to the atmosphere. At approximately 11:50 AM, the abandoned production pad flowline outlet riser was detached. Then the evacuated and opened to the atmosphere abandoned production pad flowline outlet stub was cemented (see figure 4).

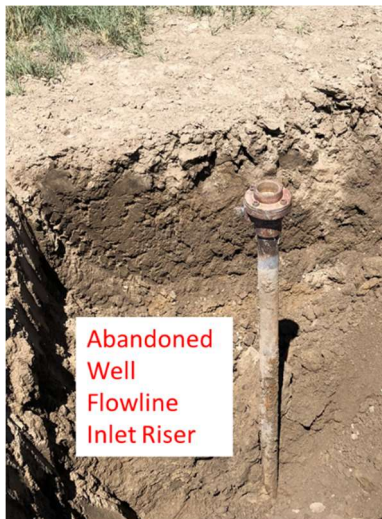
Figure 5- The Abandoned Well Flowline Inlet Riser

At approximately 2:00 PM, the abandoned well flowline inlet riser to the east (see figure 5) was observed to be evacuated and opened to the atmosphere. At approximately 2:15 PM, the abandoned well flowline inlet riser was detached. Then the evacuated and opened to the atmosphere abandoned well flowline inlet stub was cemented. (see figure 6)
