Construction and Stormwater Inspection

Operator: MDS ENERGY DEVELOPMENT - 10814

Location ID: 471039

Inspection Document #: 708200568

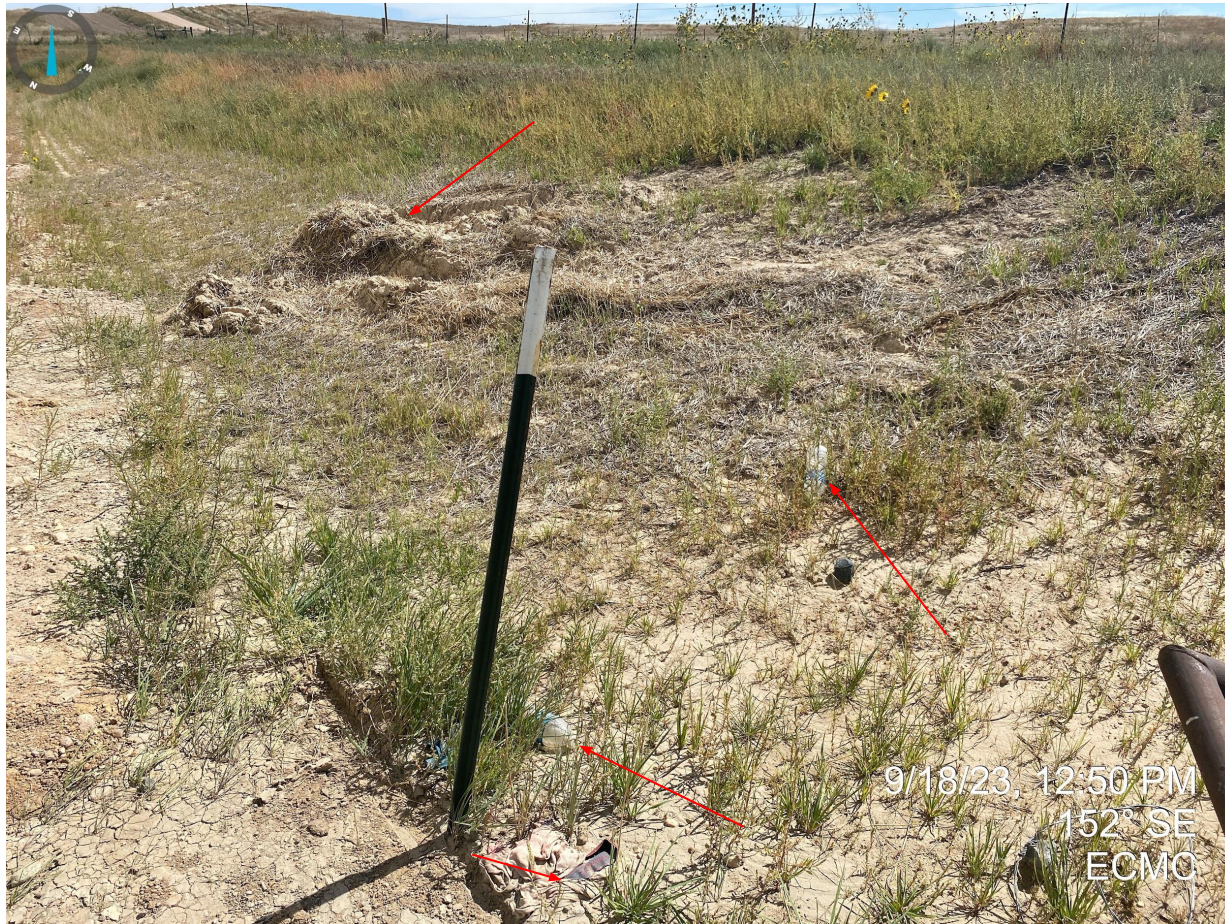
Photo 1. Taken near the location entrance. Photo illustrates trash and unstabilized soils (e.g. not consolidated) on the slopes of the location.

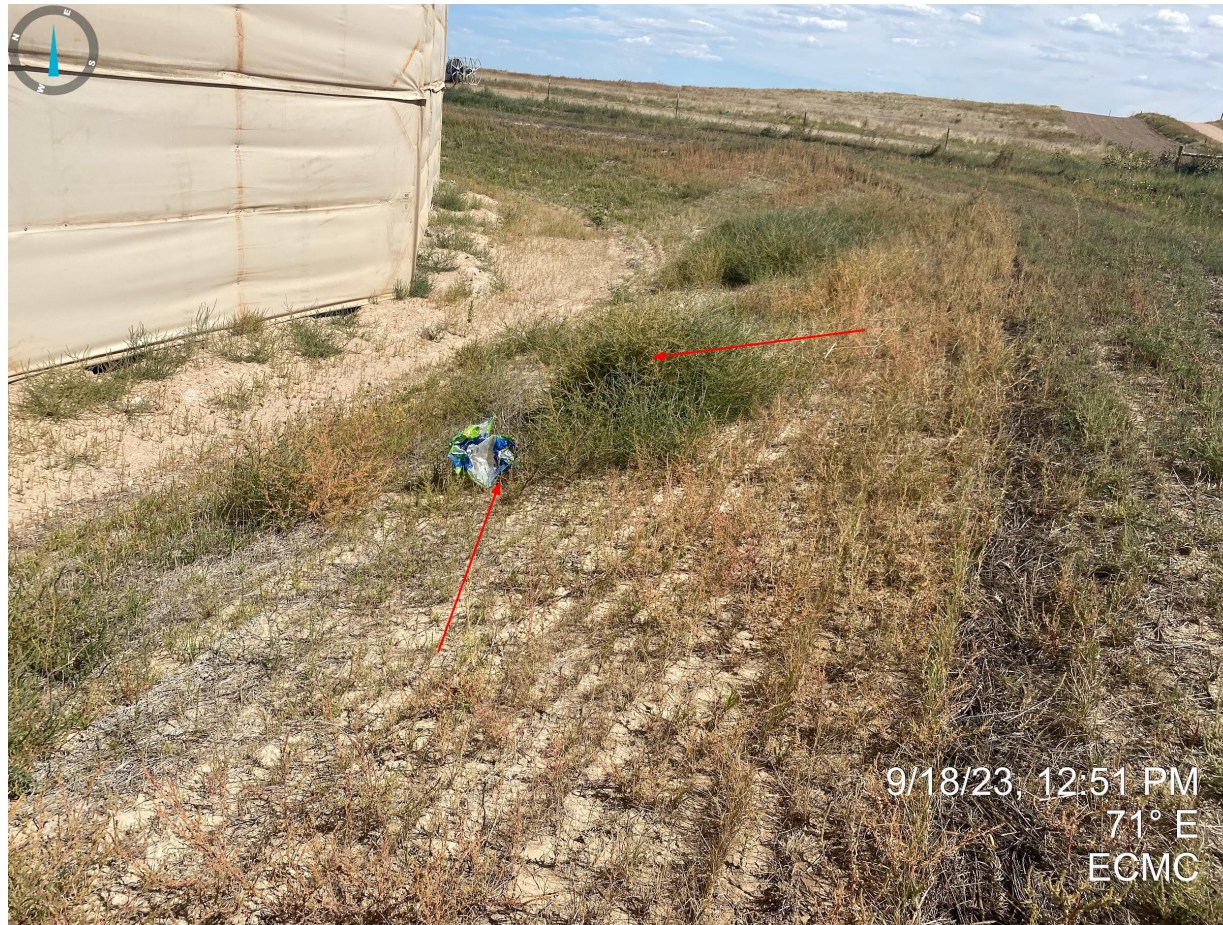
Photo 2. Taken on the south side of the location. Trash and undesirable vegetation observed outside of the active drilling operations.

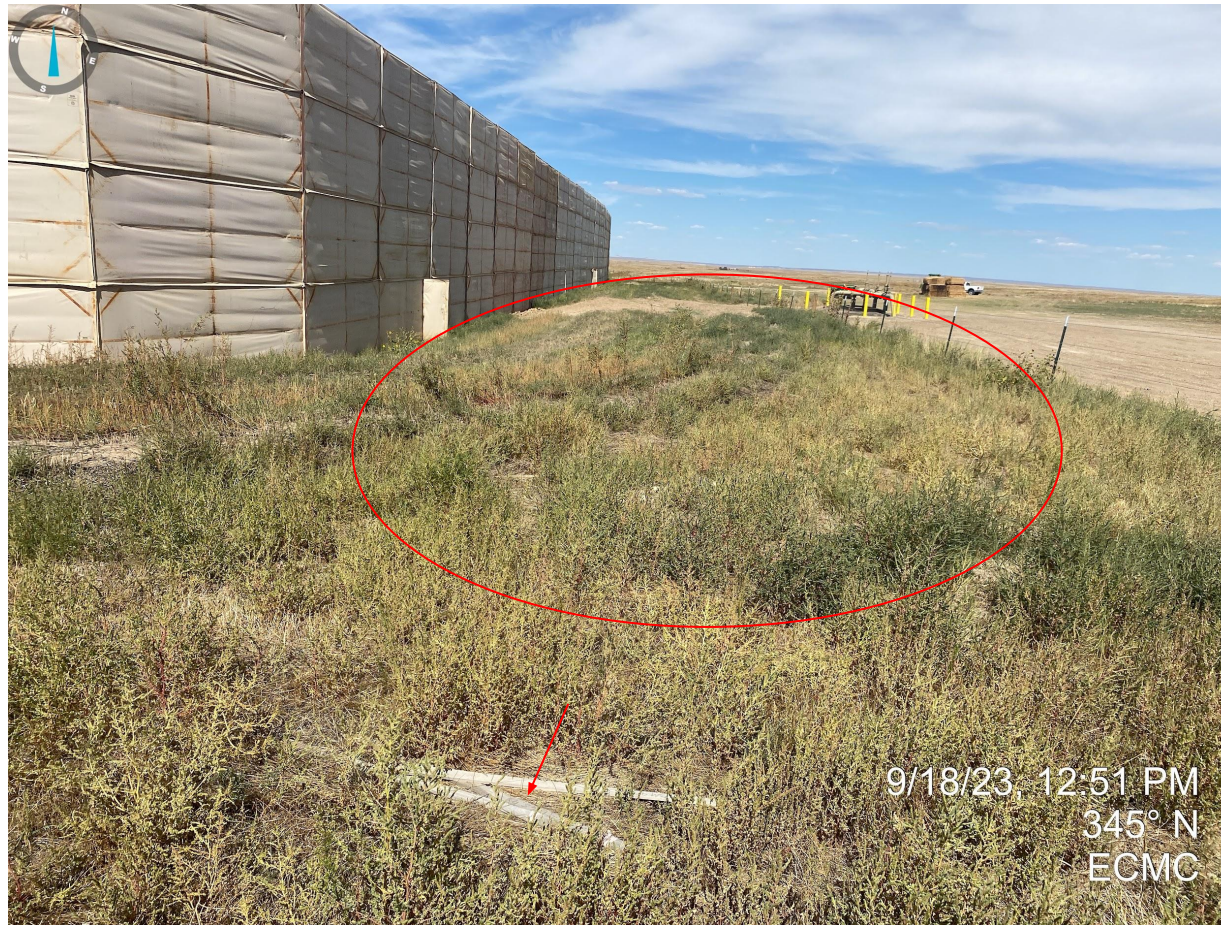
Photo 3. Taken from the southeast corner of the location. Trash/debris and the presence of undesirable vegetation (e.g. russian thistle and kochia) was observed throughout the location.

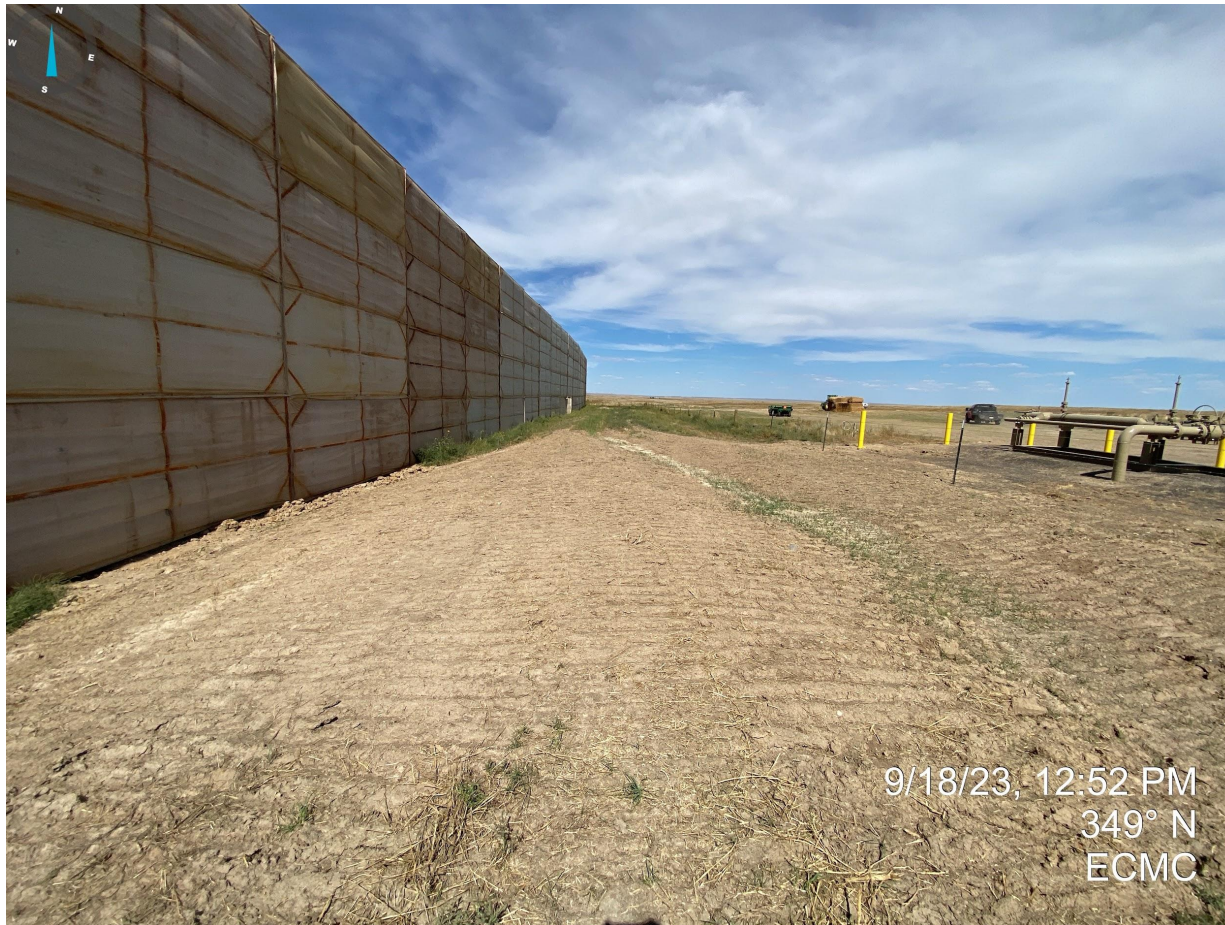
Photo 4. Taken near the east side of the location. Unstabilized soils were observed in the vicinity of midstream pipeline. The bare/exposed soils will need to be properly stabilized both temporarily (before interim reclamation activities) and also for long term stabilization to prevent wind and water erosion degradation.

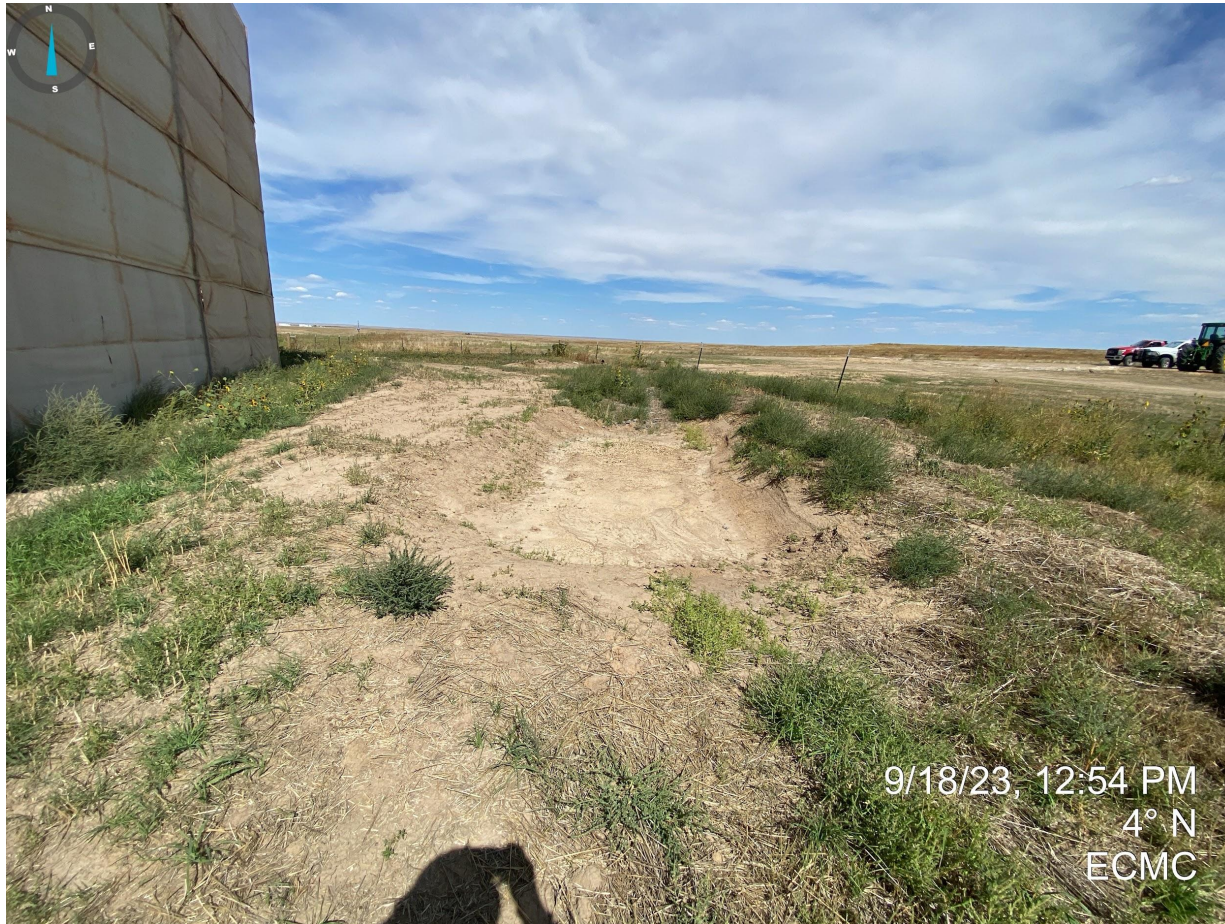
Photo 5. Taken on the east side of the location. Undesirable vegetation observed to be growing throughout the location.

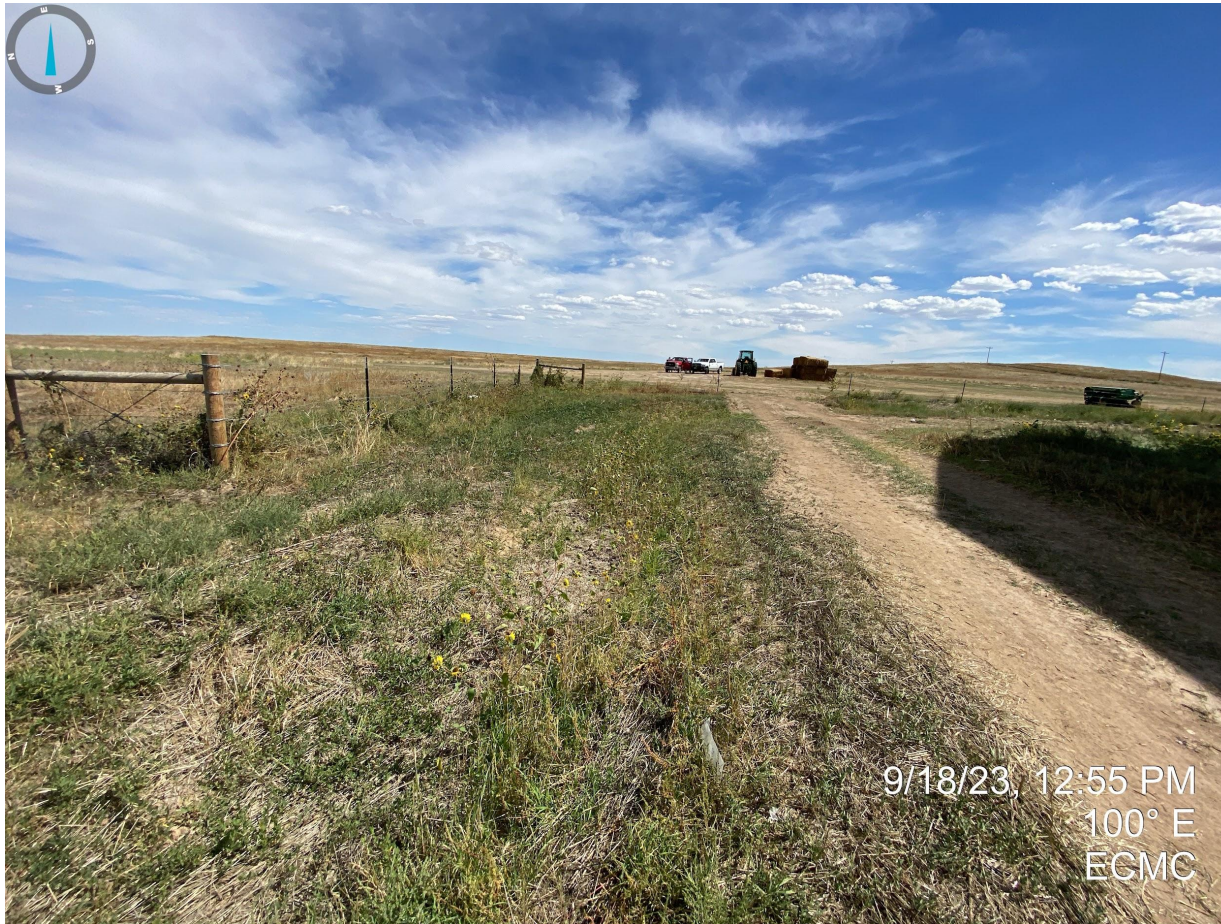
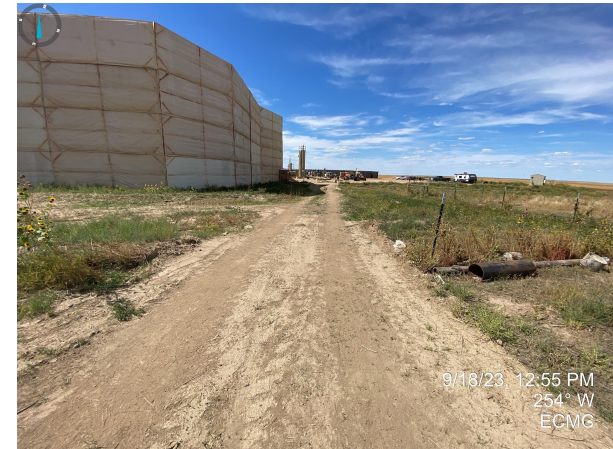
Photo 6 & 7. Taken from the east side of the location. It appears a new access road has been created in connection with midstream operations. This access road portion on the location shall be properly reclaimed in accordance with 1000 series rules.

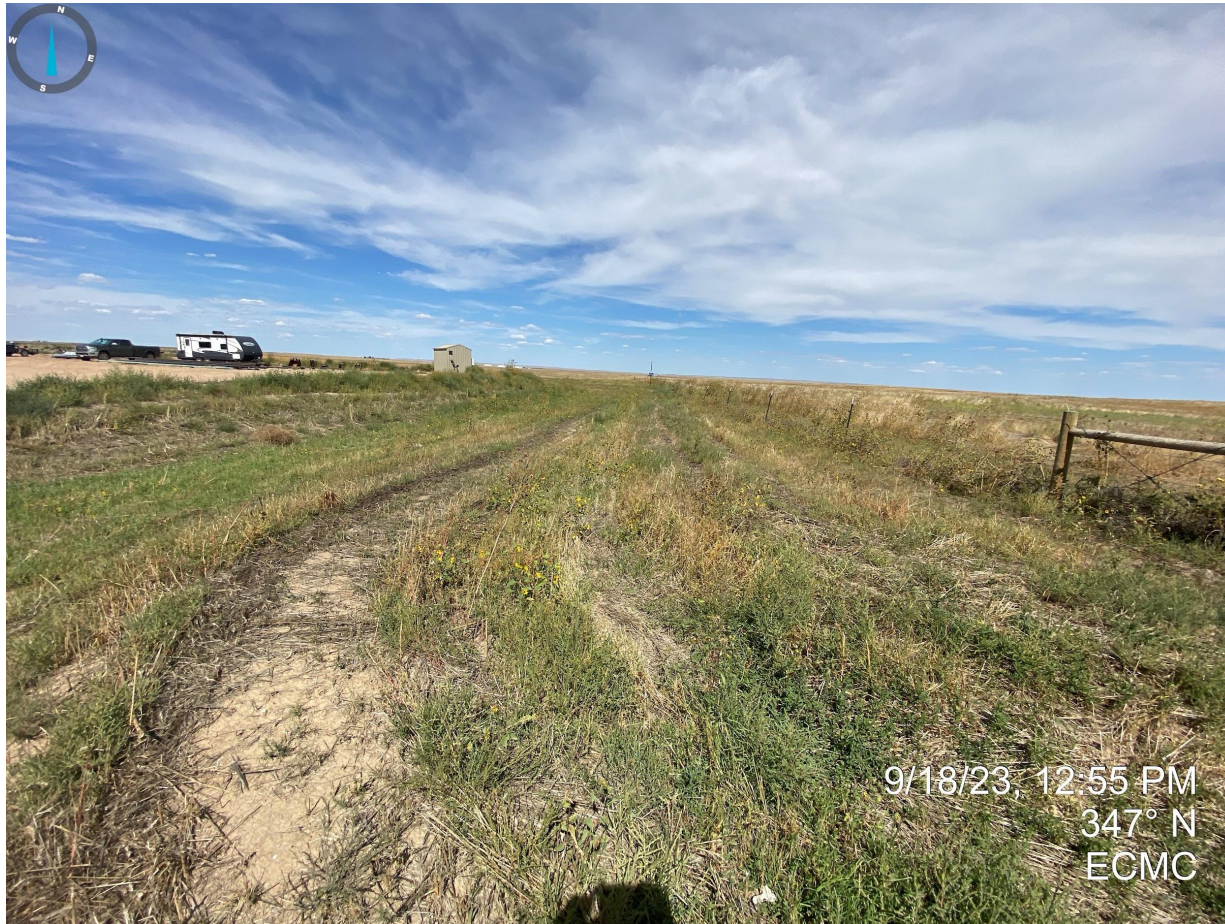
Photo 8. Taken from the east side of the location. Photo illustrates that areas not needed for active drilling do not comply with Rule 1002.c. with evidence of undesirable vegetation (e.g. russian thistle and kochia).

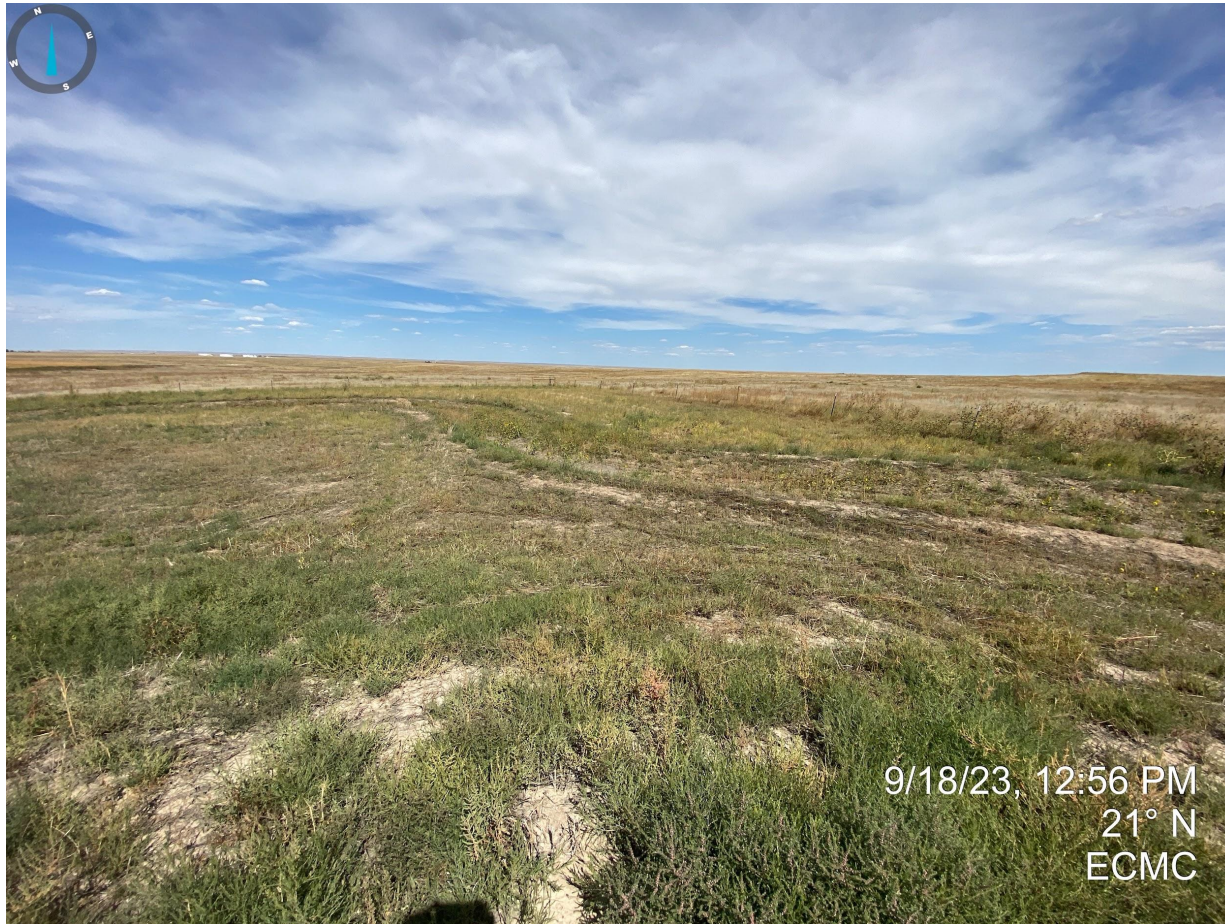
Photo 9. Taken near the northeast side of the location. Photo illustrates that areas not needed for active drilling do not comply with Rule 1002.c. with evidence of undesirable vegetation (e.g. russian thistle and kochia).

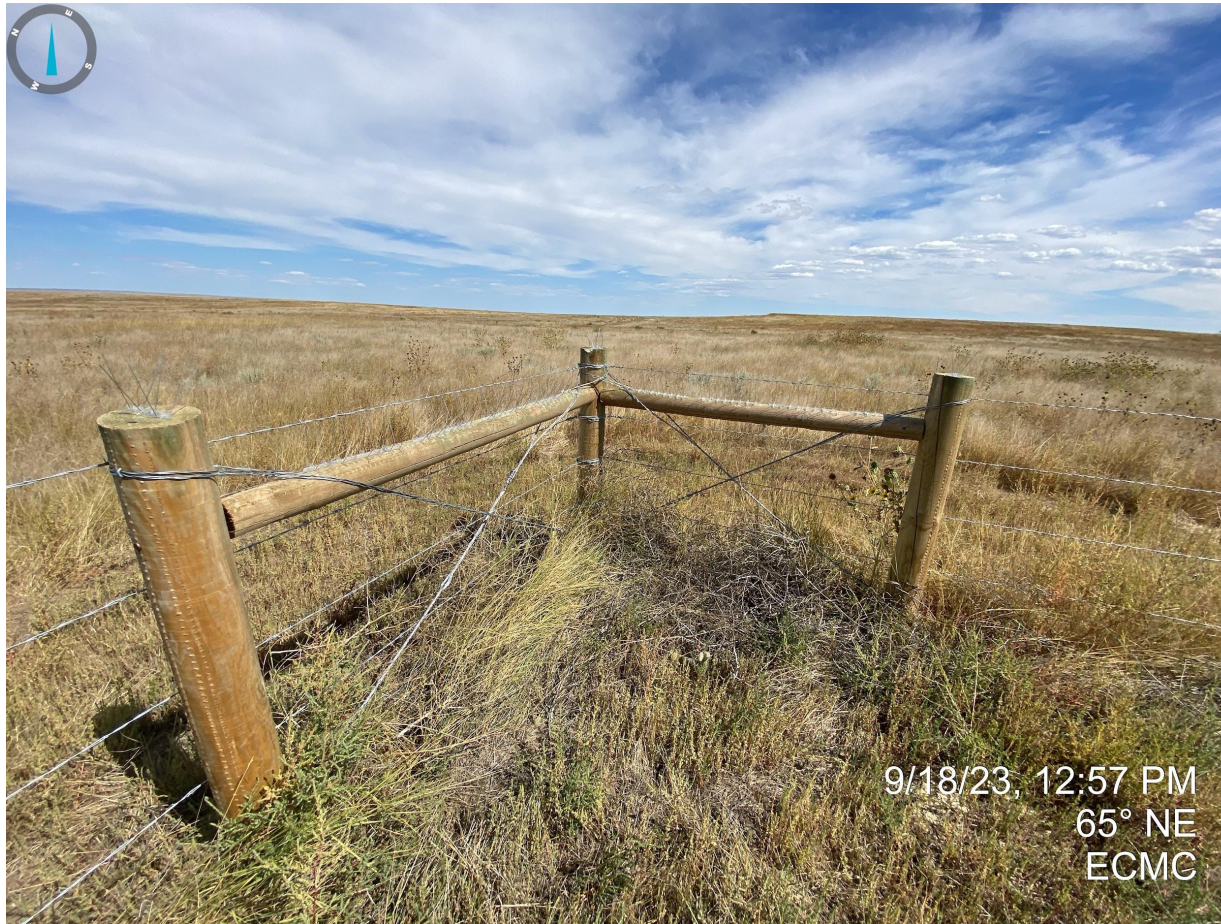
Photo 10. Taken from the northeast corner of the location. Photo illustrates that the Operator has installed raptor perch deterrents on fence post, in compliance with Wildlife BMP/COA in the approved Form 2A. Maintenance is advised on these devices to ensure they are in proper working order.

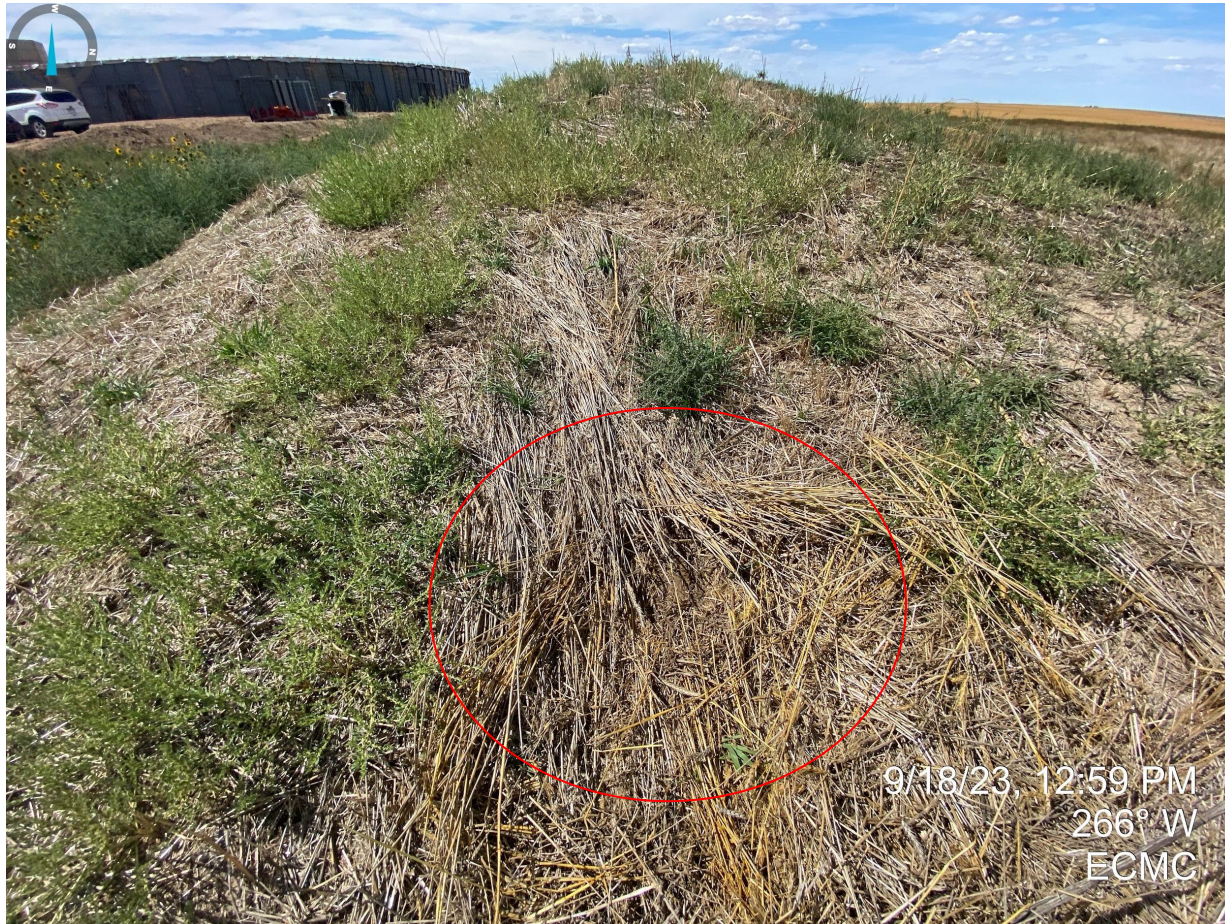
Photo 11. Taken from the east side of the topsoil stockpile. Photo illustrates that the stockpile is not in compliance with Rule 1002.c as undesirable weedy vegetation (e.g. russian thistle and kochia) was observed to be growing throughout. Additionally, straw mulch was several inches thick in areas and is possibly preventing germination of desirable vegetation.

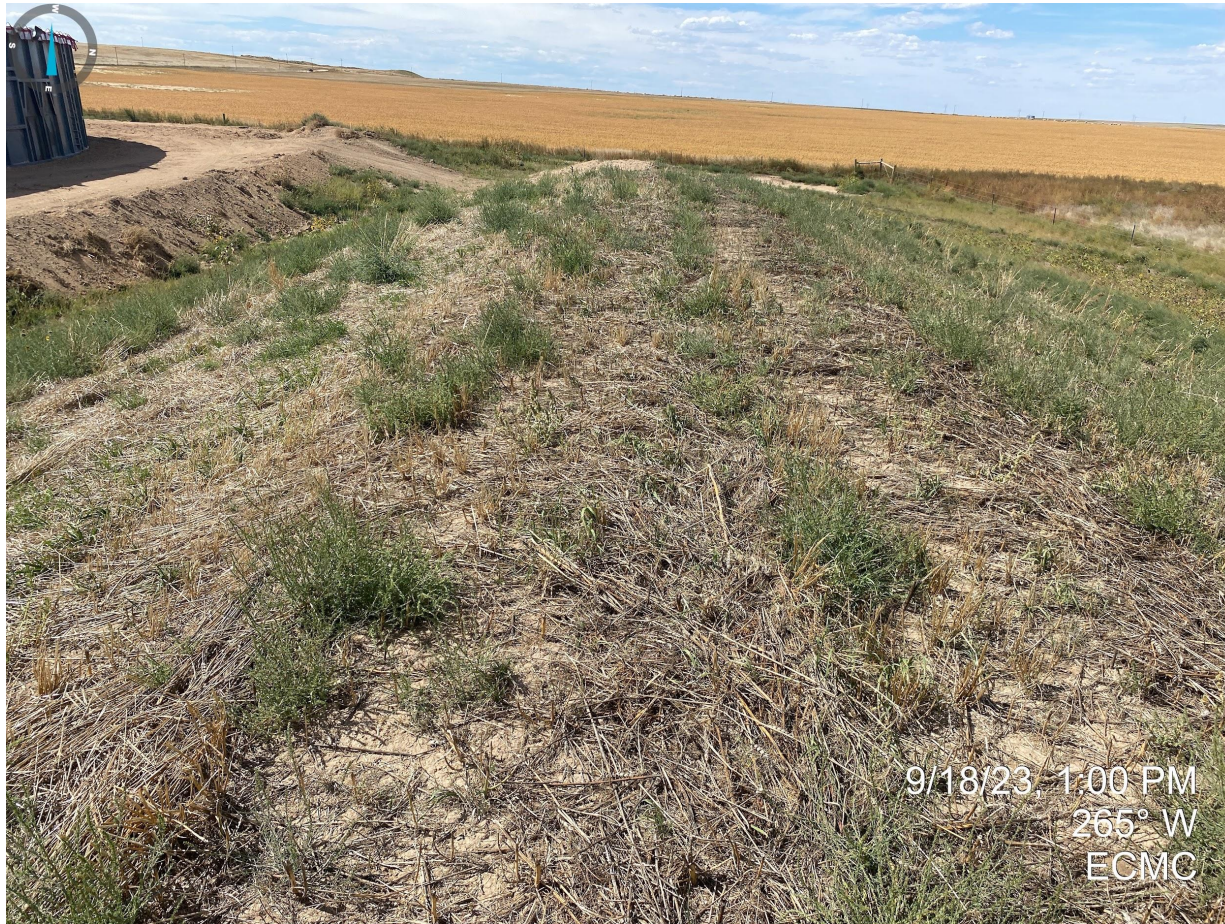
Photo 12. Facing west from the center portion of the topsoil stockpile. See comments in Photo 11.

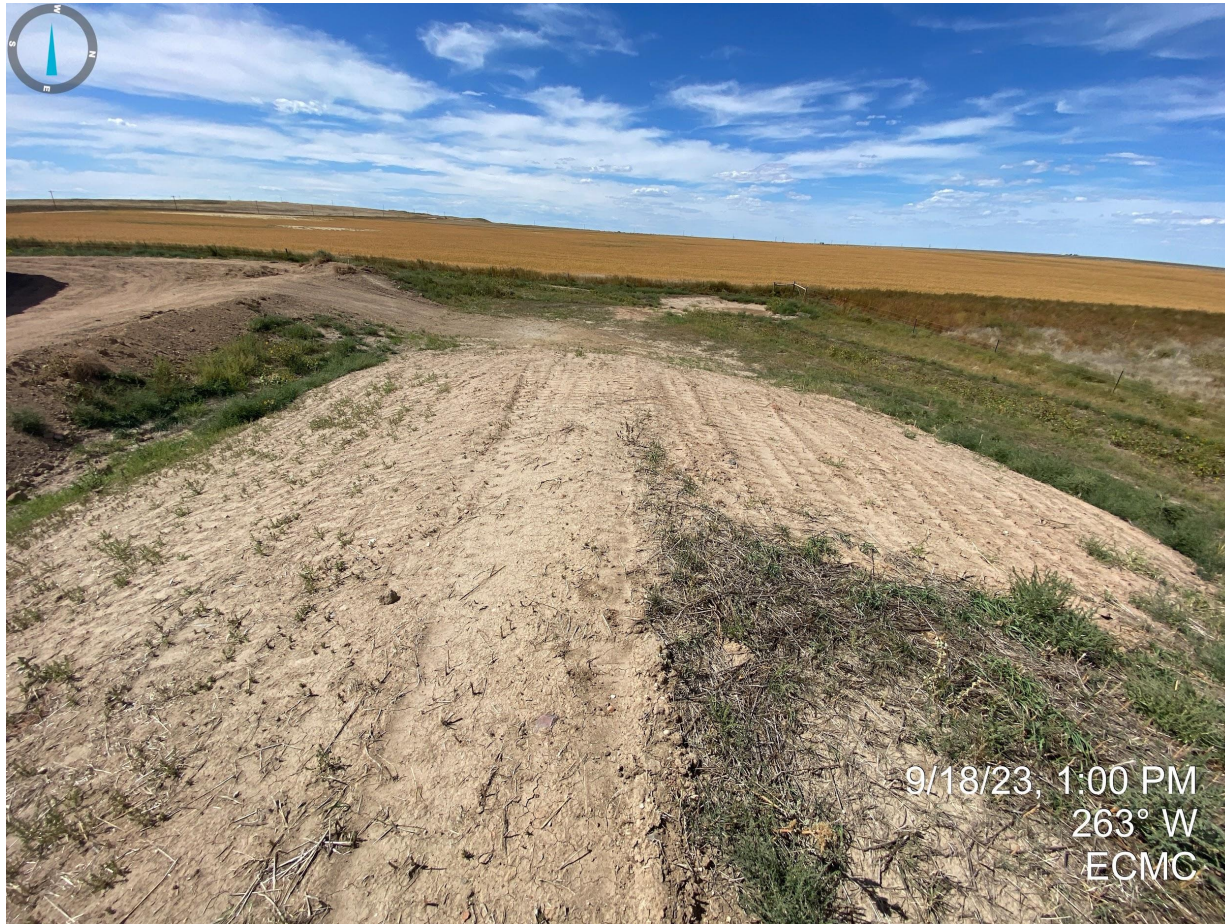
Photo 13. Taken from the western portion of the topsoil stockpile. Photo illustrates that the topsoil stockpile is not properly stabilized with evidence of bare/exposed soils.

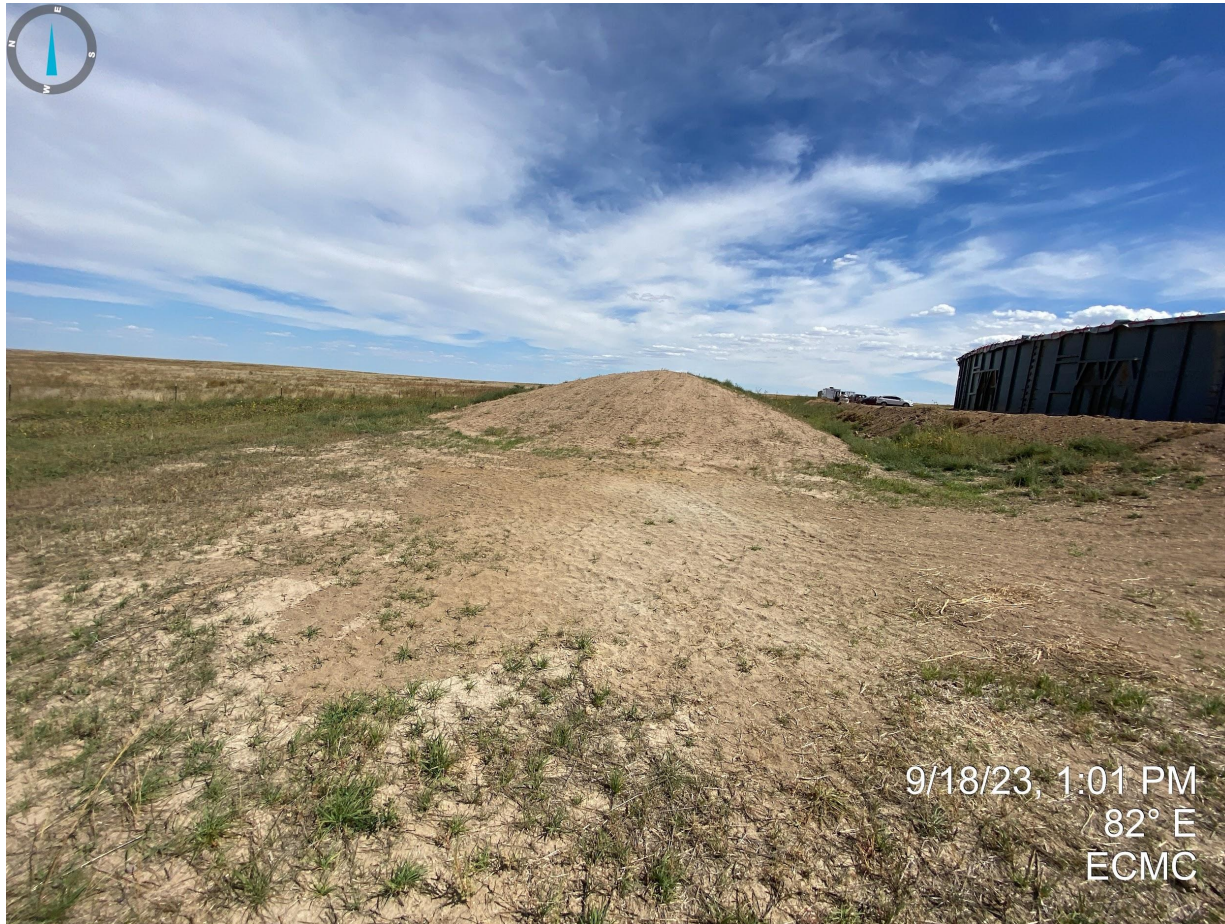
Photo 14. Taken west of the topsoil stockpile. Photo illustrates that the topsoil is not properly stabilized (e.g. exposed soils) and there are no apparent stormwater control measures/BMPs observed to prevent topsoil from erosion degradation and exiting off into the sediment trap (outside of frame to the left in photo).

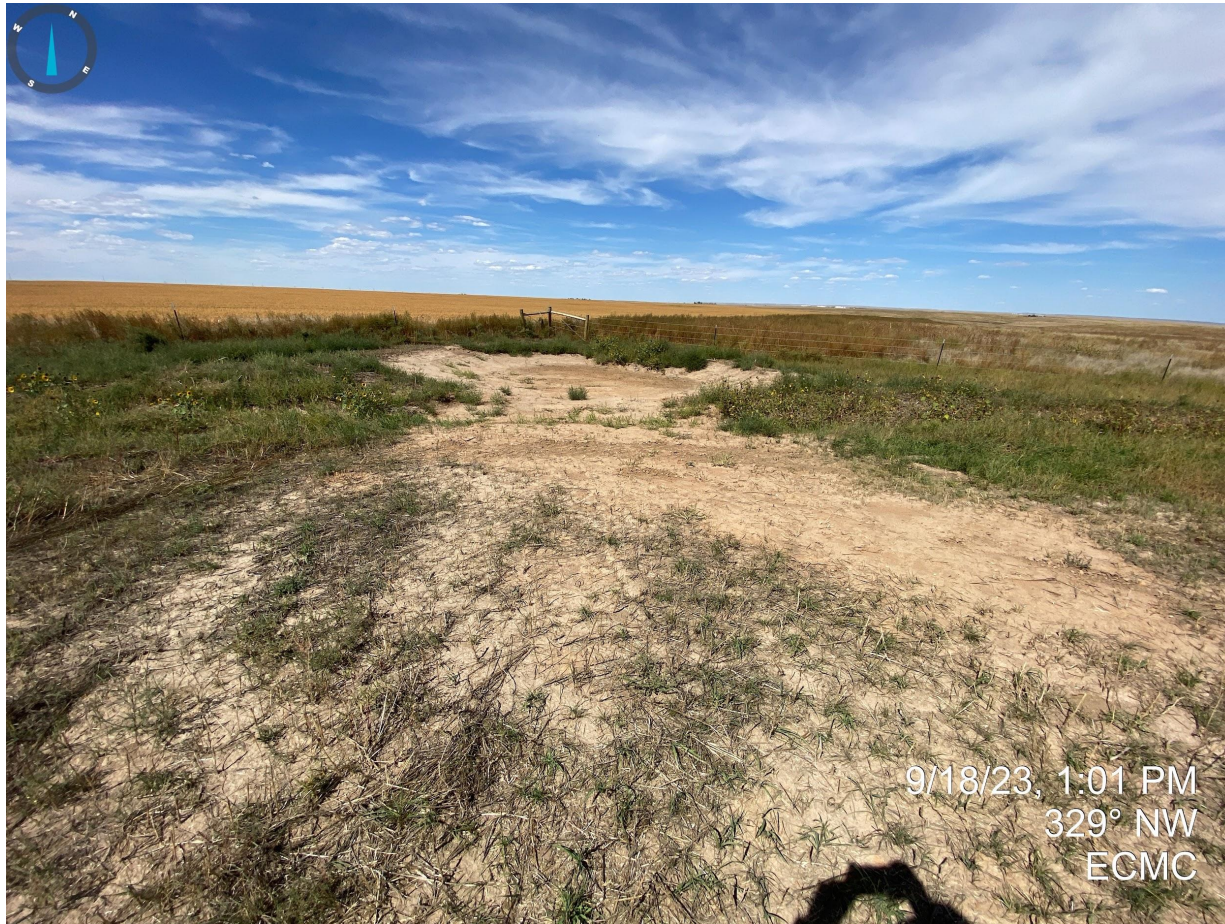
Photo 15. Facing towards the northwest corner of the location. Previous inspections documented that the sediment trap pictured here appeared to be inadequate in size to control stormwater from a location of this size. Previous corrective actions required the Operator to repair/install adequate stormwater control measures; nothing appears to have been completed as of this inspection.

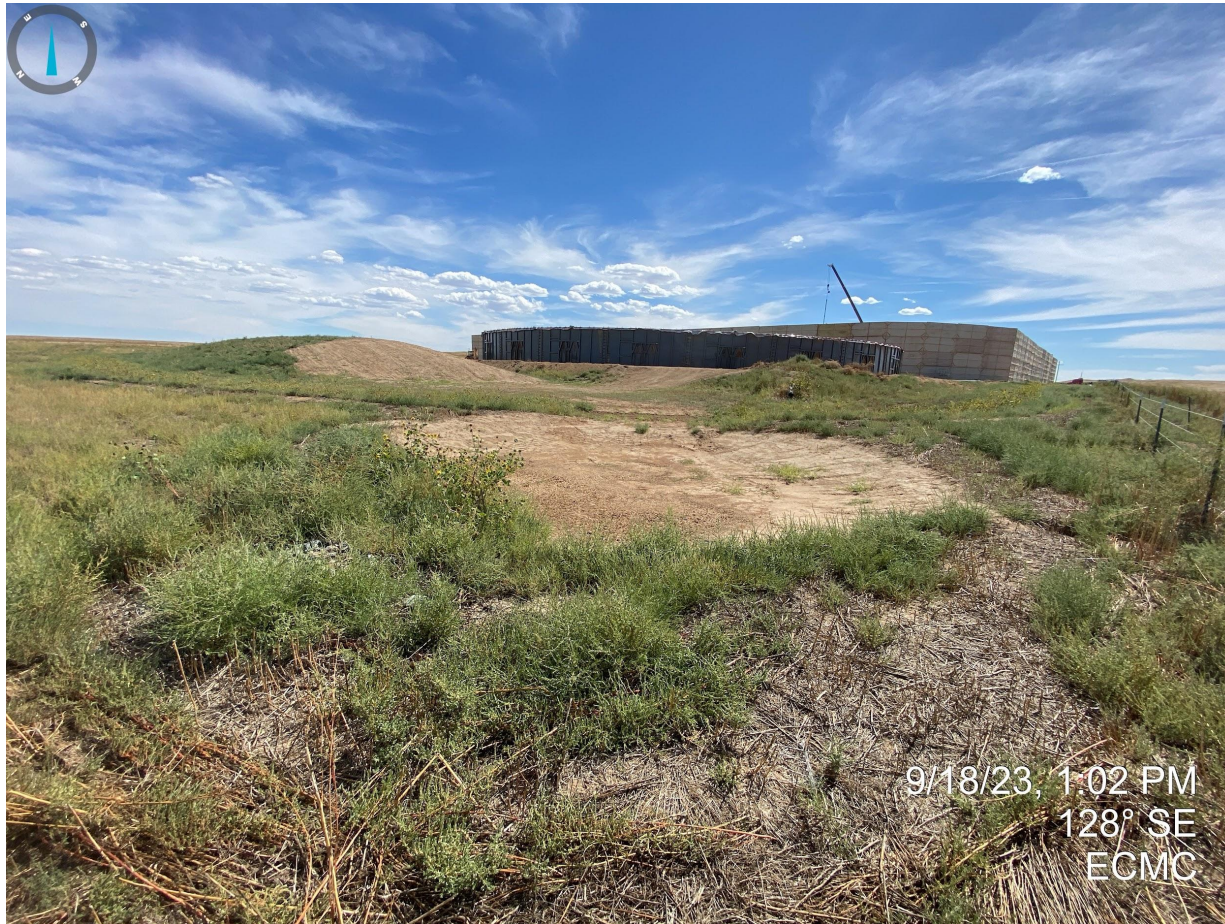
Photo 16. Taken from the northwest corner of the location; see comments in Photo 15.

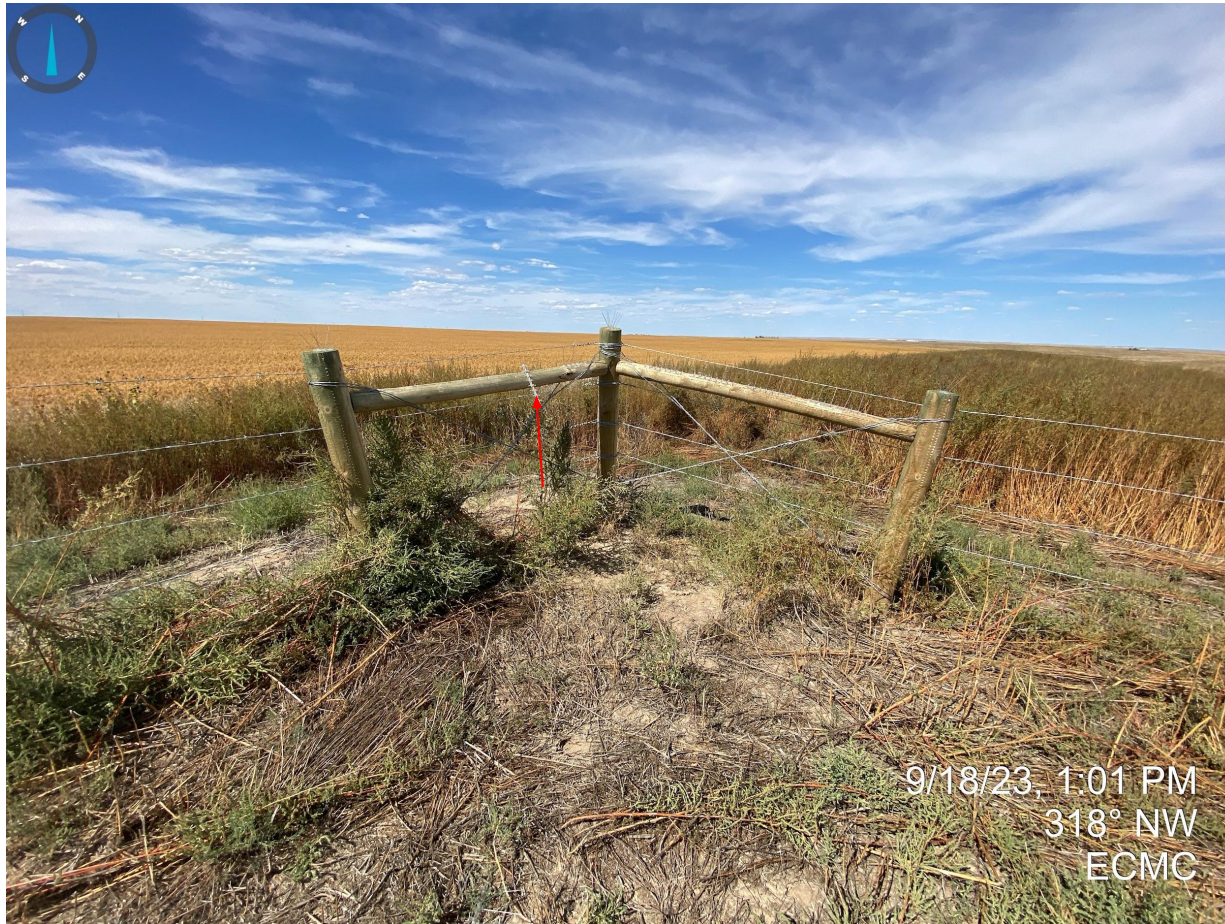
Photo 17. Taken from the northwest corner of the location. Raptor perch deterrents require maintenance.

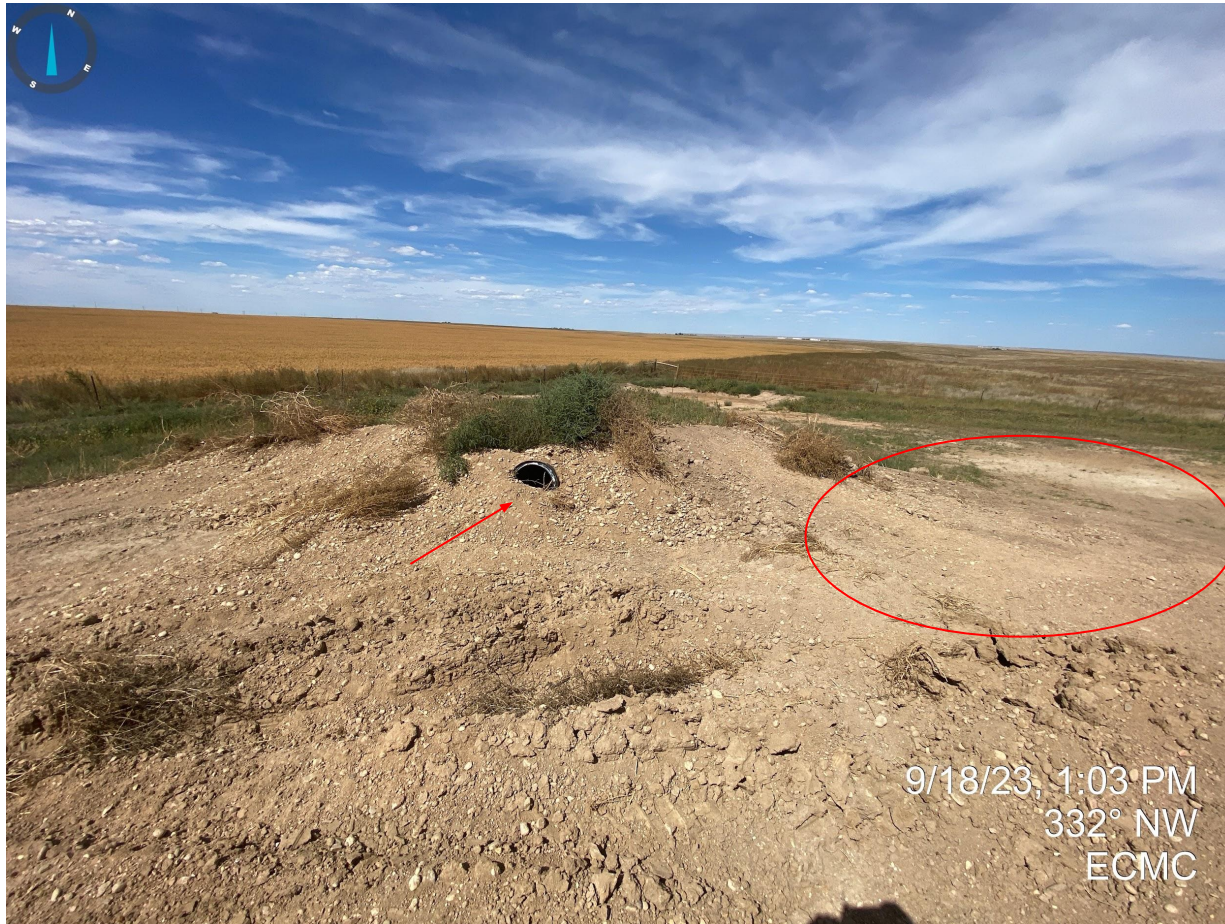
Photo 18. Taken near the northwest corner of the production areas. Stormwater control measures are partially buried and do not appear to be in properly functioning; no perimeter berm or other control measures observed right of the culvert (red circle).

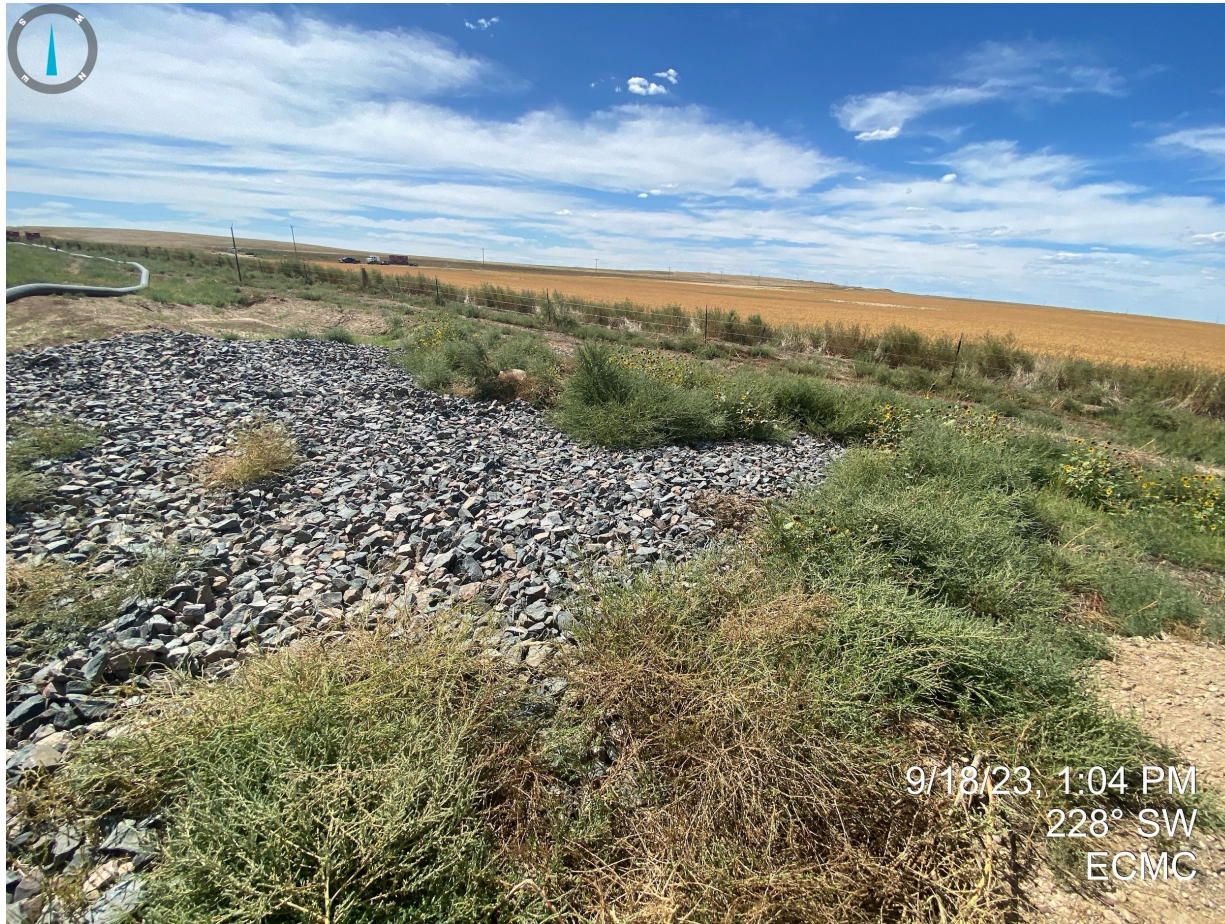
Photo 19. Taken from the west side of the location. Photo illustrates that areas not needed for active drilling do not comply with Rule 1002.c. with evidence of undesirable vegetation (e.g. russian thistle and kochia).

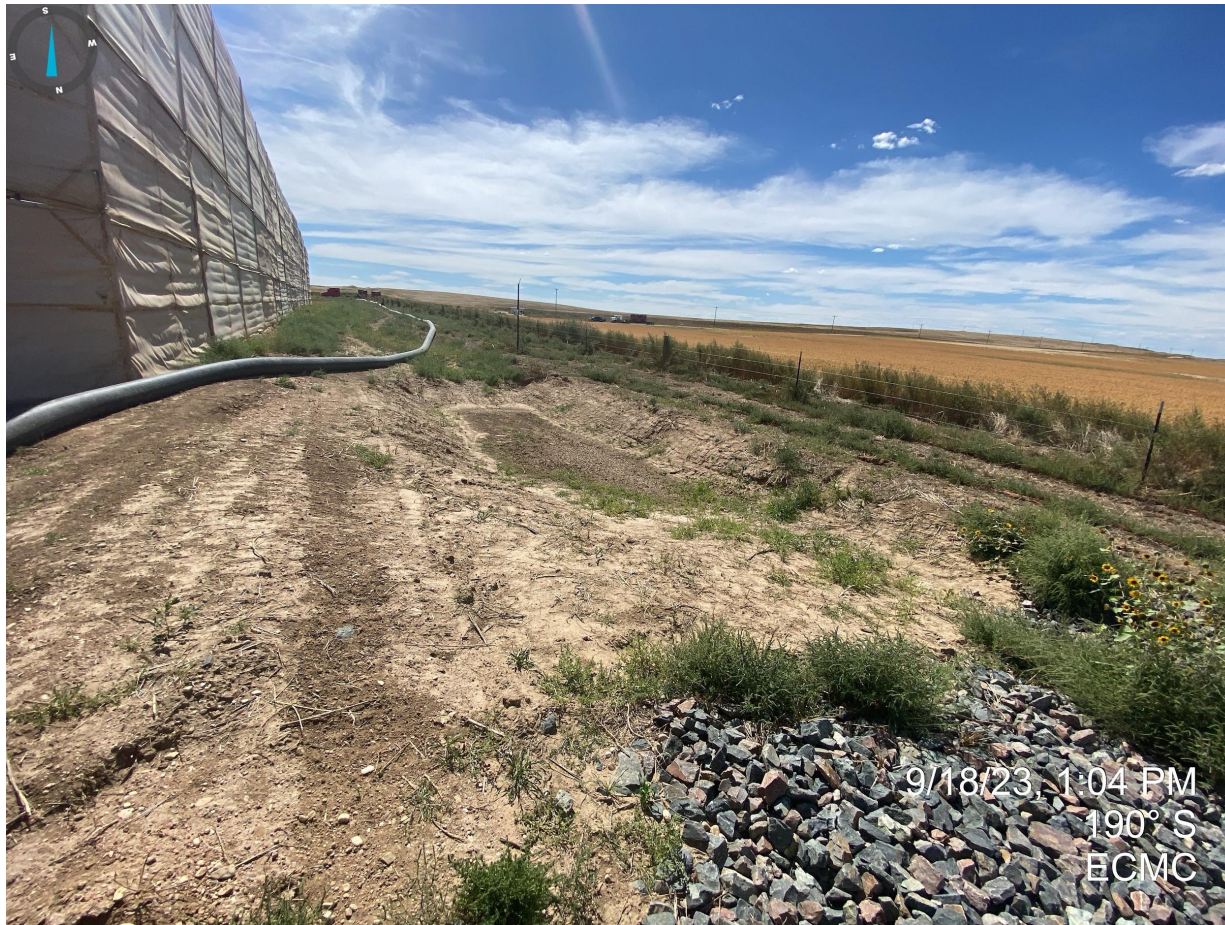
Photo 20. Taken from the west side of the location. Photo illustrates that areas not needed for active drilling do not comply with Rule 1002.c. with evidence of undesirable vegetation (e.g. russian thistle and kochia) and bare/exposed soils.
