Construction and Stormwater Inspection

Operator: MDS ENERGY DEVELOPMENT - 10814

Location ID: 471039

Inspection Document #: 708200568

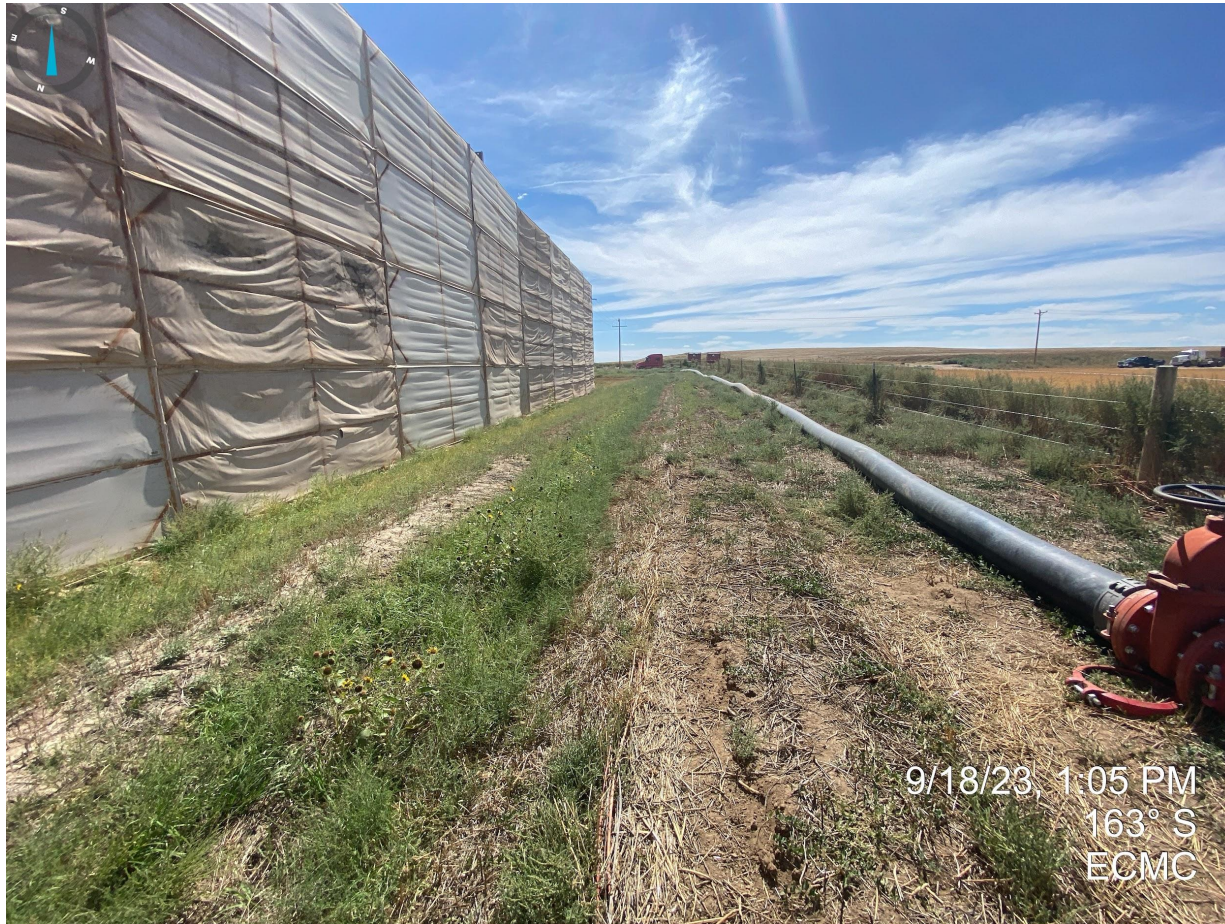
Photo 21. Taken from the west side of the location. Photo illustrates that areas not needed for active drilling do not comply with Rule 1002.c. with evidence of undesirable vegetation (e.g. russian thistle and kochia).

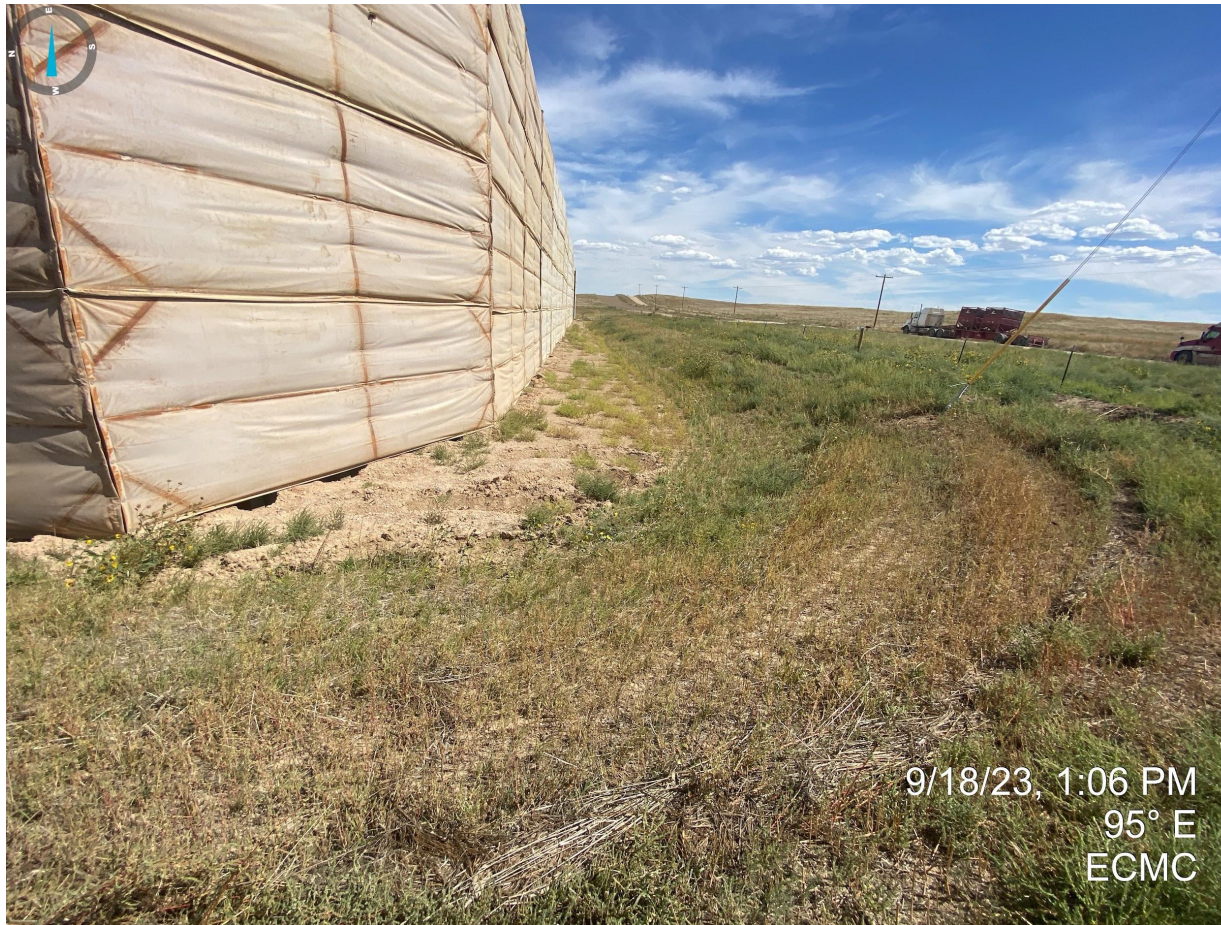
Photo 22. Taken from the west side of the location. Photo illustrates that areas not needed for active drilling do not comply with Rule 1002.c. with evidence of undesirable vegetation (e.g. russian thistle and kochia).

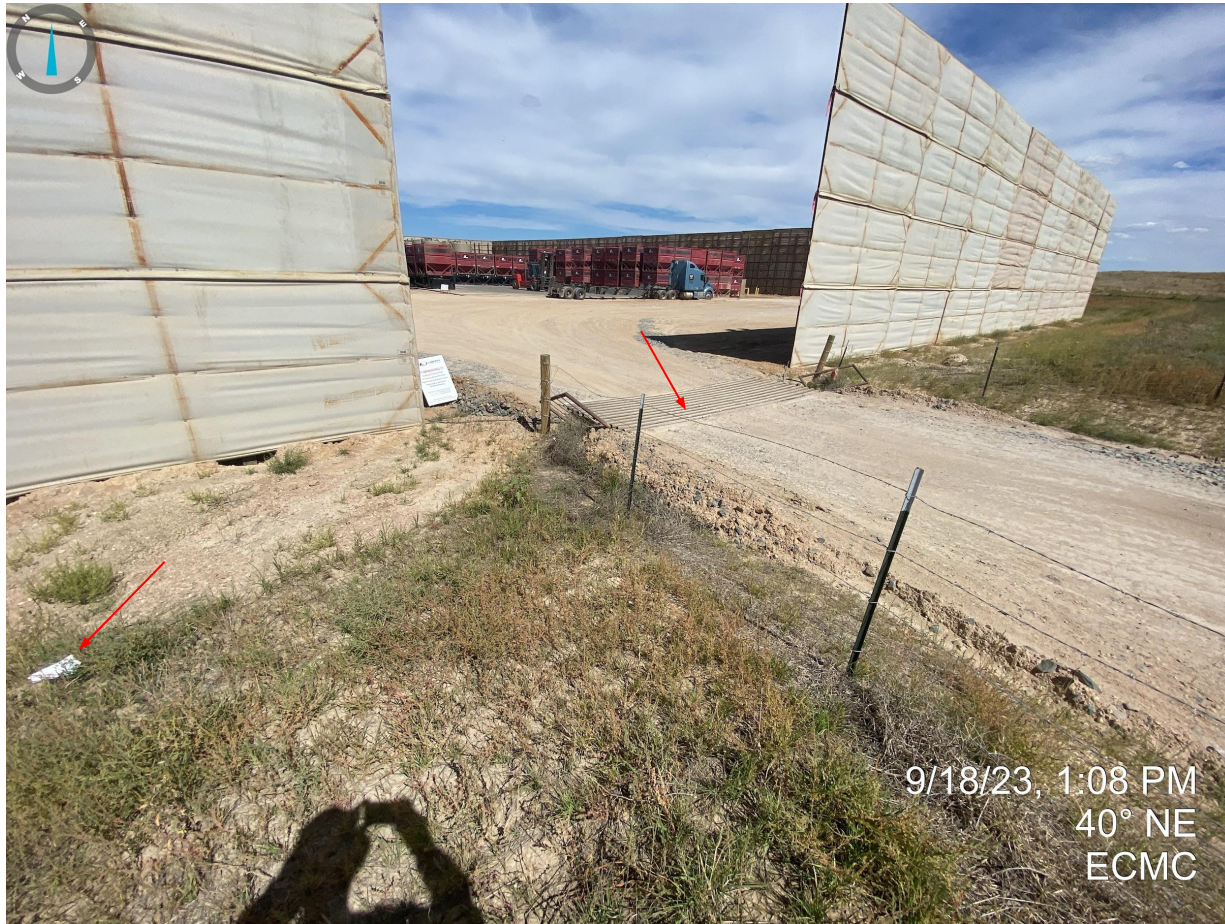
Photo 23. Taken near the entrance to the location. Photo illustrates trash and a cattle guard that requires maintenance as sediment is beginning to fill in.
