Inspection Photos

Location Name: MUSTANG RESOURCES LLC MOORE 27-42-6S-94W Pad

Location ID: 323788

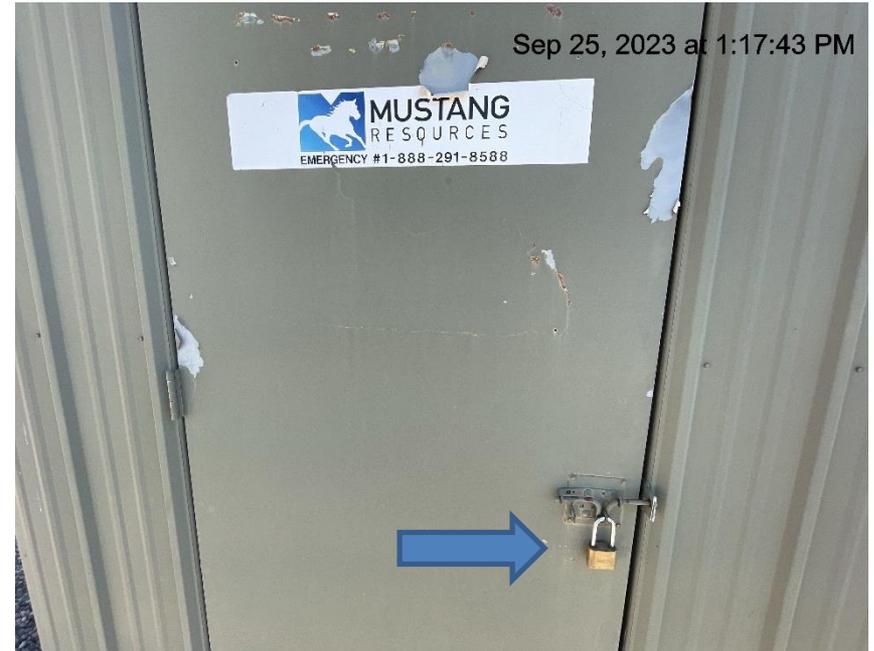
Photo # 861 Meter calibration info not conspicuously posted. Door to meter house has a lock on it, unable to check/verify cal card.

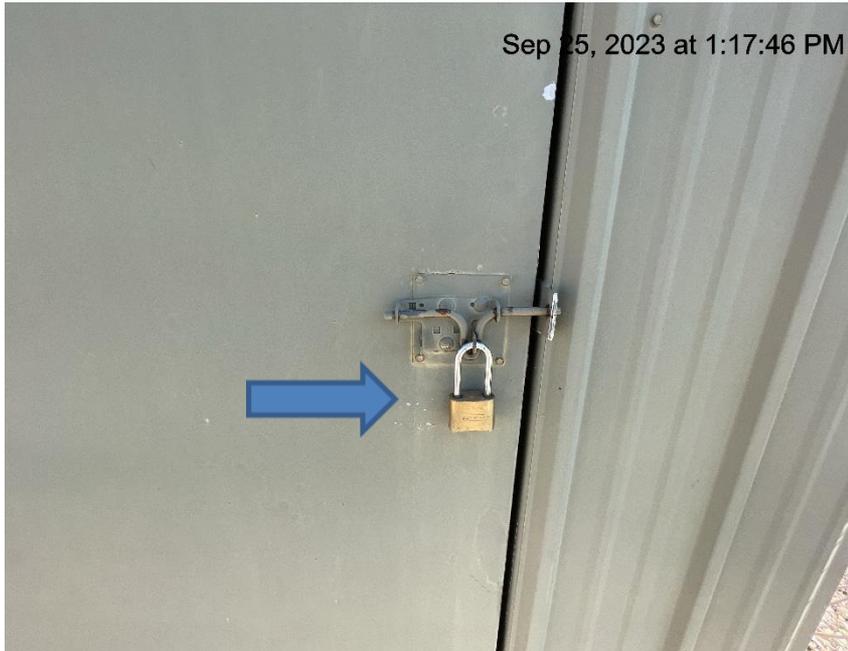
Photo # 862 Meter calibration info not conspicuously posted. Door to meter house has a lock on it, unable to check/verify cal card.

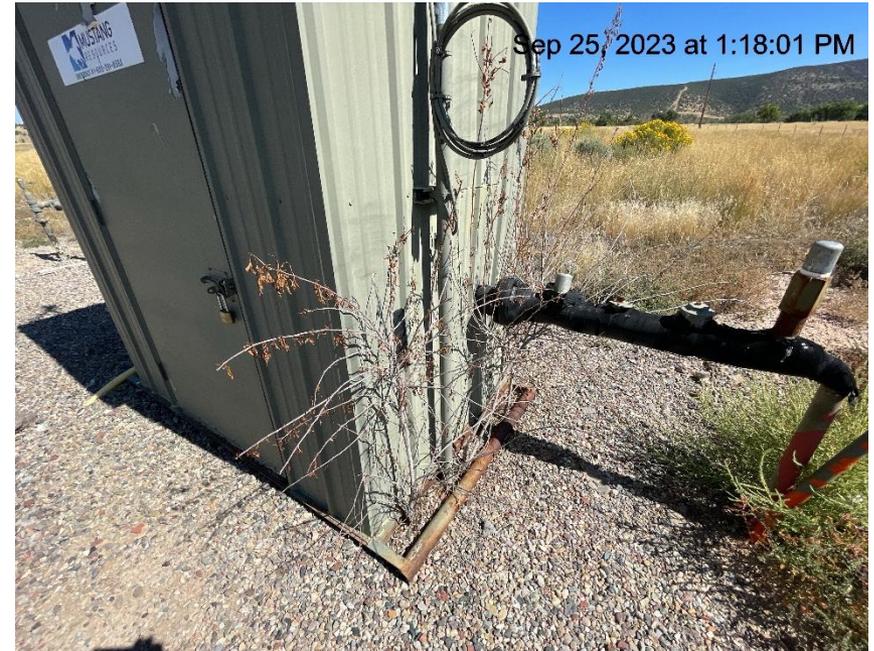
Photo # 863 Weeds/undesirable plant species

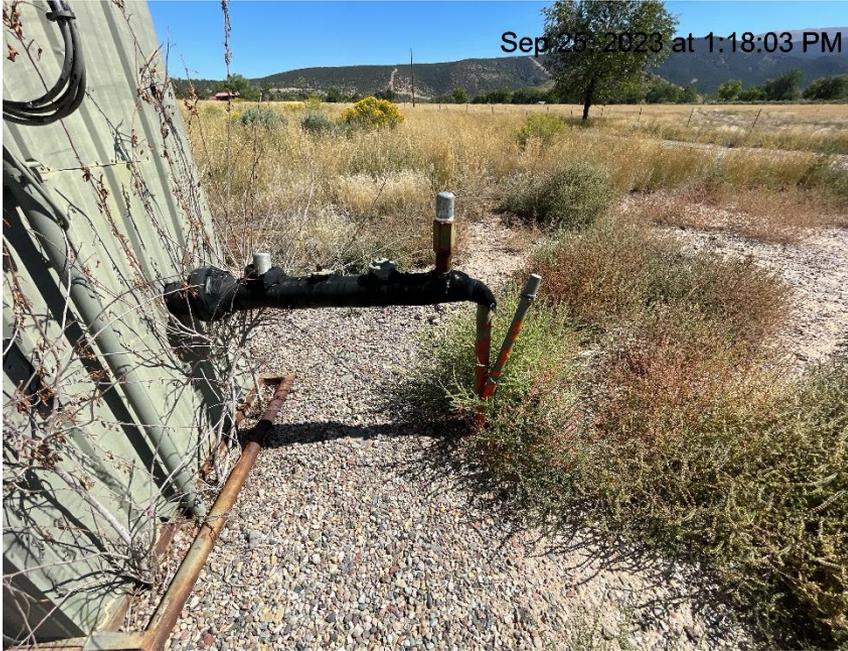
Photo # 864 Weeds/undesirable plant species

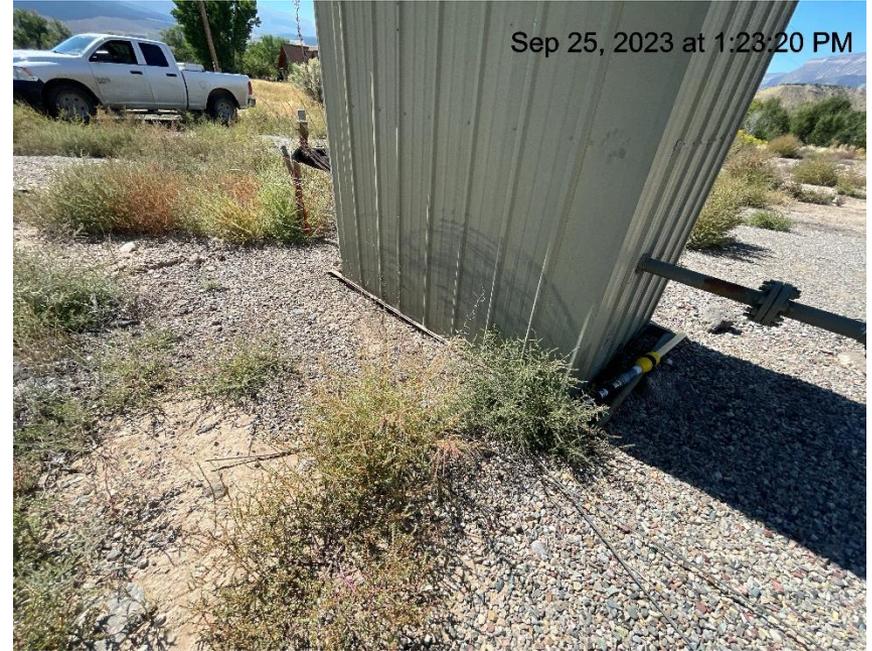
Photo # 865 Weeds/undesirable plant species

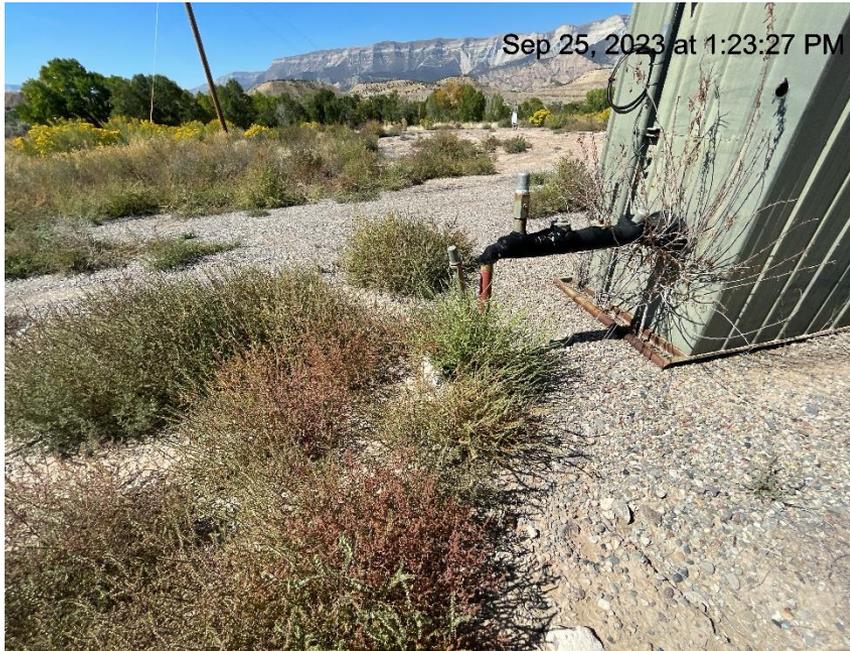
Photo # 866 Weeds/undesirable plant species
