Inspection Photos

Inspection Date: 9/12/2023

Operator: Beeman Oil and Gas Inc 7125

Location Name: Routt Bonanza-67N87W/22SENE

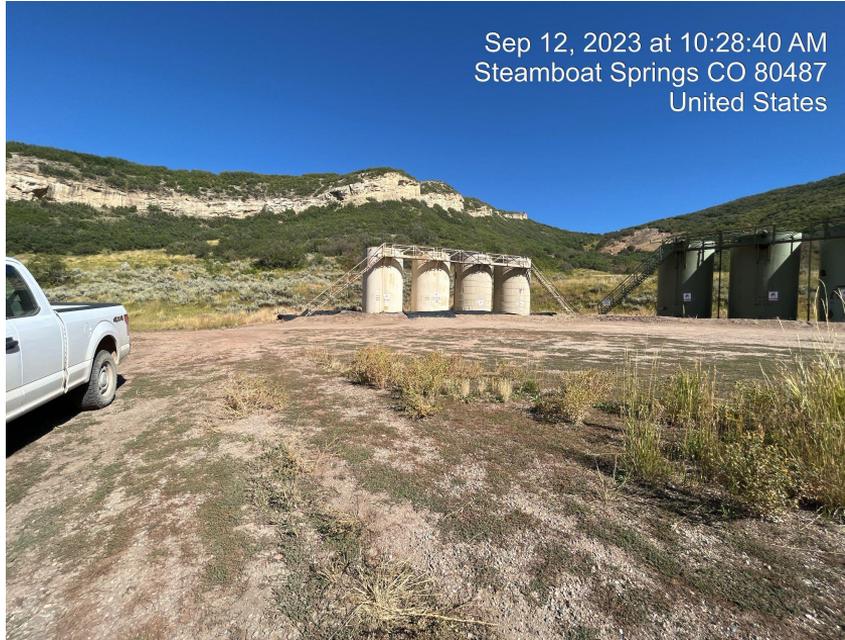
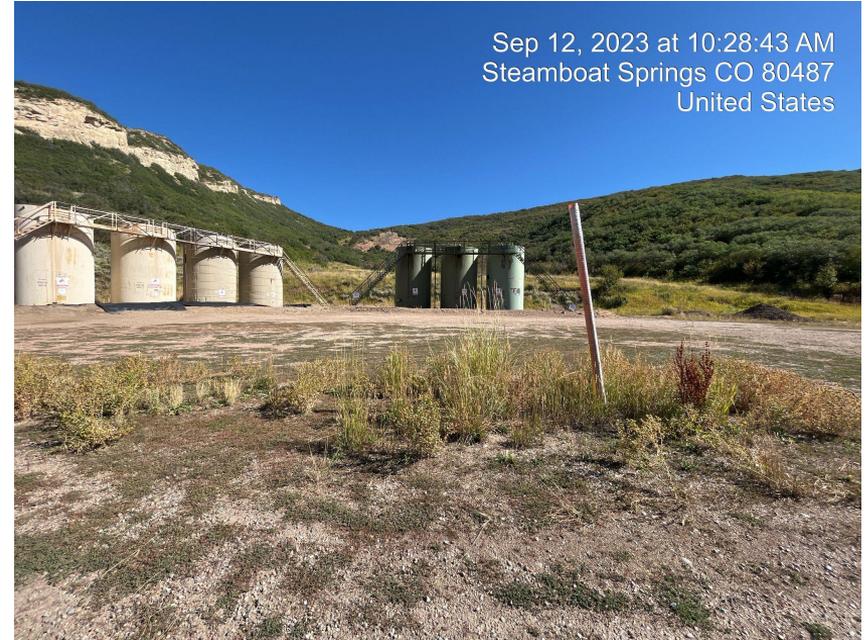
Photo 1. Site overview of the Location taken from the southern portion of the pad facing northwest.

Photo 2. Site overview of the Location taken from the southern portion of the pad facing northwest.

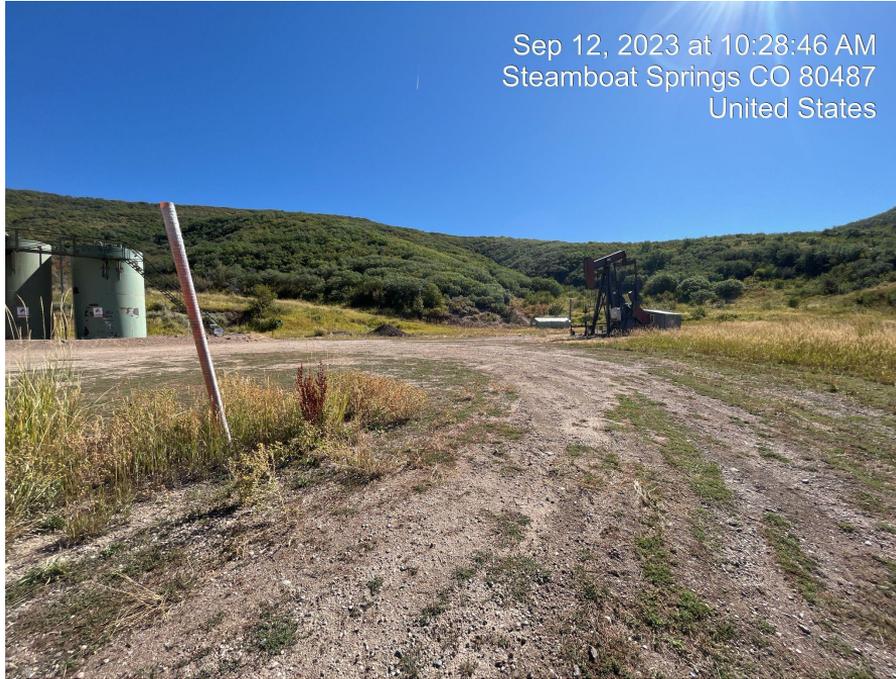
Photo 3. Site overview taken from the south of the Location facing north.

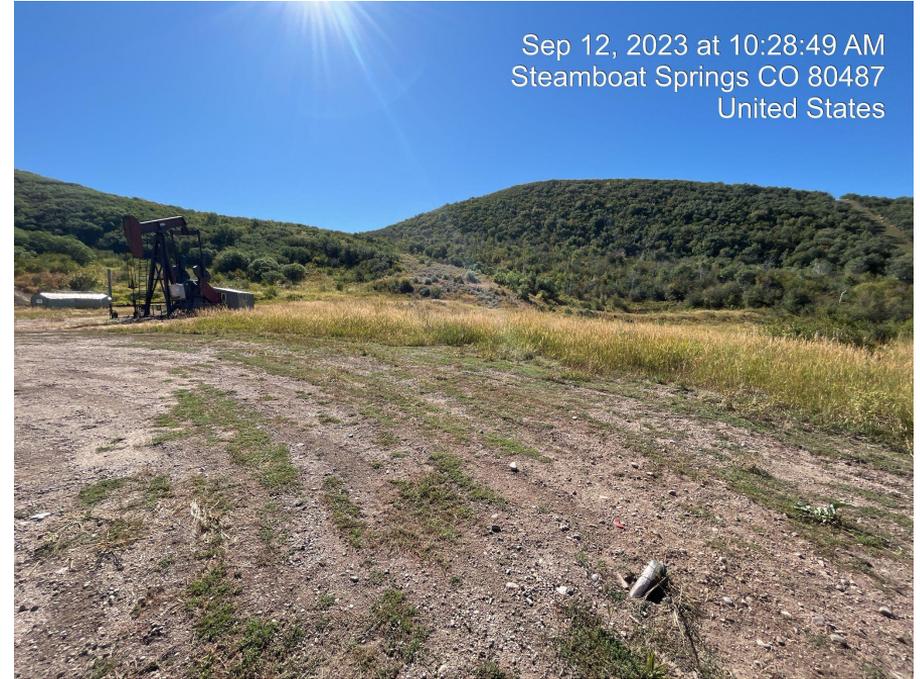
Photo 4. Site overview taken from the south of the Location facing northeast.

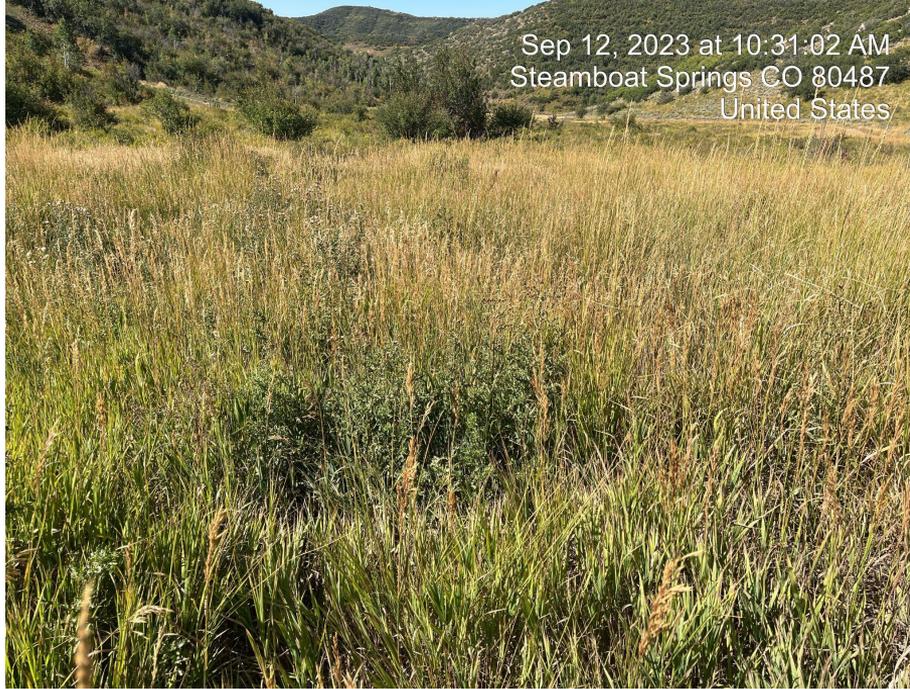
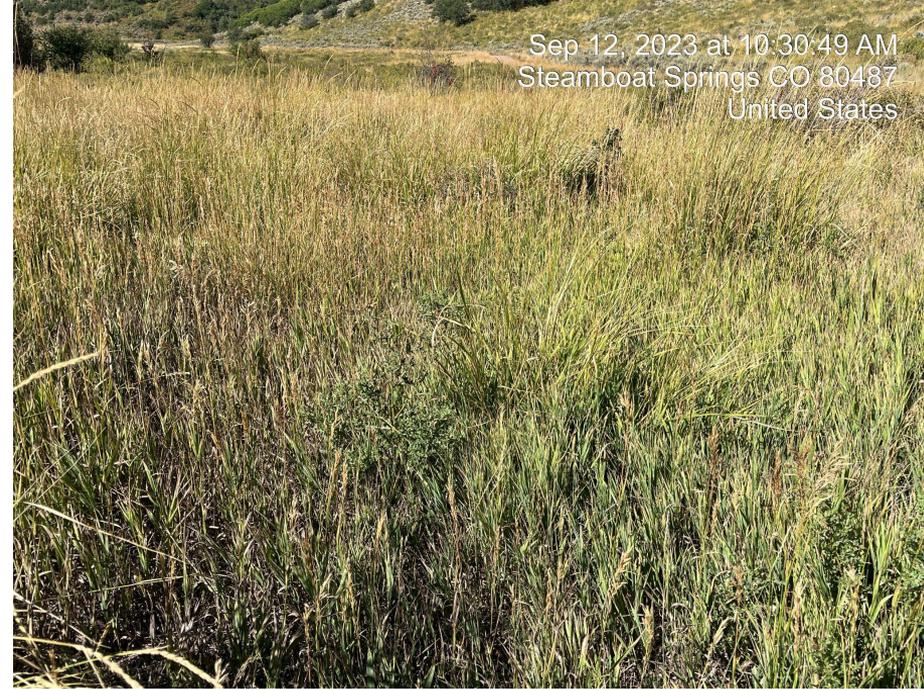
Photo 5 and 6. Overview of the Interim Reclamation taken from the south of the Location facing south.

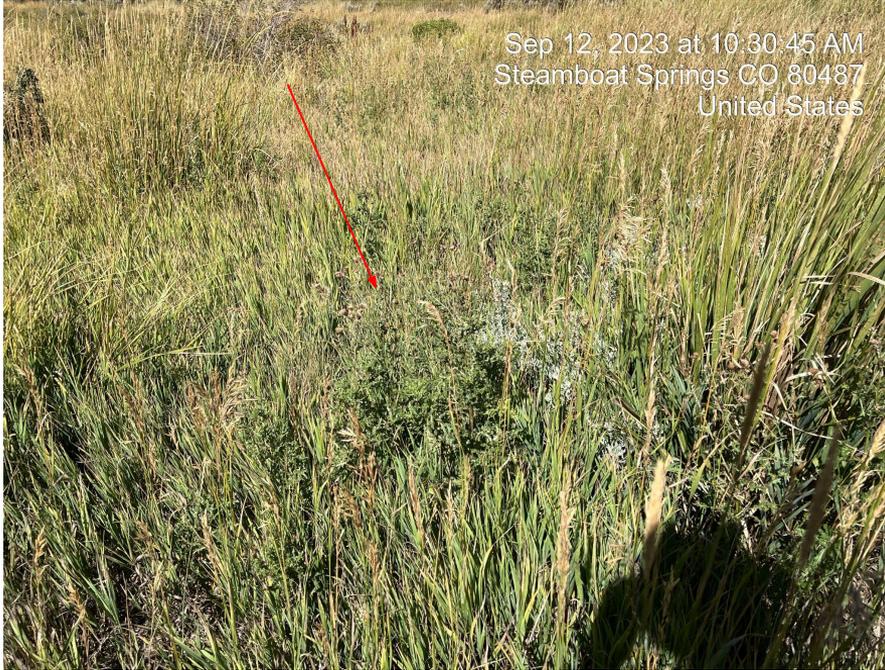
Photo 7. Noxious weeds, Canada Thistle (List B), present in Interim Reclamation area.

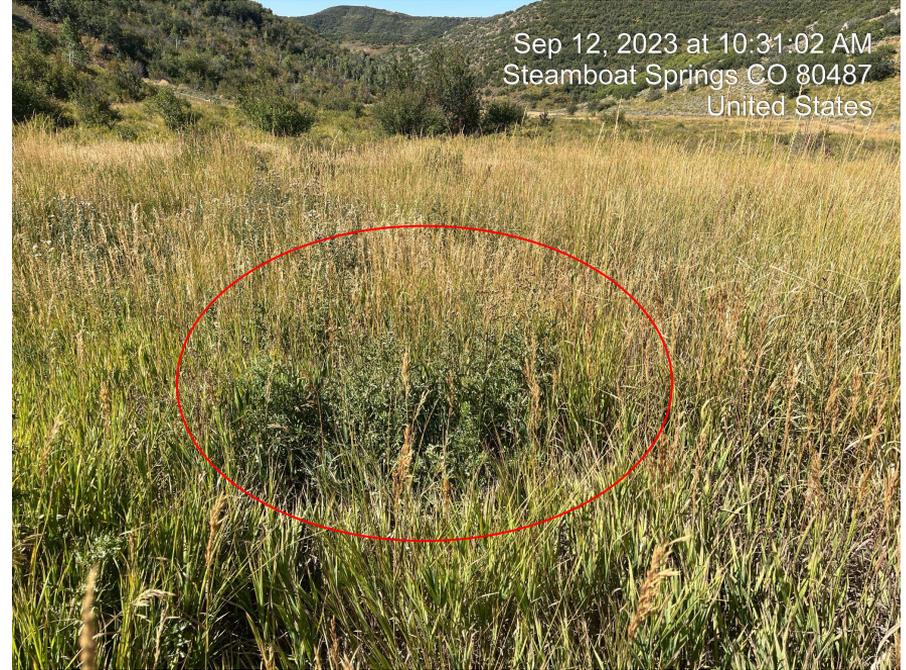
Photo 8. Site overview of the Interim Reclamation areas taken from the south of the Location facing south. Noxious weeds, Canada Thistle (List B), present.

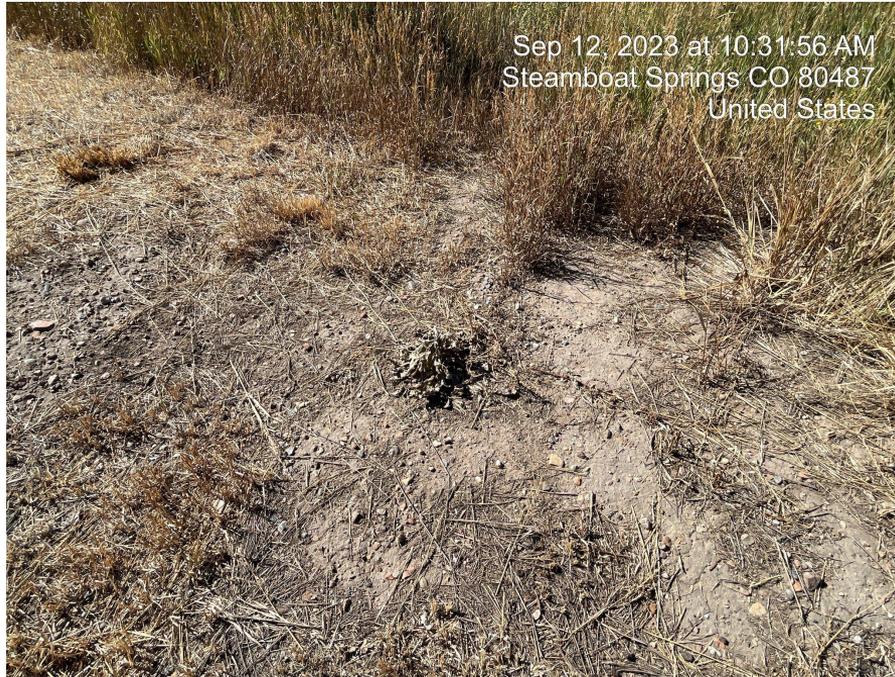
Photo 9. It appears that the Operator sprayed weeds and mowed vegetation in working pad area.

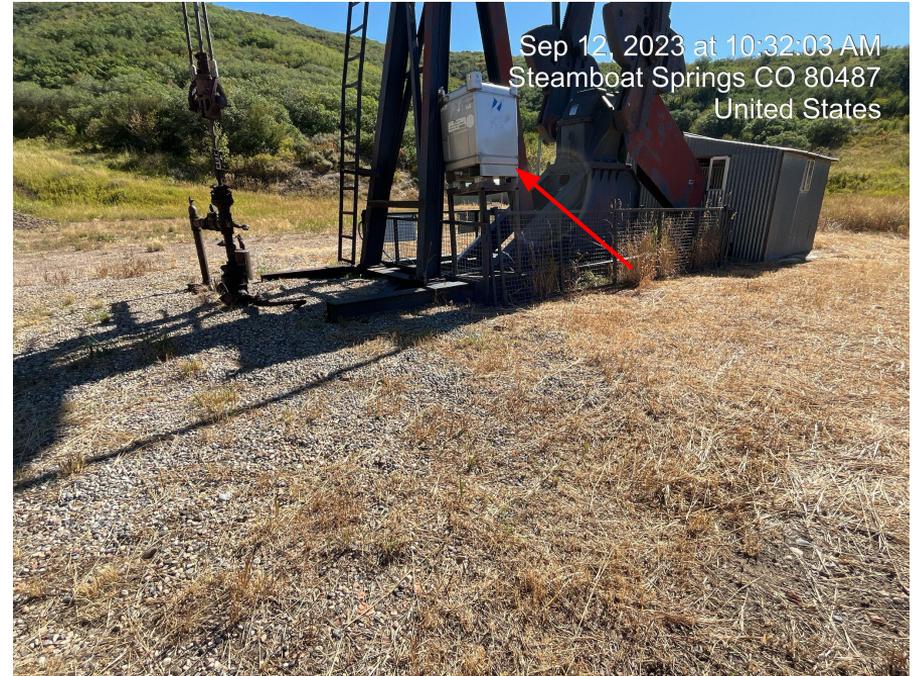
Photo 10. Observed weed debris and some vegetation growing around production area. Photo also shows an unused chemical tote documented in FIR #702800441 remaining.

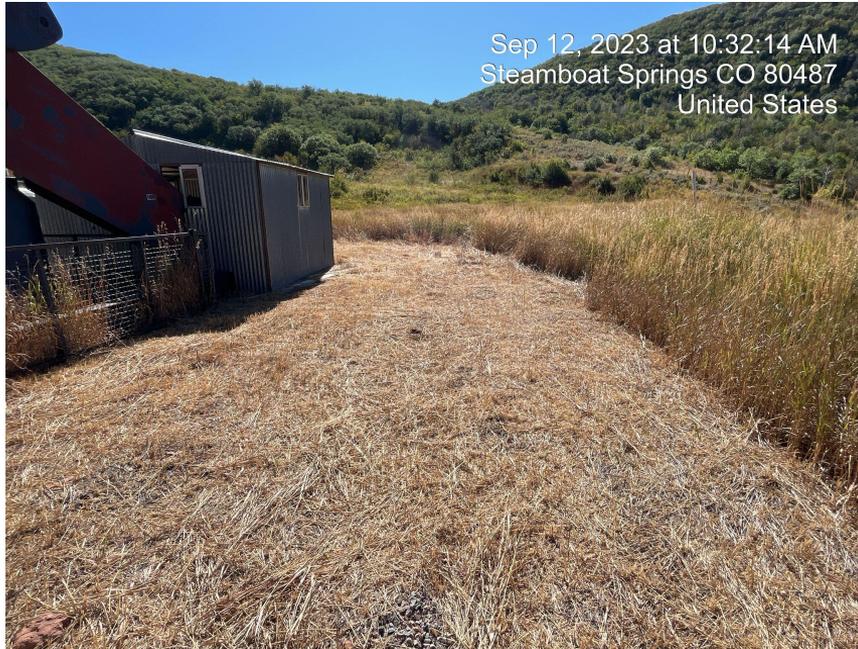
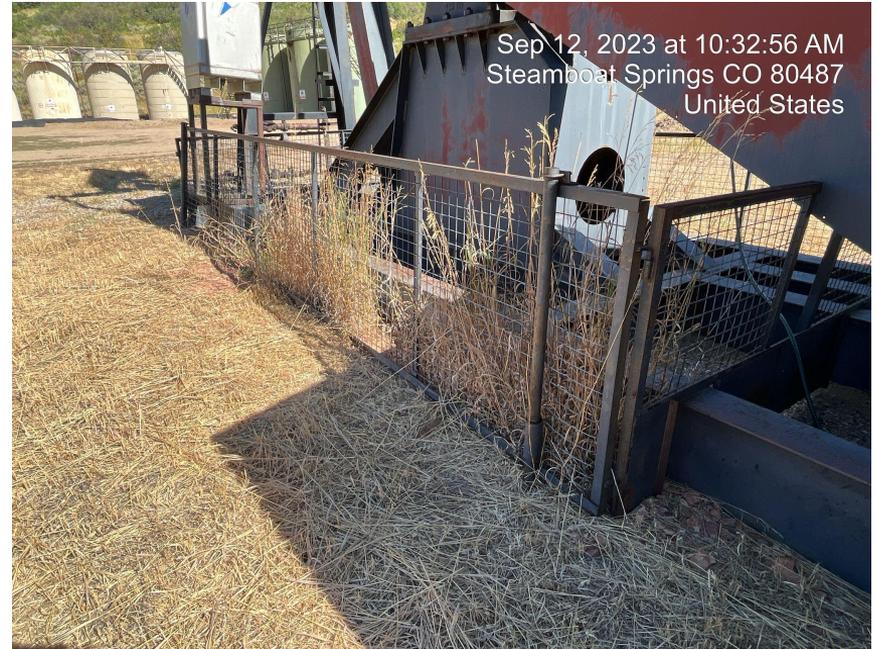
Photos 11 and 12: Evidence that the Operator sprayed for weeds and mowed vegetation in working pad area. Monitor and maintain weeds around production equipment.

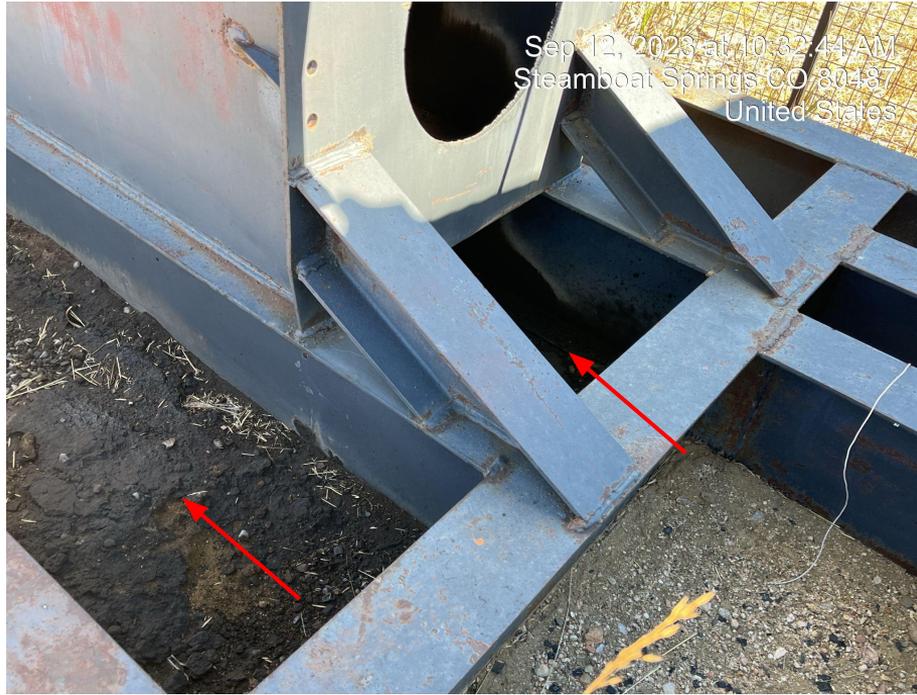
Photo 13. Stained soils observed around pumpjack.

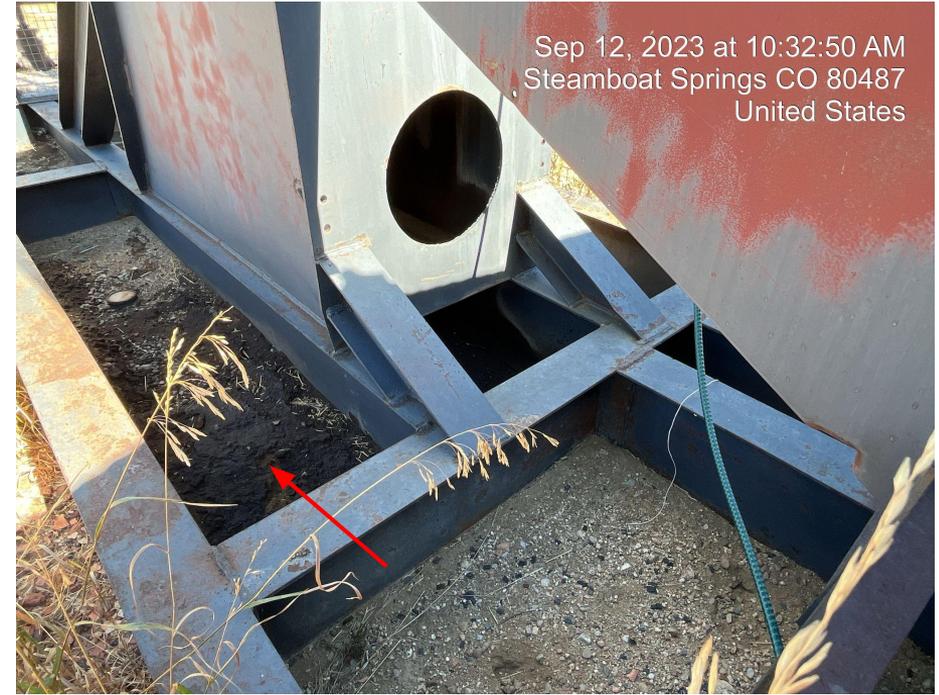
Photo 14. Stained soils observed around pumpjack.

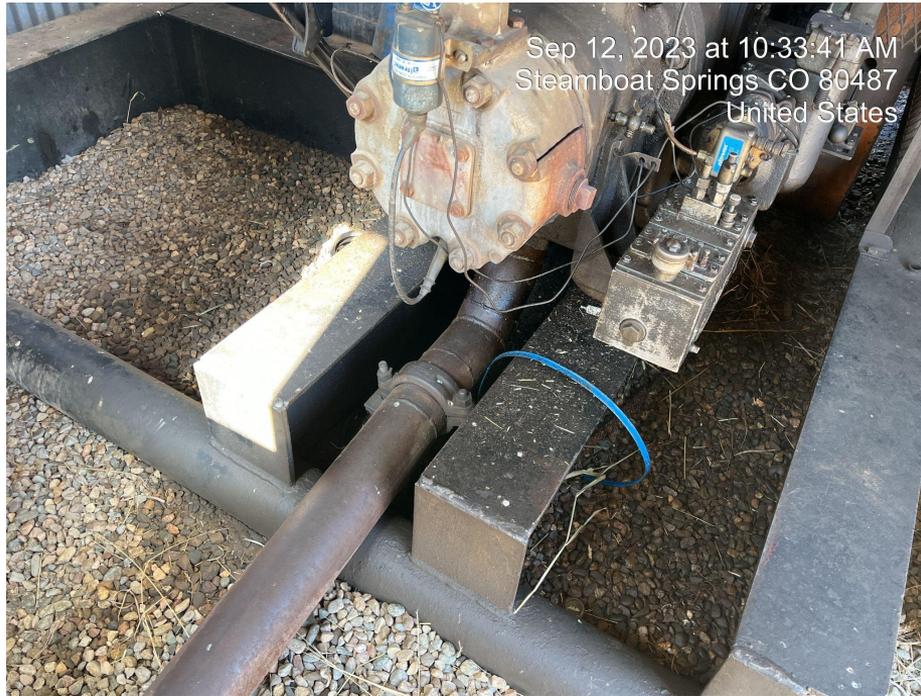
Photo 15. Stained soils seen around separator equipment, within pump jack housing shed.

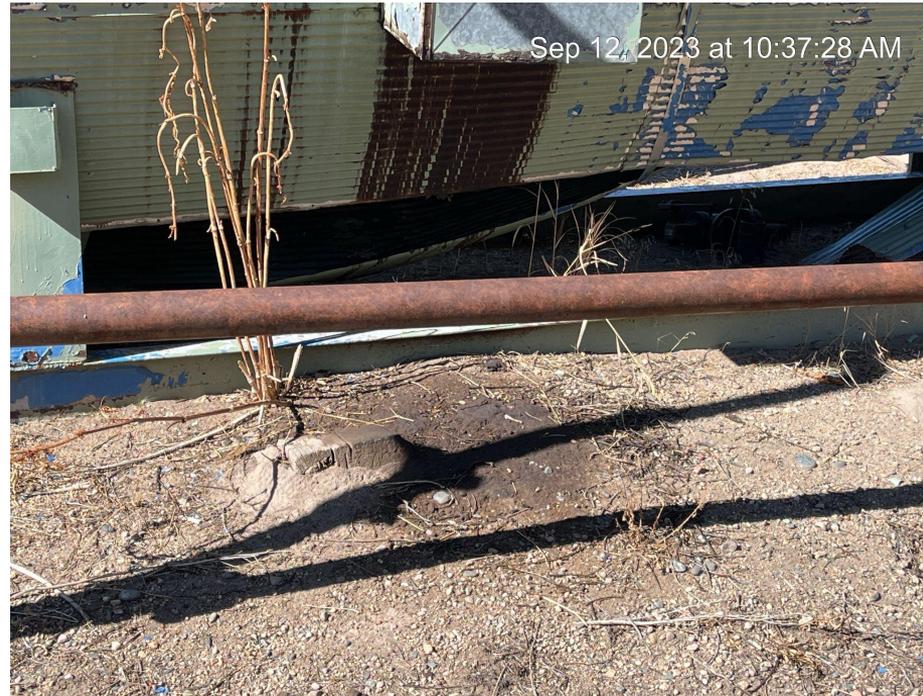
Photo 16. Stained soils seen underneath separator on southeast Location.

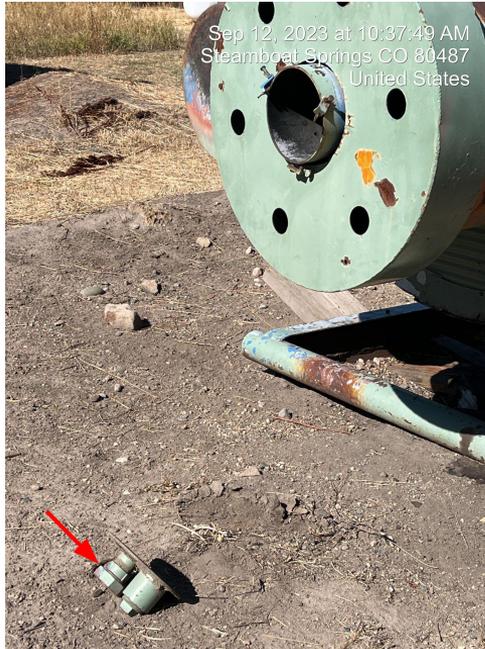
Photo 17. Valve cover not on tank. Remove if not used and implement wildlife BMPs.

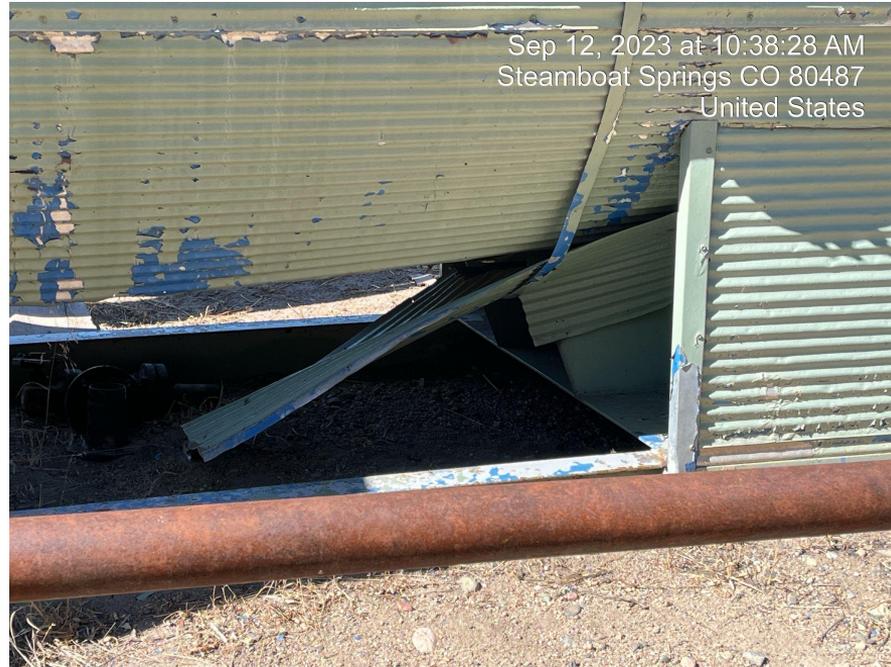
Photo 18. Panel on tank on southeast of Location are falling off. Maintenance advised.

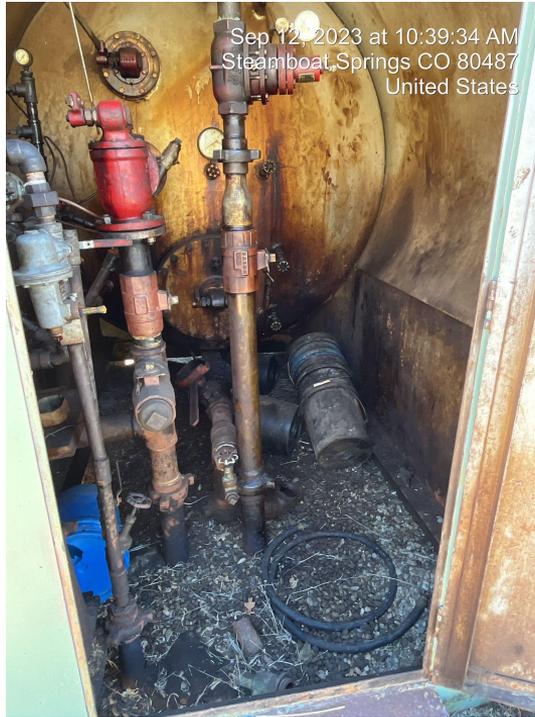
Photo 19. Stained soil observed within separator housing.

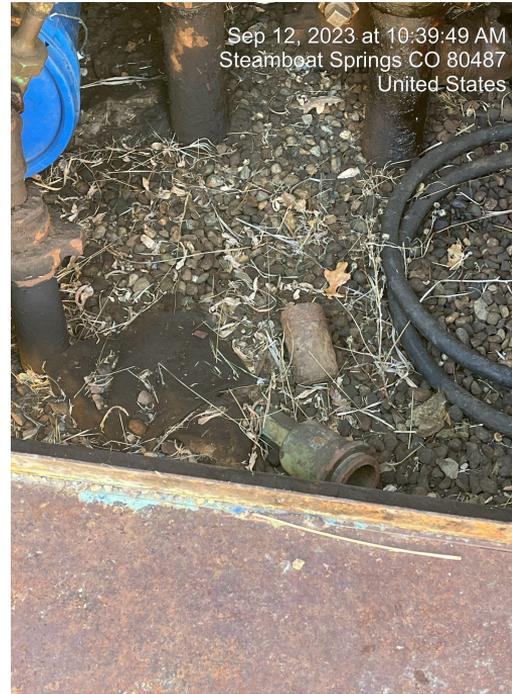
Photo 20. Trash observed, such as oily rags, buckets and excess equipment present. Oily rags/trash/debris require removal.

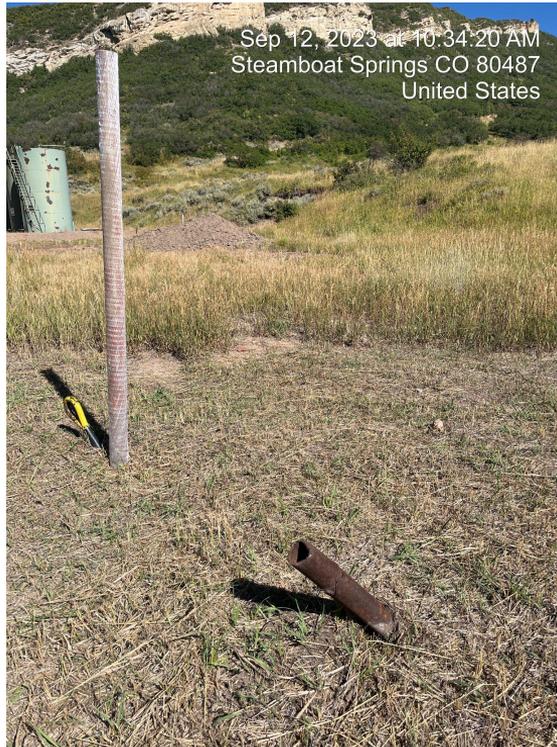
Photo 21. Remove equipment if unused.

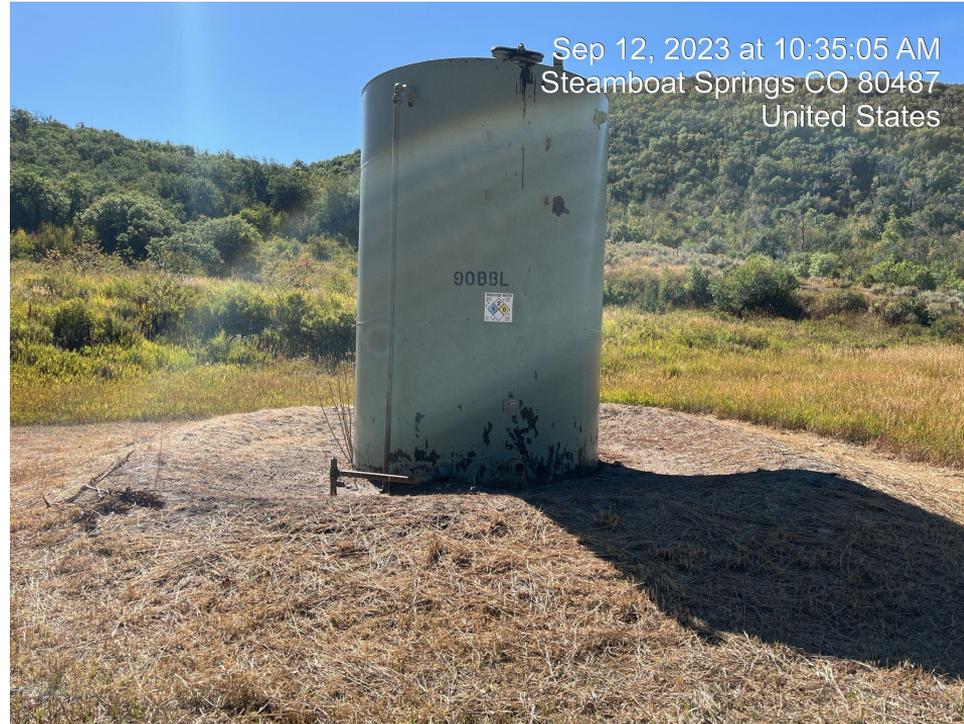
Photo 22. Secondary berm containment does not appear to be sufficient for size of tank. Signage/label at tank does not comport with 605 requirements.

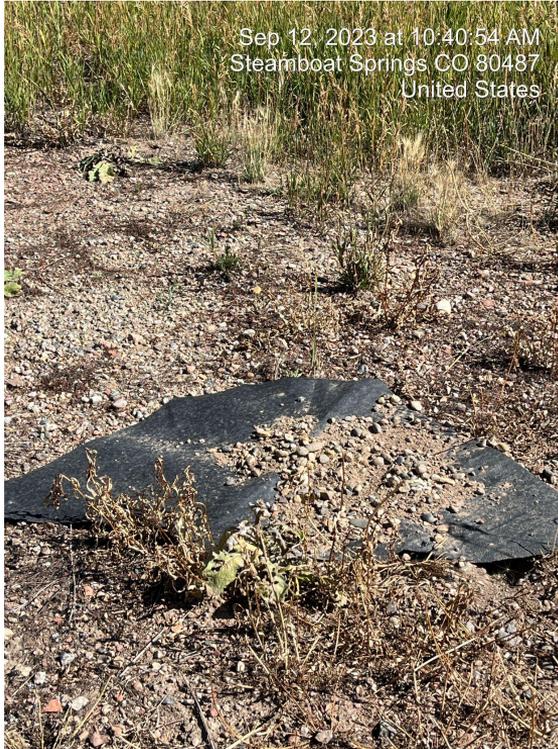
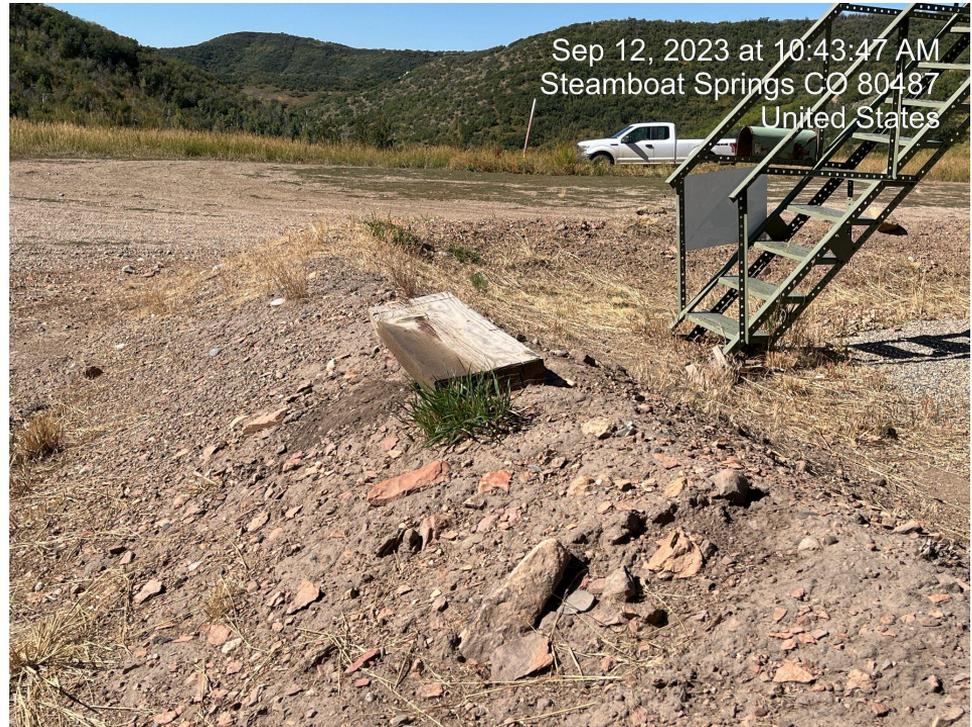
Photo 23 and 24. Trash and weed debris found across Location.

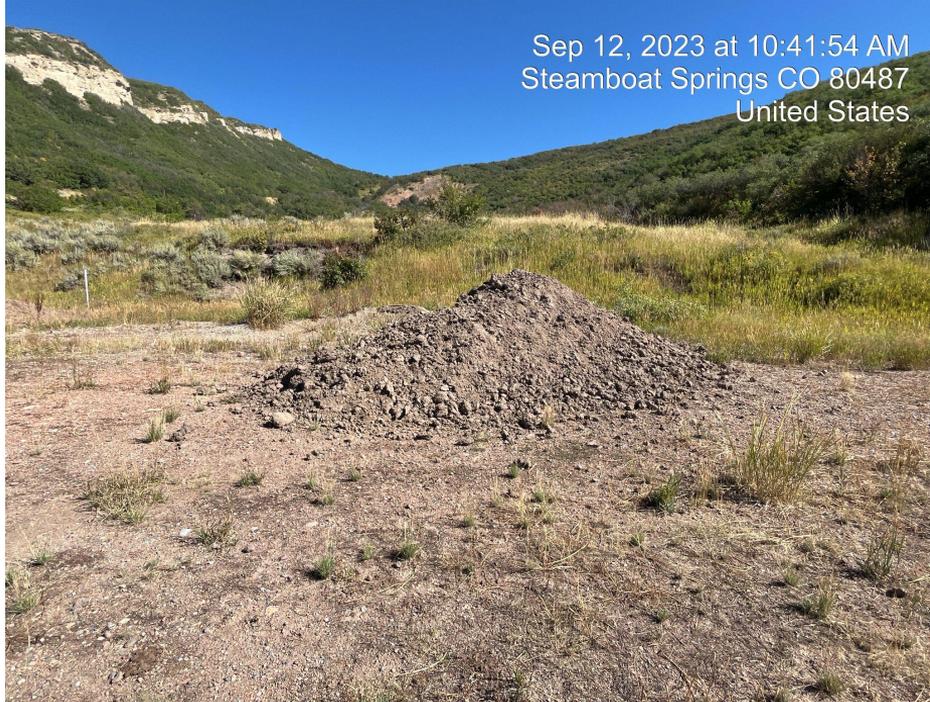
Photo 25. Soil stockpile observed without stormwater and erosion control BMPs per Rule 1002.c and 1002.f

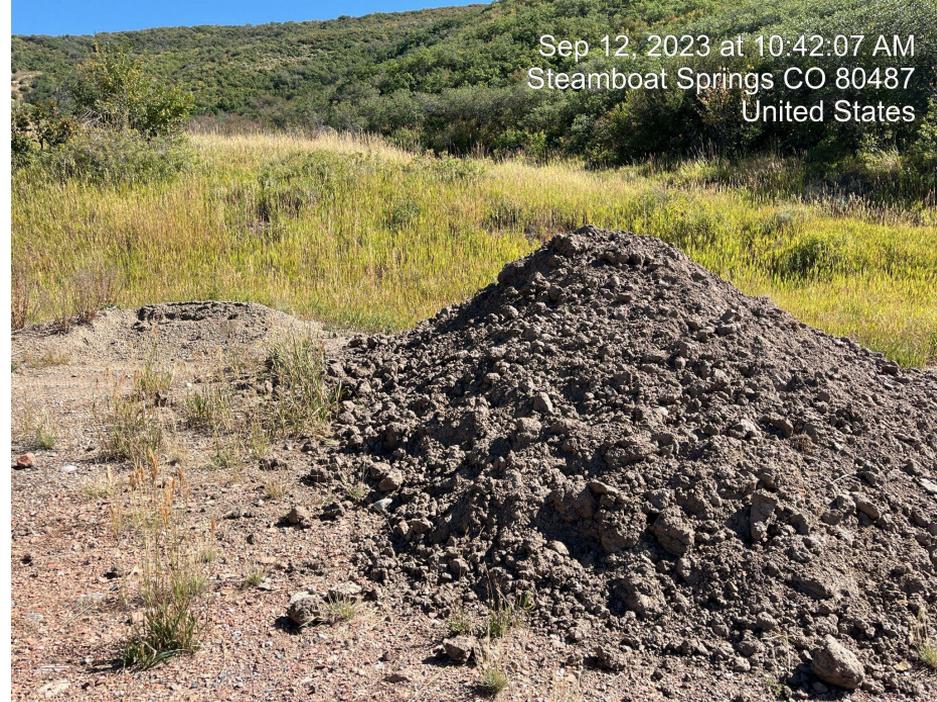
Photo 26. Soil stockpile observed without stormwater and erosion control BMPs per Rule 1002.c and 1002.f.

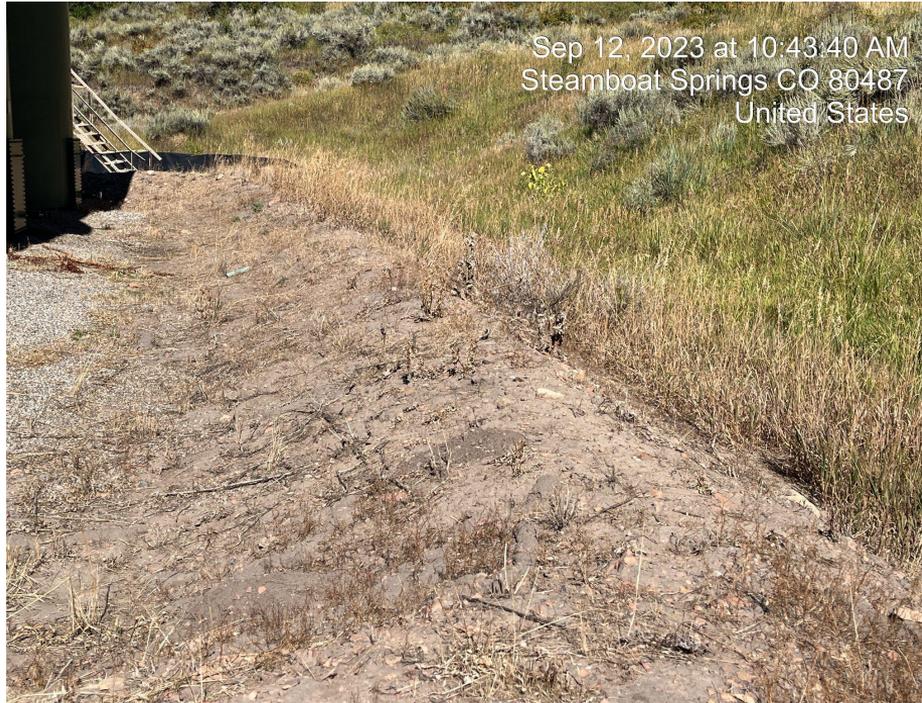
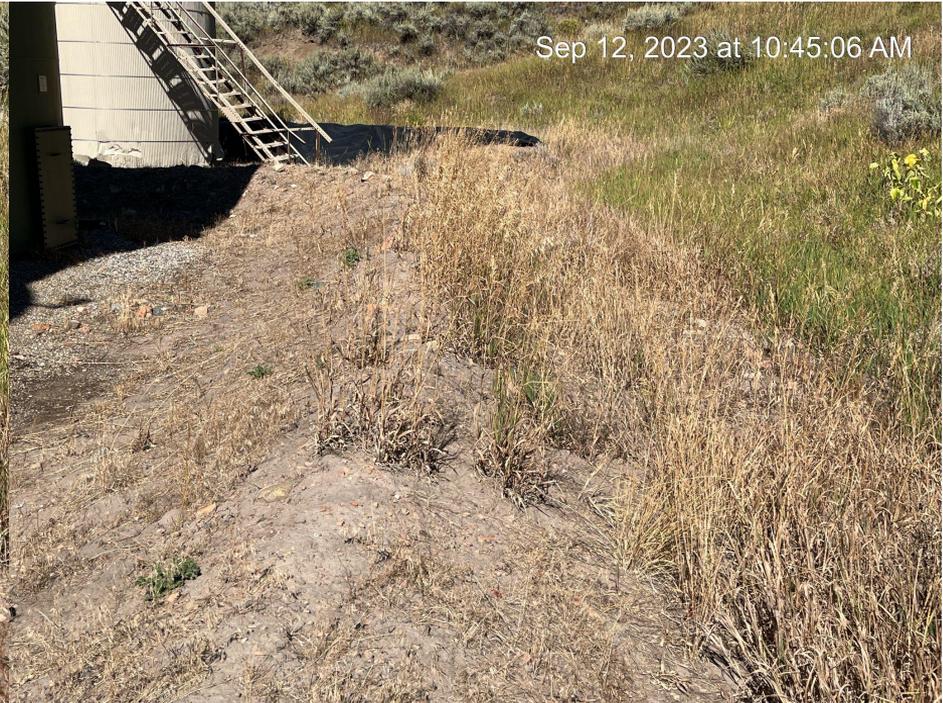
Photos 27 and 28: Photos taken from the Beeman tank battery facility on the north end of the Location. Photos show vegetation remains established on and within the secondary containment base and berm; vegetative establishment compromises the integrity of the containment BMP, and requires removal.

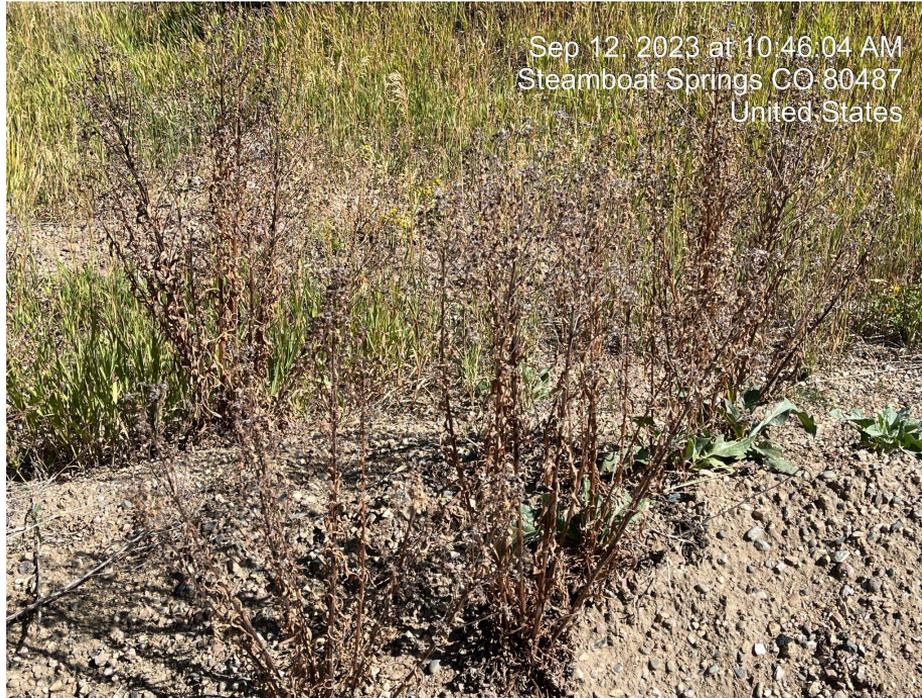
Photo 29. Weeds observed on secondary berm containment around tanks at north end of Location.

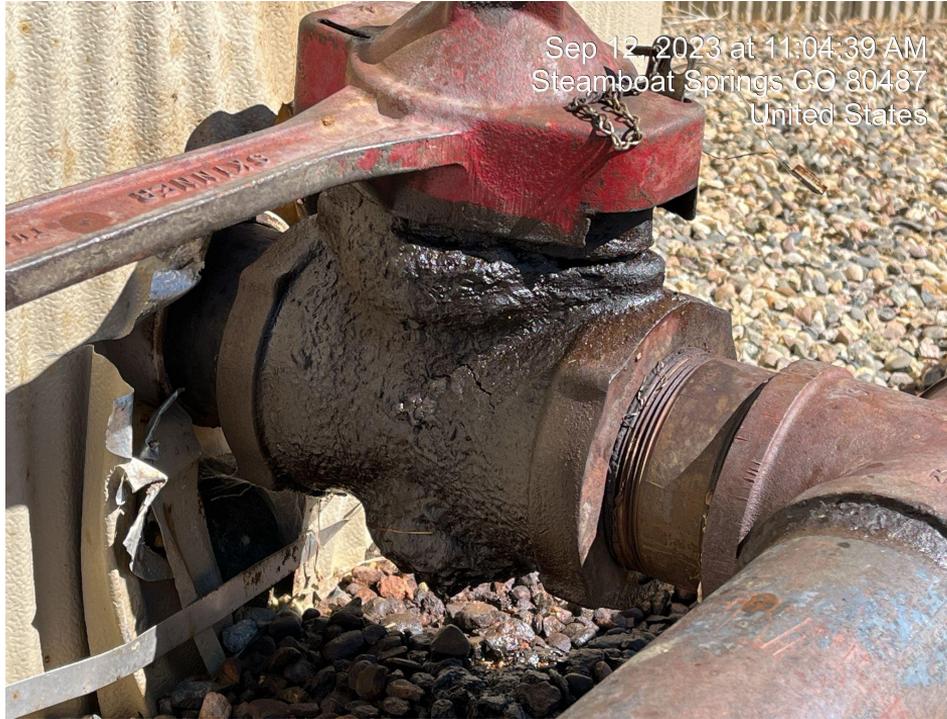
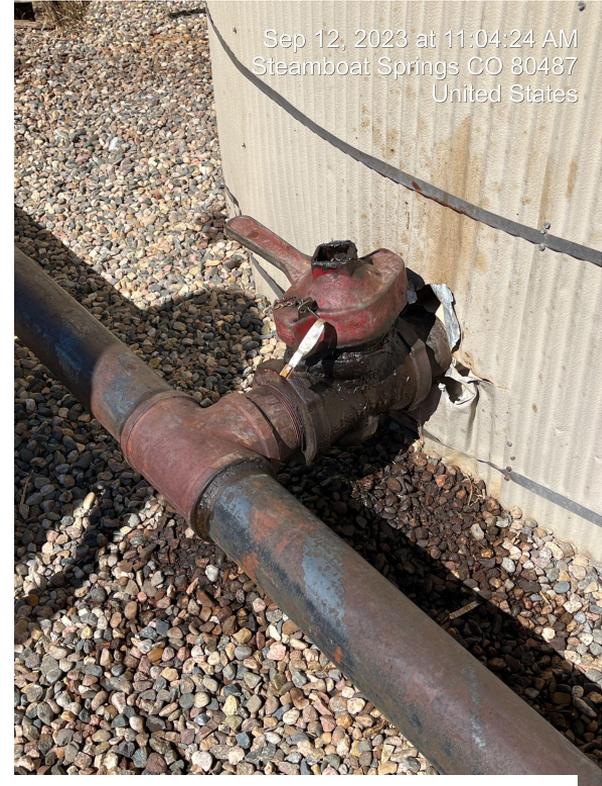
Photos 31 and 32: Photos taken from the Energy Investments tank battery facility on the northwest end of the Location. Photo shows active link from tank #3 and stained soils.

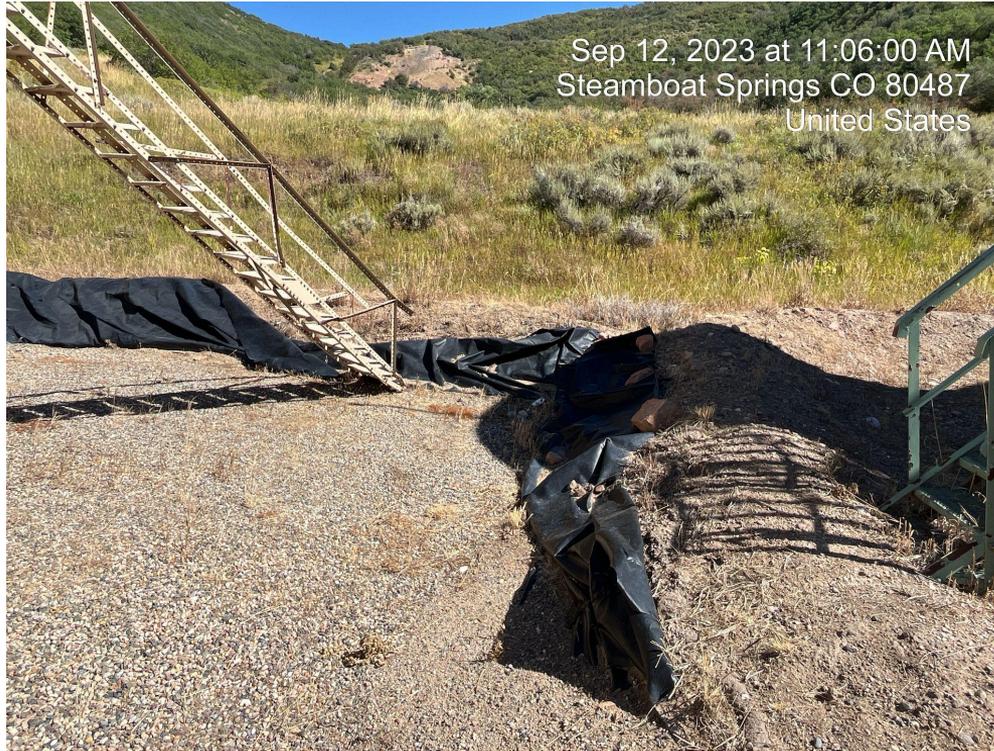
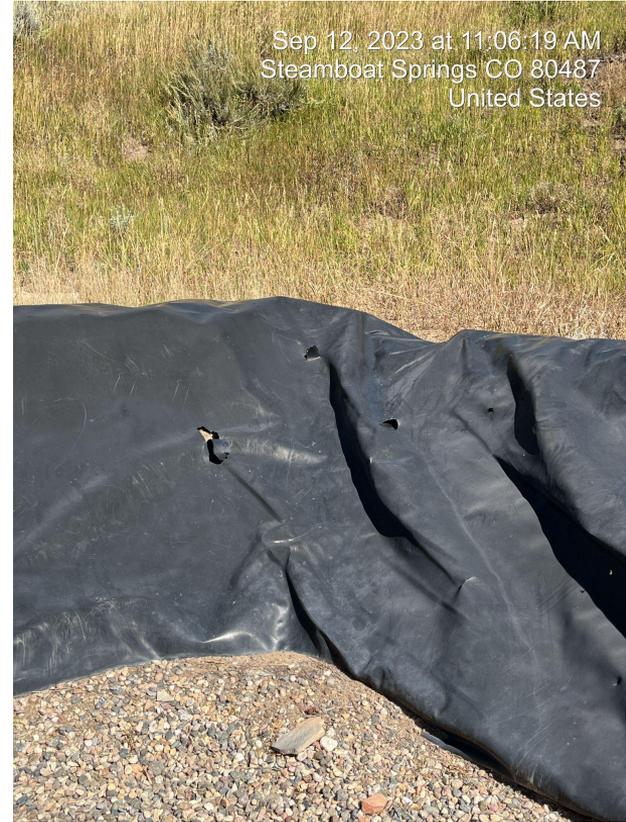
Photos 33 and 34: Photos taken from the Energy Investments tank battery facility on the northwest end of the Location. Photos show secondary containment BMP lacks integrity, and is no longer adequate to contain a spill or release; liner in disrepair/not maintained.

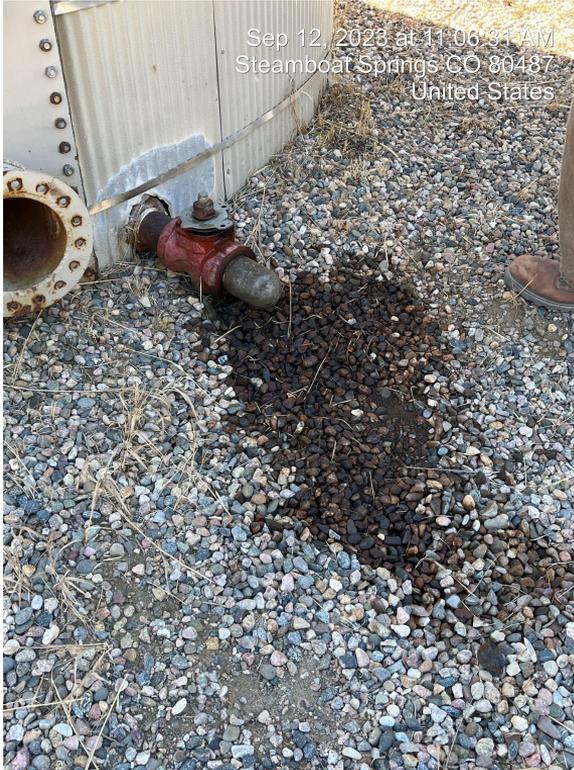
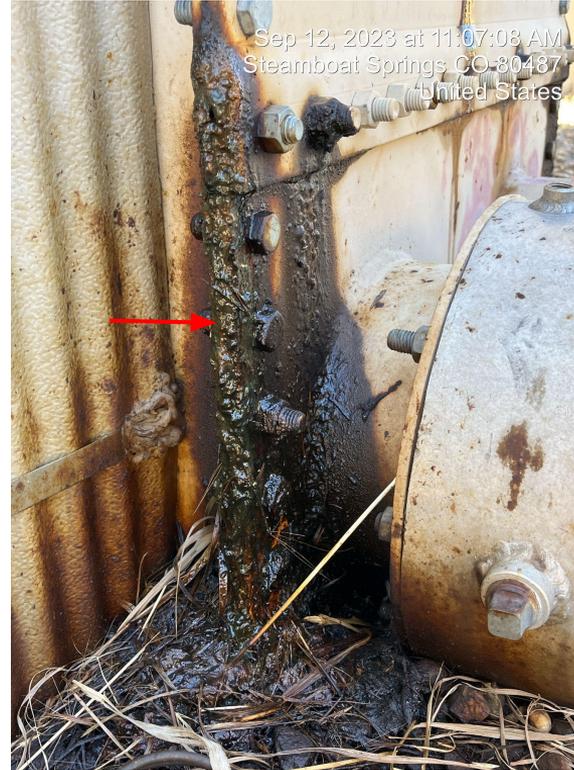
Photos 35 and 36: Photos taken from the Energy Investments tank battery facility on the northwest end of the Location. Active leak and stained soil around tank.

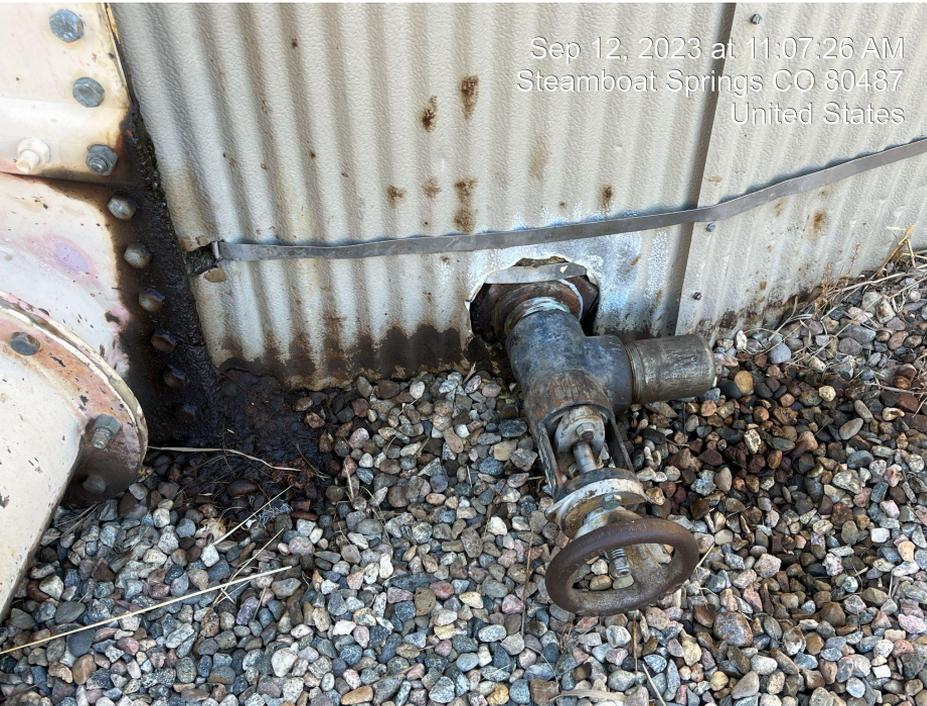
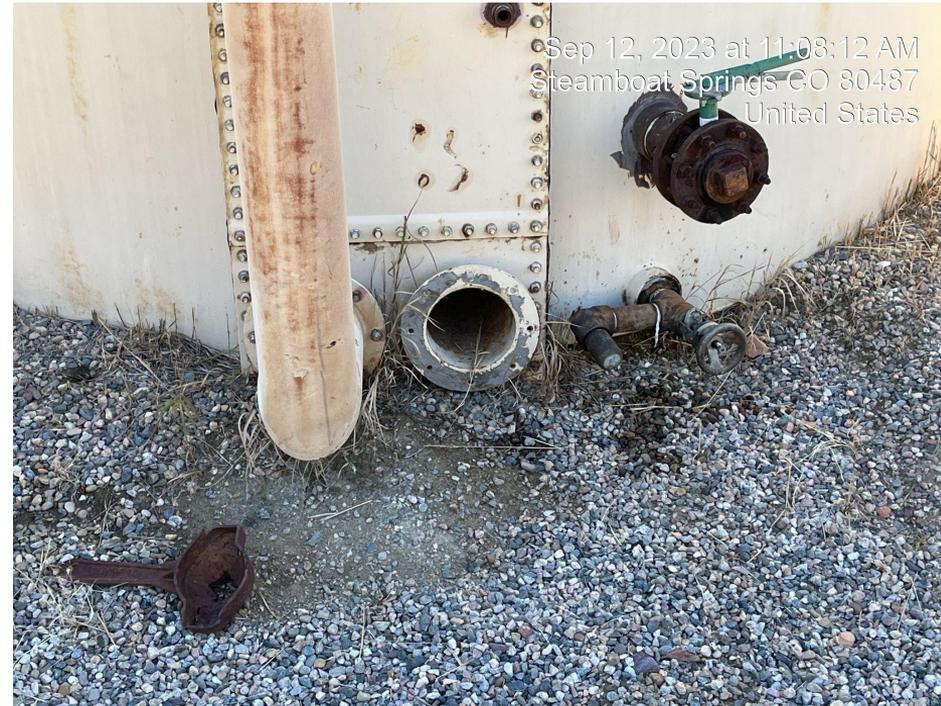
Photos 37 and 38: Photos taken from the Energy Investments tank battery facility on the northwest end of the Location. Stained soils and tank valves not covered; Replace the covers and clean stained soils.
