Inspection Photos

Inspection Date: 9/12/2023

Operator: Beeman Oil and Gas Inc 7125

Location Name: Routt Bonanza-67N87W/22SENE

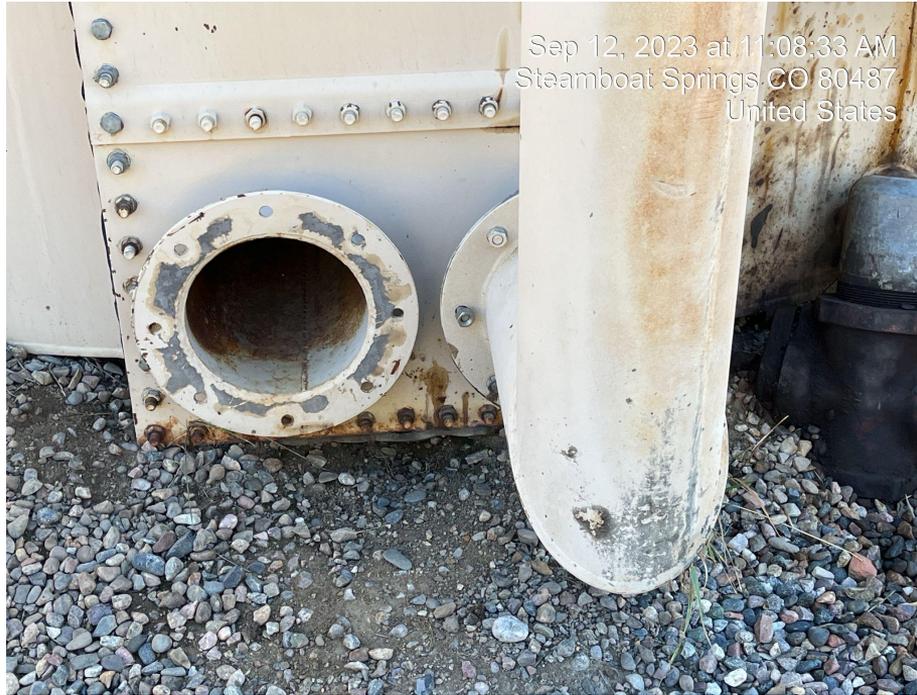
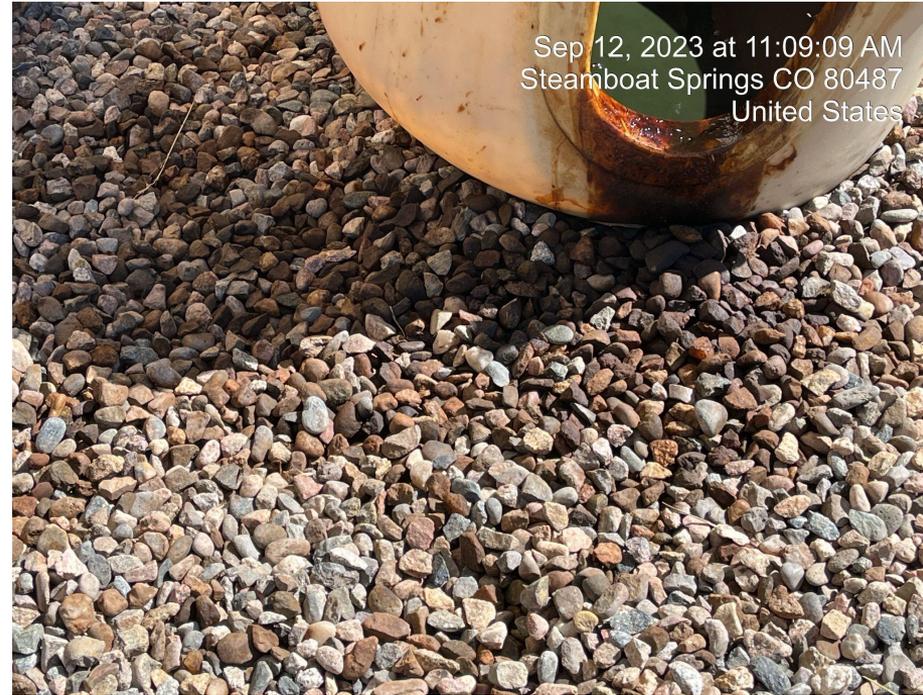
Photos 39 and 40: Photos taken from the Energy Investments tank battery facility on the northwest end of the Location; Replace the covers and clean stained soils.

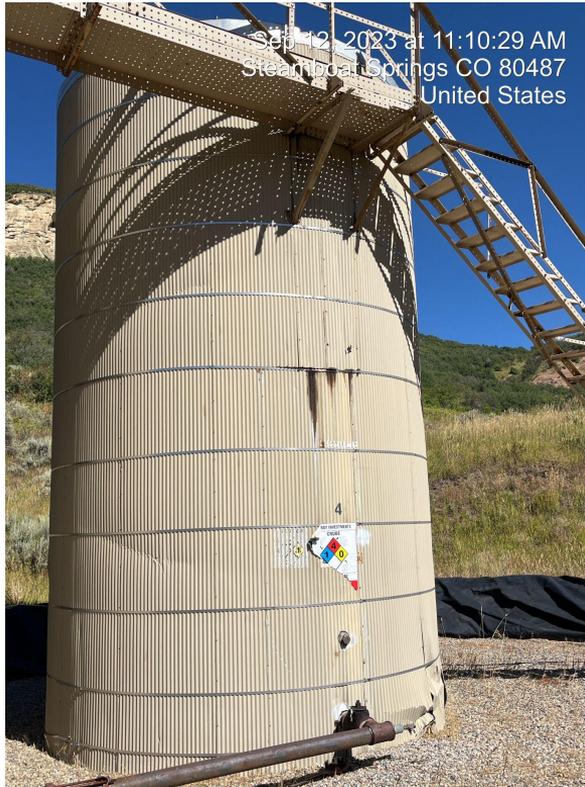
Photo 41. Photos taken from the Energy Investments tank battery facility on the northwest end of the Location. Photo example showing signage/labels don't comport with 605 requirements.

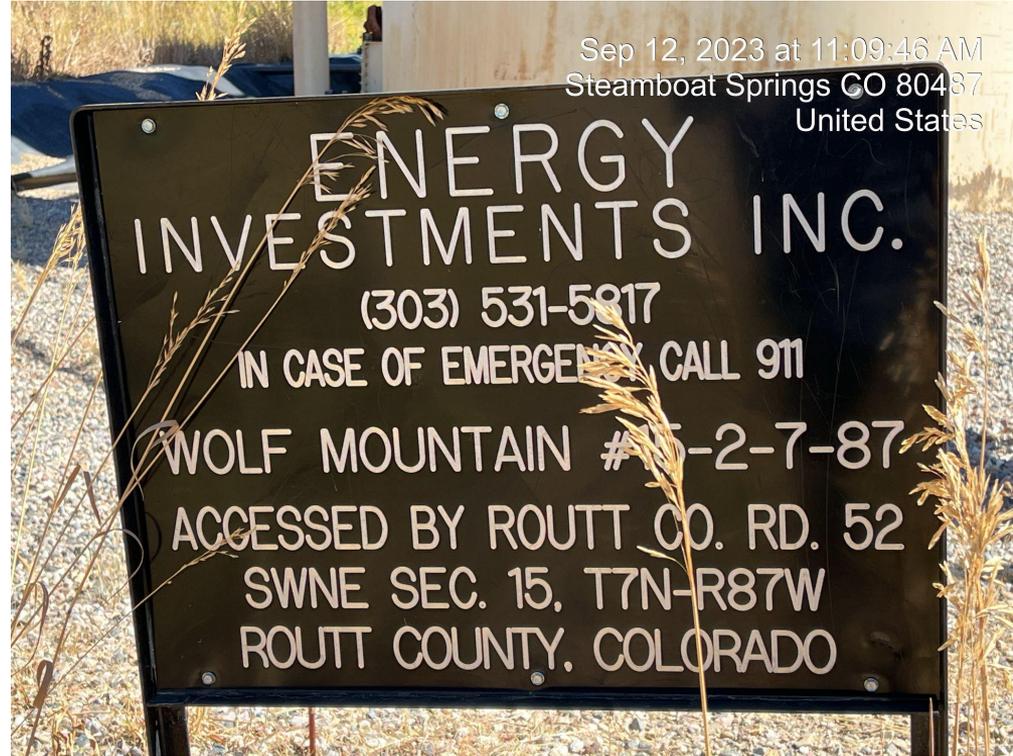
Photo 42. Photo taken from the Energy Investments tank battery facility on the northwest end of the Location. Tank battery signage does not comport with 605 requirements.
