# Inspection Photos

Operator: Beeman Oil and Gas Inc 7125

Location Name: Diamond T Sheep

Inspection Document #: 696205276

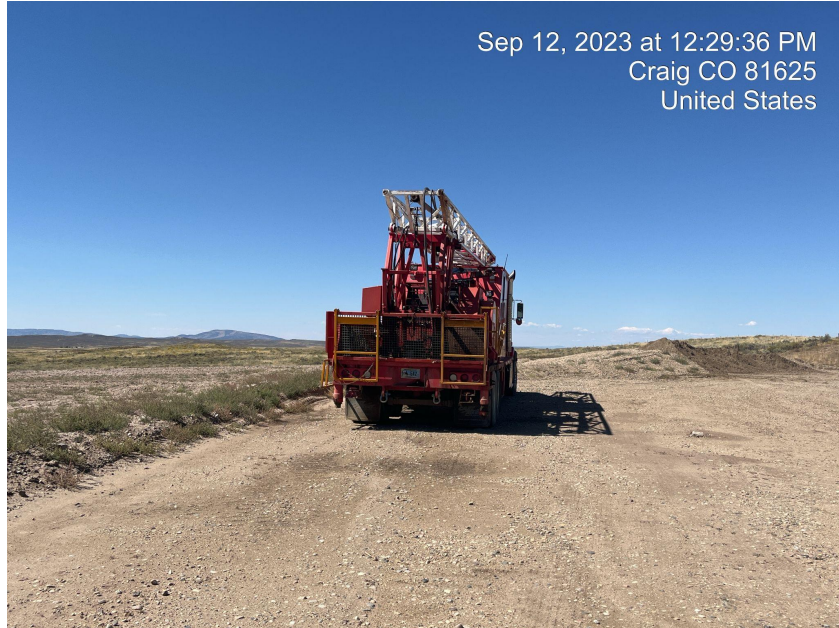
**Photo 1.** Photo taken from the south of the Location shows an overview to the west.

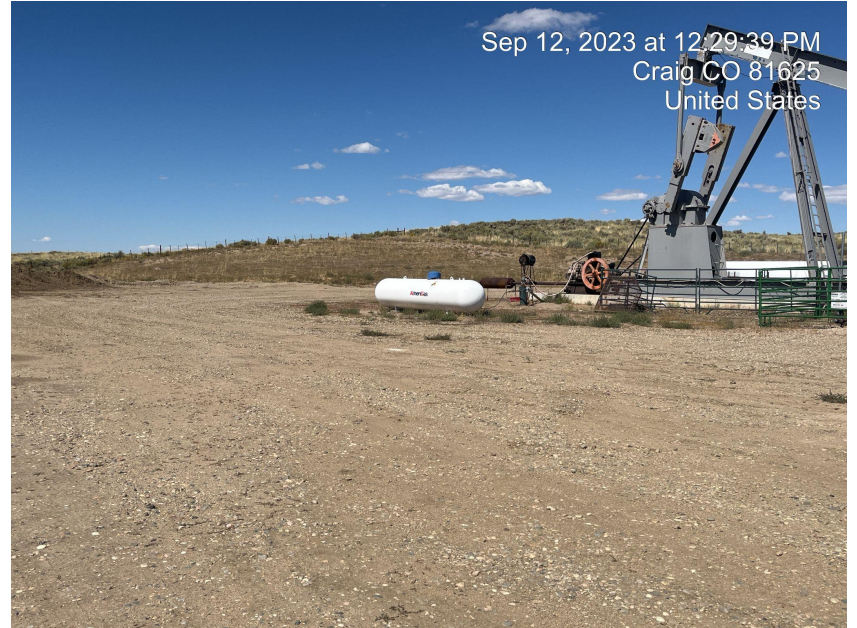
**Photo 2.** Photo taken from the south of the Location shows an overview to the northwest.

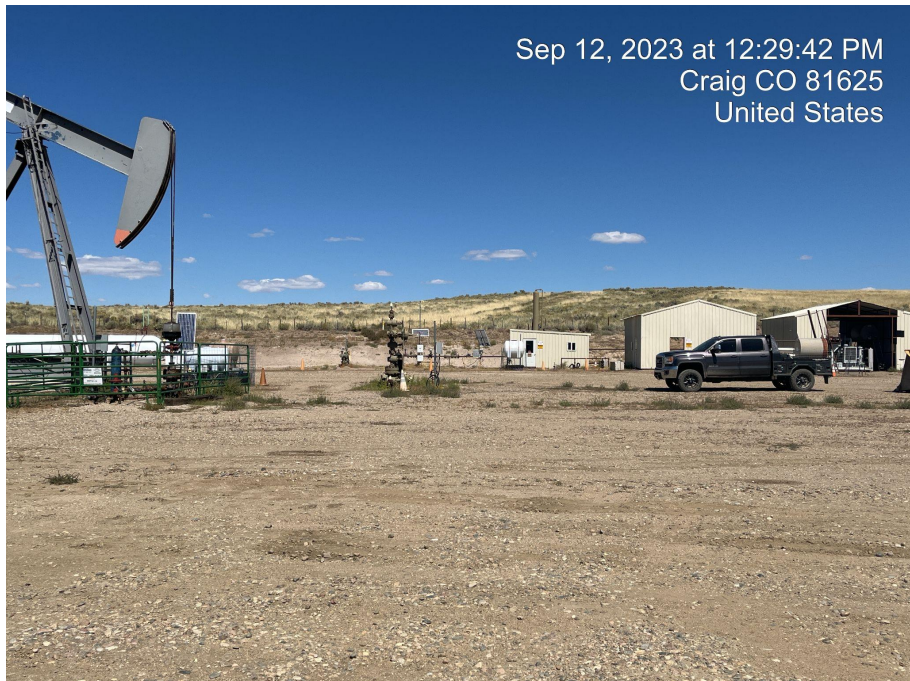
**Photo 3.** Photo taken from the south of the Location shows an overview to the north.

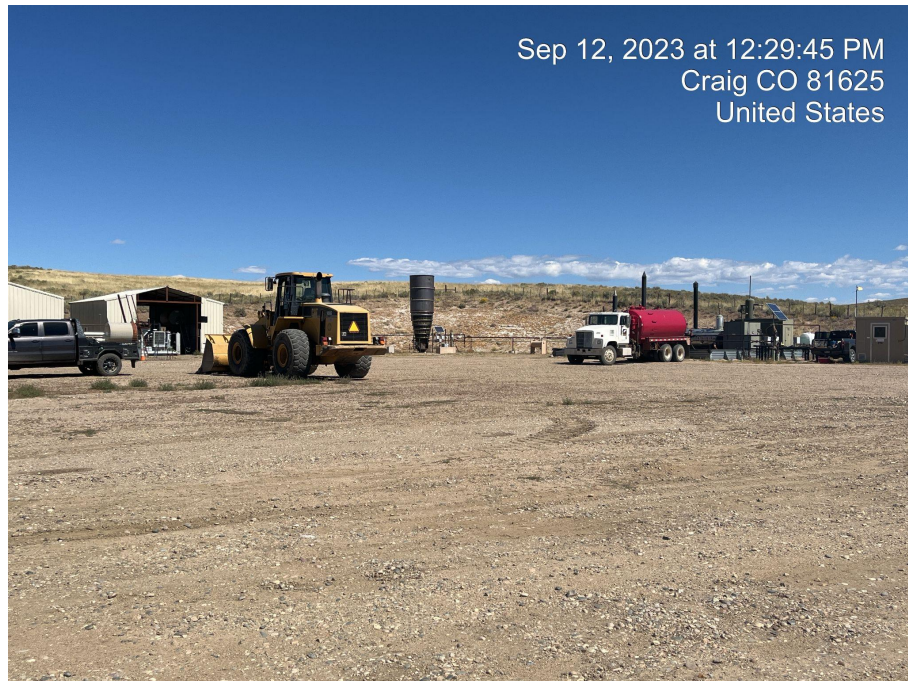
**Photo 4.** Photo taken from the south of the Location shows an overview to the northeast.

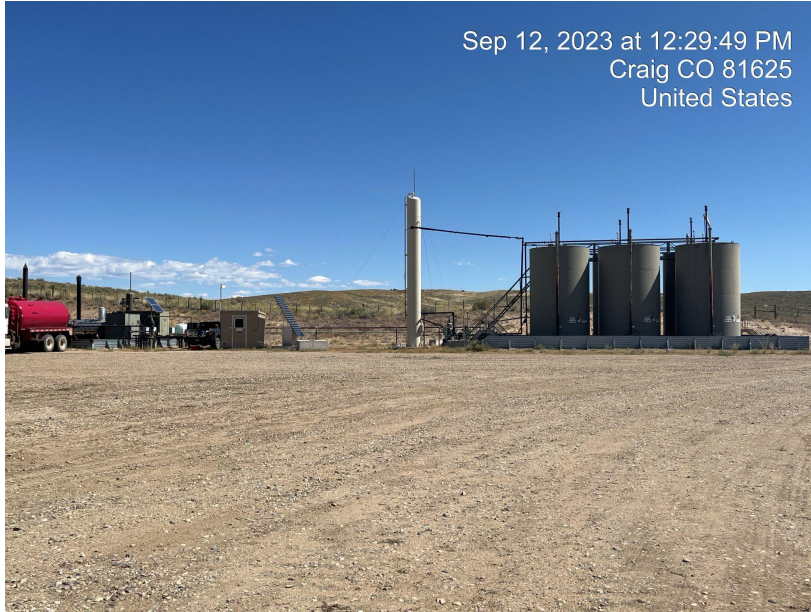
**Photo 5.** Photo taken from the south of the Location shows an overview to the northeast.

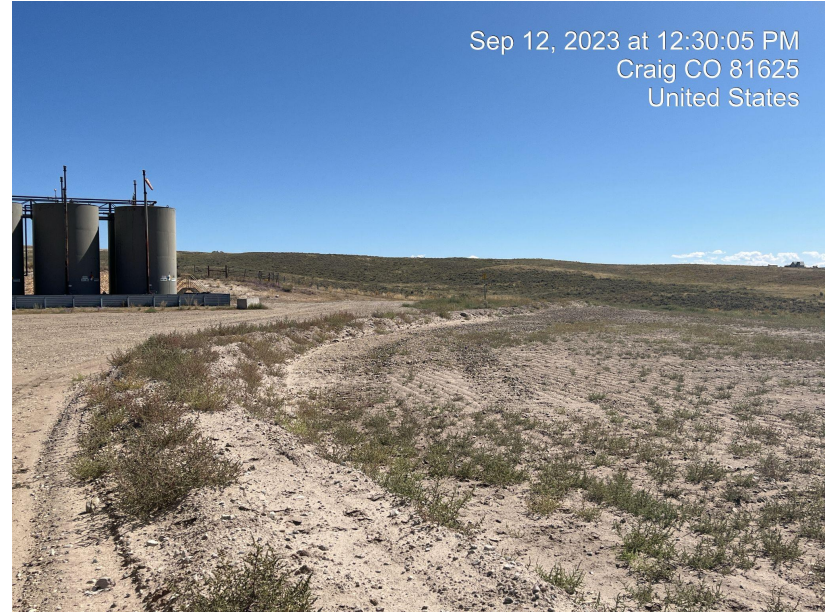
**Photo 6.** Photo taken from the south of the Location shows an overview to the east.

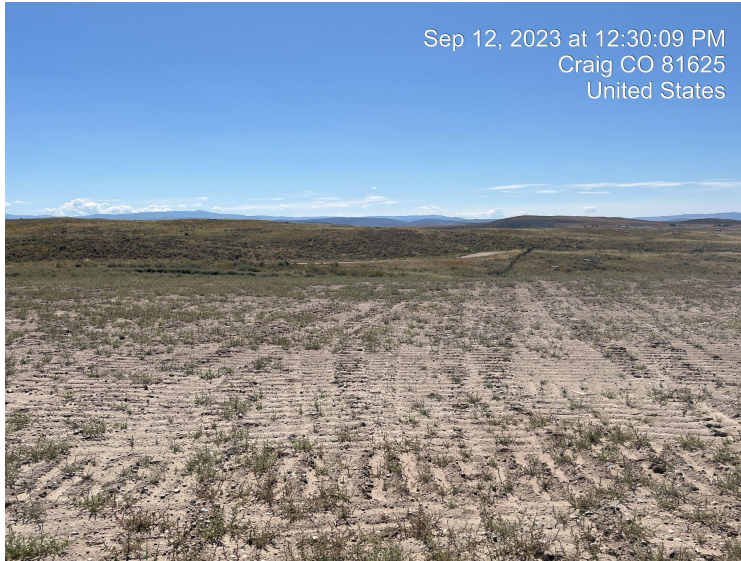
**Photo 7.** Photo taken from the south of the Location shows an overview of Interim Reclamation to the south.

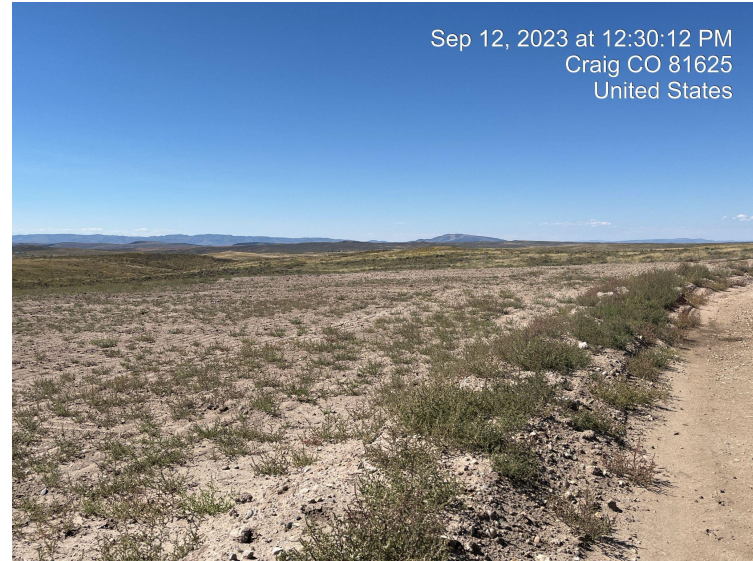
**Photo 8.** Photo taken from the south of the Location shows an overview of Interim Reclamation to the southeast.

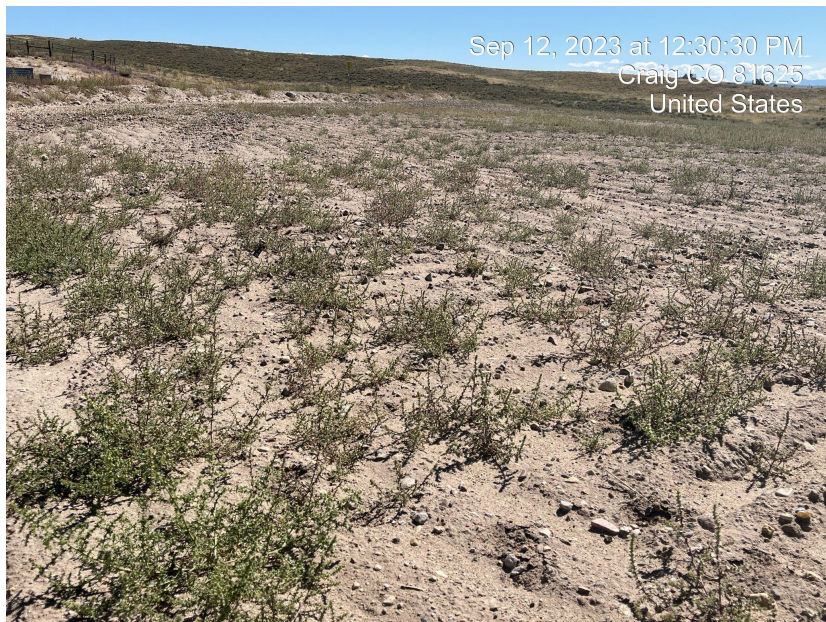
**Photo 9.** Photo taken from the south of the Location shows progress of the Interim Reclamation to the south; appears that area has been tracked.

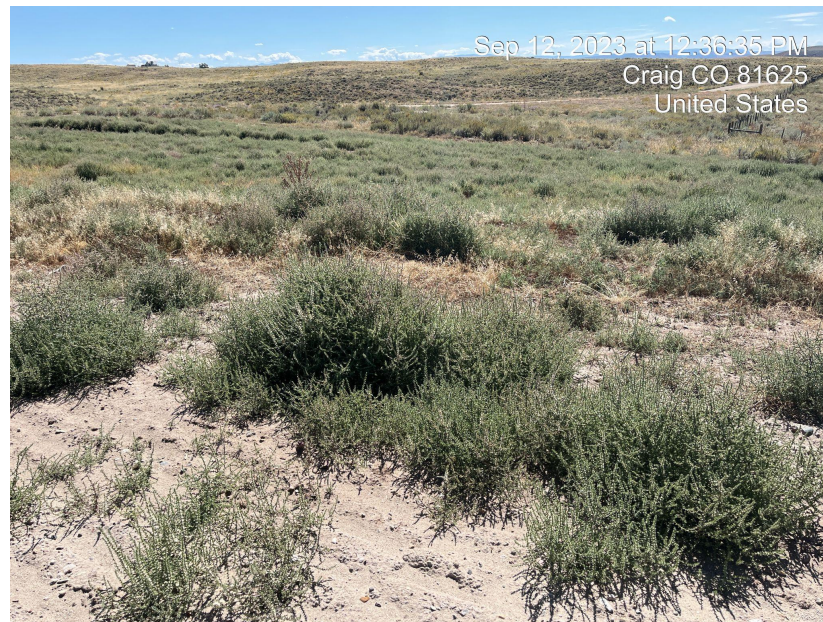
**Photo 10.** Photo taken from the south of the Location shows an overview of Interim Reclamation to the south; observed undesirable species.

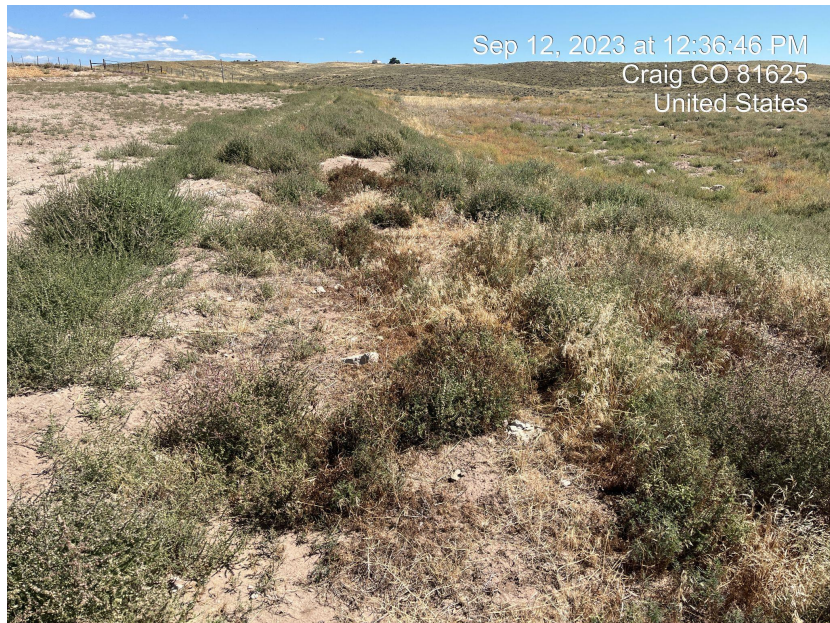
**Photo 11.** Photo of the stockpiled soil pile on the southeast of Location, covered in weeds.

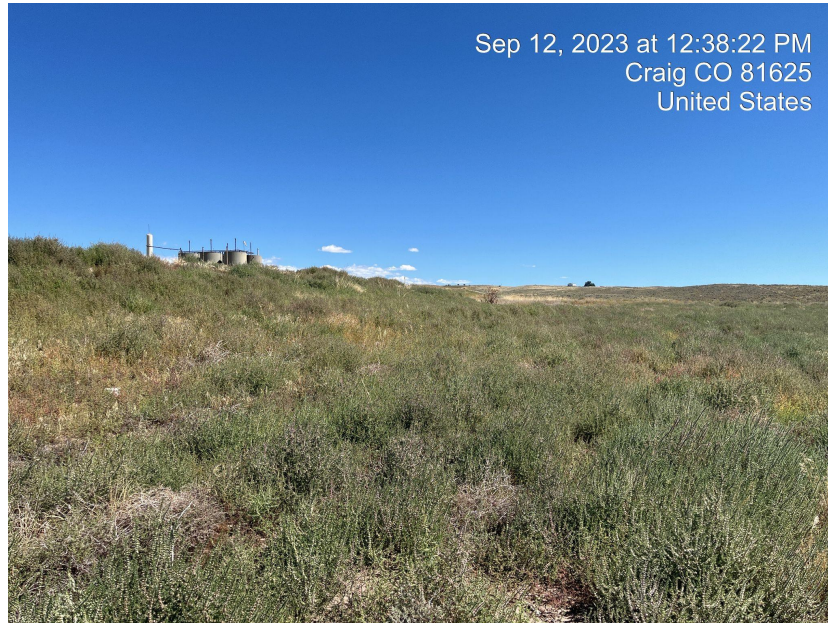
**Photo 12.** Photo of the fill slope south of the Location; weeds abundant.

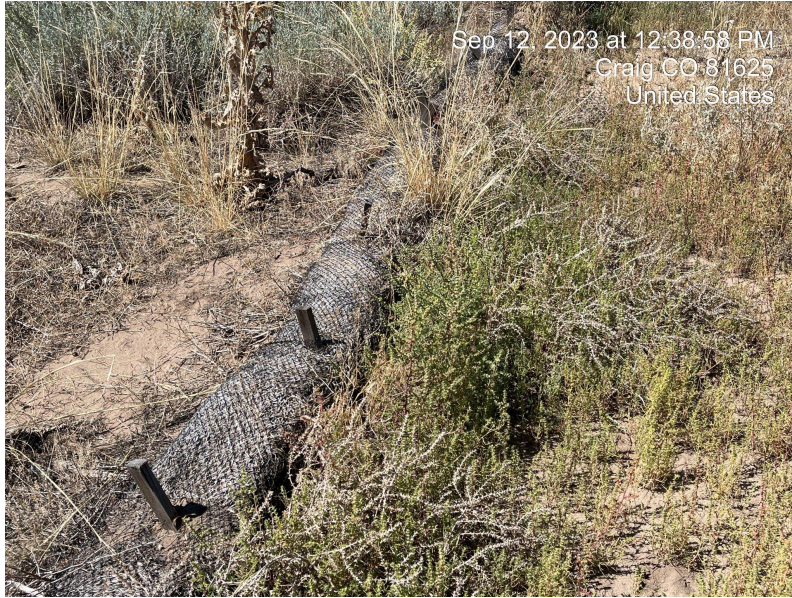
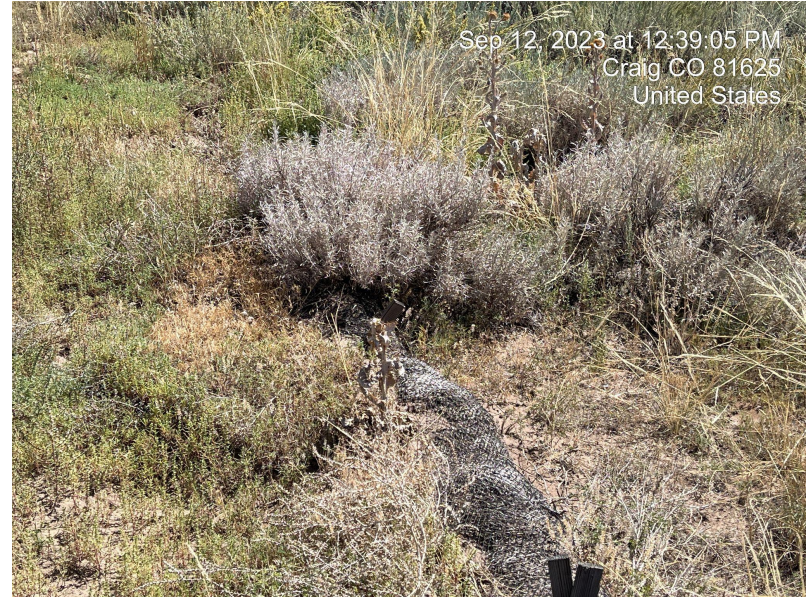
Photo 13 and 14. Wattles at the south end of the fill slope, which have deteriorated and are considered debris.

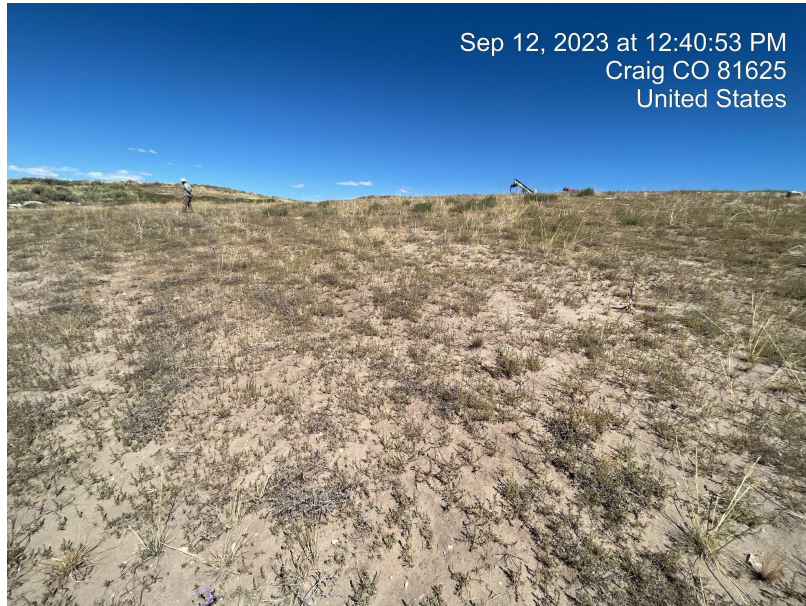
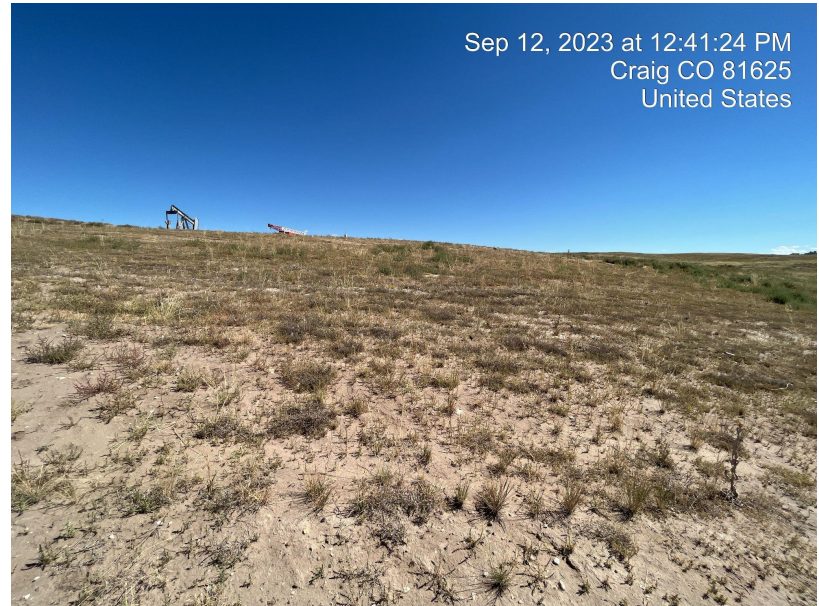
Photo 17 and 18. Erosion occurring on western edge of interim Reclamation area.

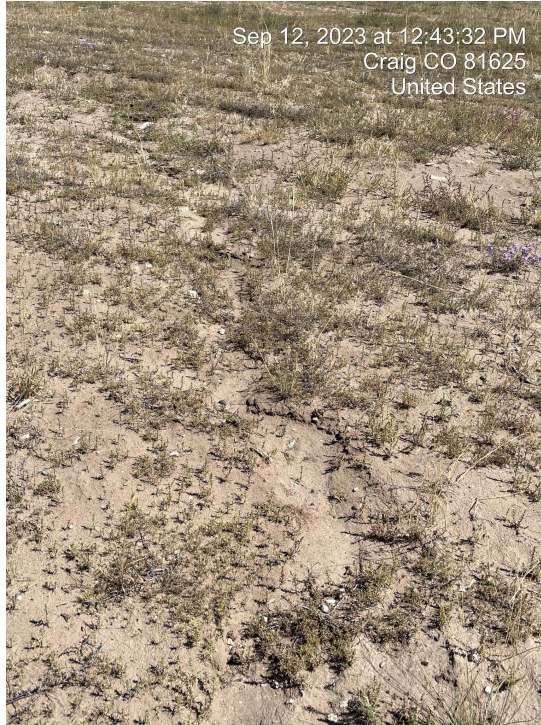
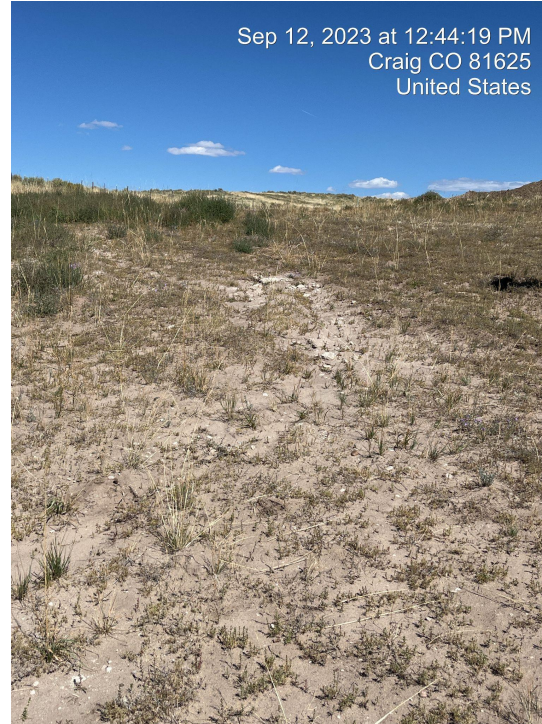
**Photos 19 and 20.** Photos taken on western interim reclamation area; Erosion occurring on western edge of interim Reclamation area.

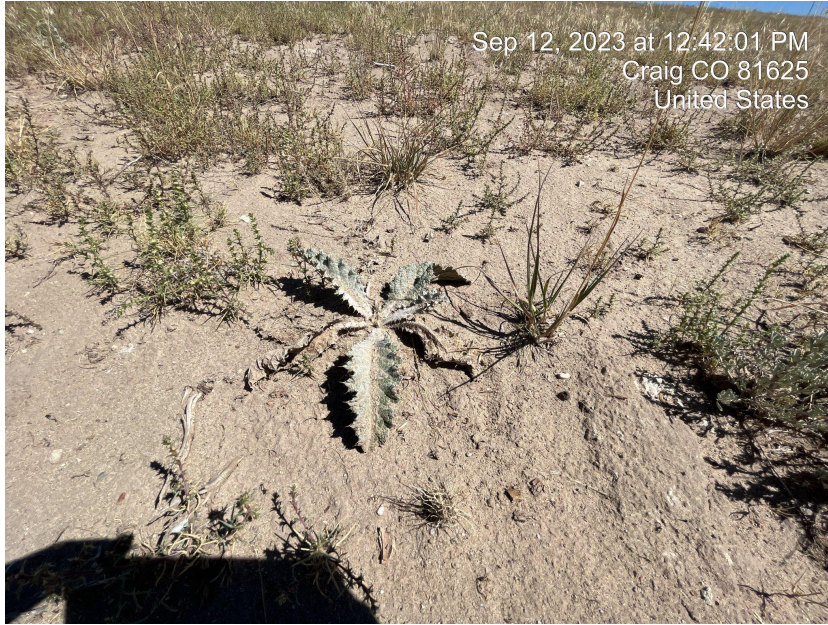
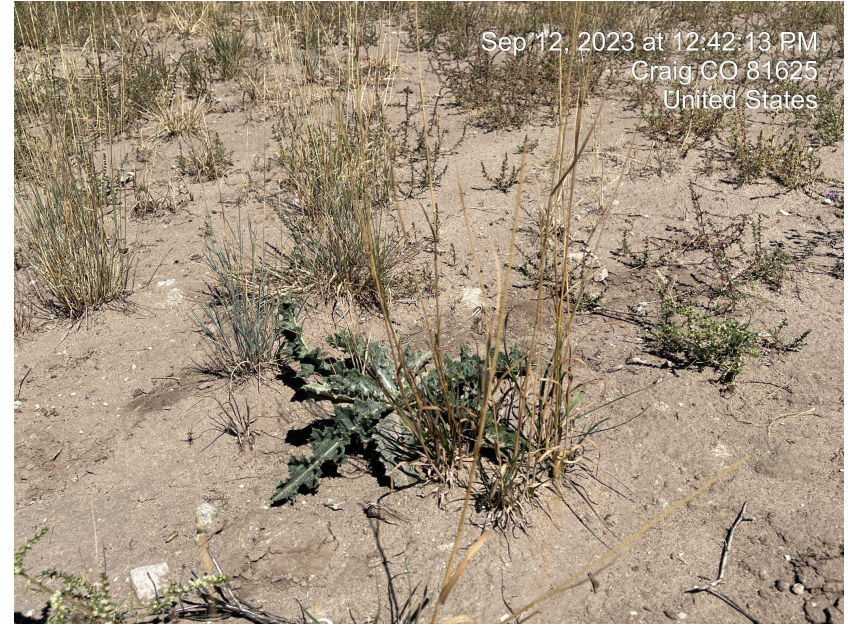
Photo 21 and 22. Noxious weeds present across location.

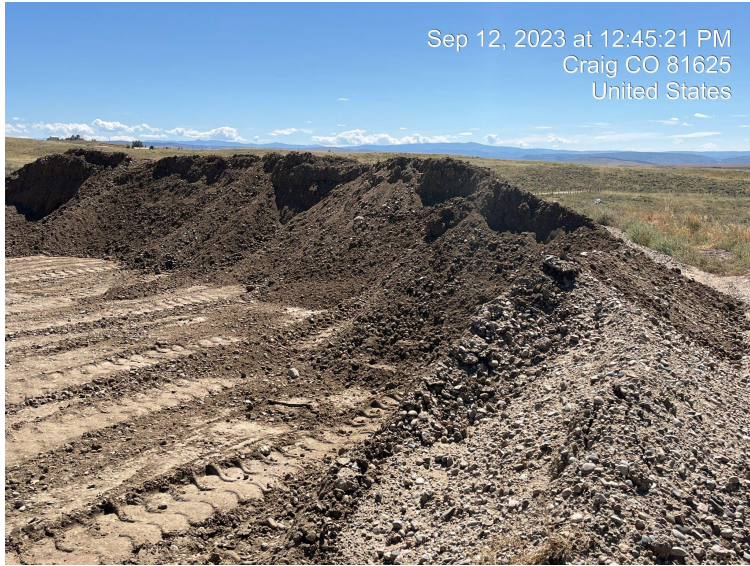
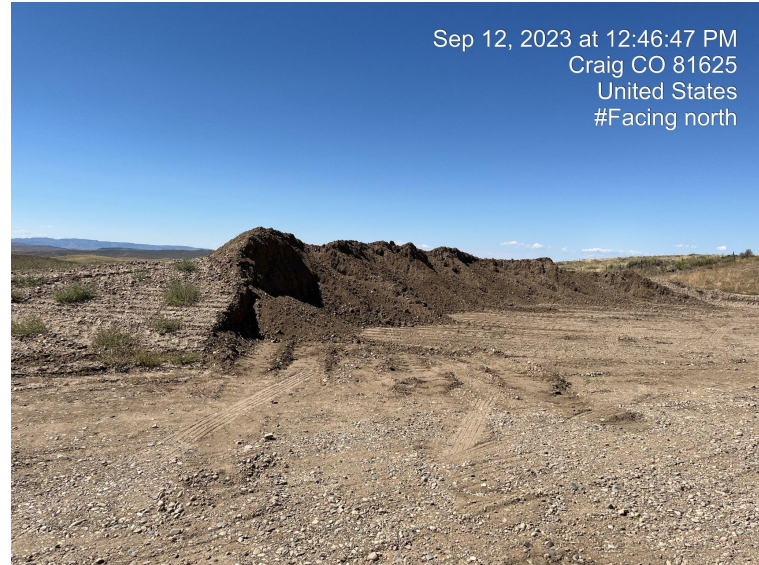
**Photo 23 and 24.** Photo taken of the stockpiled soil on the western edge of the working pad area. Operators were in process of removing soil for use on pad.

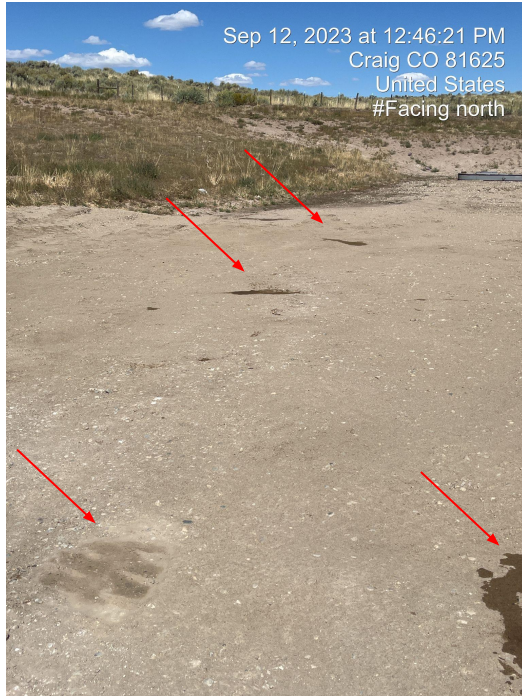
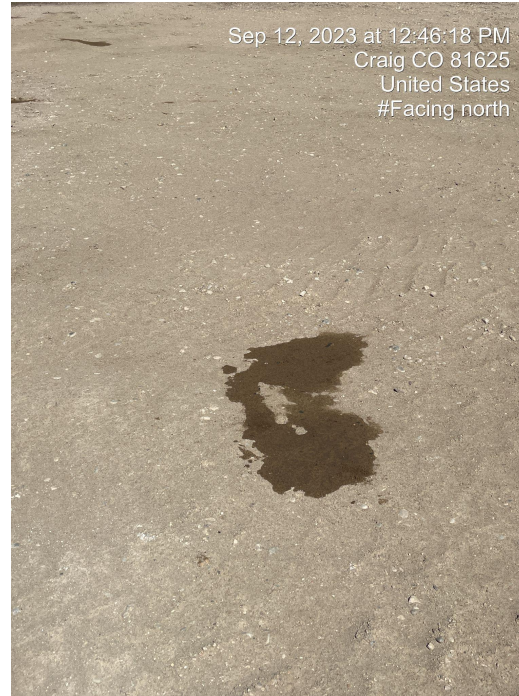
Photo 25 and 26. Stained soils found across the Location. Photos show stained soils taken on western edge of Location facing north.

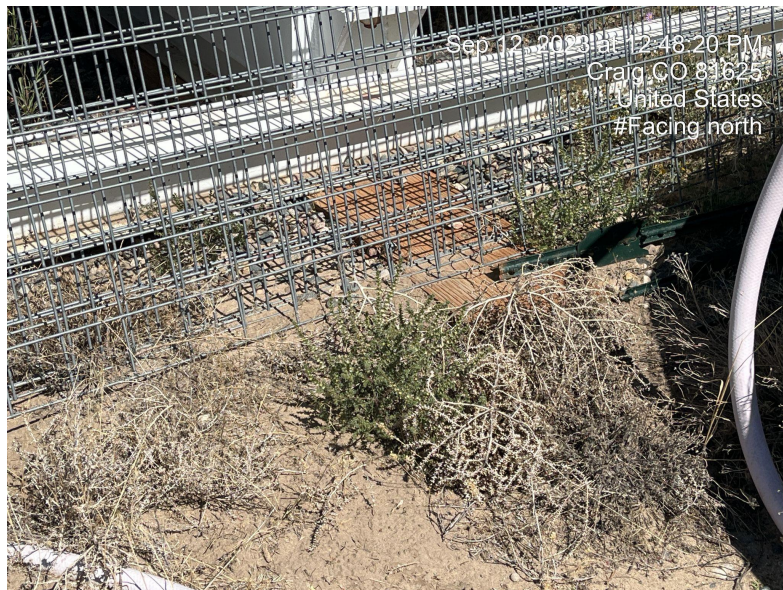
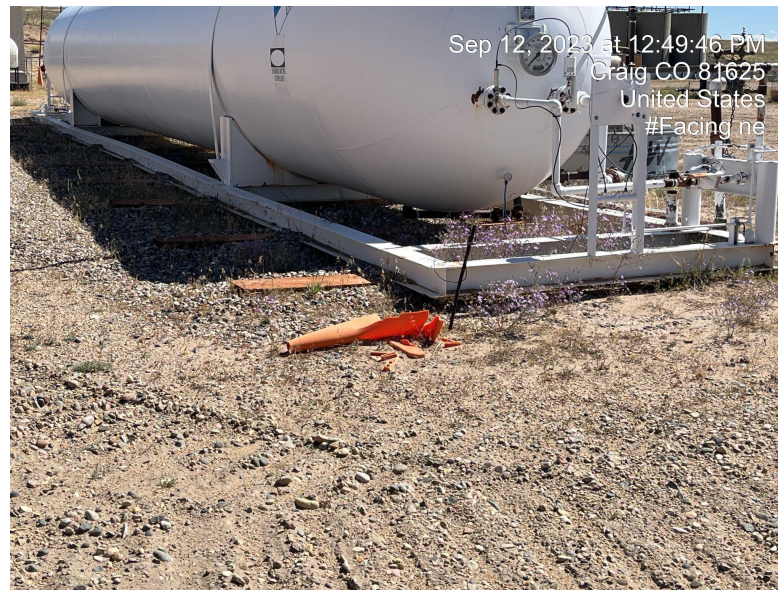
Photo 27 and 28. Photo taken near tank at western edge of Location. Trash and unused equipment found throughout the Location.

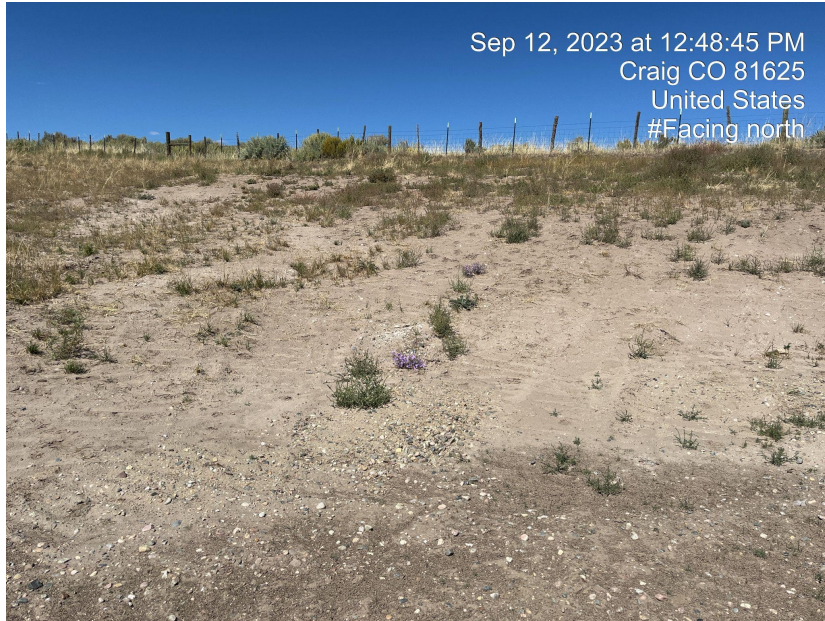
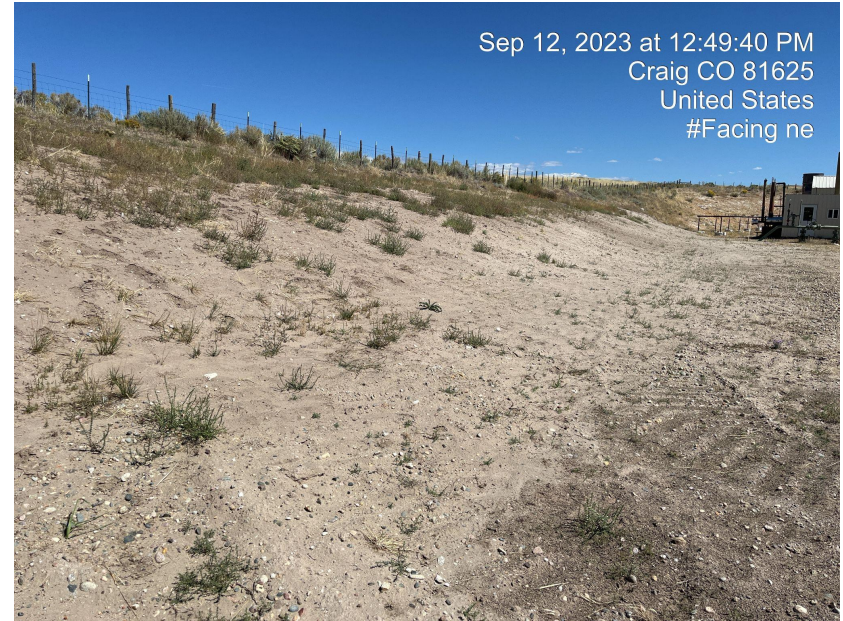
**Photo 29 and 30.** Overview of cut slope on western edge of Location. It appears that the slope was temporarily tracked, but has no additional soil stabilizing BMPs.

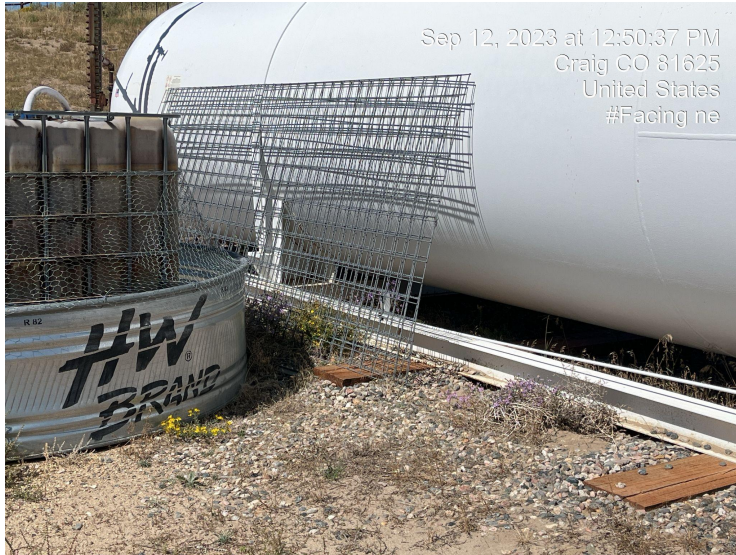
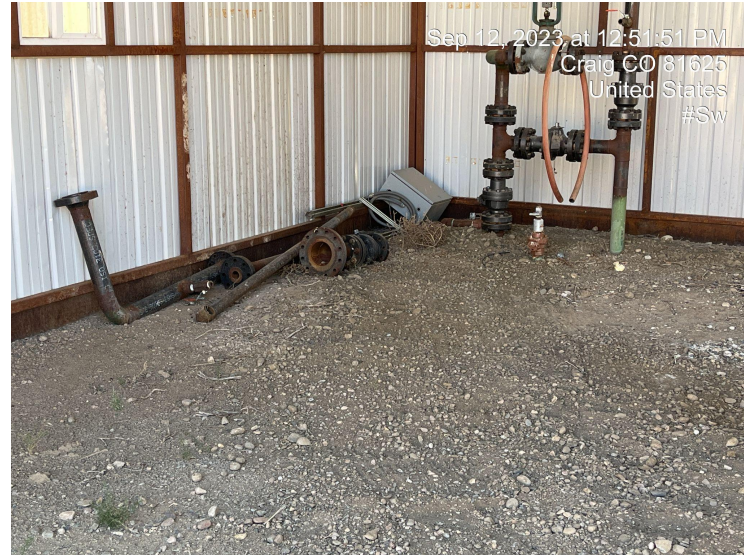
Photo 31 and 32. Trash and unused equipment found throughout the Location; hog panels near tank on western edge of Location (left) and within shed (right).

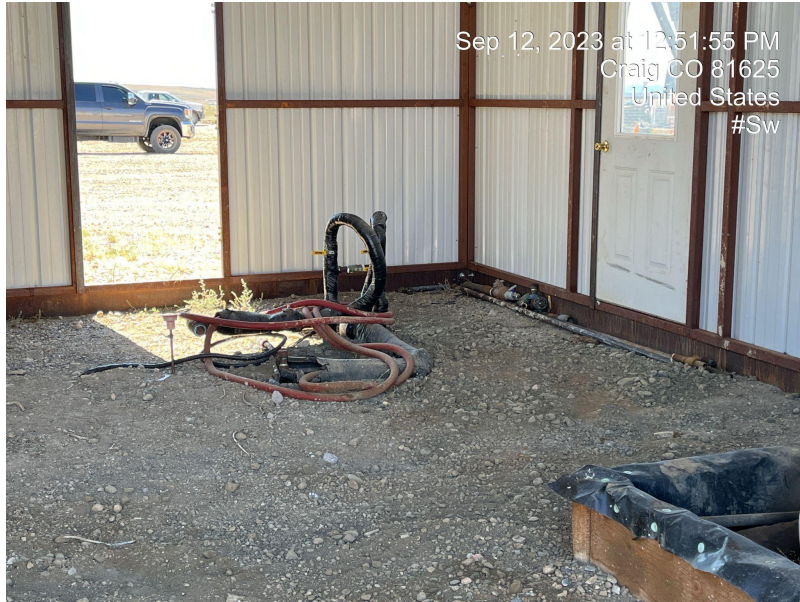
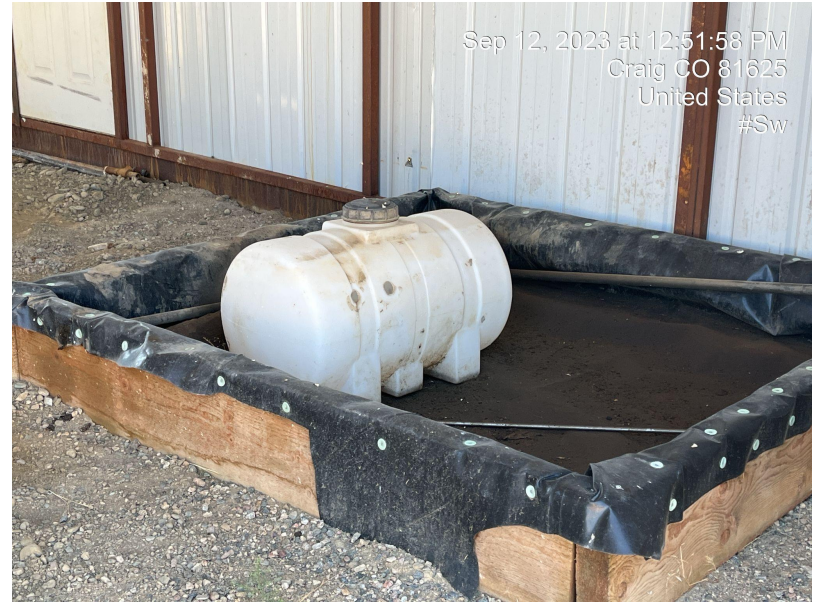
Photo 33 and 34. Trash and unused equipment found throughout the Location; photo taken within shed.

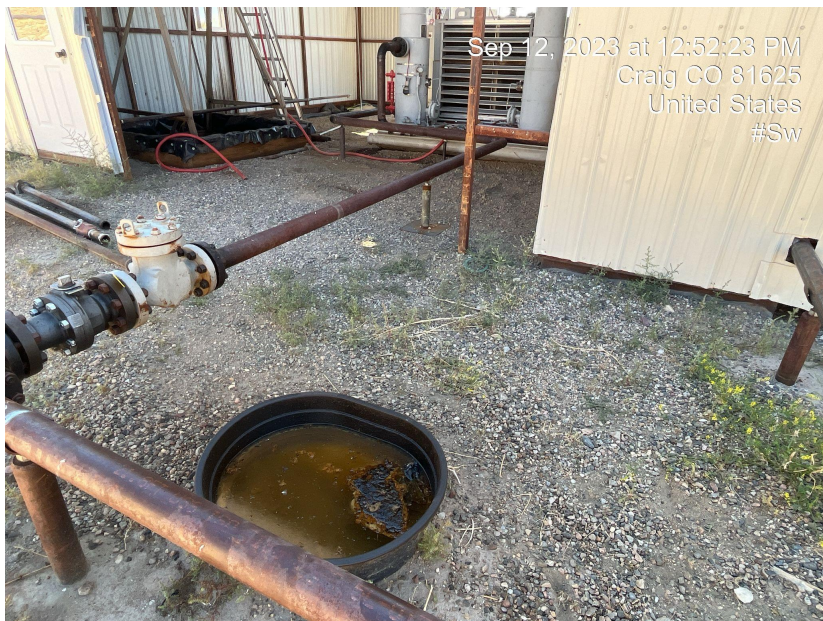
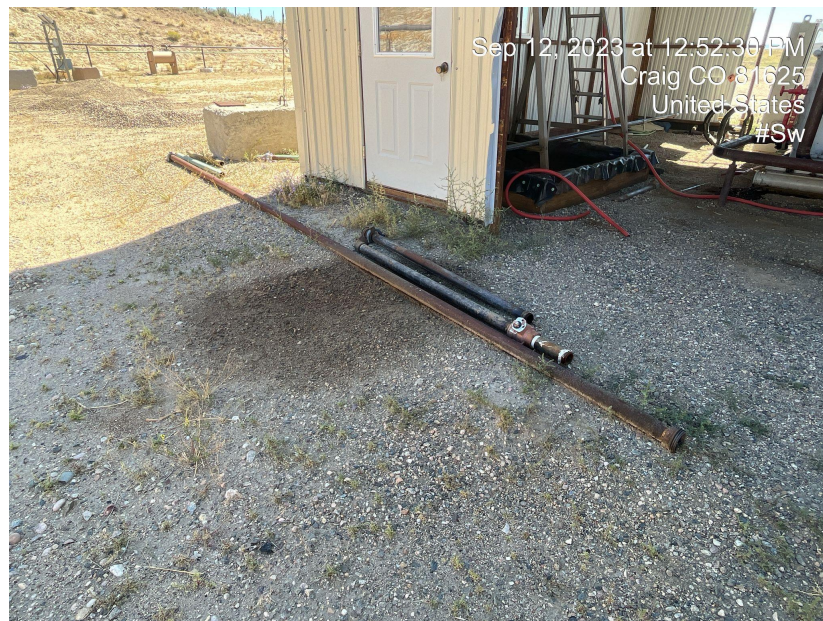
Photo 35 and 36. Photo taken north of shed; Trash and unused equipment found throughout the Location; stained soils observed.

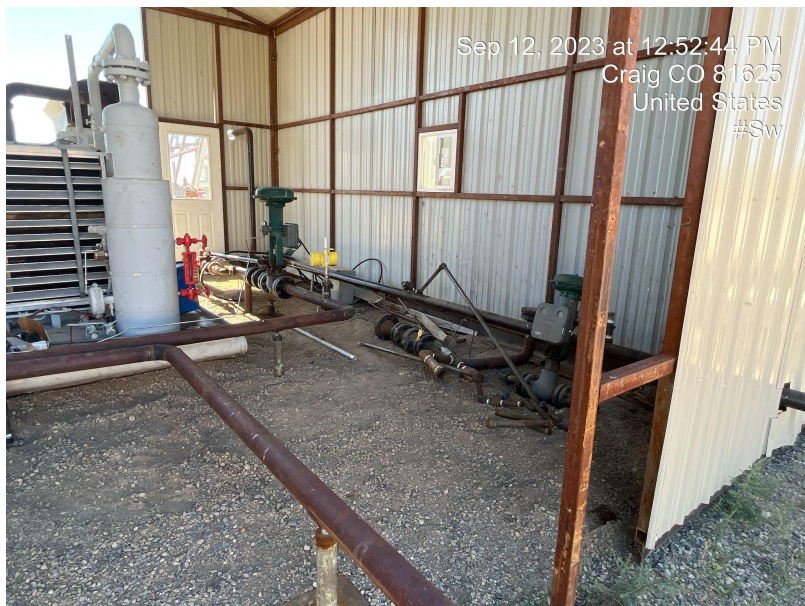
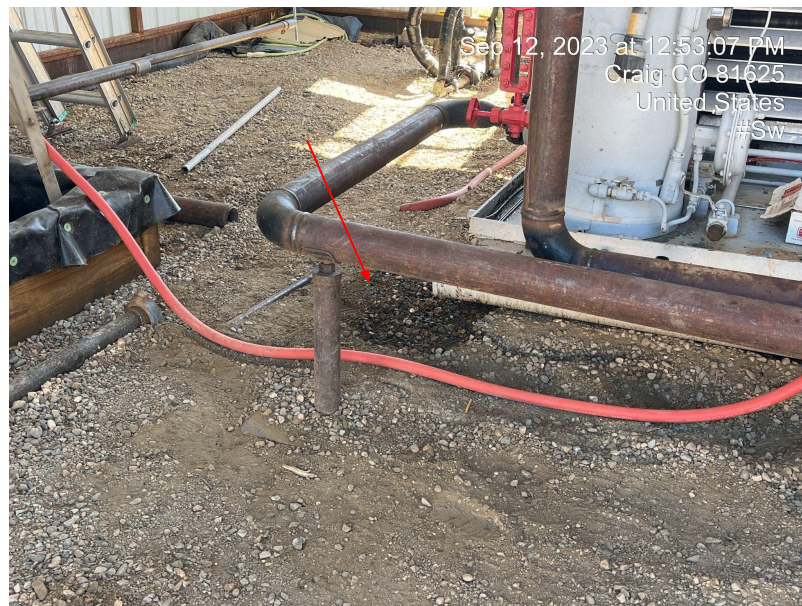
**Photo 37 and 38.** Photo taken north of shed (left); Unused equipment found throughout the Location; Within shed, stained soils observed (right).

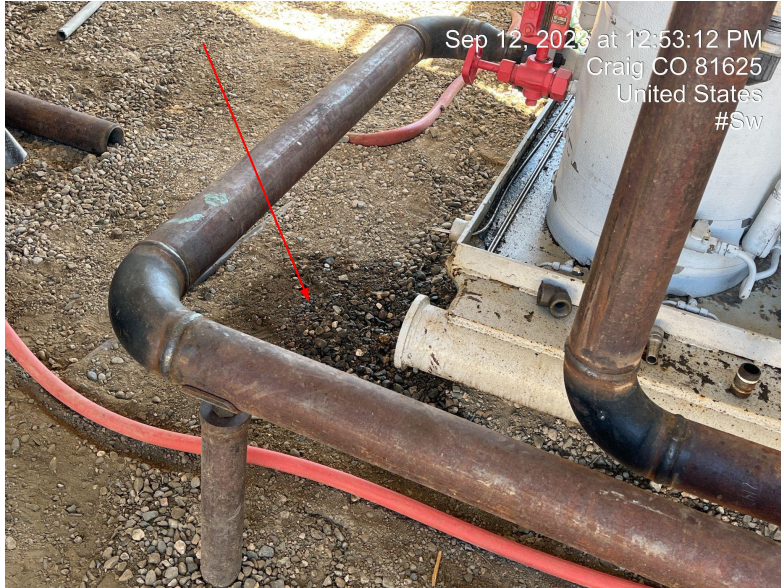
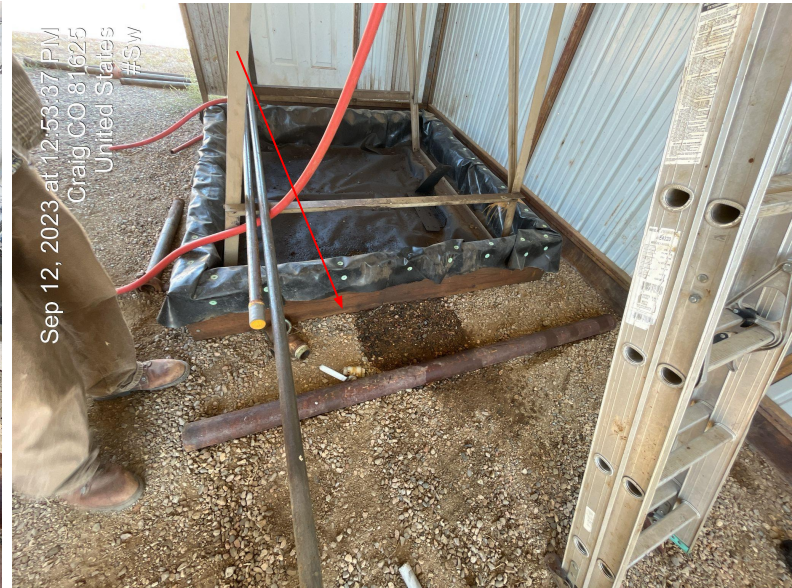
Photo 39 and 40. Stained soils found within shed underneath pipe (left) and underneath engine oil tank (right).

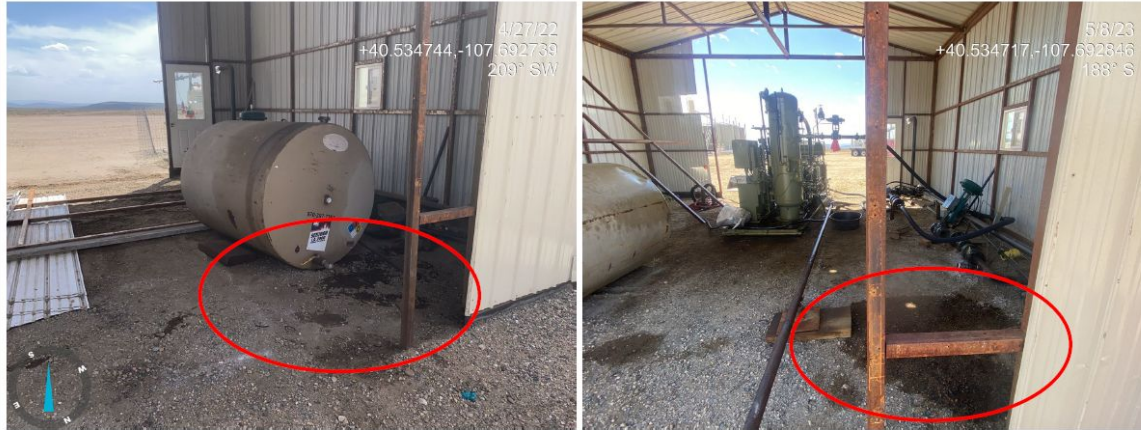
Photo 10. Photos show stained soils and unused equipment and debris throughout the shed Located at the northeast of the Location. Note the staining within the shed (circled) has increased in size and coverage since from the 4/27/22 inspection (left) to the current 5/8/23 inspection (right).

Photo 40.a: Photos above are from previous inspections dated 4/27/2022 and 5/8/2023, where the tank appears to have leaked; stained soils are observed in areas where tank was located.

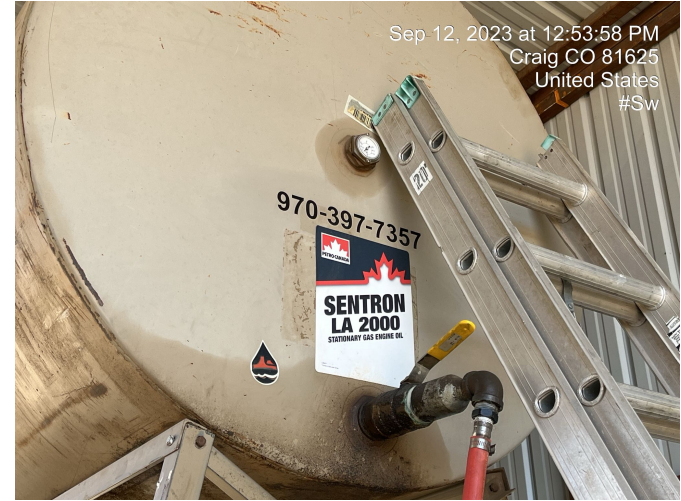
Photo 40.B. During the current inspection 9/12/23, it was observed that the same tank from the previous inspection (#702801510) was lifted onto a stand. The tank still appears to be leaking, resulting in additional spills, which is seen in Photo 40.

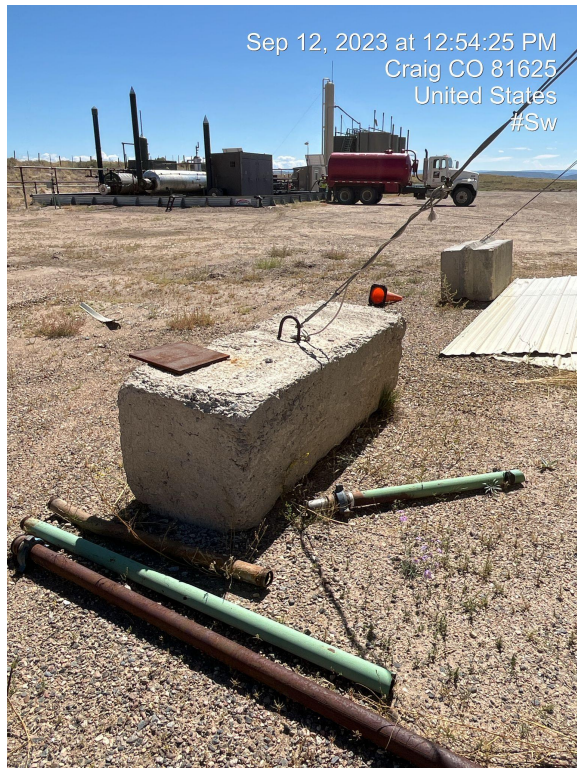
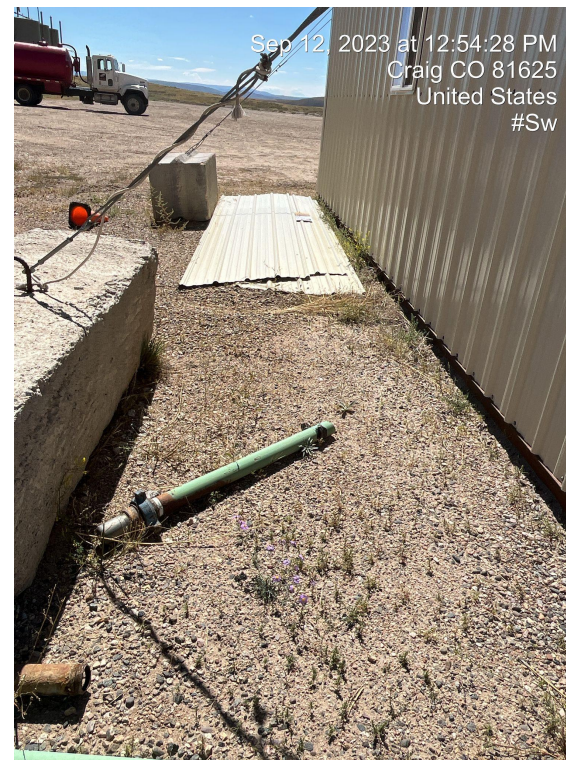
Photo 41 and 42. Unused equipment found throughout the Location; photo taken east of shed.

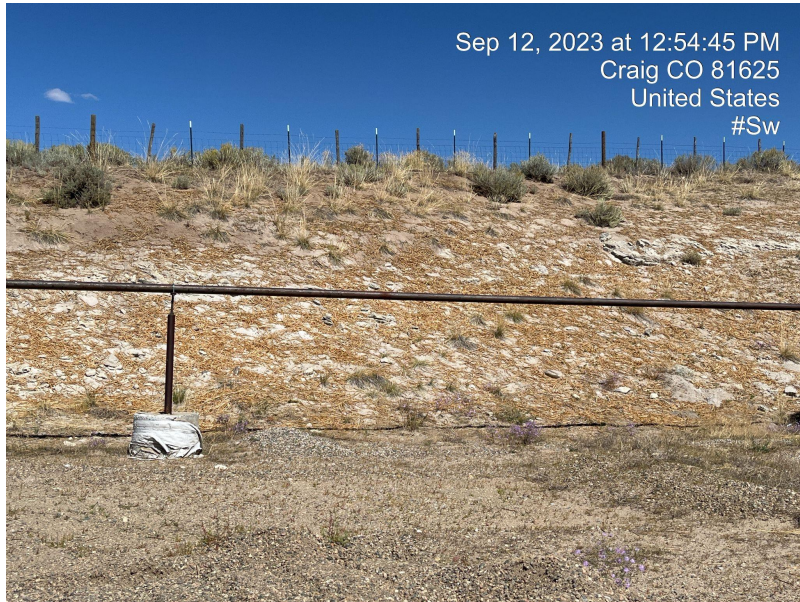
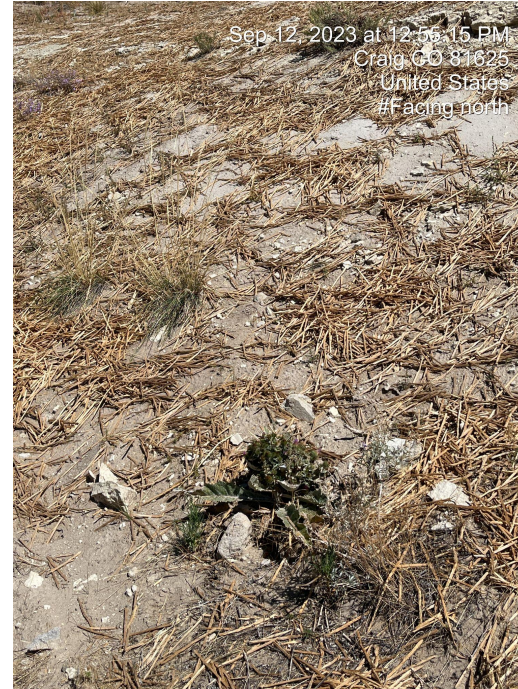
Photo 43 and 44. Photo taken of cut slope on eastern edge of Location; wood straw used for stabilization.

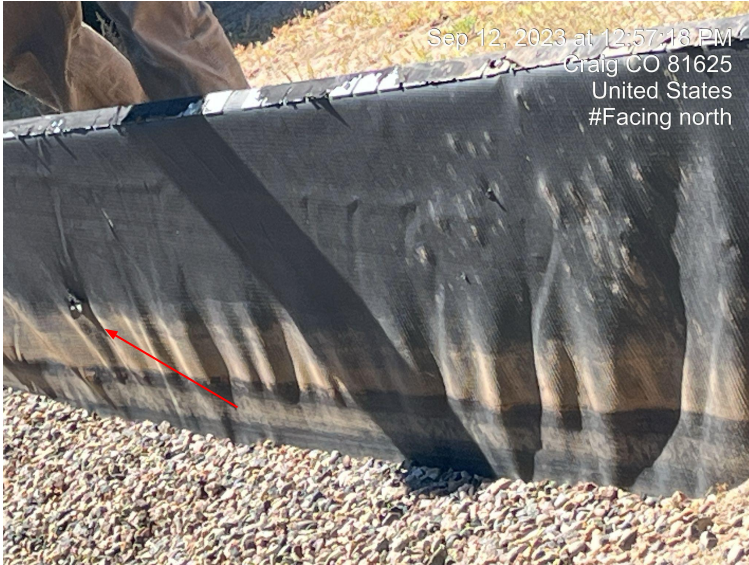
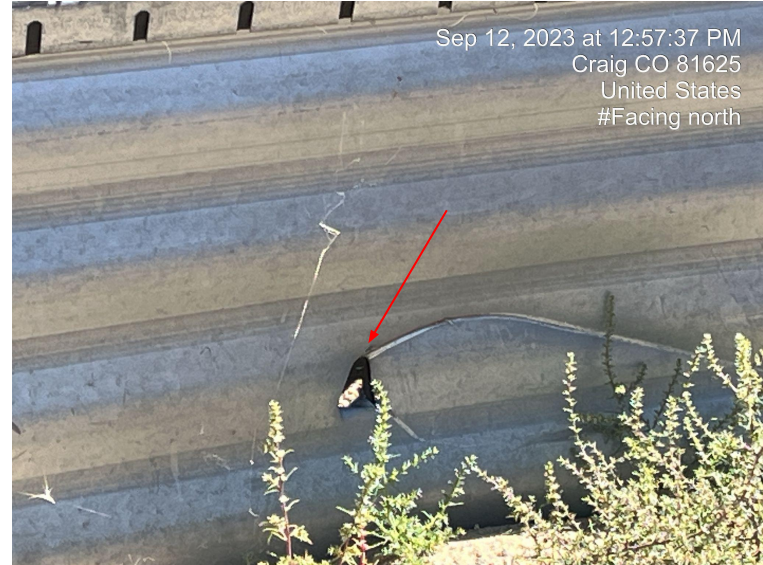
**Photo 45 and 46.** Photo taken of secondary containment on eastern edge of Location. Liner and metal containment contains a puncture mark.
