# Inspection Photos

Operator: Beeman Oil and Gas Inc 7125

Location Name: Diamond T Sheep

Inspection Document #: 696205276

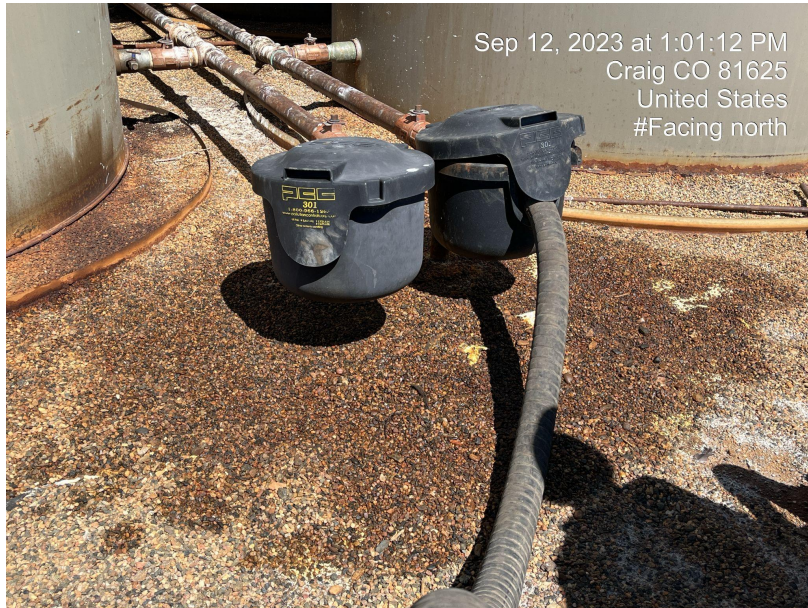
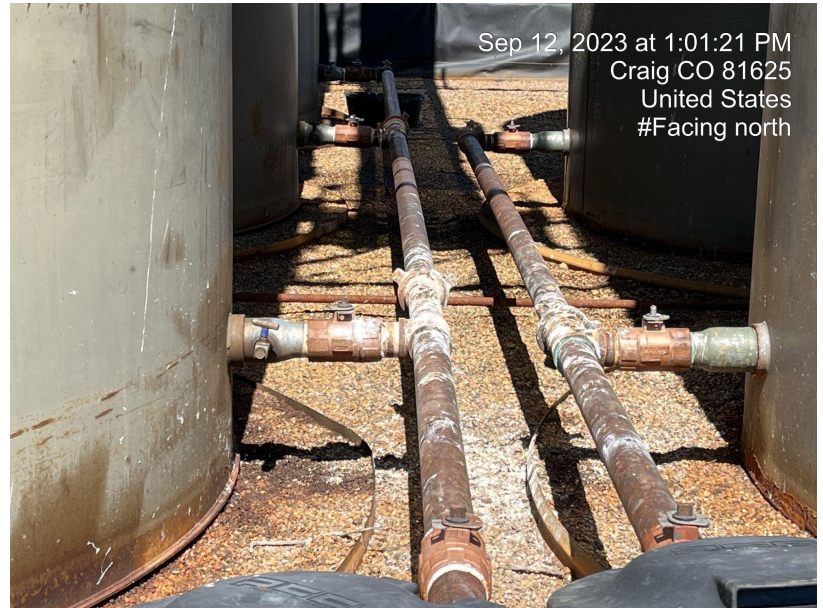
Photo 47 and 48. Photo taken of stained soils within secondary tank containment on southeast Location.

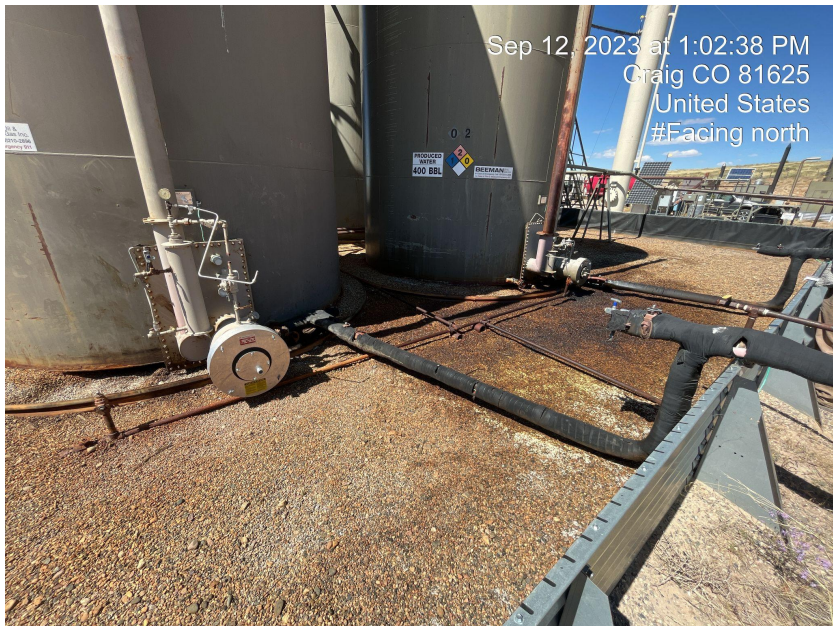
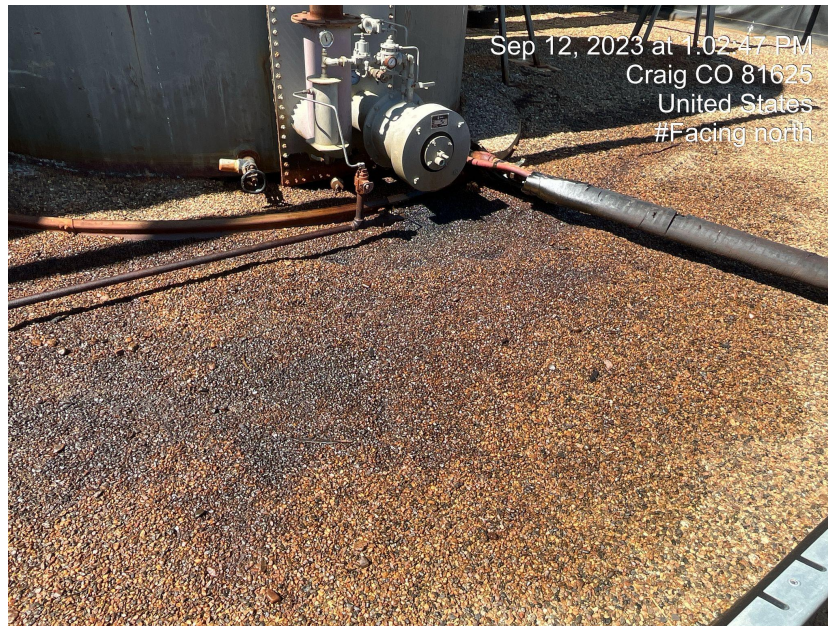
**Photo 49 and 50.** Photo taken of stained soils within secondary tank containment on southeast Location; active leak from tank (right).

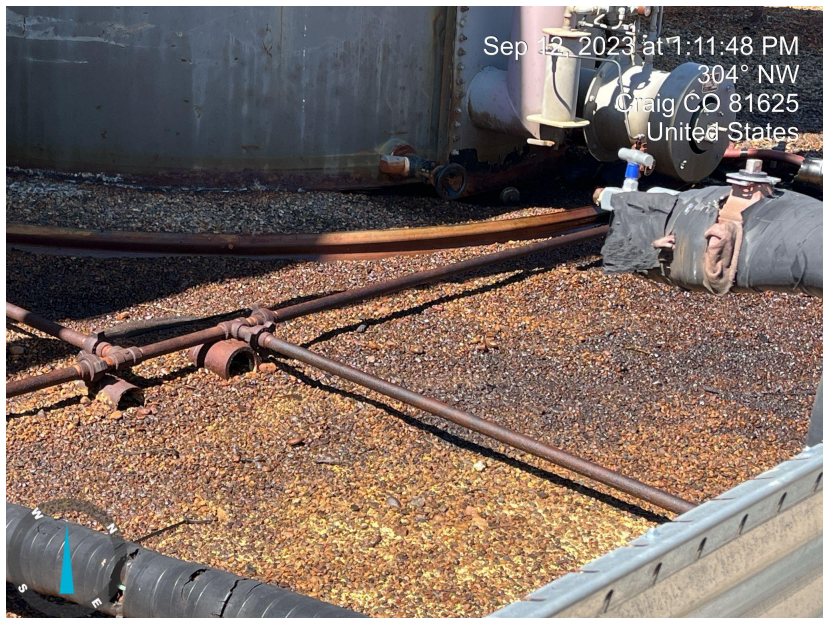
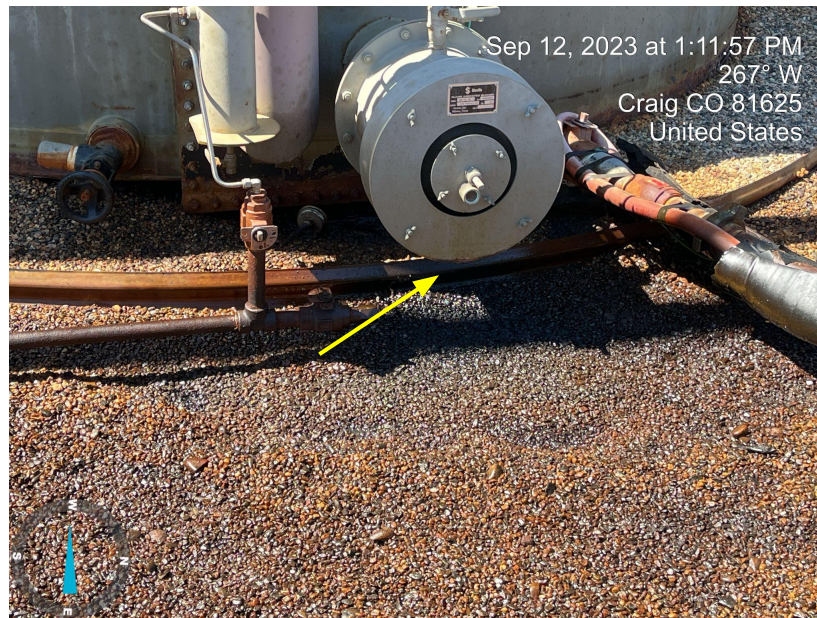
Photo 51 and 52. Photo taken of stained soils within secondary tank containment on southeast Location; active leak from tank (right).

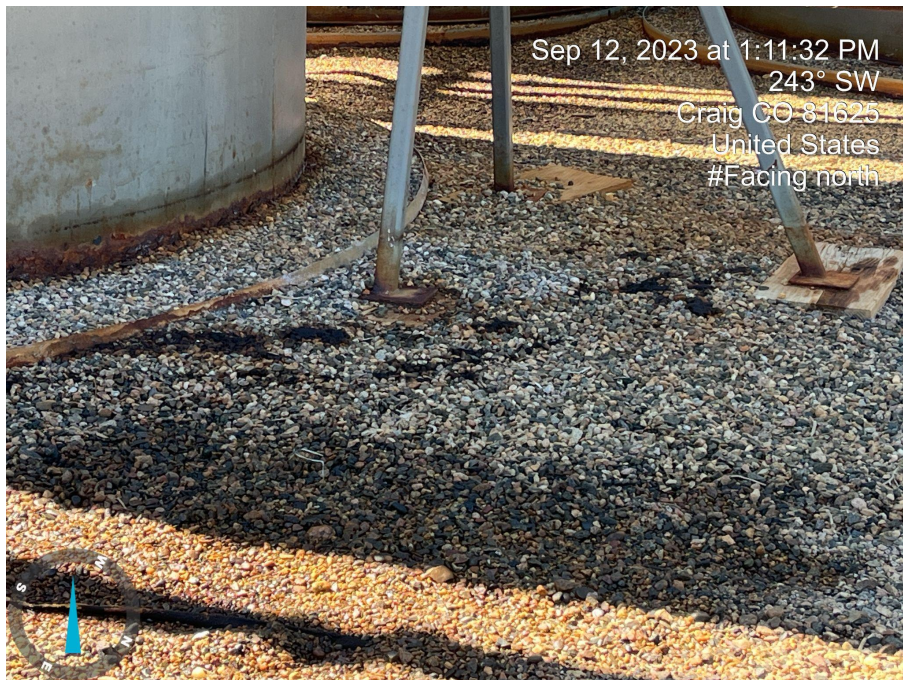
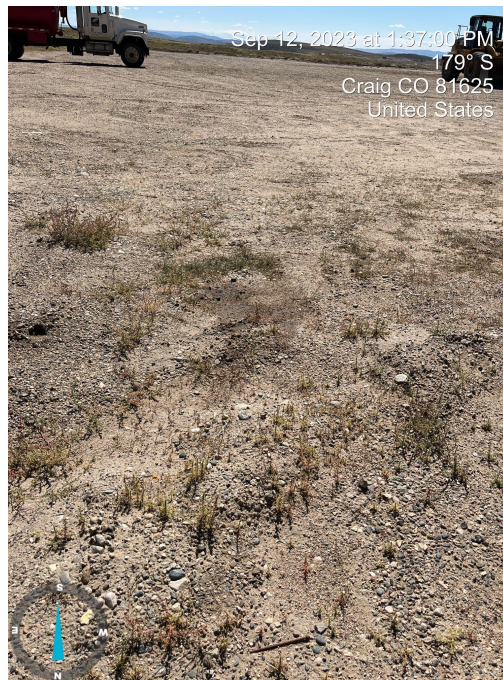
Photo 53 and 54. Photo taken of stained soils within secondary tank containment on southeast Location (left); stained soils on working pad area (right).
