Inspection Photos
Maralex Gosney 1
API 067-06570

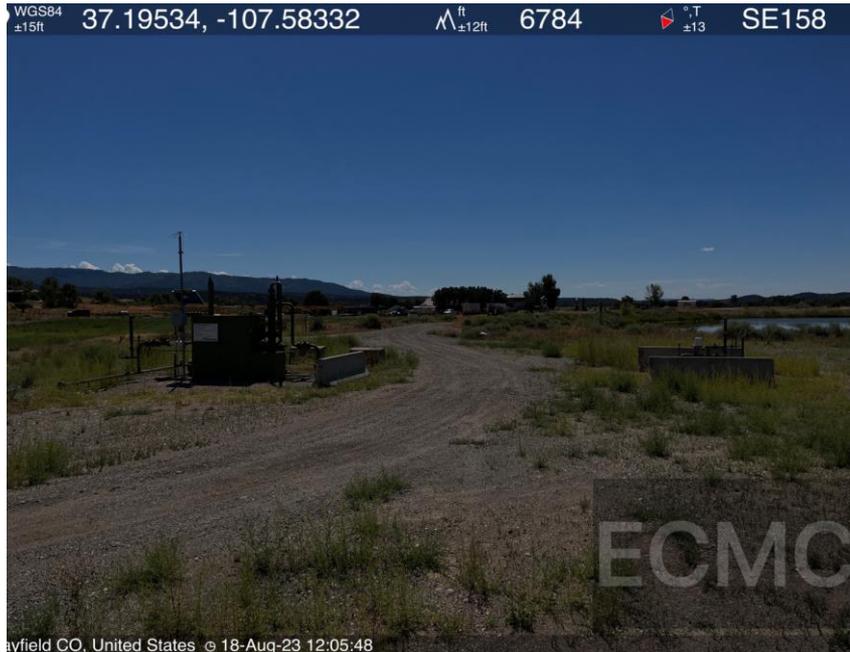
Photo #1. View of corrective action identified in FIR Doc.#712700541.

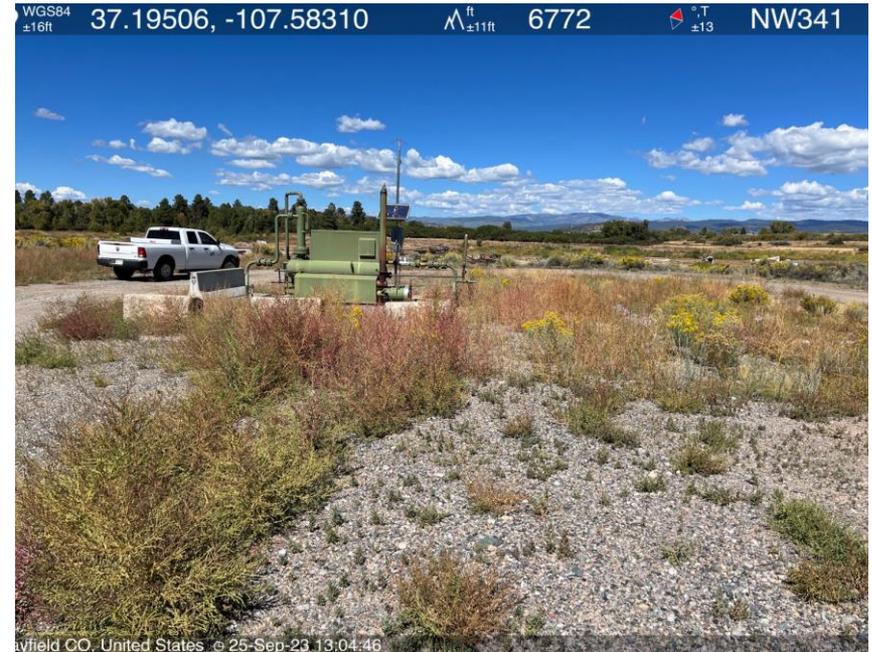
Photo #2. View of corrective action not completed. Weeds growing around separator, wellhead, and across location.

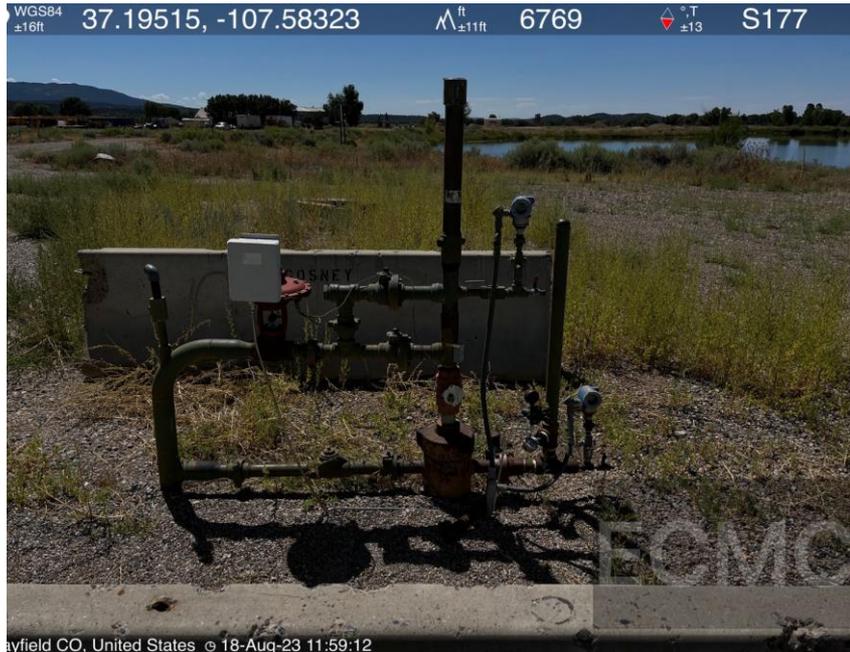
Photo #3. View of corrective action identified in FIR Doc.#712700541.

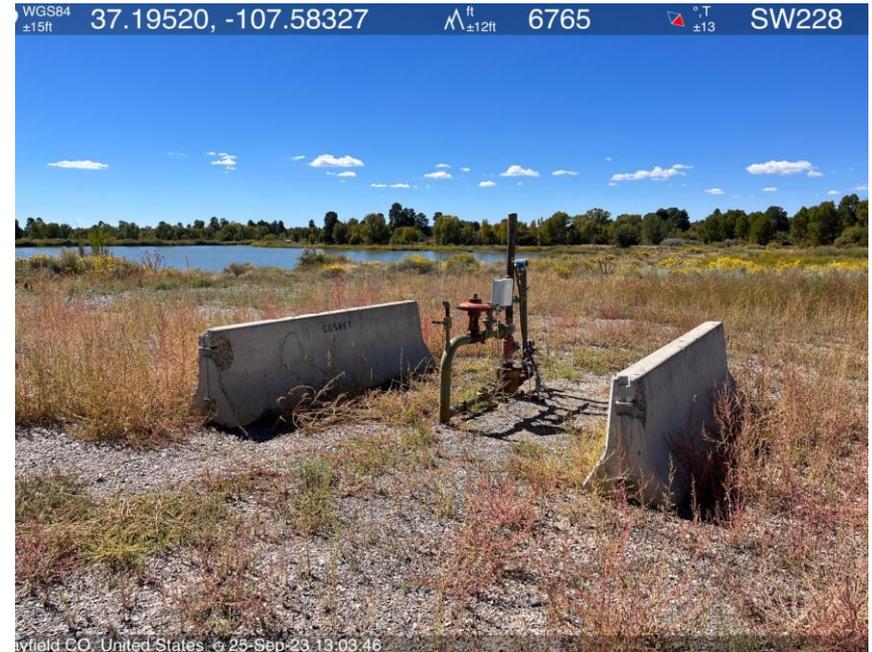
Photo #4. View of corrective action not completed. Weeds growing around wellhead, separator, and across location.

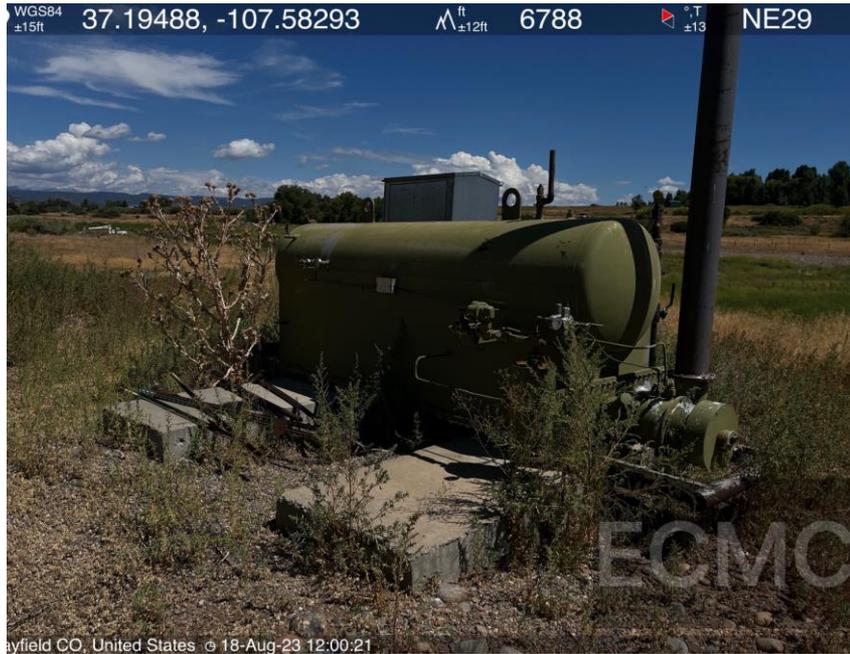
**Photo #5. View of corrective action identified in FIR
Doc.#712700541.**

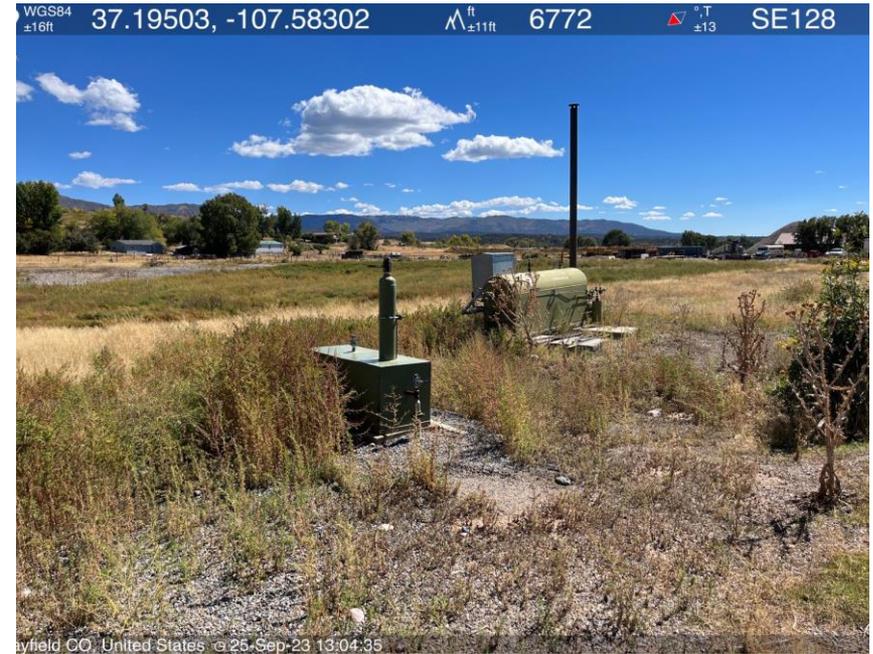
**Photo #6. View of corrective action not completed. Weeds
growing around wellhead, separator, and across location.**
