Inspection Photos Maralex Gosney 1-A API 067-09255

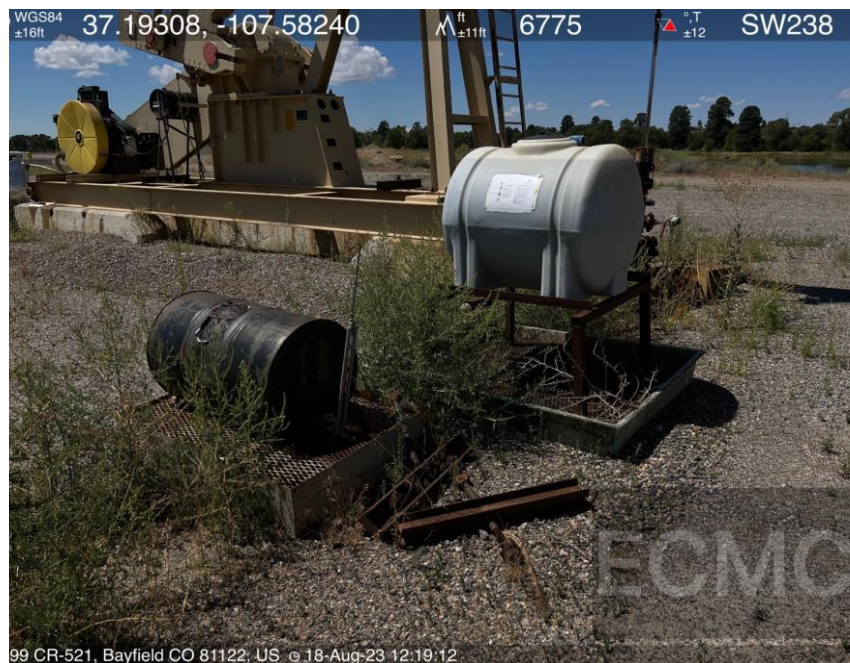
Photo #1. View of corrective action identified in FIR Doc.#712700542.

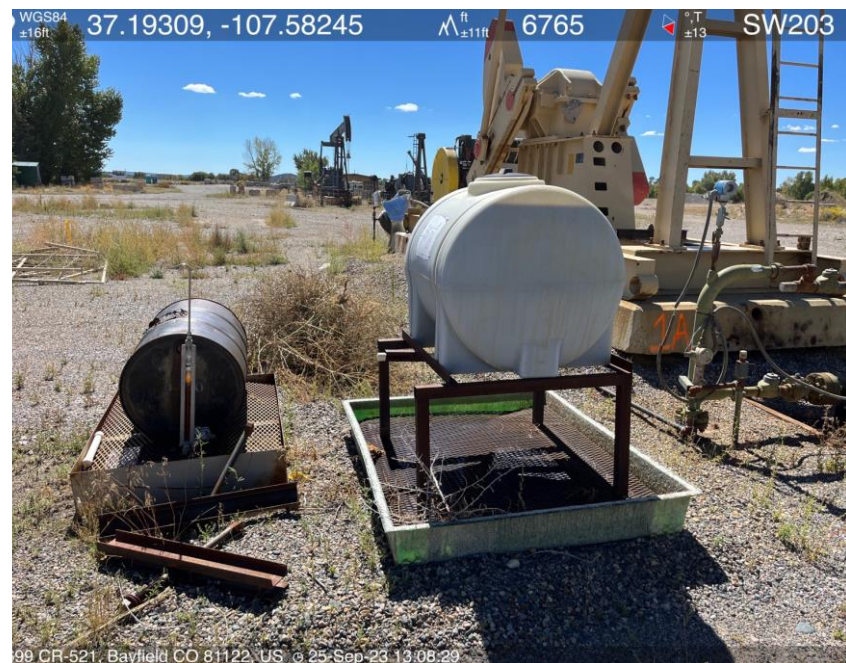
Photo #2. View of corrective action not completed at the #1-A wellhead, disconnected containers.

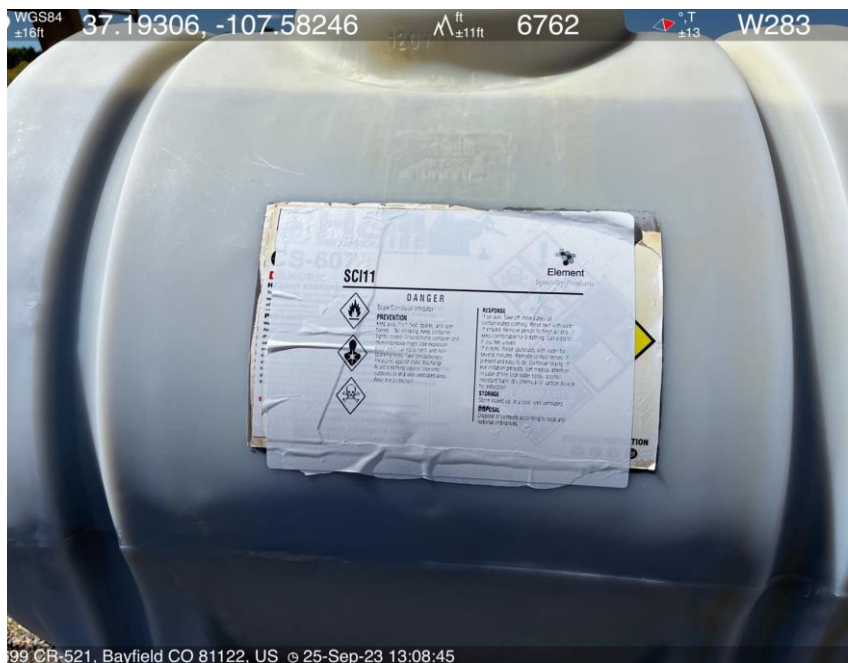
Photo #3. View of non-legible container labeling at the #1-A wellhead.

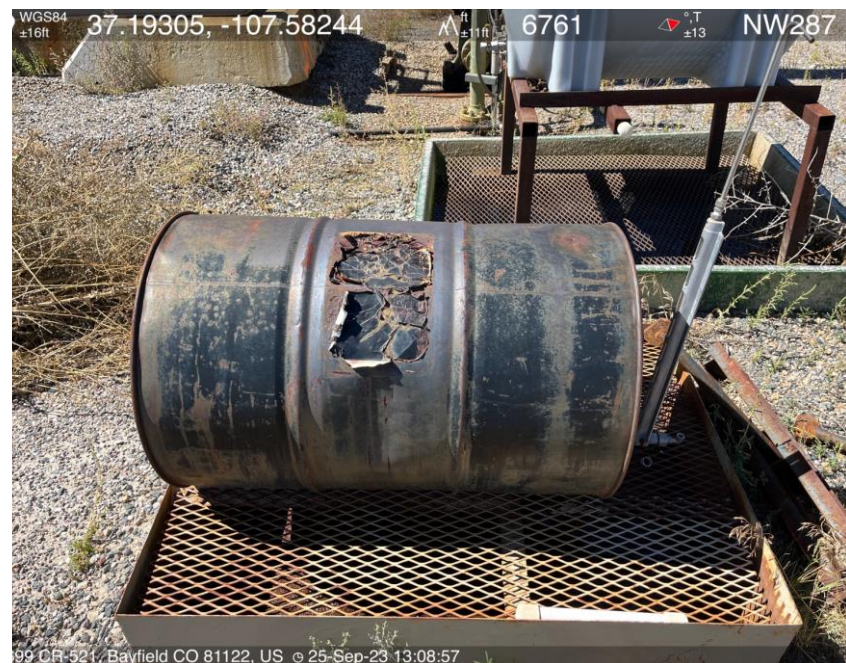
Photo #4. View of non-legible container labeling at the #1-A wellhead.

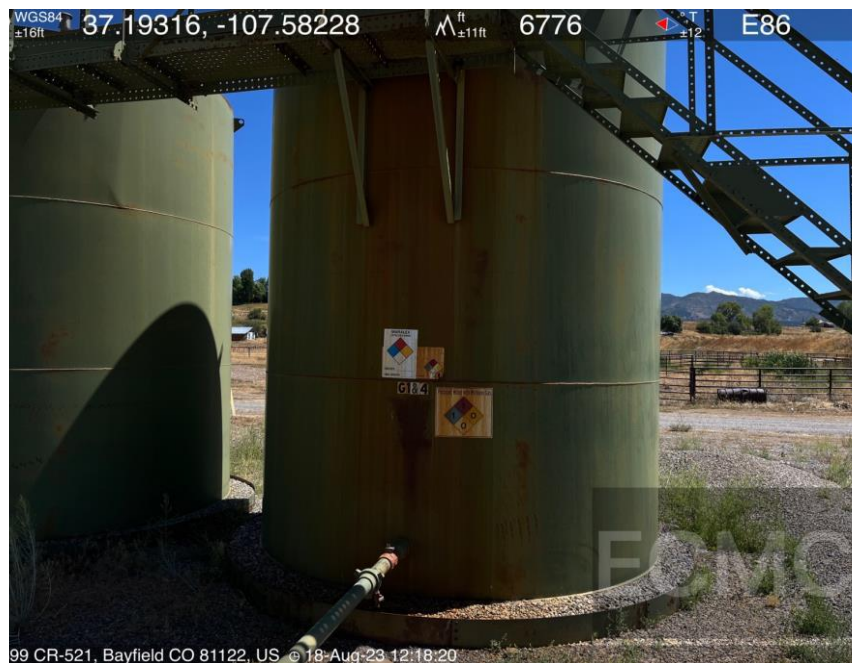
**Photo #5. View of corrective action identified in FIR
Doc.#712700542.**

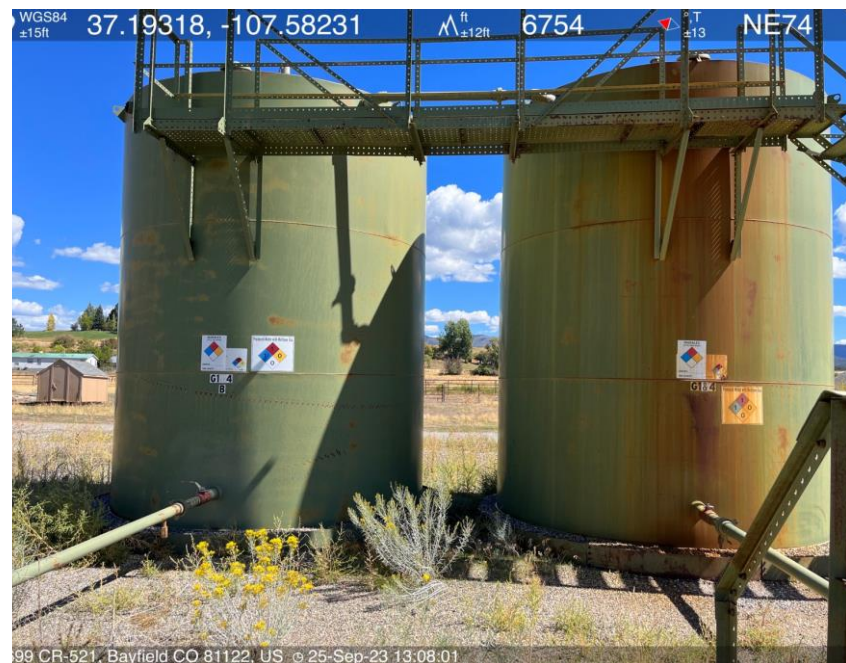
**Photo #6. View of corrective action not completed. No tank
volume posted.**

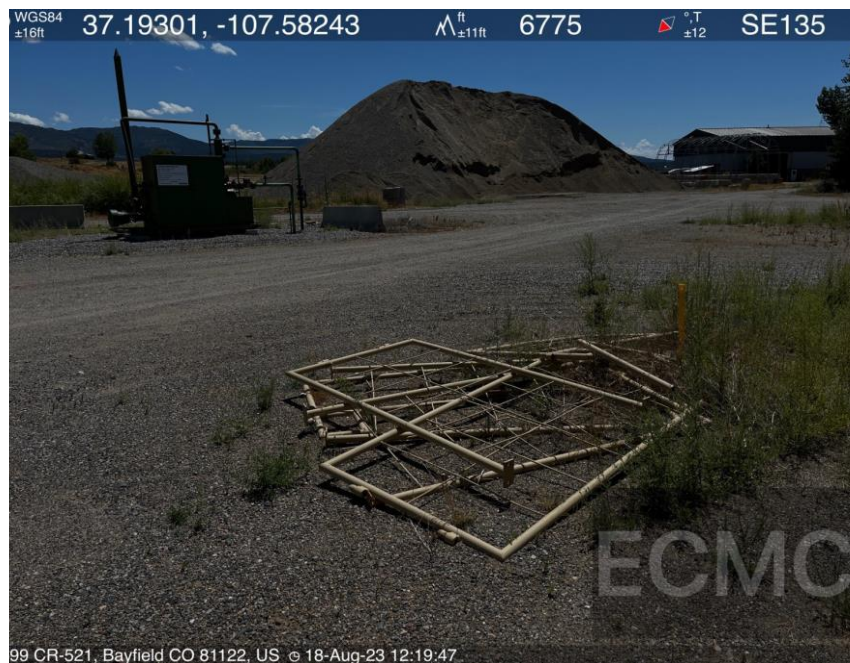
Photo #7. View of corrective action identified in FIR Doc.#712700542.

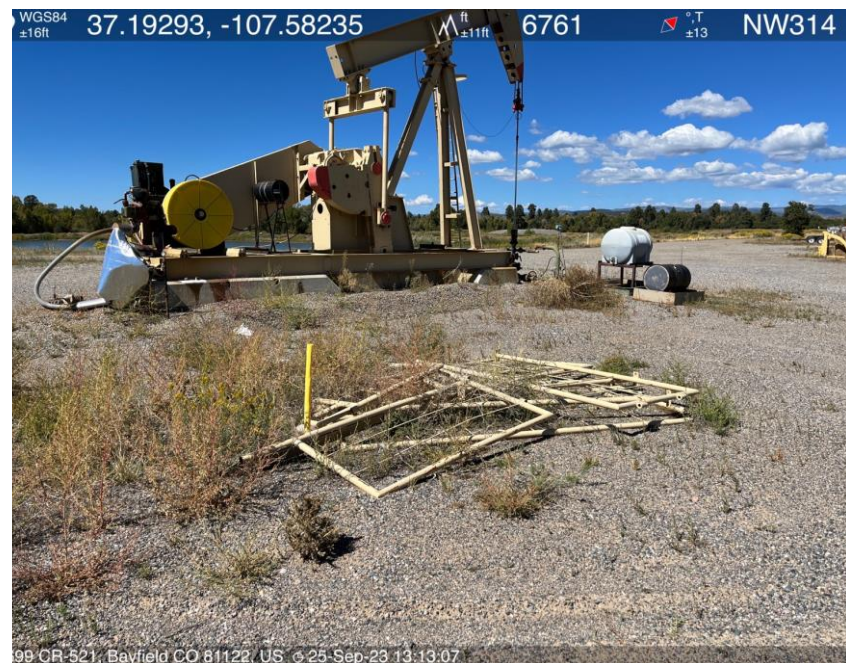
Photo #8. View of corrective action not completed. Sections of fencing on ground.

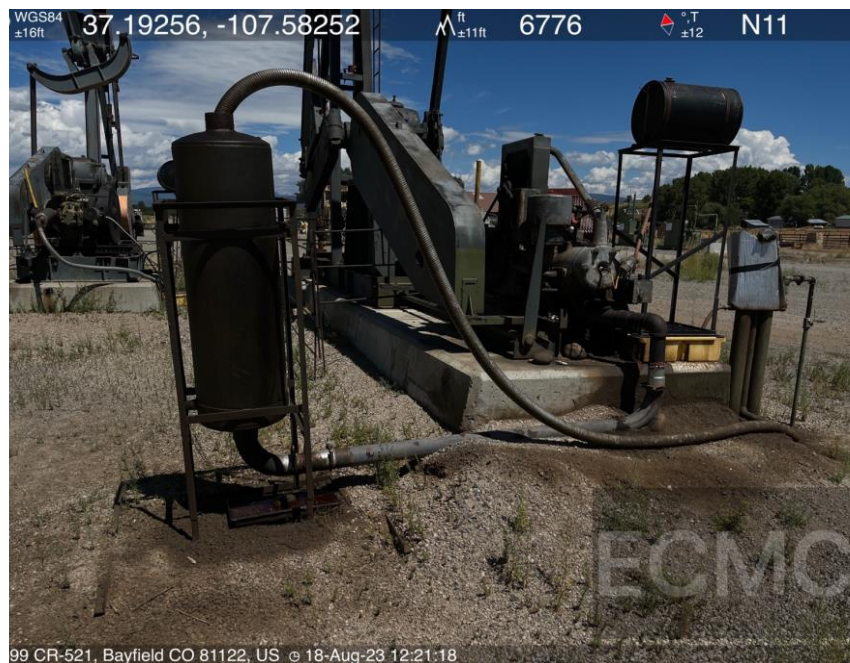
**Photo #9. View of corrective action identified in FIR
Doc.#712700542.**

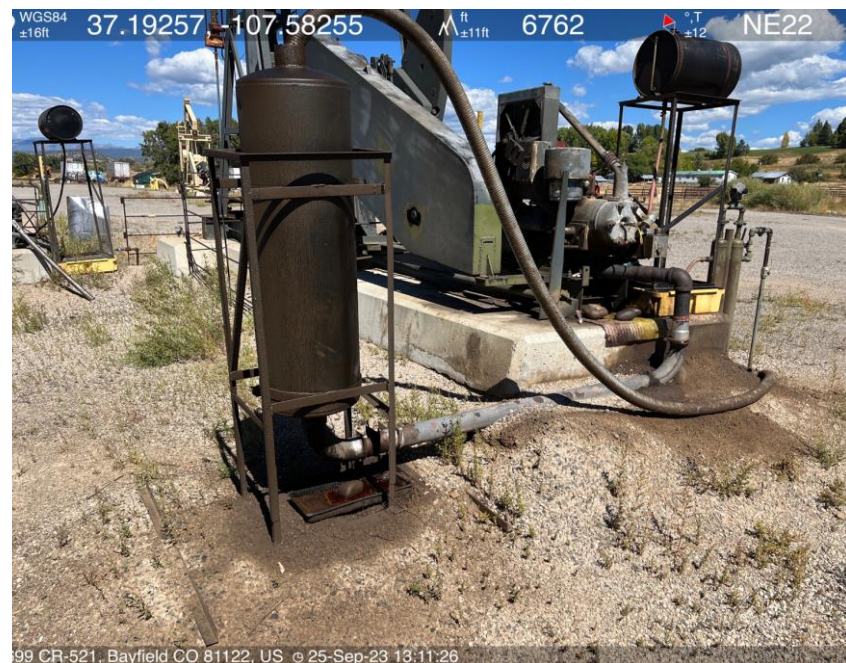
**Photo #10. View of corrective action not completed.
Impacted material on ground at the #2-A wellhead.**

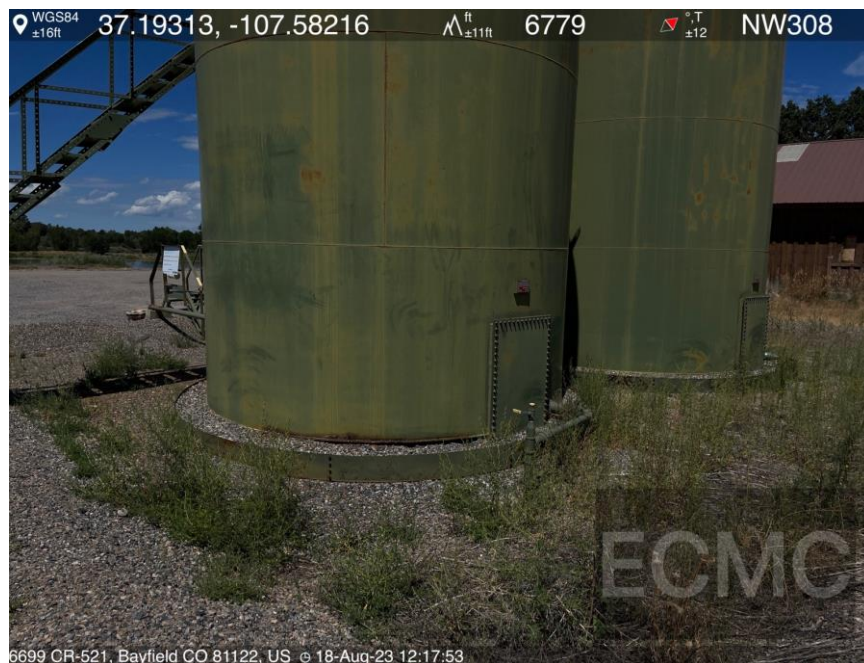
**Photo #11. View of corrective action identified in FIR
Doc.#712700542.**

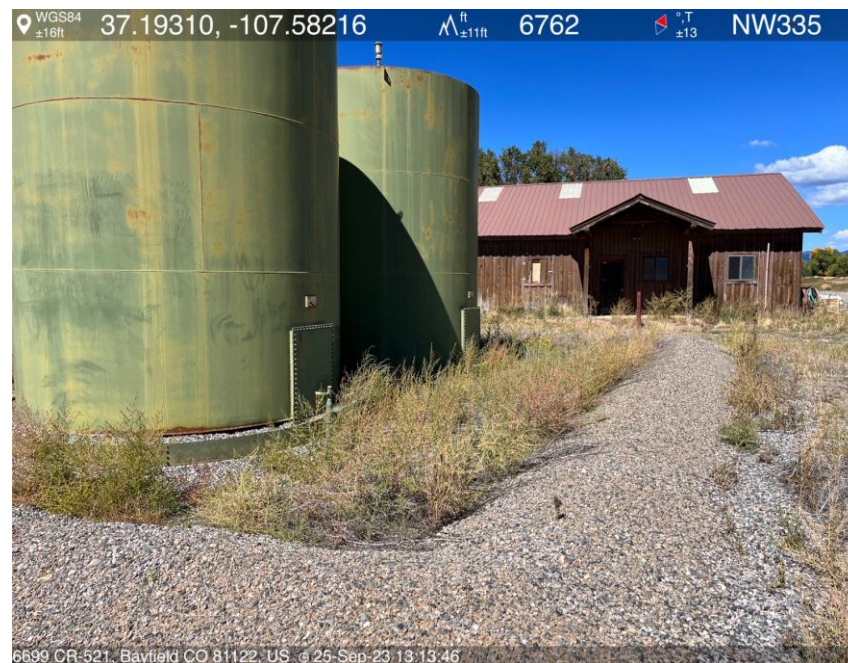
**Photo #12. View of corrective action not completed. Weeds
growing within tank battery berm.**
