Construction and Stormwater Inspection

Date: 09/27/2023

Location ID: 485033

Inspection Photos
Location Name: Dune 1
Location ID: 485033

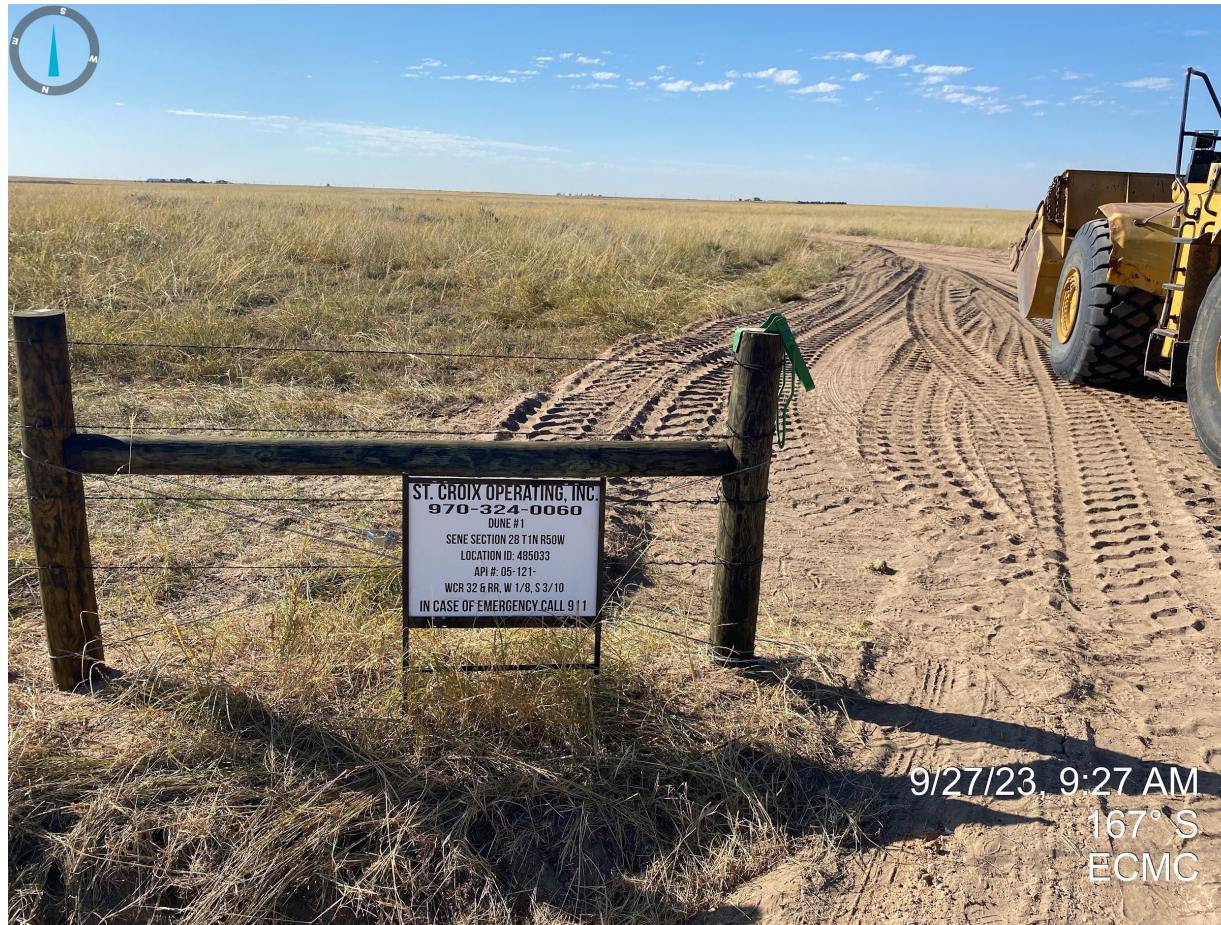
Photo 1. Taken near the location entrance. Per Rule 406.c. a copy of the approved Form 2A was posted on location.

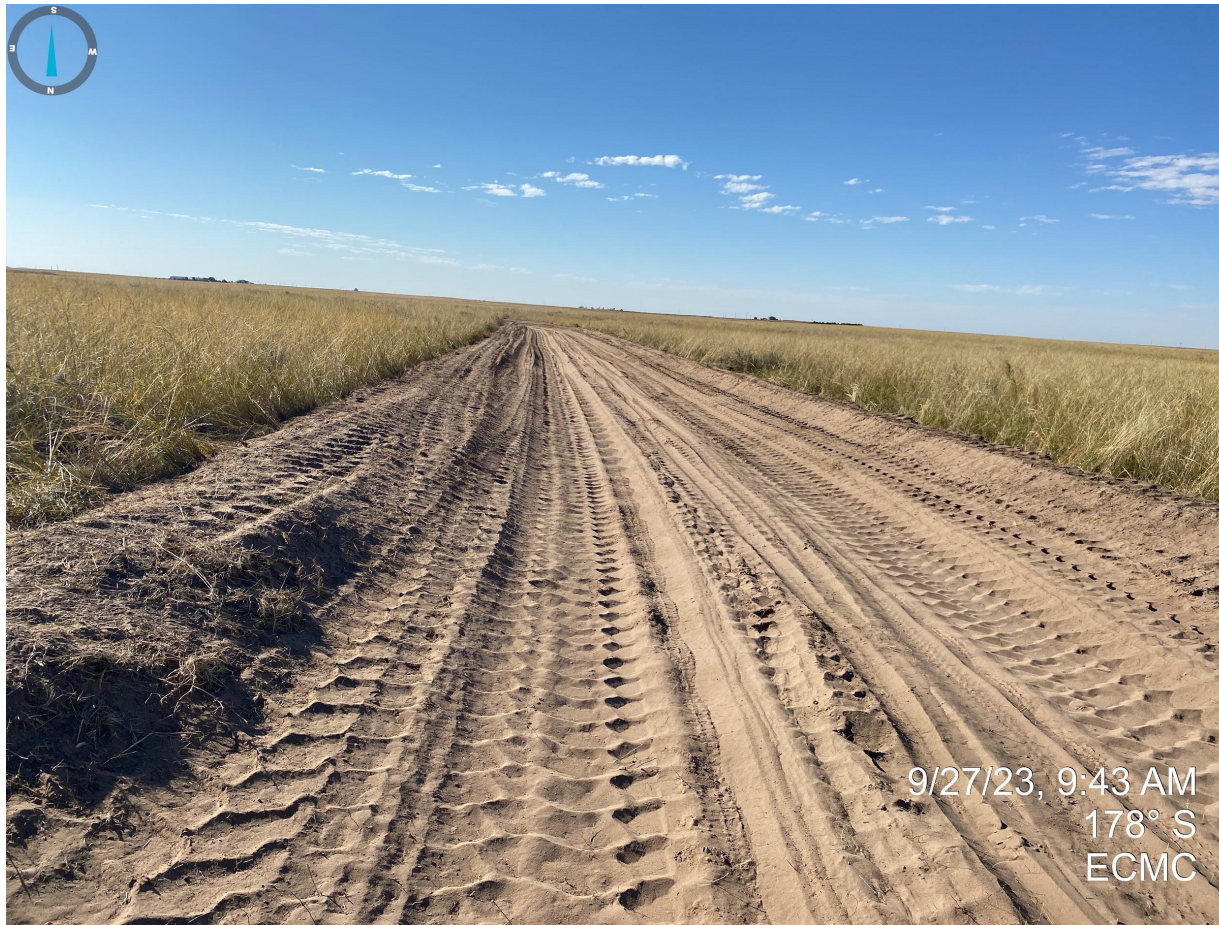
Photo 2. Taken south of the location entrance. It appears the access road has had topsoil salvaged and stored on the sides of the road. Additional BMPs are required to stabilize the stockpiled soils as wheel packing alone is not adequate due to the site conditions.

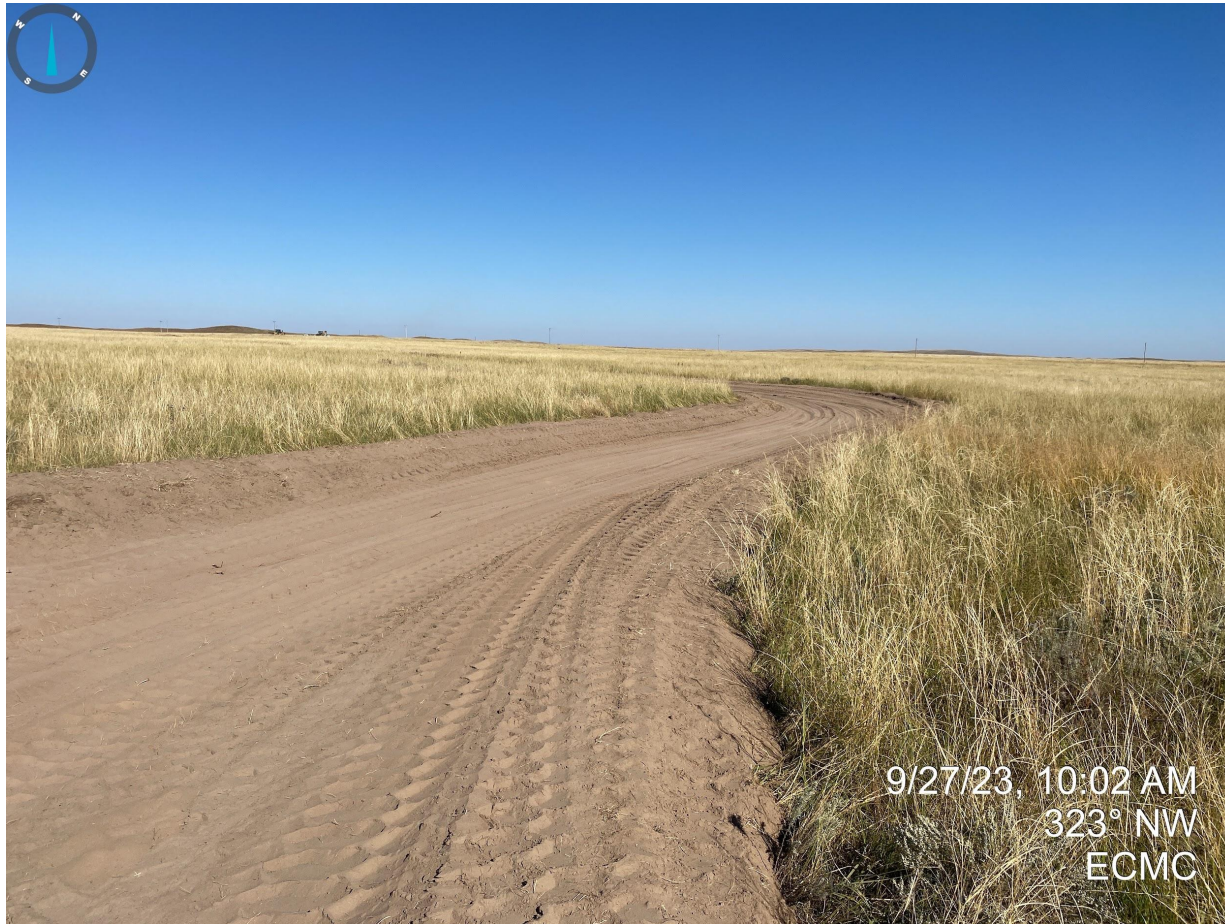
Photo 3. Taken from the drilling pad construction, facing northwest. See comments in Photo 2.

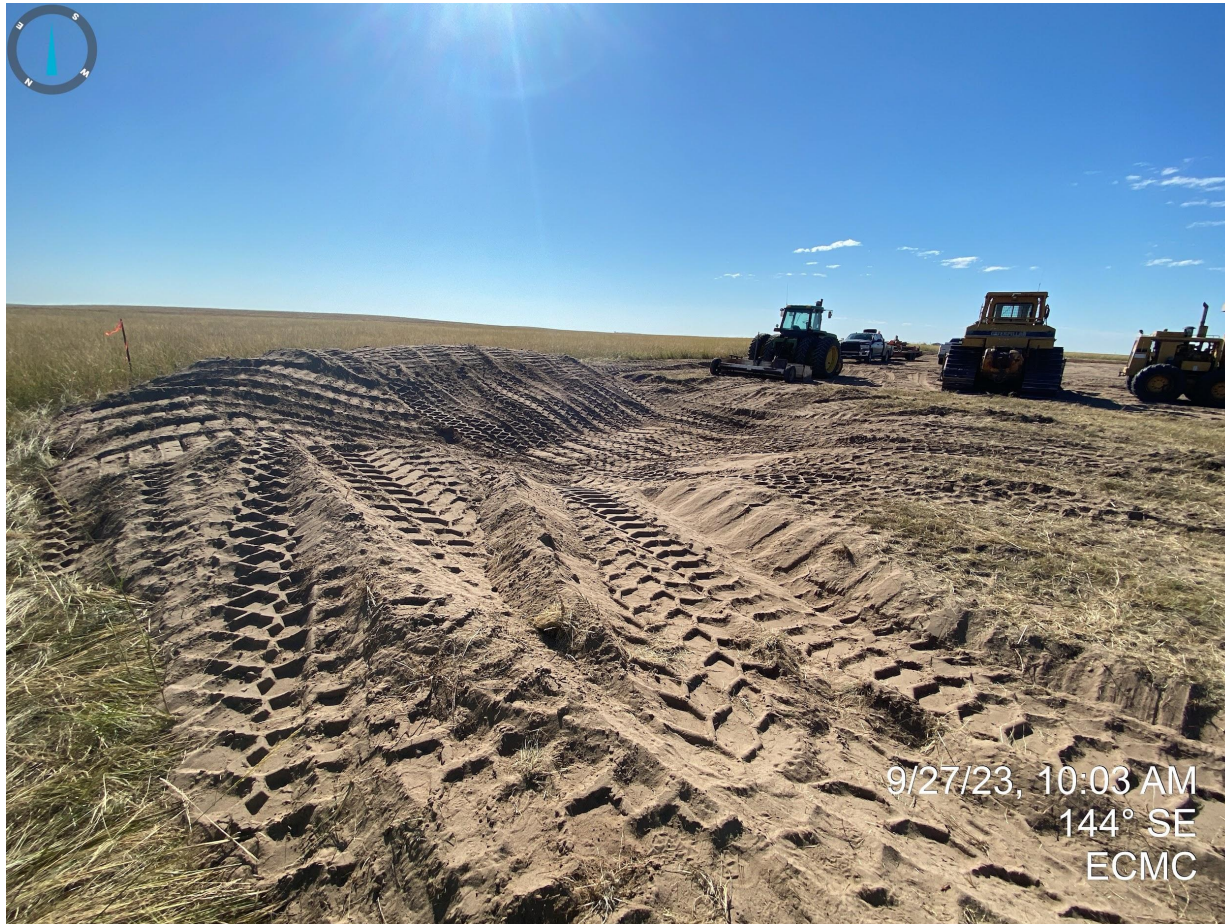
Photo 4. A sediment trap was installed on the northeast corner of the location. The sediment trap and berm material are comprised of unstabilized material and require additional BMPs to protect against wind and water erosion degradation, as wheel packing alone is not adequate due to the site conditions.

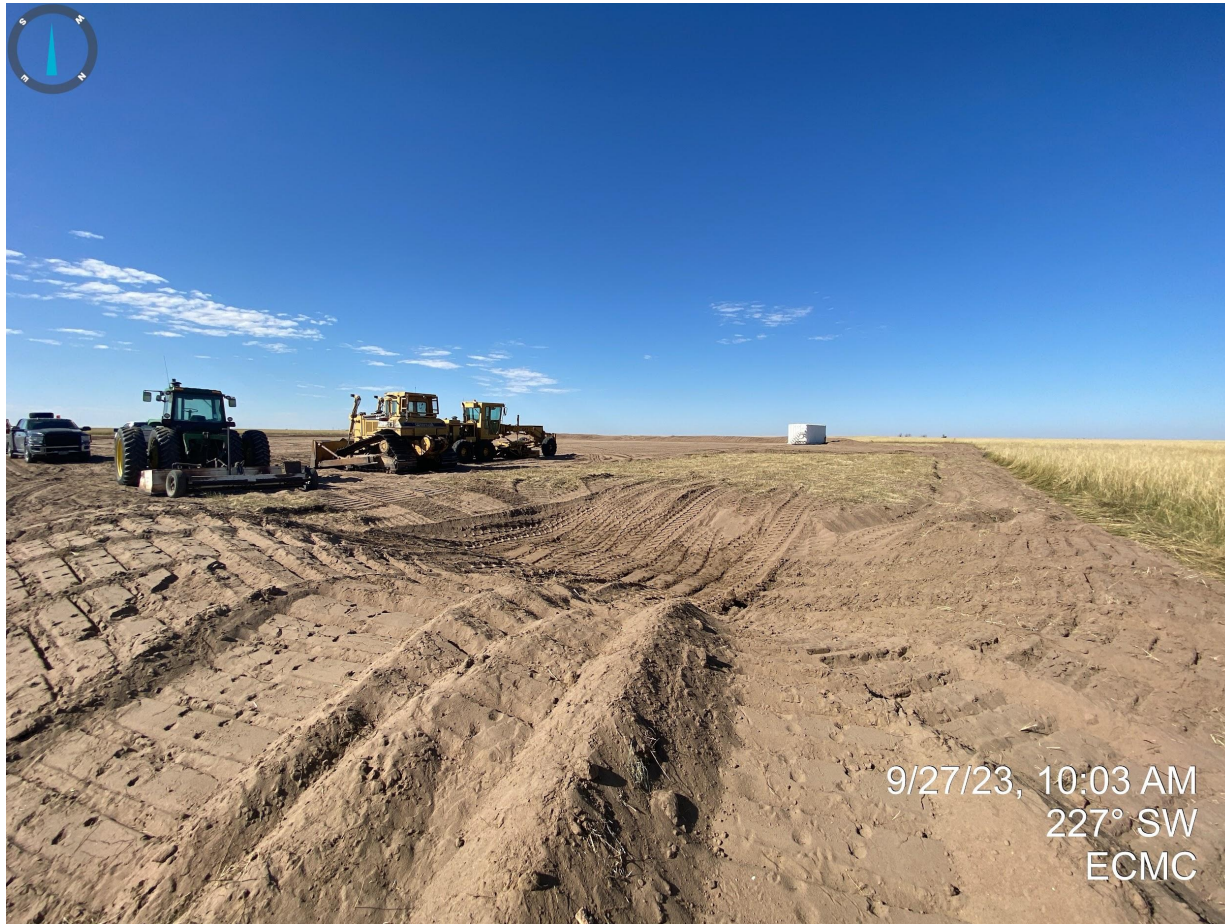
Photo 5. Taken from the northeast corner; see comments in Photo 4.

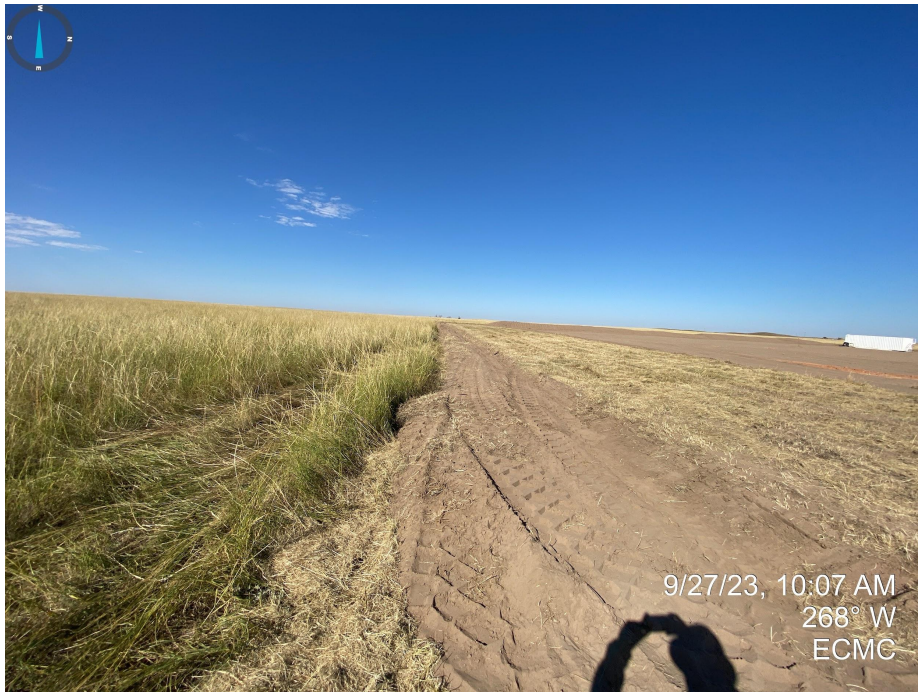
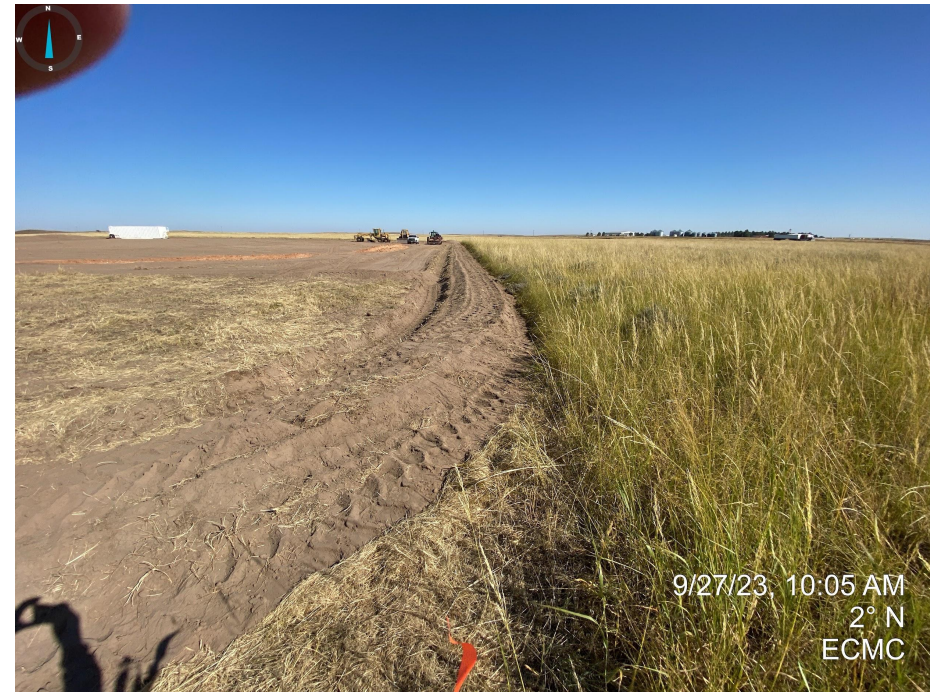
Photos 6 & 7. Taken from the southeast corner. See comments in Photo 4.

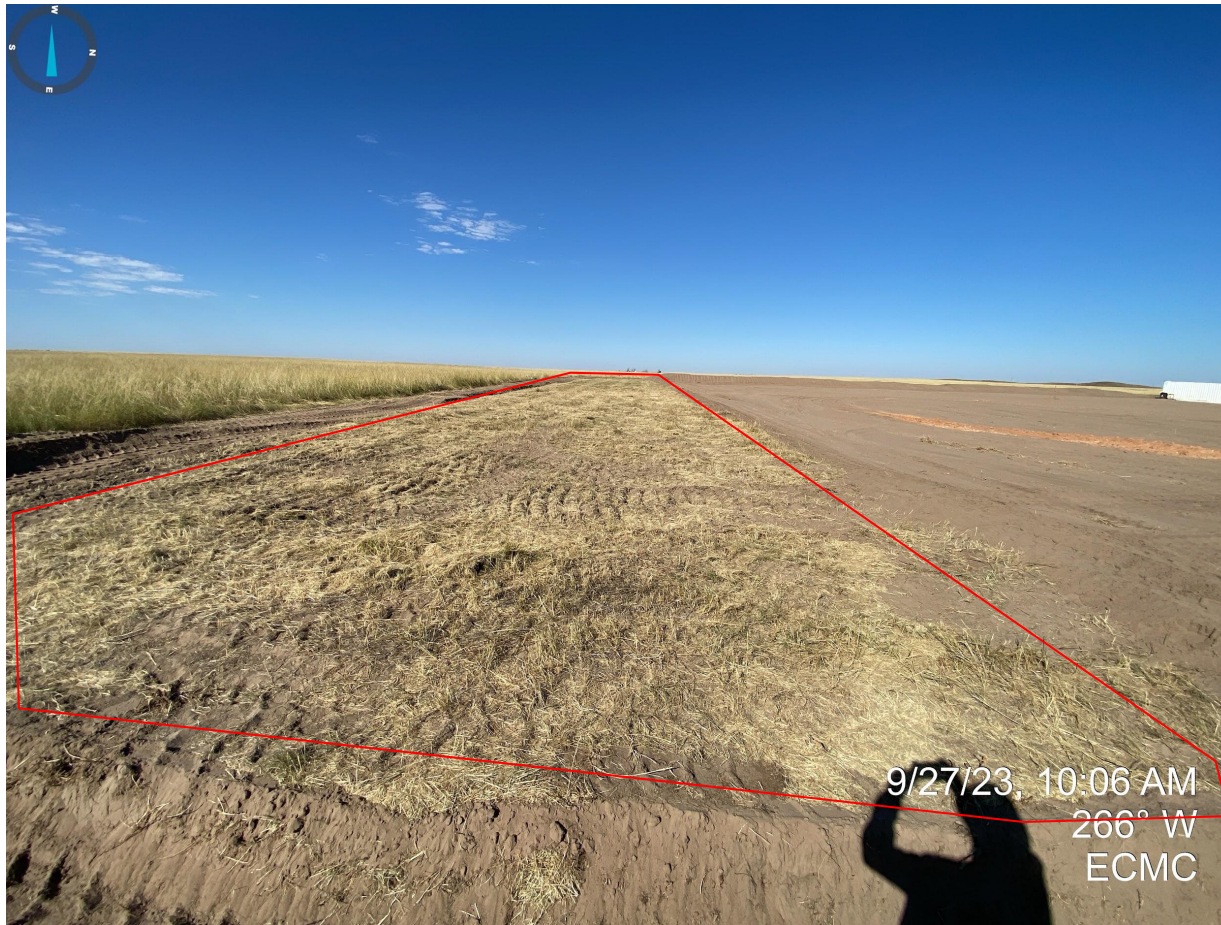
Photo 8. Taken near the southeast corner of the location. Photo illustrates that the Operator has not disturbed the entire permitted area for the construction of the pad. If the area outlined in red is to be used for any construction or drilling activities (equipment storage, parking, etc) then additional topsoil salvage shall occur within the defined area. Advise fencing or marking area to prohibit against such activity.

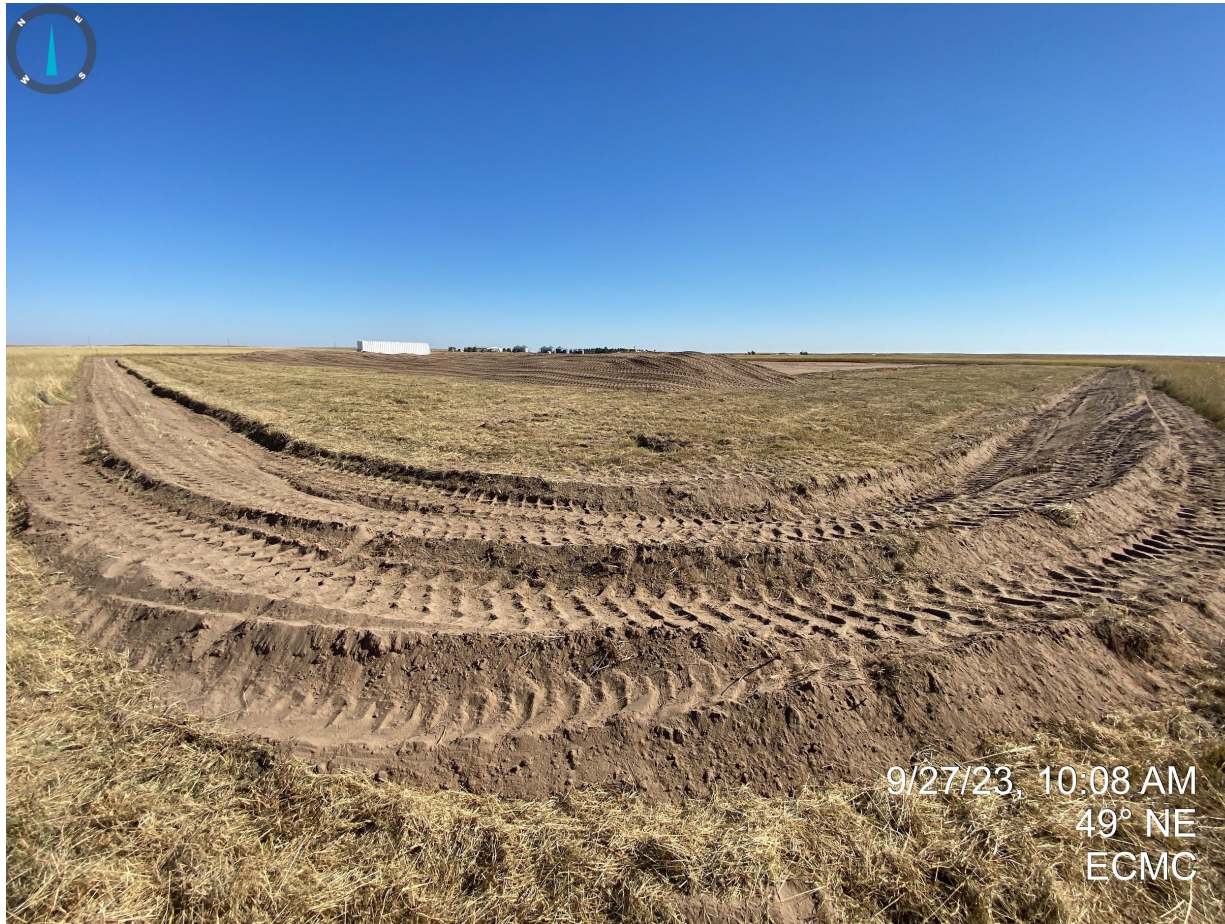
Photo 9. Taken from the southwest corner of the location; unstabilized soils observed within berm. See comments in Photo 4.

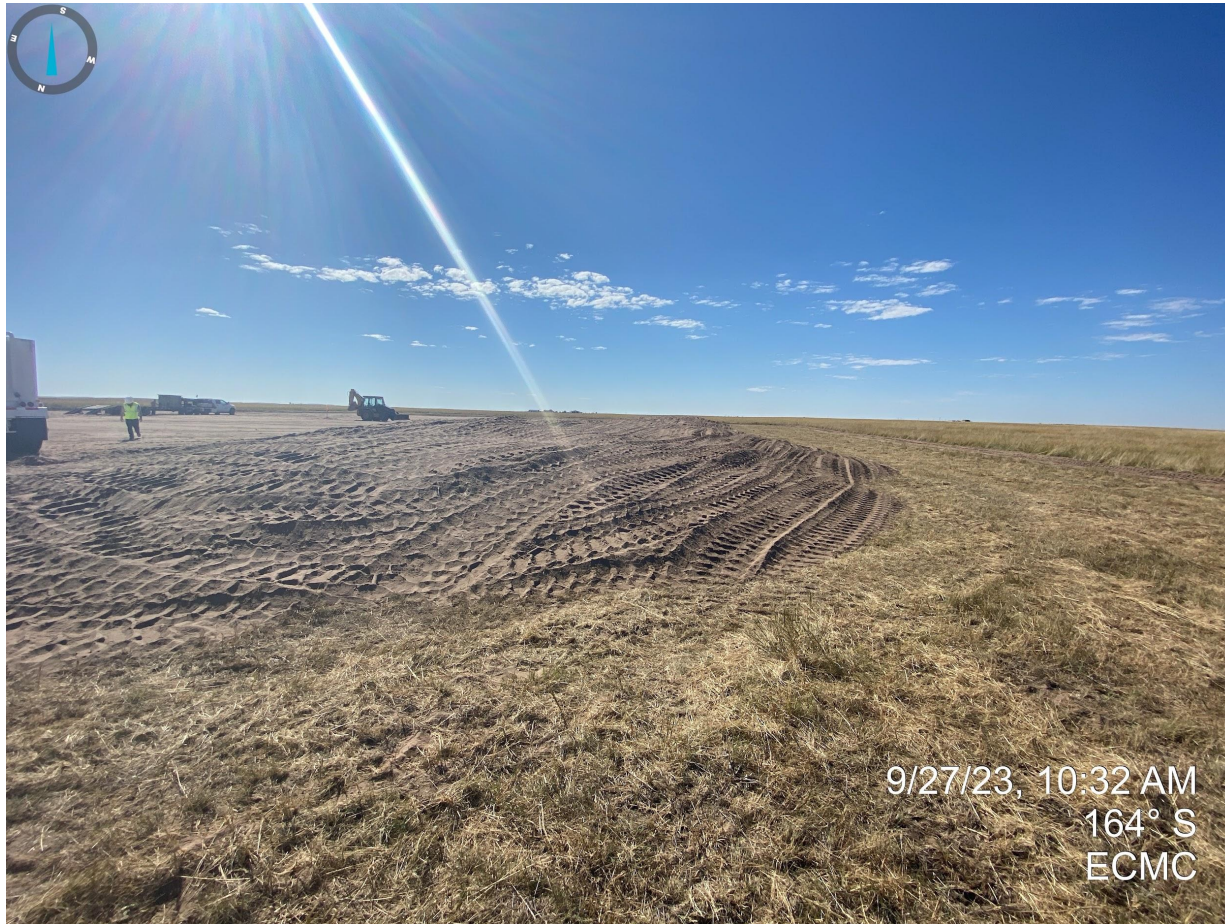
Photo 10. Taken near the northwest corner of the location, facing the topsoil stockpile. Additional BMPs are required to stabilize the stockpiled soils as wheel packing alone is not adequate due to the site conditions.

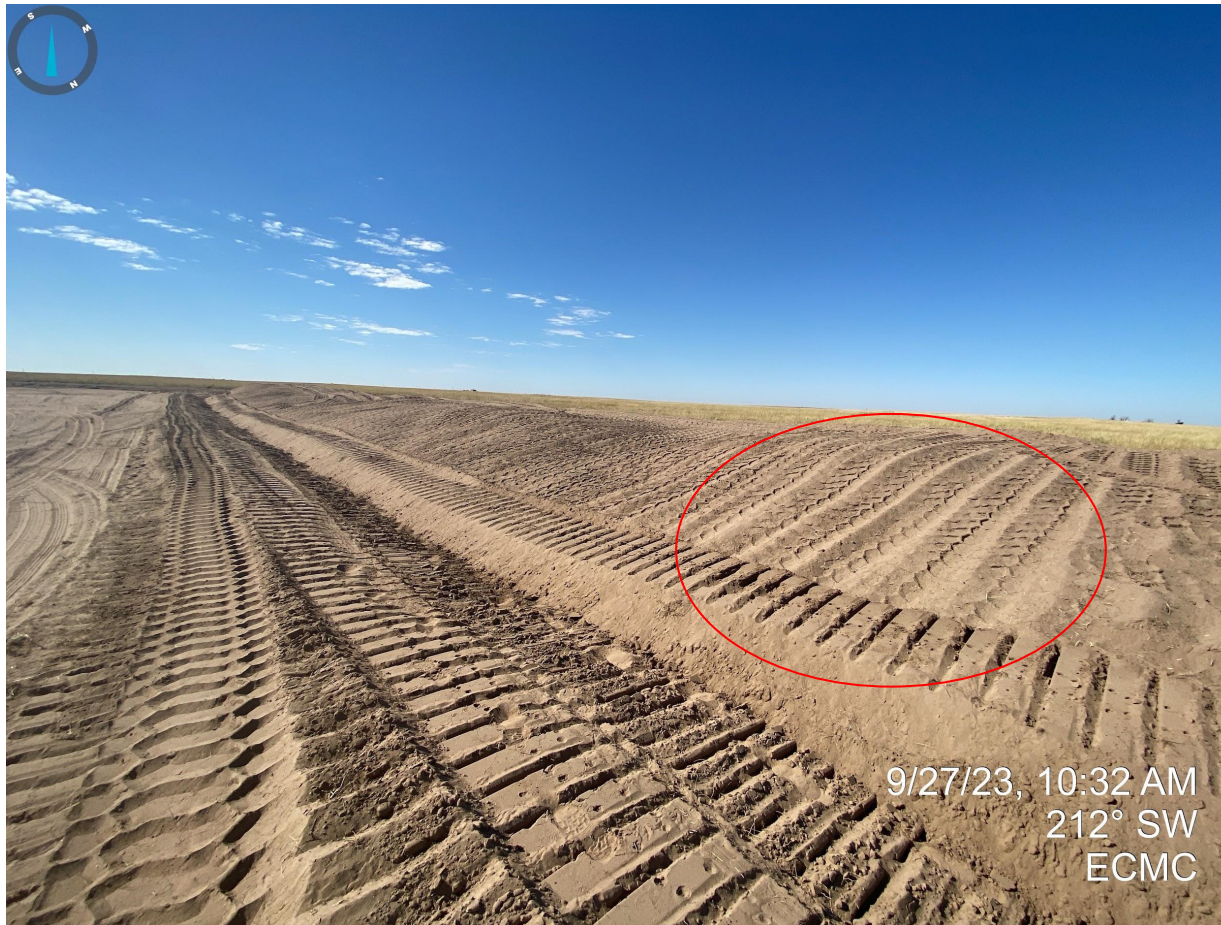
Photo 11. Taken from the northern portion of the topsoil stockpile. Wheel packing marks are parallel to the slope as opposed to perpendicular. Additional BMPs are required to stabilize the stockpiled soils as wheel packing alone is not adequate due to the site conditions.

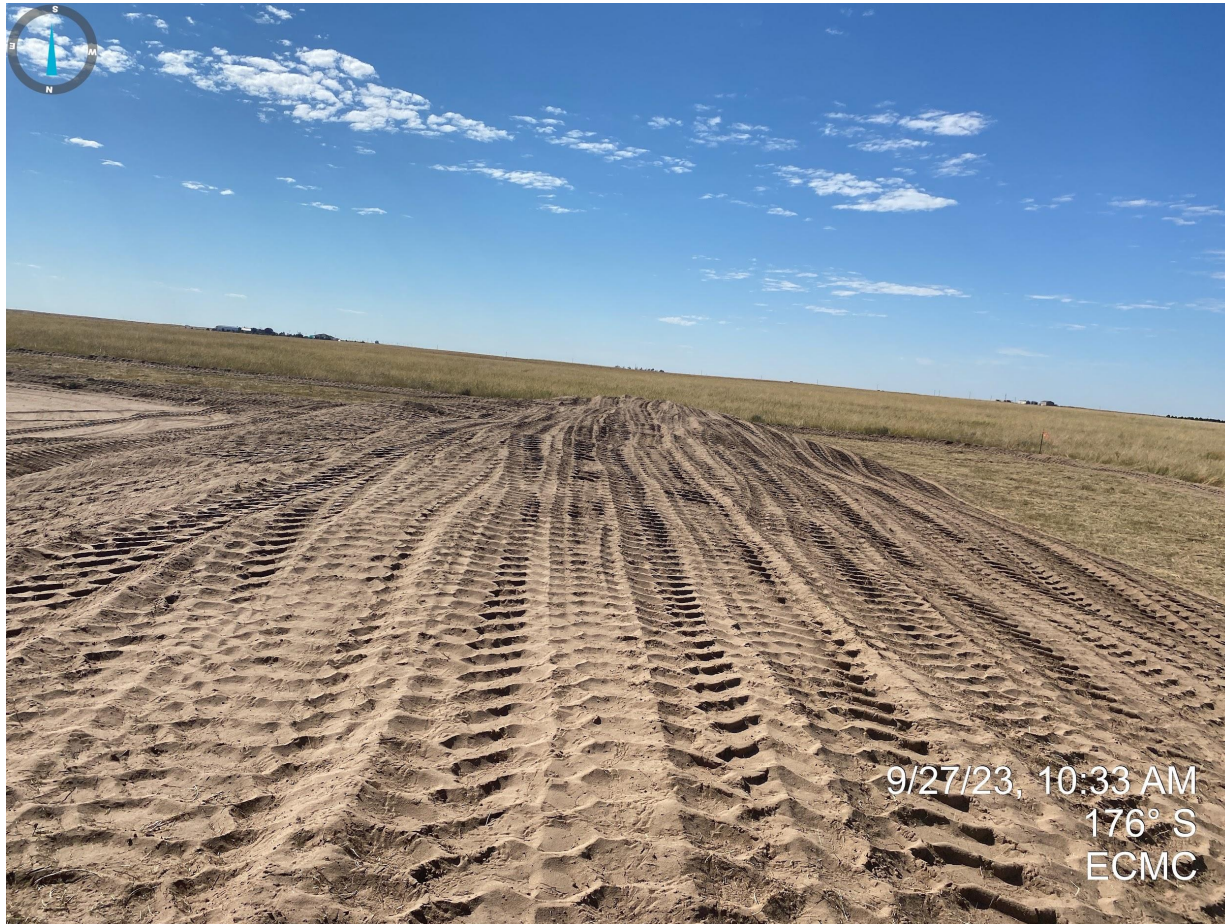
Photo 12. Taken from the middle portion of the topsoil stockpile. Additional BMPs are required to stabilize the stockpiled soils as wheel packing alone is not adequate due to the site conditions.

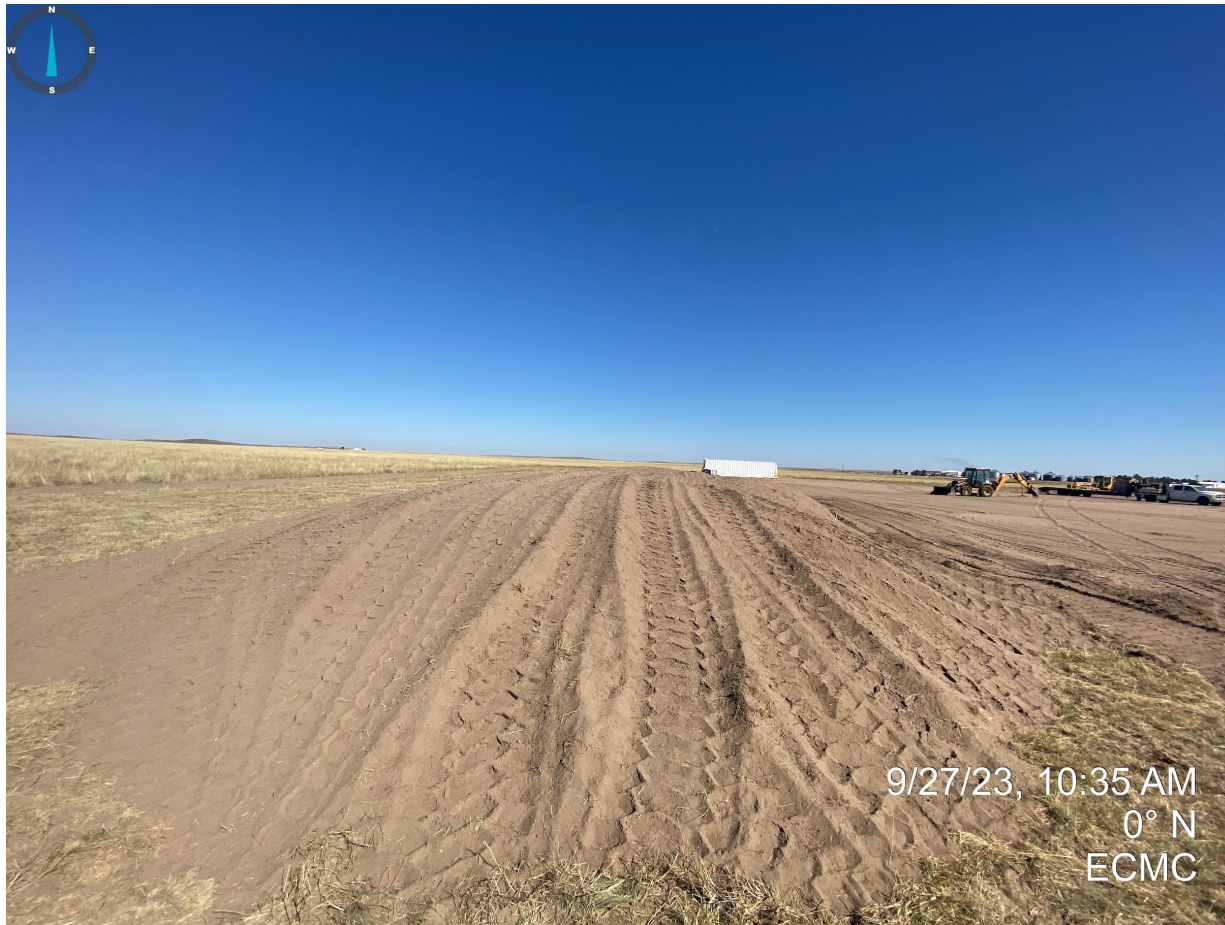
Photo 13. Taken from the southern portion of the topsoil stockpile. See comments in Photo 12.

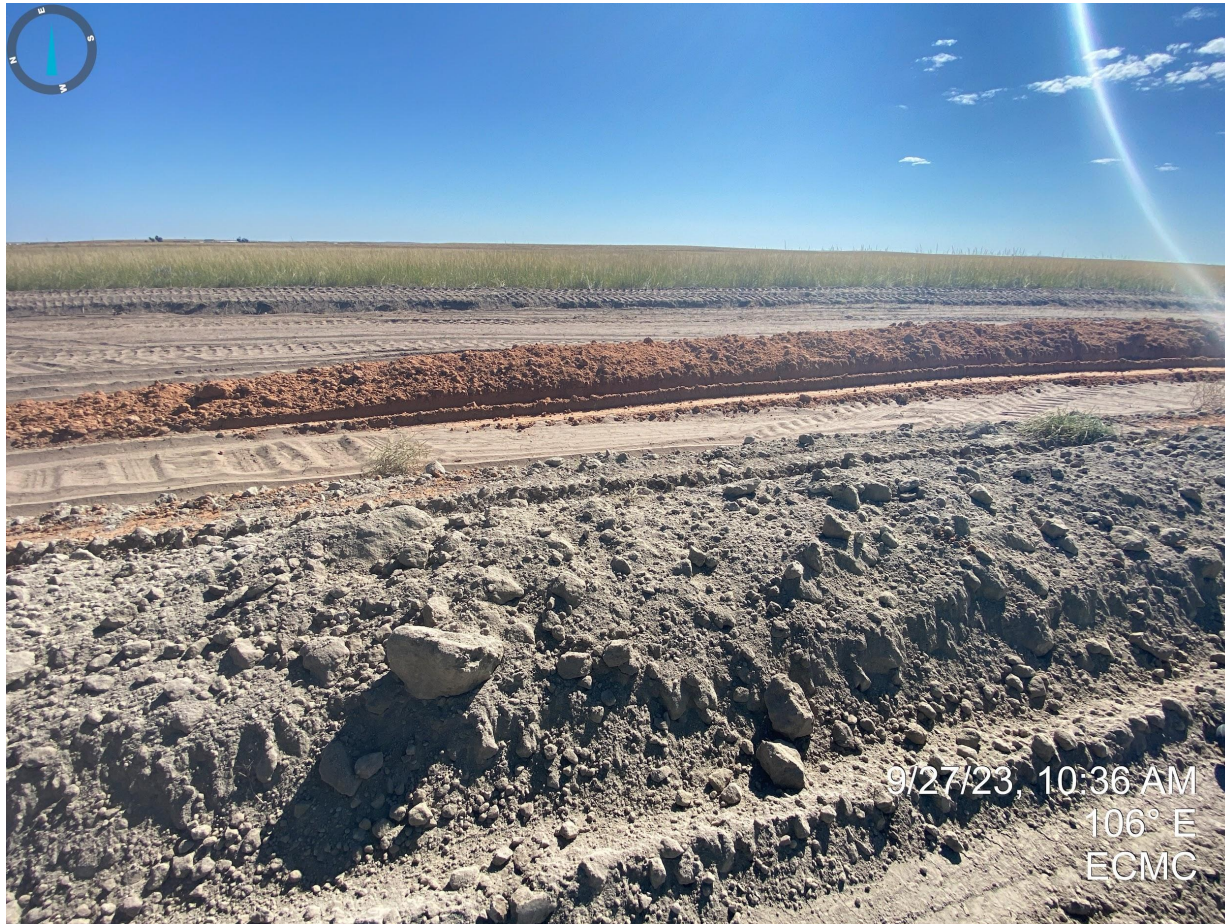
Photo 14. Taken from the eastern portion of the pad. Appears material is being brought in to stabilize the drilling pad.

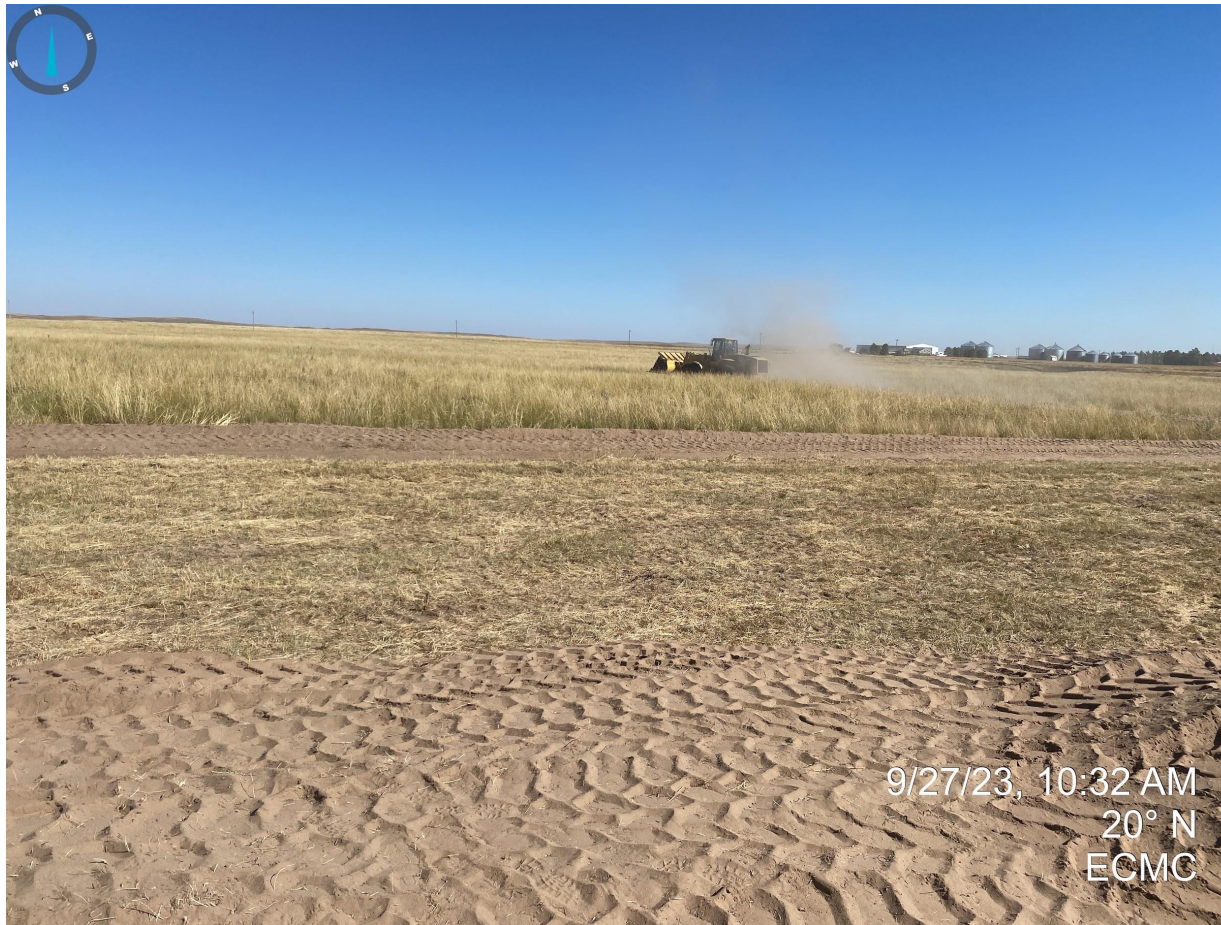
Photo 15. Taken from the northwestern portion of the location, facing the access road. Fugitive dust was observed during this inspection. Appropriate actions must be taken to mitigate fugitive dust during all operations.
