Operator: 8 North

Location Name: DF RANCH-611N61W 2SWSW

Loc ID: 461586

Inspection: 696305276

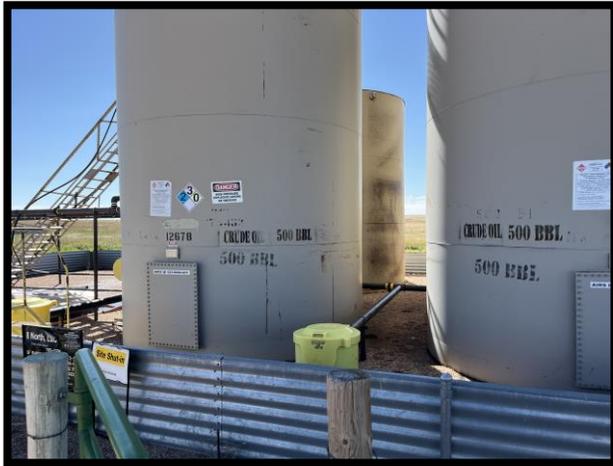
Exhibit A

CA: North Tank Capacity labels faded and are no longer visible. Install signs to comply with rule 605.h.

CA Resolution: Capacity labels have been installed to the north tank to comply with Rule 605.h.

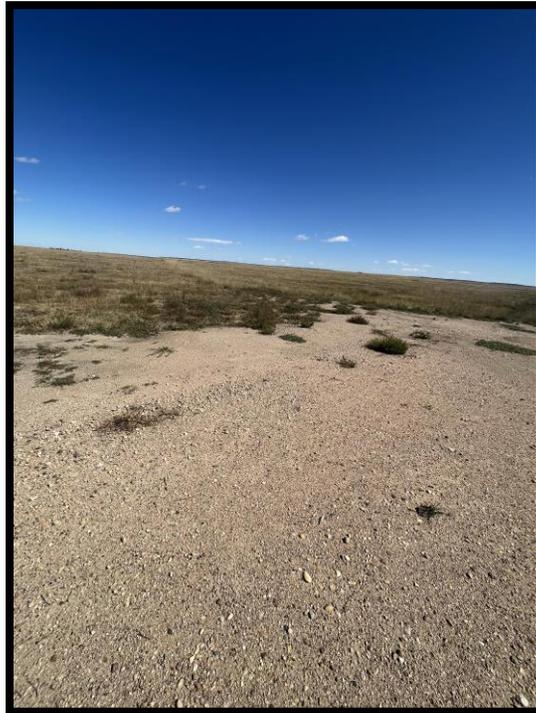
Exhibit A

CA: Unused barbed wire on northeast side of location. Comply with rule 606.

CA Resolution: Unused barbed wire has been removed and properly disposed of to comply with Rule 606.

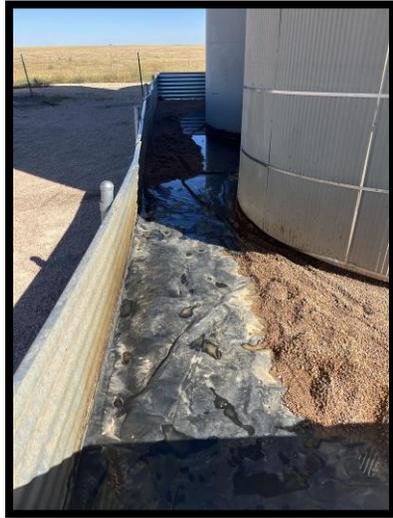
Exhibit A

CA: Stained soils at west tanks. For localized stained soils or oily waste- “properly dispose of oily waste in accordance with 905.e.”

CA Resolution: Stained soils near west tanks has been addressed by Operator and properly disposed of to comply with Rule 905.e.
