Inspection Photos

Location Name: MUSTANG RESOURCES LLC DOWNING 25-21-A-6S-94W Pad

Location ID: 323825

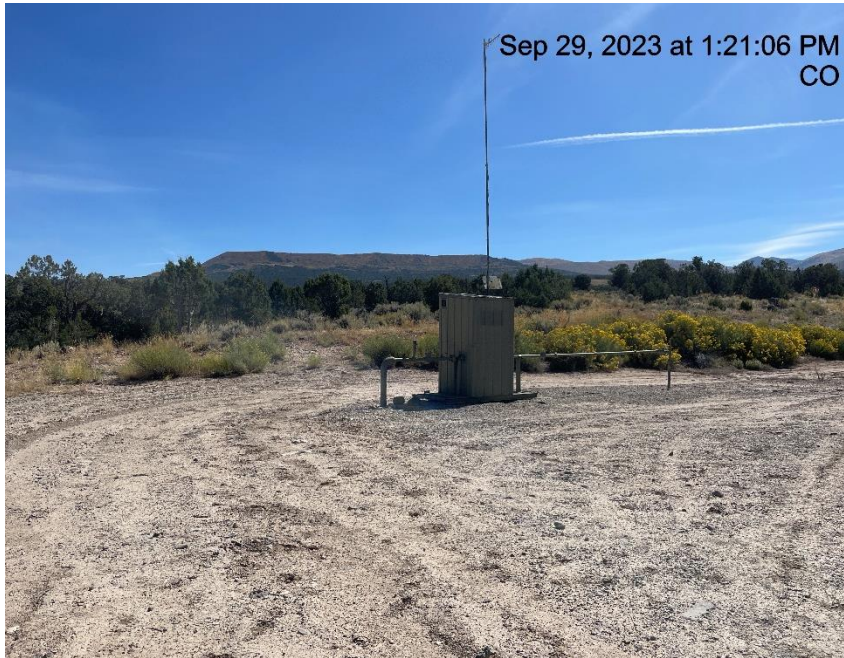
Photo # 1205 From entrance to location

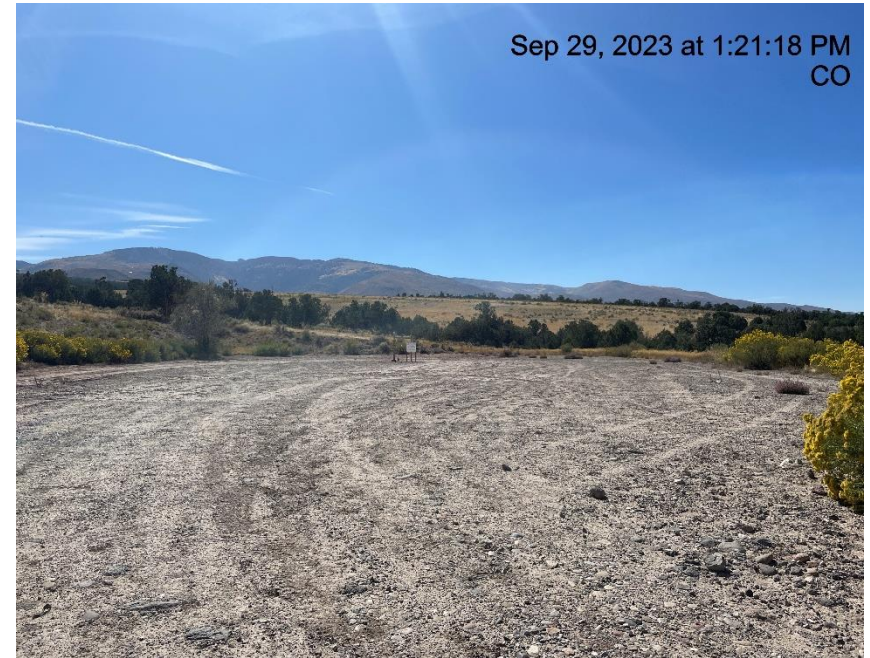
Photo # 1206 From entrance to location
