Thacker 1

Document number 712700685

Date completed 10/2/2023

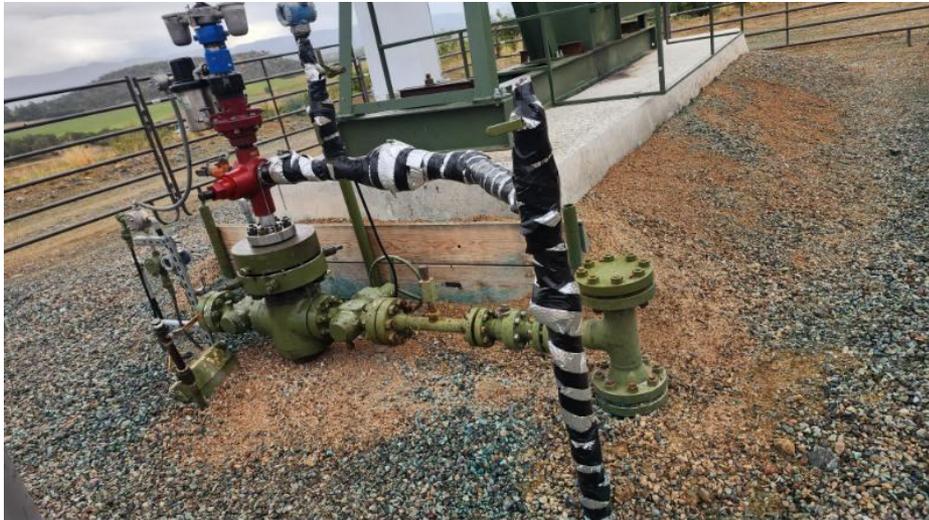
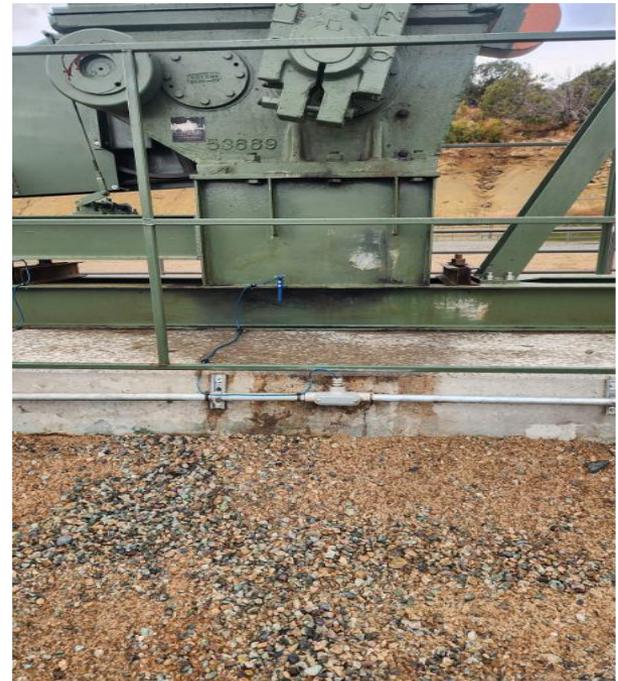
Cleaned up contaminated soil around wellhead and pump jack skid
