Final Reclamation and Stormwater Inspection

Operator: KERR MCGEE OIL & GAS ONSHORE LP -
47120

Location ID: 318739

Inspection Photos
Location Name: Kelly 1A
Location ID: 318739

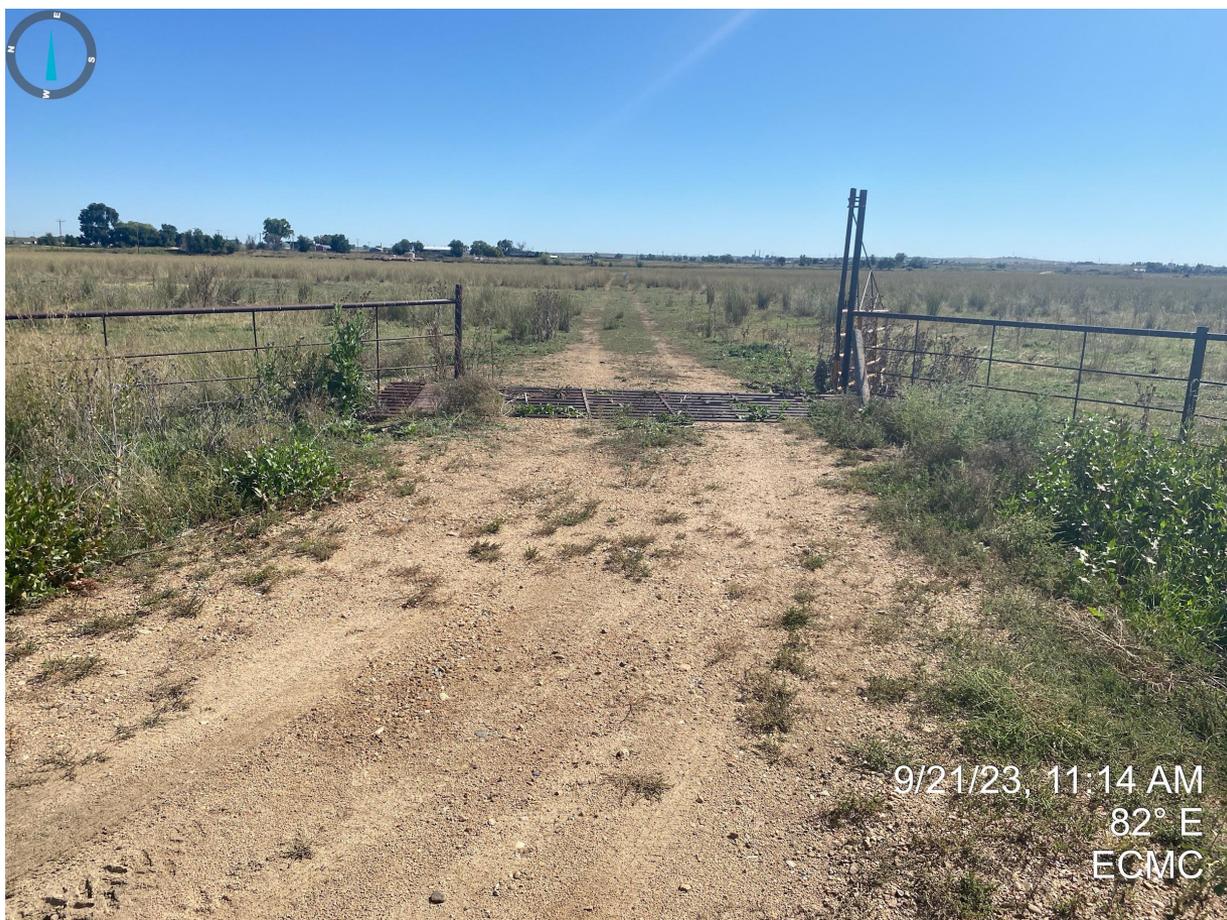
Photo 1. Taken near the entrance to the location. Photo illustrates that the approach/access road entrance has not been reclaimed and a cattle guard remains.

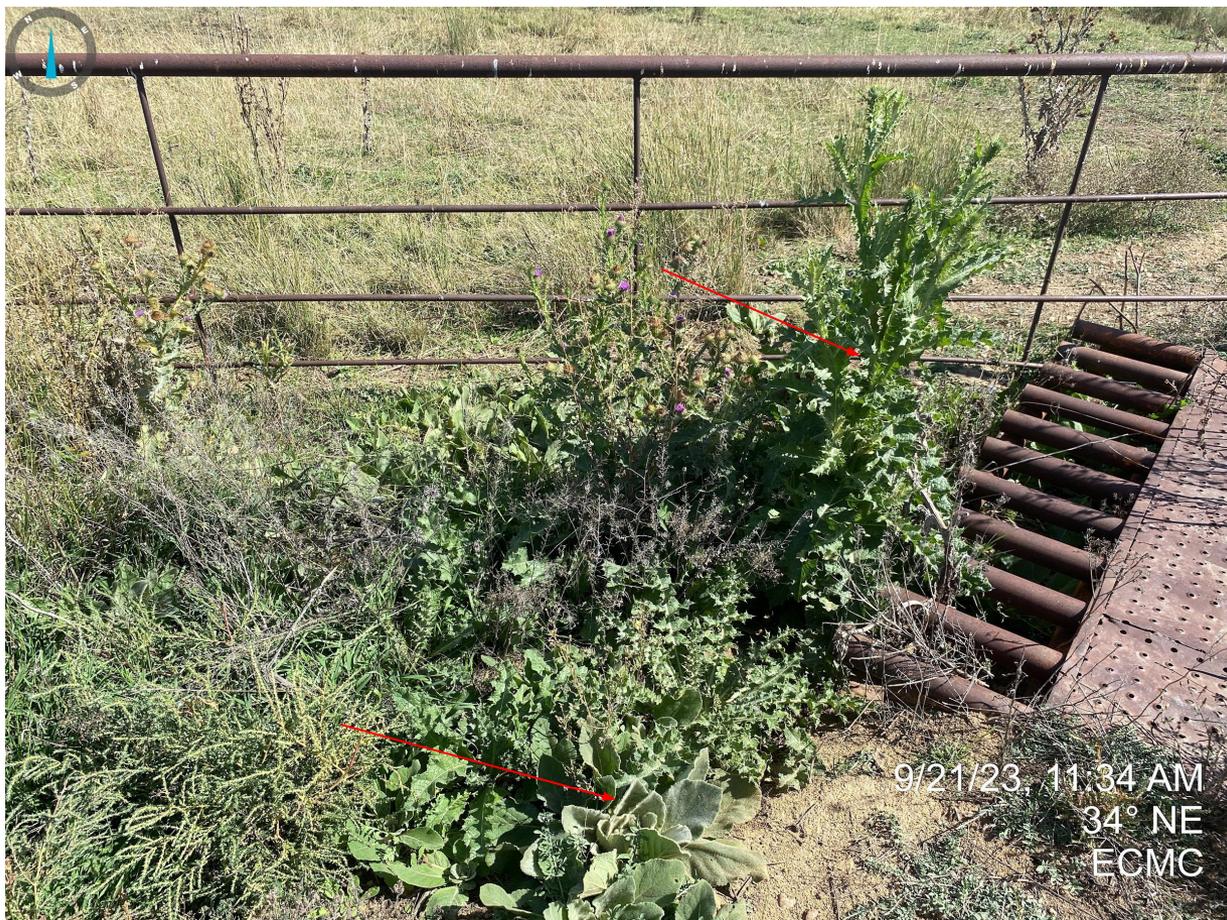
Photo 2. Taken at the entrance to the location. CO Listed Noxious weeds- common mullein and scotch thistle pictured.

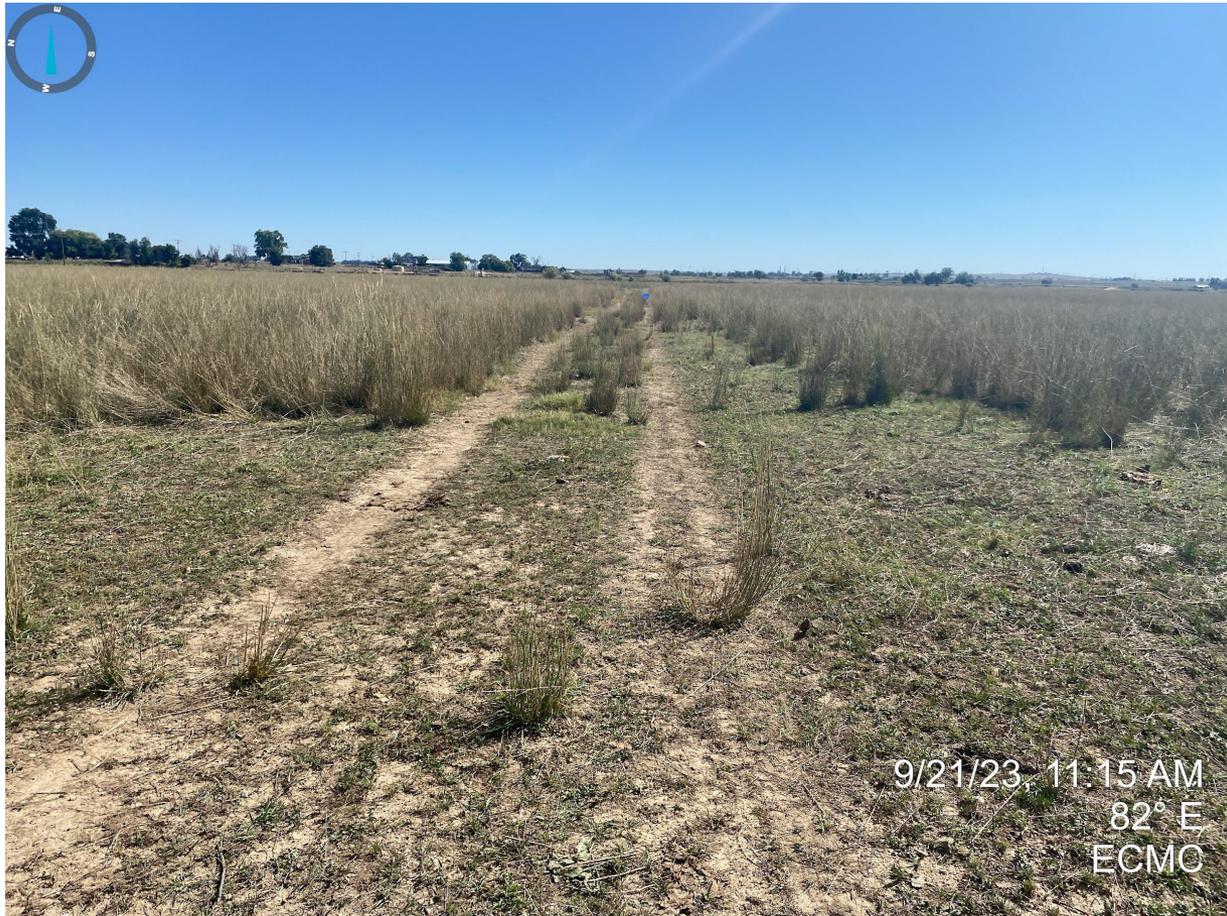
Photo 3. Taken east of the entrance. Photo illustrates that the access road does not appear to be progressing towards reclamation standards and is not reflective of adjacent reference areas.

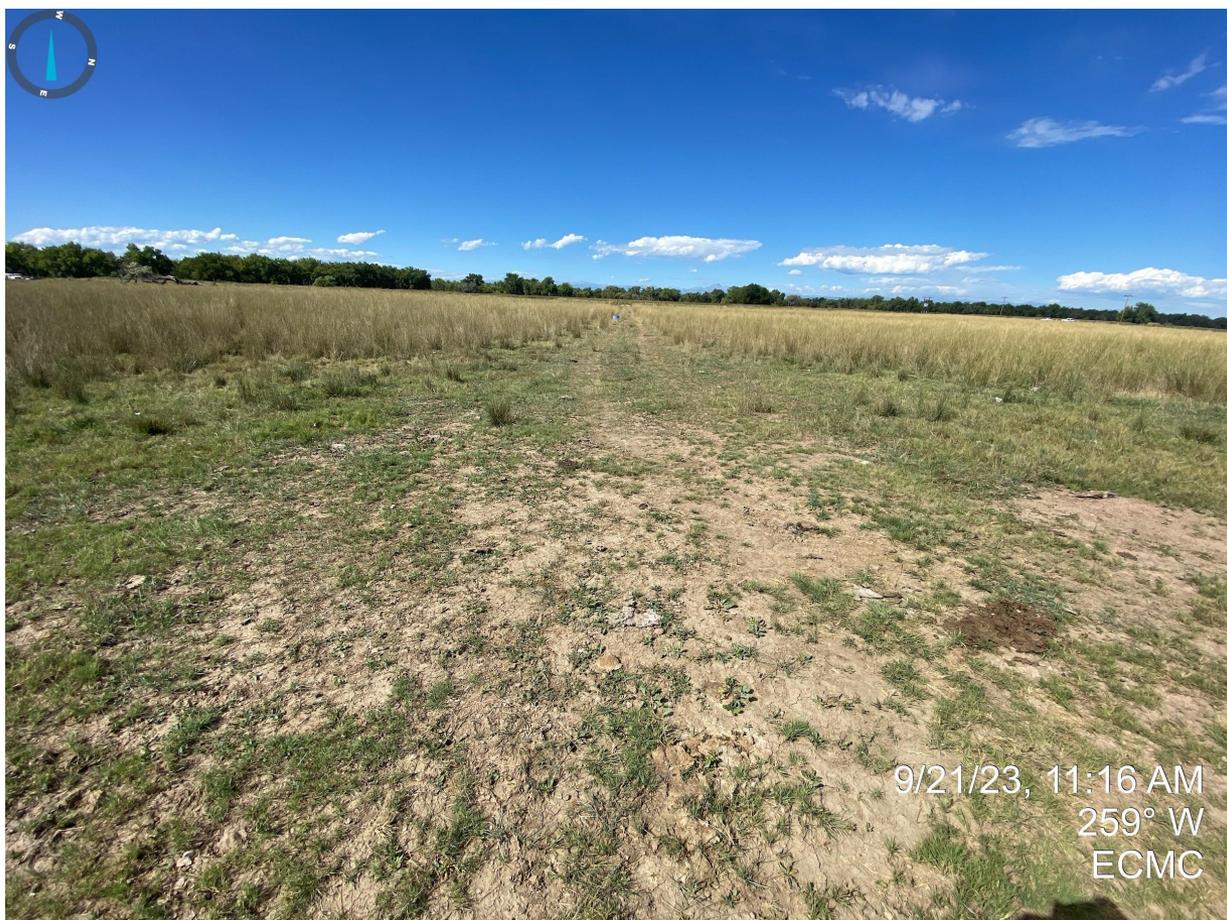
Photo 4. Taken near the former well location. Reclaimed areas do not appear to be progressing towards Rule 1004 standards and regulations with evidence of bare/exposed soils and CO Listed Noxious weed - field bindweed.

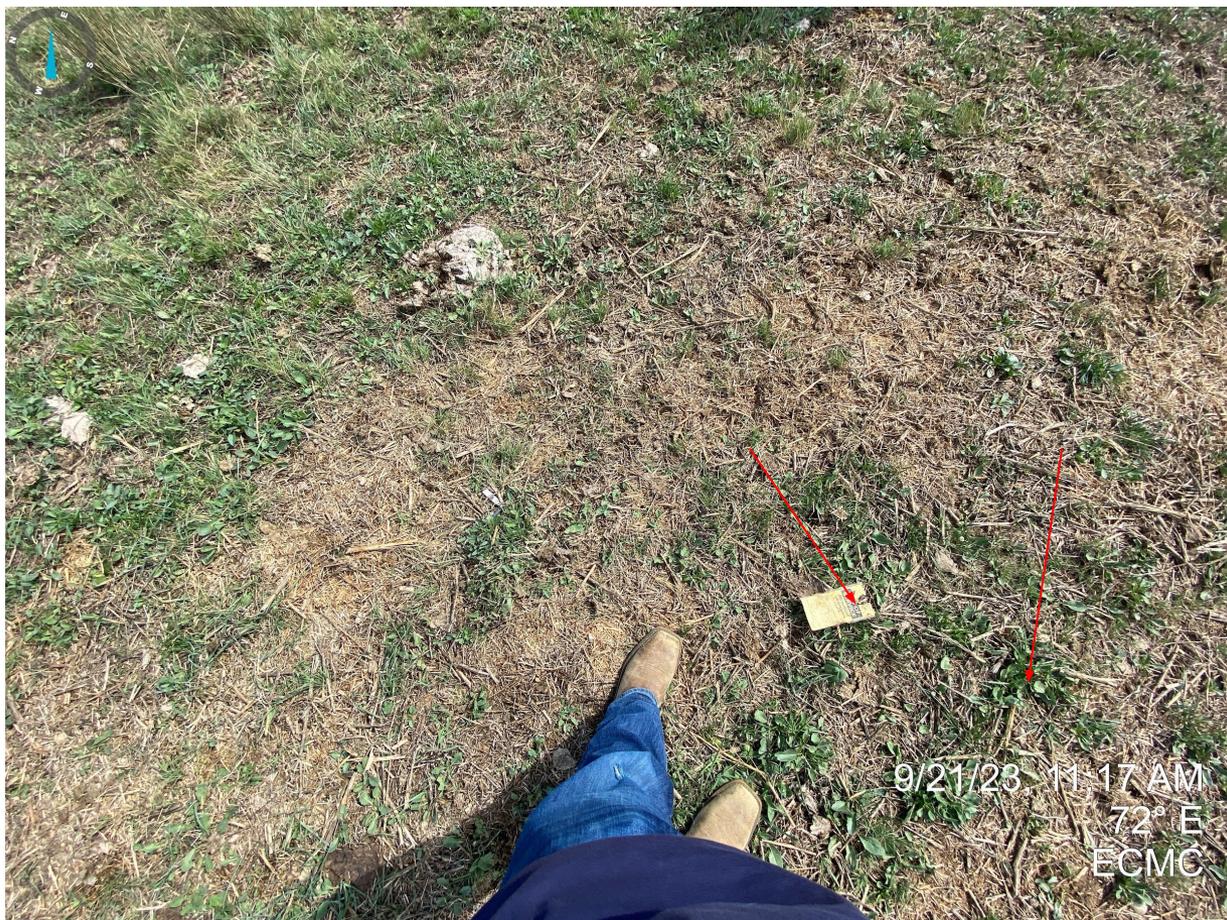
Photo 5. Close up photo taken near the former well location. Field bindweed and debris observed on location.

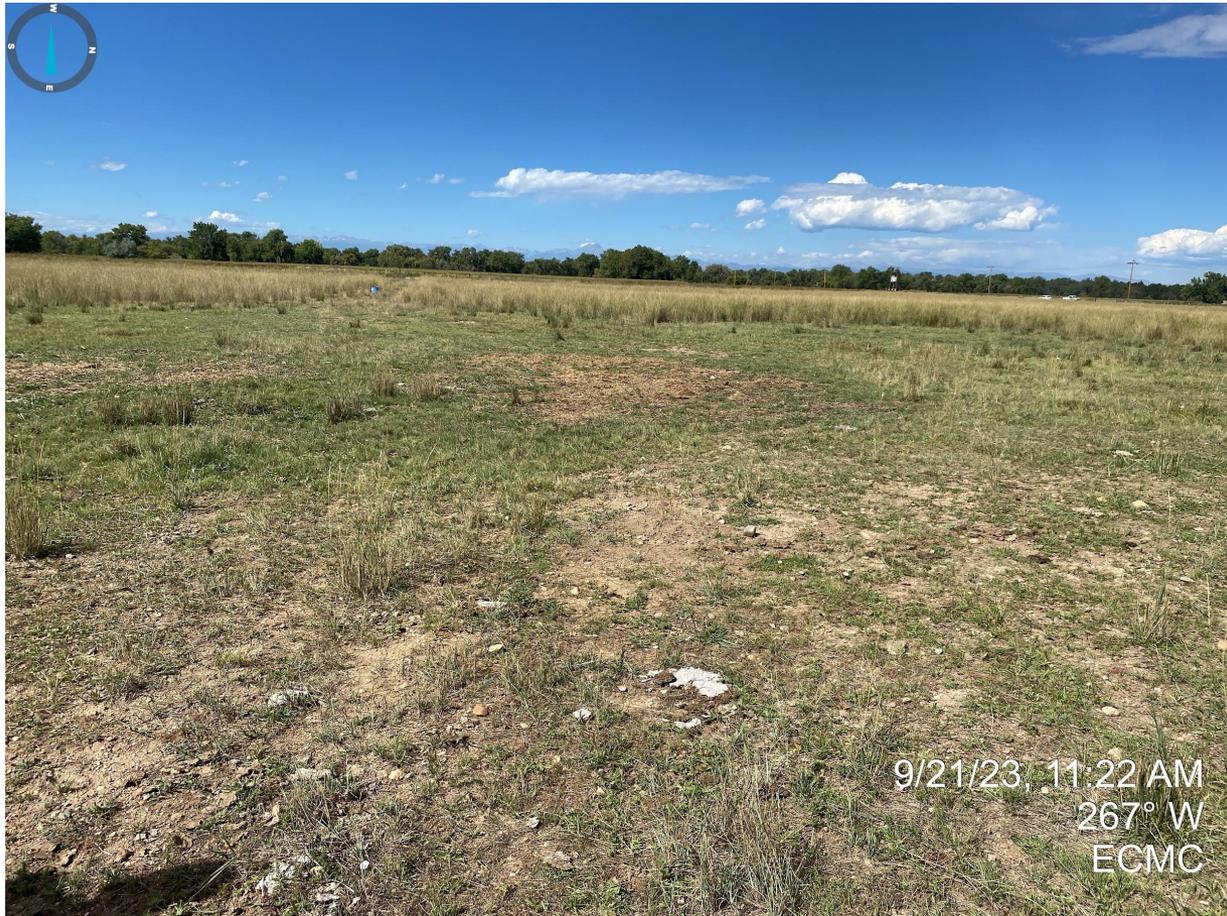
Photo 6. Taken from the northern/eastern side of the former location. See comments in Photo 4.

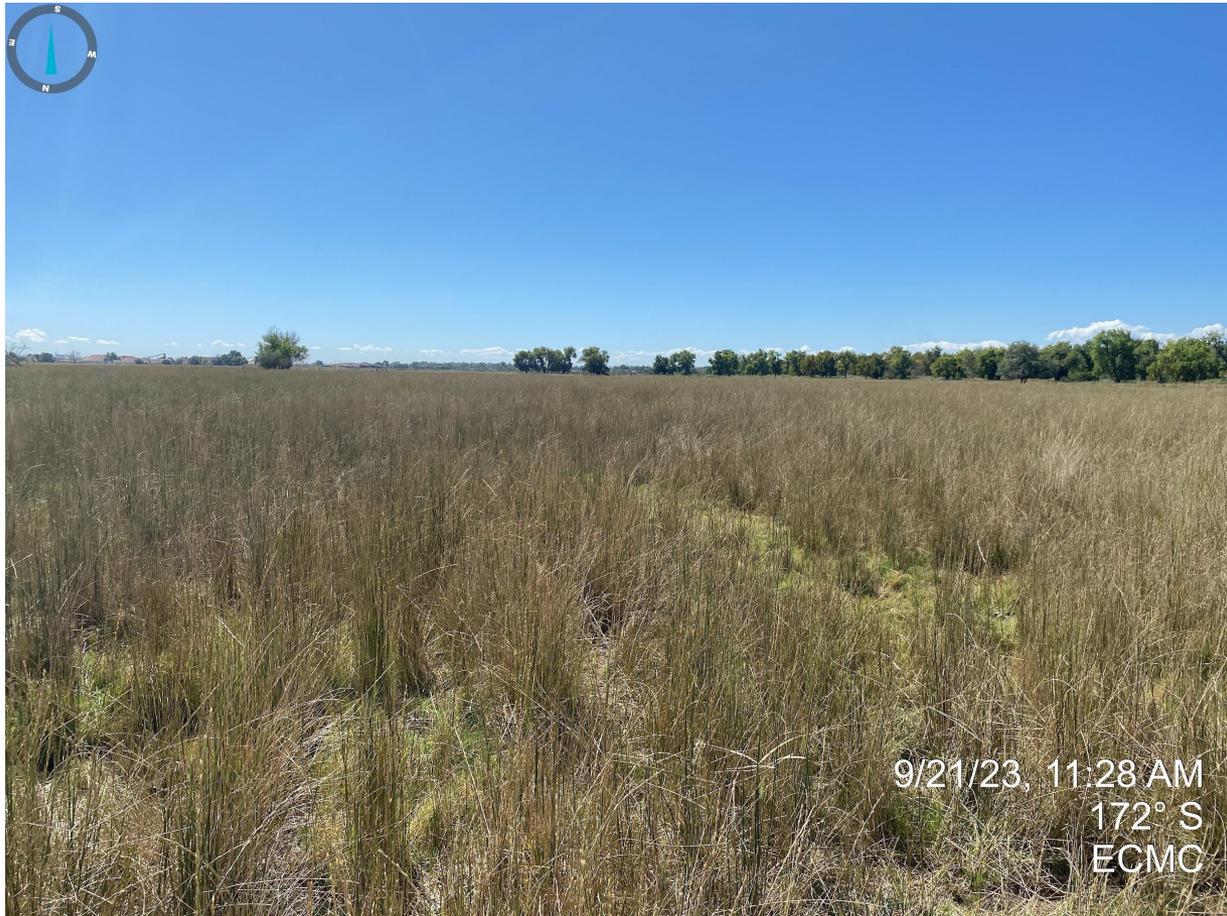
Photo 7. Taken south of the reclaimed location. Reference area pictured.
