Final Reclamation and Stormwater Inspection

Operator: KERR MCGEE OIL & GAS ONSHORE LP -
47120

Location ID: 318057

Inspection Document #: 708200577

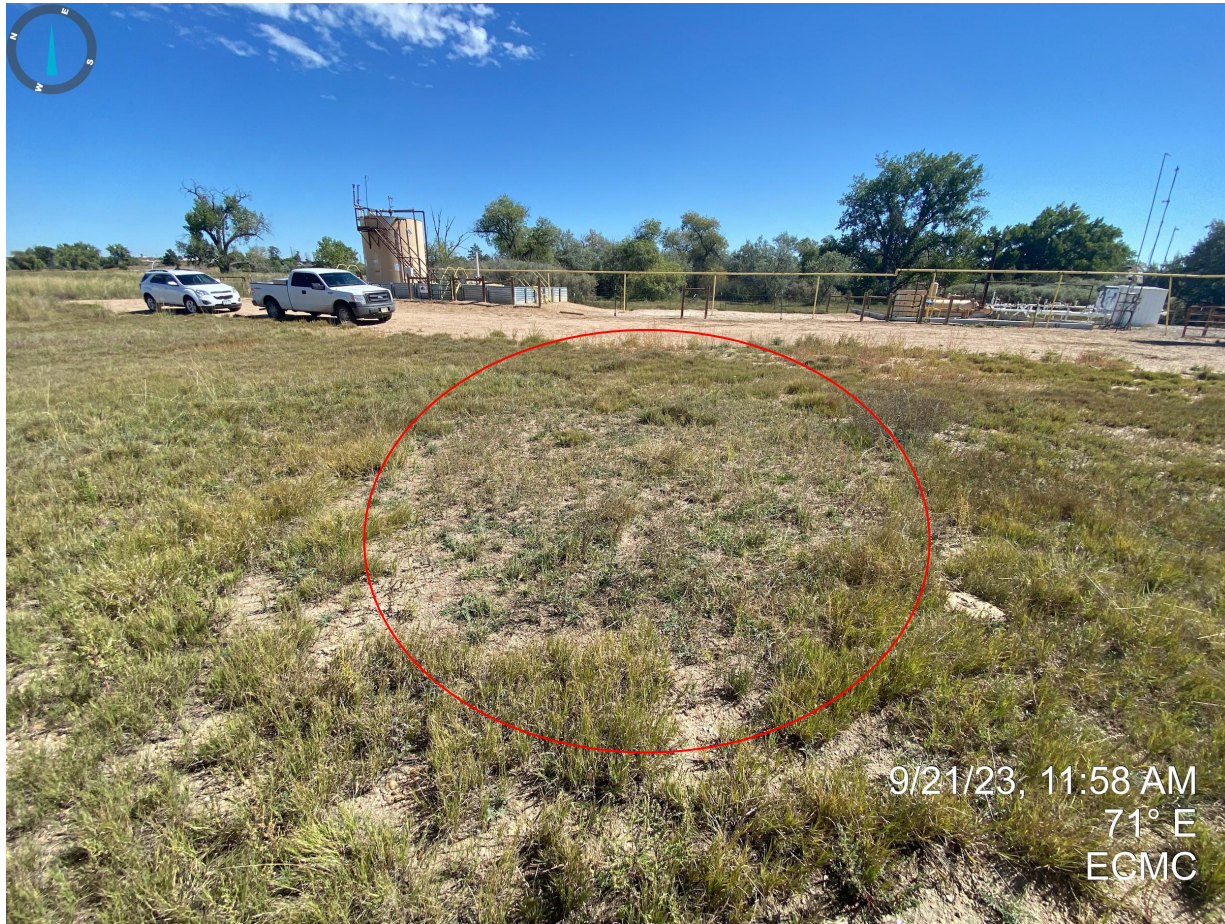
Photo 1. Taken west of the former well location. The former wellhead location (red circle) appears to be progressing towards Rule 1004 standards and regulations, though some undesirable vegetation was observed (e.g. kochia). The production facilities pictured in the background need to be decommissioned and reclaimed.

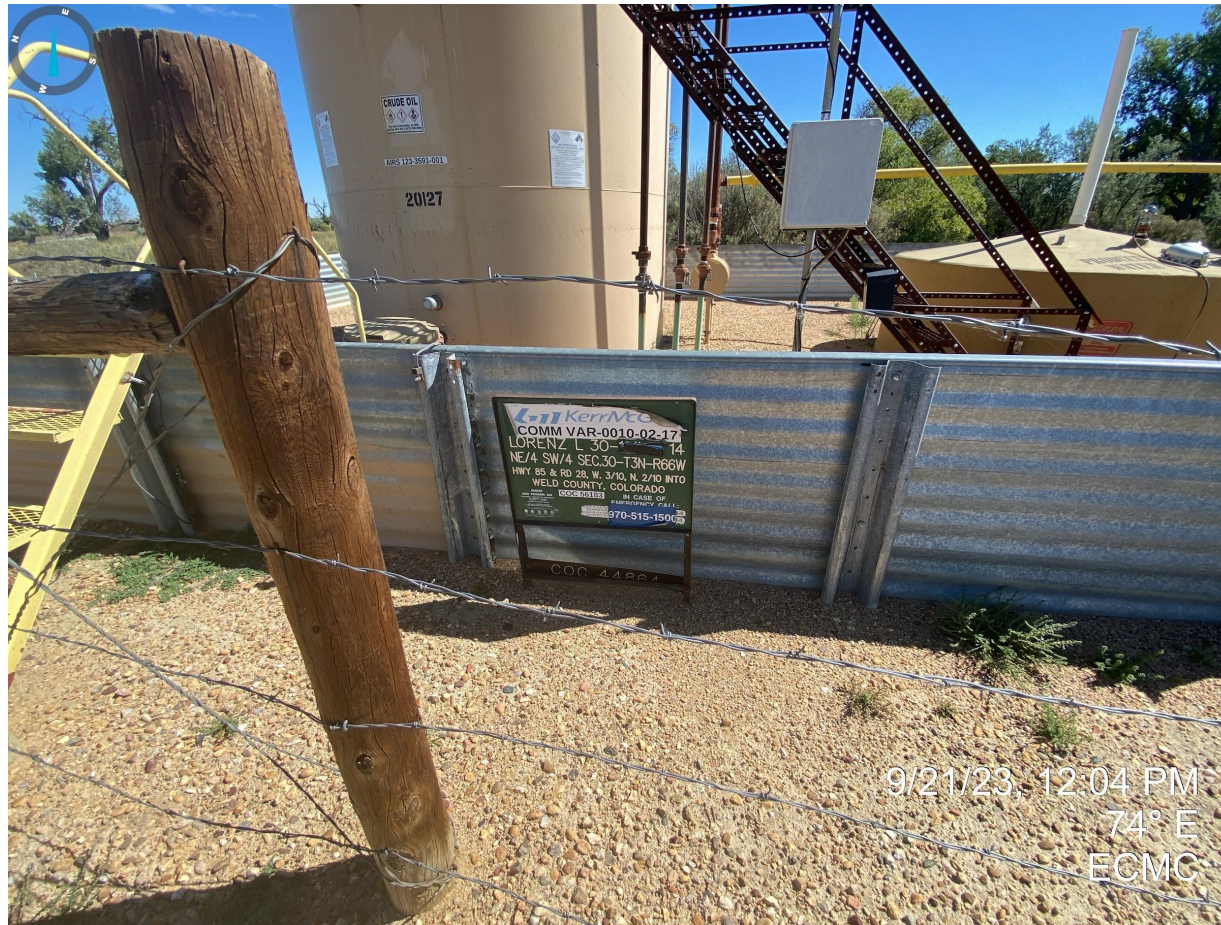
Photo 2. Reclamation rules require all debris, abandoned gathering line risers, flowline risers, and equipment (regardless of ownership) to be removed within three months of plugging (03/23/2018) the associated facility. The Operator will need to decommission the production facilities and perform reclamation.

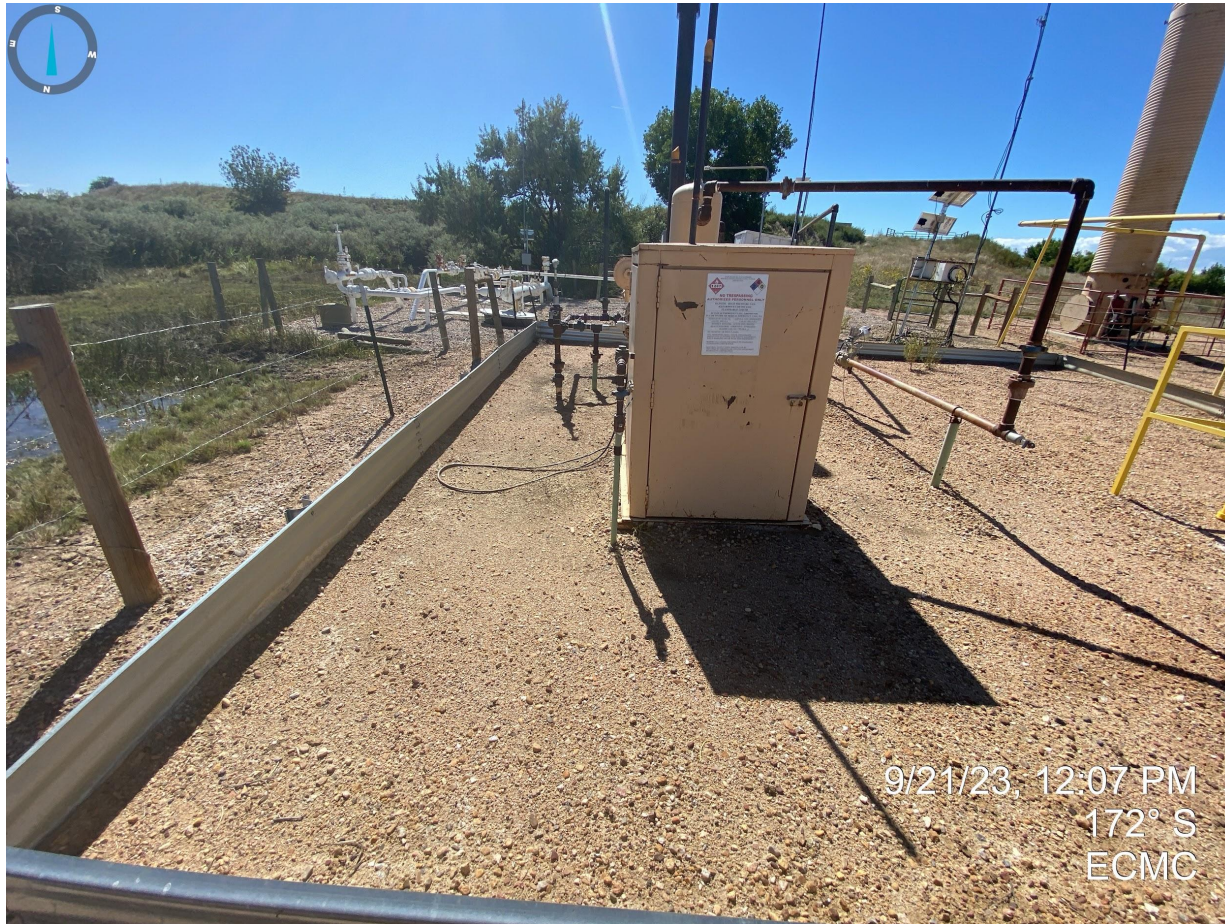
Photo 3. See comments in Photo 2.

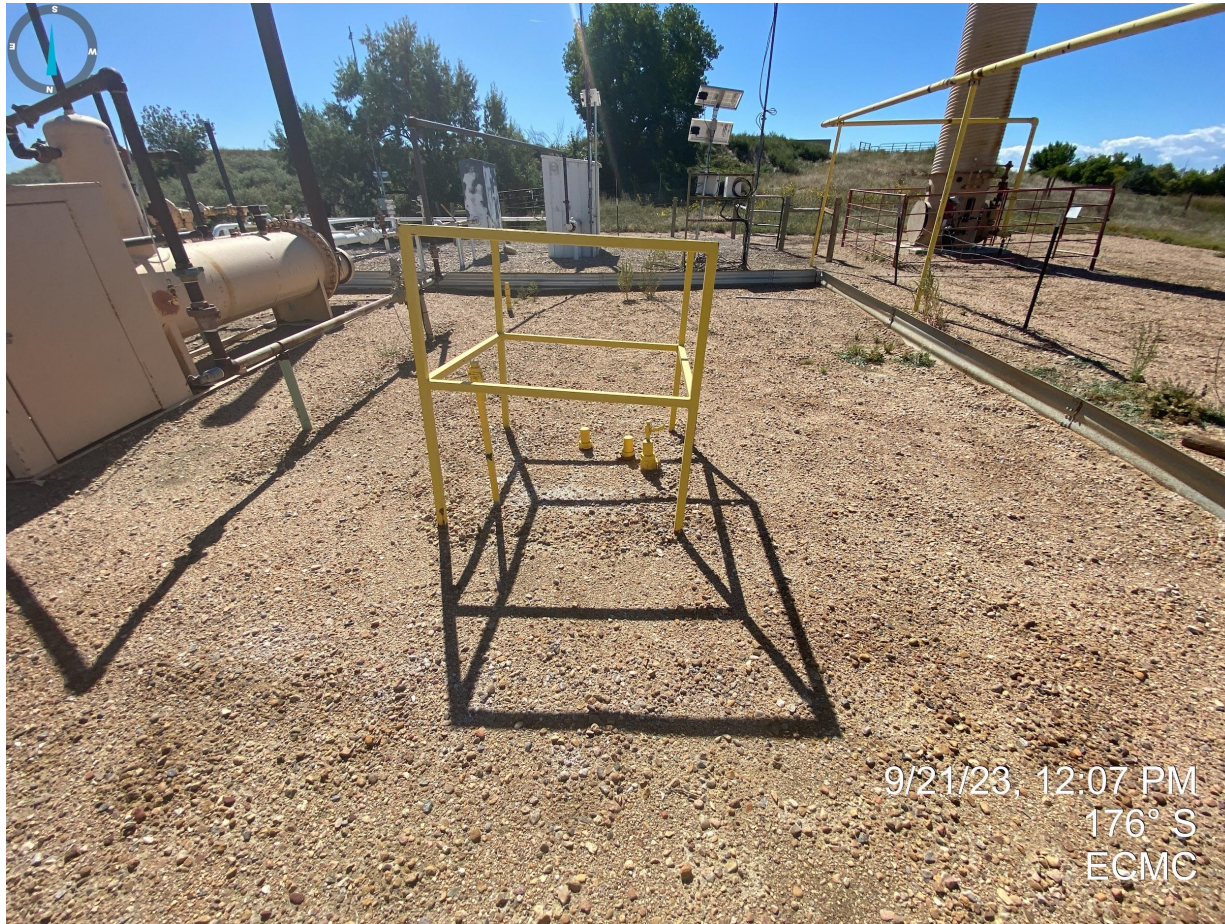
Photo 4. See comments in Photo 2.

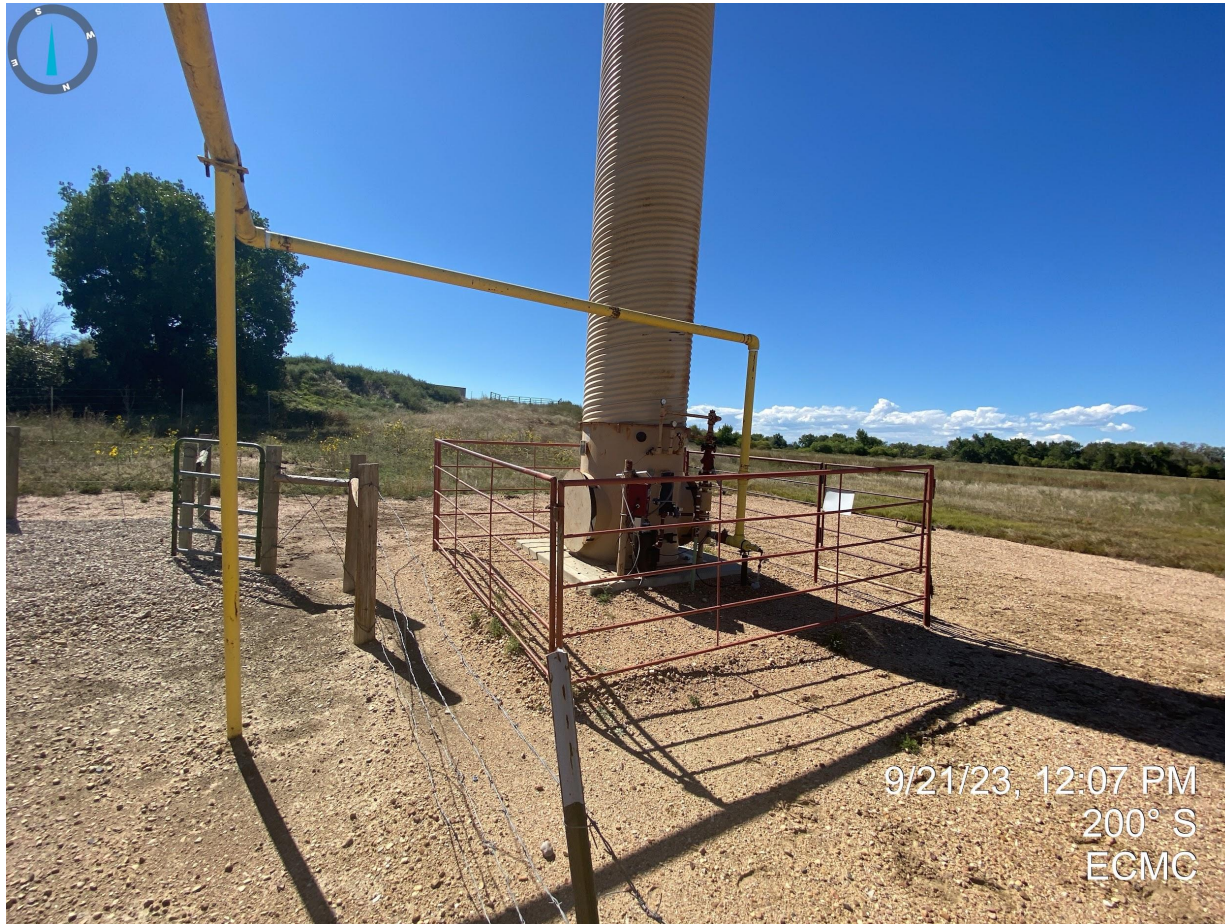
Photo 5. See comments in Photo 2.

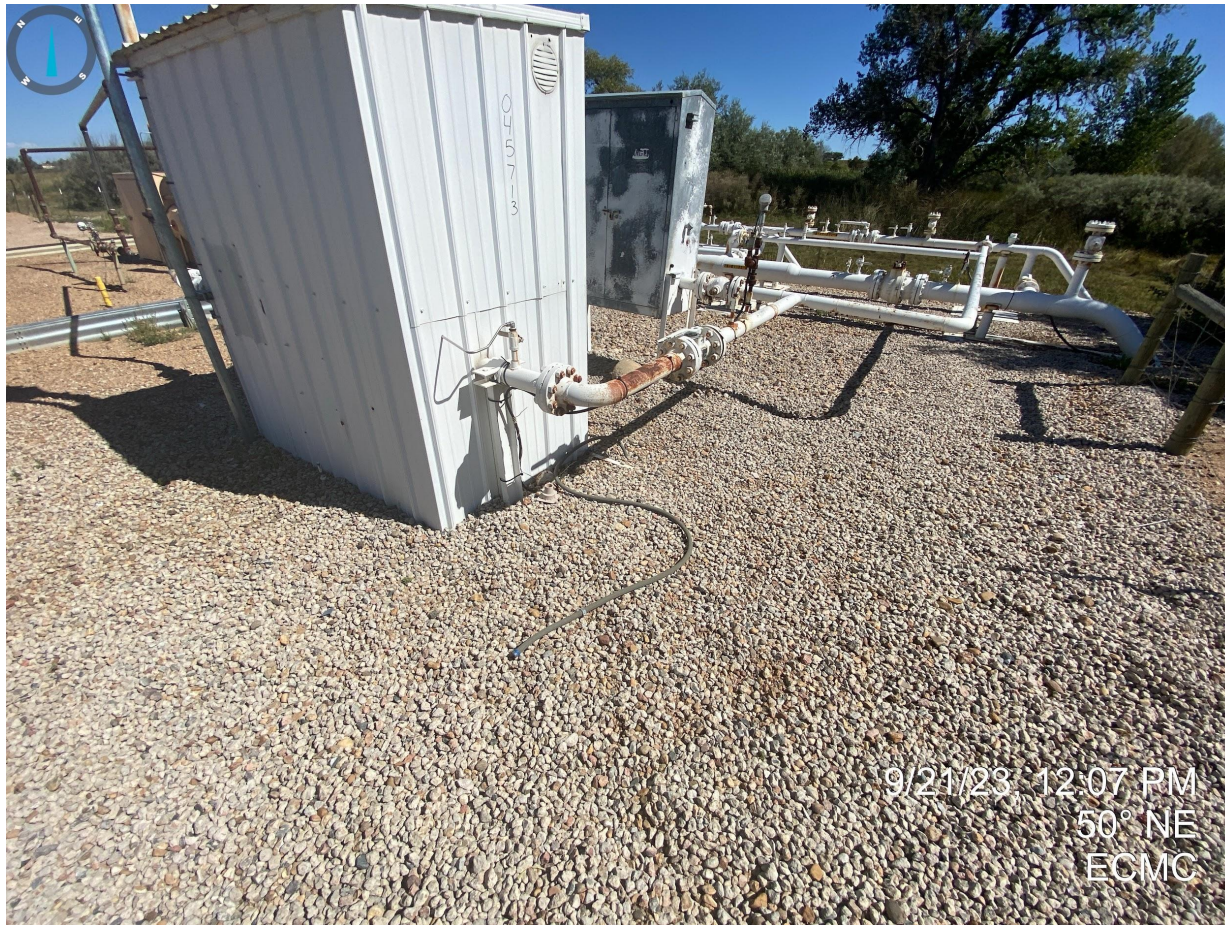
Photo 6. See comments in Photo 2.

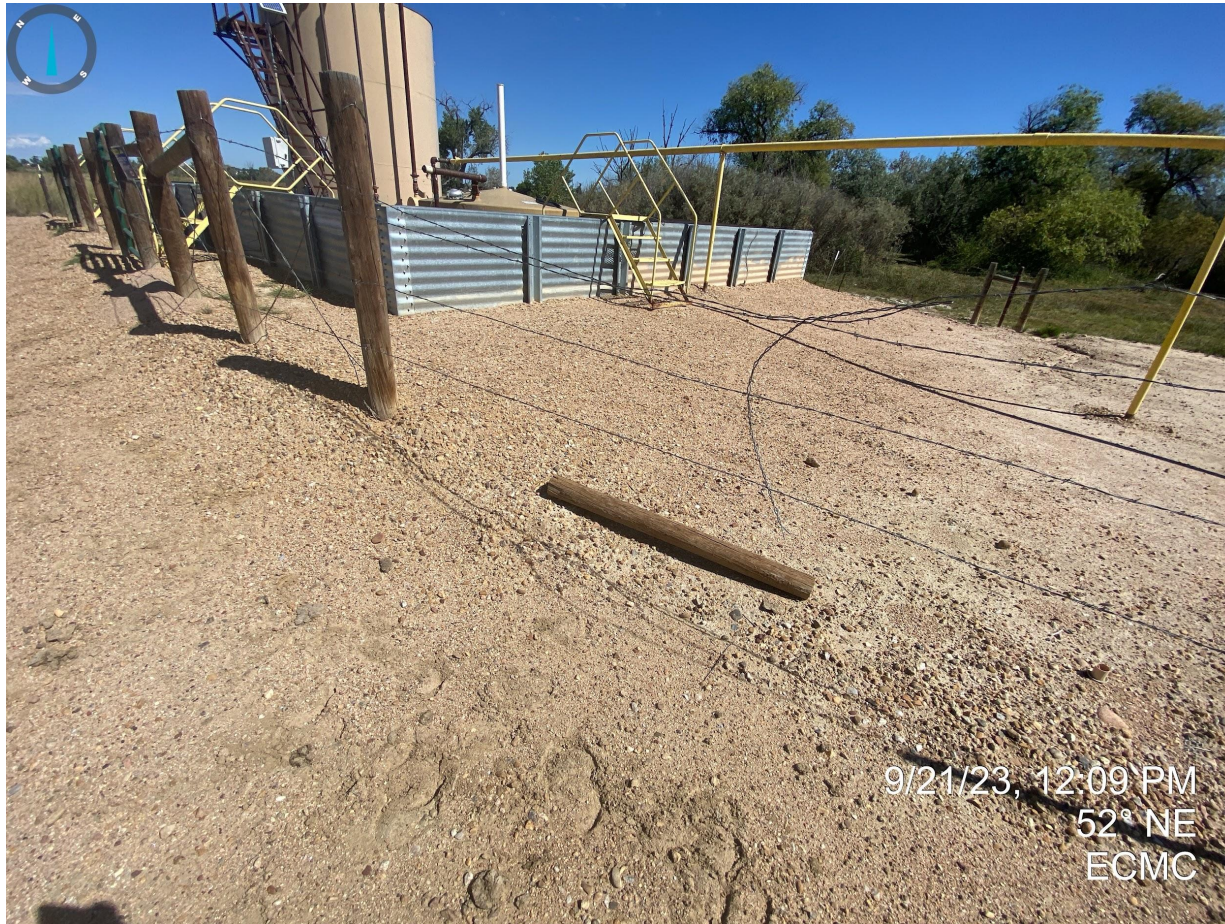
Photo 7. See comments in Photo 2.

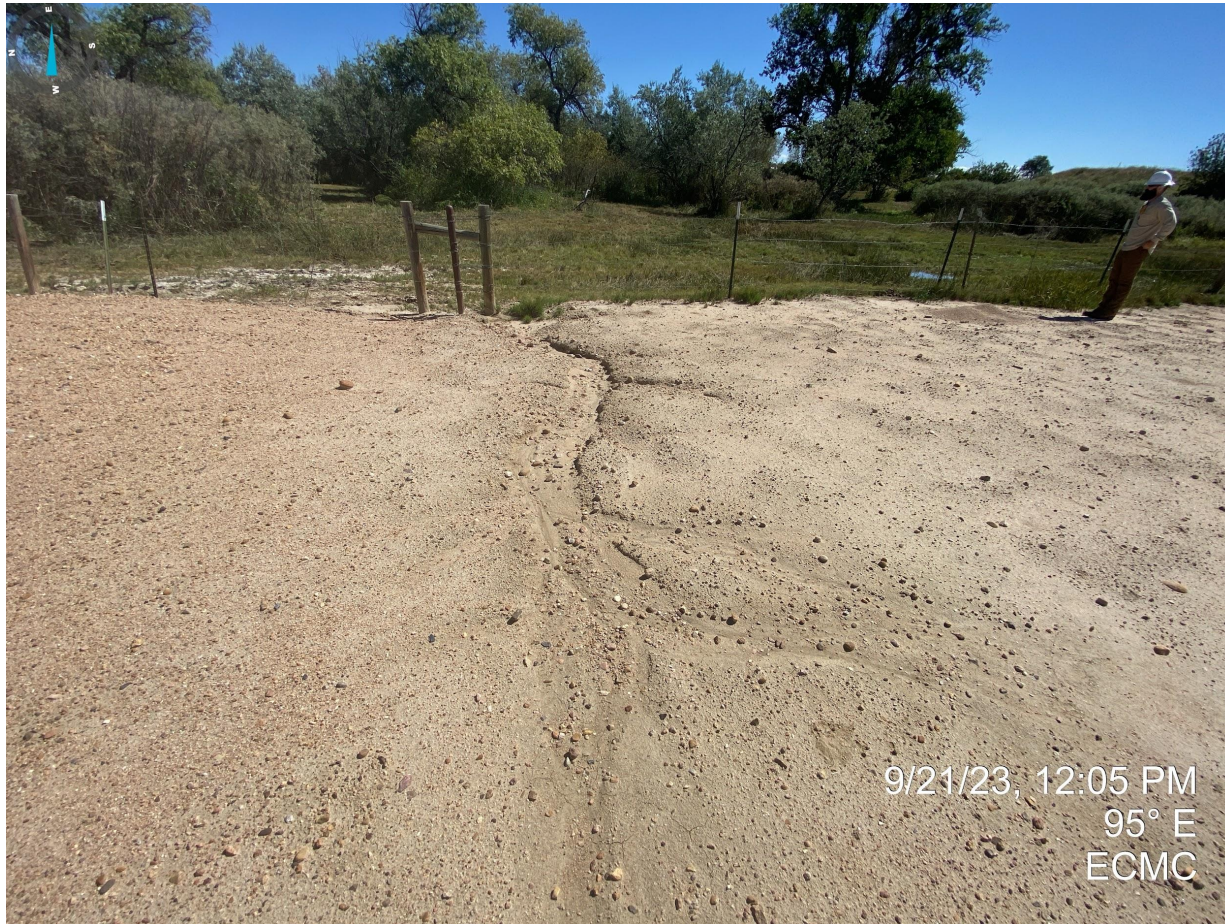
Photo 8. Taken from the center portion of the production facilities. Erosion degradation (e.g. rilling) pictured.

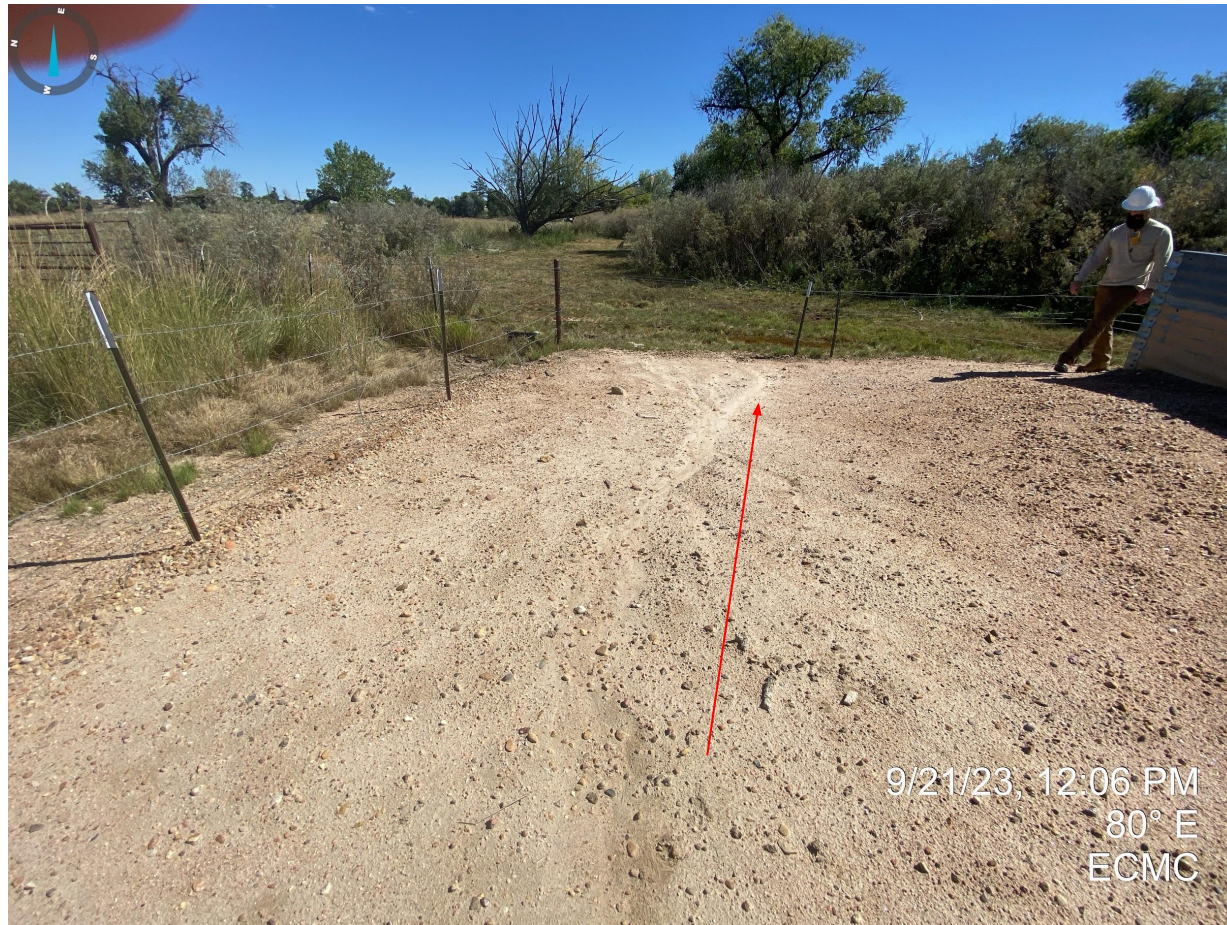
Photo 9. Taken from the northern portion of the production facilities. Erosion degradation pictured.

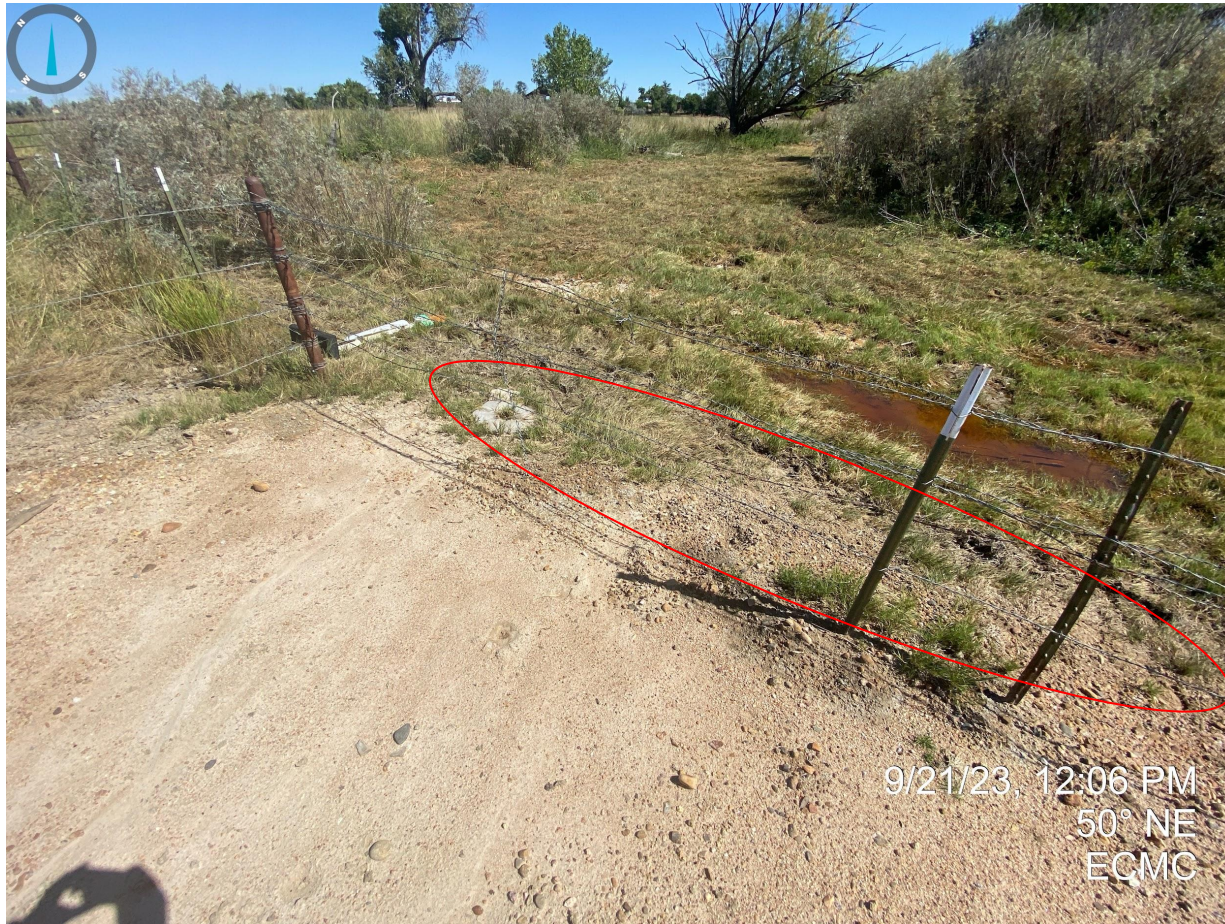
Photo 10. Off location sediment transport is evident as no stormwater control measures were observed during this inspection.
