Inspection Photos
Location Name: Bledsoe 16-34-5-44
API Number: 125-09686

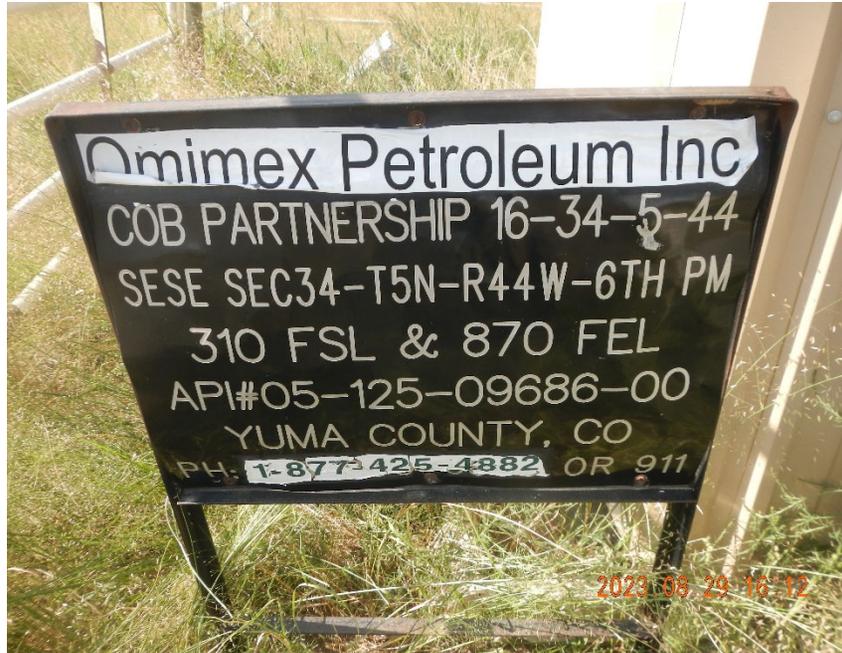
1. Well sign at well location. Wrong name correct API.

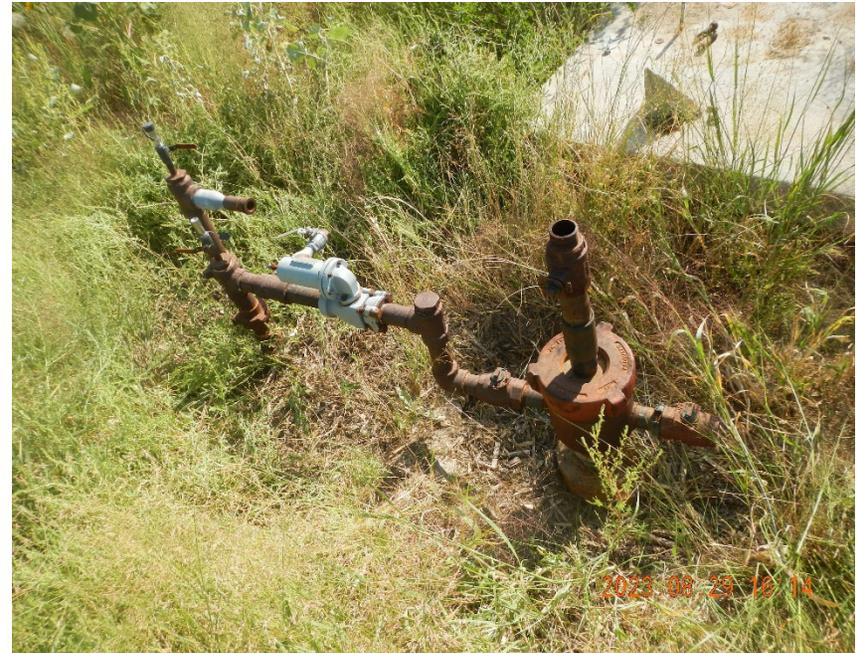
2. View of Wellhead. Note vegetation.

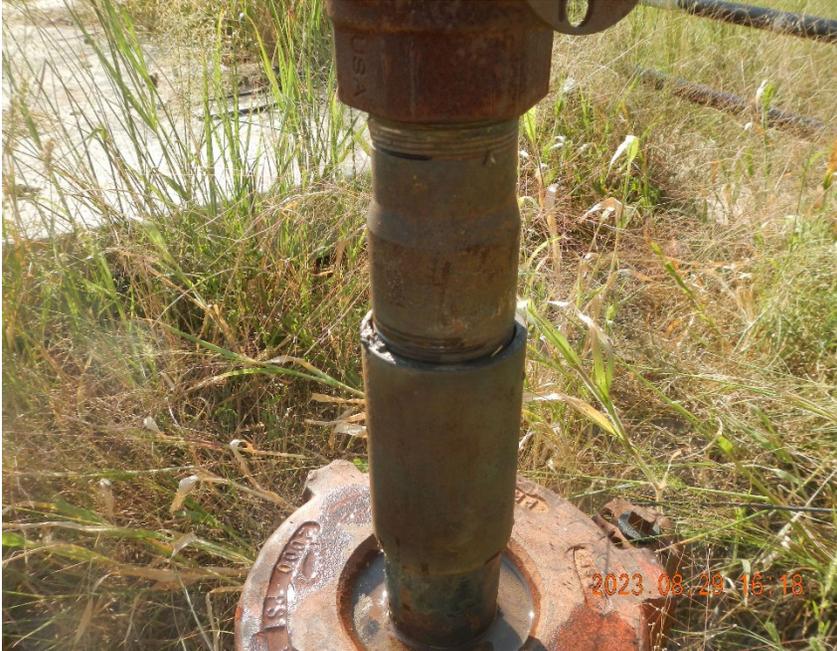
3. Gas leaking from collar and nipple connection.

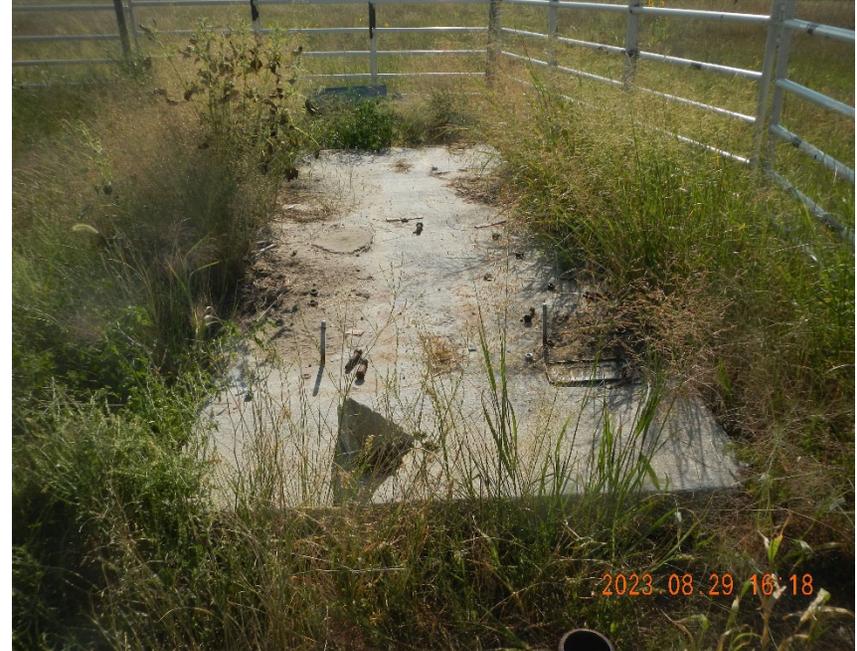
4. Pump Jack cement pad and debris. Note vegetation.

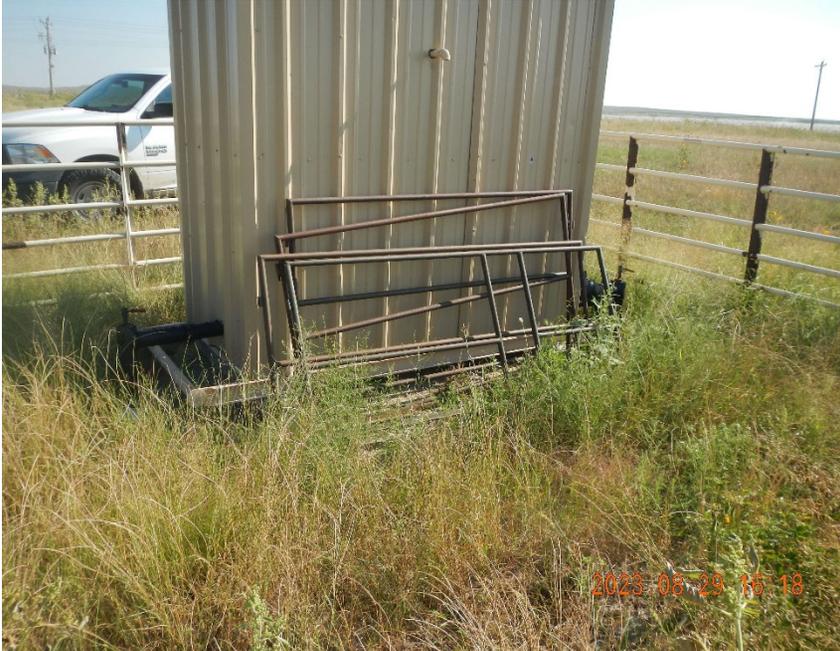
5. Pump Jack barriers left inside fencing. Note vegetation.

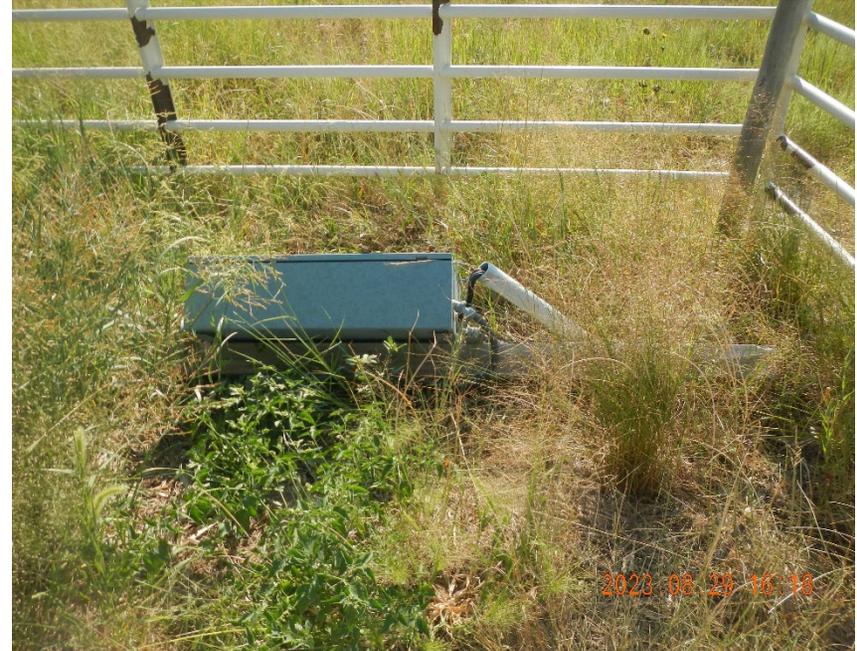
6. Downed Pump Jack Power and Control Panel. Note vegetation.

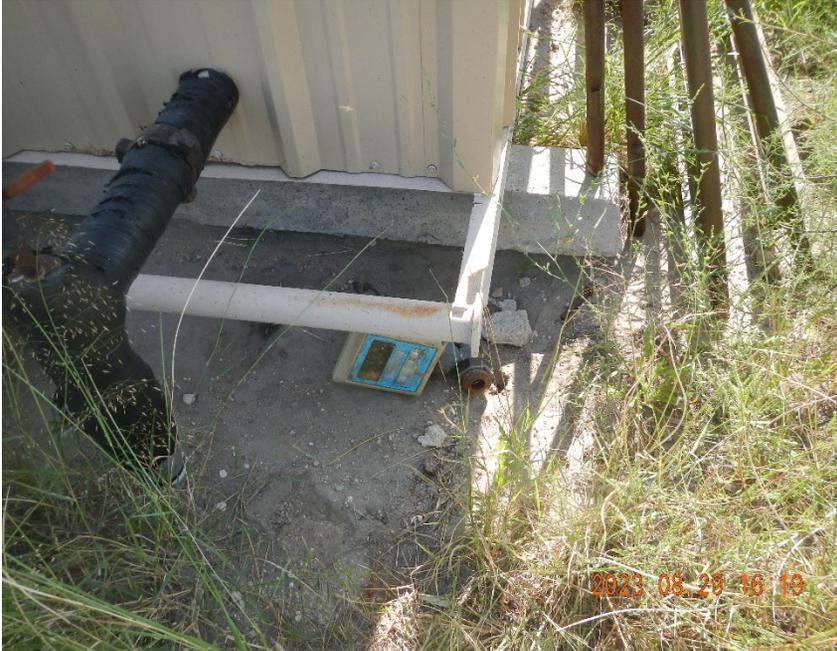
7. Production related debris by Meter Shed.

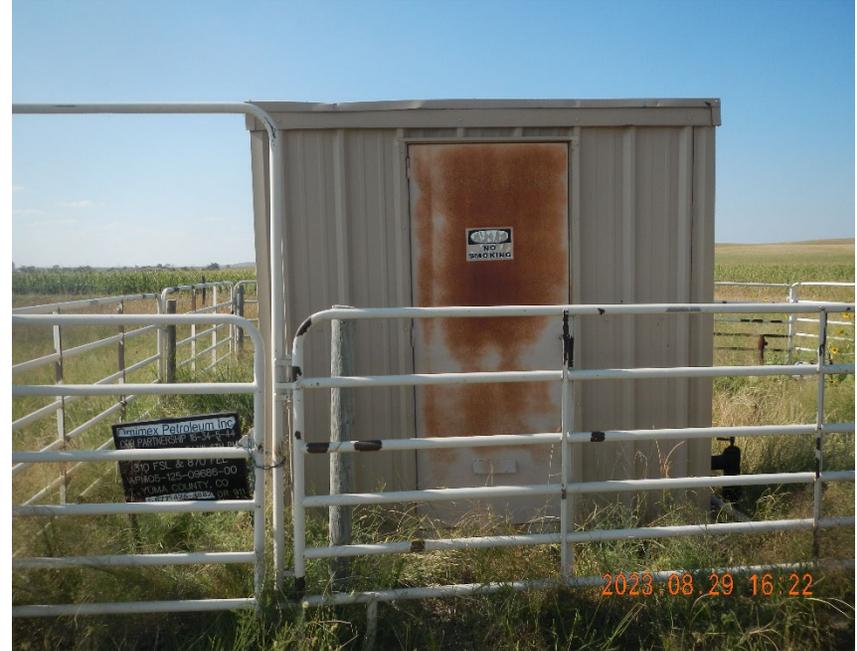
8. Meter Shed.

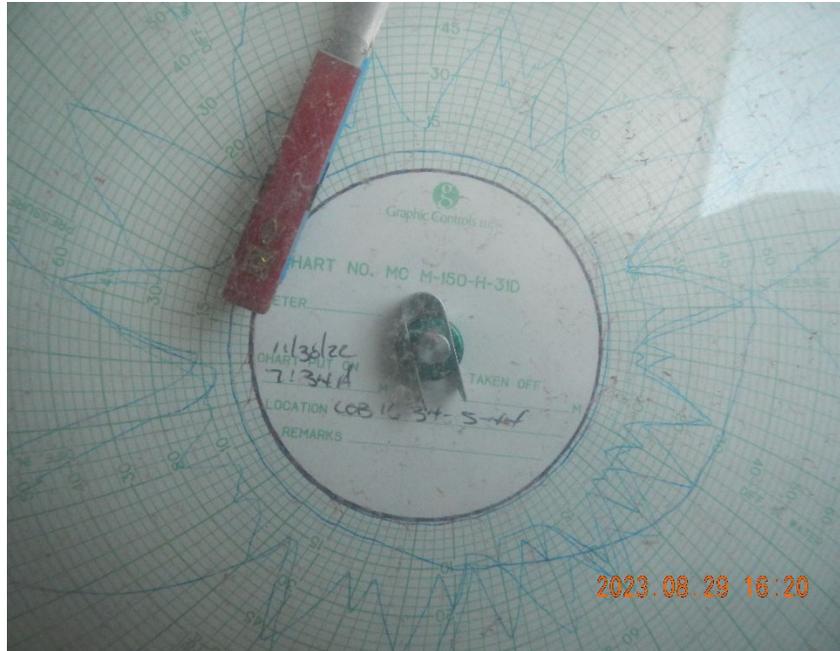
9. Chart found in Meter Box at time of inspection.

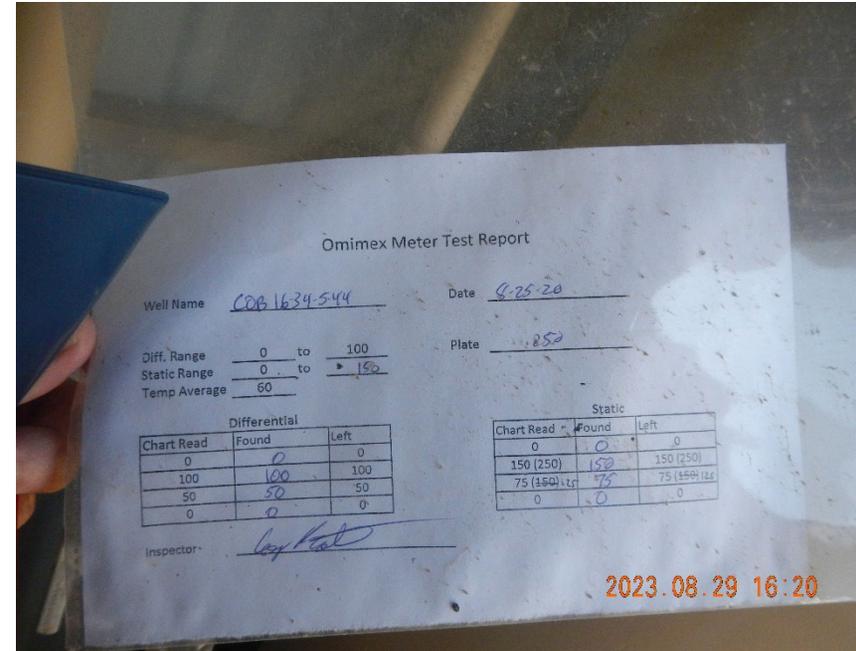
10. Meter Calibration Log found in Meter Shed at time of inspection.

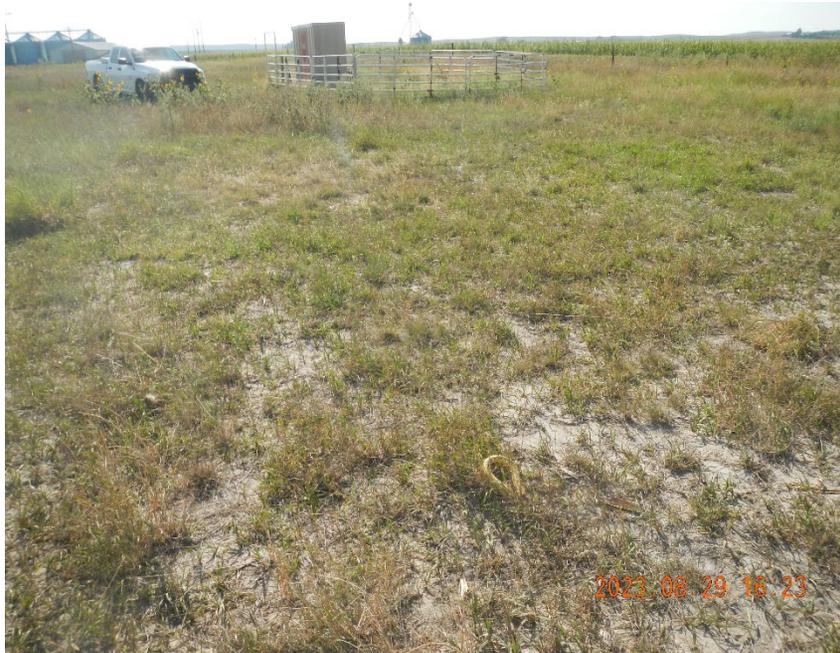
11. One located Deadman not marked. Unable to locate remaining three.

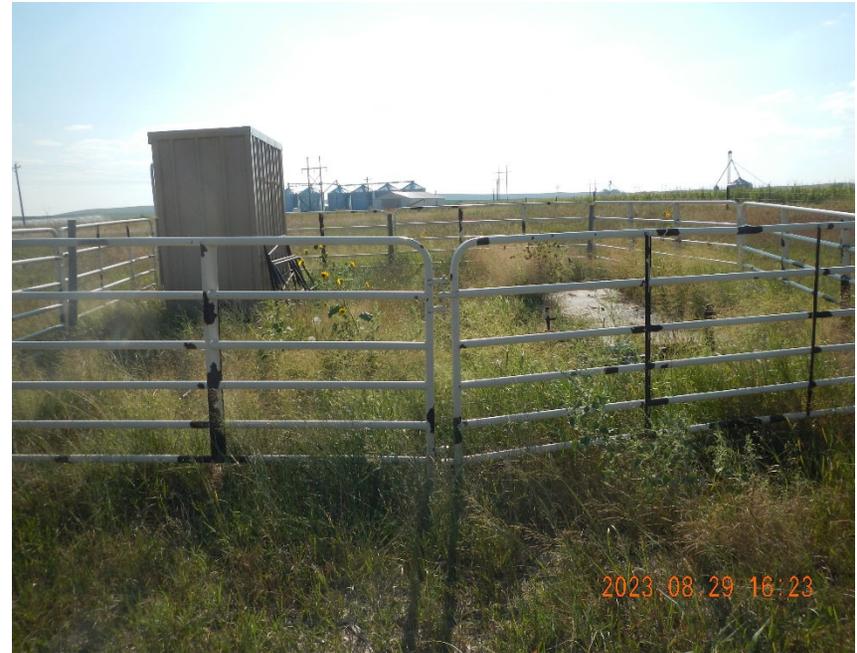
12. Location overview. Noted vegetation inside fencing.
