Inspection Photos

Operator: LARAMIE ENERGY LLC - 10433

Location ID: 334487

Inspection No: 696205312

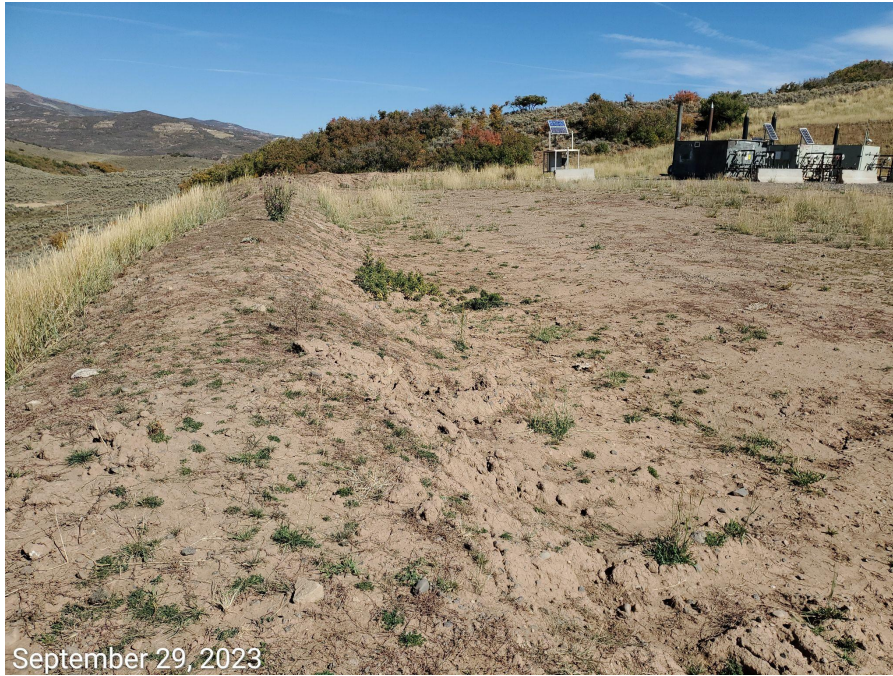
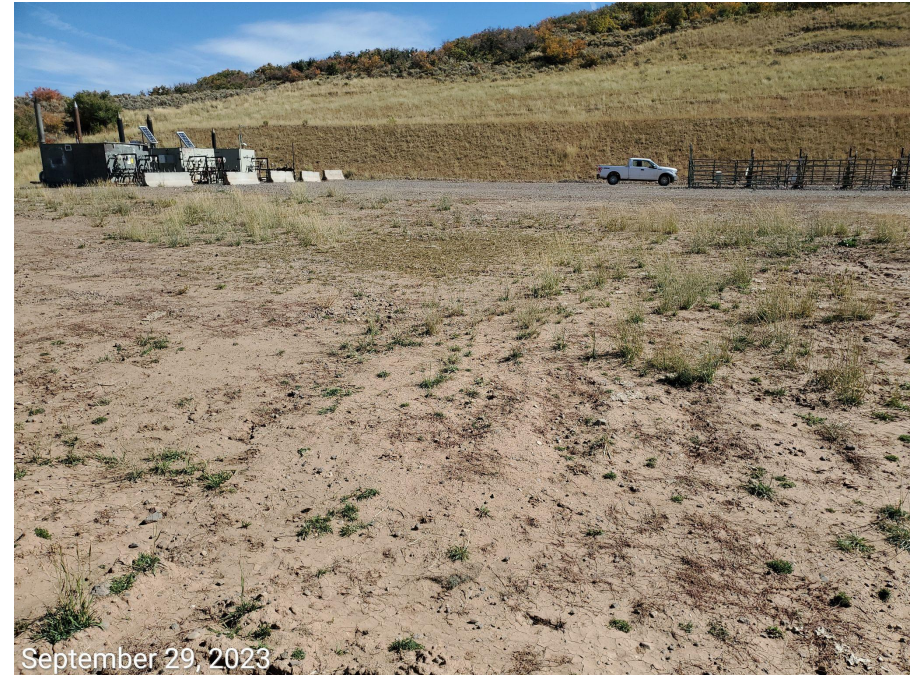
Photo 1: Photos 1-2 taken from the west end of the working pad surface. Photos provide an overview of the Location from north, northeast, southeast to south.

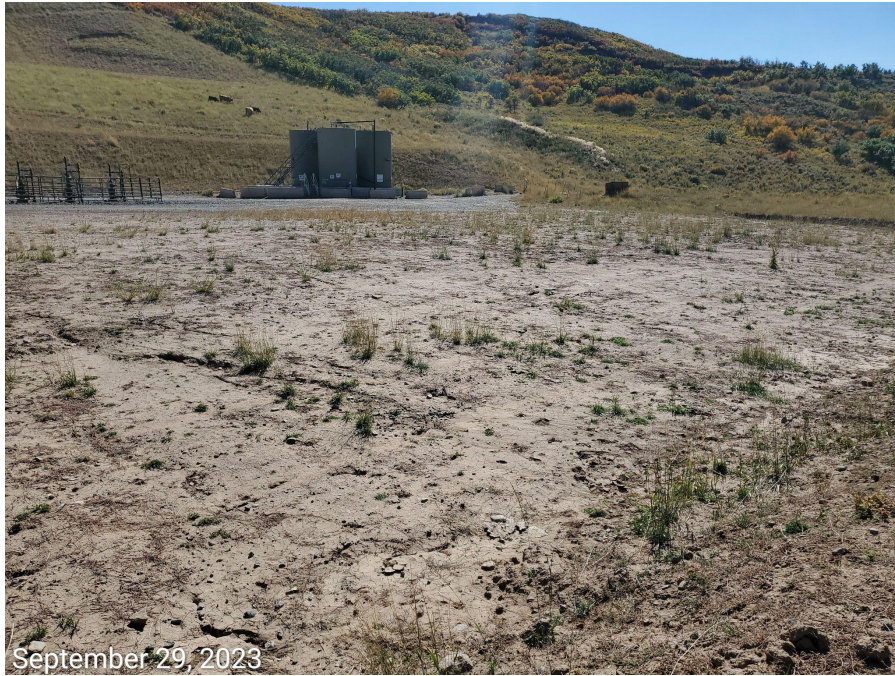
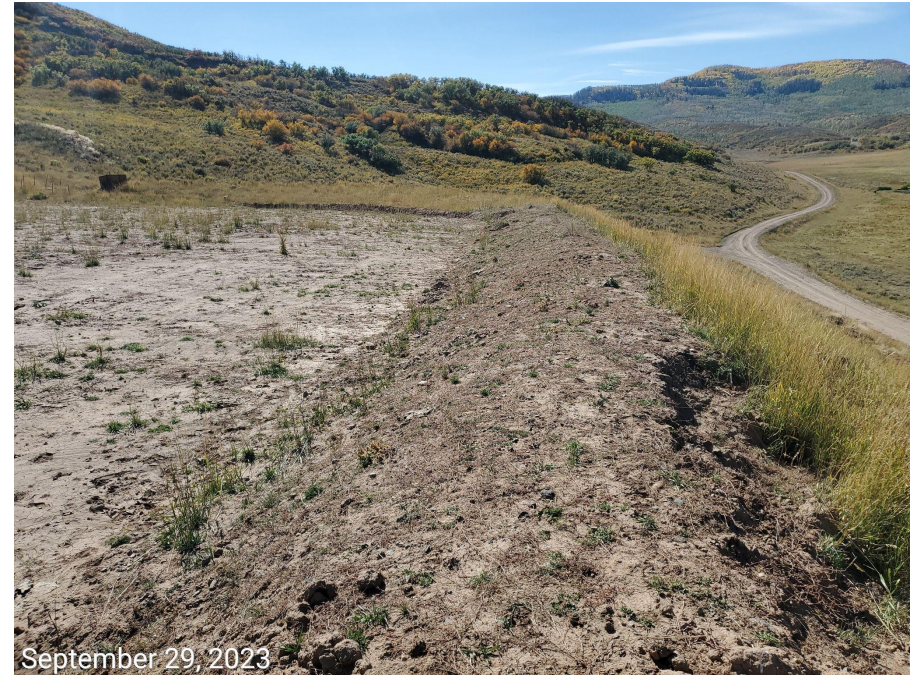
Photo 2: See comments under photo 1.

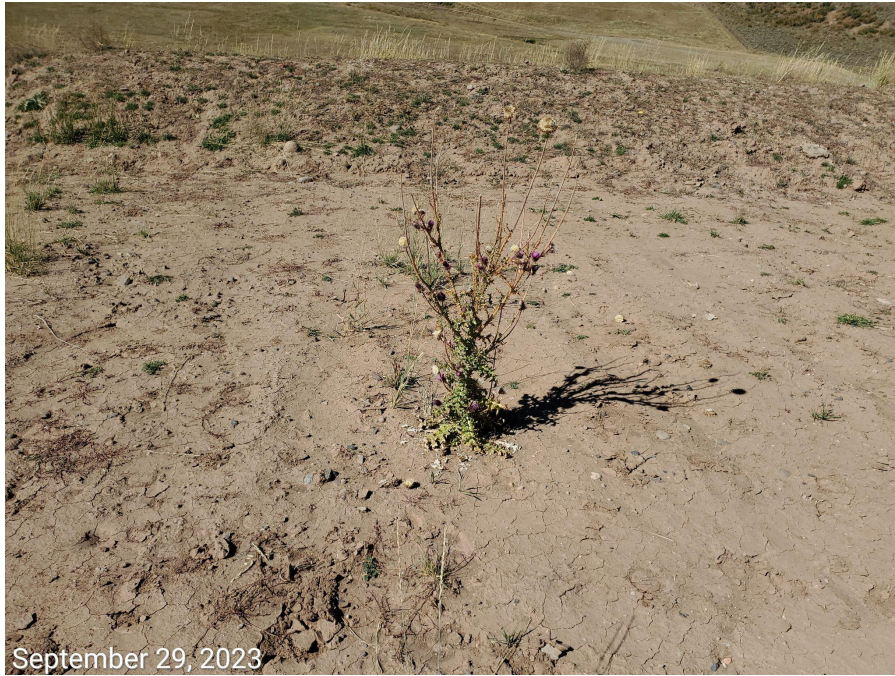
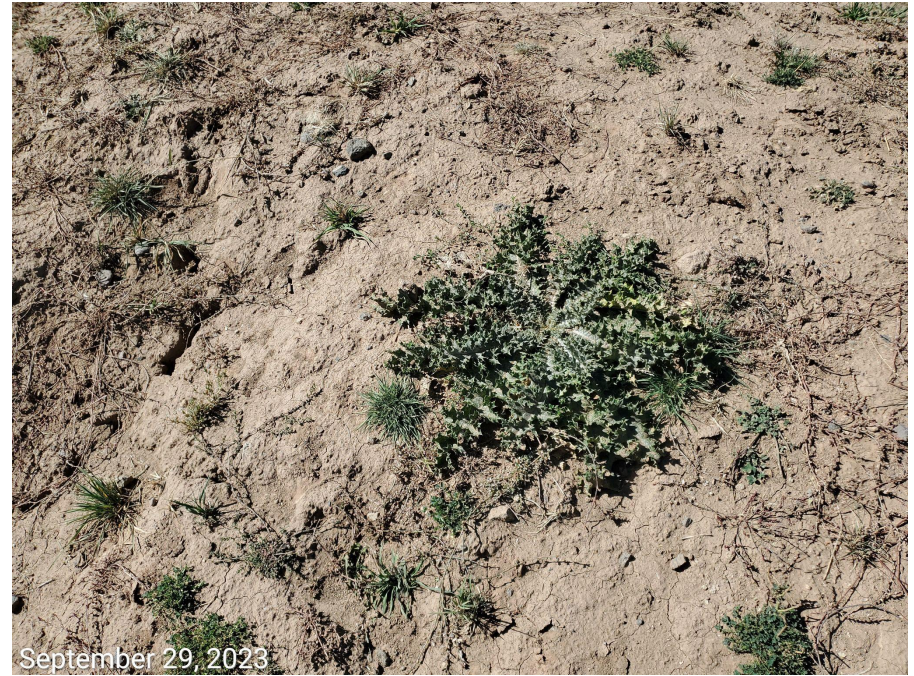
Photo 3: Photos left taken from the western areas of the WPS. Photos provide examples of Musk thistle (both mature, and rosette) establishing on the western ends of the Location.

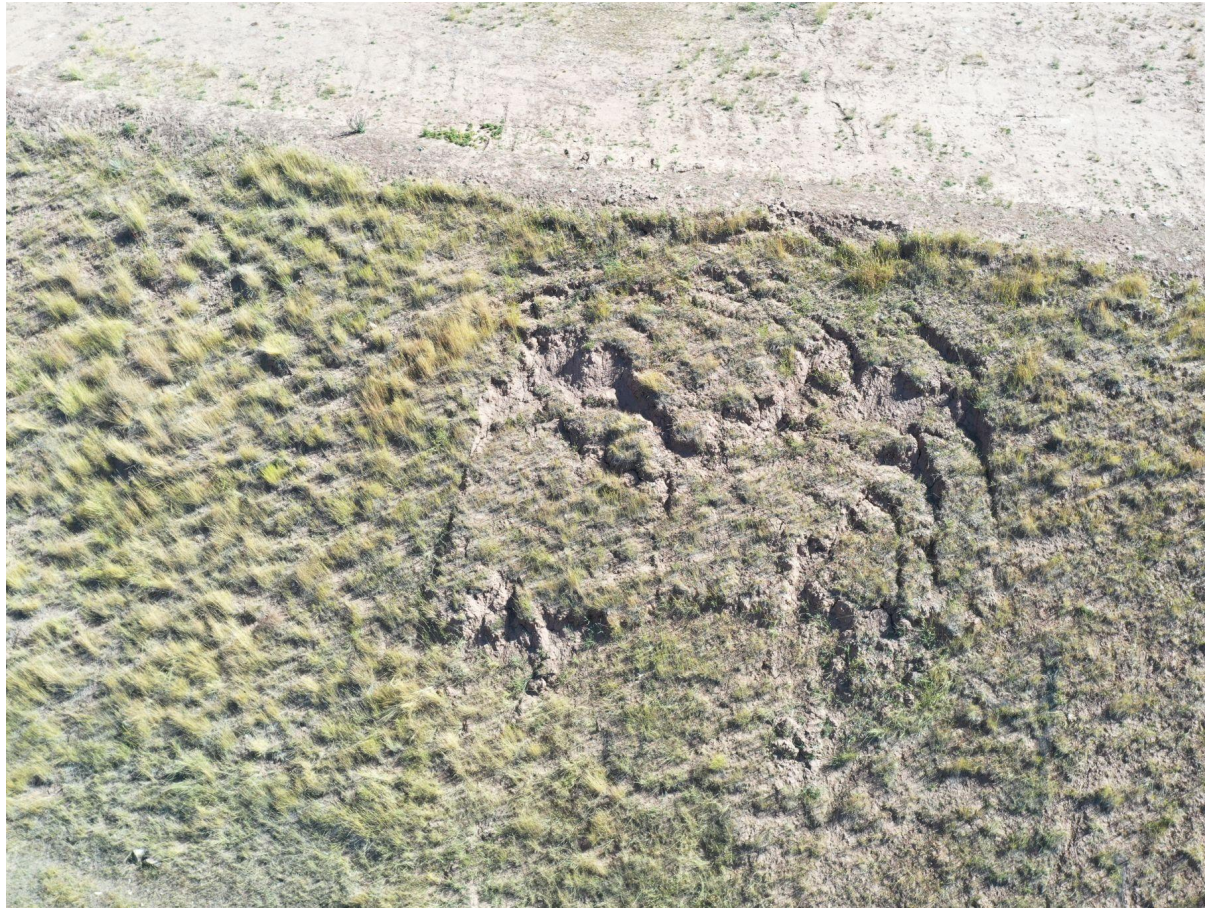
Photo 4: Photo taken with use of a sUAS. Photo shows areas on the fill slope (west end of the Location), where mass soil migration is apparent; stabilization concerns exist.

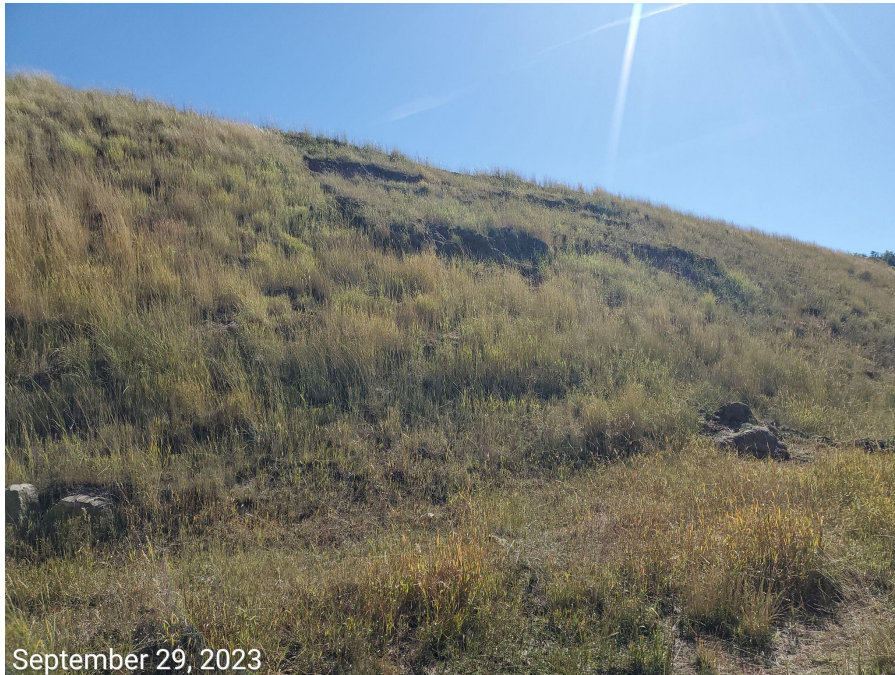
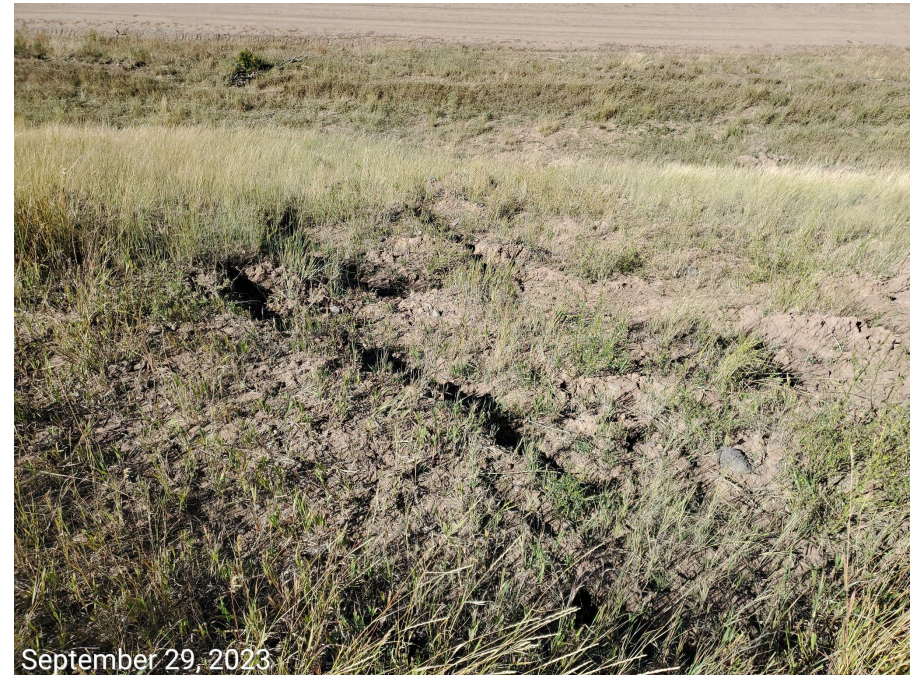
Photo 5: Continued from photo 4. Photo shows mass soil migration concerns on the fill slope of the Location.

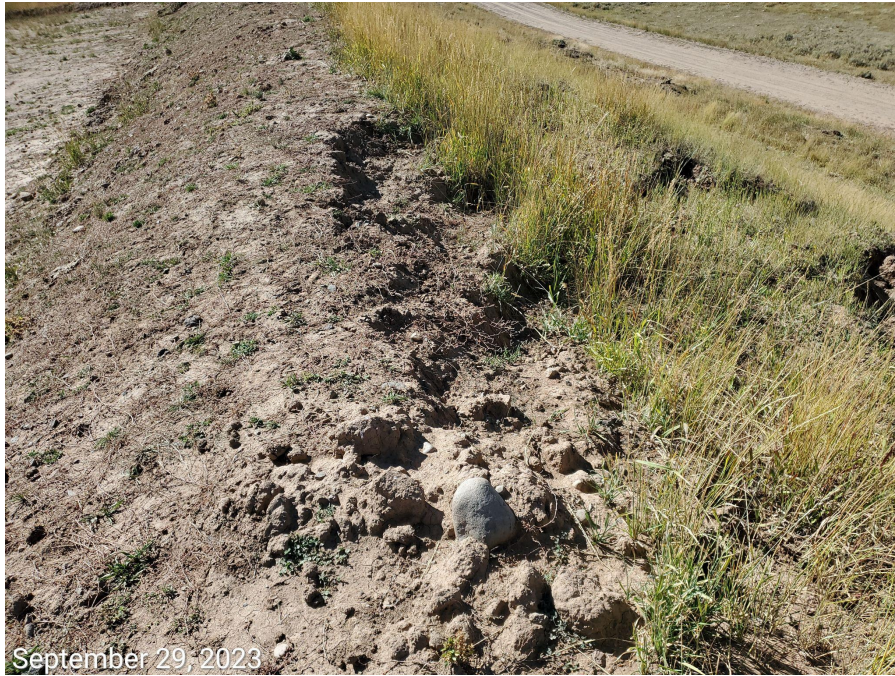
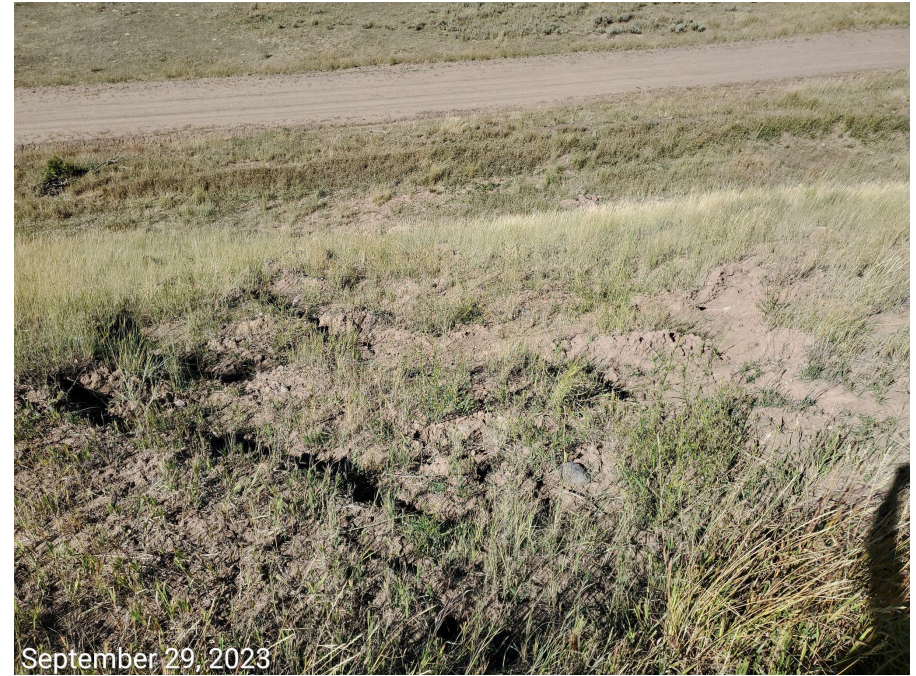
Photo 6: Continued from photo 4. Photo shows mass soil migration concerns on the fill slope of the Location.

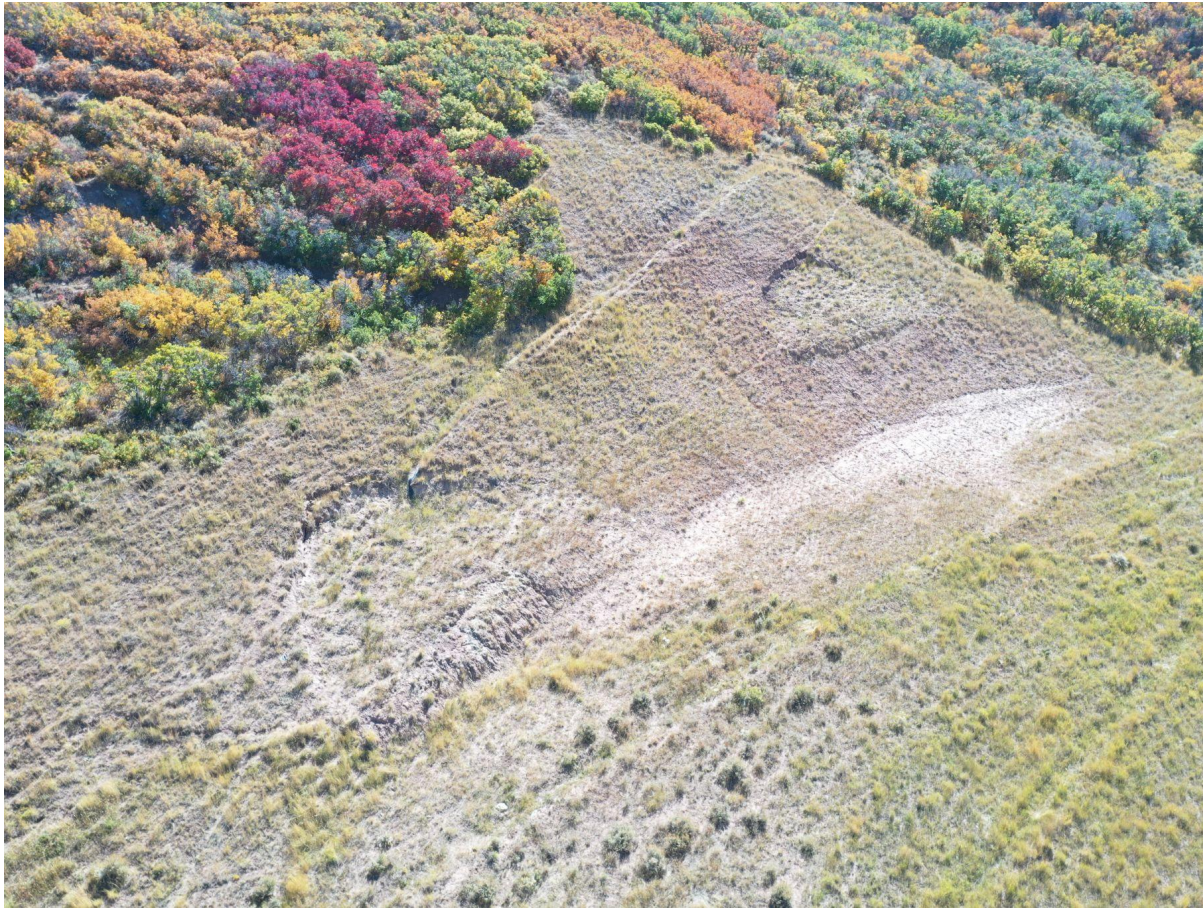
Photo 7: Photo taken with use of a sUAS. Photo shows areas on the cut slope (east end of the Location), where mass soil migration is apparent; stabilization concerns exist.

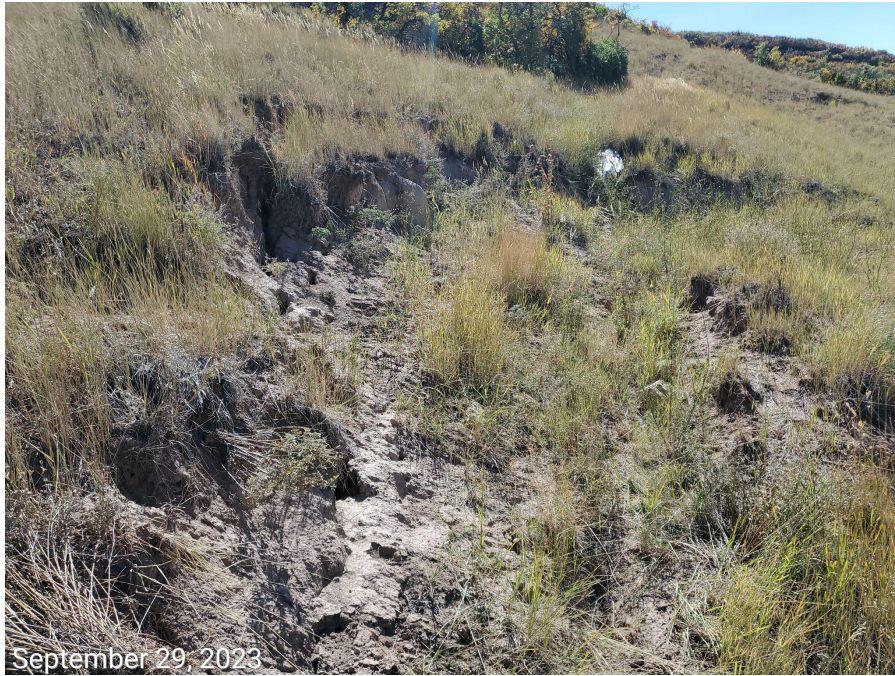
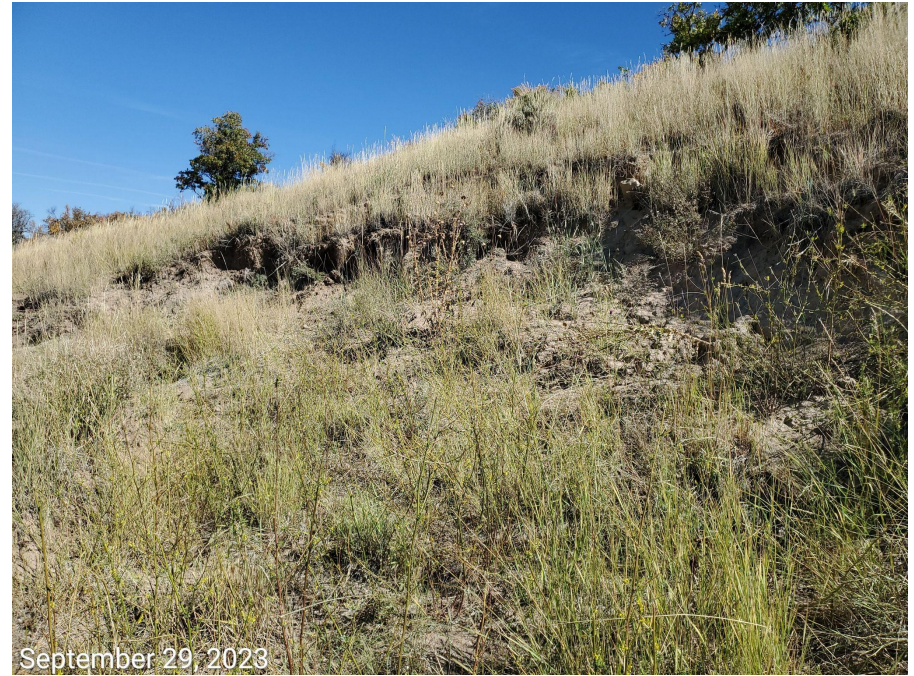
Photo 8: Continued from photo 7. Photo shows mass soil migration concerns on the cut slope of the Location.

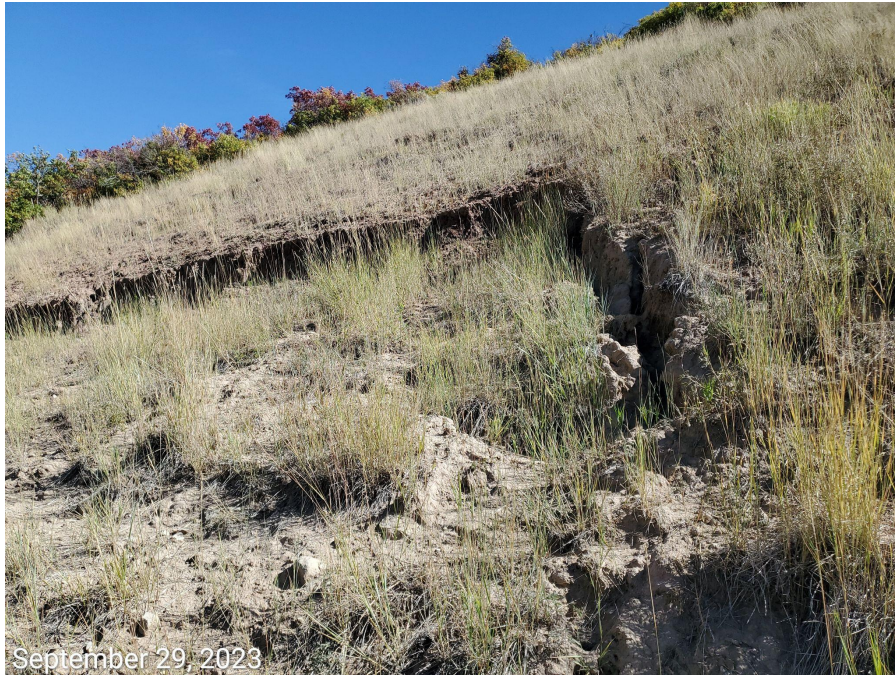
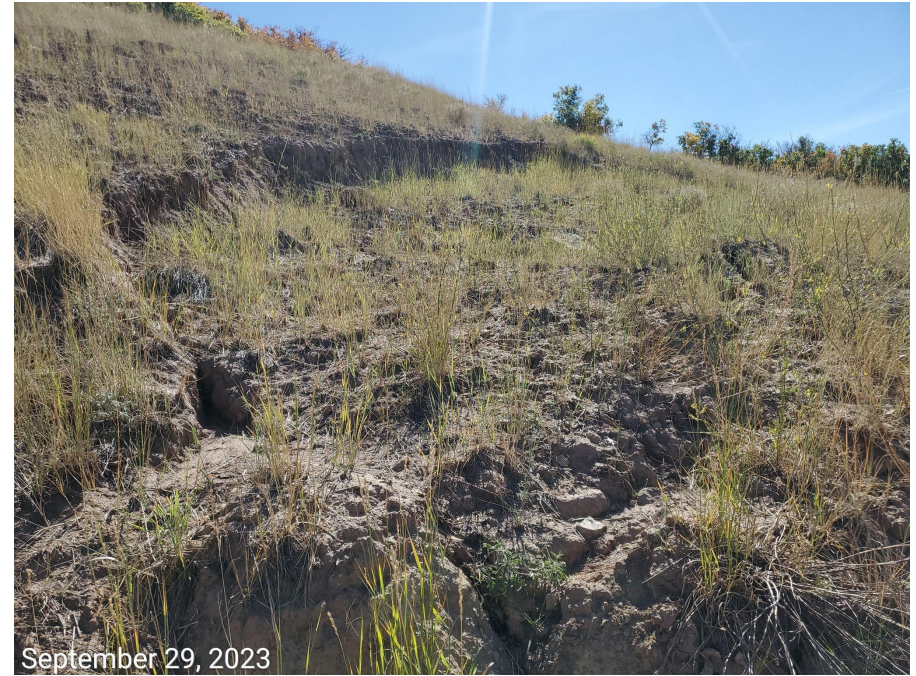
Photo 9: Continued from photo 7. Photo shows mass soil migration concerns on the cut slope of the Location.

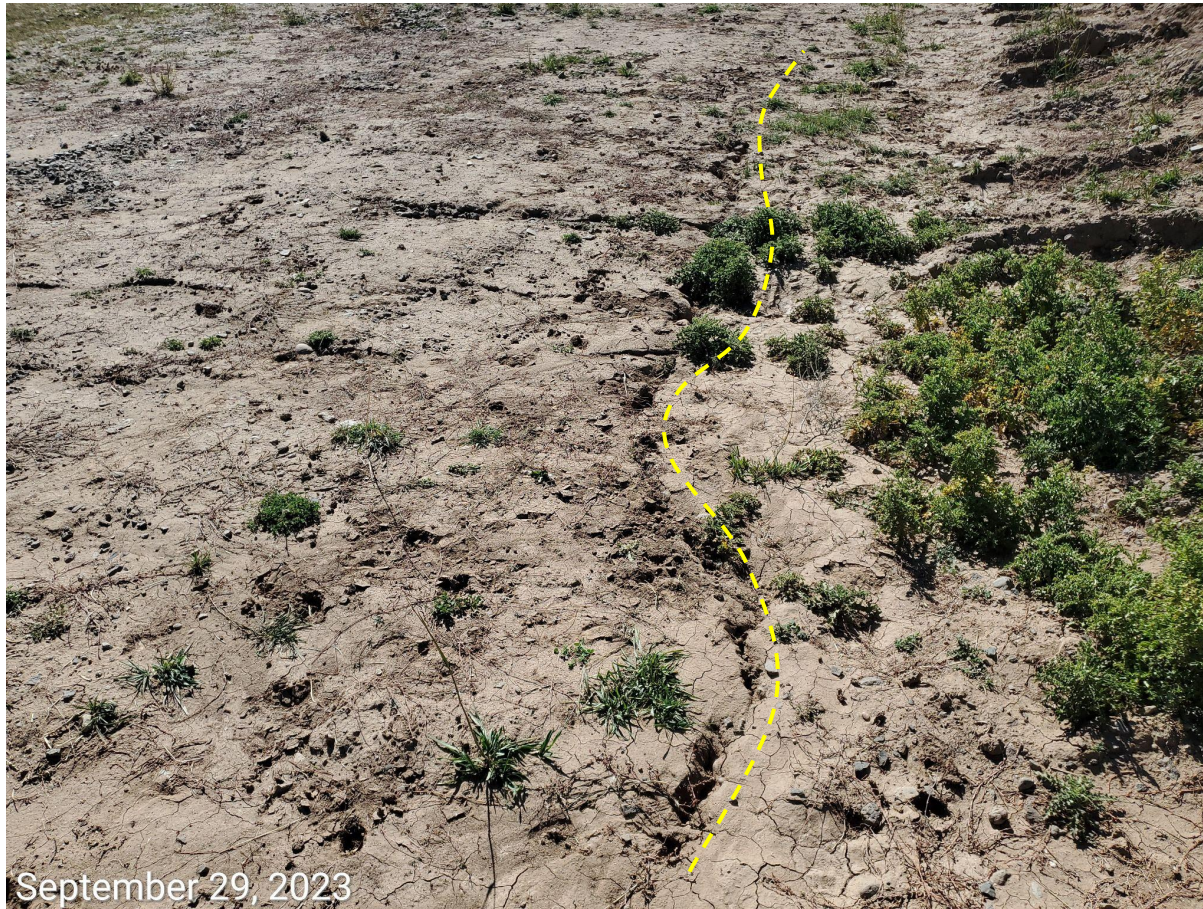
Photo 10: Photo taken from the perimeter of the working pad surface, on the northwest end of the Location, facing south. Photo shows long cracks (left of yellow line) forming on the Location; stabilization concerns exist.

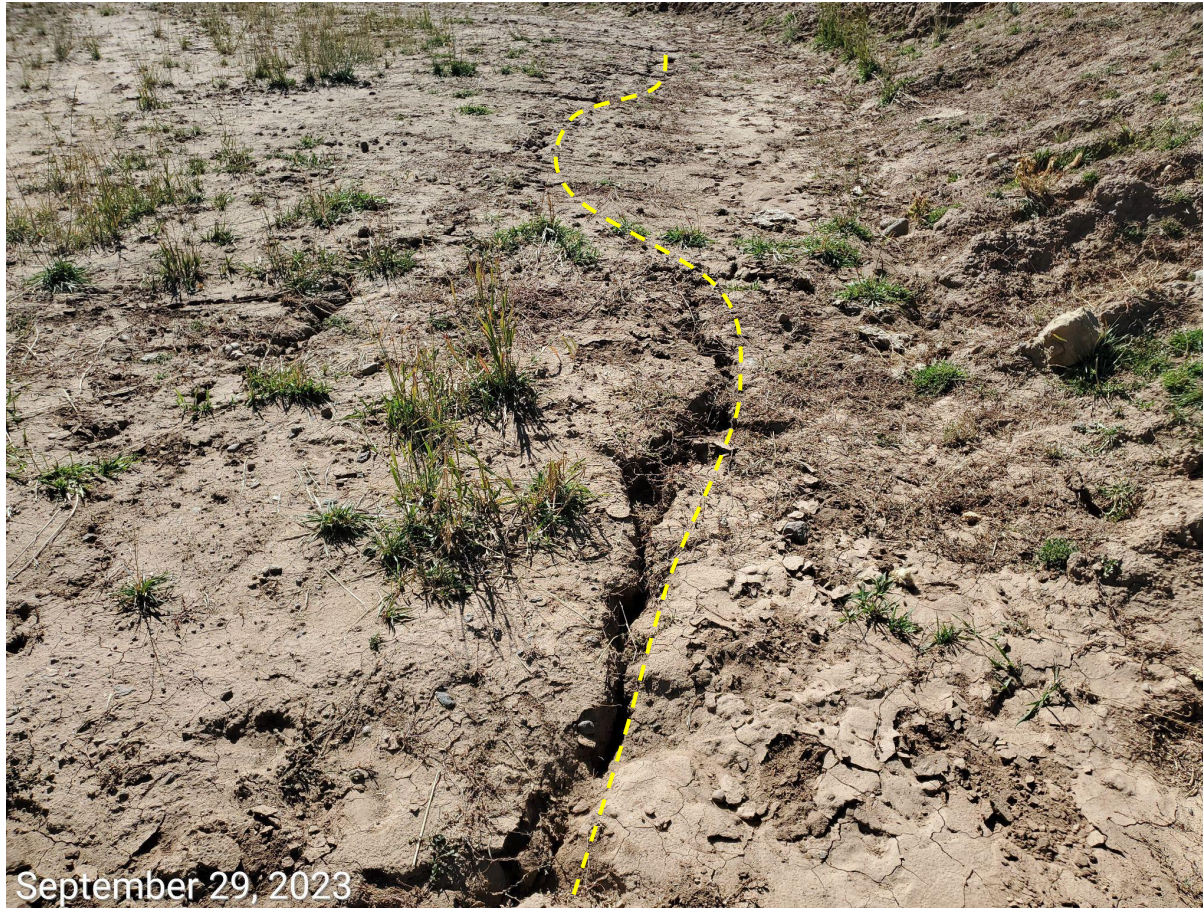
Photo 11: Photo taken from the perimeter of the working pad surface, on the central-west end of the Location, facing south. Photo shows long cracks (left of yellow line) forming on the Location; stabilization concerns exist

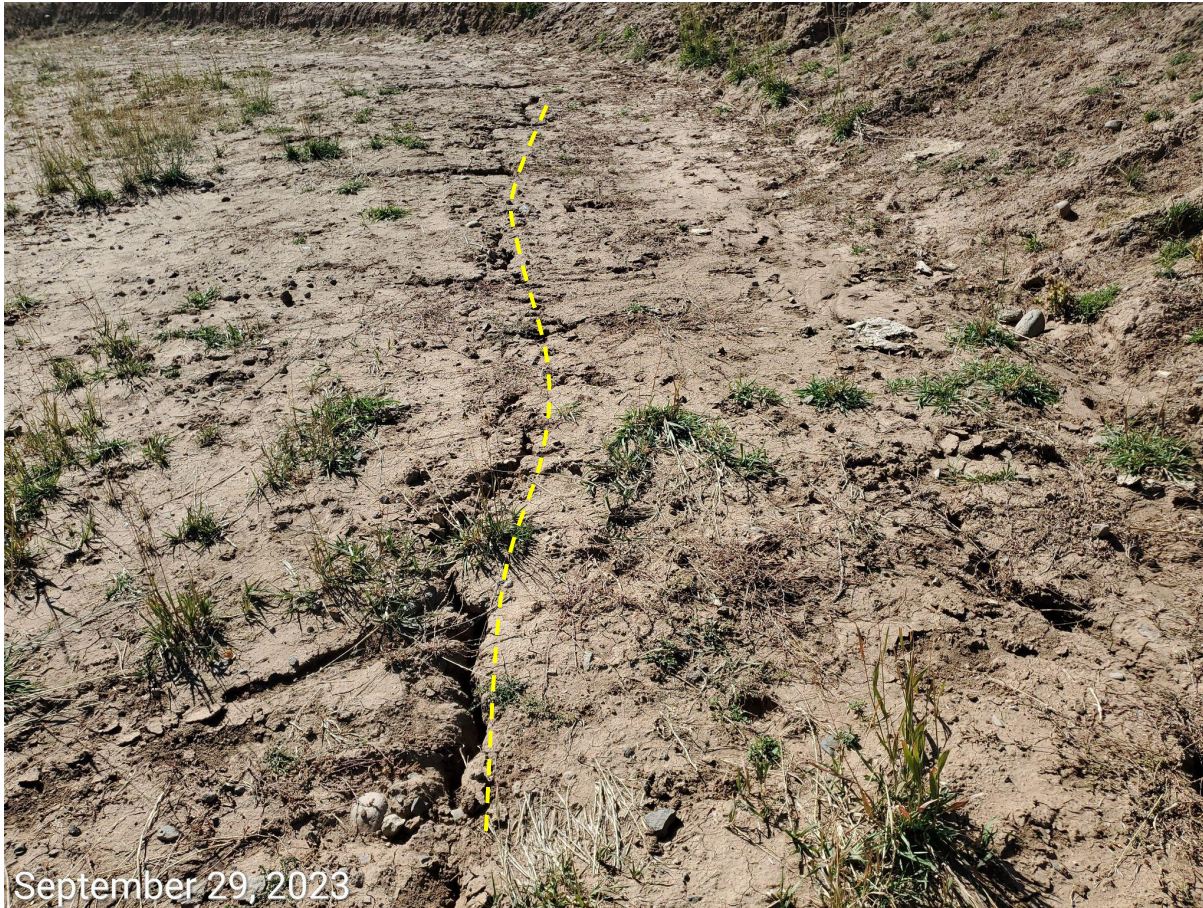
Photo 12: Photo taken from the perimeter of the working pad surface, on the southwest end of the Location, facing south. Photo shows long cracks (left of yellow line) forming on the Location; stabilization concerns exist

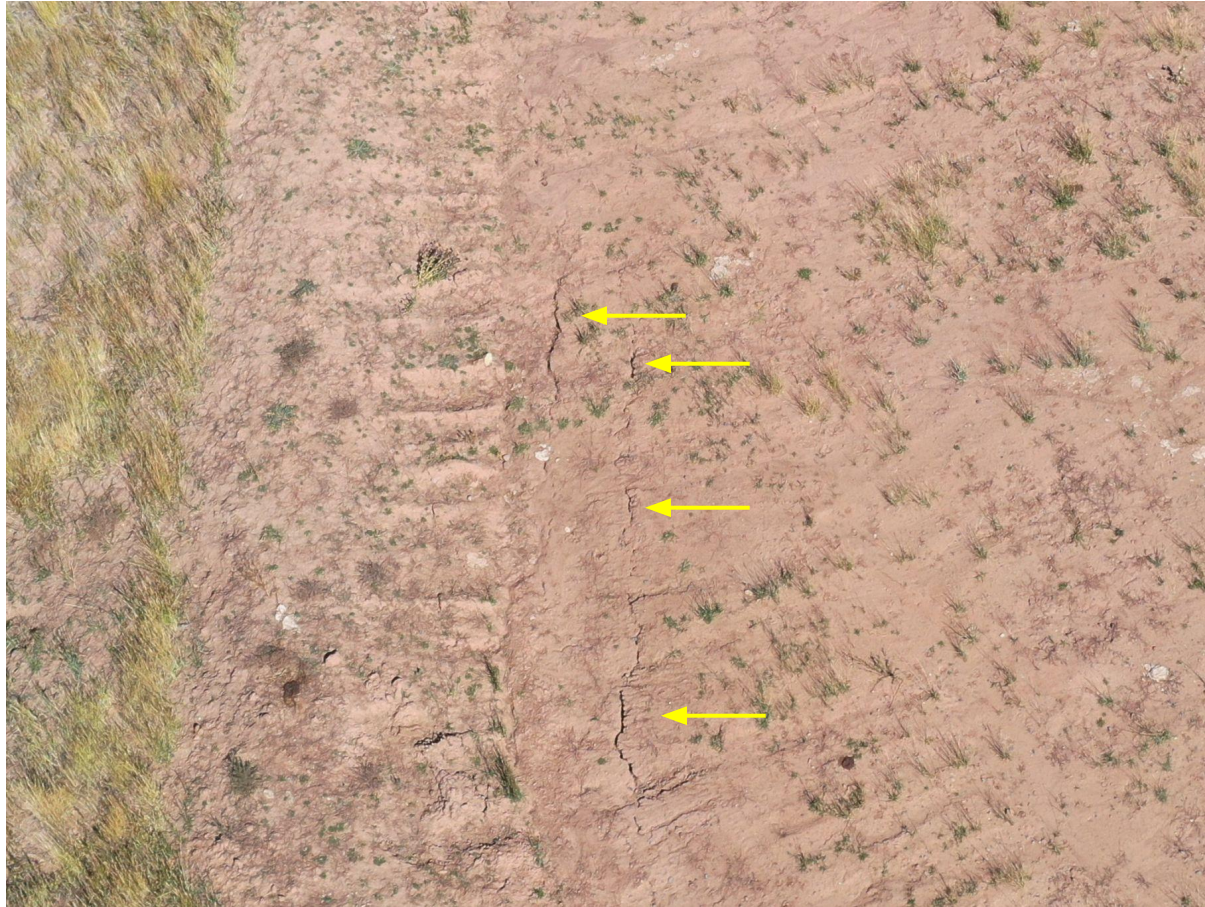
Photo 13: Photo taken with use of a sUAS. Photo example showing cracks forming on along the entire western perimeter of the working pad surface
