## Inspection Photos

Location Name: TEP ROCKY MOUNTAIN LLC, GM/13-33

Location ID: 323902

Date: 10/4/2023

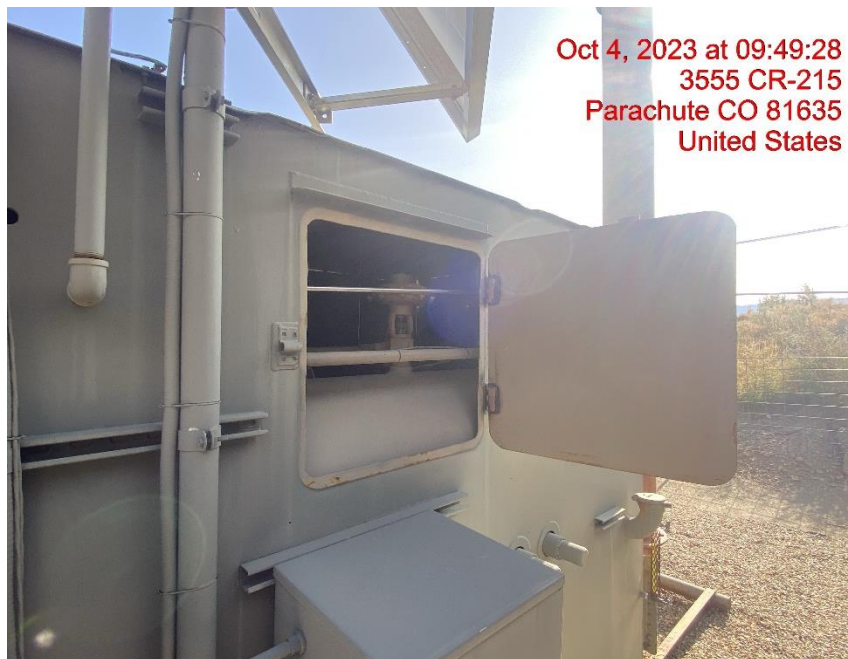
Unsecured Separator Hatch – Photo #06731

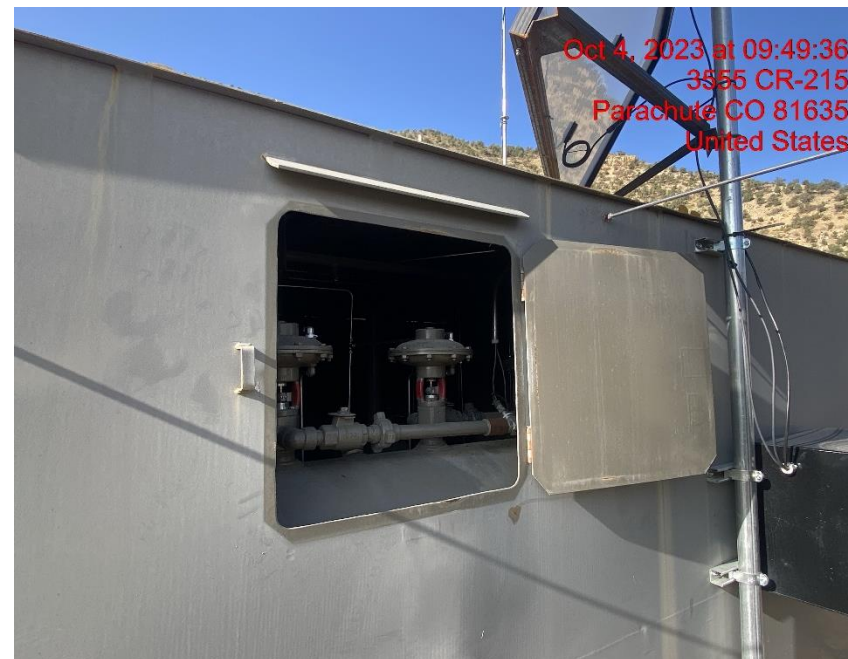
Unsecured Separator Hatch – Photo #06732

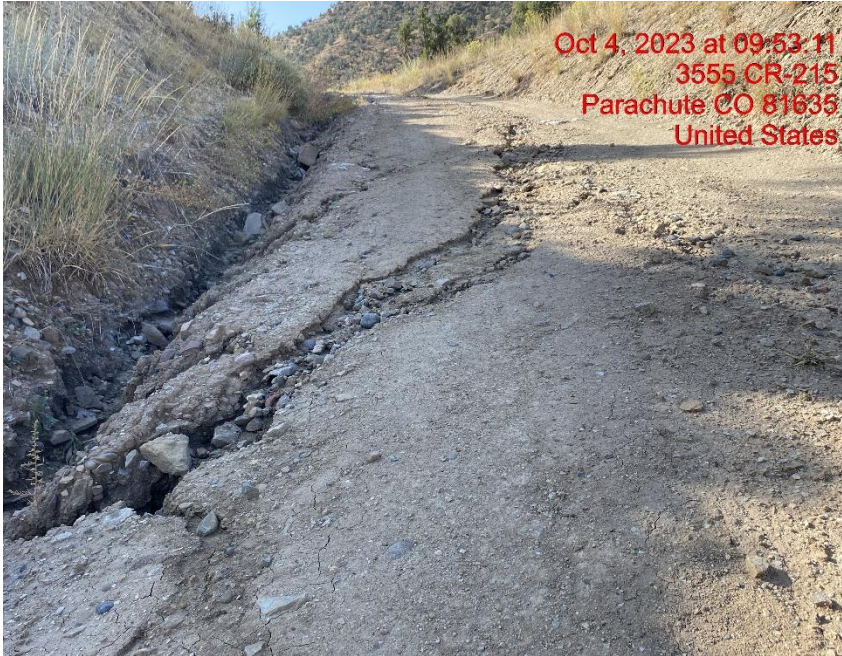
Rill Erosion Cutting Through Lease Road – Photo #06734

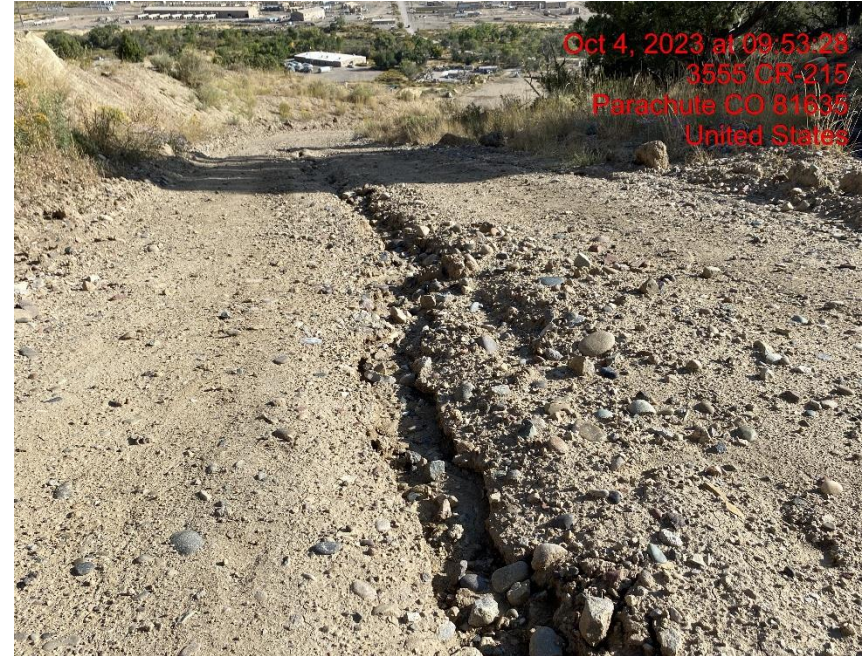
Rill Erosion Cutting Through Lease Road – Photo #06735
