## Inspection Photos

Location Name: TEP ROCKY MOUNTAIN LLC, UNOCAL-66S96W/33NWSE

Location ID: 335214

Date: 10/4/2023

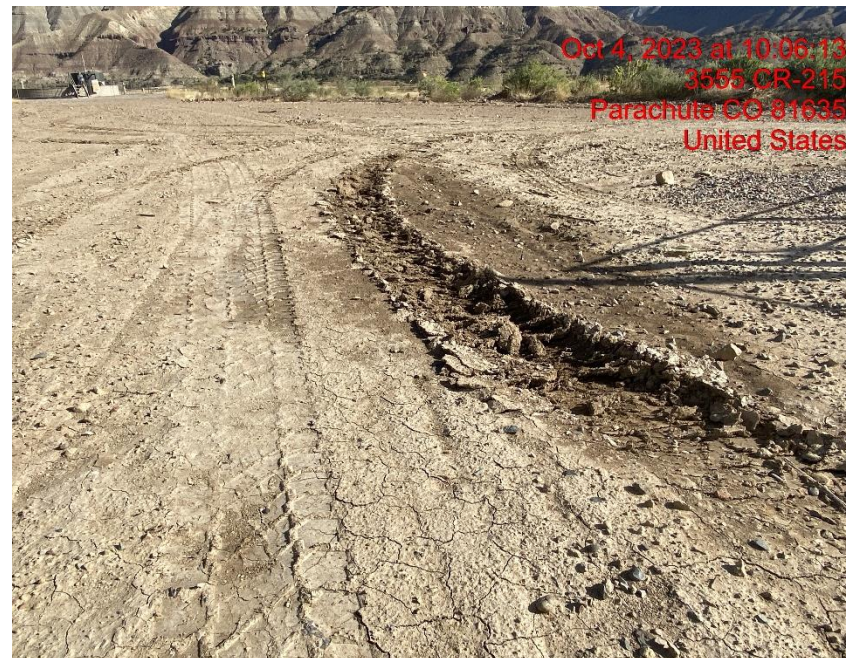
Location Lacks Stabilization – Photo #06747

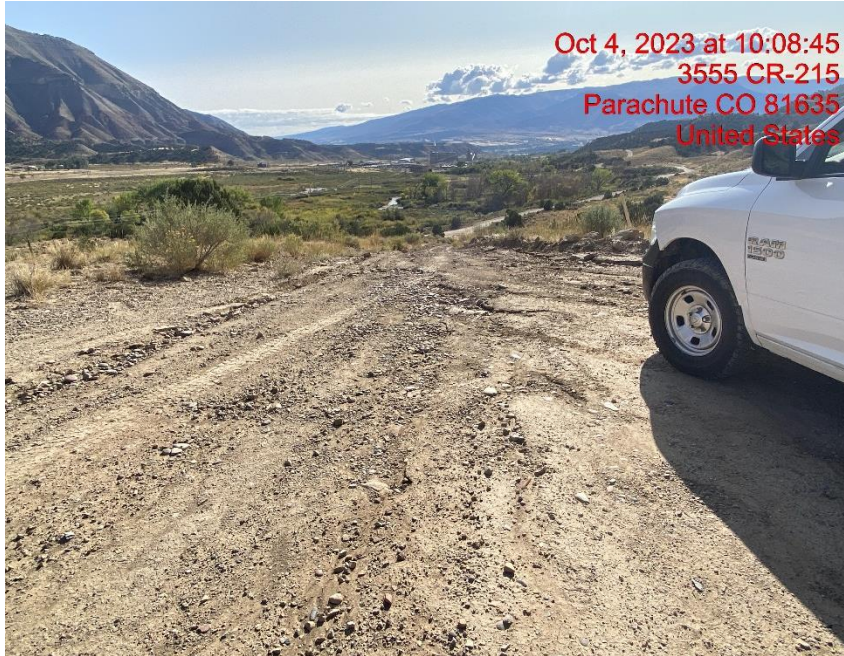
**Insufficient Vehicle Tracking BMPs at Location Entrance/Exit  
– Photo #06752**

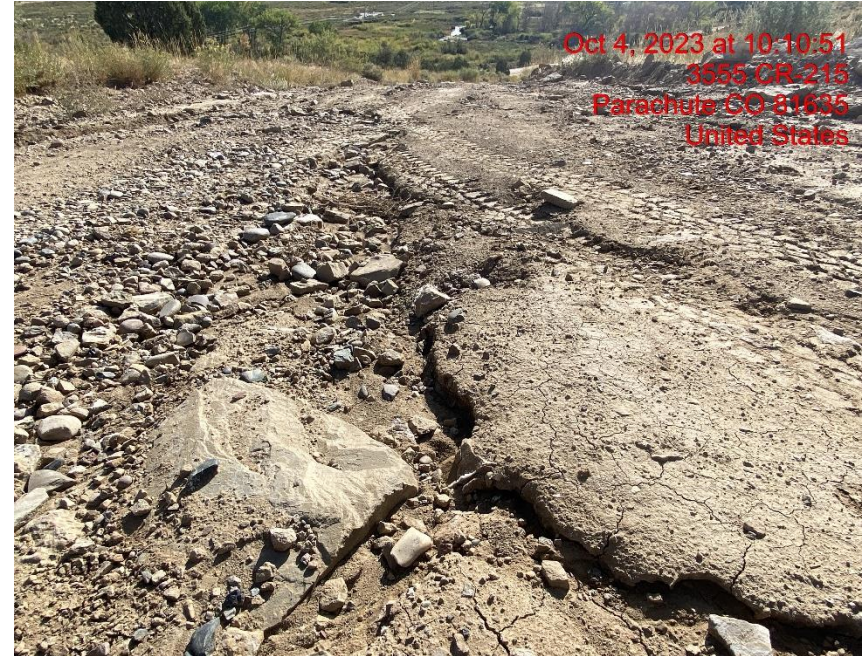
**Rill Erosion Cutting Through Lease Road – Photo #06753**

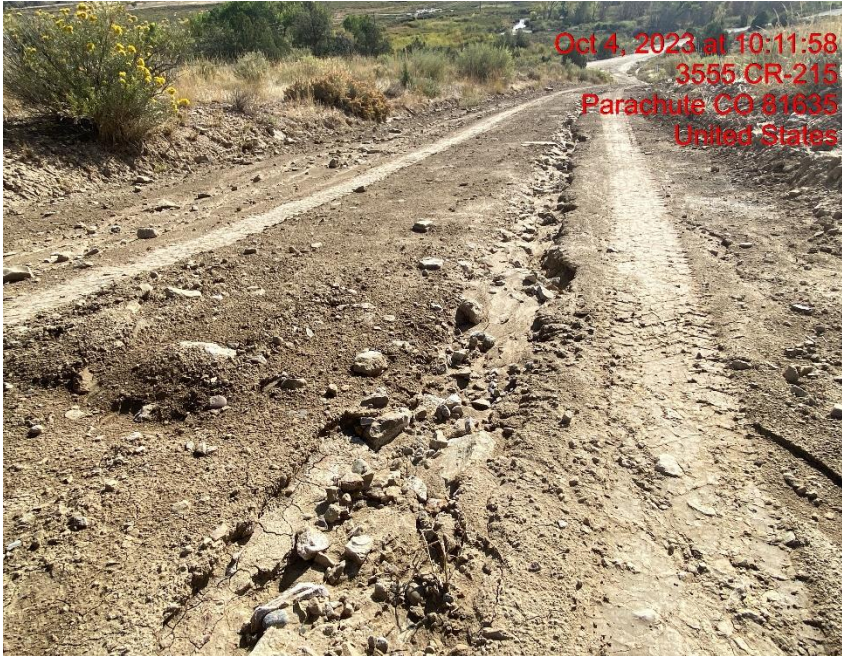
**Rill Erosion Cutting Through Lease Road – Photo #06754**
