Inspection Photos

Location Name: TEP ROCKY MOUNTAIN LLC, UNION-66S96W/33NWSE

Location ID: 335237

Date: 10/4/2023

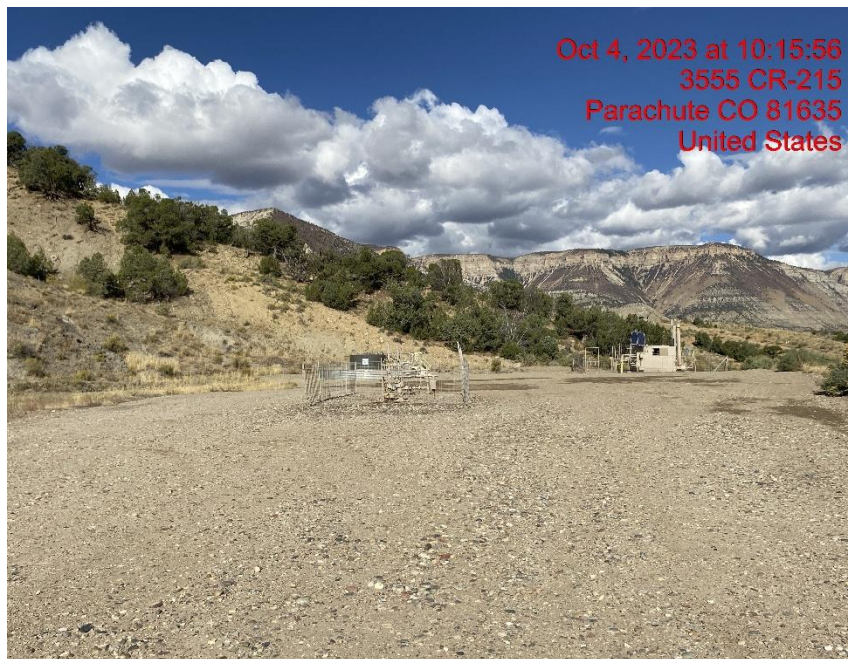
Entrance to Location – Photo #06756

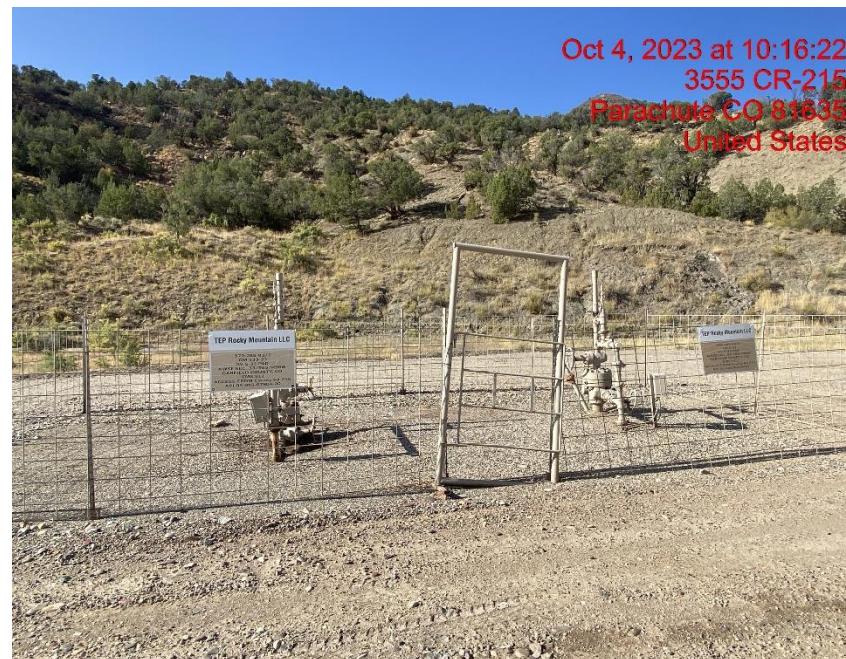
Wellheads – Photo #06757

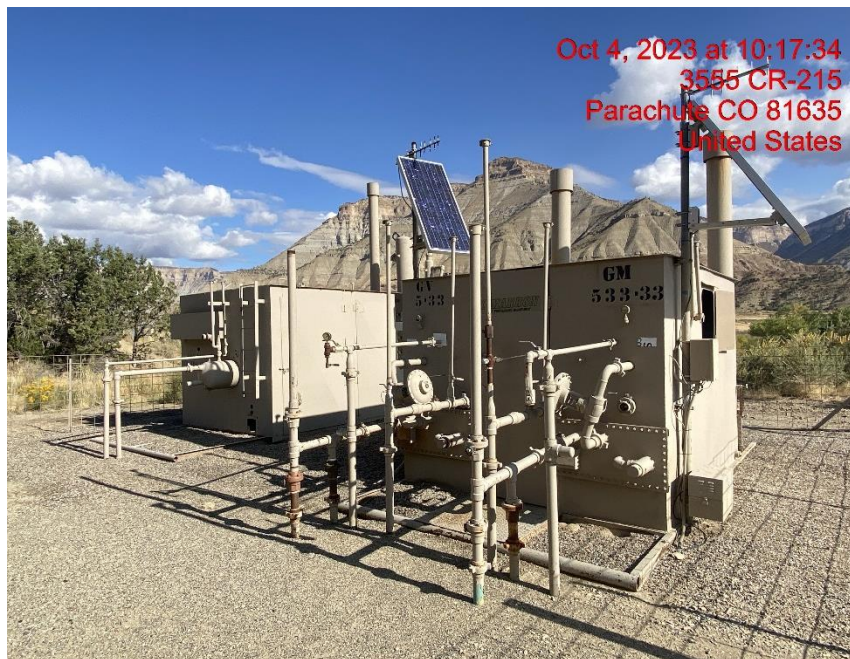
Separators – Photo #06758

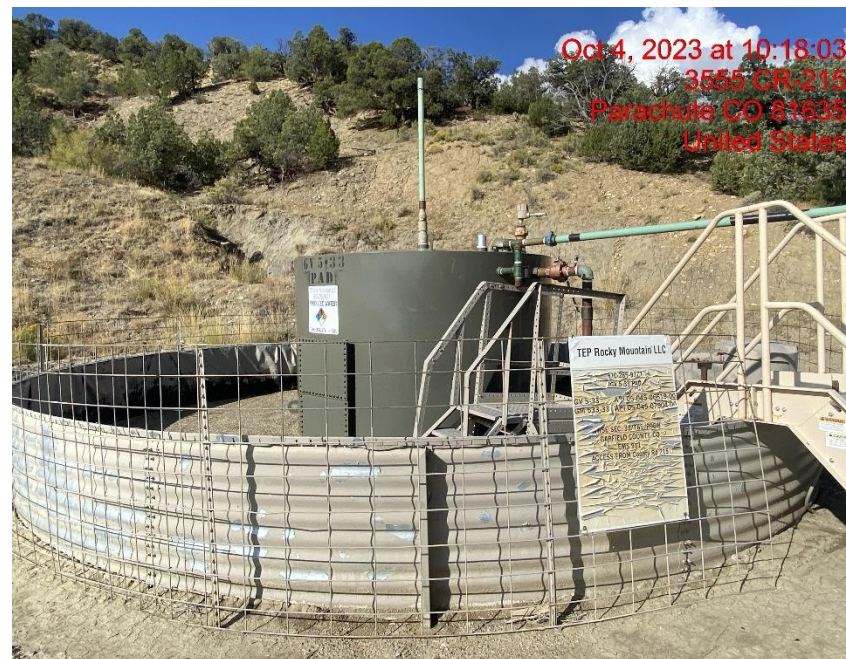
Tank Battery – Photo #06760

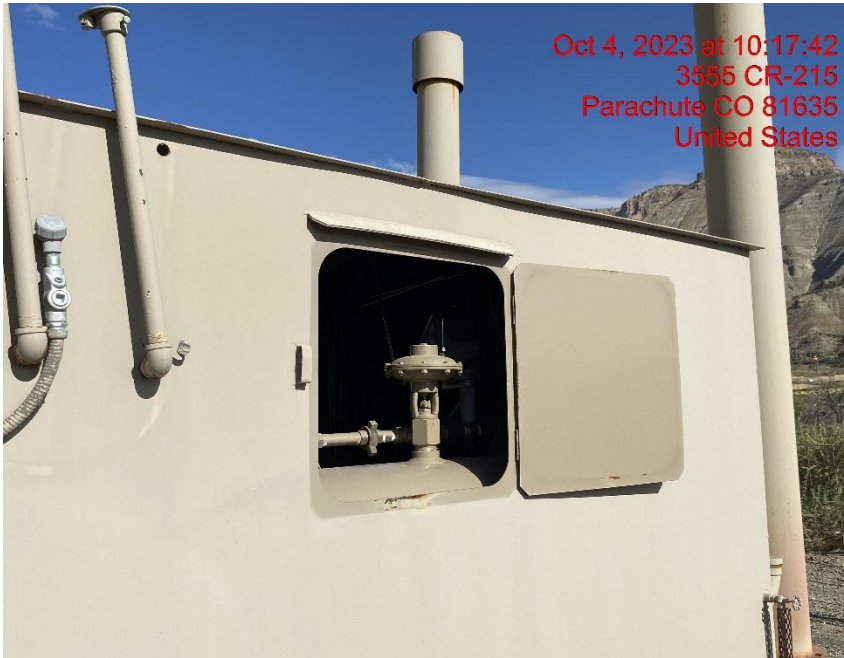
Unsecured Hatch on Separator – Photo #06759

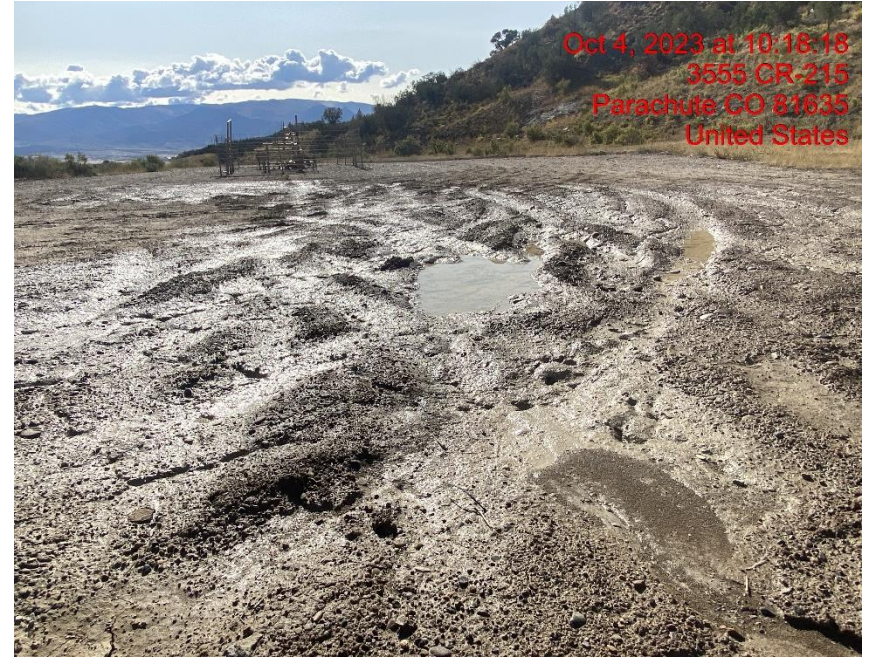
Location Lacks Stabilization – Photo #06762

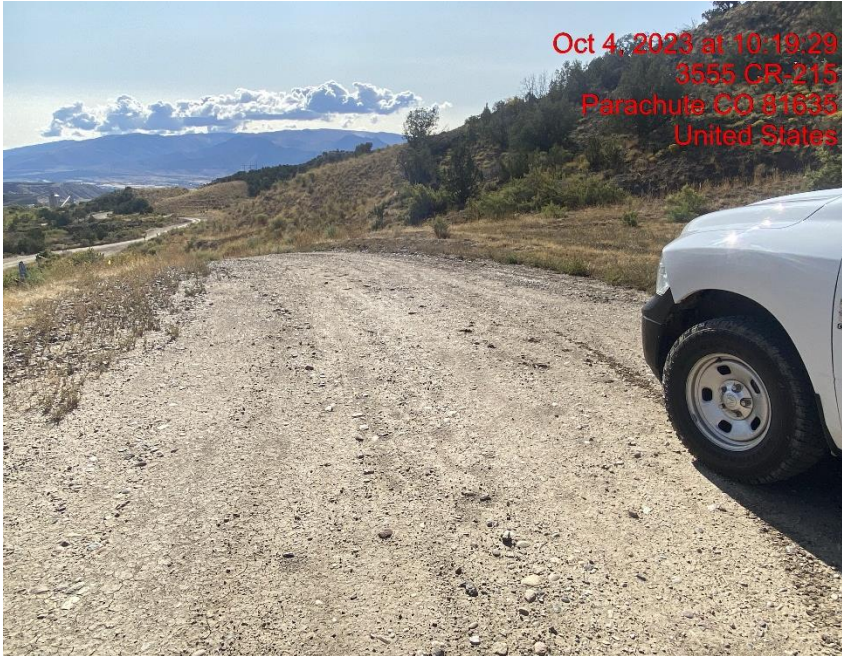
Insufficient Vehicle Tracking BMPs at Location Entrance/Exit
– Photo #06763
