## Inspection Photos

Location Name: TEP ROCKY MOUNTAIN LLC, UNOCAL-66S96W/33NESE

Location ID: 335353

Date: 10/4/2023

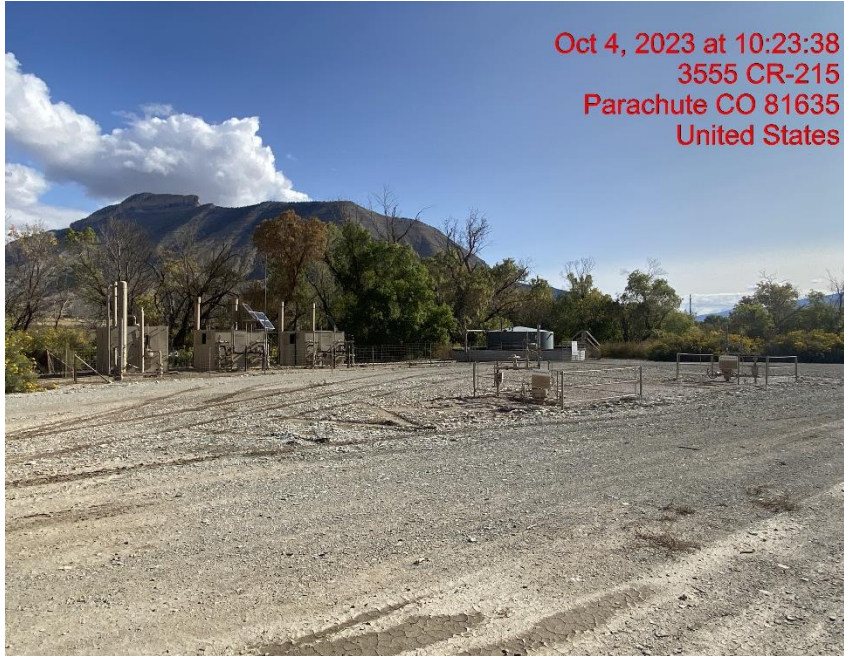
Entrance to Location – Photo #06765

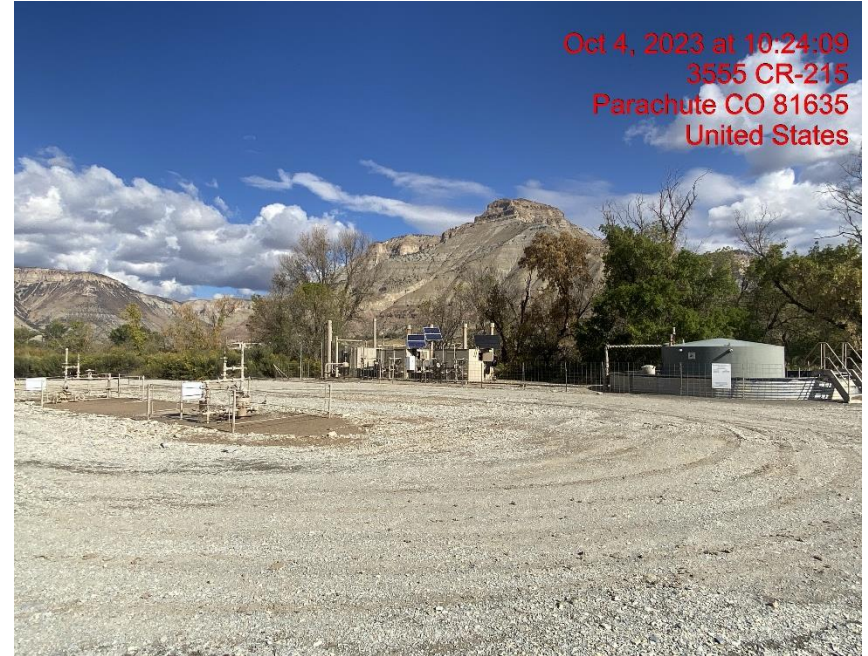
SW Corner of Location – Photo #06766

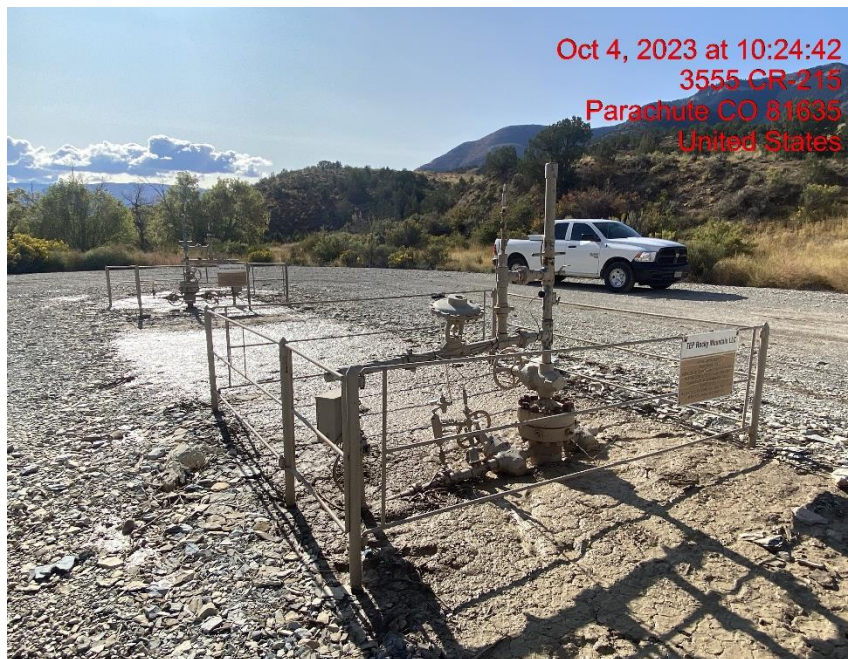
Wellheads – Photo #06767

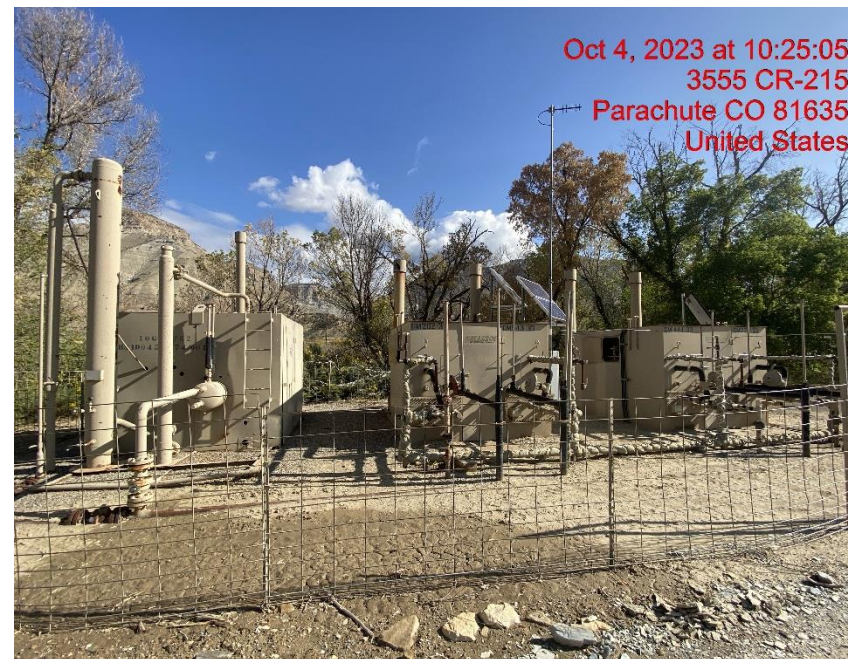
Separators – Photo #06768

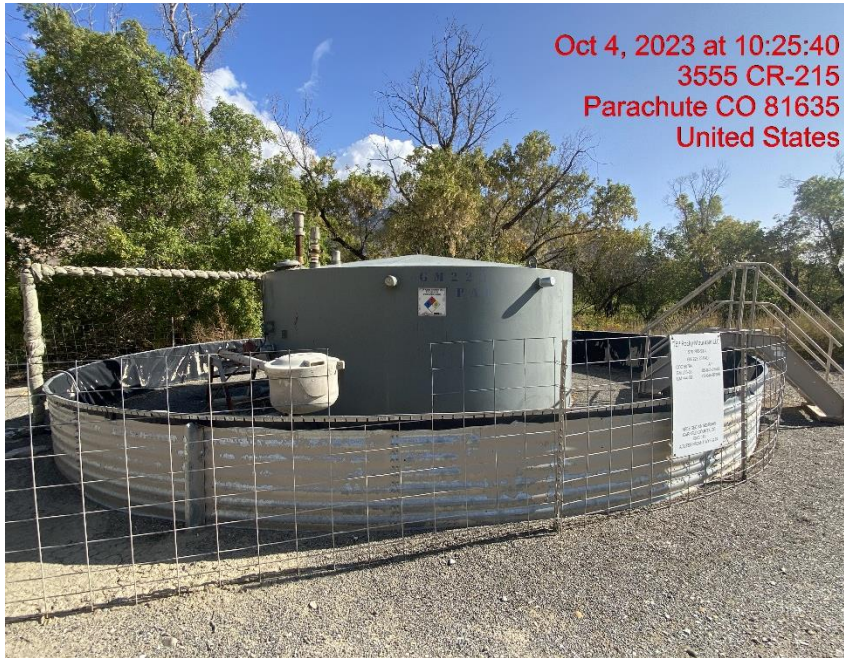
Tank Battery – Photo #06771

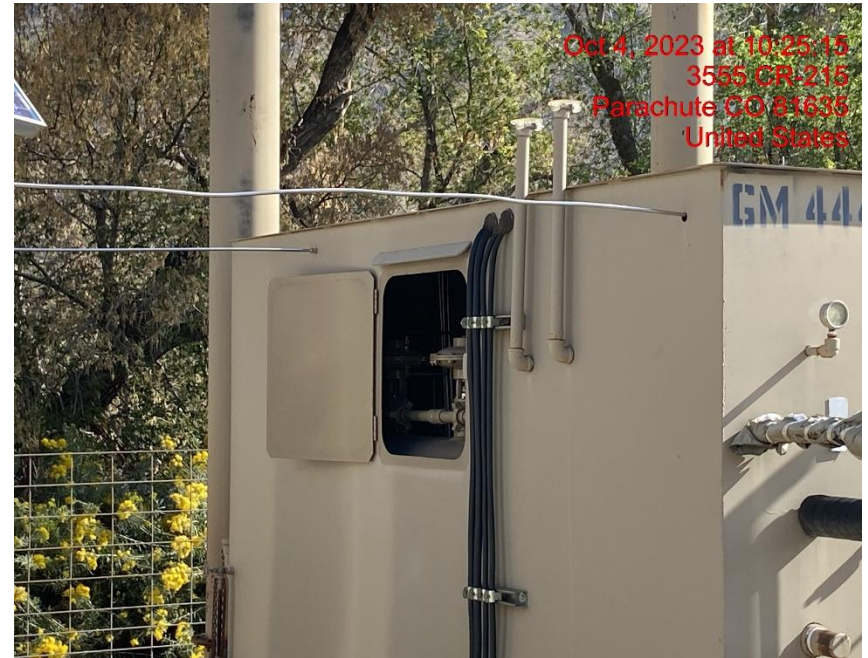
Unsecured Hatch on Separators – Photo #06769

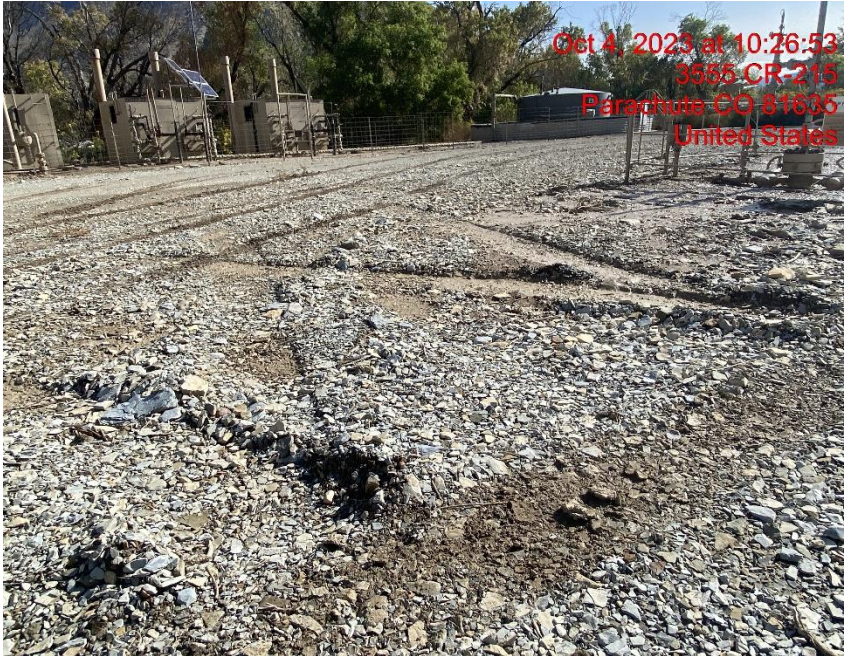
Location Lacks Stabilization – Photo #06772

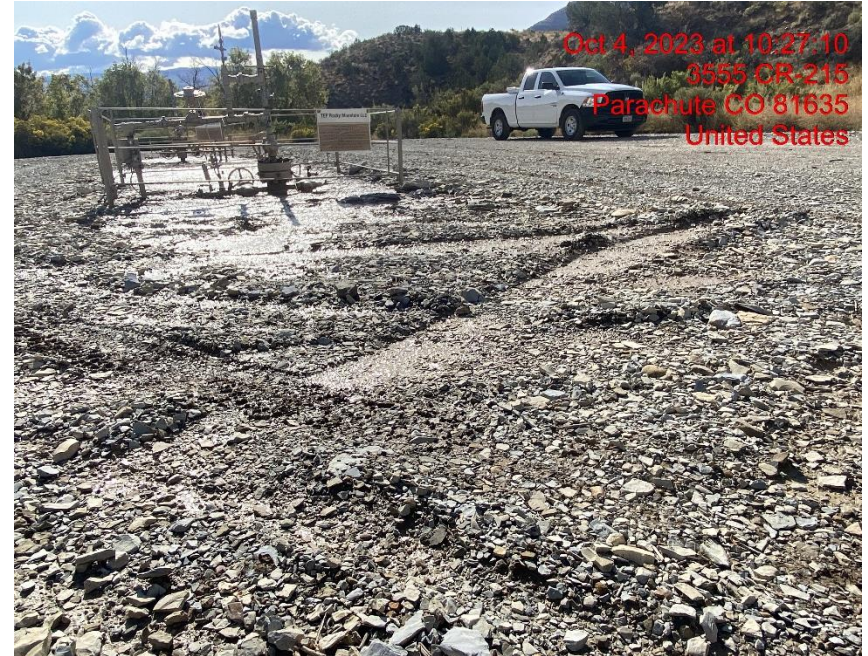
Location Lacks Stabilization – Photo #06773

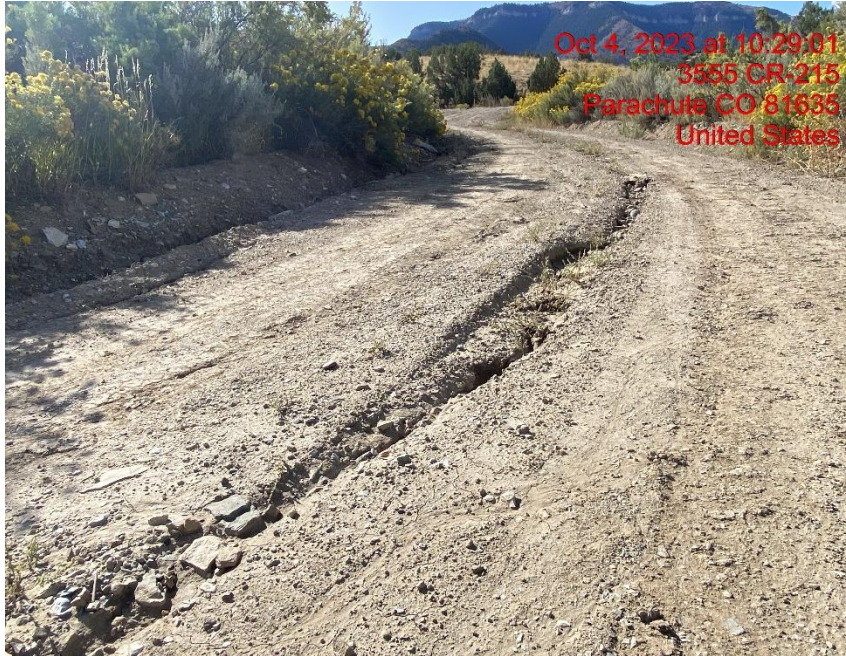
**Rill Erosion Cutting Through Access Road – Photo #06774**

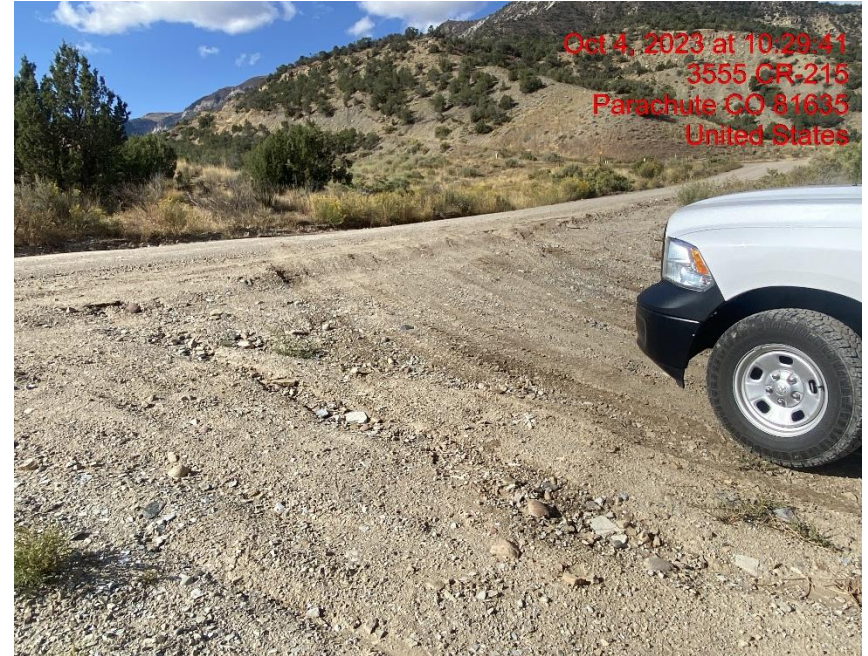
**Insufficient Vehicle Tracking BMPs at Location Entrance/Exit  
– Photo #06775**
