Inspection Photos

Location Name: CAERUS PICEANCE LLC DUNN B9E Pad

Location ID: 334833

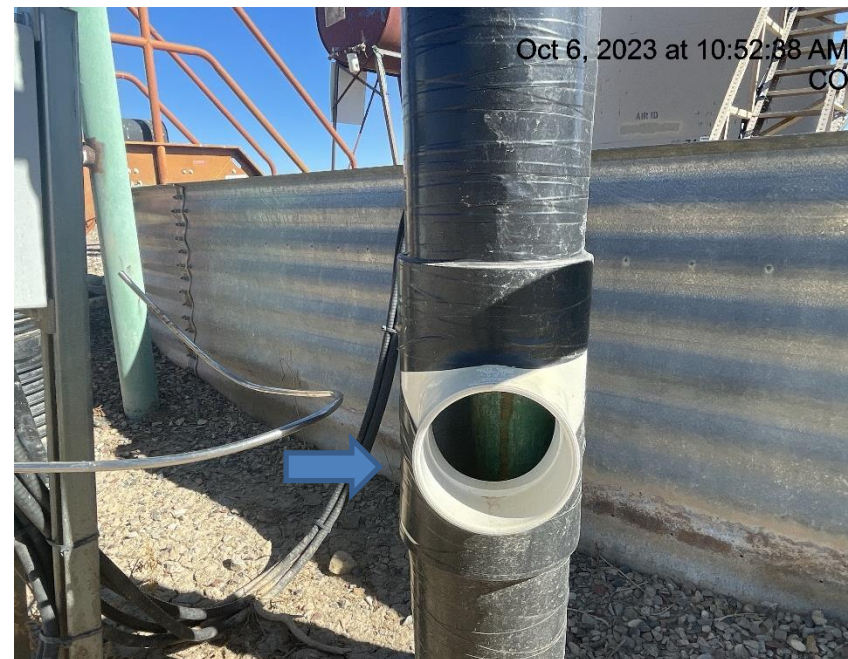
Photo # 1889 Flowline heating insulation open ended

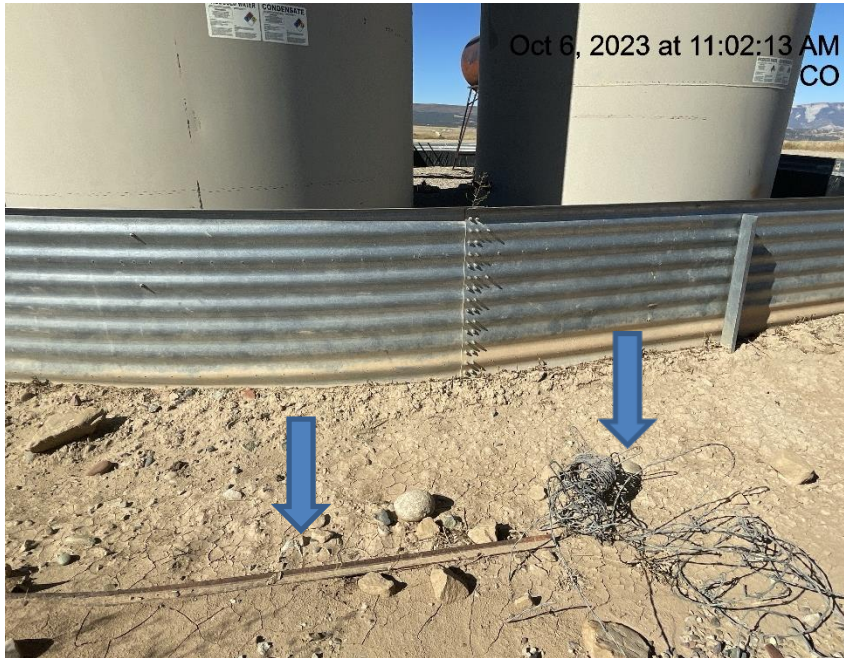
Photo # 1890 Debris
