Inspection Photos

Location Name: CAERUS PICEANCE LLC DUMAS P14 Pad

Location ID: 334619

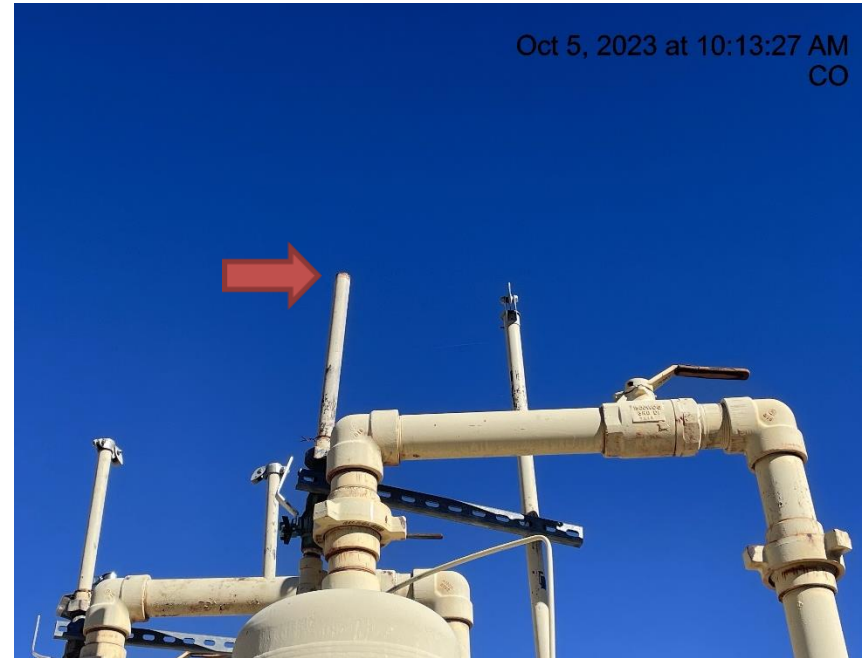
Photo # 1655 Rupture disc vent line lacks cap

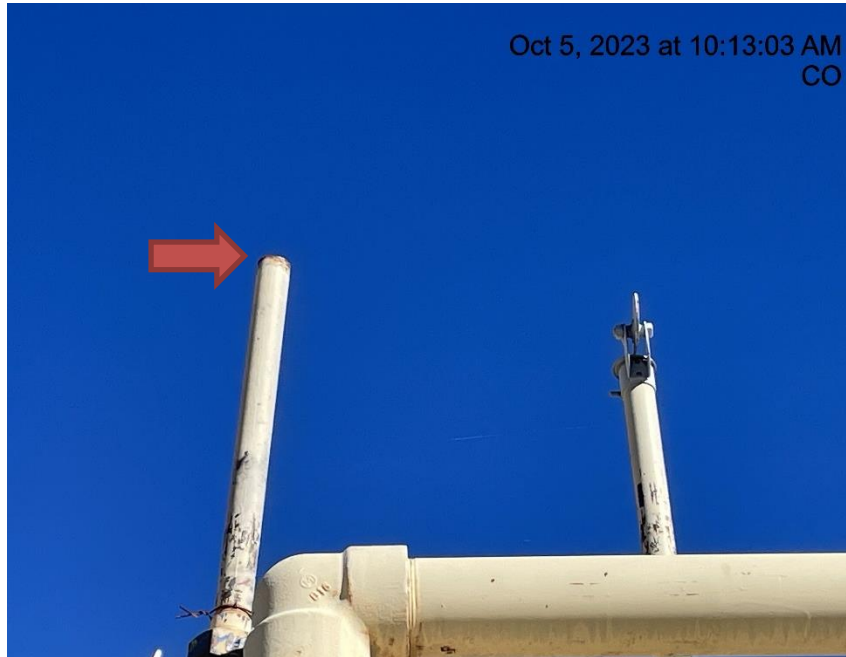
Photo # 1656 Rupture disc vent line lacks cap
