# Inspection Photos

Loc: 324843

Operator: CHEMCO INC

Inspection Date: 10/5/2023

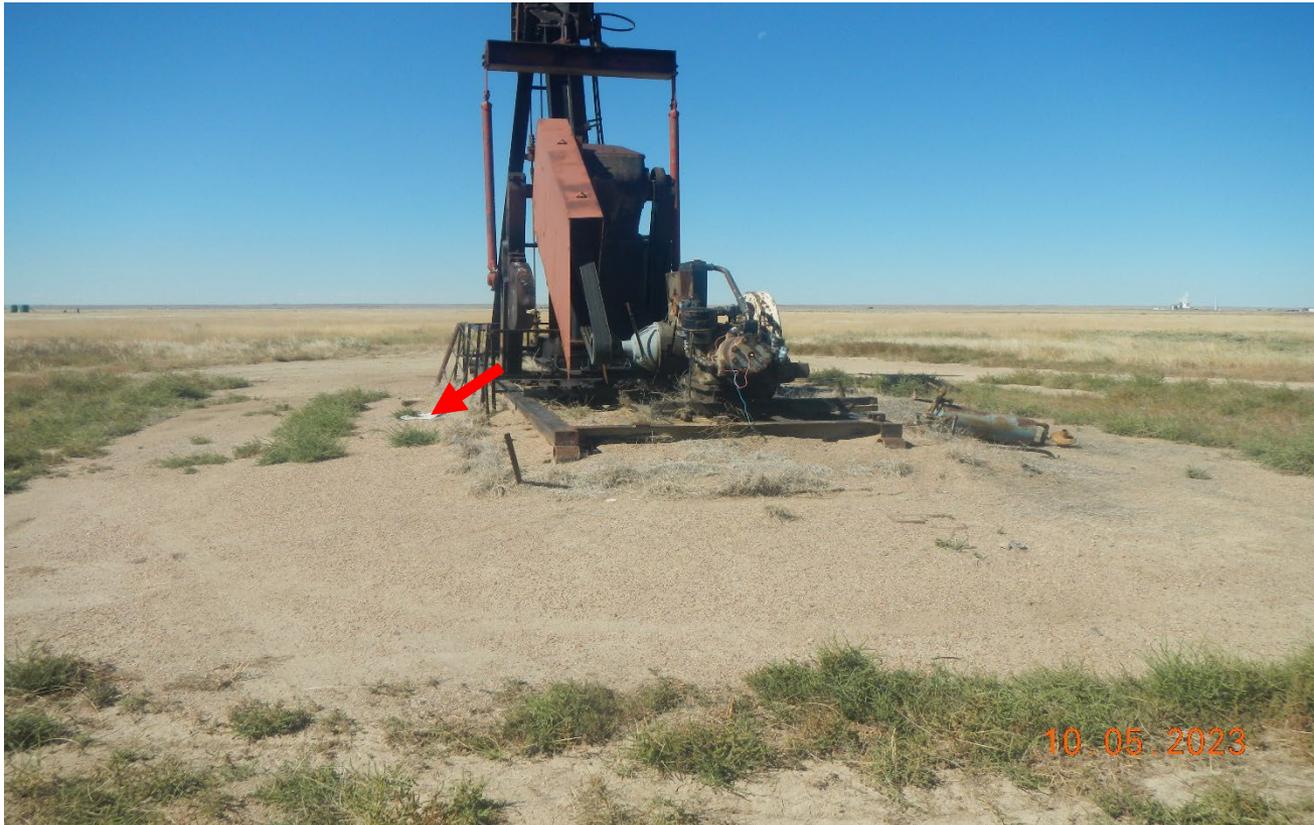
**Photo 1.** Facing toward the well site. Operators well sign is laying on the ground at red arrow.

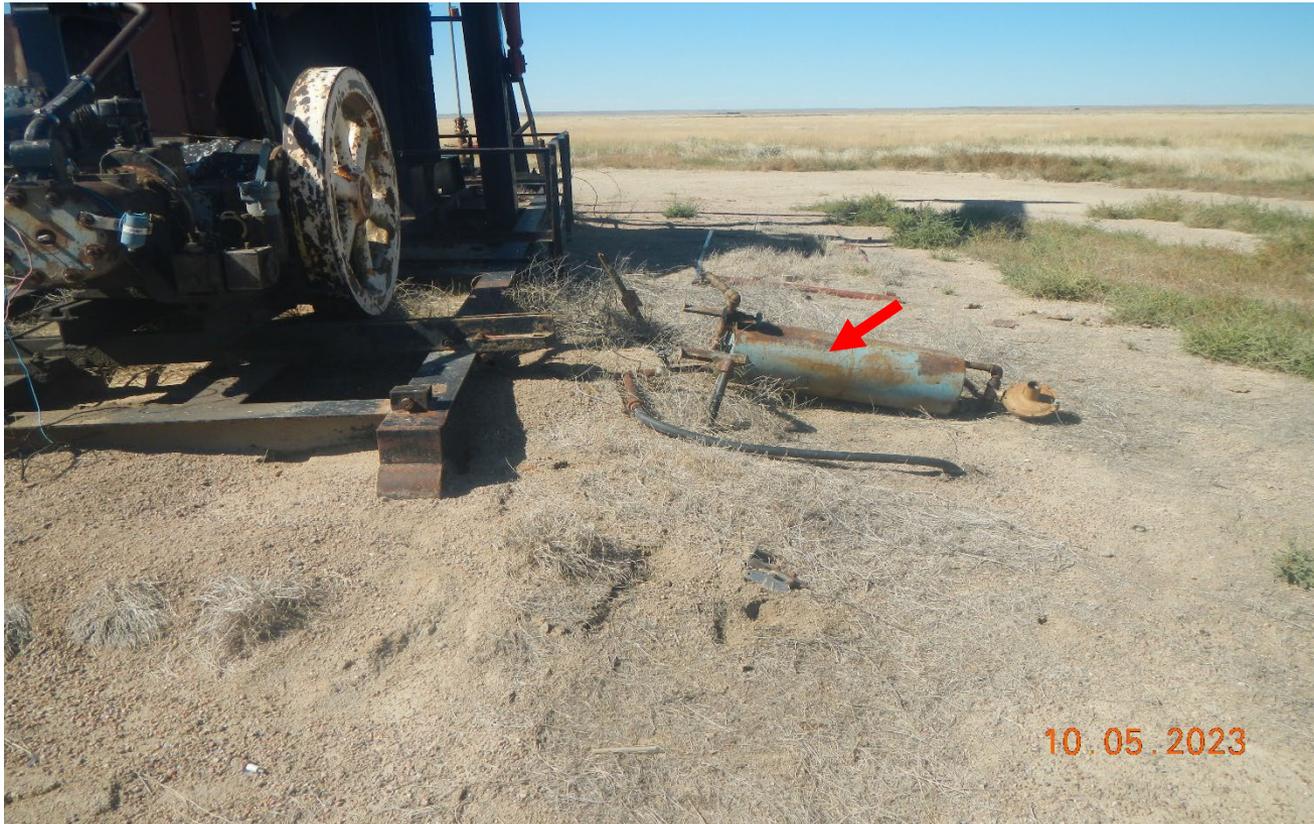
**Photo 2.** There is still unused parts that remain around the pumpjack.

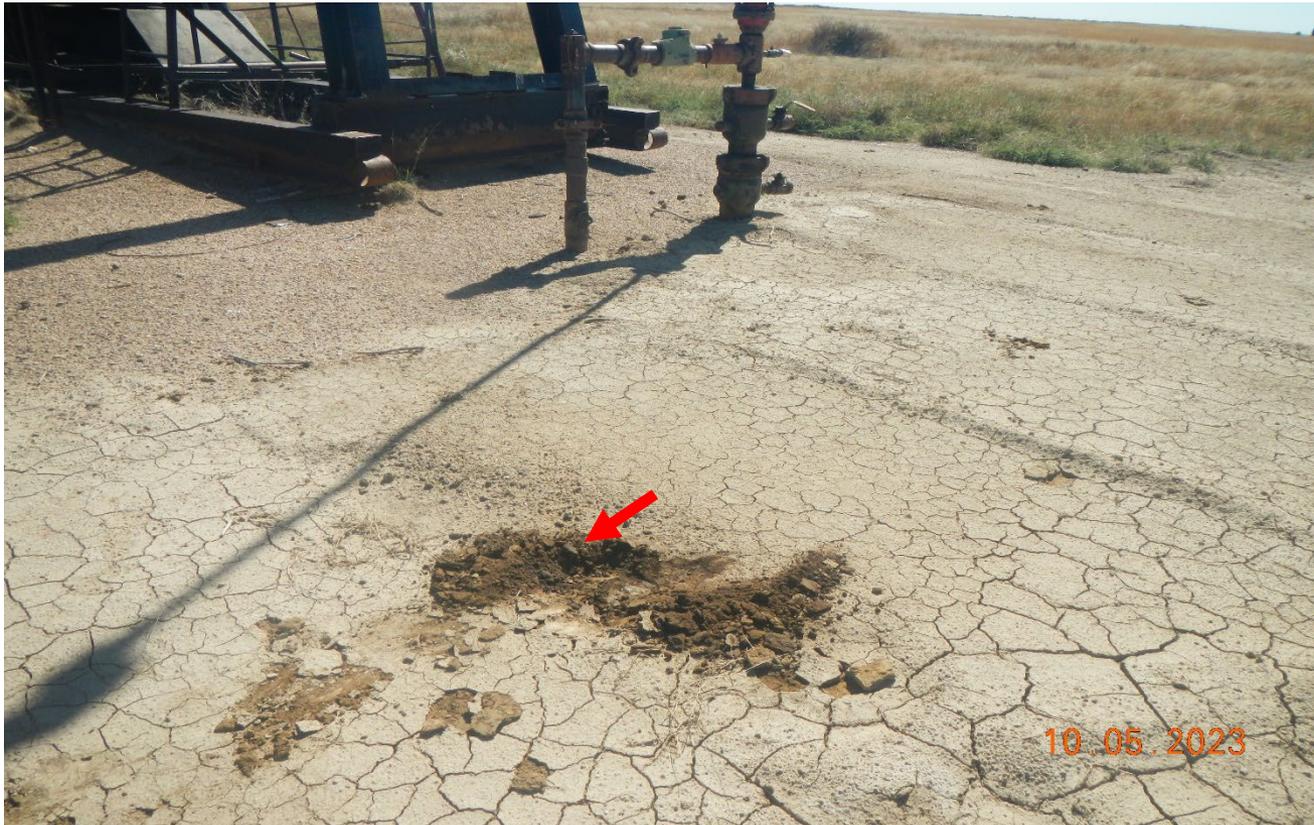
**Photo 3.** Facing toward the wellhead. There is oil stained soils. It appears dirt was placed over this area to cover up the impacted soils. Impacted soil need to be immediately excavated, cleaned up, and properly disposed per Rule 912.

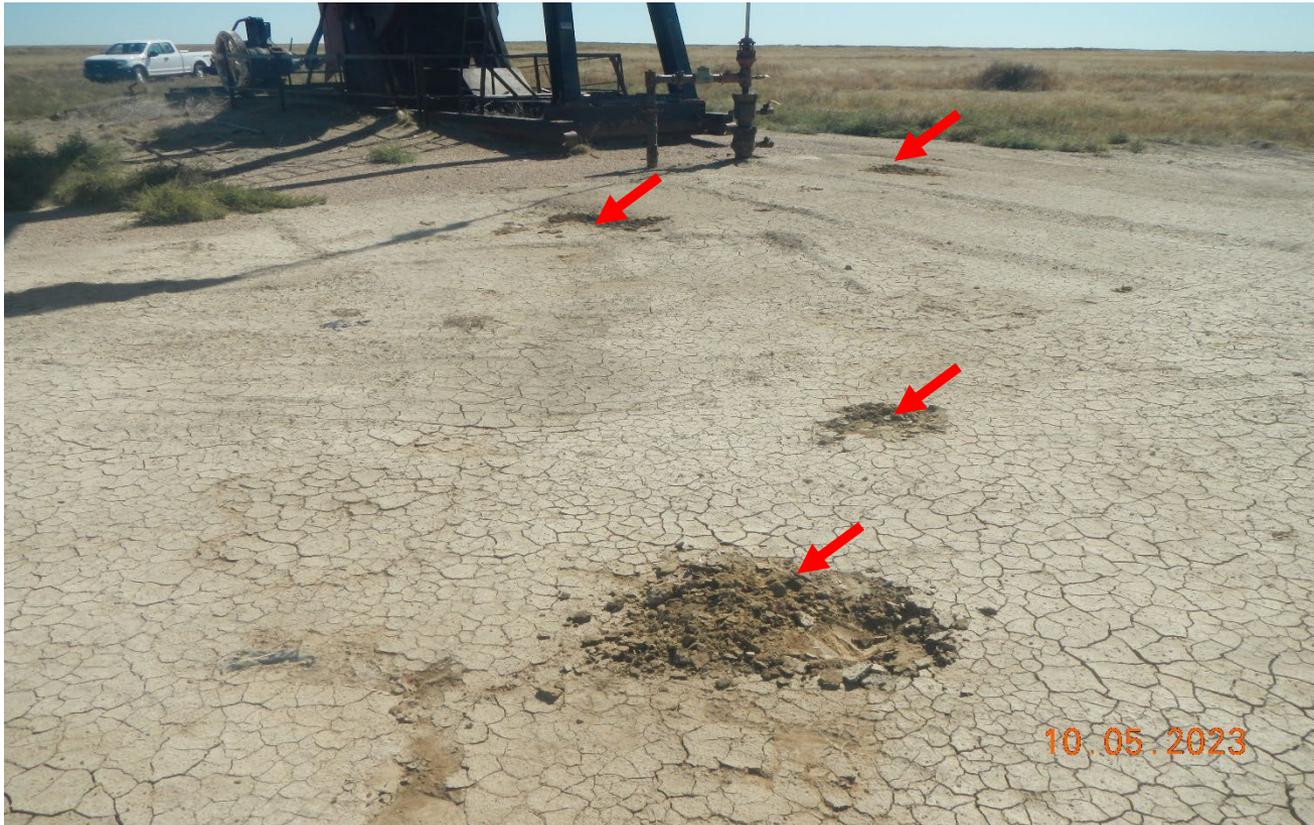
**Photo 4.** There is impacted soils that were observed in an area approximately 20x40 feet in size. After further investigation the spill appears to be reportable under 912.b. Red arrows point to areas of oil stained soils.

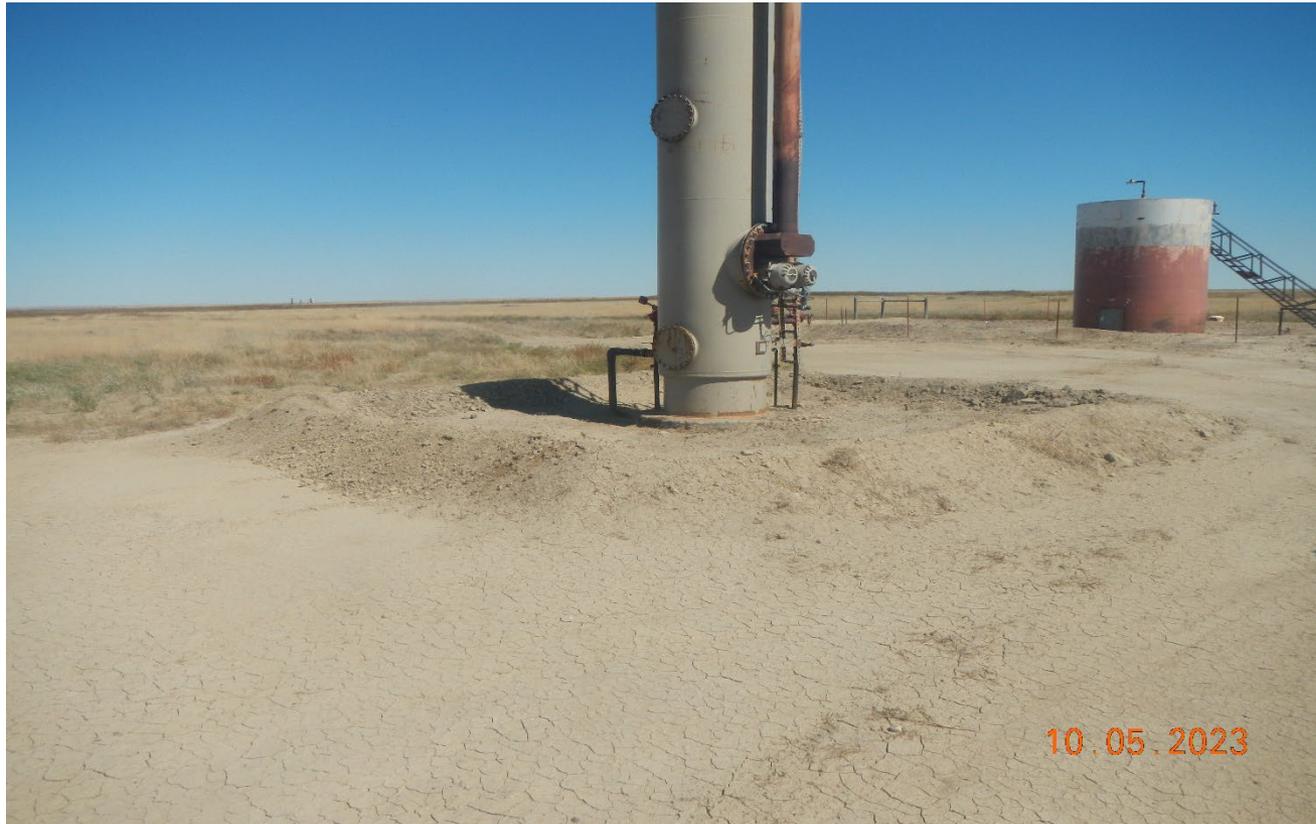
**Photo 5.** Facing northeast toward the separator. A berm was placed around the separator however the earthen berm is not properly built.

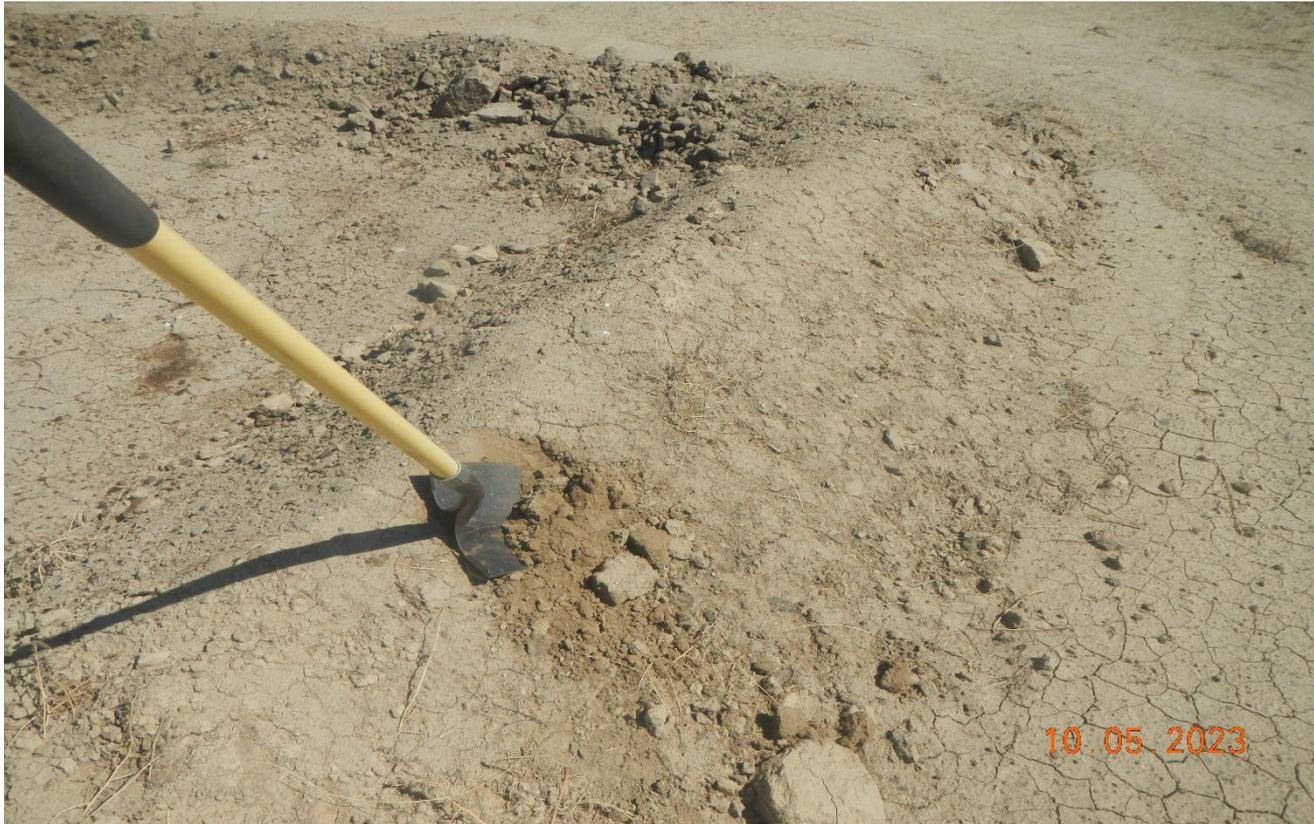
**Photo 6.** The berm around the separator is not compacted and built sufficiently for containment.

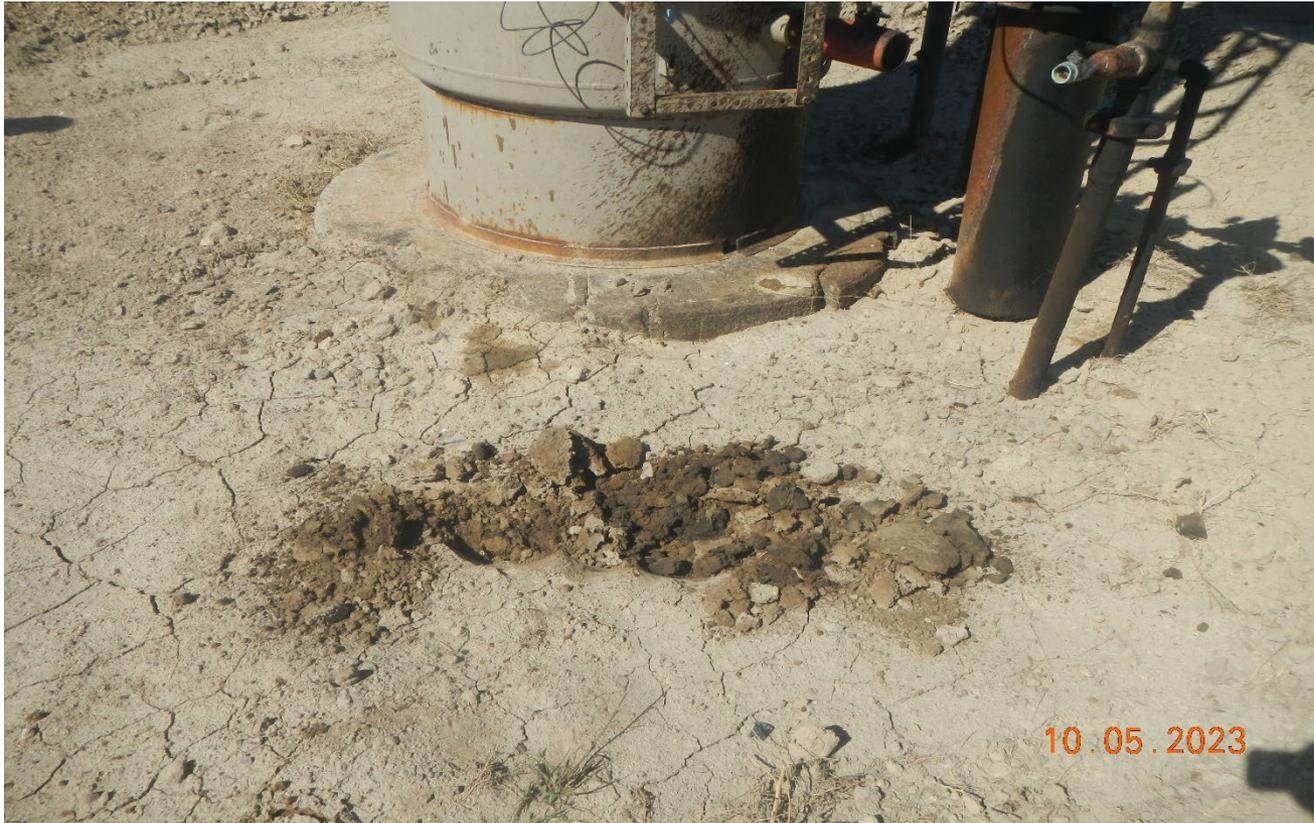
**Photo 7.** There is oil saturated soils that still remain at the separator. There was dirt spread over the stained soil to cover this spill. Impacted soil need to be immediately excavated, cleaned up, and properly disposed per Rule 912.

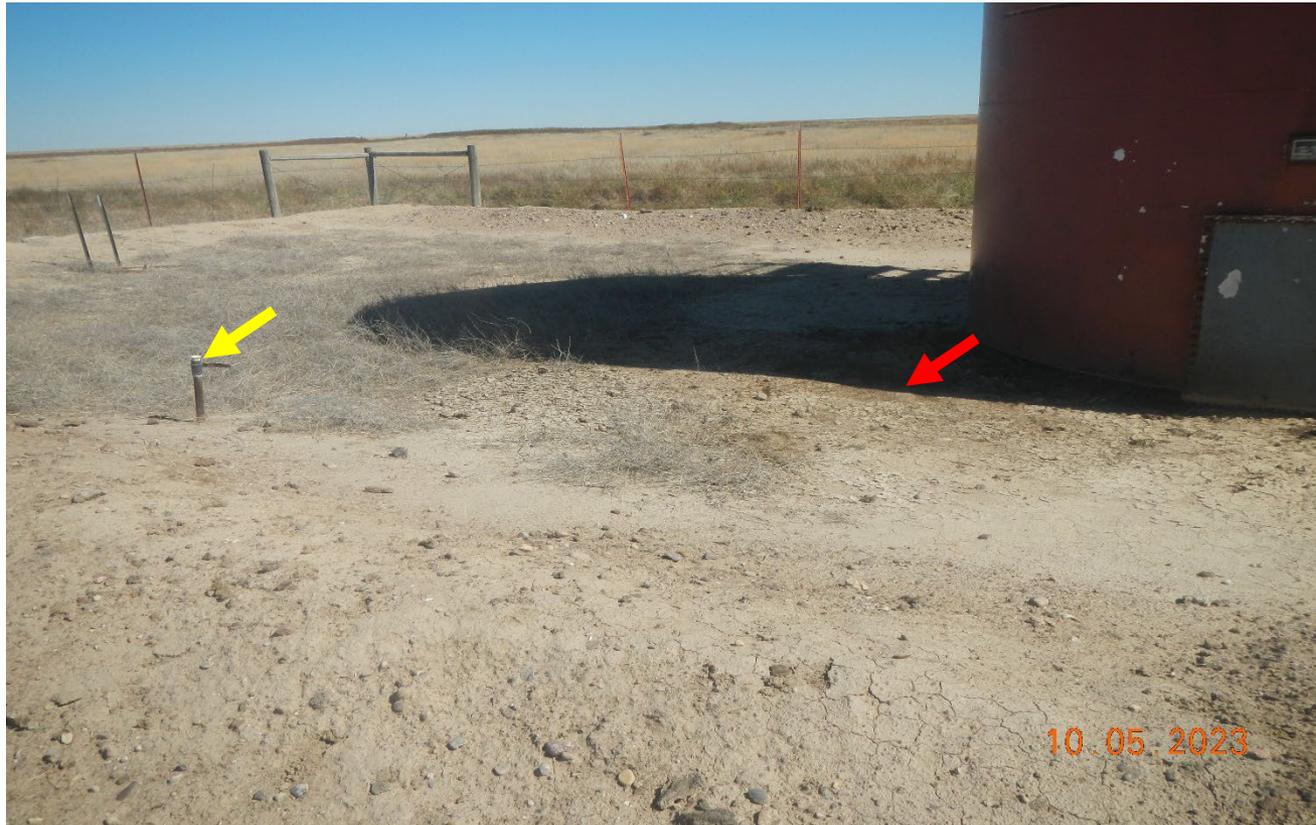
**Photo 9.** There is oil stained soils near the tank at the red arrow. There is an unused pipe riser at the yellow arrow and various plastic debris.

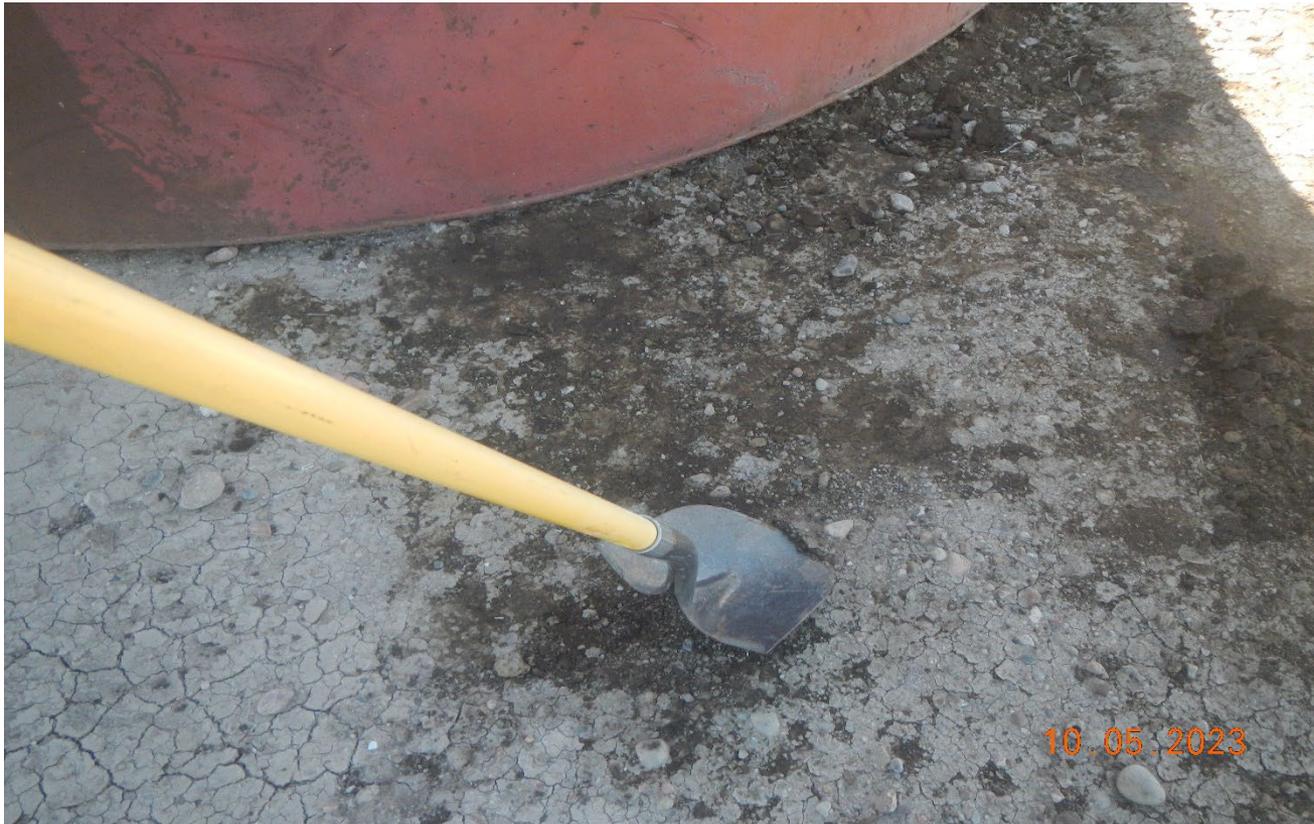
**Photo 10.** There is saturated oily soils at the tank battery that have not been cleaned up. Previous corrective action was not completed.
