Inspection Photos

Loc: 324848

Operator: CHEMCO INC

Inspection Date: 10/5/2023

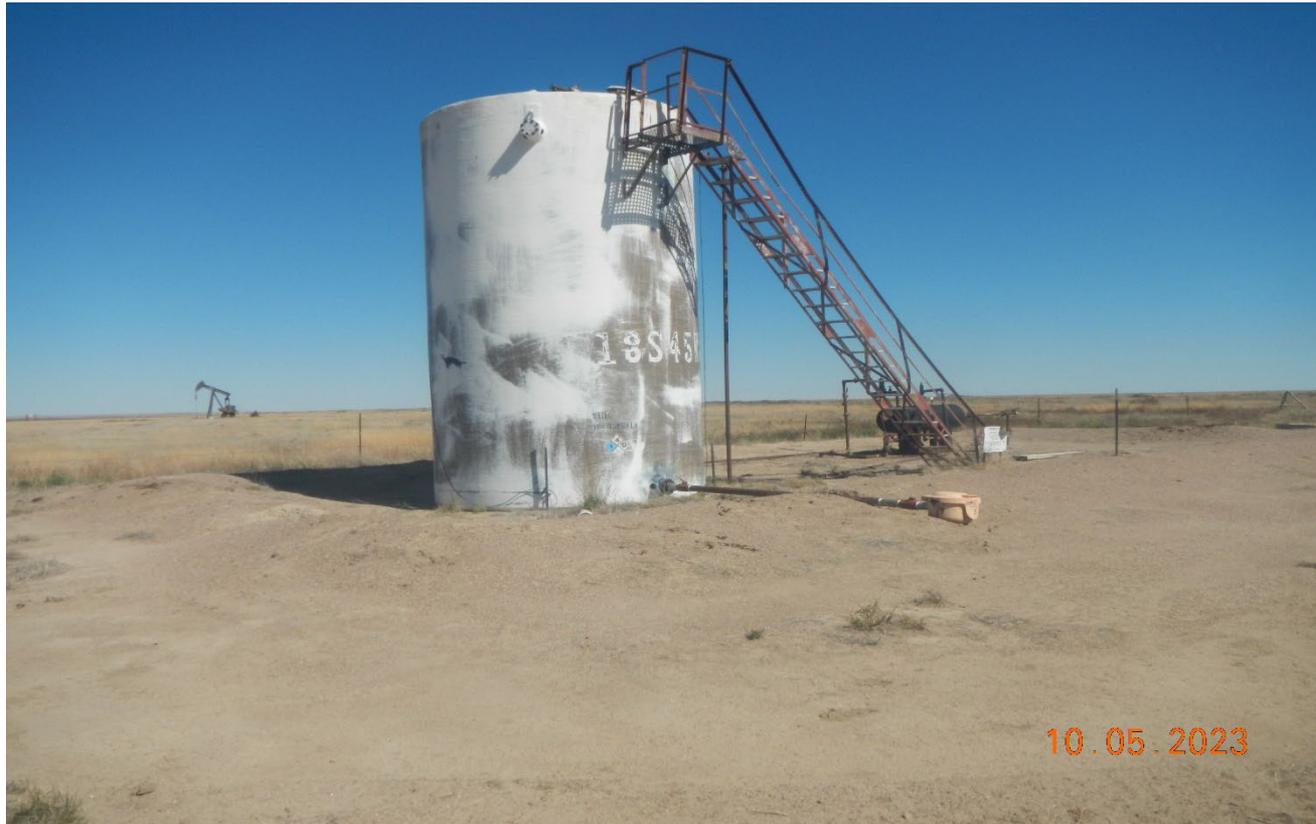
Photo 1. Facing northeast toward the tank battery. Berm is not adequate for containment.

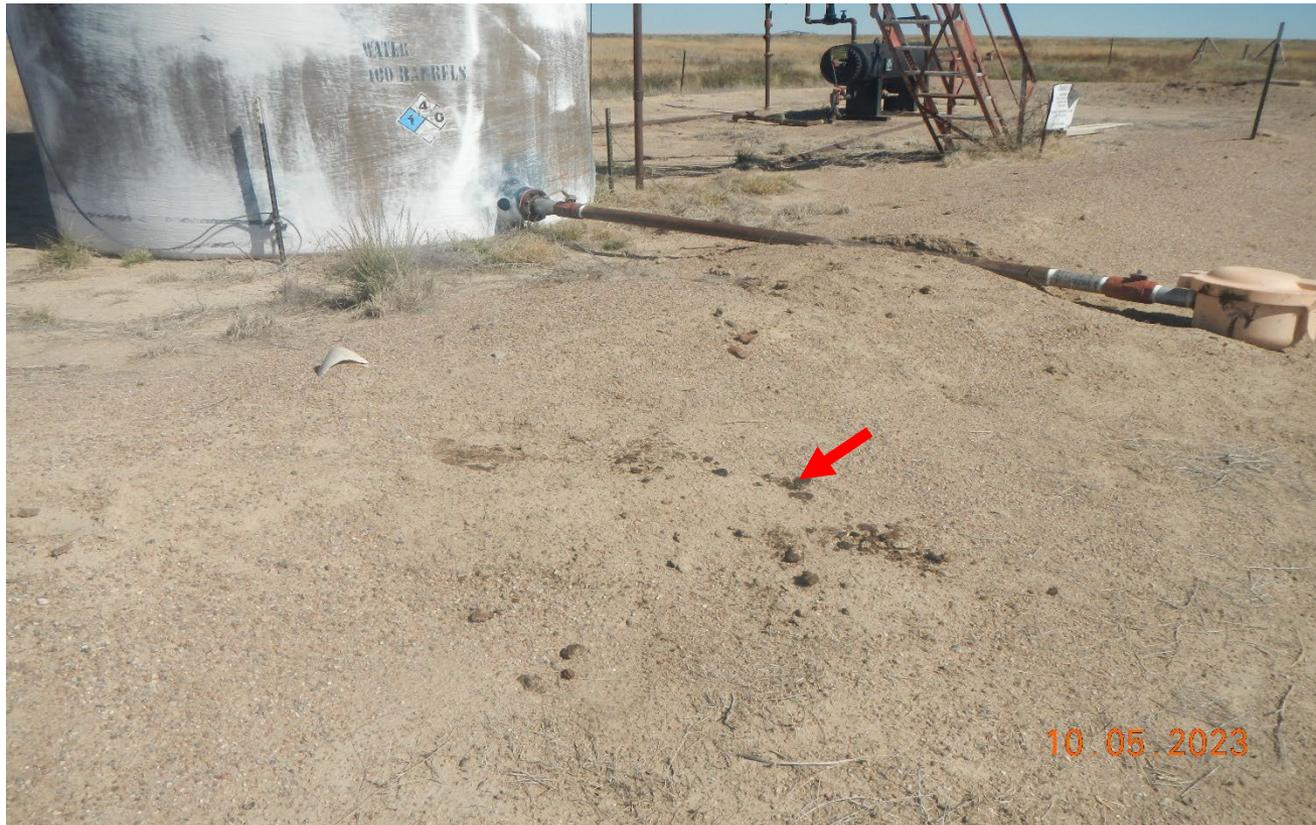
Photo 2. The pipe has been reinstalled at the tank however oily stained soil still remain.

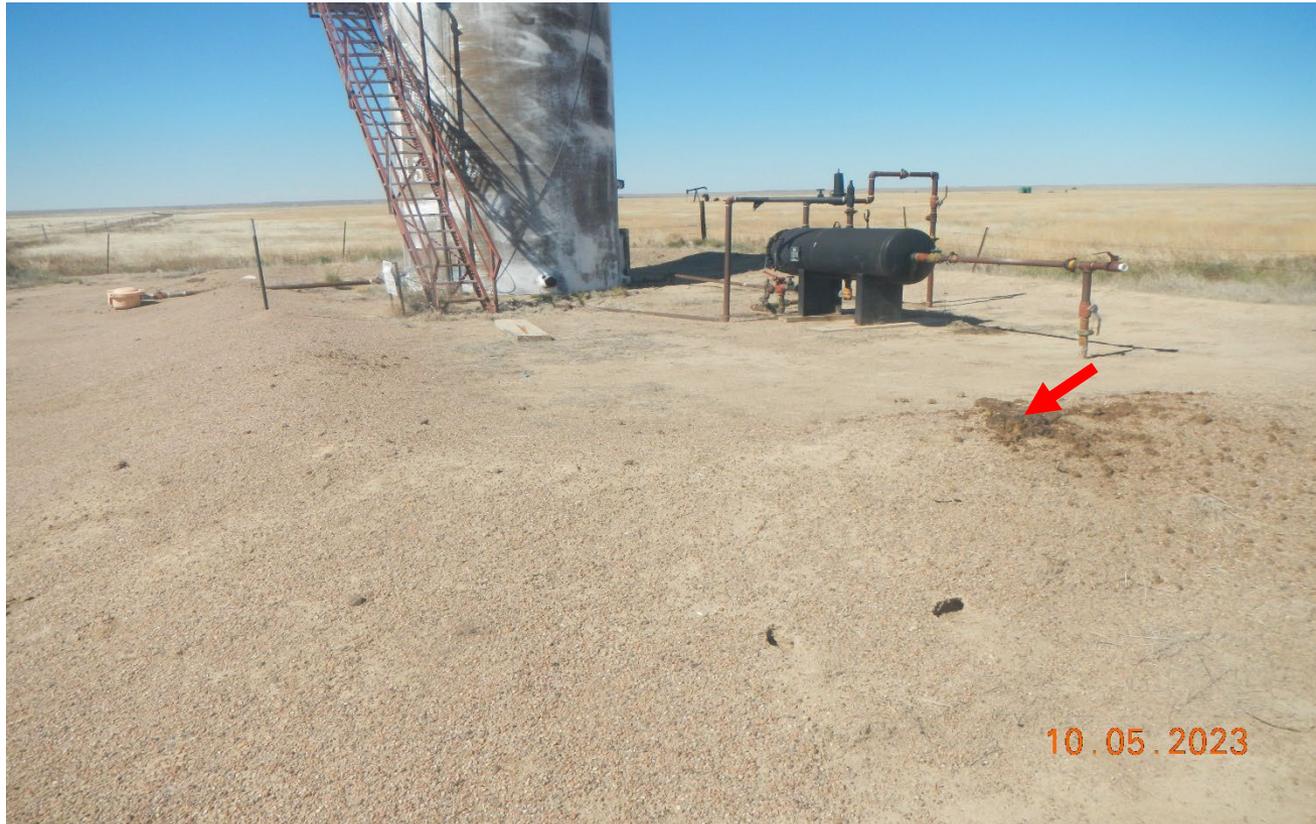
Photo 3. The berm around the tank is insufficiently sized to contain a spill./ There is oily contaminated soils on the berm (red arrow) that needs to be cleaned up and removed.

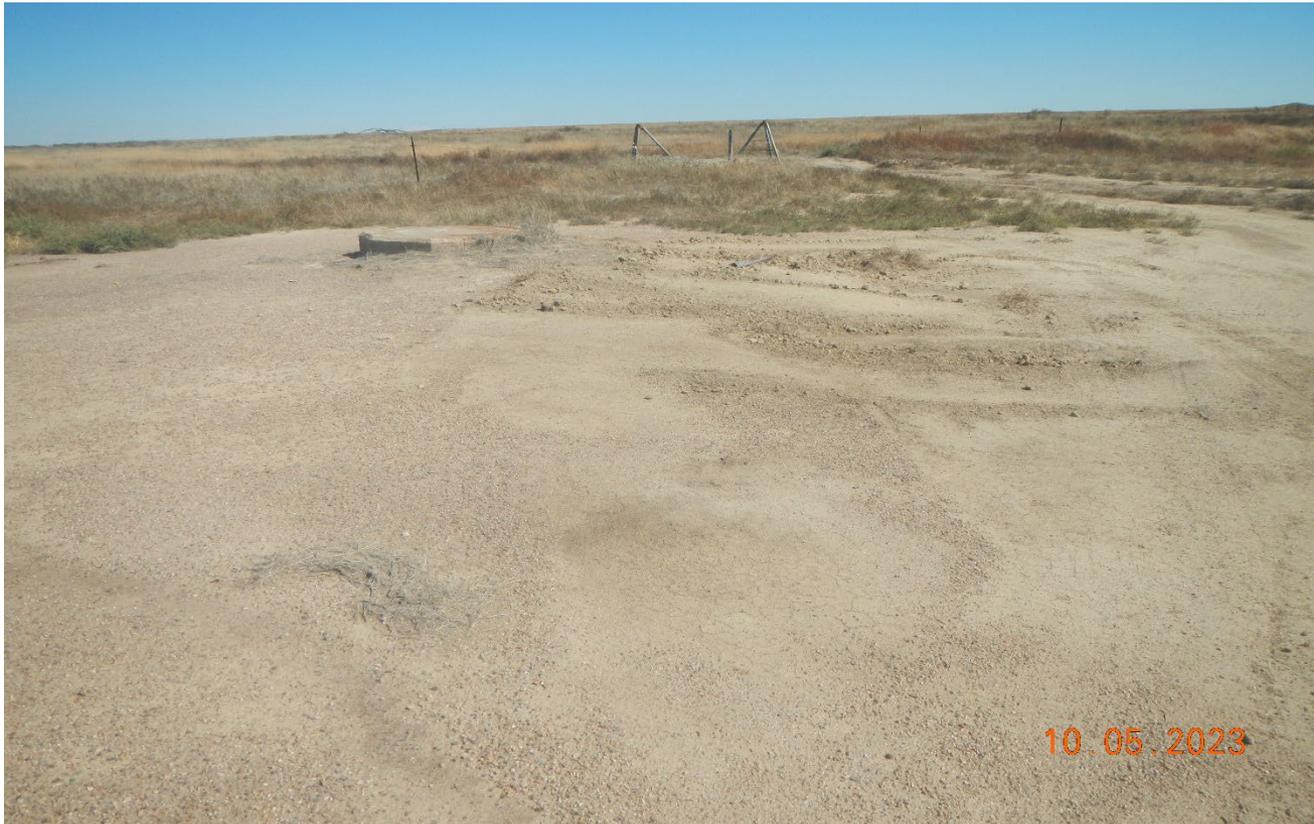
Photo 4. Facing northeast at the tank battery. This unused area of the location needs to be reclaimed.

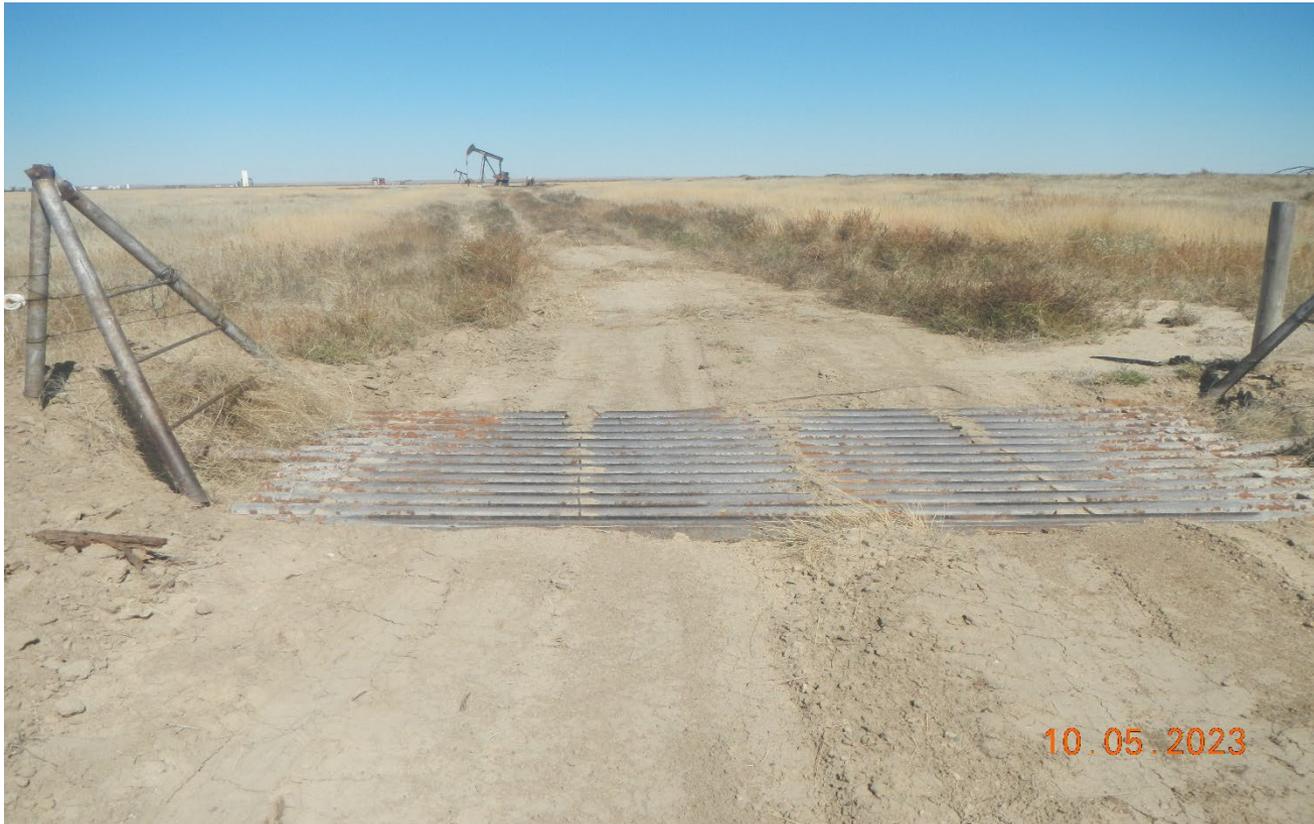
Photo 5. Facing along the access road at the cattleguard. The cattleguard has been cleaned out.

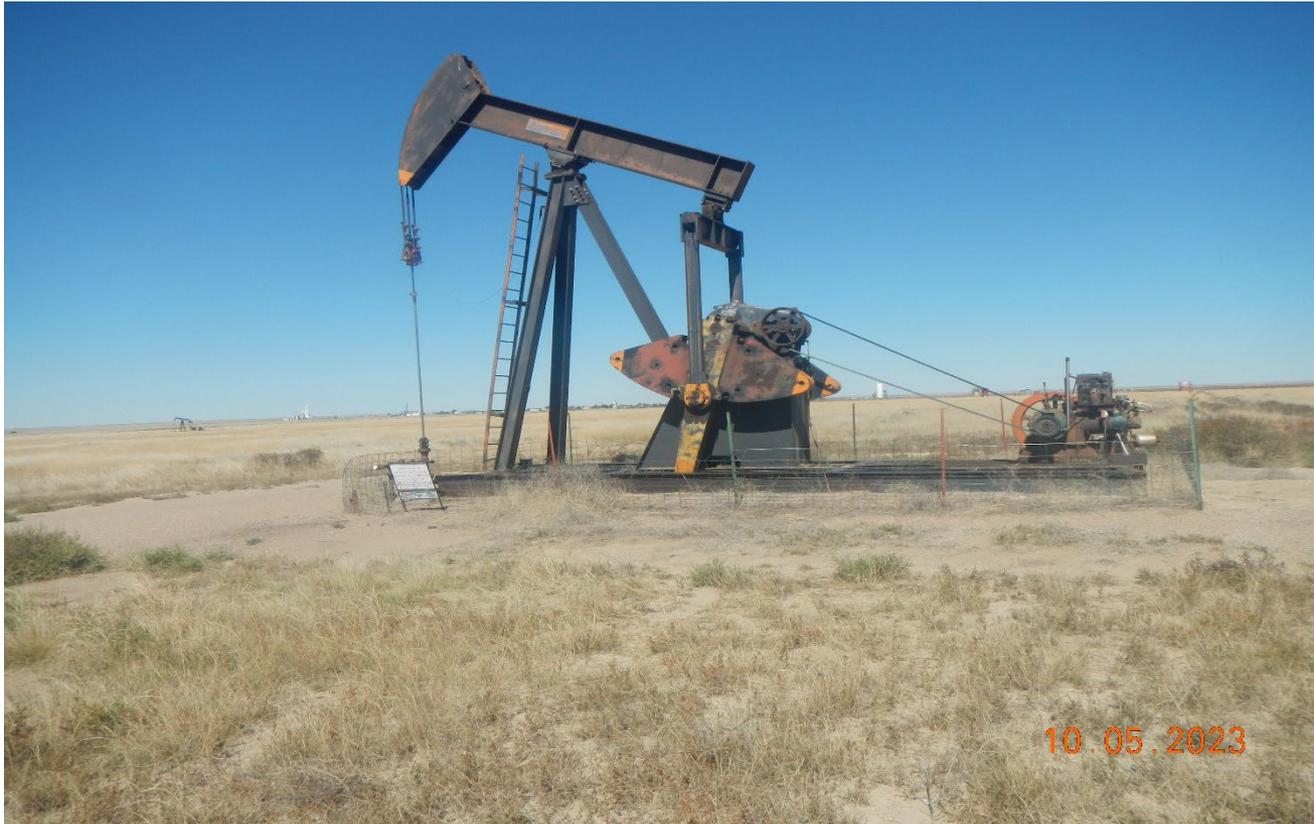
Photo 6. Facing toward the wellsite.

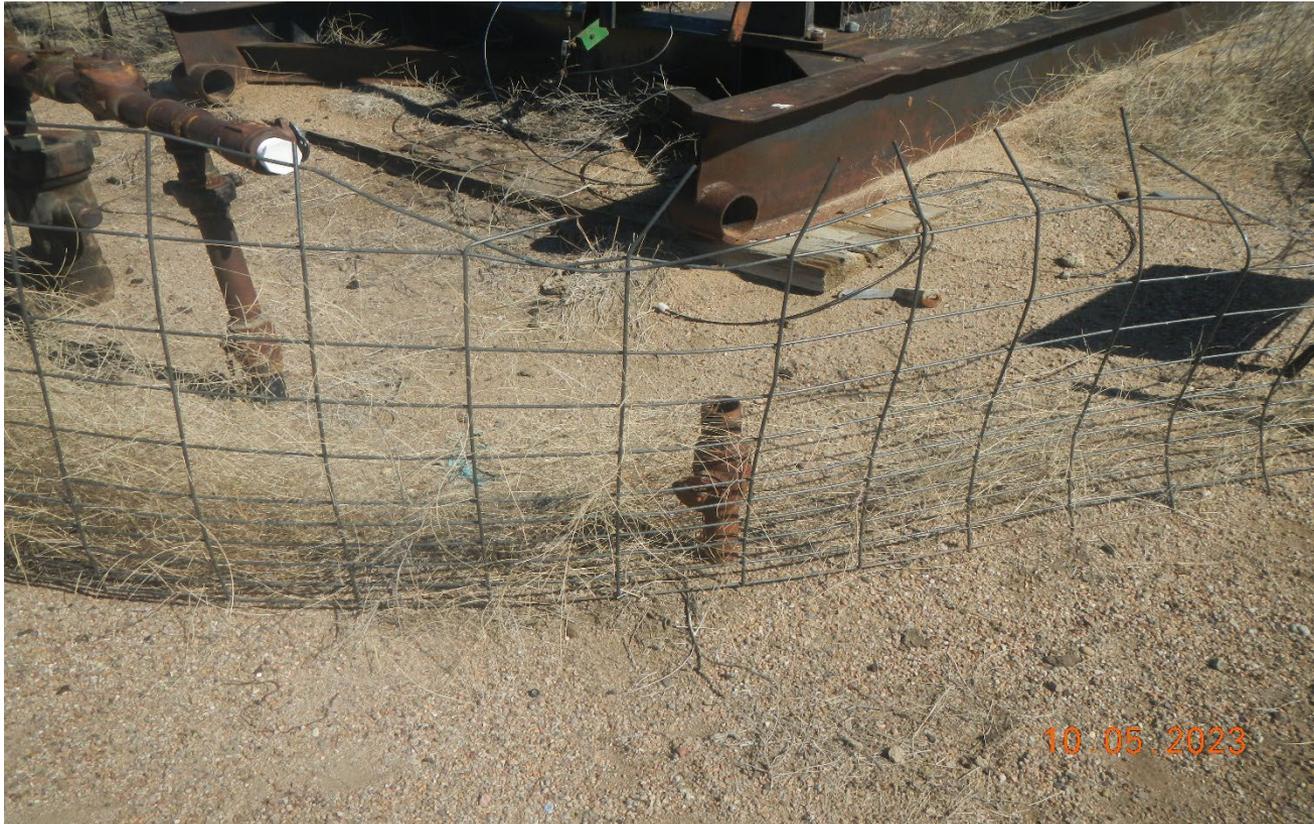
Photo 7. There is an open pipe riser that needs OOSLAT or needs to be removed.

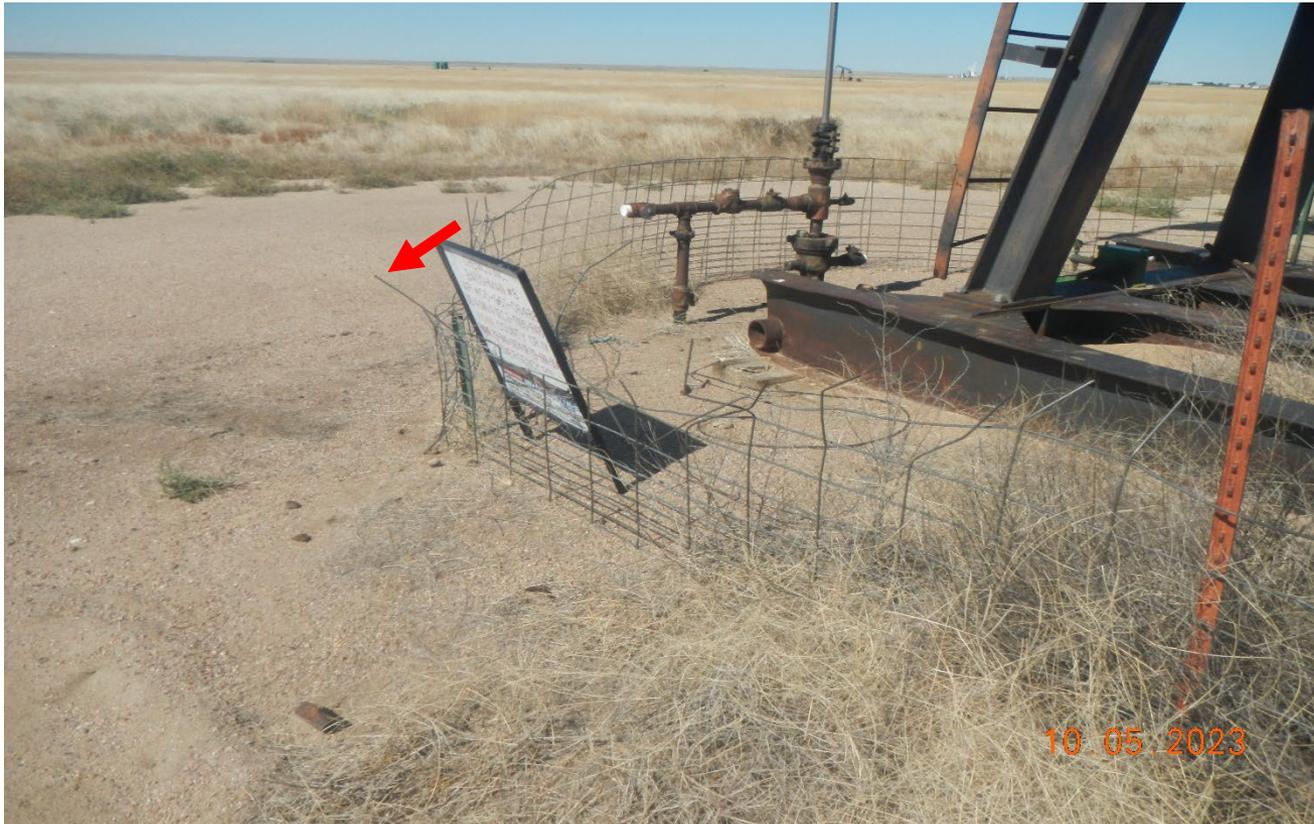
Photo 8. The fence around the pumpjack is not adequate to prevent livestock entry and is only 2ft. Tall near the well sign. There are wires stick out (red arrow) which could injury livestock..
