Construction and Stormwater Inspection

Date: 09/27/2023

Operator: DENOVA SEQUESTRATION LLC - 10790

Location ID: 483817

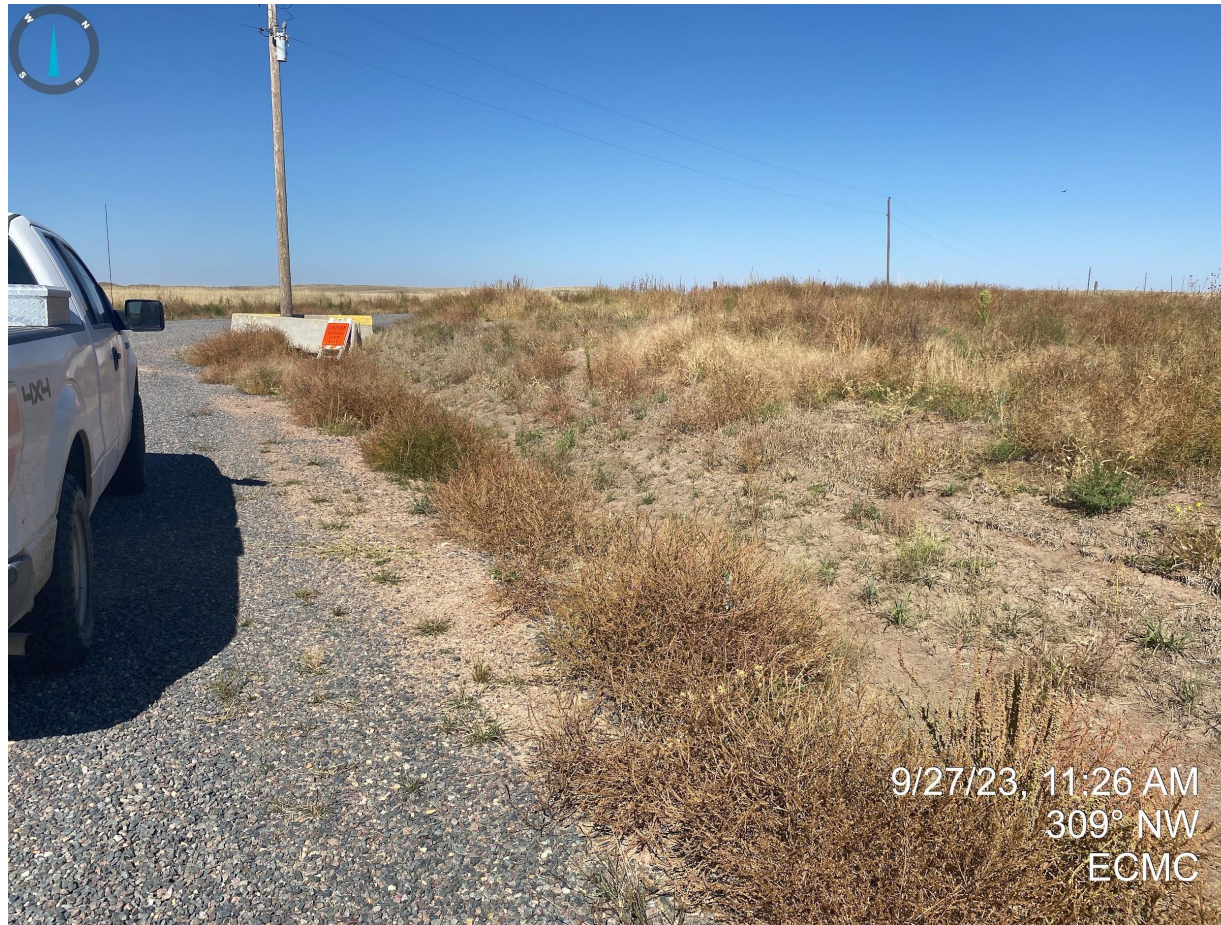
Photo 1. Taken from the entrance to the location. Undesirable vegetation (e.g. russian thistle and kochia) was observed throughout the disturbance area.

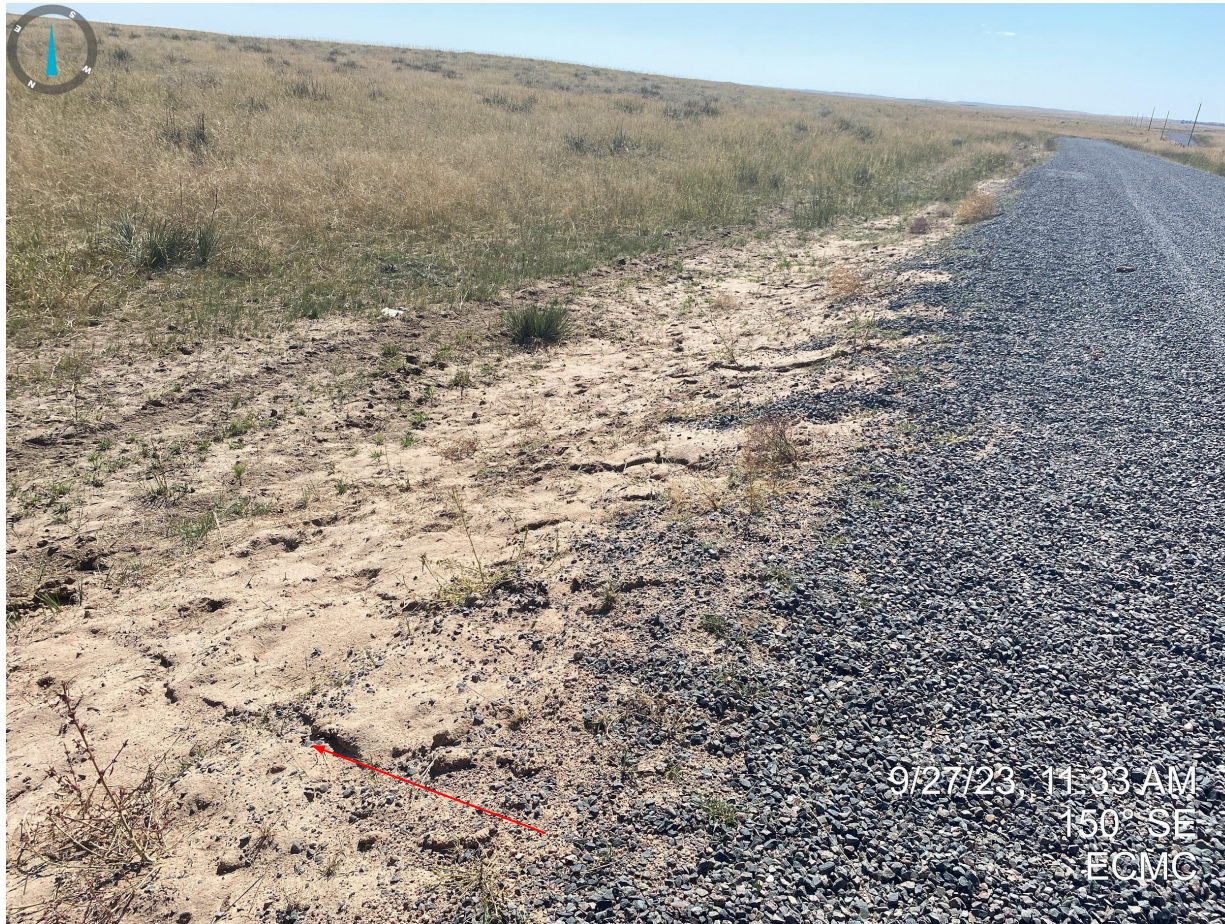
Photo 2. Taken approximately 1 mile north from the entrance. Rilling degradation was observed on the shoulders of the access road, indicating that the disturbance areas are not properly stabilized from wind and water erosion.

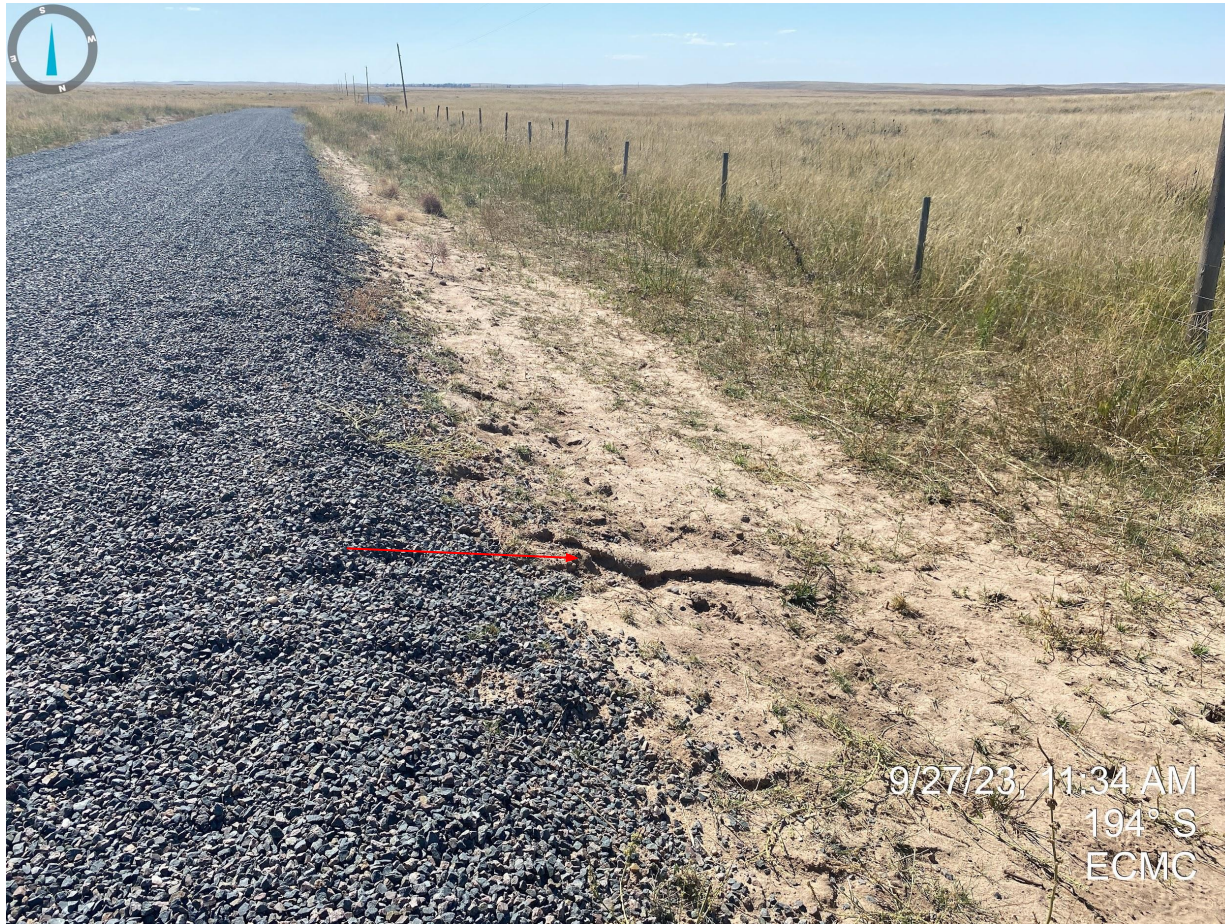
Photo 3. See comments in Photo 2.

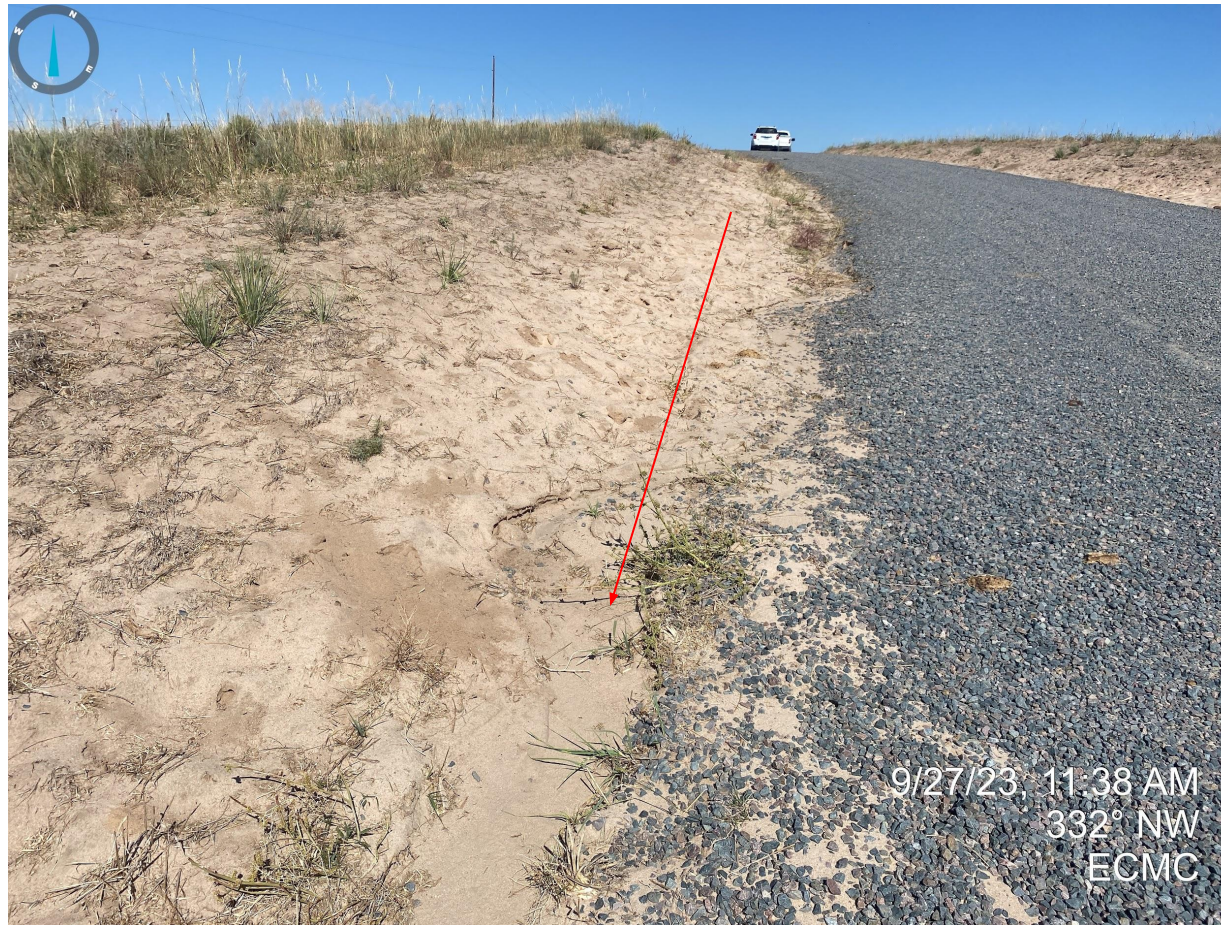
Photo 4. Taken approximately 1 mile north of the entrance. Photo illustrates that cut banks are not properly stabilized with evidence of bare/exposed soils and and erosion degradation occurring.

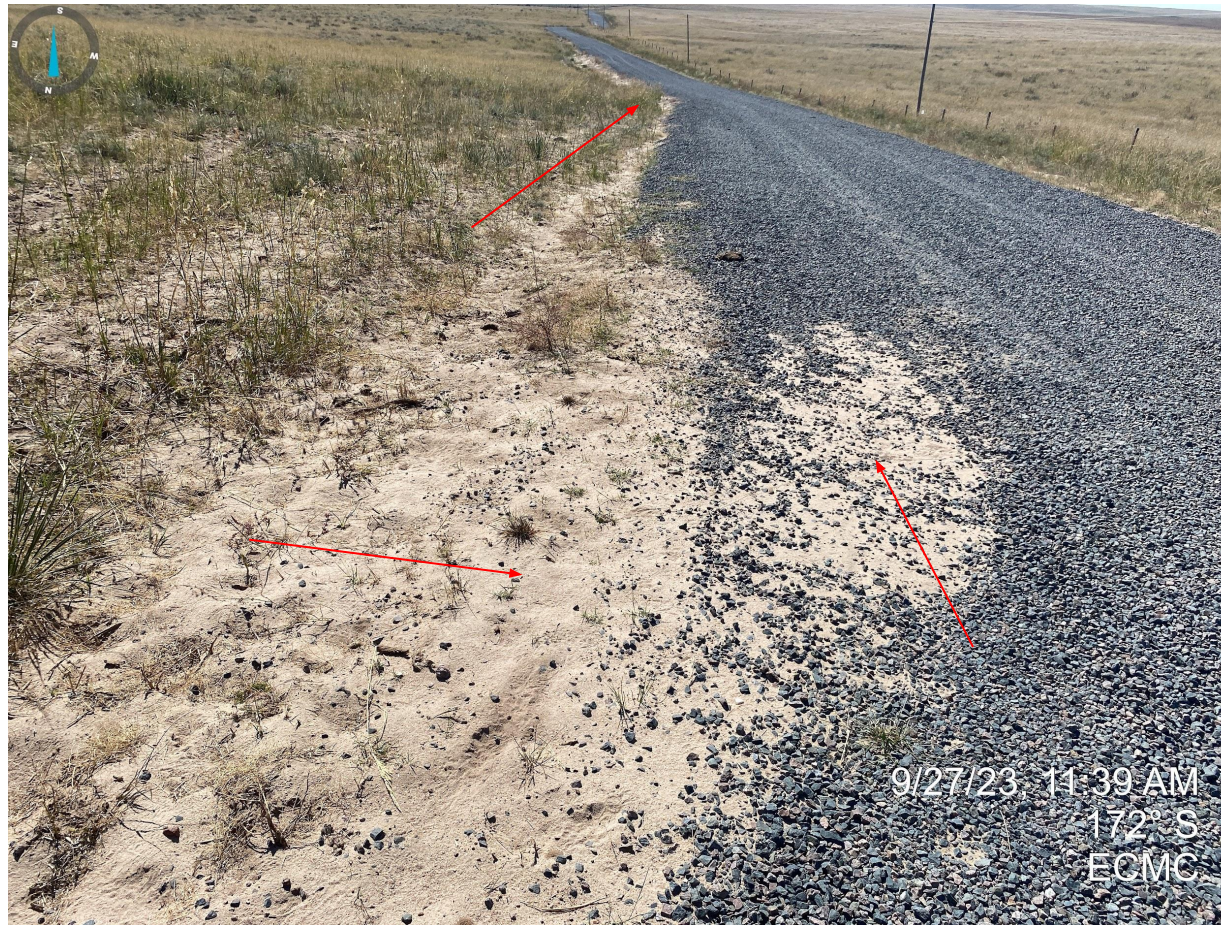
Photo 5. Taken on the opposite side of the road from Photo 4.

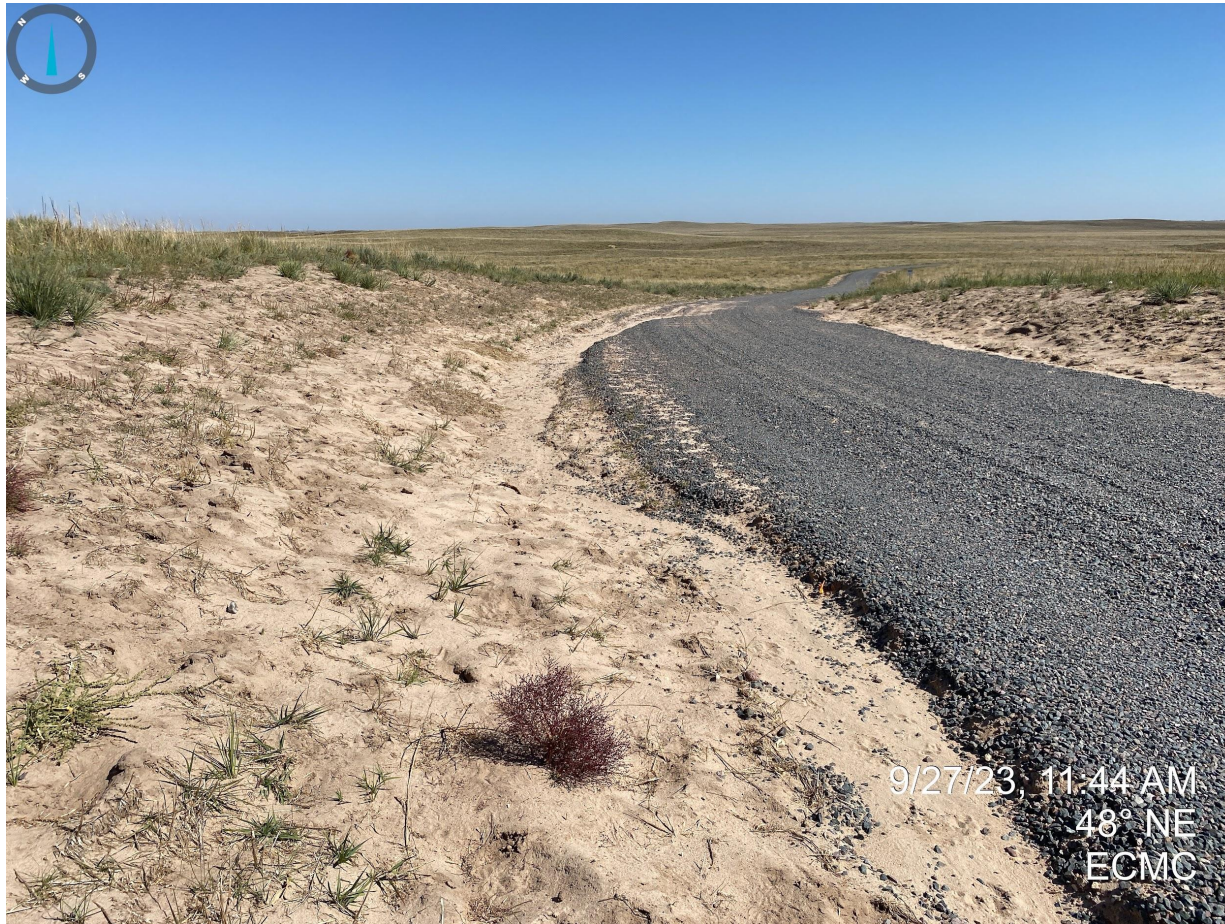
Photo 6. Taken approximately ¼ mile west of the location. Photo illustrates that cut banks are not properly stabilized with evidence of bare/exposed soils and and erosion degradation occurring.

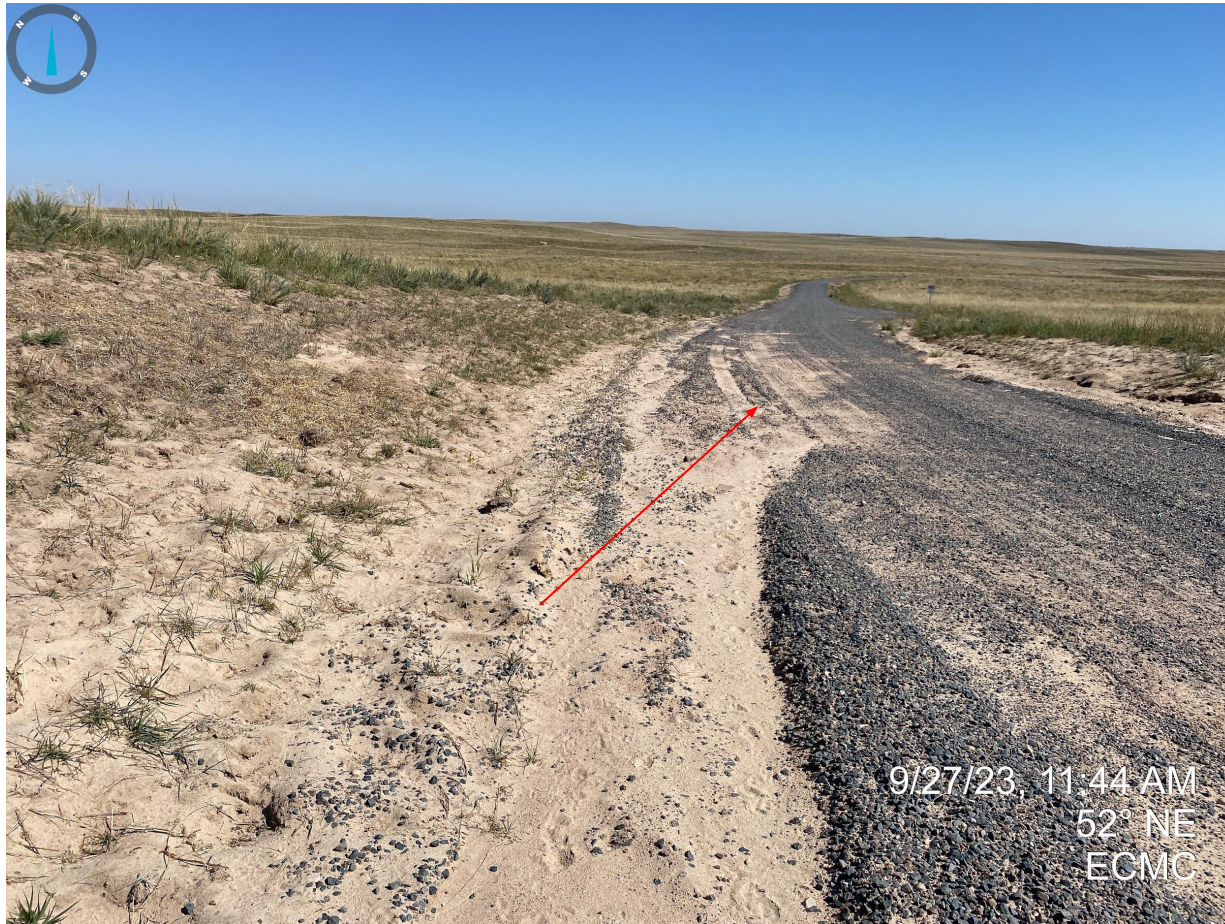
Photo 7. See comments in Photo 6. Sediment transport pictured.

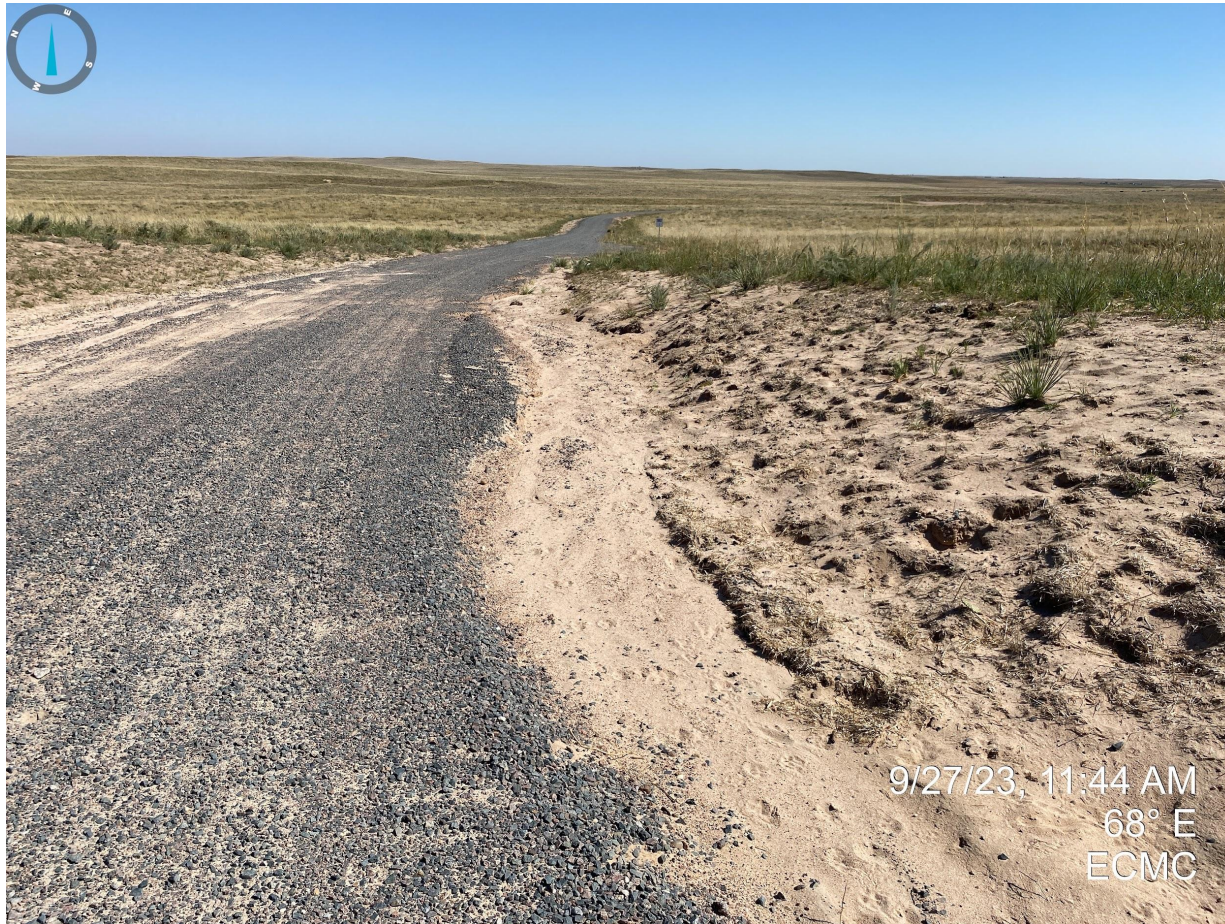
Photo 8. Opposite side of the road from Photo 7.

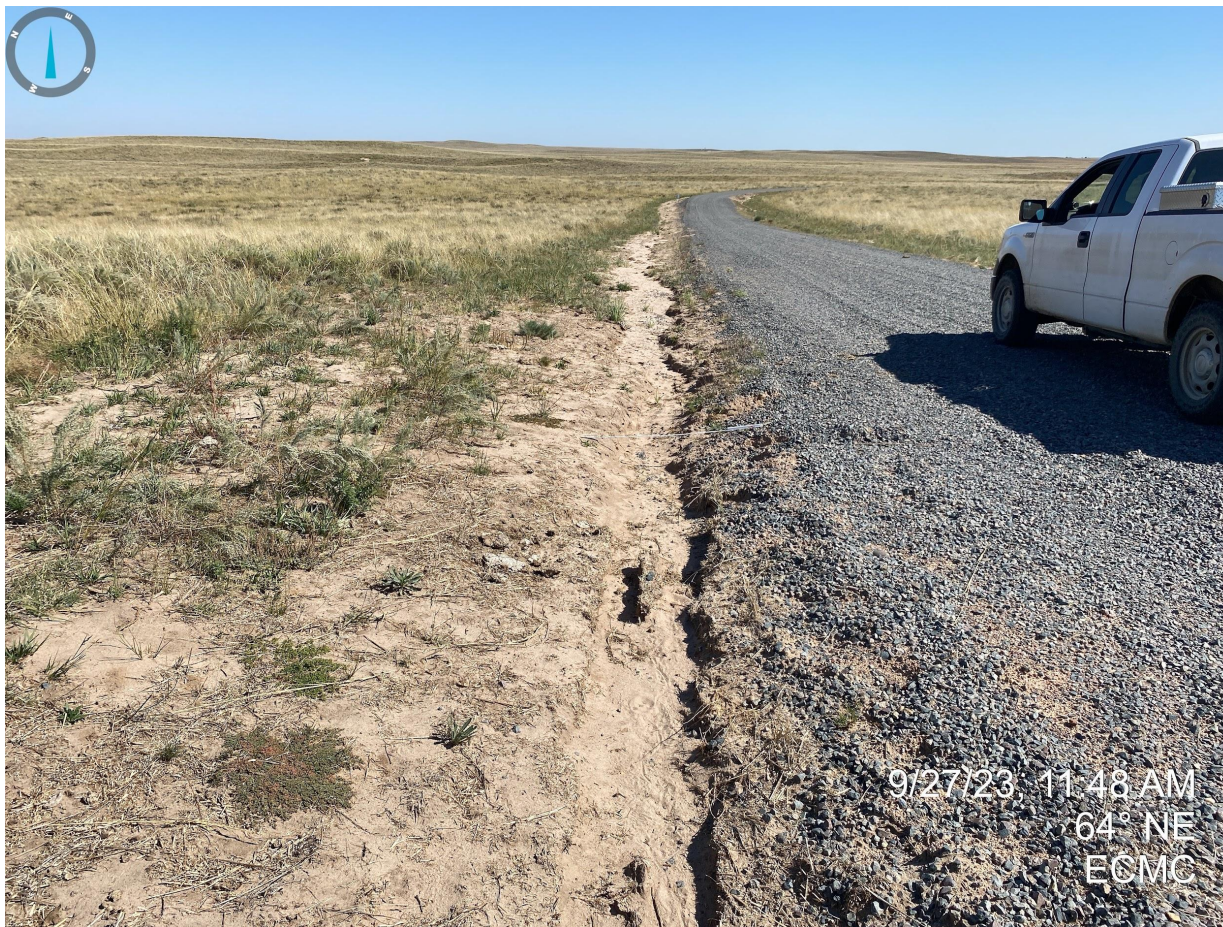
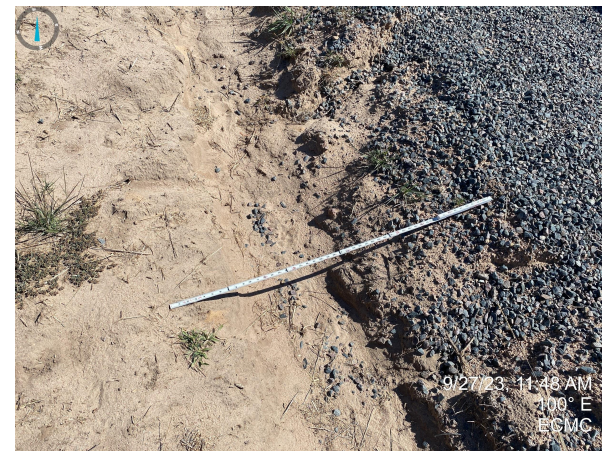
Photo 9. See comments in Photo 6. No apparent stormwater control measures observed along the access road/ditch.

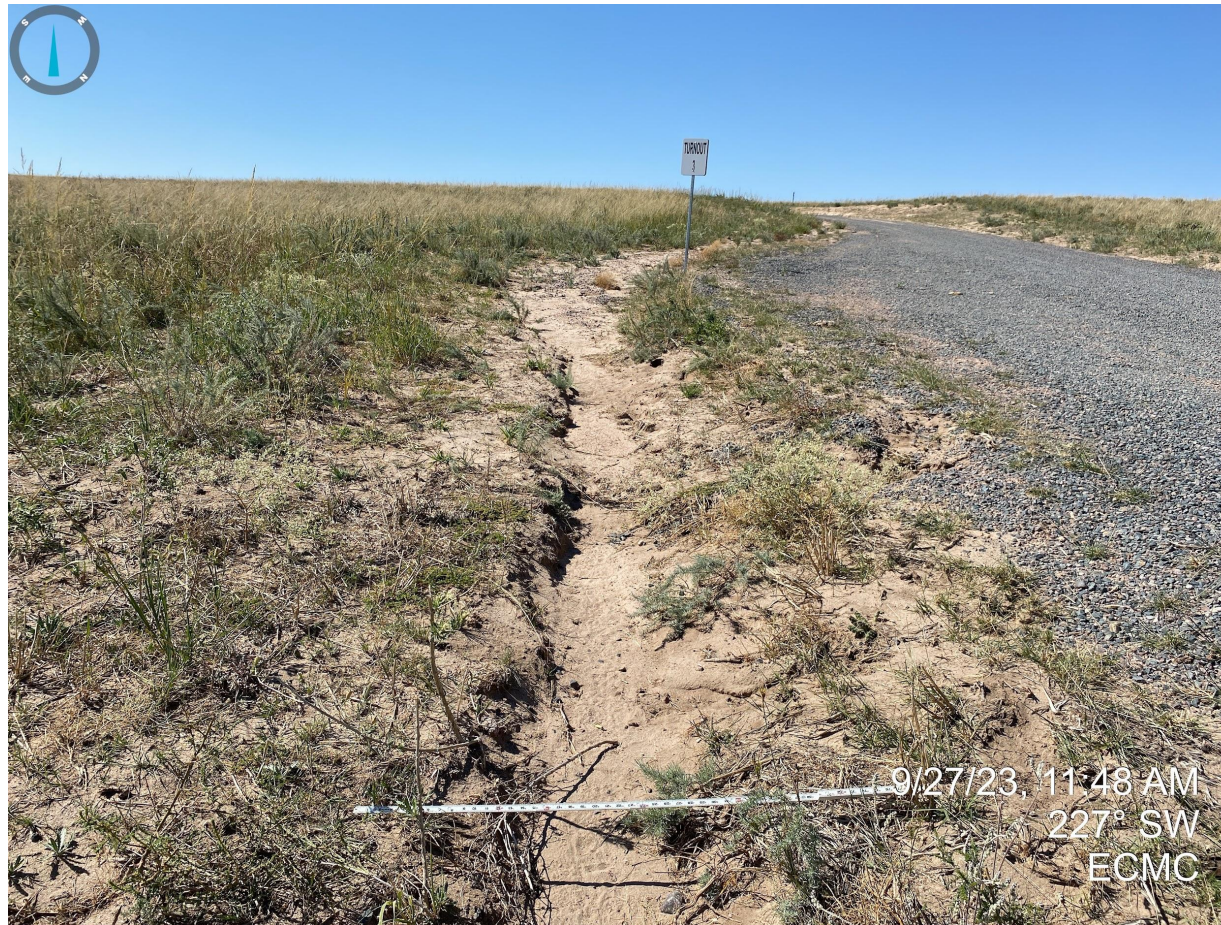
Photo 10. Southside of access road, approximately ¼ mi west of the location. Gully erosion degradation pictured; no apparent stormwater control measures/BMPs observed.

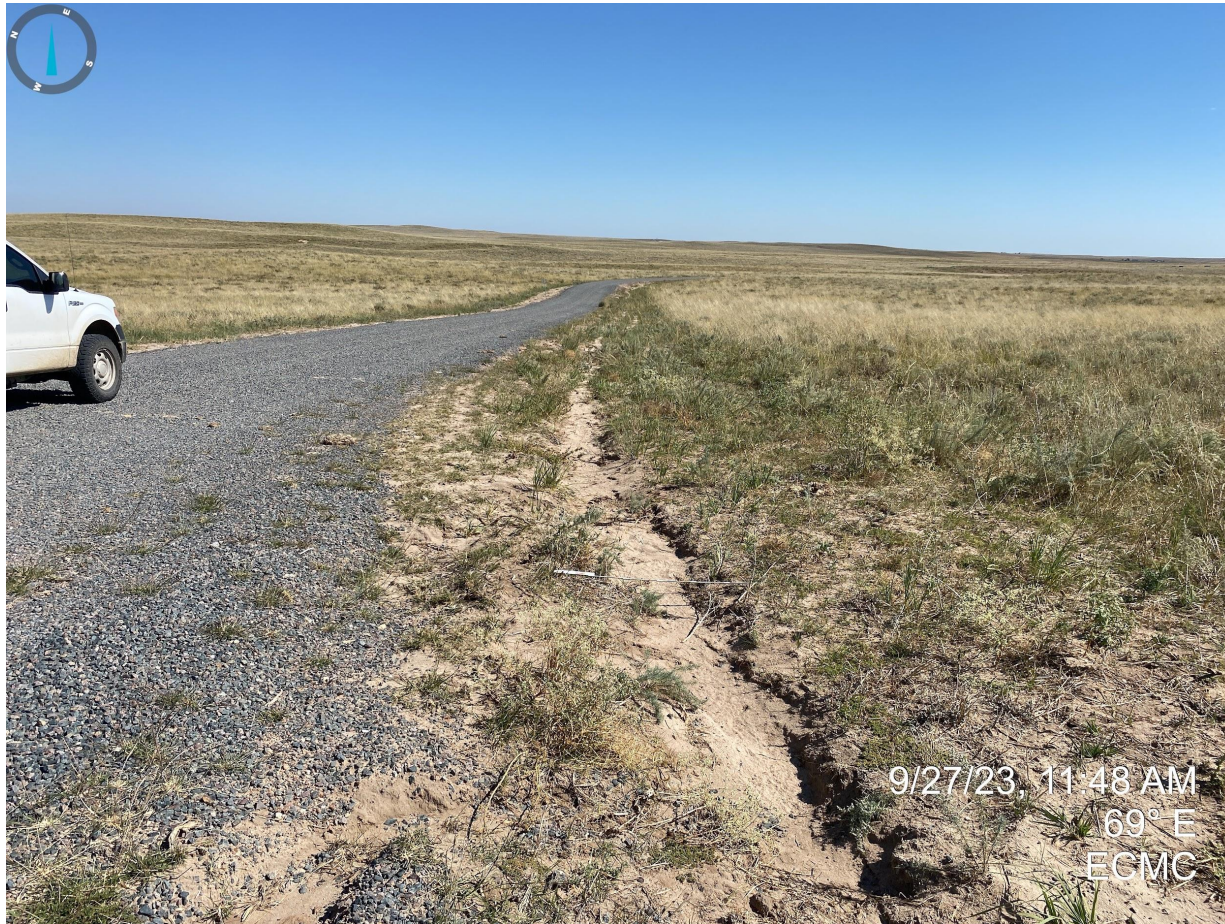
Photo 11. Continued form Photo 10.

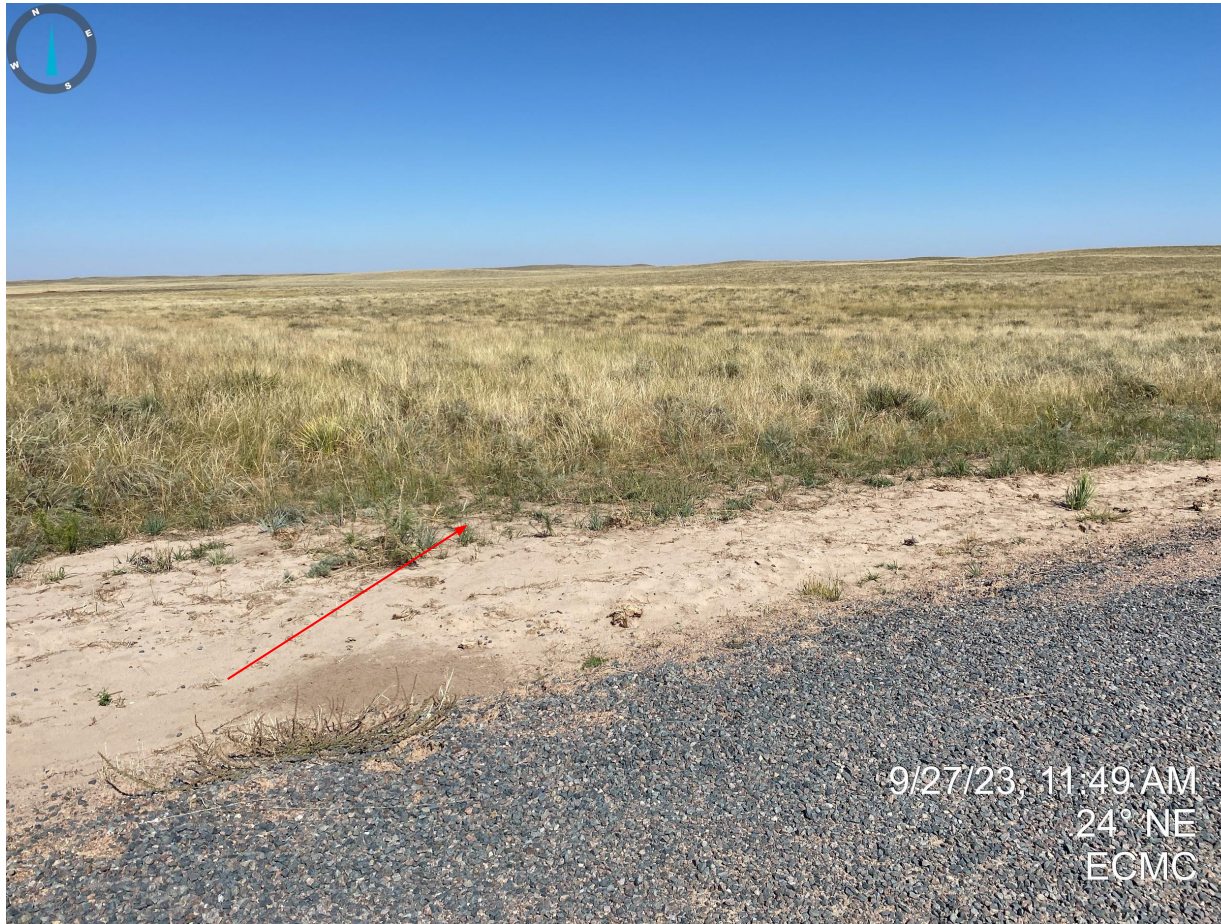
Photo 12. North side of the access road, approximately 1000' west of the location. Photo illustrates that sediment transport is beginning to migrate onto adjacent lands with no apparent stormwater control measures observed.

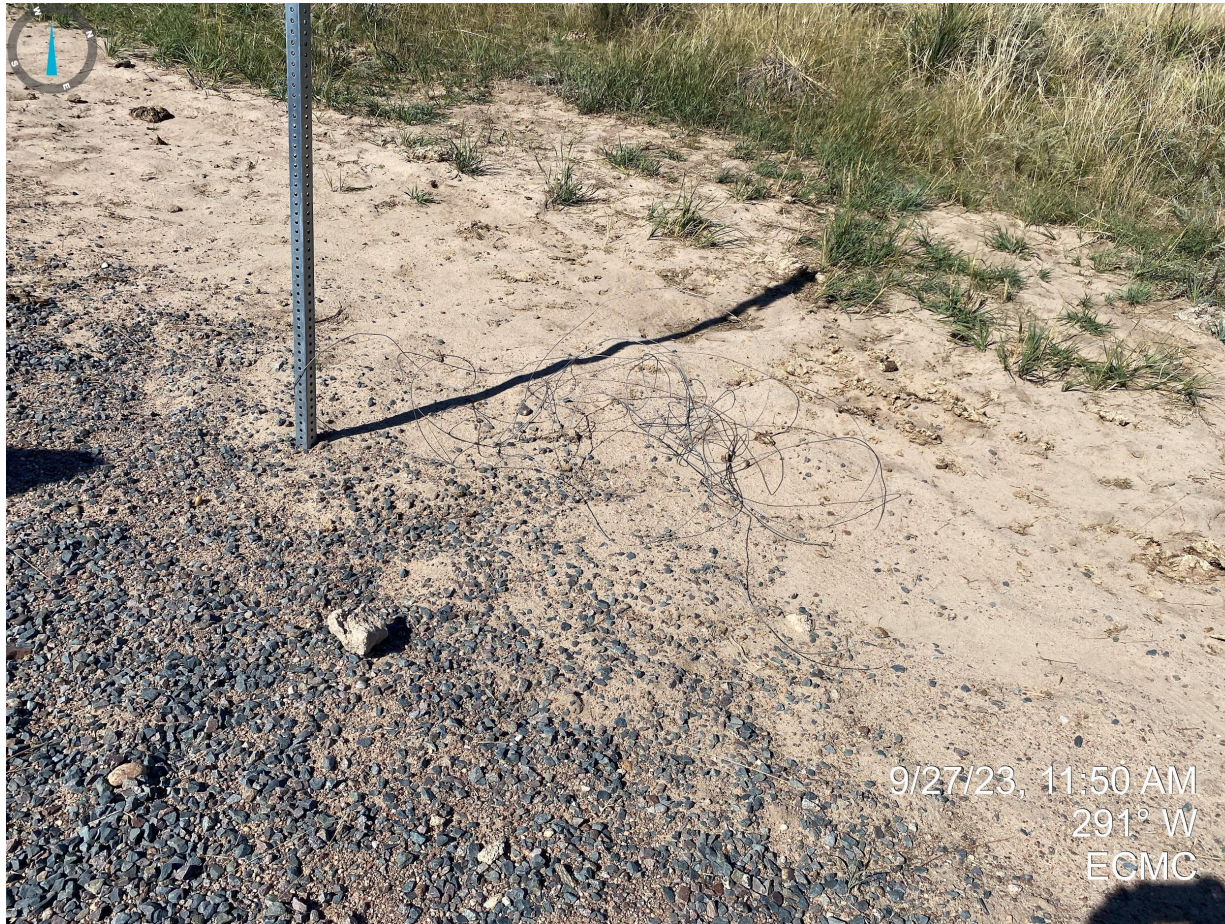
Photo 13. Taken along the access road. Debris (wire) that will need to be removed.

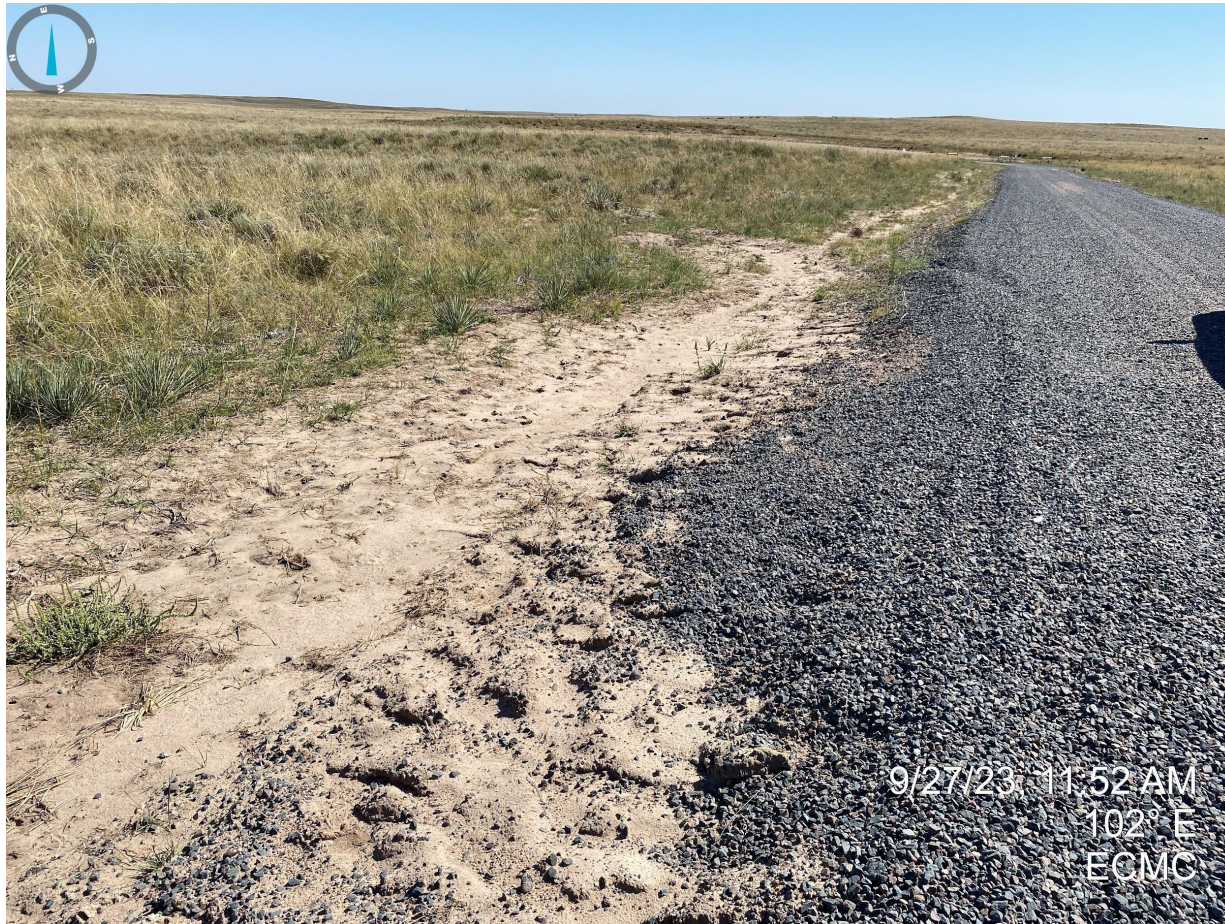
Photo 14. Taken approximately 500' west of the location. Offsite sediment transport; no apparent stormwater control measures observed.

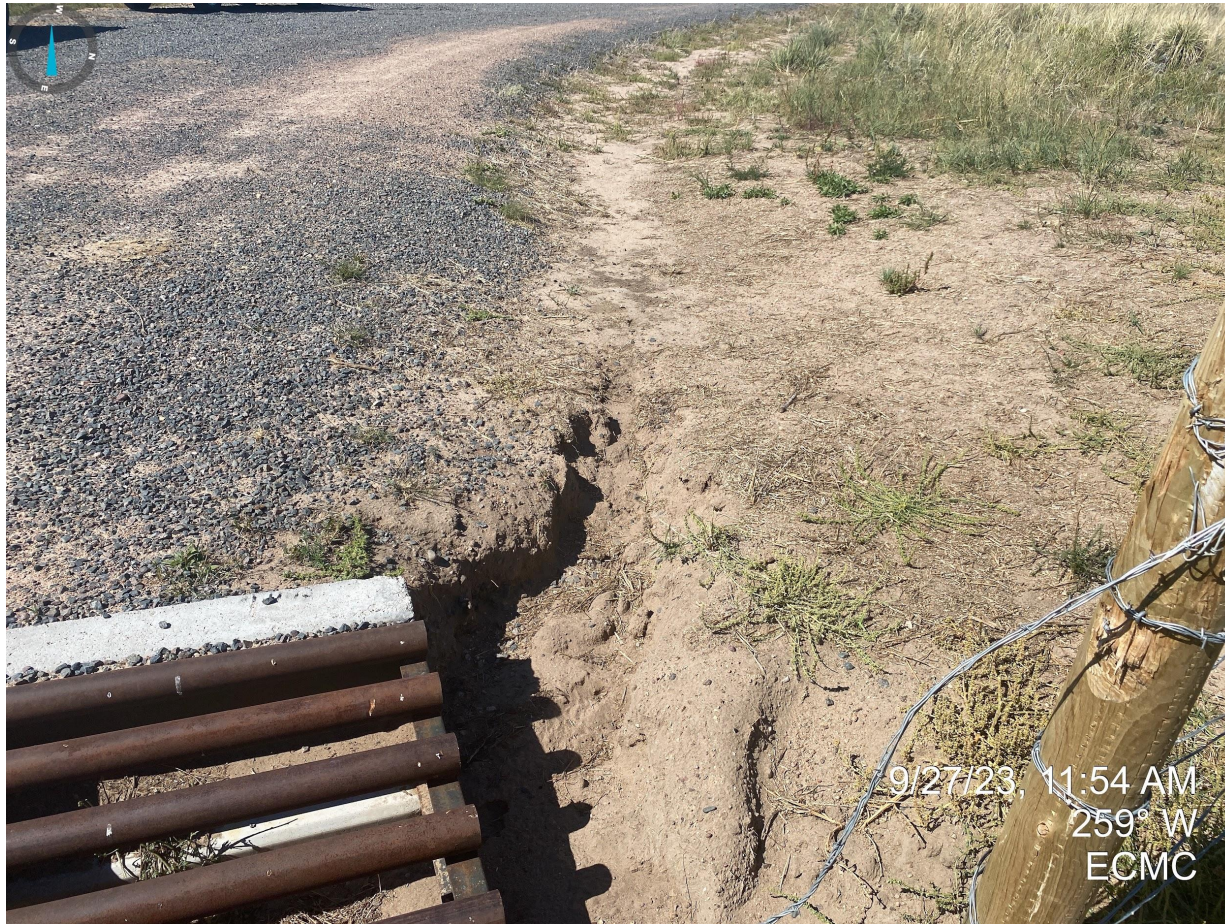
Photo 15. Taken at the location's entrance. Erosion degradation occurring at the cattle guard.

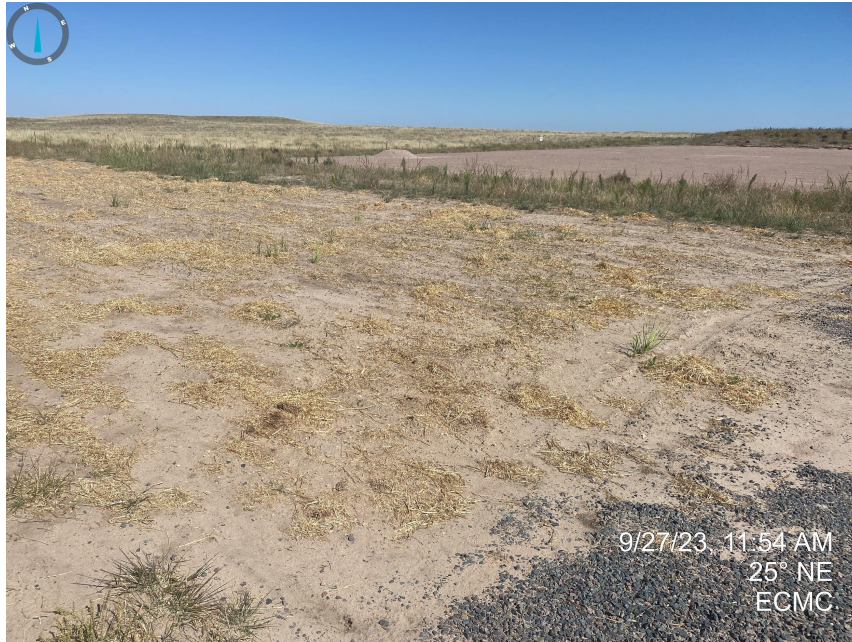
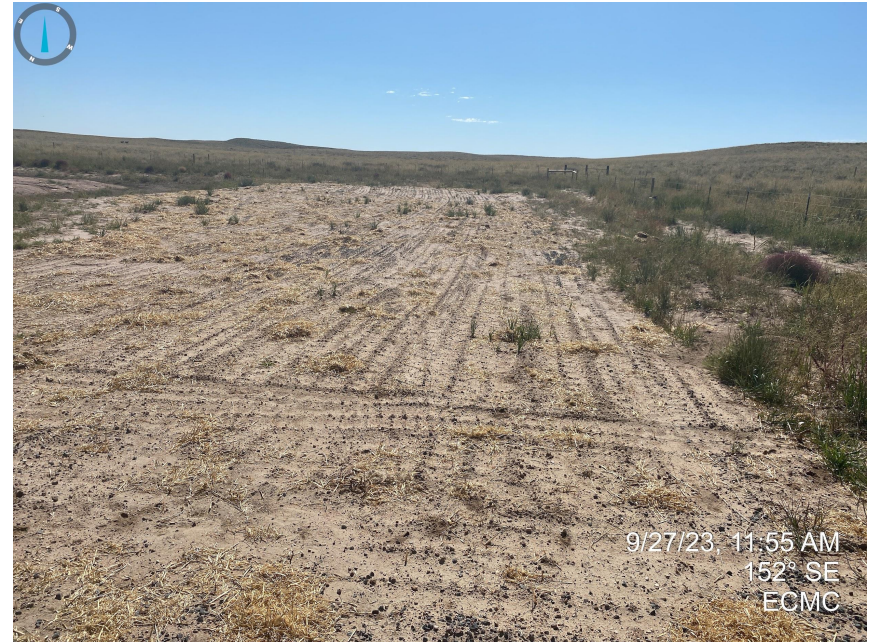
Photo 16. Taken near the location's entrance. The "parking" areas pictured were previously inspected and found to not have topsoil salvaged as required per Rule 1002.b. It appears the Operator removed most of the road base/ gravel material and seeded/mulched the area. The areas consist mainly of bare/exposed soils with gravel still present. Additional reclamation activities are required to stabilize and protect the topsoil from wind and water erosion.

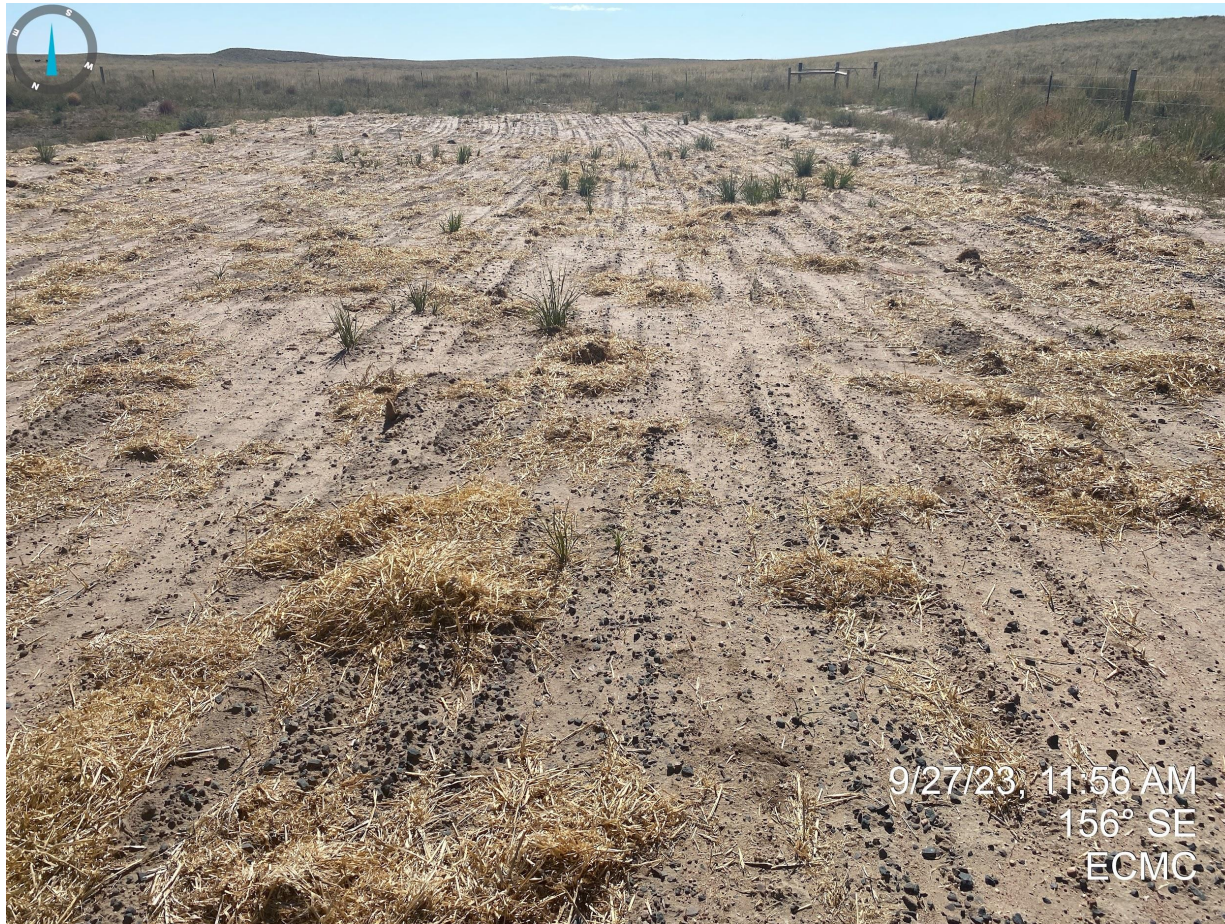
Photo 17. Continued from Photo 16.

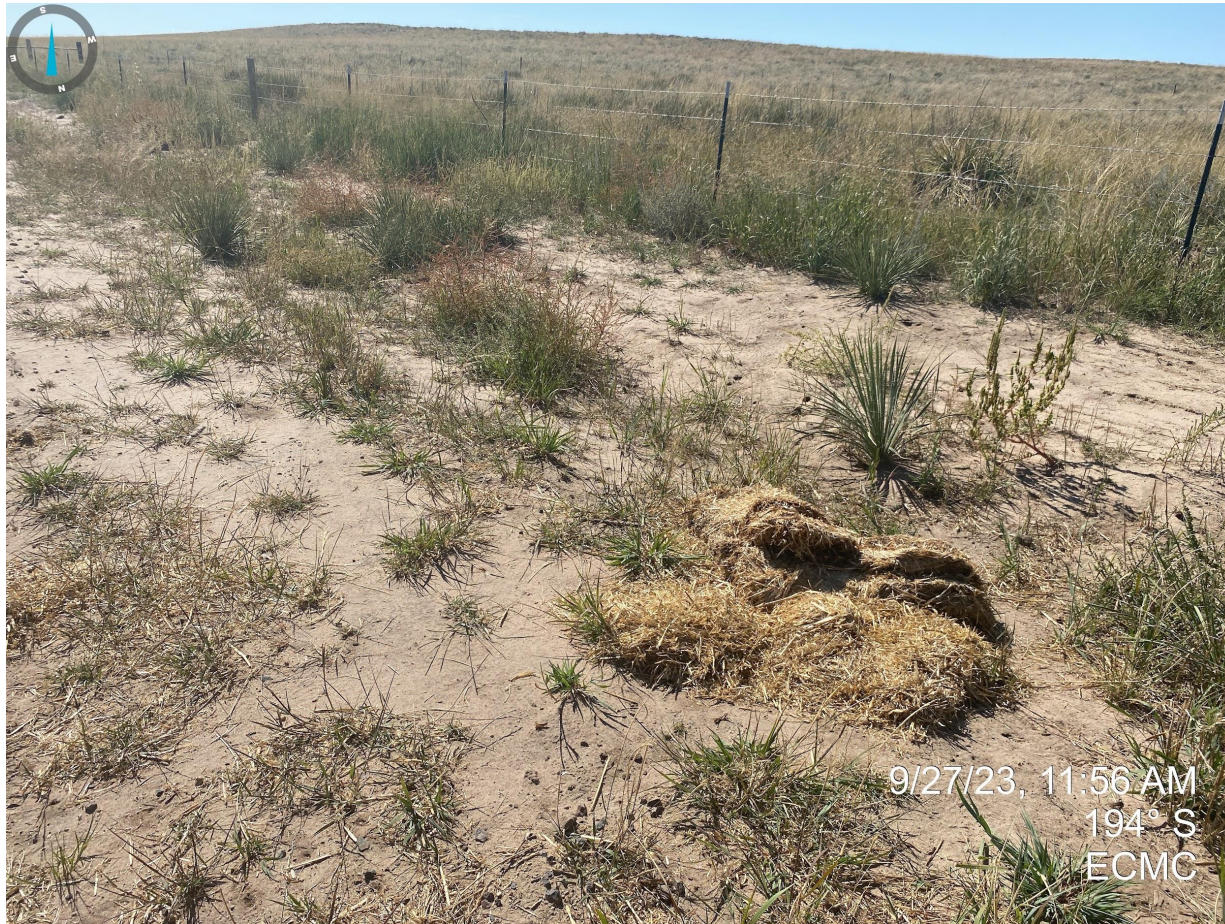
Photo 18. Taken from the western side of the location. Photo illustrates straw mulch that is now considered trash/debris. Additionally, bare/exposed soils are evident.

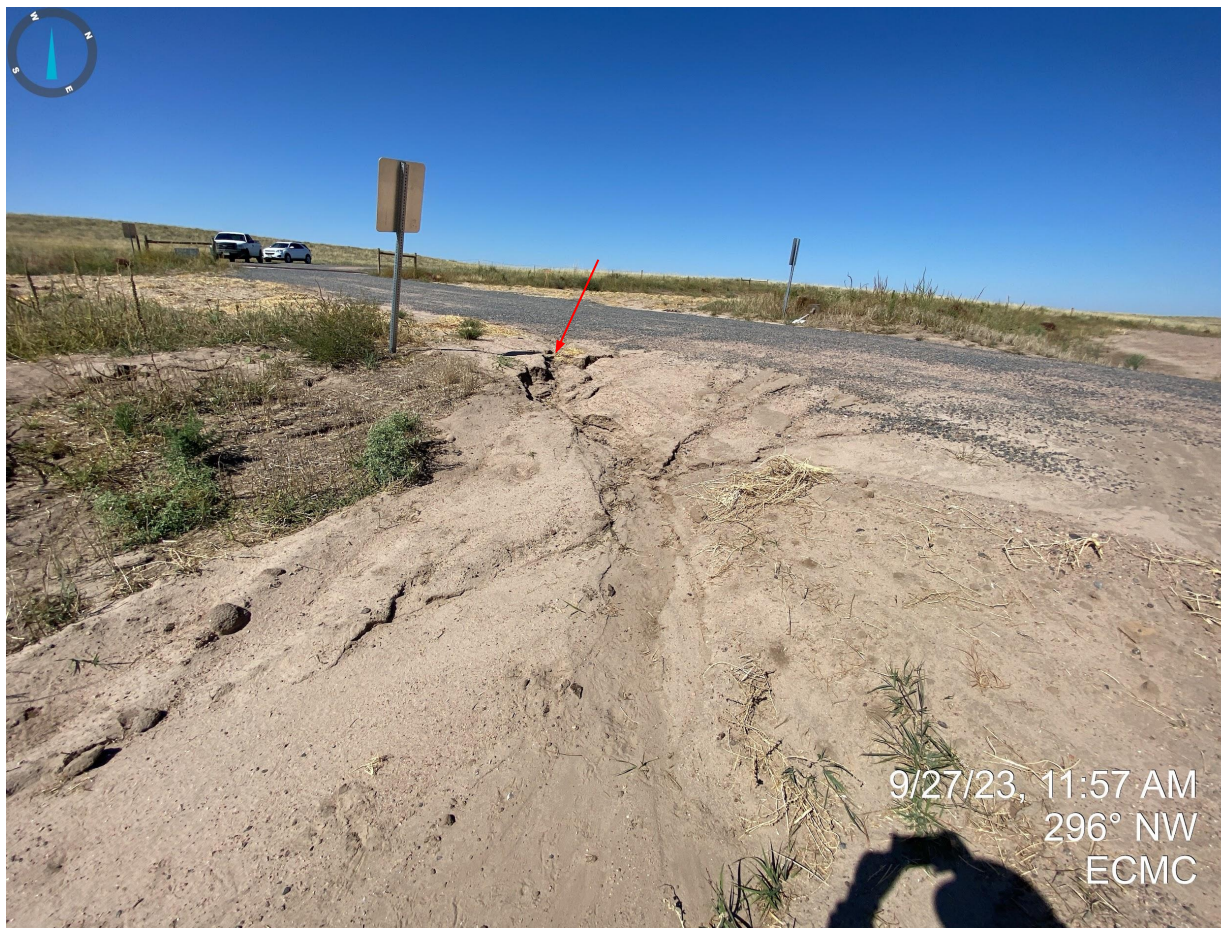
Photo 19. Taken from the sediment trap on the western side of the production pad. Rill and gully erosion degradation evident. Stormwater control measures do not appear to be adequate for this location as unstabilized soils were observed.
