Construction and Stormwater Inspection

Date: 09/27/2023

Operator: DENOVA SEQUESTRATION LLC - 10790

Location ID: 483817

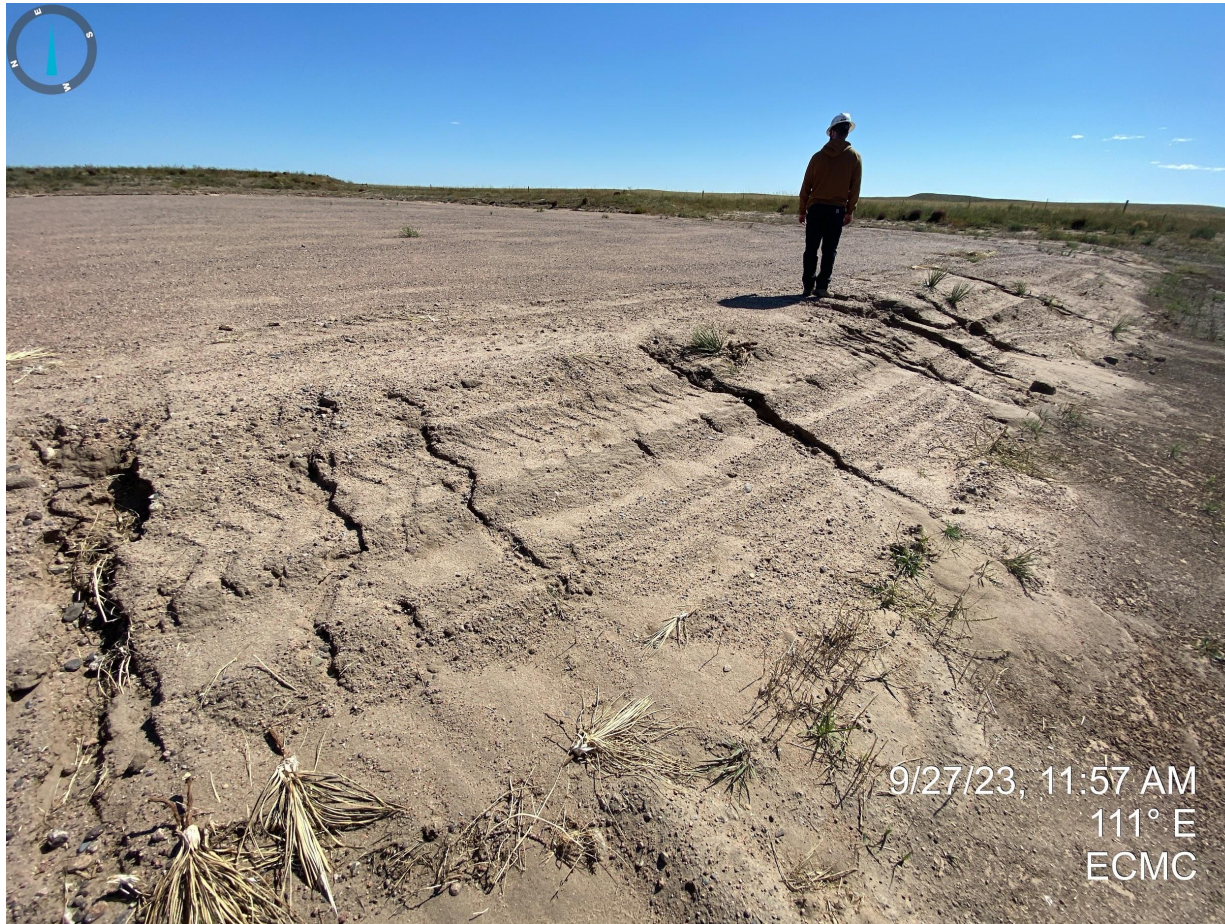
Photo 19. Taken from the sediment trap on the western side of the production pad. Rill and gully erosion degradation evident. Stormwater control measures do not appear to be adequate for this location as unstabilized soils were observed.

Photo 20. See comments in Photo 19.

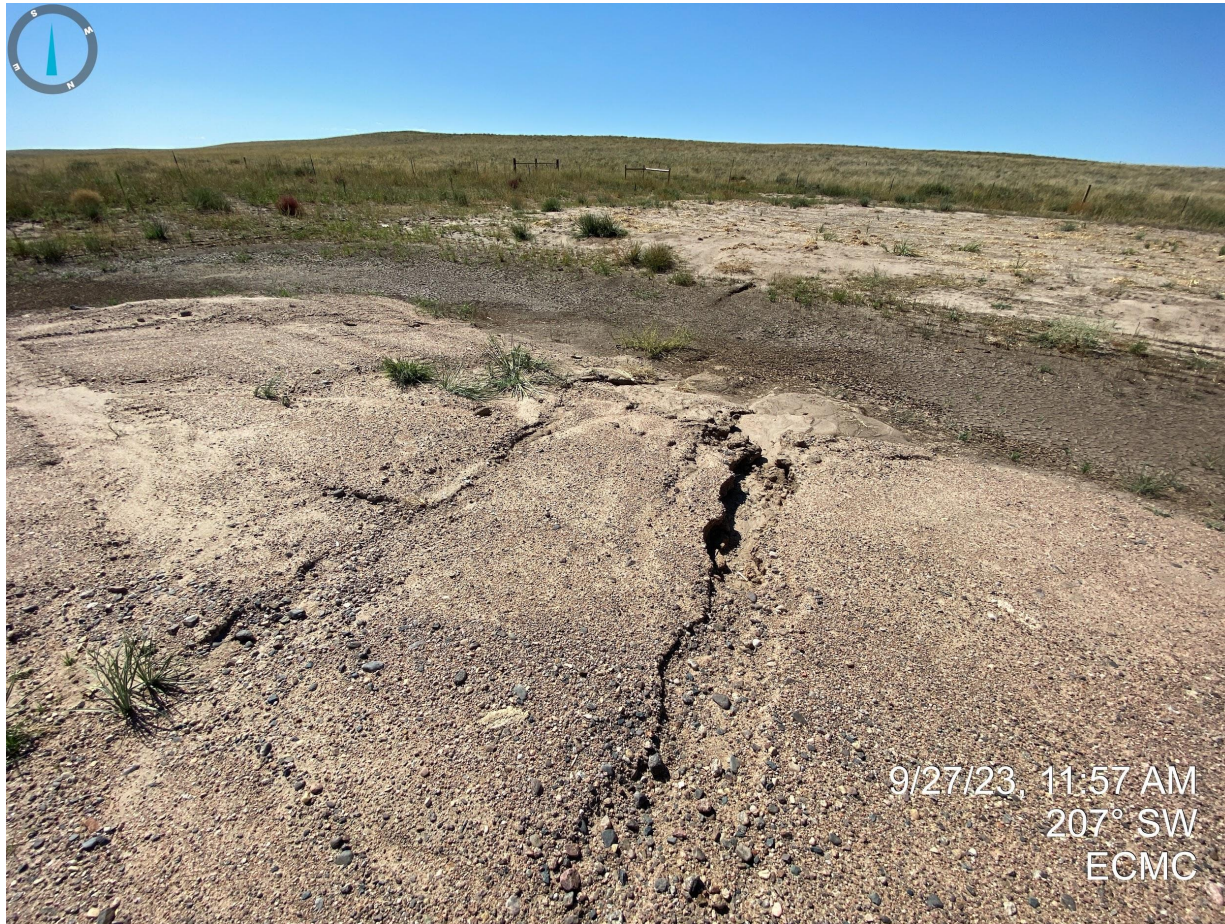
Photo 21. See comments in Photo 19.

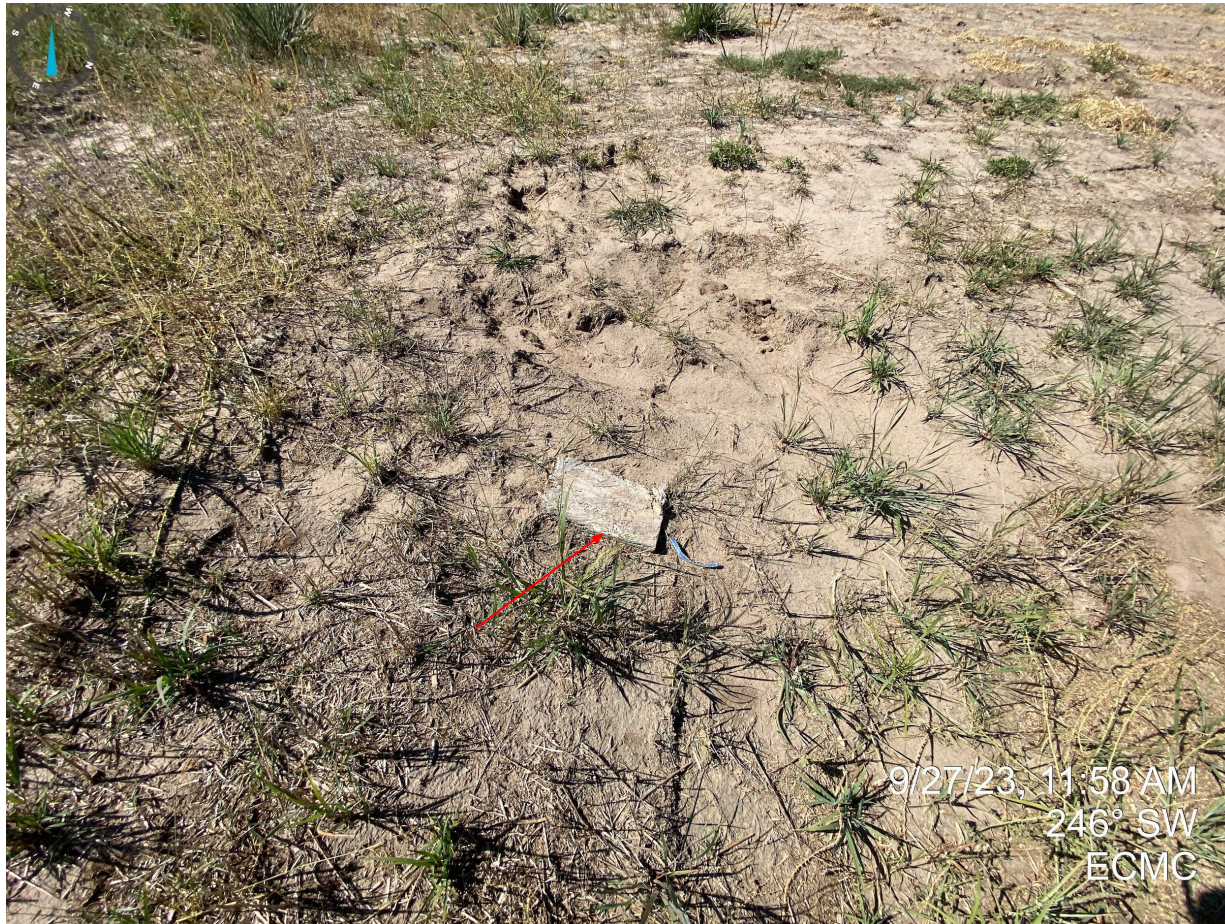
Photo 22. Example of trash/debris found within the southwestern corner of the location. Operator shall self identify all trash on location and properly remove.

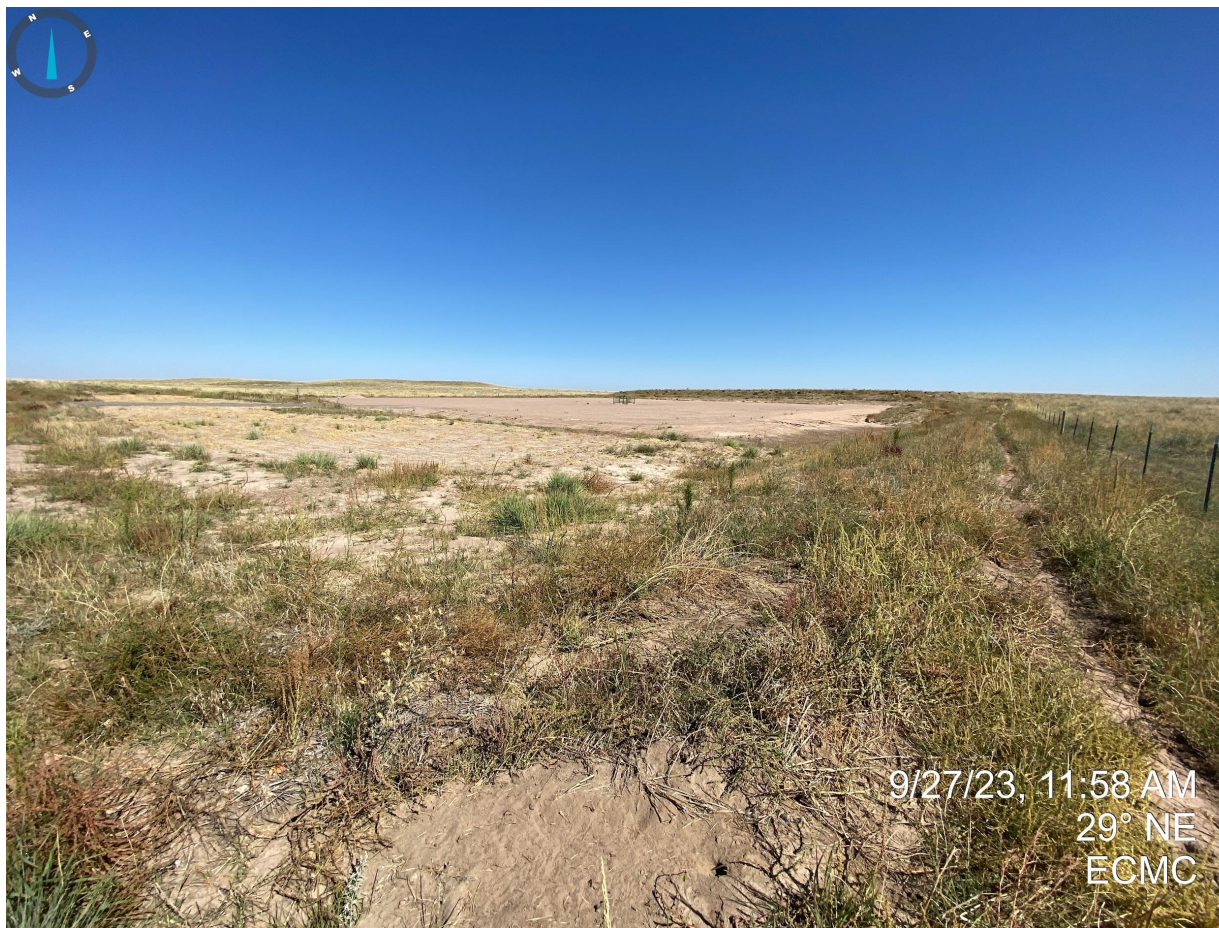
Photo 23. Taken from the southwestern corner of the location. Photo illustrates that the disturbance area is not properly stabilized against wind and water erosion (e.g. bare soils) and undesirable vegetation (e.g. kochia and russian thistle) appears to be unmanaged throughout.

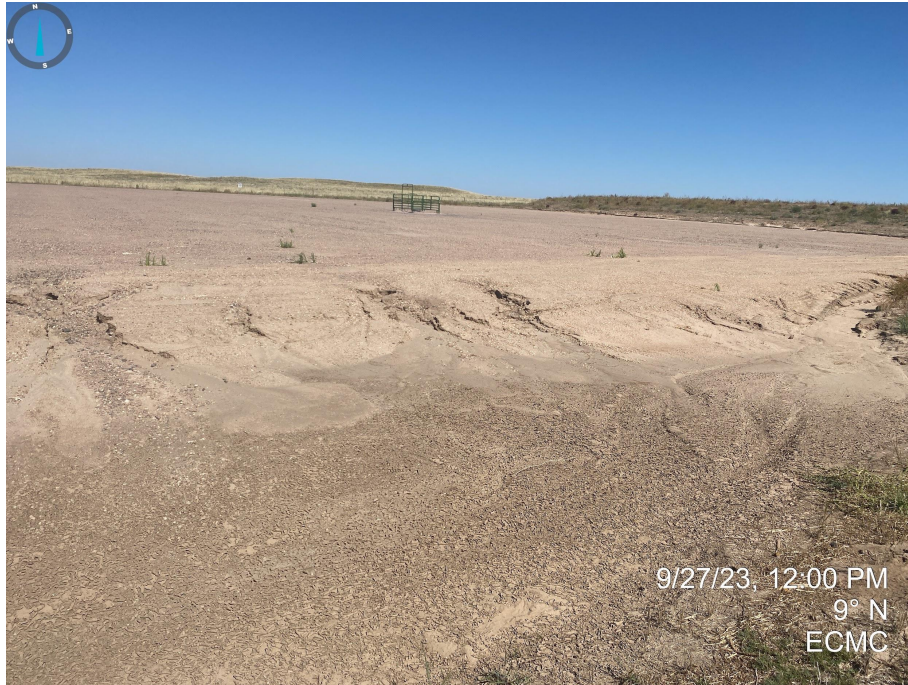
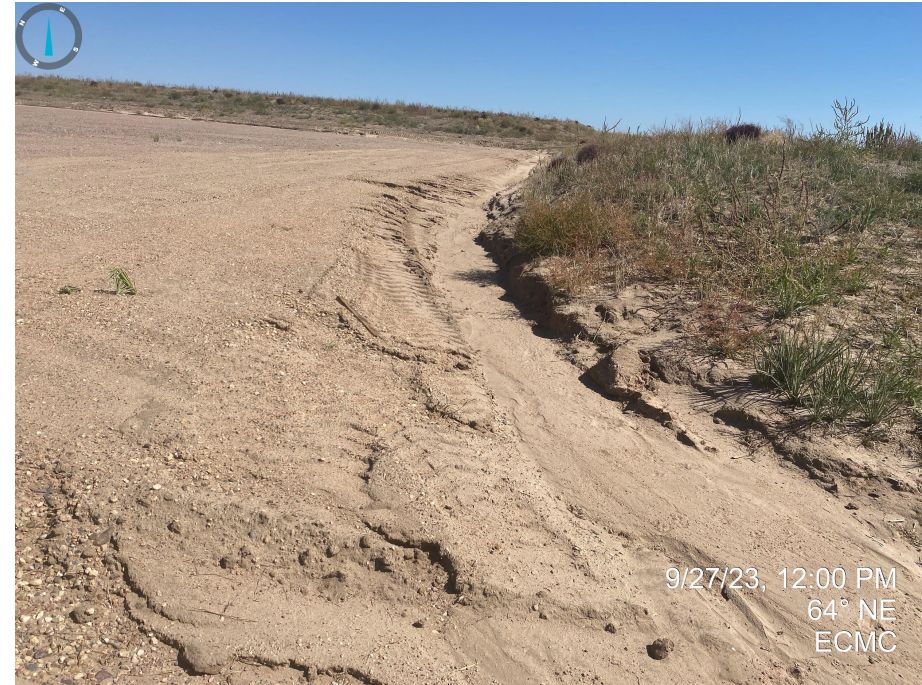
Photo 24. Taken from the southern portion of the production area. Erosion degradation observed from the unstabilized production areas.

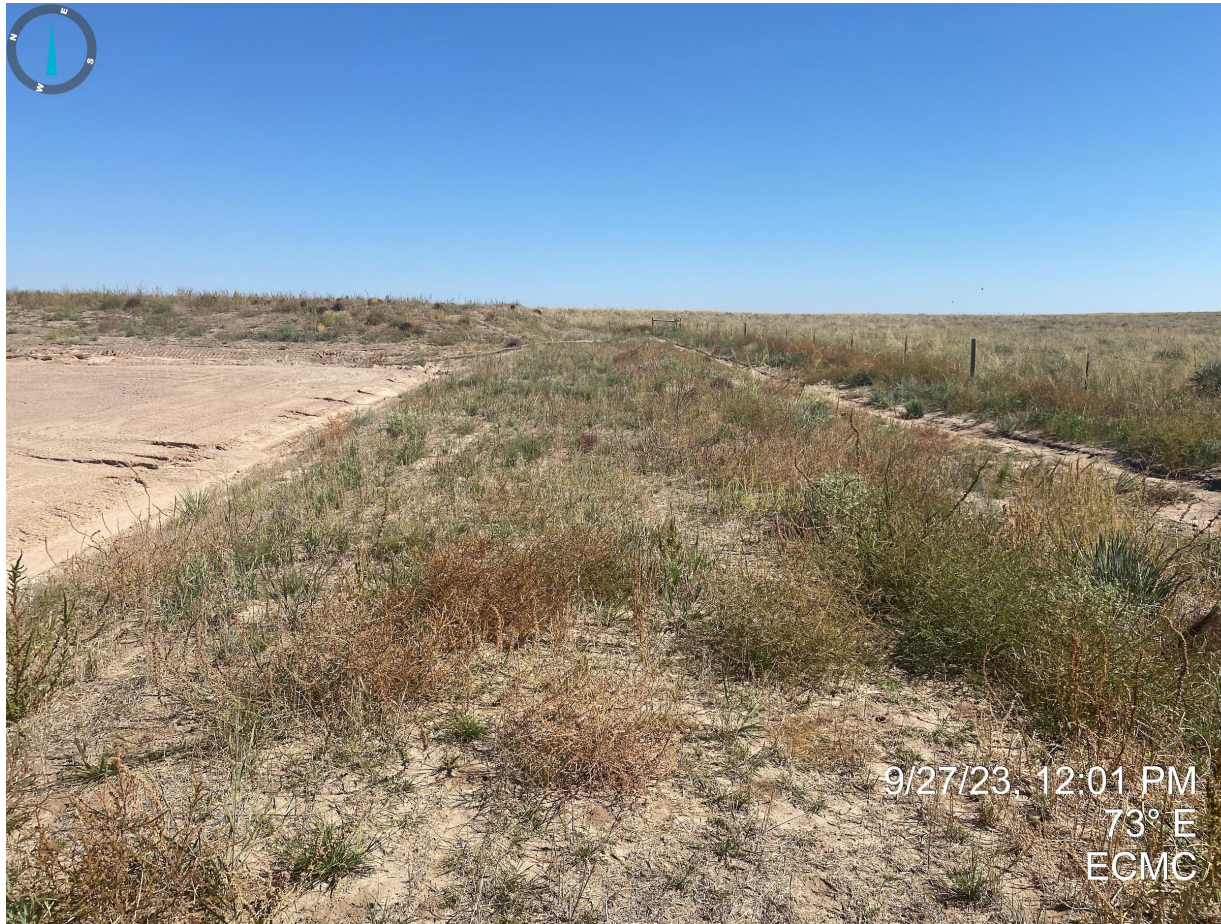
Photo 25. Taken from the southern topsoil stockpile. Non-uniform vegetative cover resulting in areas of bare/exposed soils and undesirable species (e.g. russian thistle and kochia) observed.

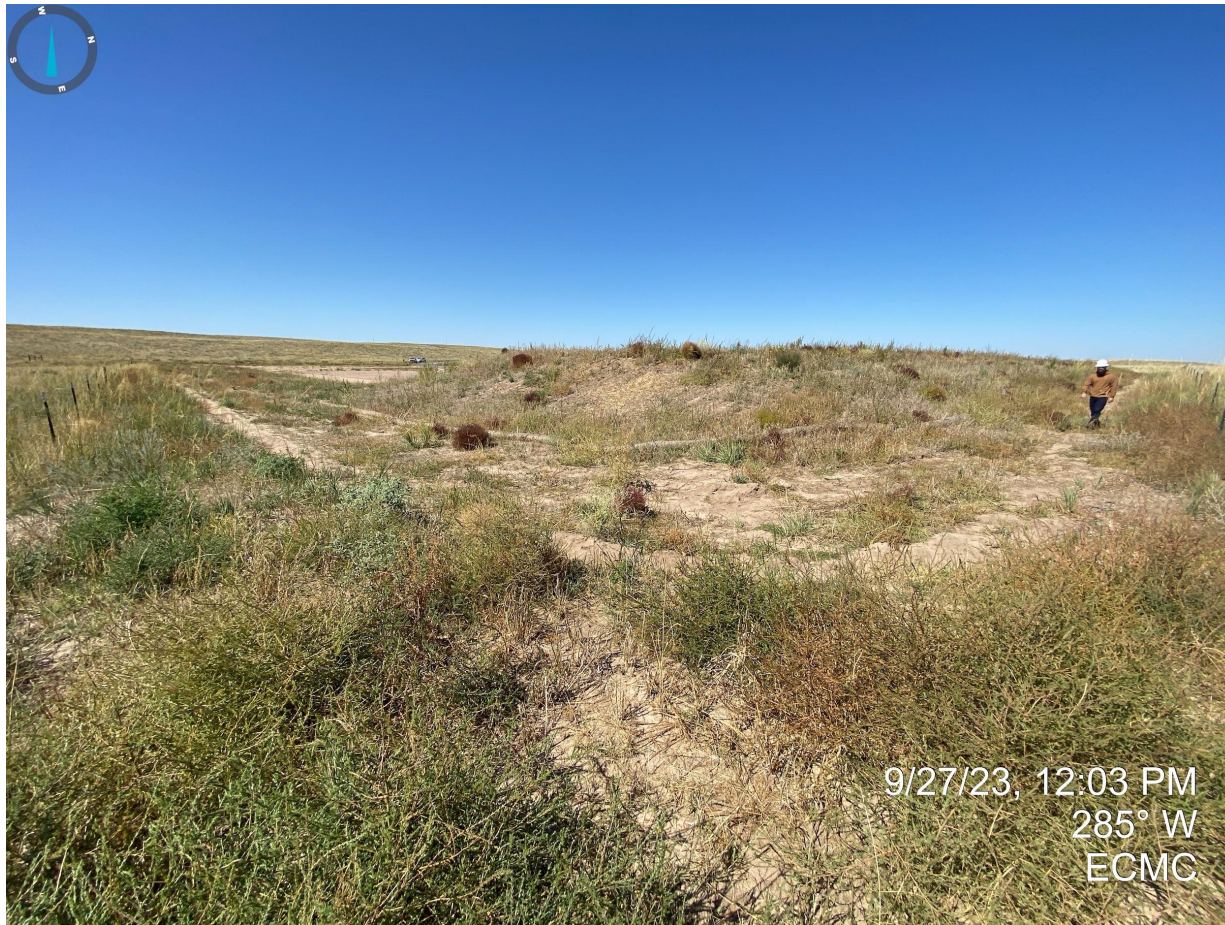
Photo 26. Taken from the southeast corner of the location. Undesirable vegetation (e.g. russian thistle and kochia) was observed throughout and does not appear to have been managed for previously.

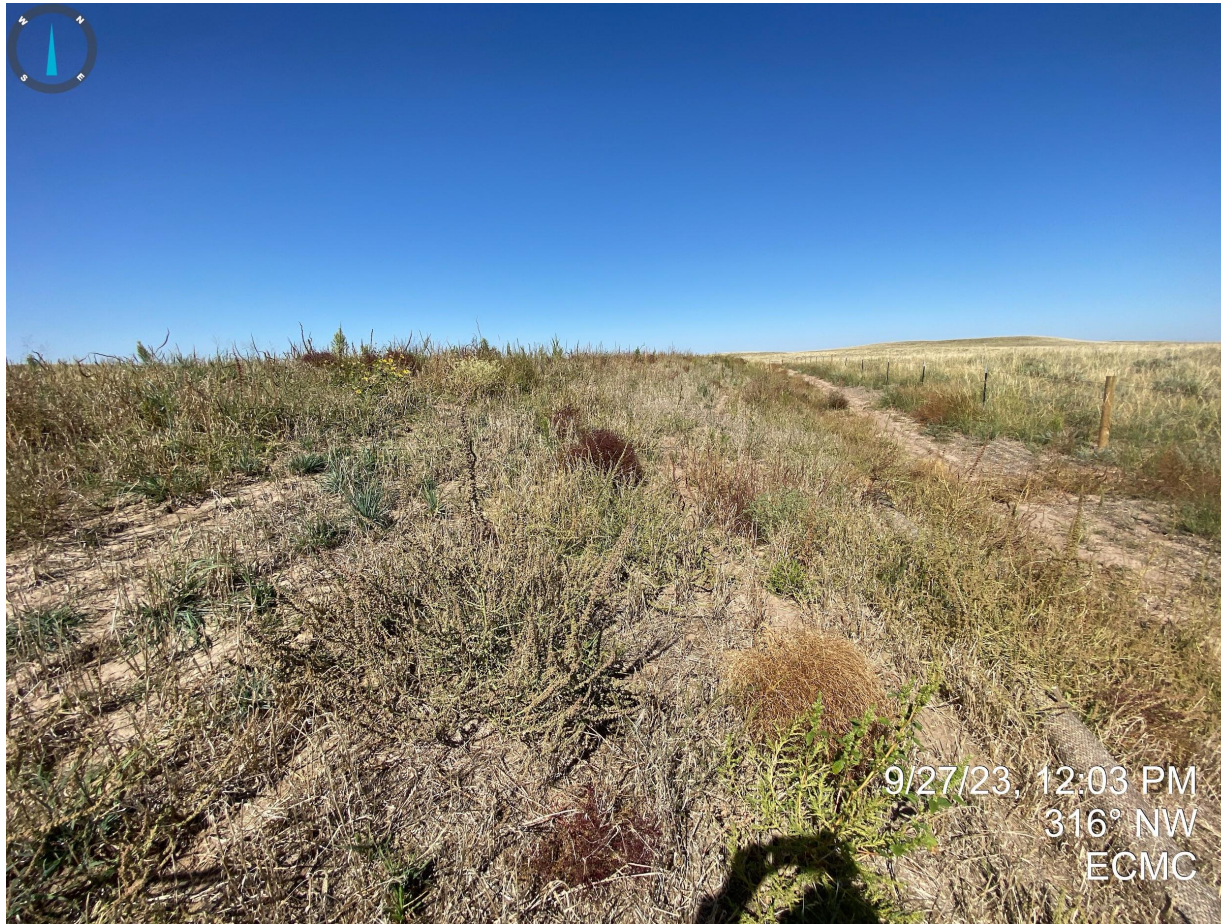
Photo 27. Taken from the southern portion of the topsoil stockpile. The stockpile pile is predominantly undesirable vegetation with very few desirable native species observed that would otherwise out compete the weedy vegetation. Additional reclamation activities are required to protect the topsoil stockpile.

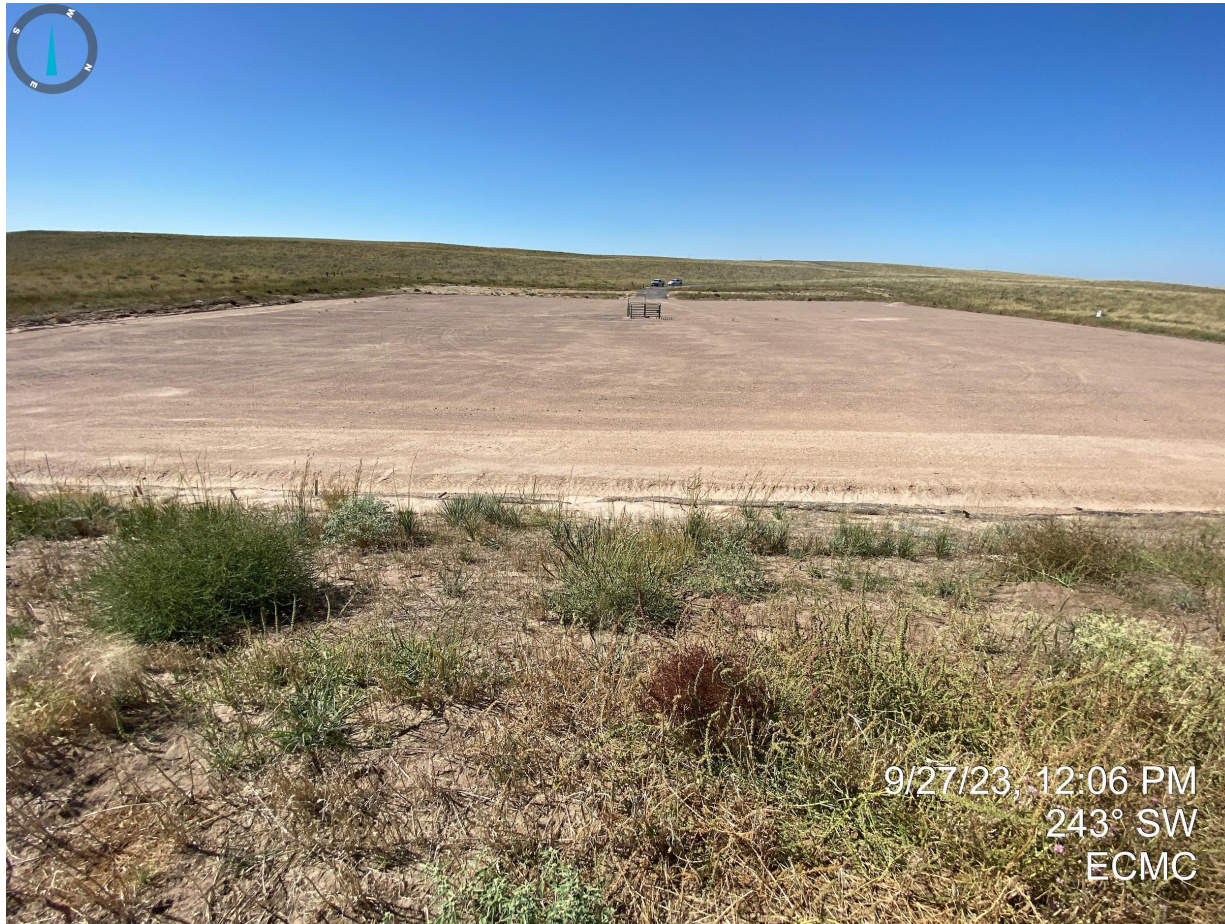
Photo 28. Middle portion of topsoil stockpile. See comments in Photo 27.

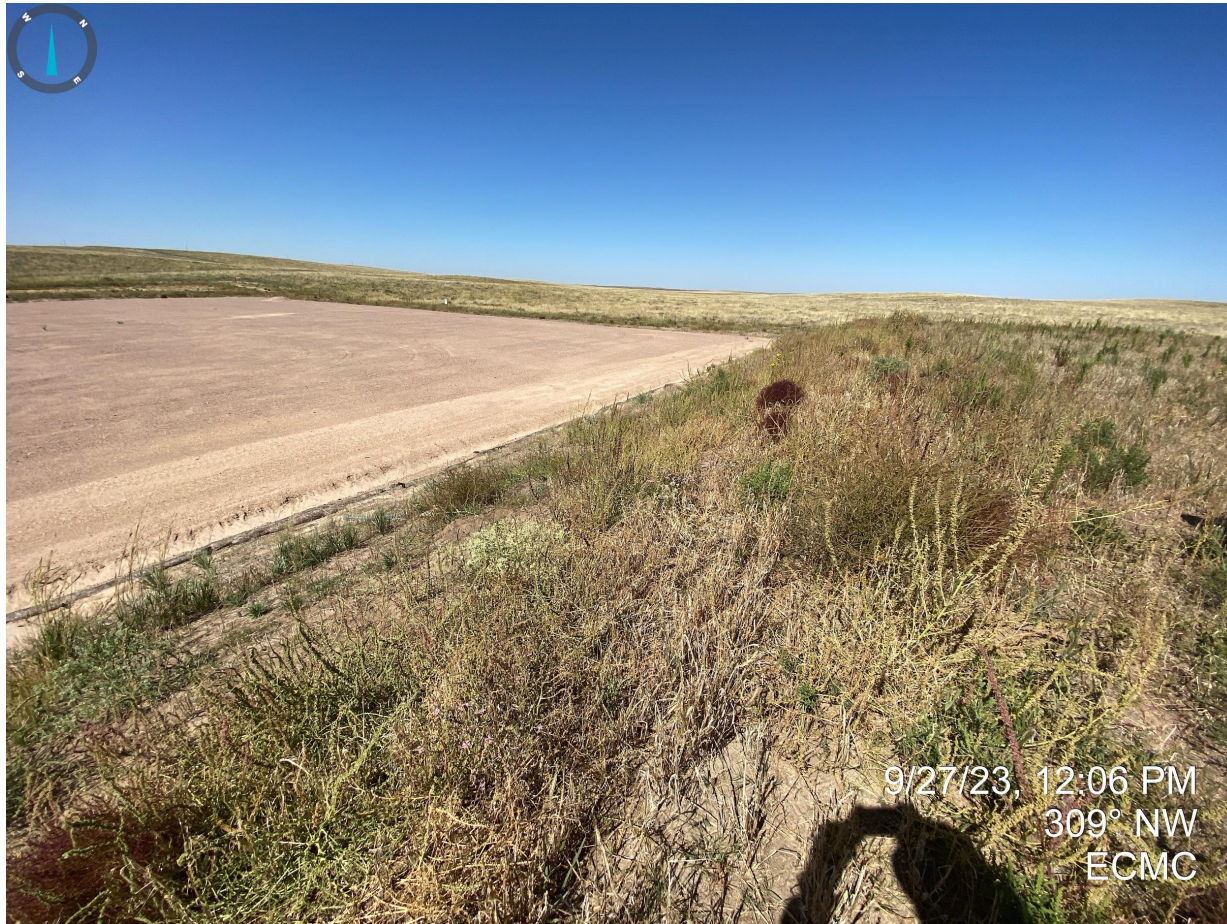
Photo 29. See comments in Photo 27.

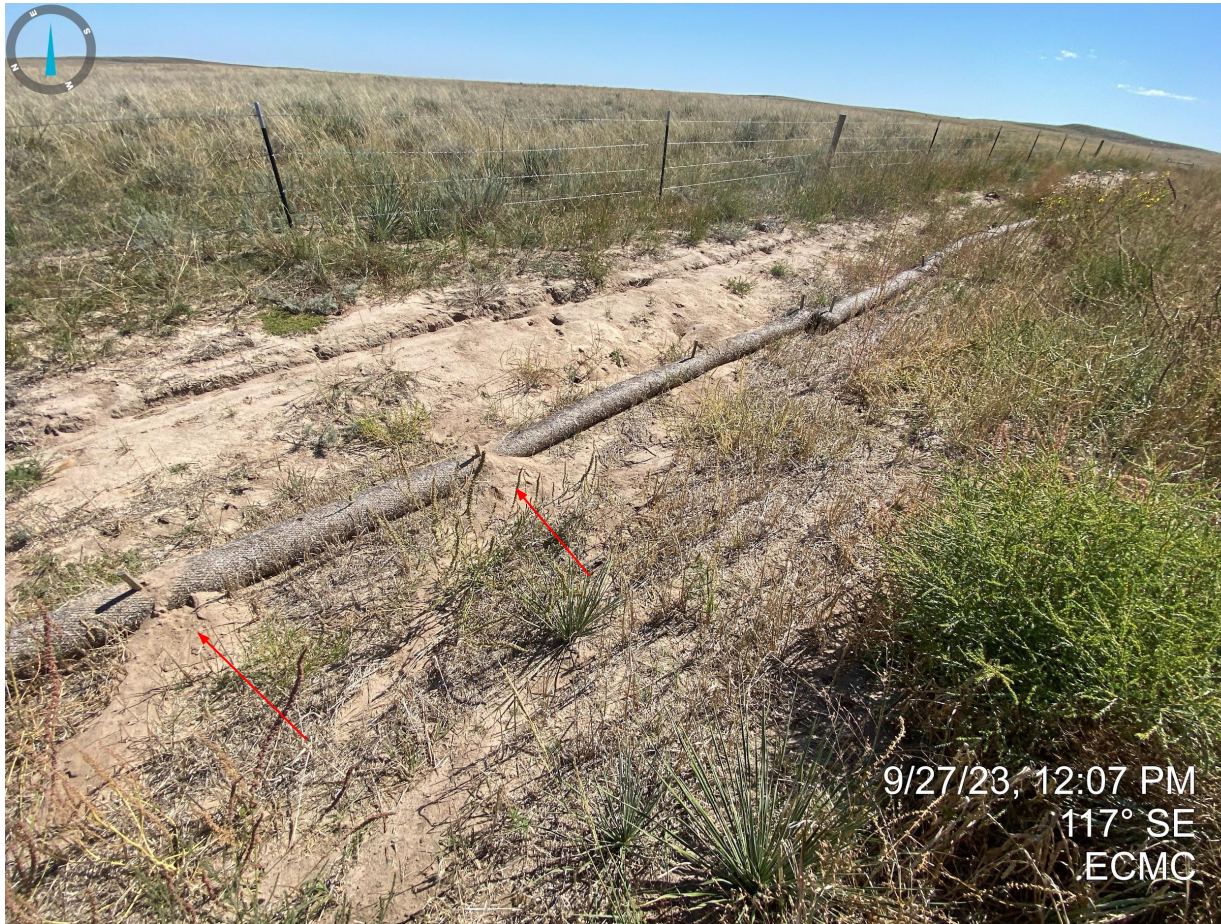
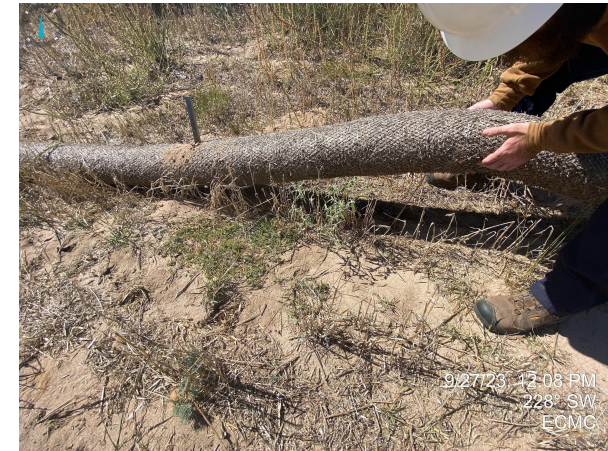
Photo 30. Taken from the eastern side of the topsoil stockpile. Stormwater control measures are not properly installed and are beginning to degrade; evidence of sedimentation around the wattles was also observed.

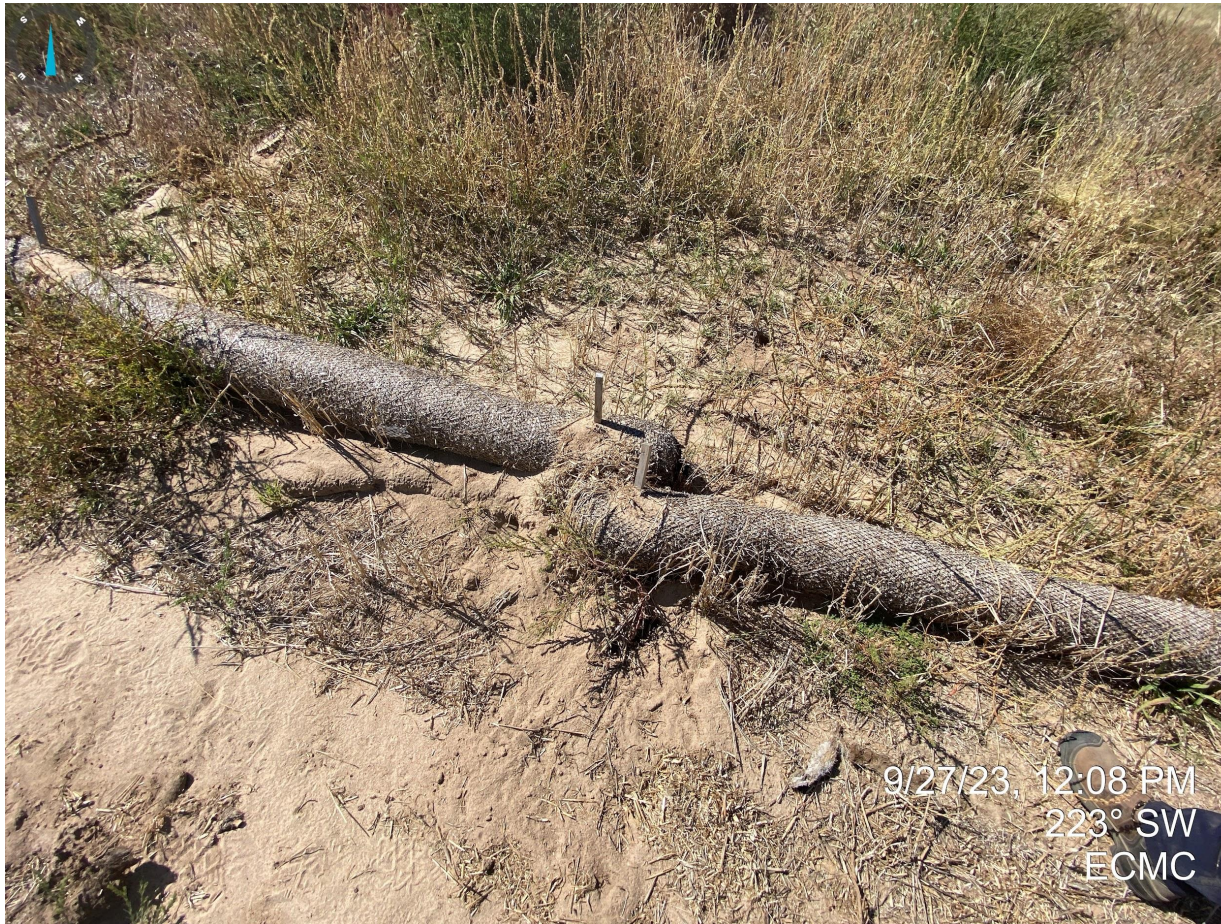
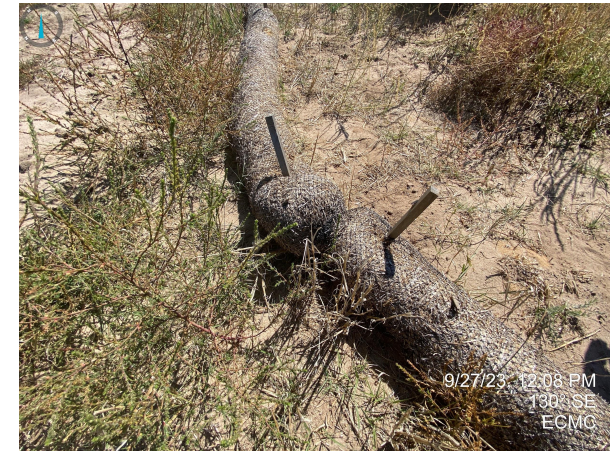
Photo 31. Continued from Photo 30.

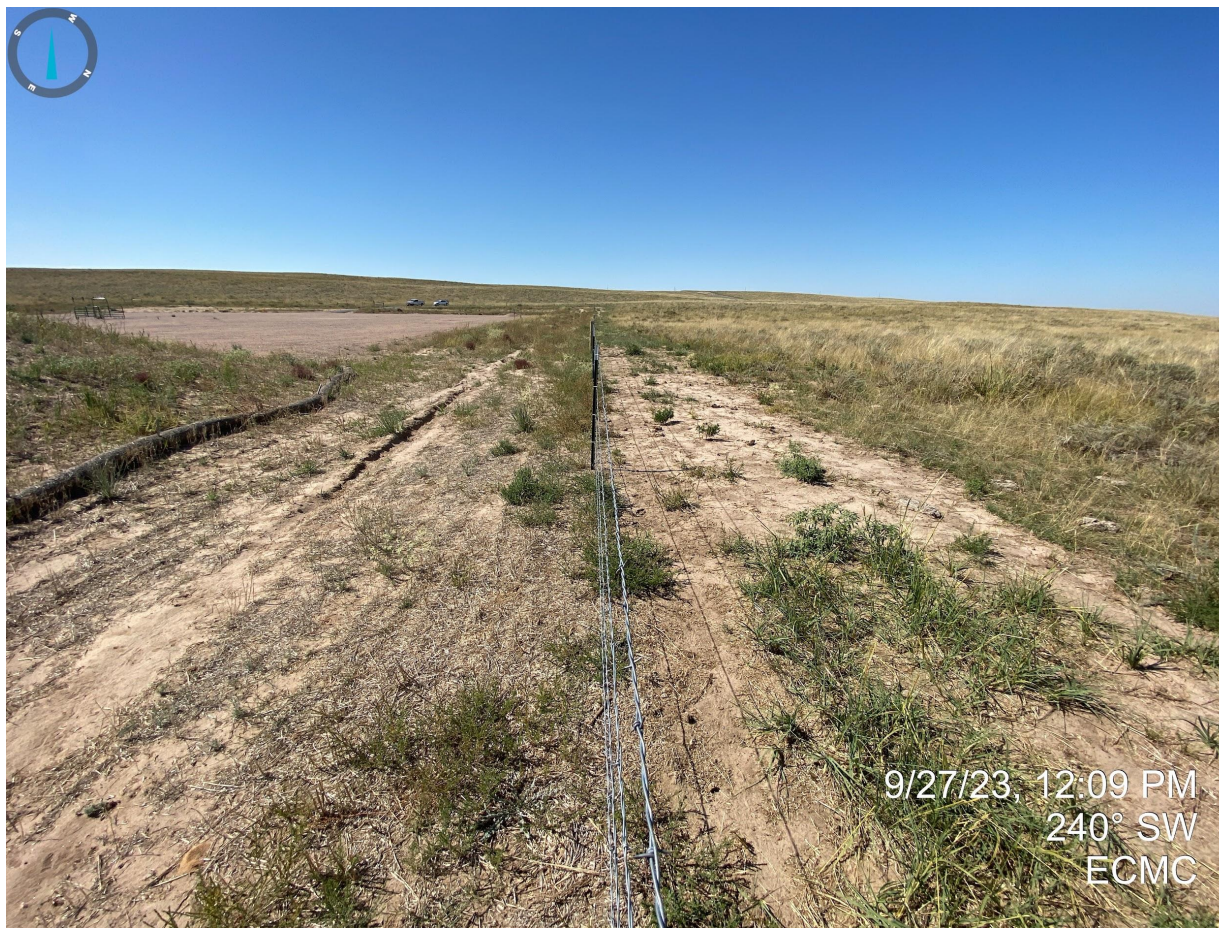
Photo 32. Taken near the northeastern corner of the location. Photo illustrates that additional disturbance was observed outside of the fenced location. Both areas are not properly stabilized against wind and water erosion and require additional reclamation/stormwater activities.

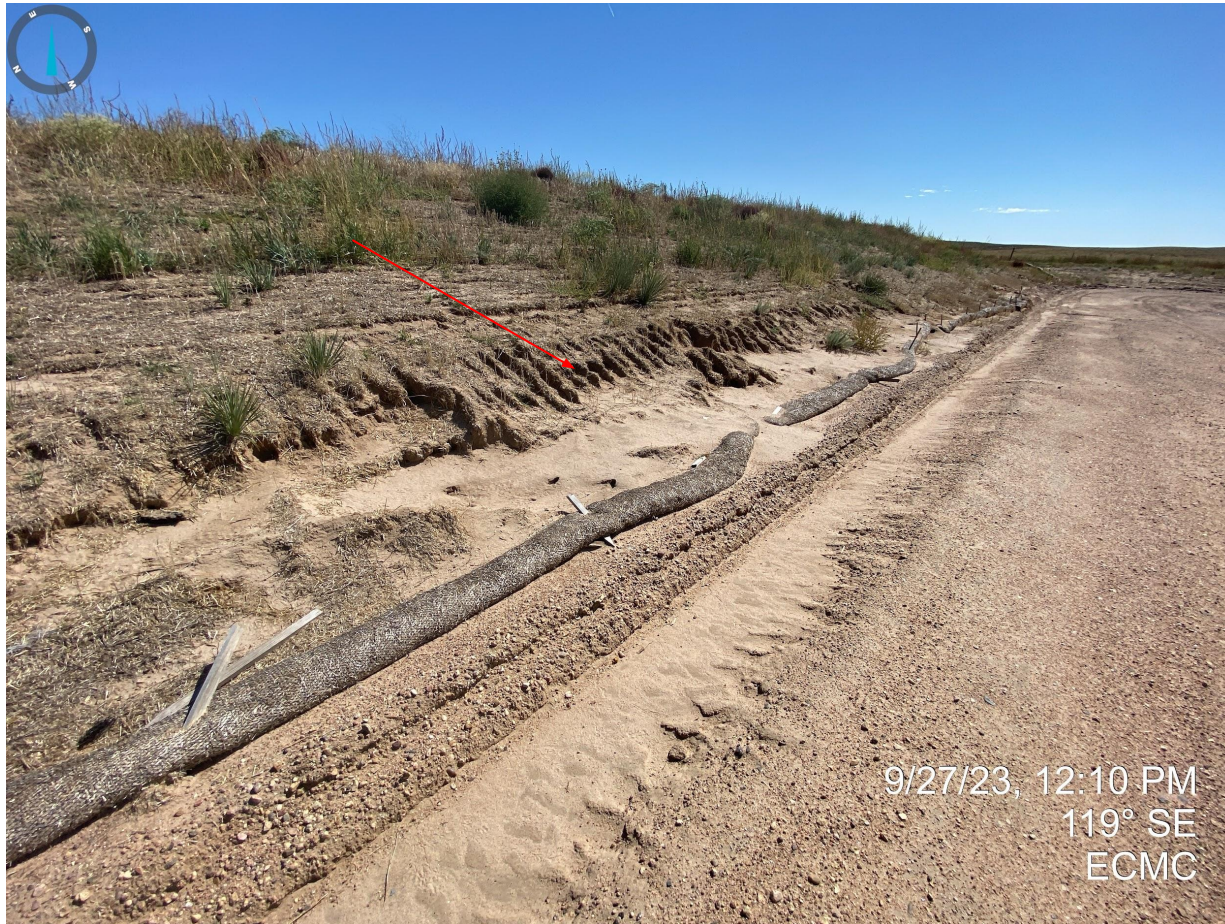
Photo 33. Taken from the western side of the topsoil stockpile. Erosion degradation and sediment transport was observed for the improperly stabilized stockpile. Stormwater control measures(straw wattles) are inadequate as they are beginning to fill with sediment, not installed correctly, and starting to degrade.

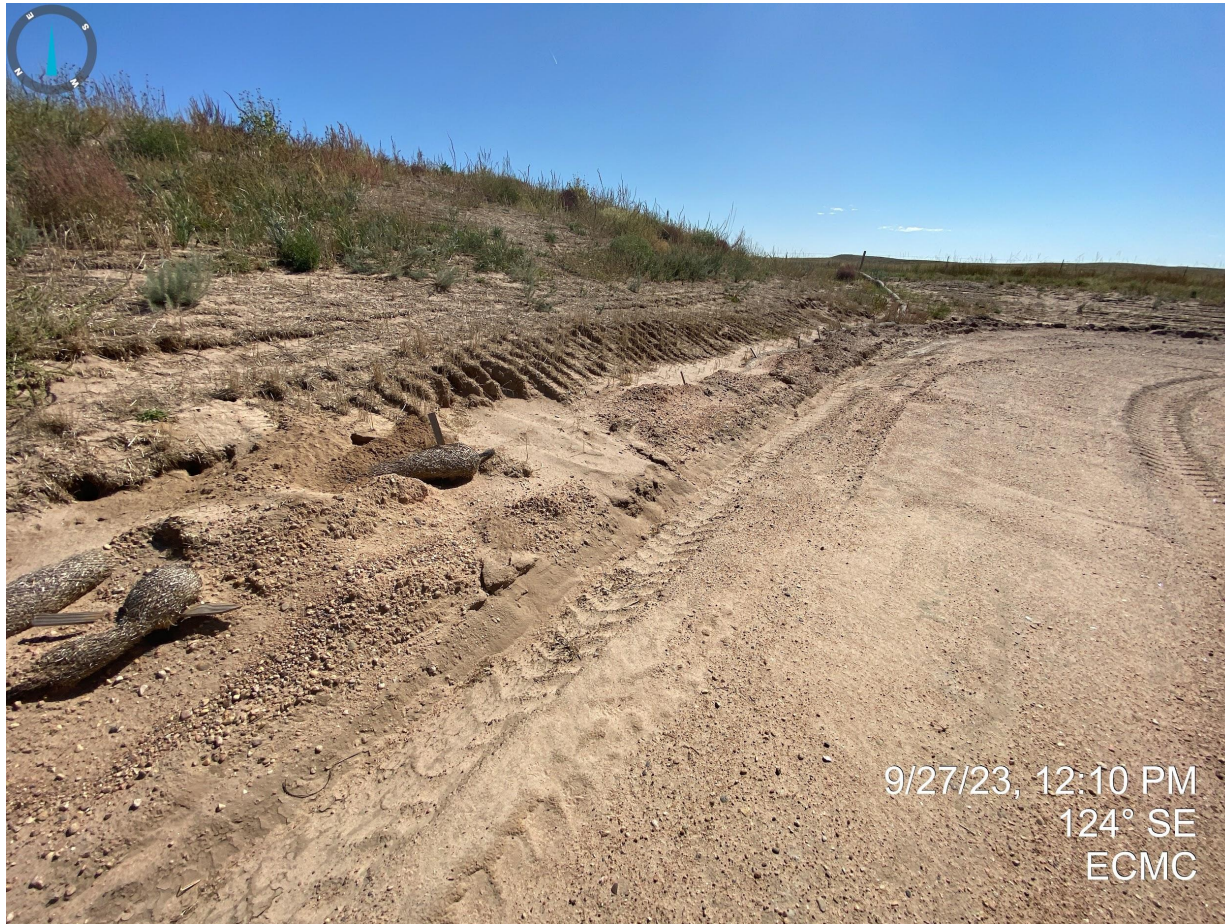
Photo 34. Continued from Photo 33.

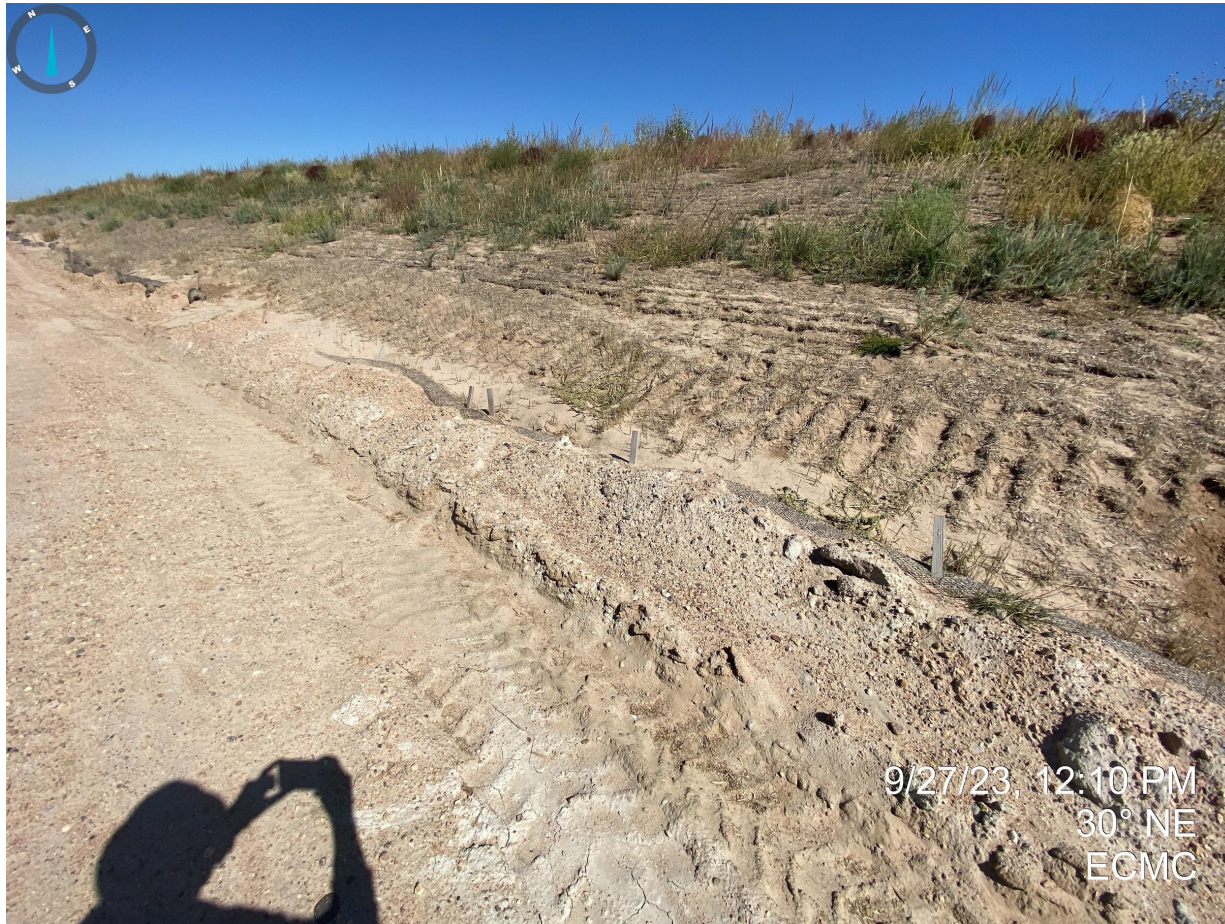
Photo 35. Continued from Photo 33.

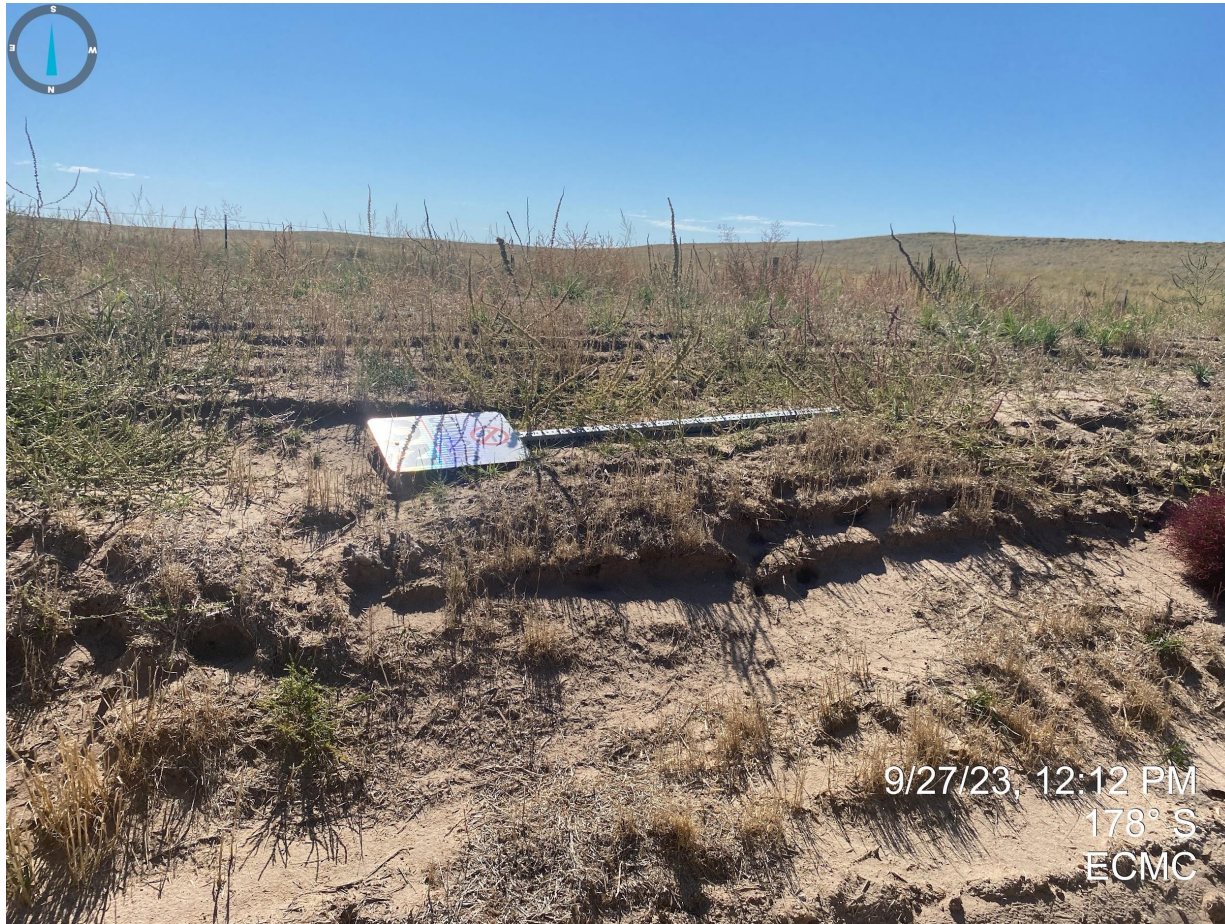
Photo 36. Erosion degradation occurring on the unstabilized topsoil stockpile; photo taken from the southern side of the location.

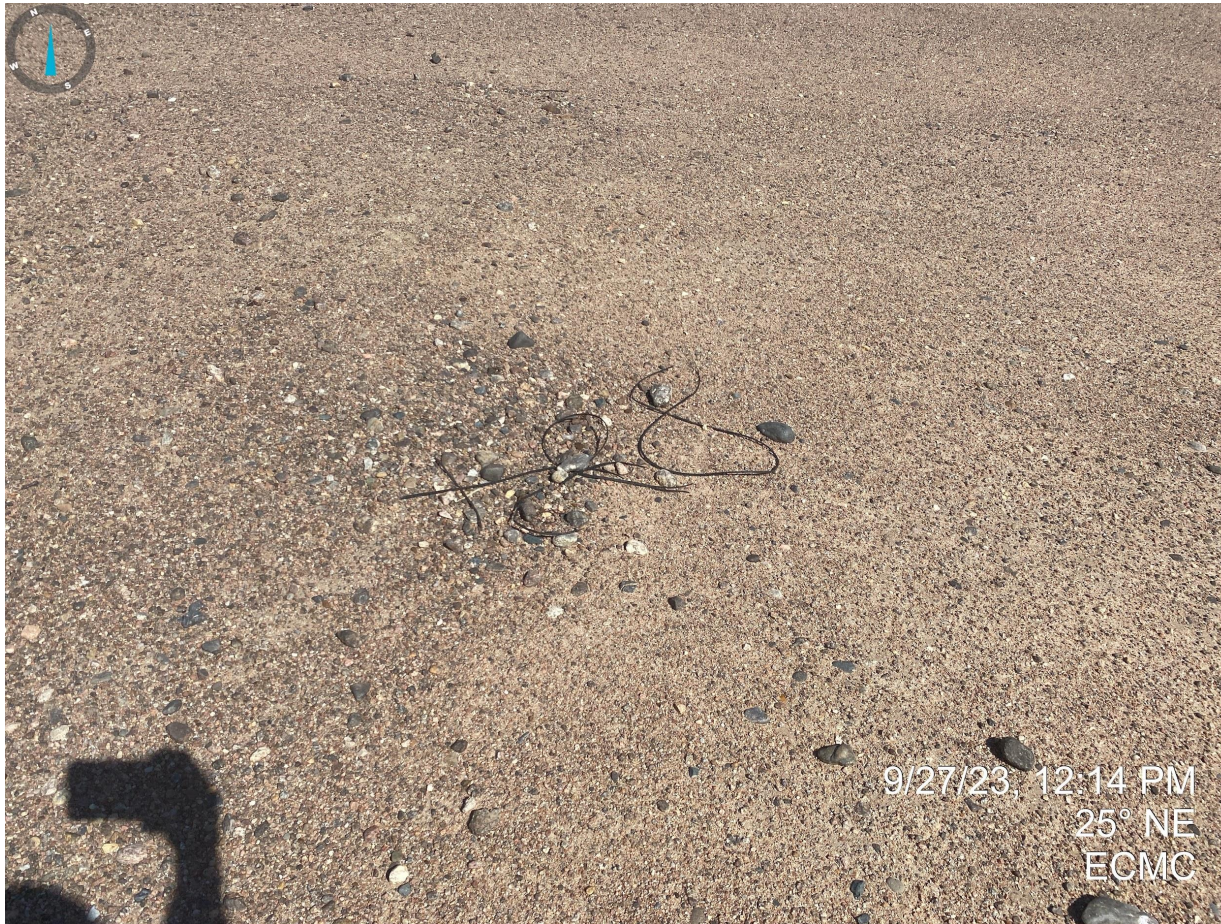
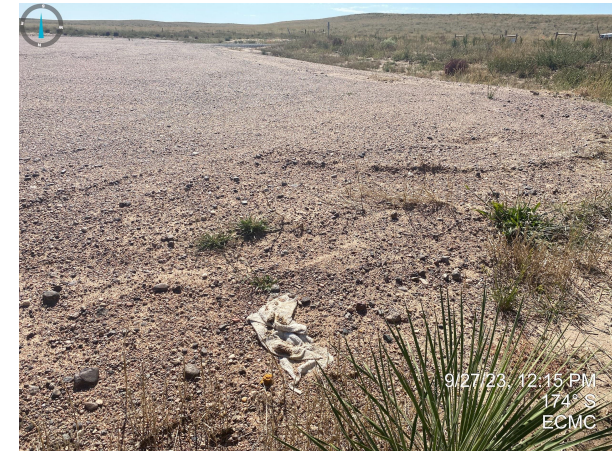
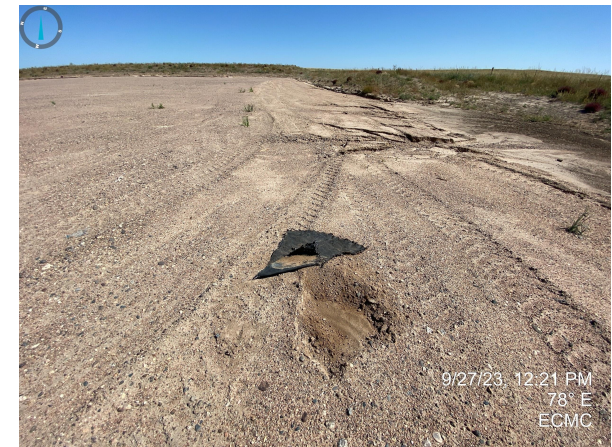
Photo 37. Trash and debris observed on the production/drilling pad.
