Construction and Stormwater Inspection

Date: 09/27/2023

Operator: DENOVA SEQUESTRATION LLC - 10790

Location ID: 483817

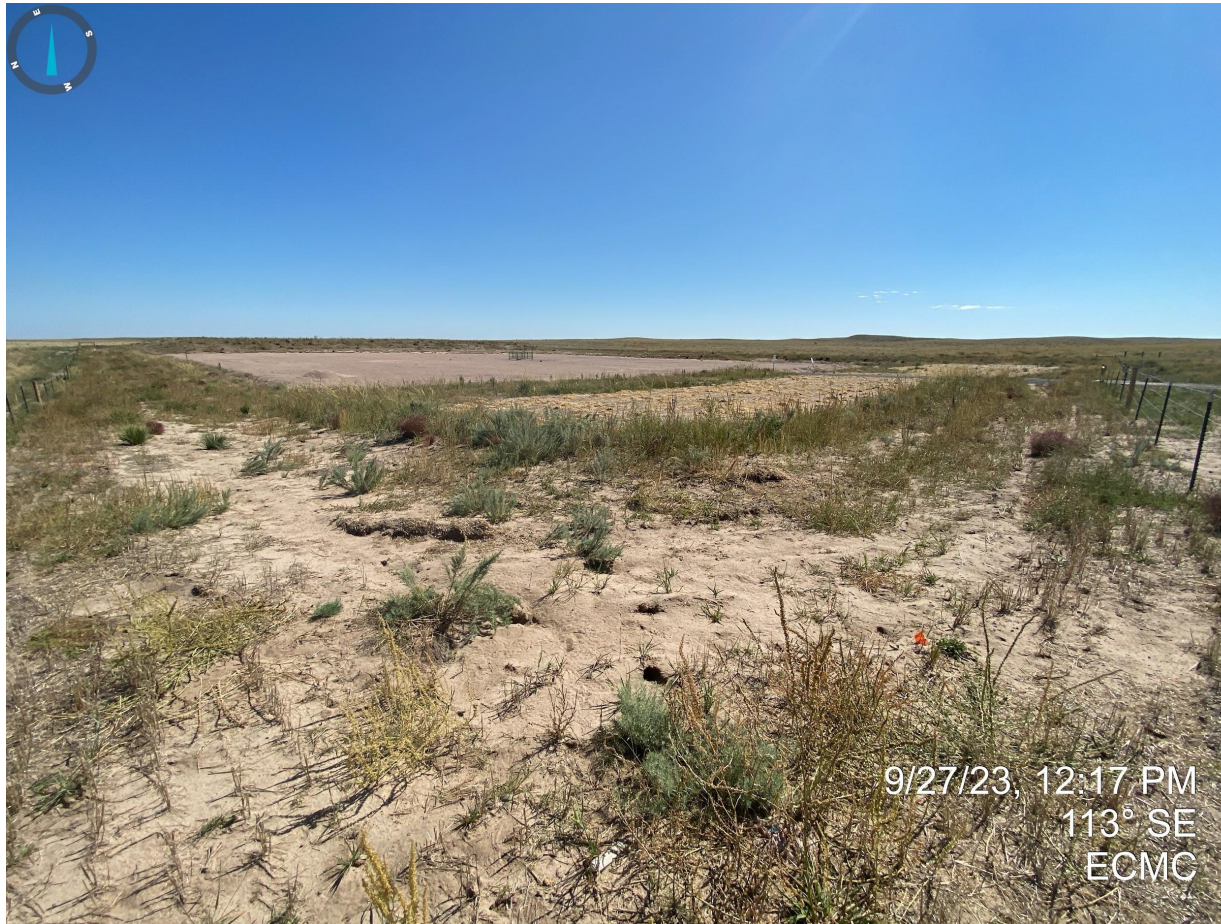
Photo 38. Taken from the northwestern corner of the location. Photo illustrates that soils are not properly stabilized and the presence of undesirable vegetation was observed. Additional reclamation activities are required to stabilize the soil from wind and water erosion degradation.
